**Report No.:** J102747  
**Nature of Work:** Demolition Survey  
**Issue Date:** 26/09/2018  
**Client Name:** WYG Engineering Ltd  
Geneva Building, Lake View Drive, Sherwood Business Park,  
Annesley, Nottingham, NG15 0ED  
**Site Address:** Kenrick Building, Former City North Campus, Birmingham City  
University, Perry Barr, B42 2US

**Order Placed By:** Reg 13(1)  
**Site Contact:** Reg 13(1)  
**Date(s) of Work:** 20/08/2018 to 23/08/2018  
**Technical Manager:** Reg 13(1) (Asbestos)  
**Assistant Surveyor(s):** Reg 13(1)

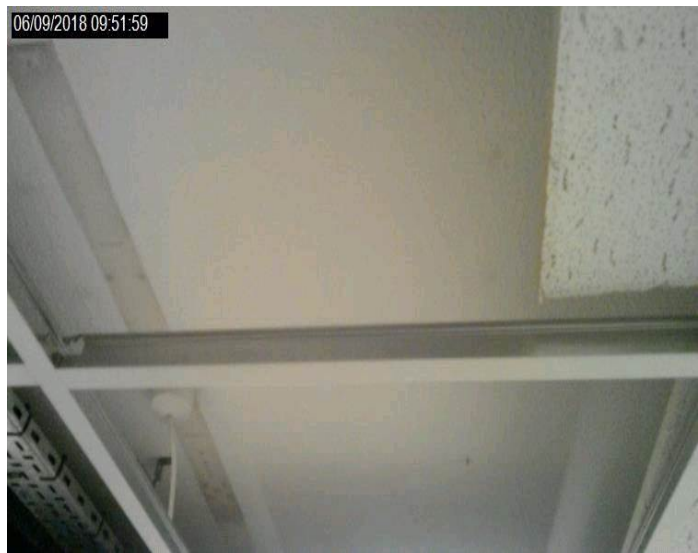
<b>Location:</b>	1.08	<b>Block:</b>	Birmingham City University	<b>Floor Level:</b> 1st Floor
<b>Sample No.:</b>	As DU002267	<b>Portal Ref No.:</b>	260

<b>Item:</b>	Textured coating to plasterboard			
<b>Asbestos Content:</b>		<b>Result Based on:</b>		
No Asbestos Detected		Strongly presumed		
<b>Sample Analysed By:</b>	Not applicable	<b>Extent:</b>	8 m <sup>2</sup>	
<b>Comments:</b> To half the ceiling only seperated by timber

<b>Material Assessment Total Score: 0</b>		<b>Likelihood of Disturbance Assessment Total Score: 0</b>		<b>Management Assessment</b>  <b>Licensable:</b> No  <b>Recommendations:</b> Not Applicable  <b>Reinspection Interval:</b> Not Applicable  <b>Overall Risk Category:</b> E0
<b>Product Type:</b>	0 Not Applicable	<b>Location:</b>	0 Not Applicable	
<b>Condition:</b>	0 Not Applicable	<b>Accessibility:</b>	0 Not Applicable	
<b>Surface Treatment:</b>	0 Not Applicable			
<b>Asbestos Type:</b>	0 Not Applicable	<b>Extent Score:</b>	0 Not Applicable

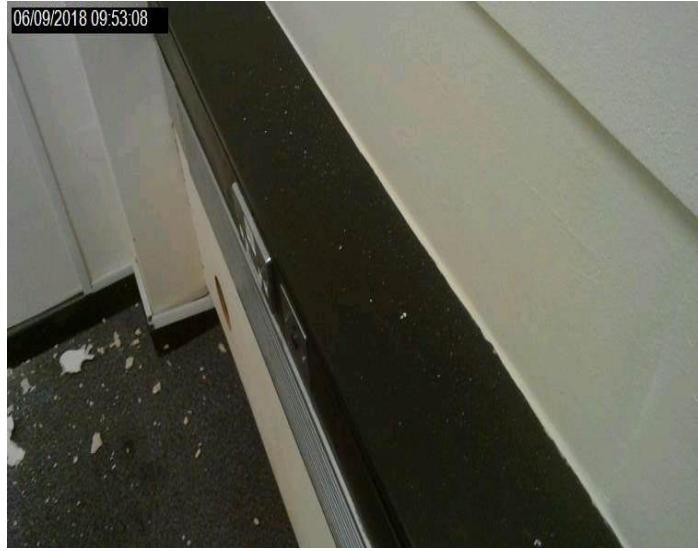
<b>Location:</b>	1.08	<b>Block:</b>	Birmingham City University	<b>Floor Level:</b> 1st Floor
<b>Sample No.:</b>	As DU002269	<b>Portal Ref No.:</b>	262

<b>Item:</b>	Asbestos Cement window sill			
<b>Asbestos Content:</b>	<b>Result Based on:</b>			
Chrysotile	Strongly presumed			
<b>Sample Analysed By:</b>	Not applicable	<b>Extent:</b>	2 linear metres	
<b>Comments:</b>

<b>Material Assessment Total Score: 4</b>		<b>Likelihood of Disturbance Assessment Total Score: 4</b>		<b>Management Assessment</b>  <b>Licensable:</b> No  <b>Recommendations:</b> Program removal  <b>Reinspection Interval:</b> Not Applicable  <b>Overall Risk Category:</b> C8
<b>Product Type:</b>	1 (Asbestos cement)	<b>Location:</b>	2 (Rooms up to 100 sq m)	
<b>Condition:</b>	1 (Minor scratches)	<b>Accessibility:</b>	1 (Occasionally likely to be disturbed)	
<b>Surface Treatment:</b>	1 (Unencapsulated asbestos cement)			
<b>Asbestos Type:</b>	1 (Chrysotile)	<b>Extent Score:</b>	1 (<10 sq m or 10m pipe run)

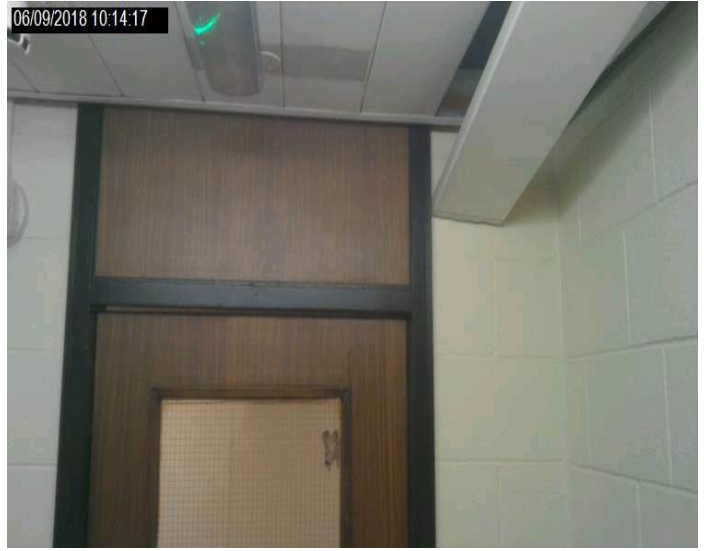
<b>Location:</b>	1.99A	<b>Block:</b>	Birmingham City University	<b>Floor Level:</b> 1st Floor
<b>Sample No.:</b>	DU002273	<b>Portal Ref No.:</b>	266

<b>Item:</b>	Insulating board door header panels			
<b>Asbestos Content:</b>		<b>Result Based on:</b>		
No Asbestos Detected		Analysis of sample using PLM		
<b>Sample Analysed By:</b>	Reg 13(1)	<b>Extent:</b>	10 m <sup>2</sup>	
<b>Comments:</b> To all doors within this area

<b>Material Assessment Total Score: 0</b>		<b>Likelihood of Disturbance Assessment Total Score: 0</b>		<b>Management Assessment</b>  <b>Licensable:</b> Yes  <b>Recommendations:</b> Not Applicable  <b>Reinspection Interval:</b> Not Applicable  <b>Overall Risk Category:</b> E0
<b>Product Type:</b>	0 Not Applicable	<b>Location:</b>	0 Not Applicable	
<b>Condition:</b>	0 Not Applicable	<b>Accessibility:</b>	0 Not Applicable	
<b>Surface Treatment:</b>	0 Not Applicable			
<b>Asbestos Type:</b>	0 Not Applicable	<b>Extent Score:</b>	0 Not Applicable

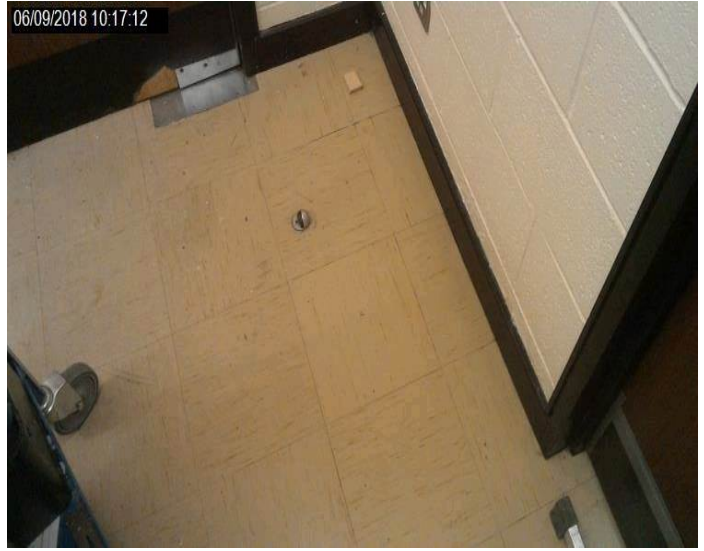
<b>Location:</b>	1.99A	<b>Block:</b>	Birmingham City University	<b>Floor Level:</b> 1st Floor
<b>Sample No.:</b>	As DU002272	<b>Portal Ref No.:</b>	267

<b>Item:</b>	Asbestos Thermoplastic floor tiles			
<b>Asbestos Content:</b>	<b>Result Based on:</b>			
Chrysotile in adhesive only	Strongly presumed			
<b>Sample Analysed By:</b>	Not applicable	<b>Extent:</b>	10 m <sup>2</sup>	
<b>Comments:</b>

<b>Material Assessment Total Score: 3</b>		<b>Likelihood of Disturbance Assessment Total Score: 7</b>		<b>Management Assessment</b>  <b>Licensable:</b> No  <b>Recommendations:</b> Program removal  <b>Reinspection Interval:</b> Not Applicable  <b>Overall Risk Category:</b> C10
<b>Product Type:</b>	1 (Asbestos thermoplastic)	<b>Location:</b>	2 (Rooms up to 100 sq m)	
<b>Condition:</b>	1 (Minor scratches)	<b>Accessibility:</b>	3 (Routinely disturbed)	
<b>Surface Treatment:</b>	0 (Composite material)			
<b>Asbestos Type:</b>	1 (Chrysotile)	<b>Extent Score:</b>	2 (>10 - <50 sq m or >10m - <50m pipe run)

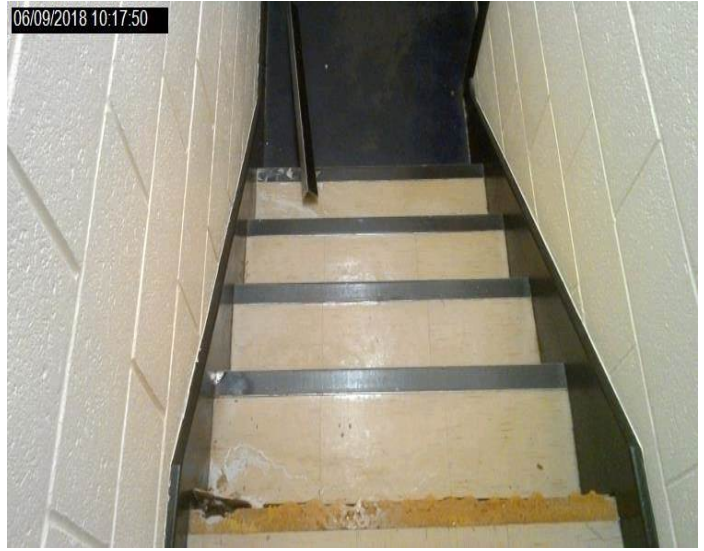
<b>Location:</b>	1.99A	<b>Block:</b>	Birmingham City University	<b>Floor Level:</b> 1st Floor
<b>Sample No.:</b>	DU002274	<b>Portal Ref No.:</b>	268

<b>Item:</b>	Reinforced plastic stair nosing			
<b>Asbestos Content:</b>		<b>Result Based on:</b>		
No Asbestos Detected		Analysis of sample using PLM		
<b>Sample Analysed By:</b>	Reg 13(1)	<b>Extent:</b>	5 linear metres	
<b>Comments:</b>

<b>Material Assessment Total Score: 0</b>		<b>Likelihood of Disturbance Assessment Total Score: 0</b>		<b>Management Assessment</b>  <b>Licensable:</b> No  <b>Recommendations:</b> Not Applicable  <b>Reinspection Interval:</b> Not Applicable  <b>Overall Risk Category:</b> E0
<b>Product Type:</b>	0 Not Applicable	<b>Location:</b>	0 Not Applicable	
<b>Condition:</b>	0 Not Applicable	<b>Accessibility:</b>	0 Not Applicable	
<b>Surface Treatment:</b>	0 Not Applicable			
<b>Asbestos Type:</b>	0 Not Applicable	<b>Extent Score:</b>	0 Not Applicable

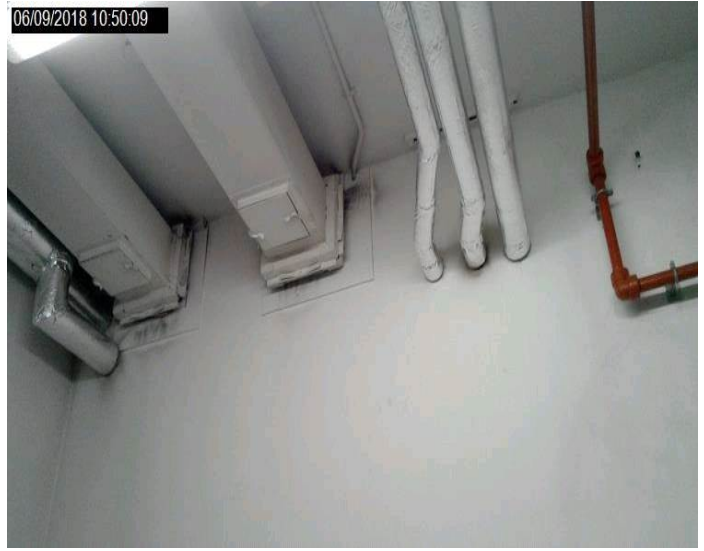
<b>Location:</b>	1.13	<b>Block:</b>	Birmingham City University	<b>Floor Level:</b> 1st Floor
<b>Sample No.:</b>	DU002277	<b>Portal Ref No.:</b>	272

<b>Item:</b>	Insulating board panels			
<b>Asbestos Content:</b>		<b>Result Based on:</b>		
No Asbestos Detected		Analysis of sample using PLM		
<b>Sample Analysed By:</b>	Reg 13(1)	<b>Extent:</b>	3 m <sup>2</sup>	
<b>Comments:</b> 3 x areas where ducting passes through the walls

<b>Material Assessment Total Score:</b> 0		<b>Likelihood of Disturbance Assessment Total Score:</b> 0		<b>Management Assessment</b>  <b>Licensable:</b> Yes  <b>Recommendations:</b> Not Applicable  <b>Reinspection Interval:</b> Not Applicable  <b>Overall Risk Category:</b> E0
<b>Product Type:</b>	0 Not Applicable	<b>Location:</b>	0 Not Applicable	
<b>Condition:</b>	0 Not Applicable	<b>Accessibility:</b>	0 Not Applicable	
<b>Surface Treatment:</b>	0 Not Applicable			
<b>Asbestos Type:</b>	0 Not Applicable	<b>Extent Score:</b>	0 Not Applicable

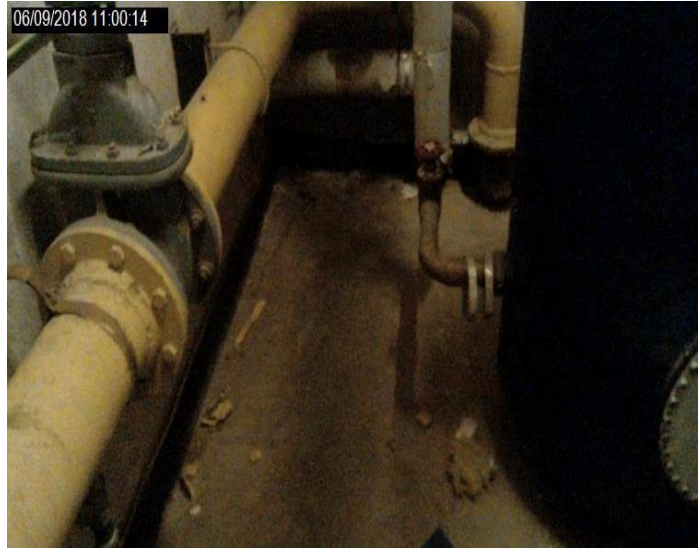
<b>Location:</b>	1.14	<b>Block:</b>	Birmingham City University	<b>Floor Level:</b> 1st Floor
<b>Sample No.:</b>	DU002278	<b>Portal Ref No.:</b>	273

<b>Item:</b>	Asbestos Compressed fibre gasket			
<b>Asbestos Content:</b>	Result Based on:			
Chrysotile	Analysis of sample using PLM			
<b>Sample Analysed By:</b> Reg 13(1)	<b>Extent:</b>	3 units		
<b>Comments:</b> To yellow gas pipework

<b>Material Assessment Total Score: 5</b>		<b>Likelihood of Disturbance Assessment Total Score: 4</b>		<b>Management Assessment</b>  <b>Licensable:</b> No  <b>Recommendations:</b> Program removal  <b>Reinspection Interval:</b> Not Applicable  <b>Overall Risk Category:</b> C9
<b>Product Type:</b>	2 (Compressed asbestos fibre)	<b>Location:</b>	2 (Rooms up to 100 sq m)	
<b>Condition:</b>	1 (Minor scratches)	<b>Accessibility:</b>	1 (Occasionally likely to be disturbed)	
<b>Surface Treatment:</b>	1 (Enclosed textile/paper)			
<b>Asbestos Type:</b>	1 (Chrysotile)	<b>Extent Score:</b>	1 (<10 sq m or 10m pipe run)

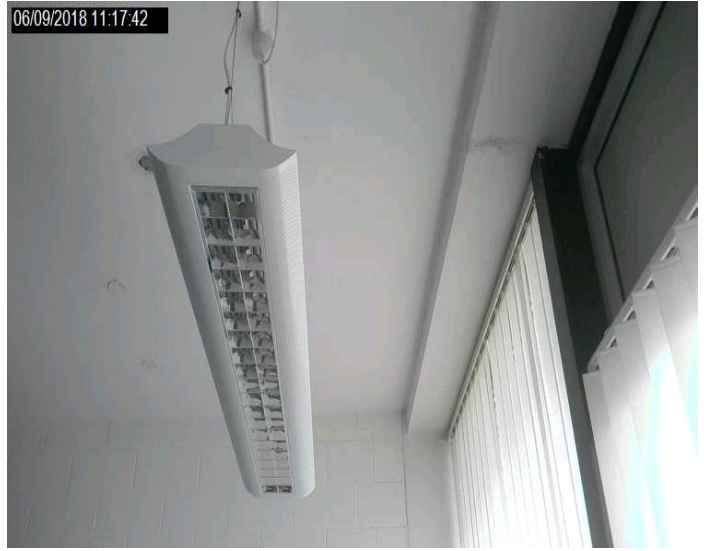
<b>Location:</b>	1.21	<b>Block:</b>	Birmingham City University	<b>Floor Level:</b> 1st Floor
<b>Sample No.:</b>	DU002280	<b>Portal Ref No.:</b>	275

<b>Item:</b>	Textured coating to plasterboard			
<b>Asbestos Content:</b>	<b>Result Based on:</b>			
No Asbestos Detected	Analysis of sample using PLM			
<b>Sample Analysed By:</b>	Reg 13(1)	<b>Extent:</b>	20 m <sup>2</sup>	
<b>Comments:</b>

<b>Material Assessment Total Score: 0</b>		<b>Likelihood of Disturbance Assessment Total Score: 0</b>		<b>Management Assessment</b>  <b>Licensable:</b> No  <b>Recommendations:</b> Not Applicable  <b>Reinspection Interval:</b> Not Applicable  <b>Overall Risk Category:</b> E0
<b>Product Type:</b>	0 Not Applicable	<b>Location:</b>	0 Not Applicable	
<b>Condition:</b>	0 Not Applicable	<b>Accessibility:</b>	0 Not Applicable	
<b>Surface Treatment:</b>	0 Not Applicable			
<b>Asbestos Type:</b>	0 Not Applicable	<b>Extent Score:</b>	0 Not Applicable

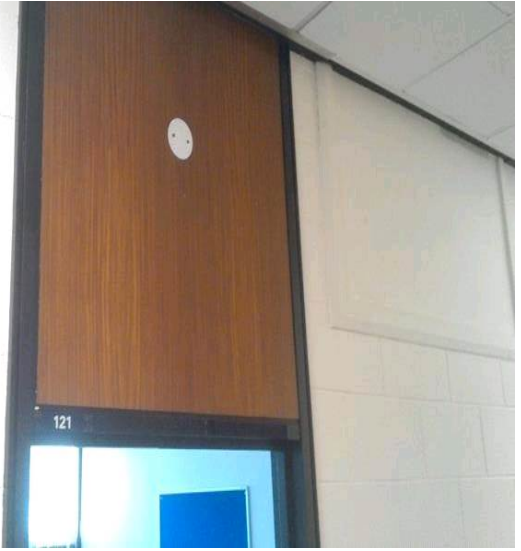
<b>Location:</b>	1.99C	<b>Block:</b>	Birmingham City University		<b>Floor Level:</b> 1st Floor
<b>Sample No.:</b>	DU002282	<b>Portal Ref No.:</b>	277	06/09/2018 11:26:37

<b>Item:</b>	Insulating board door header panels				
<b>Asbestos Content:</b>		<b>Result Based on:</b>			
No Asbestos Detected		Analysis of sample using PLM			
<b>Sample Analysed By:</b>	Reg 13(1)	<b>Extent:</b>	10 m <sup>2</sup>		
<b>Comments:</b> To all doors within this area, where timber panels are present

<b>Material Assessment Total Score: 0</b>		<b>Likelihood of Disturbance Assessment Total Score: 0</b>		<b>Management Assessment</b>  <b>Licensable:</b> Yes  <b>Recommendations:</b> Not Applicable  <b>Reinspection Interval:</b> Not Applicable  <b>Overall Risk Category:</b> E0
<b>Product Type:</b>	0 Not Applicable	<b>Location:</b>	0 Not Applicable	
<b>Condition:</b>	0 Not Applicable	<b>Accessibility:</b>	0 Not Applicable	
<b>Surface Treatment:</b>	0 Not Applicable			
<b>Asbestos Type:</b>	0 Not Applicable	<b>Extent Score:</b>	0 Not Applicable

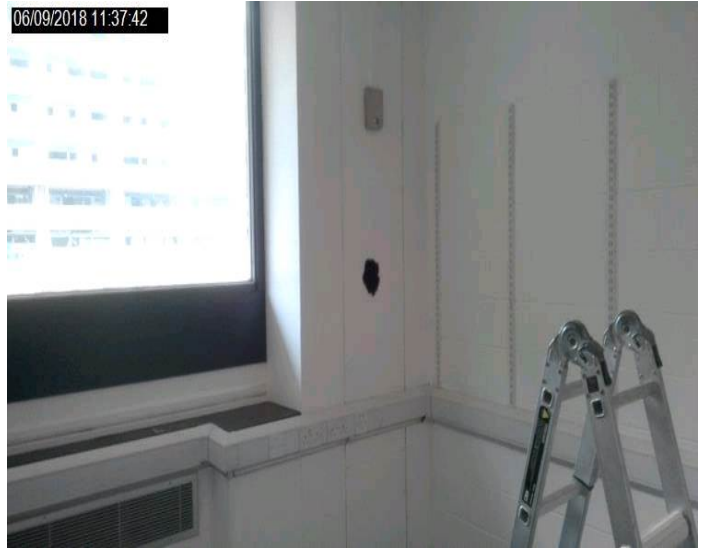
<b>Location:</b>	1.20	<b>Block:</b>	Birmingham City University		<b>Floor Level:</b> 1st Floor
<b>Sample No.:</b>	DU002284	<b>Portal Ref No.:</b>	279

<b>Item:</b>	Insulating board panel				
<b>Asbestos Content:</b>		<b>Result Based on:</b>			
No Asbestos Detected		Analysis of sample using PLM			
<b>Sample Analysed By:</b>	Reg 13(1)	<b>Extent:</b>	3 m <sup>2</sup>		
<b>Comments:</b>

<b>Material Assessment Total Score: 0</b>		<b>Likelihood of Disturbance Assessment Total Score: 0</b>		<b>Management Assessment</b>  <b>Licensable:</b> Yes  <b>Recommendations:</b> Not Applicable  <b>Reinspection Interval:</b> Not Applicable  <b>Overall Risk Category:</b> E0
<b>Product Type:</b>	0 Not Applicable	<b>Location:</b>	0 Not Applicable	
<b>Condition:</b>	0 Not Applicable	<b>Accessibility:</b>	0 Not Applicable	
<b>Surface Treatment:</b>	0 Not Applicable			
<b>Asbestos Type:</b>	0 Not Applicable	<b>Extent Score:</b>	0 Not Applicable

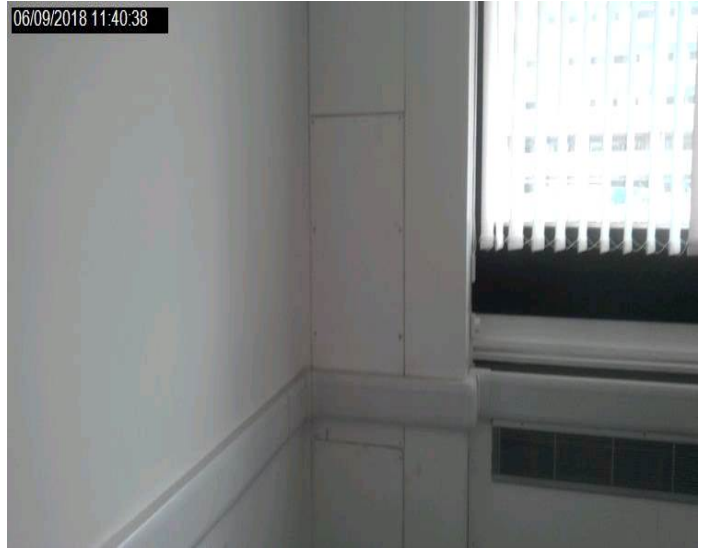
<b>Location:</b>	1.20A	<b>Block:</b>	Birmingham City University	<b>Floor Level:</b> 1st Floor
<b>Sample No.:</b>	As DU002284	<b>Portal Ref No.:</b>	281

<b>Item:</b>	Insulating board panel			
<b>Asbestos Content:</b>		<b>Result Based on:</b>		
No Asbestos Detected		Strongly presumed		
<b>Sample Analysed By:</b>	Not applicable	<b>Extent:</b>	3 m <sup>2</sup>	
<b>Comments:</b>

<b>Material Assessment Total Score: 0</b>		<b>Likelihood of Disturbance Assessment Total Score: 0</b>		<b>Management Assessment</b>  <b>Licensable:</b> Yes  <b>Recommendations:</b> Not Applicable  <b>Reinspection Interval:</b> Not Applicable  <b>Overall Risk Category:</b> E0
<b>Product Type:</b>	0 Not Applicable	<b>Location:</b>	0 Not Applicable	
<b>Condition:</b>	0 Not Applicable	<b>Accessibility:</b>	0 Not Applicable	
<b>Surface Treatment:</b>	0 Not Applicable			
<b>Asbestos Type:</b>	0 Not Applicable	<b>Extent Score:</b>	0 Not Applicable

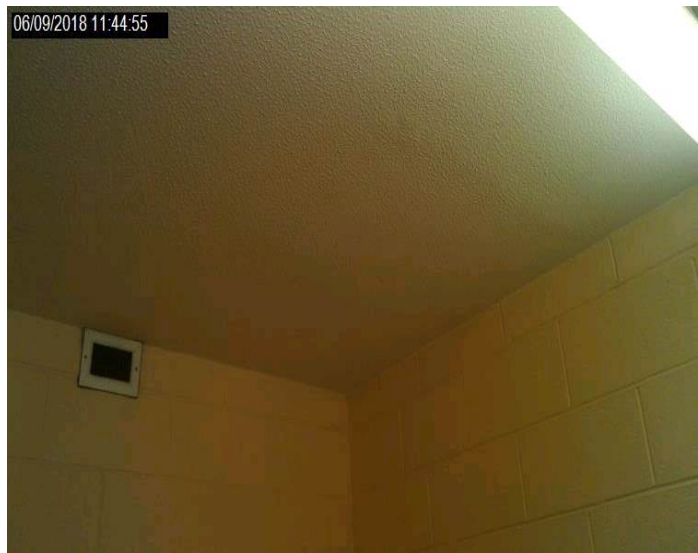
<b>Location:</b>	1.23	<b>Block:</b>	Birmingham City University	<b>Floor Level:</b> 1st Floor
<b>Sample No.:</b>	As DU002280	<b>Portal Ref No.:</b>	282

<b>Item:</b>	Textured coating to plasterboard			
<b>Asbestos Content:</b>		<b>Result Based on:</b>		
No Asbestos Detected		Strongly presumed		
<b>Sample Analysed By:</b>	Not applicable	<b>Extent:</b>	6 m <sup>2</sup>	
<b>Comments:</b>

<b>Material Assessment Total Score: 0</b>		<b>Likelihood of Disturbance Assessment Total Score: 0</b>		<b>Management Assessment</b>  <b>Licensable:</b> No  <b>Recommendations:</b> Not Applicable  <b>Reinspection Interval:</b> Not Applicable  <b>Overall Risk Category:</b> E0
<b>Product Type:</b>	0 Not Applicable	<b>Location:</b>	0 Not Applicable	
<b>Condition:</b>	0 Not Applicable	<b>Accessibility:</b>	0 Not Applicable	
<b>Surface Treatment:</b>	0 Not Applicable			
<b>Asbestos Type:</b>	0 Not Applicable	<b>Extent Score:</b>	0 Not Applicable

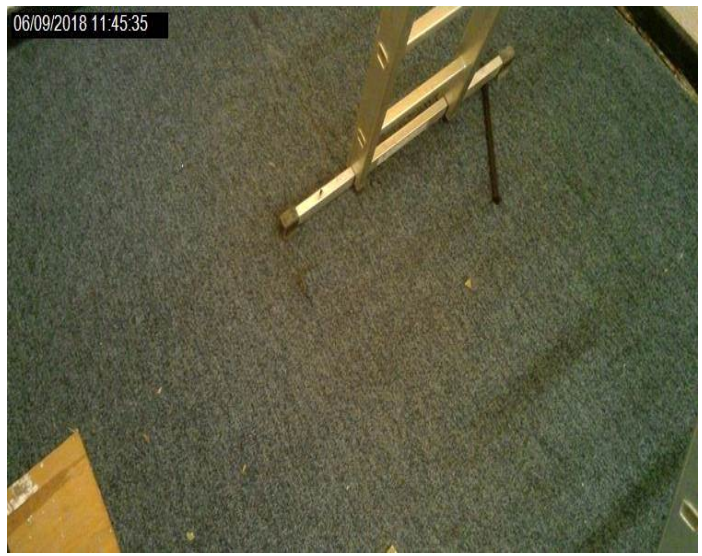
<b>Location:</b>	1.23	<b>Block:</b>	Birmingham City University	<b>Floor Level:</b> 1st Floor
<b>Sample No.:</b>	DU002285	<b>Portal Ref No.:</b>	283

<b>Item:</b>	Thermoplastic floor tiles with bitumen adhesive			
<b>Asbestos Content:</b>	<b>Result Based on:</b>			
No Asbestos Detected in tile or adhesive		Analysis of sample using PLM		
<b>Sample Analysed By:</b>	Reg 13(1)	<b>Extent:</b>	8 m <sup>2</sup>	
<b>Comments:</b>

<b>Material Assessment Total Score: 0</b>		<b>Likelihood of Disturbance Assessment Total Score: 0</b>		<b>Management Assessment</b>  <b>Licensable:</b> No  <b>Recommendations:</b> Not Applicable  <b>Reinspection Interval:</b> Not Applicable  <b>Overall Risk Category:</b> E0
<b>Product Type:</b>	0 Not Applicable	<b>Location:</b>	0 Not Applicable	
<b>Condition:</b>	0 Not Applicable	<b>Accessibility:</b>	0 Not Applicable	
<b>Surface Treatment:</b>	0 Not Applicable			
<b>Asbestos Type:</b>	0 Not Applicable	<b>Extent Score:</b>	0 Not Applicable

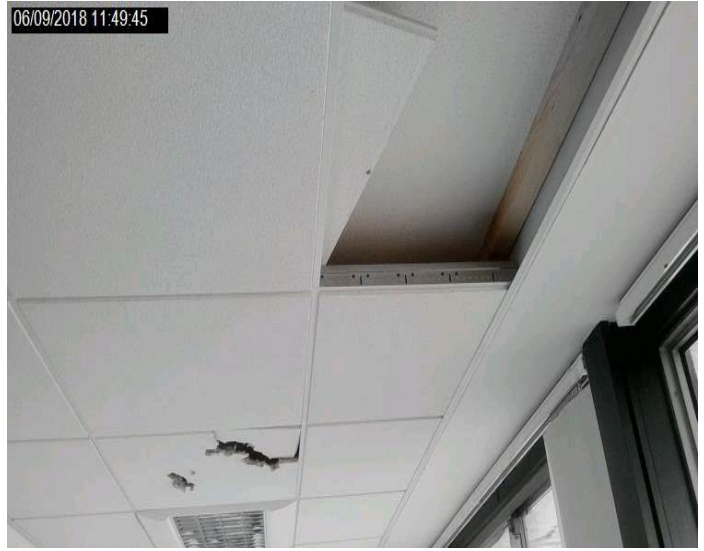
<b>Location:</b>	1.22	<b>Block:</b>	Birmingham City University	<b>Floor Level:</b> 1st Floor
<b>Sample No.:</b>	As DU002280	<b>Portal Ref No.:</b>	285

<b>Item:</b>	Textured coating to plasterboard			
<b>Asbestos Content:</b>		<b>Result Based on:</b>		
No Asbestos Detected		Strongly presumed		
<b>Sample Analysed By:</b>	Not applicable	<b>Extent:</b>	12 m <sup>2</sup>	
<b>Comments:</b>

<b>Material Assessment Total Score: 0</b>		<b>Likelihood of Disturbance Assessment Total Score: 0</b>		<b>Management Assessment</b>  <b>Licensable:</b> No  <b>Recommendations:</b> Not Applicable  <b>Reinspection Interval:</b> Not Applicable  <b>Overall Risk Category:</b> E0
<b>Product Type:</b>	0 Not Applicable	<b>Location:</b>	0 Not Applicable	
<b>Condition:</b>	0 Not Applicable	<b>Accessibility:</b>	0 Not Applicable	
<b>Surface Treatment:</b>	0 Not Applicable			
<b>Asbestos Type:</b>	0 Not Applicable	<b>Extent Score:</b>	0 Not Applicable

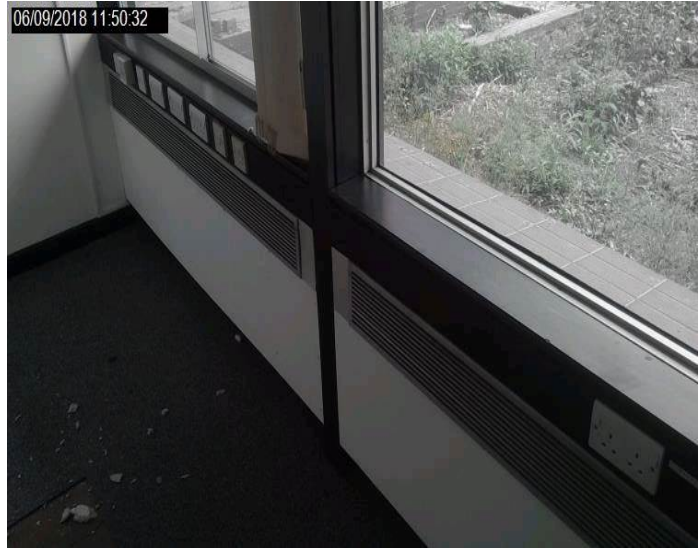
<b>Location:</b>	1.22	<b>Block:</b>	Birmingham City University	<b>Floor Level:</b> 1st Floor
<b>Sample No.:</b>	DU002286	<b>Portal Ref No.:</b>	286

<b>Item:</b>	Asbestos Cement window sill			
<b>Asbestos Content:</b>	Result Based on:			
Chrysotile	Analysis of sample using PLM			
<b>Sample Analysed By:</b> Reg 13(1)	<b>Extent:</b>	4 linear metres		
<b>Comments:</b>

<b>Material Assessment Total Score: 4</b>		<b>Likelihood of Disturbance Assessment Total Score: 4</b>		<b>Management Assessment</b>  <b>Licensable:</b> No  <b>Recommendations:</b> Program removal  <b>Reinspection Interval:</b> Not Applicable  <b>Overall Risk Category:</b> C8
<b>Product Type:</b>	1 (Asbestos cement)	<b>Location:</b>	2 (Rooms up to 100 sq m)	
<b>Condition:</b>	1 (Minor scratches)	<b>Accessibility:</b>	1 (Occasionally likely to be disturbed)	
<b>Surface Treatment:</b>	1 (Unencapsulated asbestos cement)			
<b>Asbestos Type:</b>	1 (Chrysotile)	<b>Extent Score:</b>	1 (<10 sq m or 10m pipe run)

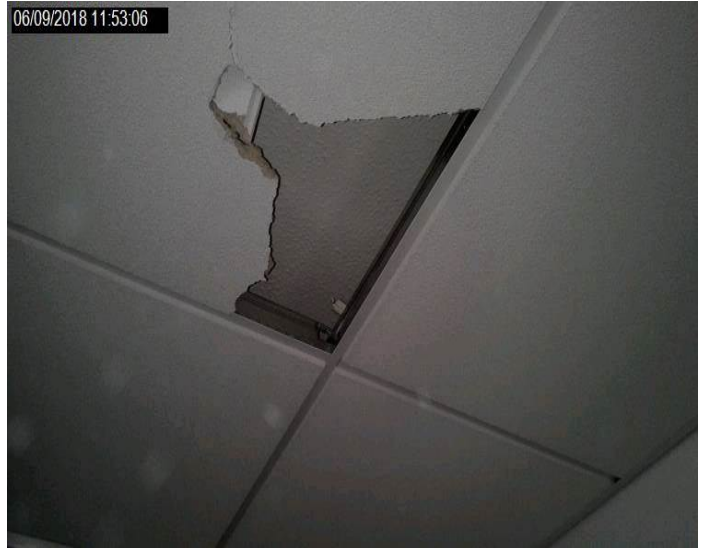
<b>Location:</b>	1.22A	<b>Block:</b>	Birmingham City University	<b>Floor Level:</b> 1st Floor
<b>Sample No.:</b>	As DU002280	<b>Portal Ref No.:</b>	287

<b>Item:</b>	Textured coating to plasterboard			
<b>Asbestos Content:</b>		<b>Result Based on:</b>		
No Asbestos Detected		Strongly presumed		
<b>Sample Analysed By:</b>	Not applicable	<b>Extent:</b>	12 m <sup>2</sup>	
<b>Comments:</b>

<b>Material Assessment Total Score: 0</b>		<b>Likelihood of Disturbance Assessment Total Score: 0</b>		<b>Management Assessment</b>  <b>Licensable:</b> No  <b>Recommendations:</b> Not Applicable  <b>Reinspection Interval:</b> Not Applicable  <b>Overall Risk Category:</b> E0
<b>Product Type:</b>	0 Not Applicable	<b>Location:</b>	0 Not Applicable	
<b>Condition:</b>	0 Not Applicable	<b>Accessibility:</b>	0 Not Applicable	
<b>Surface Treatment:</b>	0 Not Applicable			
<b>Asbestos Type:</b>	0 Not Applicable	<b>Extent Score:</b>	0 Not Applicable

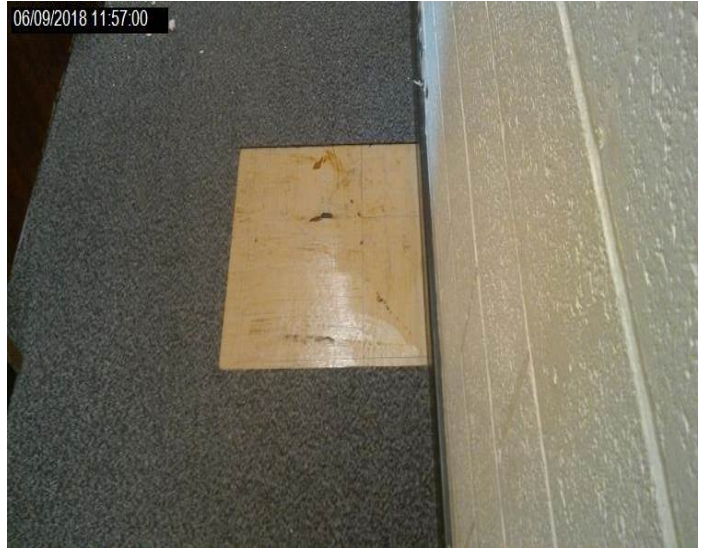
<b>Location:</b>	1.99D	<b>Block:</b>	Birmingham City University	<b>Floor Level:</b> 1st Floor
<b>Sample No.:</b>	As DU002285	<b>Portal Ref No.:</b>	290

<b>Item:</b>	Thermoplastic floor tiles			
<b>Asbestos Content:</b>		<b>Result Based on:</b>		
No Asbestos Detected in tile or adhesive		Strongly presumed		
<b>Sample Analysed By:</b>	Not applicable	<b>Extent:</b>	20 m <sup>2</sup>	
<b>Comments:</b>

<b>Material Assessment Total Score: 0</b>		<b>Likelihood of Disturbance Assessment Total Score: 0</b>		<b>Management Assessment</b>  <b>Licensable:</b> No  <b>Recommendations:</b> Not Applicable  <b>Reinspection Interval:</b> Not Applicable  <b>Overall Risk Category:</b> E0
<b>Product Type:</b>	0 Not Applicable	<b>Location:</b>	0 Not Applicable	
<b>Condition:</b>	0 Not Applicable	<b>Accessibility:</b>	0 Not Applicable	
<b>Surface Treatment:</b>	0 Not Applicable			
<b>Asbestos Type:</b>	0 Not Applicable	<b>Extent Score:</b>	0 Not Applicable

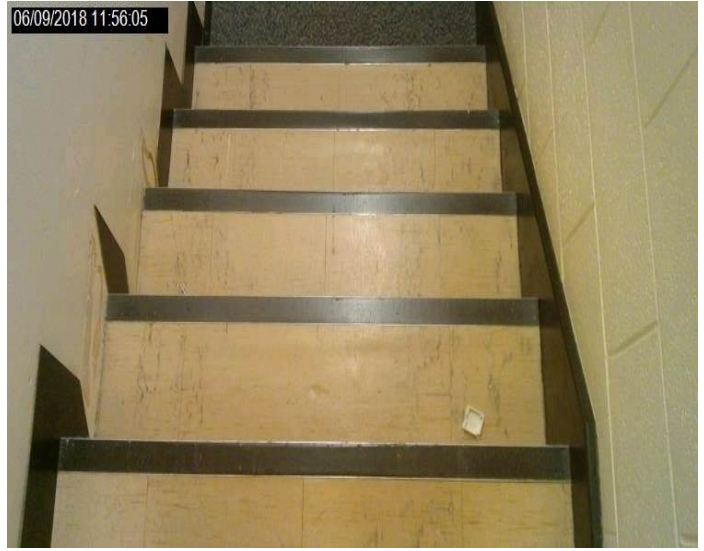
<b>Location:</b>	1.99D	<b>Block:</b>	Birmingham City University	<b>Floor Level:</b> 1st Floor
<b>Sample No.:</b>	As DU002274	<b>Portal Ref No.:</b>	291

<b>Item:</b>	Reinforced plastic stair nosing			
<b>Asbestos Content:</b>		<b>Result Based on:</b>		
No Asbestos Detected		Strongly presumed		
<b>Sample Analysed By:</b>	Not applicable	<b>Extent:</b>	5 linear metres	
<b>Comments:</b>

<b>Material Assessment Total Score: 0</b>		<b>Likelihood of Disturbance Assessment Total Score: 0</b>		<b>Management Assessment</b>  <b>Licensable:</b> No  <b>Recommendations:</b> Not Applicable  <b>Reinspection Interval:</b> Not Applicable  <b>Overall Risk Category:</b> E0
<b>Product Type:</b>	0 Not Applicable	<b>Location:</b>	0 Not Applicable	
<b>Condition:</b>	0 Not Applicable	<b>Accessibility:</b>	0 Not Applicable	
<b>Surface Treatment:</b>	0 Not Applicable			
<b>Asbestos Type:</b>	0 Not Applicable	<b>Extent Score:</b>	0 Not Applicable

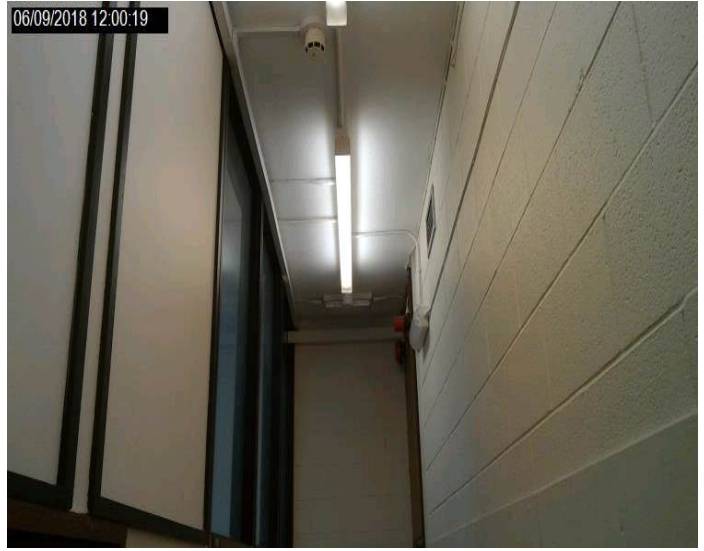
<b>Location:</b>	1.99D	<b>Block:</b>	Birmingham City University	<b>Floor Level:</b> 1st Floor
<b>Sample No.:</b>	As DU002280	<b>Portal Ref No.:</b>	292

<b>Item:</b>	Textured coating to plasterboard			
<b>Asbestos Content:</b>		<b>Result Based on:</b>		
No Asbestos Detected		Strongly presumed		
<b>Sample Analysed By:</b>	Not applicable	<b>Extent:</b>	20 m <sup>2</sup>	
<b>Comments:</b>

<b>Material Assessment Total Score: 0</b>		<b>Likelihood of Disturbance Assessment Total Score: 0</b>		<b>Management Assessment</b>  <b>Licensable:</b> No  <b>Recommendations:</b> Not Applicable  <b>Reinspection Interval:</b> Not Applicable  <b>Overall Risk Category:</b> E0
<b>Product Type:</b>	0 Not Applicable	<b>Location:</b>	0 Not Applicable	
<b>Condition:</b>	0 Not Applicable	<b>Accessibility:</b>	0 Not Applicable	
<b>Surface Treatment:</b>	0 Not Applicable			
<b>Asbestos Type:</b>	0 Not Applicable	<b>Extent Score:</b>	0 Not Applicable

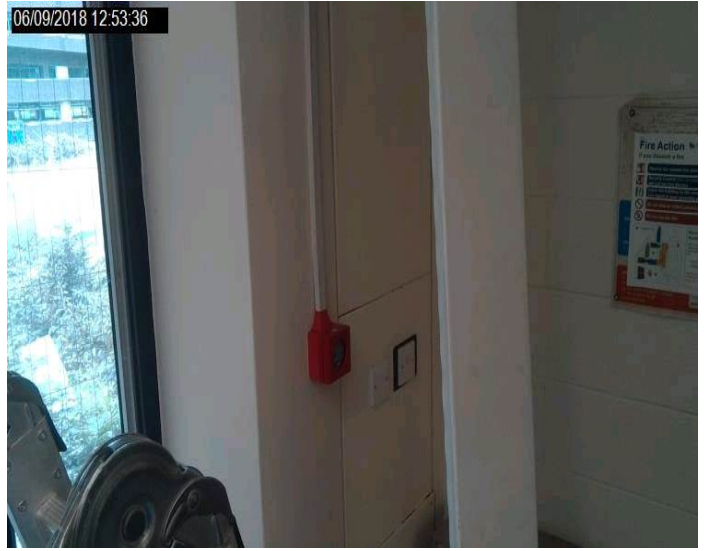
<b>Location:</b>	1.99E	<b>Block:</b>	Birmingham City University		<b>Floor Level:</b> 1st Floor
<b>Sample No.:</b>	As DU002284	<b>Portal Ref No.:</b>	293

<b>Item:</b>	Insulating board panel				
<b>Asbestos Content:</b>		<b>Result Based on:</b>			
No Asbestos Detected		Strongly presumed			
<b>Sample Analysed By:</b>	Not applicable	<b>Extent:</b>	3 m <sup>2</sup>		
<b>Comments:</b>

<b>Material Assessment Total Score: 0</b>		<b>Likelihood of Disturbance Assessment Total Score: 0</b>		<b>Management Assessment</b>  <b>Licensable:</b> Yes  <b>Recommendations:</b> Not Applicable  <b>Reinspection Interval:</b> Not Applicable  <b>Overall Risk Category:</b> E0
<b>Product Type:</b>	0 Not Applicable	<b>Location:</b>	0 Not Applicable	
<b>Condition:</b>	0 Not Applicable	<b>Accessibility:</b>	0 Not Applicable	
<b>Surface Treatment:</b>	0 Not Applicable			
<b>Asbestos Type:</b>	0 Not Applicable	<b>Extent Score:</b>	0 Not Applicable

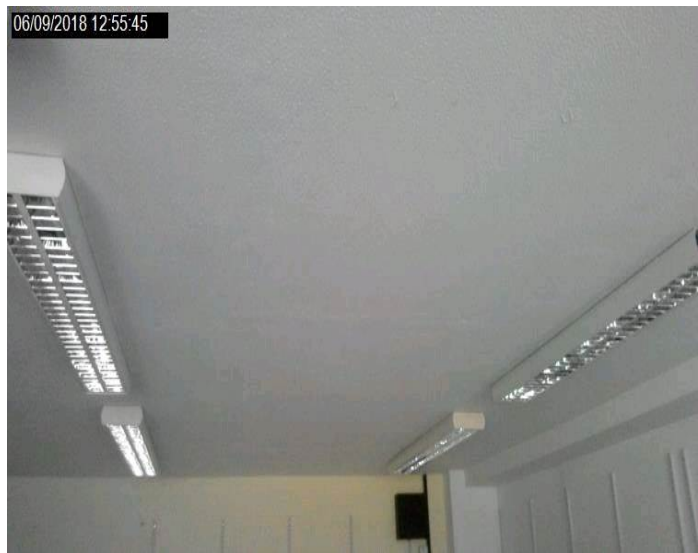
<b>Location:</b>	1.24	<b>Block:</b>	Birmingham City University	<b>Floor Level:</b> 1st Floor
<b>Sample No.:</b>	As DU002280	<b>Portal Ref No.:</b>	294

<b>Item:</b>	Textured coating to plasterboard			
<b>Asbestos Content:</b>		<b>Result Based on:</b>		
No Asbestos Detected		Strongly presumed		
<b>Sample Analysed By:</b>	Not applicable	<b>Extent:</b>	35 m <sup>2</sup>	
<b>Comments:</b>

<b>Material Assessment Total Score: 0</b>		<b>Likelihood of Disturbance Assessment Total Score: 0</b>		<b>Management Assessment</b>  <b>Licensable:</b> No  <b>Recommendations:</b> Not Applicable  <b>Reinspection Interval:</b> Not Applicable  <b>Overall Risk Category:</b> E0
<b>Product Type:</b>	0 Not Applicable	<b>Location:</b>	0 Not Applicable	
<b>Condition:</b>	0 Not Applicable	<b>Accessibility:</b>	0 Not Applicable	
<b>Surface Treatment:</b>	0 Not Applicable			
<b>Asbestos Type:</b>	0 Not Applicable	<b>Extent Score:</b>	0 Not Applicable

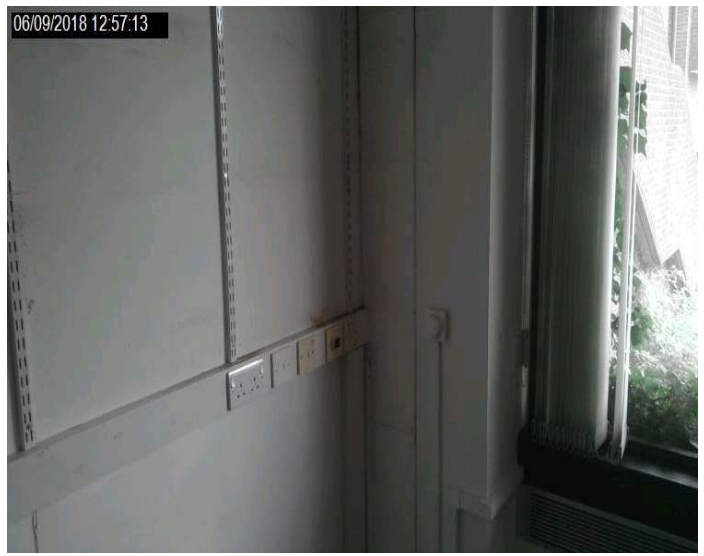
<b>Location:</b>	1.24	<b>Block:</b>	Birmingham City University	<b>Floor Level:</b> 1st Floor
<b>Sample No.:</b>	As DU002284	<b>Portal Ref No.:</b>	296

<b>Item:</b>	Insulating board panel			
<b>Asbestos Content:</b>		<b>Result Based on:</b>		
No Asbestos Detected		Strongly presumed		
<b>Sample Analysed By:</b>	Not applicable	<b>Extent:</b>	2 m <sup>2</sup>	
<b>Comments:</b>

<b>Material Assessment Total Score: 0</b>		<b>Likelihood of Disturbance Assessment Total Score: 0</b>		<b>Management Assessment</b>  <b>Licensable:</b> Yes  <b>Recommendations:</b> Not Applicable  <b>Reinspection Interval:</b> Not Applicable  <b>Overall Risk Category:</b> E0
<b>Product Type:</b>	0 Not Applicable	<b>Location:</b>	0 Not Applicable	
<b>Condition:</b>	0 Not Applicable	<b>Accessibility:</b>	0 Not Applicable	
<b>Surface Treatment:</b>	0 Not Applicable			
<b>Asbestos Type:</b>	0 Not Applicable	<b>Extent Score:</b>	0 Not Applicable

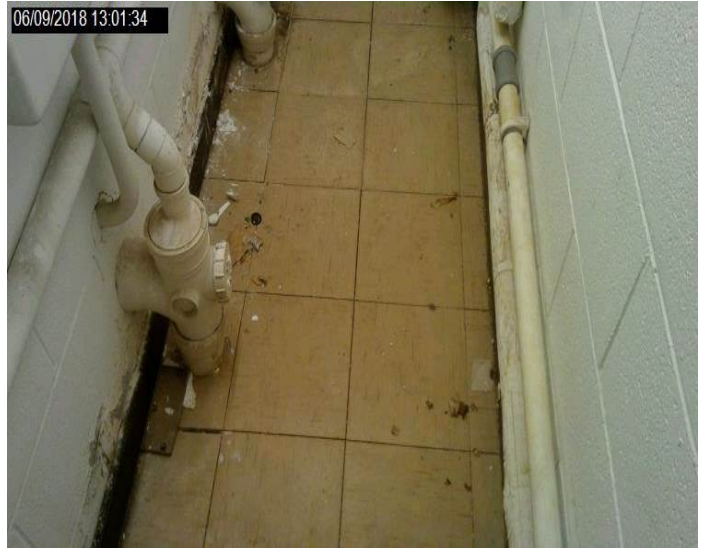
<b>Location:</b>	1.26	<b>Block:</b>	Birmingham City University	<b>Floor Level:</b> 1st Floor
<b>Sample No.:</b>	DU002288	<b>Portal Ref No.:</b>	297

<b>Item:</b>	Asbestos Thermoplastic floor tiles with bitumen adhesive			
<b>Asbestos Content:</b>	Result Based on:			
Chrysotile in adhesive only	Analysis of sample using PLM			
<b>Sample Analysed By:</b> Reg 13(1)	<b>Extent:</b>	10 m <sup>2</sup>		
<b>Comments:</b>

<b>Material Assessment Total Score: 3</b>		<b>Likelihood of Disturbance Assessment Total Score: 7</b>		<b>Management Assessment</b>  <b>Licensable:</b> No  <b>Recommendations:</b> Program removal  <b>Reinspection Interval:</b> Not Applicable  <b>Overall Risk Category:</b> C10
<b>Product Type:</b>	1 (Asbestos thermoplastic)	<b>Location:</b>	2 (Rooms up to 100 sq m)	
<b>Condition:</b>	1 (Minor scratches)	<b>Accessibility:</b>	3 (Routinely disturbed)	
<b>Surface Treatment:</b>	0 (Composite material)			
<b>Asbestos Type:</b>	1 (Chrysotile)	<b>Extent Score:</b>	2 (>10 - <50 sq m or >10m - <50m pipe run)

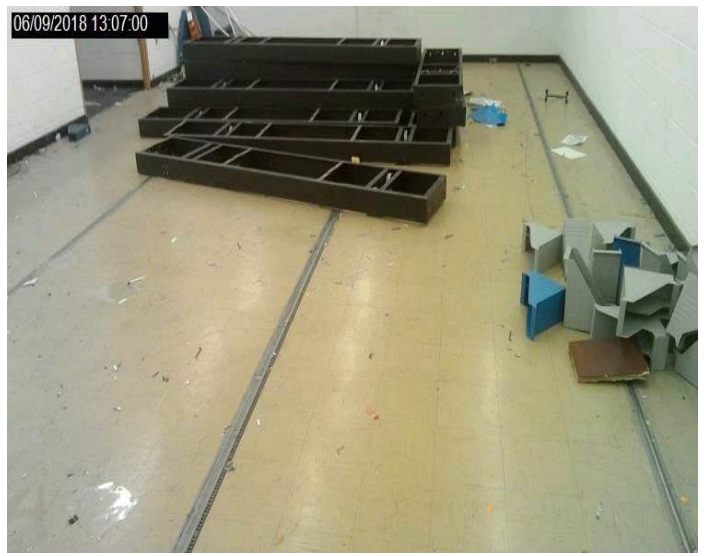
<b>Location:</b>	1.28	<b>Block:</b>	Birmingham City University	<b>Floor Level:</b> 1st Floor
<b>Sample No.:</b>	DU002289	<b>Portal Ref No.:</b>	298

<b>Item:</b>	Asbestos Thermoplastic floor tiles with bitumen adhesive			
<b>Asbestos Content:</b>	<b>Result Based on:</b>			
Chrysotile in adhesive only	Analysis of sample using PLM			
<b>Sample Analysed By:</b> Reg 13(1)	<b>Extent:</b>	65 m <sup>2</sup>		
<b>Comments:</b>

<b>Material Assessment Total Score: 3</b>		<b>Likelihood of Disturbance Assessment Total Score: 8</b>		<b>Management Assessment</b>  <b>Licensable:</b> No  <b>Recommendations:</b> Program removal  <b>Reinspection Interval:</b> Not Applicable  <b>Overall Risk Category:</b> B11
<b>Product Type:</b>	1 (Asbestos thermoplastic)	<b>Location:</b>	2 (Rooms up to 100 sq m)	
<b>Condition:</b>	1 (Minor scratches)	<b>Accessibility:</b>	3 (Routinely disturbed)	
<b>Surface Treatment:</b>	0 (Composite material)			
<b>Asbestos Type:</b>	1 (Chrysotile)	<b>Extent Score:</b>	3 (>50 sq m or >50m pipe run)

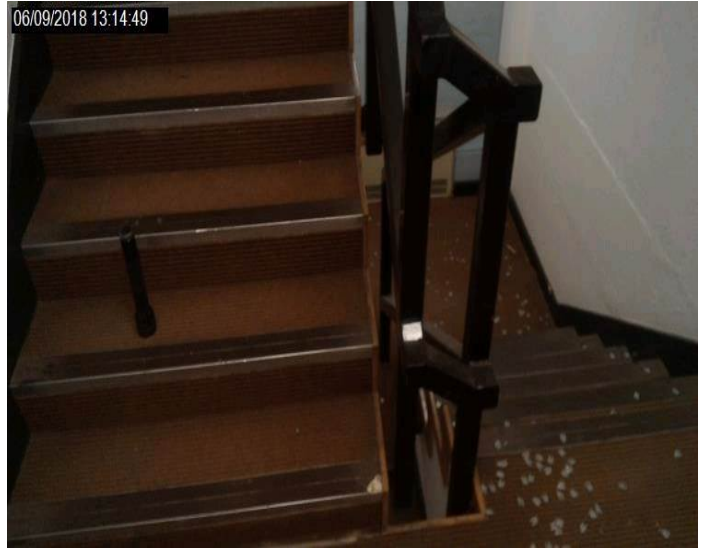
<b>Location:</b>	1.00	<b>Block:</b>	Birmingham City University	<b>Floor Level:</b> 1st Floor
<b>Sample No.:</b>	DU002291	<b>Portal Ref No.:</b>	301

<b>Item:</b>	Reinforced plastic stair nosing			
<b>Asbestos Content:</b>		<b>Result Based on:</b>		
No Asbestos Detected		Analysis of sample using PLM		
<b>Sample Analysed By:</b>	Reg 13(1)	<b>Extent:</b>	15 linear metres	
<b>Comments:</b>

<b>Material Assessment Total Score: 0</b>		<b>Likelihood of Disturbance Assessment Total Score: 0</b>		<b>Management Assessment</b>  <b>Licensable:</b> No  <b>Recommendations:</b> Not Applicable  <b>Reinspection Interval:</b> Not Applicable  <b>Overall Risk Category:</b> E0
<b>Product Type:</b>	0 Not Applicable	<b>Location:</b>	0 Not Applicable	
<b>Condition:</b>	0 Not Applicable	<b>Accessibility:</b>	0 Not Applicable	
<b>Surface Treatment:</b>	0 Not Applicable			
<b>Asbestos Type:</b>	0 Not Applicable	<b>Extent Score:</b>	0 Not Applicable

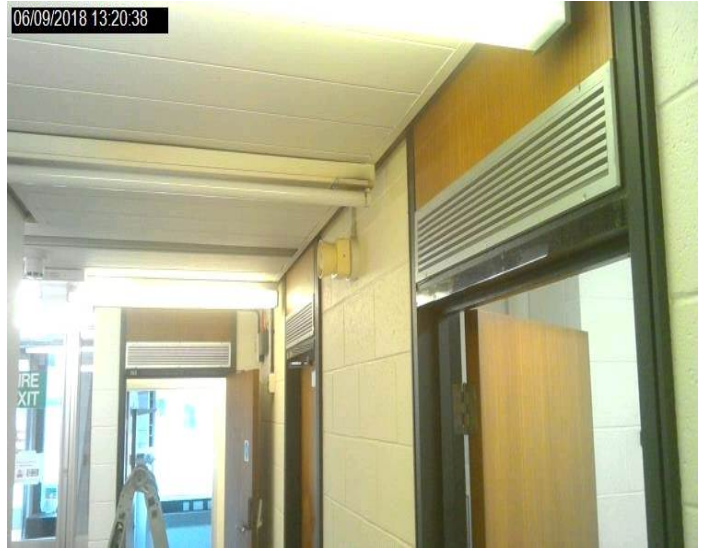
<b>Location:</b>	1.99F	<b>Block:</b>	Birmingham City University	<b>Floor Level:</b> 1st Floor
<b>Sample No.:</b>	DU002292	<b>Portal Ref No.:</b>	302

<b>Item:</b>	Insulating board door headers			
<b>Asbestos Content:</b>		<b>Result Based on:</b>		
No Asbestos Detected		Analysis of sample using PLM		
<b>Sample Analysed By:</b>	Reg 13(1)	<b>Extent:</b>	14 m <sup>2</sup>	
<b>Comments:</b> Above all doors where timber panel is visible 7 doors in total

<b>Material Assessment Total Score: 0</b>		<b>Likelihood of Disturbance Assessment Total Score: 0</b>		<b>Management Assessment</b>  <b>Licensable:</b> Yes  <b>Recommendations:</b> Not Applicable  <b>Reinspection Interval:</b> Not Applicable  <b>Overall Risk Category:</b> E0
<b>Product Type:</b>	0 Not Applicable	<b>Location:</b>	0 Not Applicable	
<b>Condition:</b>	0 Not Applicable	<b>Accessibility:</b>	0 Not Applicable	
<b>Surface Treatment:</b>	0 Not Applicable			
<b>Asbestos Type:</b>	0 Not Applicable	<b>Extent Score:</b>	0 Not Applicable

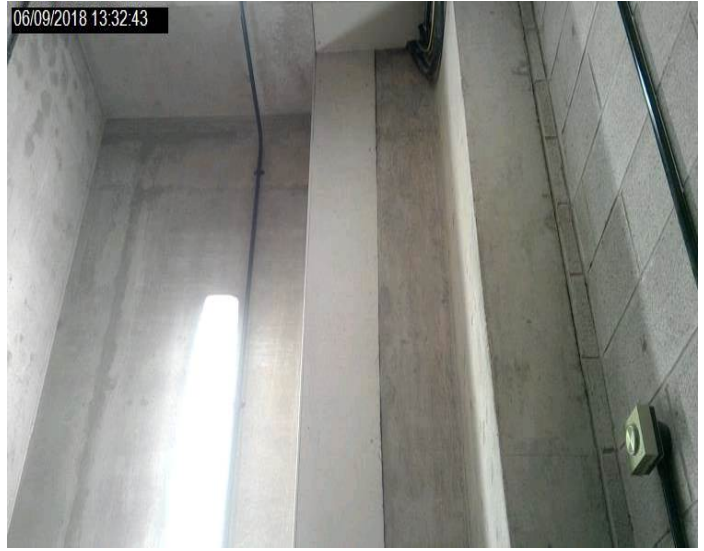
<b>Location:</b>	1.31	<b>Block:</b>	Birmingham City University	<b>Floor Level:</b> Ground Floor
<b>Sample No.:</b>	DU002293	<b>Portal Ref No.:</b>	303

<b>Item:</b>	Insulating board boxing			
<b>Asbestos Content:</b>		<b>Result Based on:</b>		
No Asbestos Detected		Analysis of sample using PLM		
<b>Sample Analysed By:</b>	Reg 13(1)	<b>Extent:</b>	4 m <sup>2</sup>	
<b>Comments:</b> Floor to ceiling

<b>Material Assessment Total Score: 0</b>		<b>Likelihood of Disturbance Assessment Total Score: 0</b>		<b>Management Assessment</b>  <b>Licensable:</b> Yes  <b>Recommendations:</b> Not Applicable  <b>Reinspection Interval:</b> Not Applicable  <b>Overall Risk Category:</b> E0
<b>Product Type:</b>	0 Not Applicable	<b>Location:</b>	0 Not Applicable	
<b>Condition:</b>	0 Not Applicable	<b>Accessibility:</b>	0 Not Applicable	
<b>Surface Treatment:</b>	0 Not Applicable			
<b>Asbestos Type:</b>	0 Not Applicable	<b>Extent Score:</b>	0 Not Applicable

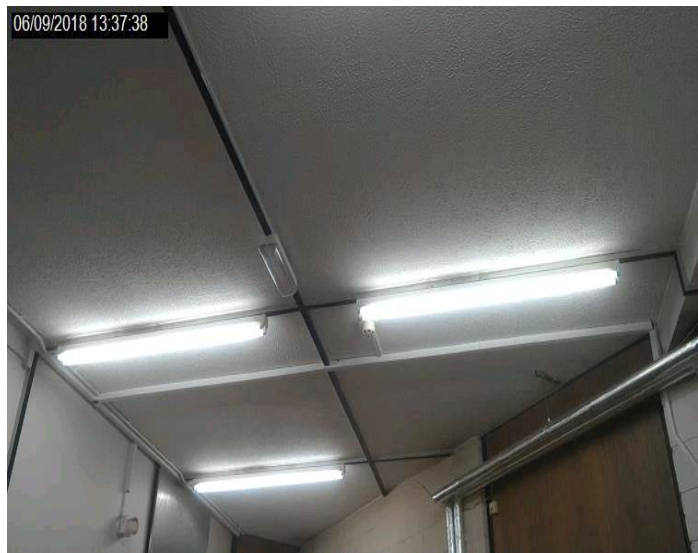
<b>Location:</b>	1.99A	<b>Block:</b>	Birmingham City University	<b>Floor Level:</b> Ground Floor
<b>Sample No.:</b>	DU002295	<b>Portal Ref No.:</b>	305

<b>Item:</b>	Textured coating to concrete			
<b>Asbestos Content:</b>	<b>Result Based on:</b>			
No Asbestos Detected	Analysis of sample using PLM			
<b>Sample Analysed By:</b> Reg 13(1)	<b>Extent:</b>	35 m <sup>2</sup>		
<b>Comments:</b>

<b>Material Assessment Total Score: 0</b>		<b>Likelihood of Disturbance Assessment Total Score: 0</b>		<b>Management Assessment</b>  <b>Licensable:</b> No  <b>Recommendations:</b> Not Applicable  <b>Reinspection Interval:</b> Not Applicable  <b>Overall Risk Category:</b> E0
<b>Product Type:</b>	0 Not Applicable	<b>Location:</b>	0 Not Applicable	
<b>Condition:</b>	0 Not Applicable	<b>Accessibility:</b>	0 Not Applicable	
<b>Surface Treatment:</b>	0 Not Applicable			
<b>Asbestos Type:</b>	0 Not Applicable	<b>Extent Score:</b>	0 Not Applicable

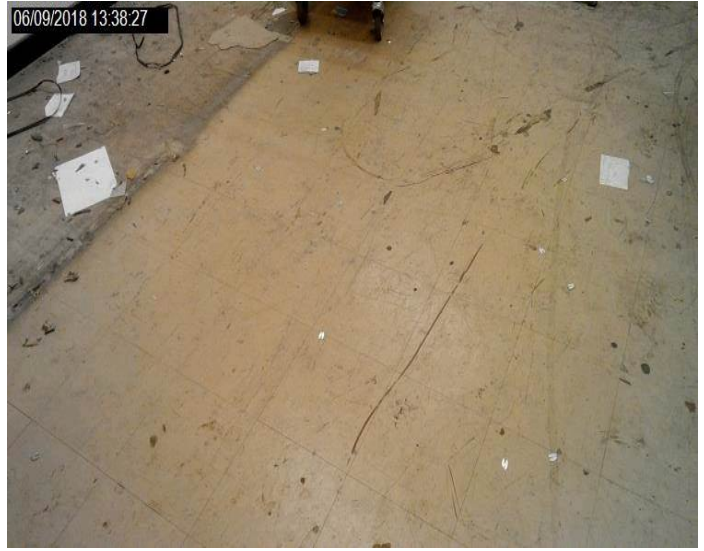
<b>Location:</b>	1.99A	<b>Block:</b>	Birmingham City University	<b>Floor Level:</b> Ground Floor
<b>Sample No.:</b>	DU002296	<b>Portal Ref No.:</b>	306

<b>Item:</b>	Asbestos Thermoplastic floor tiles with bitumen adhesive			
<b>Asbestos Content:</b>	Result Based on:			
Chrysotile in adhesive only	Analysis of sample using PLM			
<b>Sample Analysed By:</b> Reg 13(1)	<b>Extent:</b>	35 m <sup>2</sup>		
<b>Comments:</b>

<b>Material Assessment Total Score: 3</b>		<b>Likelihood of Disturbance Assessment Total Score: 7</b>		<b>Management Assessment</b>  <b>Licensable:</b> No  <b>Recommendations:</b> Program removal  <b>Reinspection Interval:</b> Not Applicable  <b>Overall Risk Category:</b> C10
<b>Product Type:</b>	1 (Asbestos thermoplastic)	<b>Location:</b>	2 (Rooms up to 100 sq m)	
<b>Condition:</b>	1 (Minor scratches)	<b>Accessibility:</b>	3 (Routinely disturbed)	
<b>Surface Treatment:</b>	0 (Composite material)			
<b>Asbestos Type:</b>	1 (Chrysotile)	<b>Extent Score:</b>	2 (>10 - <50 sq m or >10m - <50m pipe run)

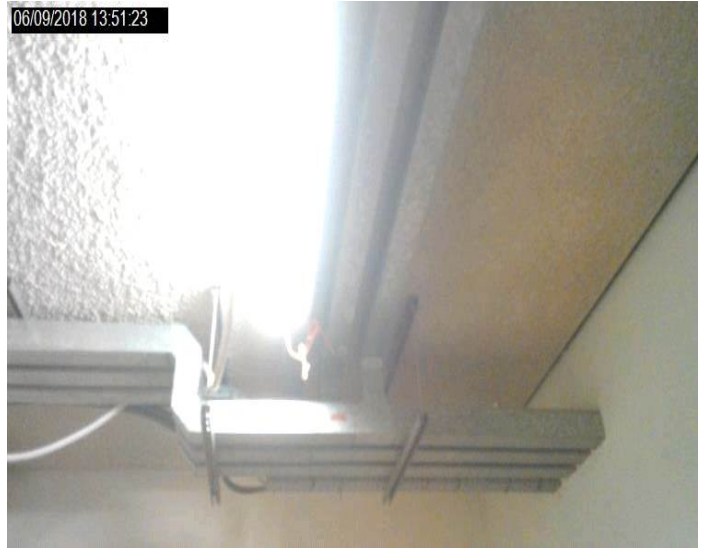
<b>Location:</b>	1.33	<b>Block:</b>	Birmingham City University	<b>Floor Level:</b> Ground Floor
<b>Sample No.:</b>	DU002297	<b>Portal Ref No.:</b>	307

<b>Item:</b>	Spray coating			
<b>Asbestos Content:</b>		<b>Result Based on:</b>		
No Asbestos Detected		Analysis of sample using PLM		
<b>Sample Analysed By:</b>	Reg 13(1)	<b>Extent:</b>	10 m <sup>2</sup>	
<b>Comments:</b> Fire protection

<b>Material Assessment Total Score: 0</b>		<b>Likelihood of Disturbance Assessment Total Score: 0</b>		<b>Management Assessment</b>  <b>Licensable:</b> Yes  <b>Recommendations:</b> Not Applicable  <b>Reinspection Interval:</b> Not Applicable  <b>Overall Risk Category:</b> E0
<b>Product Type:</b>	0 Not Applicable	<b>Location:</b>	0 Not Applicable	
<b>Condition:</b>	0 Not Applicable	<b>Accessibility:</b>	0 Not Applicable	
<b>Surface Treatment:</b>	0 Not Applicable			
<b>Asbestos Type:</b>	0 Not Applicable	<b>Extent Score:</b>	0 Not Applicable

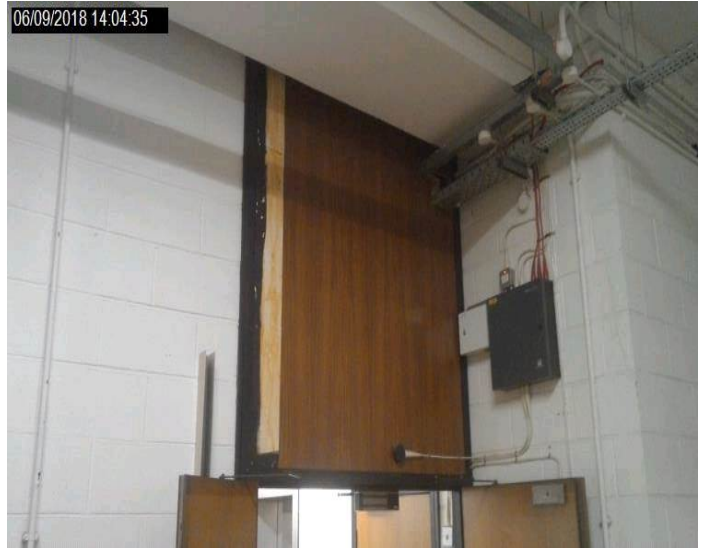
<b>Location:</b>	1.34	<b>Block:</b>	Birmingham City University	<b>Floor Level:</b> Ground Floor
<b>Sample No.:</b>	DU002298	<b>Portal Ref No.:</b>	308

<b>Item:</b>	Insulating board door header			
<b>Asbestos Content:</b>		<b>Result Based on:</b>		
No Asbestos Detected		Analysis of sample using PLM		
<b>Sample Analysed By:</b>	Reg 13(1)	<b>Extent:</b>	8 m <sup>2</sup>	
<b>Comments:</b> Double skin

<b>Material Assessment Total Score: 0</b>		<b>Likelihood of Disturbance Assessment Total Score: 0</b>		<b>Management Assessment</b>  <b>Licensable:</b> Yes  <b>Recommendations:</b> Not Applicable  <b>Reinspection Interval:</b> Not Applicable  <b>Overall Risk Category:</b> E0
<b>Product Type:</b>	0 Not Applicable	<b>Location:</b>	0 Not Applicable	
<b>Condition:</b>	0 Not Applicable	<b>Accessibility:</b>	0 Not Applicable	
<b>Surface Treatment:</b>	0 Not Applicable			
<b>Asbestos Type:</b>	0 Not Applicable	<b>Extent Score:</b>	0 Not Applicable

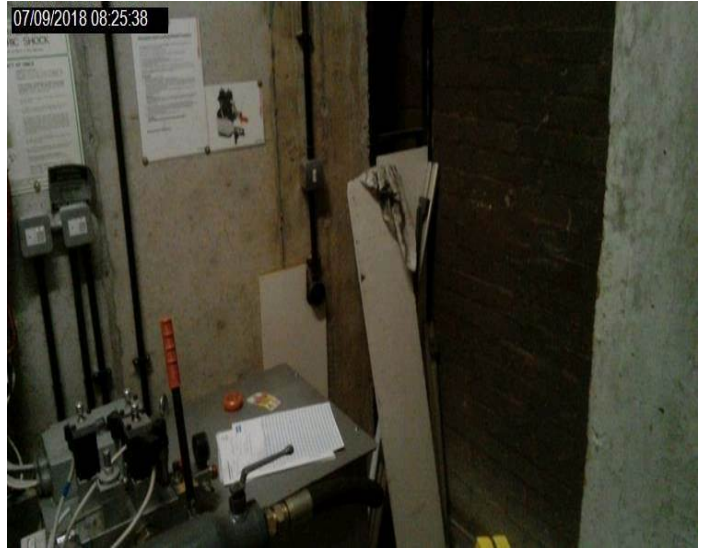
<b>Location:</b>	1.31A	<b>Block:</b>	Birmingham City University	<b>Floor Level:</b> Ground Floor
<b>Sample No.:</b>	DU002299	<b>Portal Ref No.:</b>	309

<b>Item:</b>	Insulating board boxing			
<b>Asbestos Content:</b>		<b>Result Based on:</b>		
No Asbestos Detected		Analysis of sample using PLM		
<b>Sample Analysed By:</b>	Reg 13(1)	<b>Extent:</b>	3 linear metres	
<b>Comments:</b> Floor to ceiling

<b>Material Assessment Total Score: 0</b>		<b>Likelihood of Disturbance Assessment Total Score: 0</b>		<b>Management Assessment</b>  <b>Licensable:</b> Yes  <b>Recommendations:</b> Not Applicable  <b>Reinspection Interval:</b> Not Applicable  <b>Overall Risk Category:</b> E0
<b>Product Type:</b>	0 Not Applicable	<b>Location:</b>	0 Not Applicable	
<b>Condition:</b>	0 Not Applicable	<b>Accessibility:</b>	0 Not Applicable	
<b>Surface Treatment:</b>	0 Not Applicable			
<b>Asbestos Type:</b>	0 Not Applicable	<b>Extent Score:</b>	0 Not Applicable

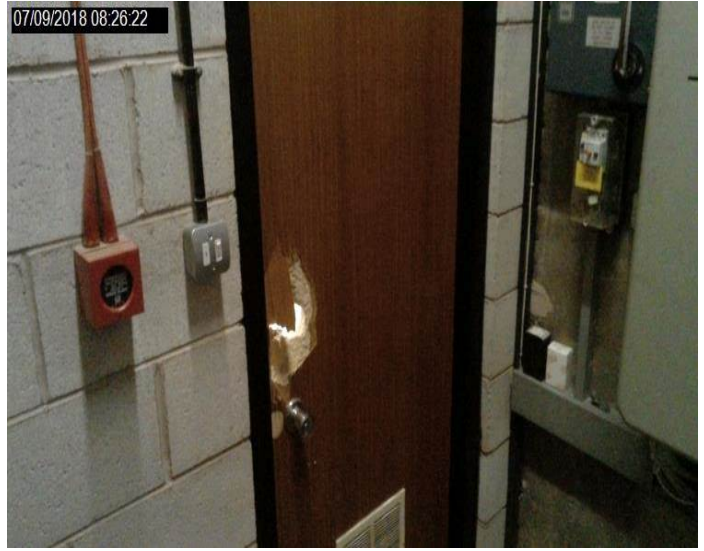
<b>Location:</b>	1.31A	<b>Block:</b>	Birmingham City University	<b>Floor Level:</b> Ground Floor
<b>Sample No.:</b>	DU002300	<b>Portal Ref No.:</b>	310

<b>Item:</b>	Insulating board internally to door			
<b>Asbestos Content:</b>		<b>Result Based on:</b>		
No Asbestos Detected		Analysis of sample using PLM		
<b>Sample Analysed By:</b>	Reg 13(1)	<b>Extent:</b>	2 m <sup>2</sup>	
<b>Comments:</b> Vermiculite

<b>Material Assessment Total Score: 0</b>		<b>Likelihood of Disturbance Assessment Total Score: 0</b>		<b>Management Assessment</b>  <b>Licensable:</b> Yes  <b>Recommendations:</b> Not Applicable  <b>Reinspection Interval:</b> Not Applicable  <b>Overall Risk Category:</b> E0
<b>Product Type:</b>	0 Not Applicable	<b>Location:</b>	0 Not Applicable	
<b>Condition:</b>	0 Not Applicable	<b>Accessibility:</b>	0 Not Applicable	
<b>Surface Treatment:</b>	0 Not Applicable			
<b>Asbestos Type:</b>	0 Not Applicable	<b>Extent Score:</b>	0 Not Applicable

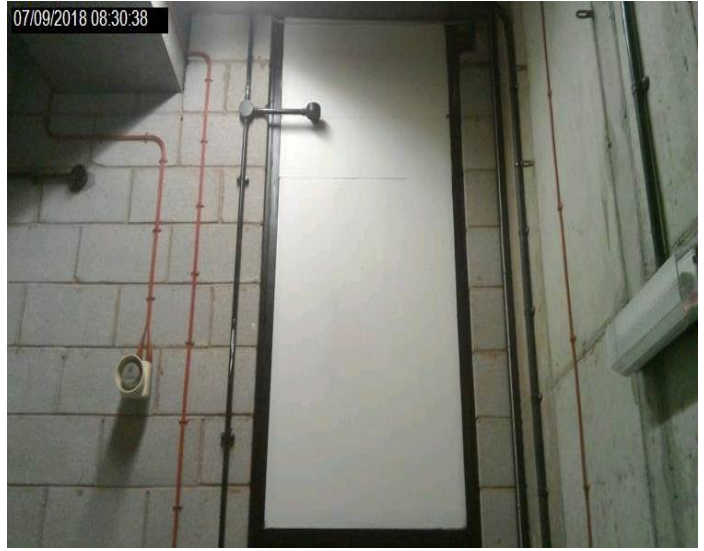
<b>Location:</b>	1.31A	<b>Block:</b>	Birmingham City University	<b>Floor Level:</b> Ground Floor
<b>Sample No.:</b>	DU002301	<b>Portal Ref No.:</b>	311

<b>Item:</b>	Insulating board door header panel			
<b>Asbestos Content:</b>		<b>Result Based on:</b>		
No Asbestos Detected		Analysis of sample using PLM		
<b>Sample Analysed By:</b>	Reg 13(1)	<b>Extent:</b>	4 m <sup>2</sup>	
<b>Comments:</b> Double skin

<b>Material Assessment Total Score: 0</b>		<b>Likelihood of Disturbance Assessment Total Score: 0</b>		<b>Management Assessment</b>  <b>Licensable:</b> Yes  <b>Recommendations:</b> Not Applicable  <b>Reinspection Interval:</b> Not Applicable  <b>Overall Risk Category:</b> E0
<b>Product Type:</b>	0 Not Applicable	<b>Location:</b>	0 Not Applicable	
<b>Condition:</b>	0 Not Applicable	<b>Accessibility:</b>	0 Not Applicable	
<b>Surface Treatment:</b>	0 Not Applicable			
<b>Asbestos Type:</b>	0 Not Applicable	<b>Extent Score:</b>	0 Not Applicable
