**Report No.:** J102747  
**Nature of Work:** Demolition Survey  
**Issue Date:** 26/09/2018  
**Client Name:** WYG Engineering Ltd  
Geneva Building, Lake View Drive, Sherwood Business Park,  
Annesley, Nottingham, NG15 0ED  
**Site Address:** Kenrick Building, Former City North Campus, Birmingham City  
University, Perry Barr, B42 2US

**Order Placed By:** Reg 13(1)  
**Site Contact:** Reg 13(1)  
**Date(s) of Work:** 20/08/2018 to 23/08/2018  
**Technical Manager:** Reg 13(1) (Asbestos)  
**Assistant Surveyor(s):** Reg 13(1)

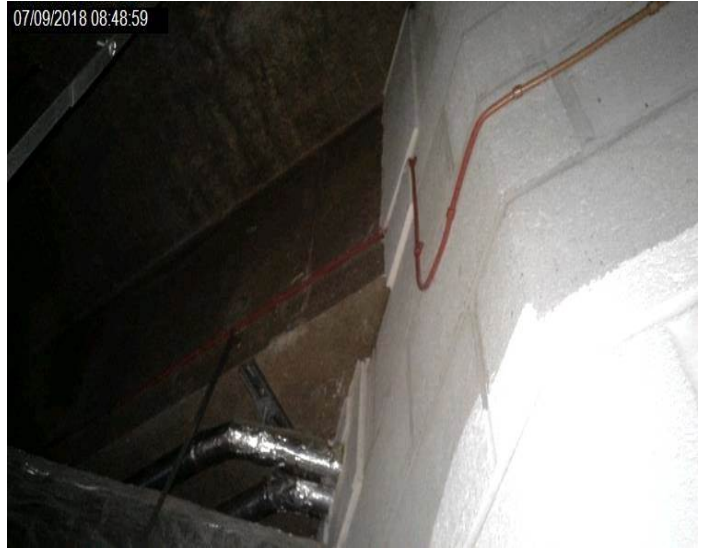
<b>Location:</b>	1.99B	<b>Block:</b>	Birmingham City University	<b>Floor Level:</b> Ground Floor
<b>Sample No.:</b>	DU002302	<b>Portal Ref No.:</b>	313

<b>Item:</b>	Insulating board panels			
<b>Asbestos Content:</b>		<b>Result Based on:</b>		
No Asbestos Detected		Analysis of sample using PLM		
<b>Sample Analysed By:</b>	Reg 13(1)	<b>Extent:</b>	4 m <sup>2</sup>	
<b>Comments:</b> Acting as fire protection to metal ducting where it passes through the walls

<b>Material Assessment Total Score: 0</b>		<b>Likelihood of Disturbance Assessment Total Score: 0</b>		<b>Management Assessment</b>  <b>Licensable:</b> Yes  <b>Recommendations:</b> Not Applicable  <b>Reinspection Interval:</b> Not Applicable  <b>Overall Risk Category:</b> E0
<b>Product Type:</b>	0 Not Applicable	<b>Location:</b>	0 Not Applicable	
<b>Condition:</b>	0 Not Applicable	<b>Accessibility:</b>	0 Not Applicable	
<b>Surface Treatment:</b>	0 Not Applicable			
<b>Asbestos Type:</b>	0 Not Applicable	<b>Extent Score:</b>	0 Not Applicable

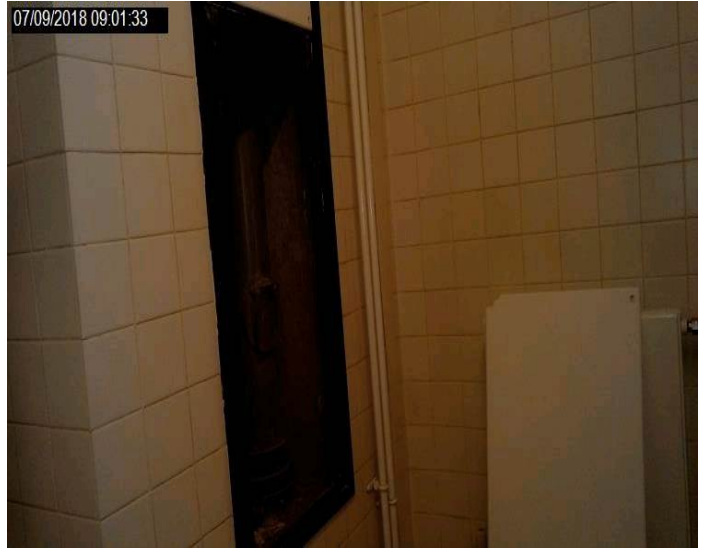
<b>Location:</b>	1.38	<b>Block:</b>	Birmingham City University	<b>Floor Level:</b> Ground Floor
<b>Sample No.:</b>	DU002303	<b>Portal Ref No.:</b>	314

<b>Item:</b>	Insulating board panel to riser			
<b>Asbestos Content:</b>		<b>Result Based on:</b>		
No Asbestos Detected		Analysis of sample using PLM		
<b>Sample Analysed By:</b>	Reg 13(1)	<b>Extent:</b>	2 m <sup>2</sup>	
<b>Comments:</b>

<b>Material Assessment Total Score: 0</b>		<b>Likelihood of Disturbance Assessment Total Score: 0</b>		<b>Management Assessment</b>  <b>Licensable:</b> Yes  <b>Recommendations:</b> Not Applicable  <b>Reinspection Interval:</b> Not Applicable  <b>Overall Risk Category:</b> E0
<b>Product Type:</b>	0 Not Applicable	<b>Location:</b>	0 Not Applicable	
<b>Condition:</b>	0 Not Applicable	<b>Accessibility:</b>	0 Not Applicable	
<b>Surface Treatment:</b>	0 Not Applicable			
<b>Asbestos Type:</b>	0 Not Applicable	<b>Extent Score:</b>	0 Not Applicable

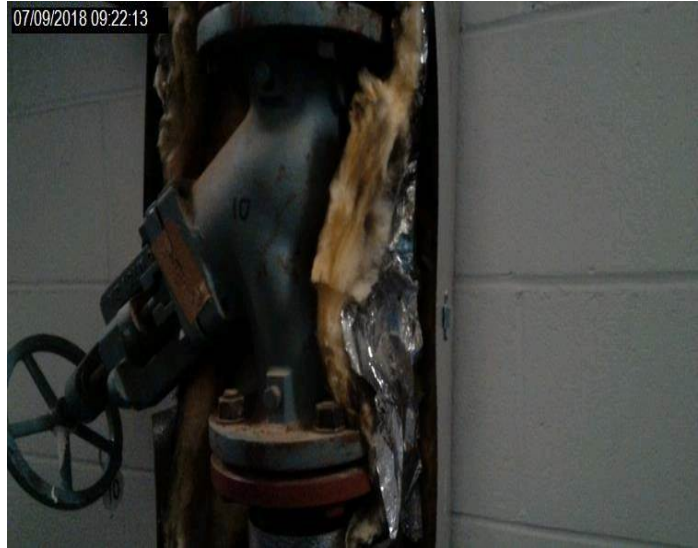
<b>Location:</b>	1.39	<b>Block:</b>	Birmingham City University	<b>Floor Level:</b> Ground Floor
<b>Sample No.:</b>	DU002304	<b>Portal Ref No.:</b>	316

<b>Item:</b>	Asbestos Compressed fibre gasket to pipework flanges			
<b>Asbestos Content:</b>	Result Based on:			
Chrysotile	Analysis of sample using PLM			
<b>Sample Analysed By:</b> Reg 13(1)	<b>Extent:</b>	20 units		
<b>Comments:</b>

<b>Material Assessment Total Score: 5</b>		<b>Likelihood of Disturbance Assessment Total Score: 4</b>		<b>Management Assessment</b>  <b>Licensable:</b> No  <b>Recommendations:</b> Program removal  <b>Reinspection Interval:</b> Not Applicable  <b>Overall Risk Category:</b> C9
<b>Product Type:</b>	2 (Compressed asbestos fibre)	<b>Location:</b>	2 (Rooms up to 100 sq m)	
<b>Condition:</b>	1 (Minor scratches)	<b>Accessibility:</b>	1 (Occasionally likely to be disturbed)	
<b>Surface Treatment:</b>	1 (Enclosed textile/paper)			
<b>Asbestos Type:</b>	1 (Chrysotile)	<b>Extent Score:</b>	1 (<10 sq m or 10m pipe run)

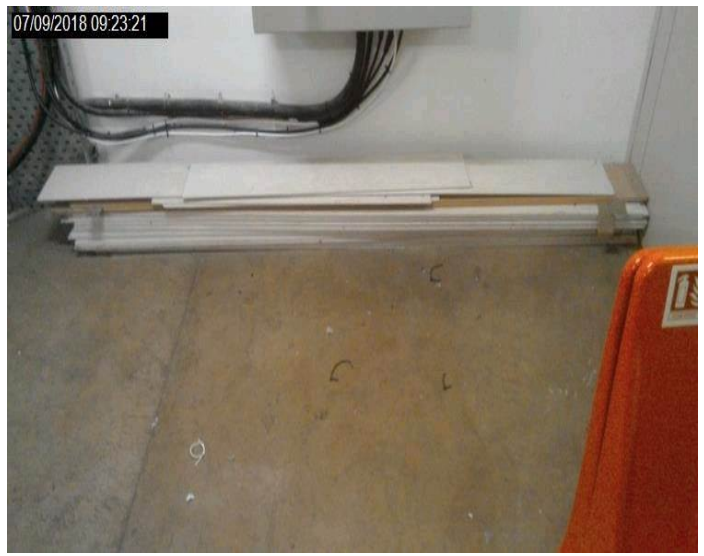
<b>Location:</b>	1.39	<b>Block:</b>	Birmingham City University	<b>Floor Level:</b> Ground Floor
<b>Sample No.:</b>	DU002305	<b>Portal Ref No.:</b>	317

<b>Item:</b>	Loose insulating board panels			
<b>Asbestos Content:</b>		<b>Result Based on:</b>		
No Asbestos Detected		Analysis of sample using PLM		
<b>Sample Analysed By:</b>	Reg 13(1)	<b>Extent:</b>	4 m <sup>2</sup>	
<b>Comments:</b>

<b>Material Assessment Total Score: 0</b>		<b>Likelihood of Disturbance Assessment Total Score: 0</b>		<b>Management Assessment</b>  <b>Licensable:</b> Yes  <b>Recommendations:</b> Not Applicable  <b>Reinspection Interval:</b> Not Applicable  <b>Overall Risk Category:</b> E0
<b>Product Type:</b>	0 Not Applicable	<b>Location:</b>	0 Not Applicable	
<b>Condition:</b>	0 Not Applicable	<b>Accessibility:</b>	0 Not Applicable	
<b>Surface Treatment:</b>	0 Not Applicable			
<b>Asbestos Type:</b>	0 Not Applicable	<b>Extent Score:</b>	0 Not Applicable

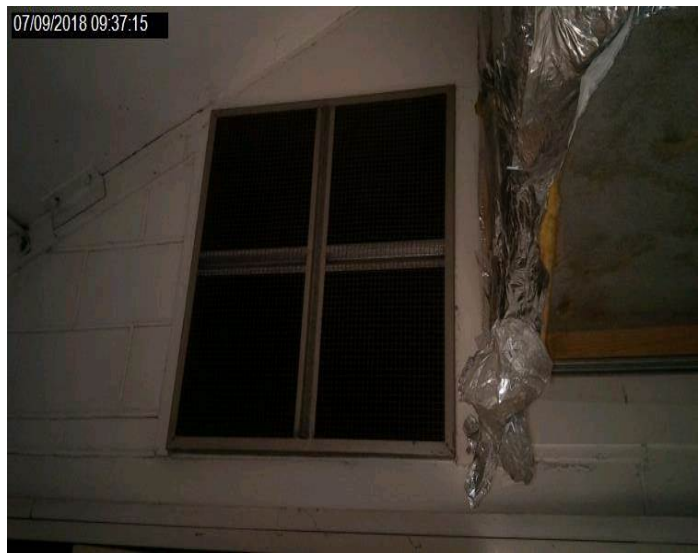
<b>Location:</b>	1.39C	<b>Block:</b>	Birmingham City University	<b>Floor Level:</b> Ground Floor
<b>Sample No.:</b>	DU002307	<b>Portal Ref No.:</b>	321

<b>Item:</b>	Insulating board fire break			
<b>Asbestos Content:</b>			<b>Result Based on:</b>	
No Asbestos Detected		Analysis of sample using PLM		
<b>Sample Analysed By:</b>	Reg 13(1)	<b>Extent:</b>	8 m <sup>2</sup>	
<b>Comments:</b> Firebreak where metal ducting passes through walls

<b>Material Assessment Total Score: 0</b>		<b>Likelihood of Disturbance Assessment Total Score: 0</b>		<b>Management Assessment</b>  <b>Licensable:</b> Yes  <b>Recommendations:</b> Not Applicable  <b>Reinspection Interval:</b> Not Applicable  <b>Overall Risk Category:</b> E0
<b>Product Type:</b>	0 Not Applicable	<b>Location:</b>	0 Not Applicable	
<b>Condition:</b>	0 Not Applicable	<b>Accessibility:</b>	0 Not Applicable	
<b>Surface Treatment:</b>	0 Not Applicable			
<b>Asbestos Type:</b>	0 Not Applicable	<b>Extent Score:</b>	0 Not Applicable

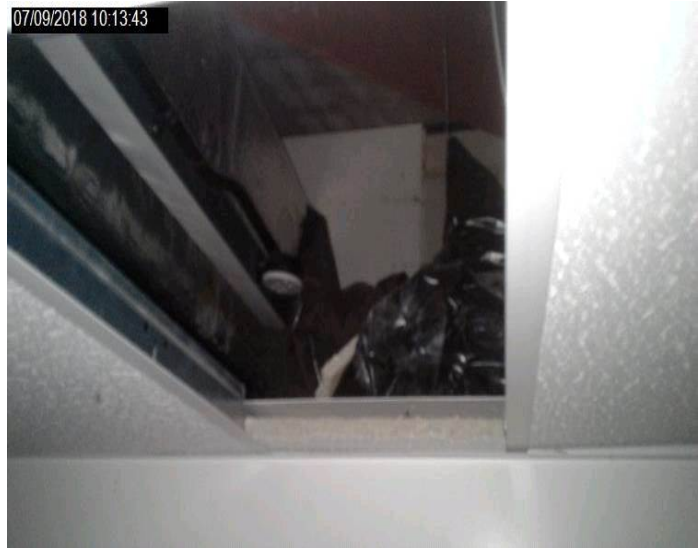
<b>Location:</b>	1.40	<b>Block:</b>	Birmingham City University	<b>Floor Level:</b> Ground Floor
<b>Sample No.:</b>	As DU002302	<b>Portal Ref No.:</b>	327

<b>Item:</b>	Insulating board panel			
<b>Asbestos Content:</b>		<b>Result Based on:</b>		
No Asbestos Detected		Strongly presumed		
<b>Sample Analysed By:</b>	Not applicable	<b>Extent:</b>	8 m <sup>2</sup>	
<b>Comments:</b> Acting as fire protection to metal ducting where it passes through the walls

<b>Material Assessment Total Score:</b> 0		<b>Likelihood of Disturbance Assessment Total Score:</b> 0		<b>Management Assessment</b>  <b>Licensable:</b> Yes  <b>Recommendations:</b> Not Applicable  <b>Reinspection Interval:</b> Not Applicable  <b>Overall Risk Category:</b> E0
<b>Product Type:</b>	0 Not Applicable	<b>Location:</b>	0 Not Applicable	
<b>Condition:</b>	0 Not Applicable	<b>Accessibility:</b>	0 Not Applicable	
<b>Surface Treatment:</b>	0 Not Applicable			
<b>Asbestos Type:</b>	0 Not Applicable	<b>Extent Score:</b>	0 Not Applicable

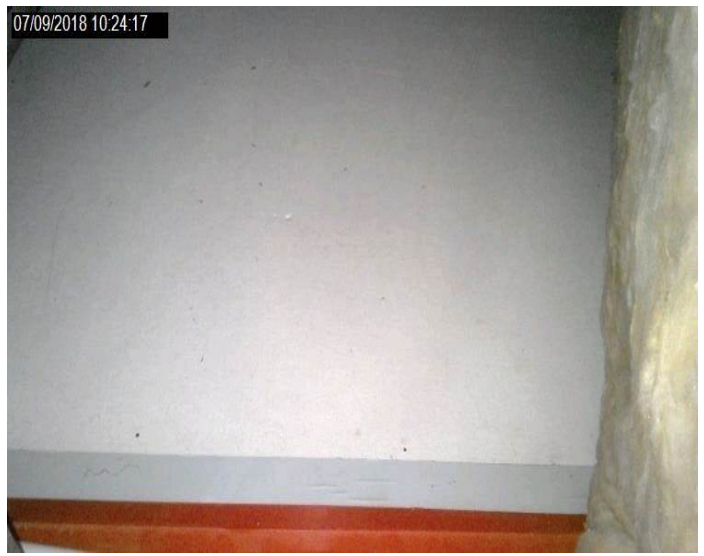
<b>Location:</b>	1.99C	<b>Block:</b>	Birmingham City University	<b>Floor Level:</b> Ground Floor
<b>Sample No.:</b>	DU002310	<b>Portal Ref No.:</b>	330

<b>Item:</b>	Insulating board header			
<b>Asbestos Content:</b>		<b>Result Based on:</b>		
No Asbestos Detected		Analysis of sample using PLM		
<b>Sample Analysed By:</b>	Reg 13(1)	<b>Extent:</b>	4 m <sup>2</sup>	
<b>Comments:</b> Above double doors within ceiling void

<b>Material Assessment Total Score: 0</b>		<b>Likelihood of Disturbance Assessment Total Score: 0</b>		<b>Management Assessment</b>  <b>Licensable:</b> Yes  <b>Recommendations:</b> Not Applicable  <b>Reinspection Interval:</b> Not Applicable  <b>Overall Risk Category:</b> E0
<b>Product Type:</b>	0 Not Applicable	<b>Location:</b>	0 Not Applicable	
<b>Condition:</b>	0 Not Applicable	<b>Accessibility:</b>	0 Not Applicable	
<b>Surface Treatment:</b>	0 Not Applicable			
<b>Asbestos Type:</b>	0 Not Applicable	<b>Extent Score:</b>	0 Not Applicable

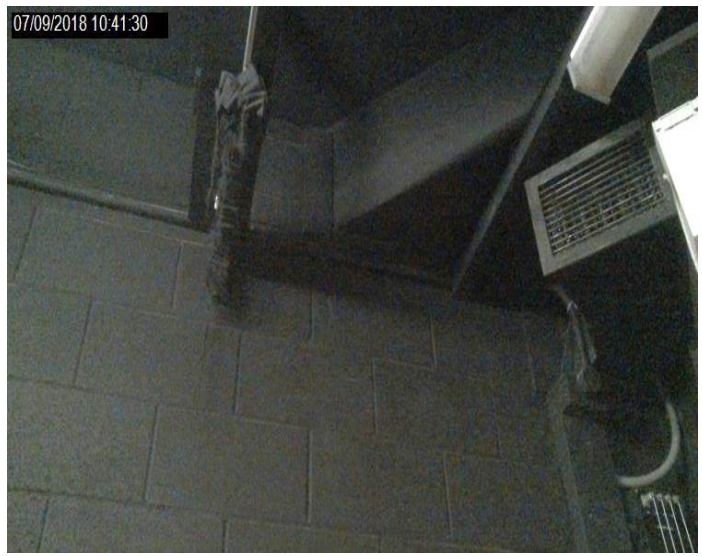
<b>Location:</b>	1.40B	<b>Block:</b>	Birmingham City University	<b>Floor Level:</b> Ground Floor
<b>Sample No.:</b>	DU002312	<b>Portal Ref No.:</b>	332

<b>Item:</b>	Insulating board panels			
<b>Asbestos Content:</b>		<b>Result Based on:</b>		
No Asbestos Detected		Analysis of sample using PLM		
<b>Sample Analysed By:</b>	Reg 13(1)	<b>Extent:</b>	4 m <sup>2</sup>	
<b>Comments:</b> Where ducting passes through the walls

<b>Material Assessment Total Score: 0</b>		<b>Likelihood of Disturbance Assessment Total Score: 0</b>		<b>Management Assessment</b>  <b>Licensable:</b> Yes  <b>Recommendations:</b> Not Applicable  <b>Reinspection Interval:</b> Not Applicable  <b>Overall Risk Category:</b> E0
<b>Product Type:</b>	0 Not Applicable	<b>Location:</b>	0 Not Applicable	
<b>Condition:</b>	0 Not Applicable	<b>Accessibility:</b>	0 Not Applicable	
<b>Surface Treatment:</b>	0 Not Applicable			
<b>Asbestos Type:</b>	0 Not Applicable	<b>Extent Score:</b>	0 Not Applicable

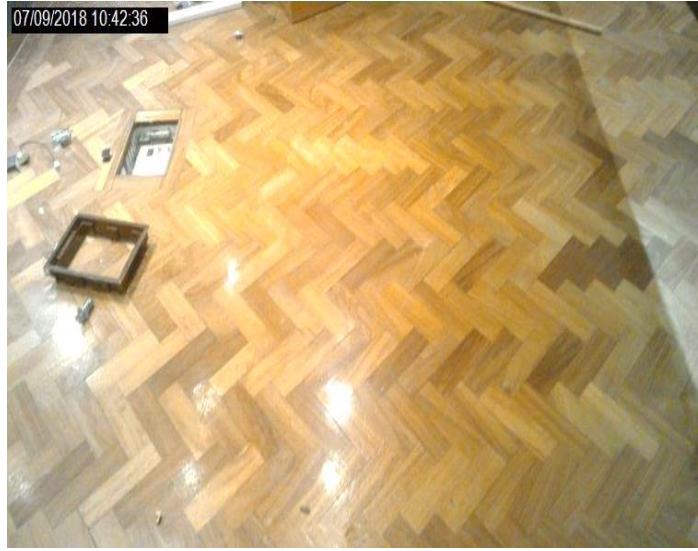
<b>Location:</b>	1.40B	<b>Block:</b>	Birmingham City University	<b>Floor Level:</b> Ground Floor
<b>Sample No.:</b>	DU002313	<b>Portal Ref No.:</b>	333

<b>Item:</b>	Bitumen adhesive			
<b>Asbestos Content:</b>		<b>Result Based on:</b>		
No Asbestos Detected		Analysis of sample using PLM		
<b>Sample Analysed By:</b>	Reg 13(1)	<b>Extent:</b>	40 m <sup>2</sup>	
<b>Comments:</b> Beneath parquet flooring

<b>Material Assessment Total Score: 0</b>		<b>Likelihood of Disturbance Assessment Total Score: 0</b>		<b>Management Assessment</b>  <b>Licensable:</b> No  <b>Recommendations:</b> Not Applicable  <b>Reinspection Interval:</b> Not Applicable  <b>Overall Risk Category:</b> E0
<b>Product Type:</b>	0 Not Applicable	<b>Location:</b>	0 Not Applicable	
<b>Condition:</b>	0 Not Applicable	<b>Accessibility:</b>	0 Not Applicable	
<b>Surface Treatment:</b>	0 Not Applicable			
<b>Asbestos Type:</b>	0 Not Applicable	<b>Extent Score:</b>	0 Not Applicable

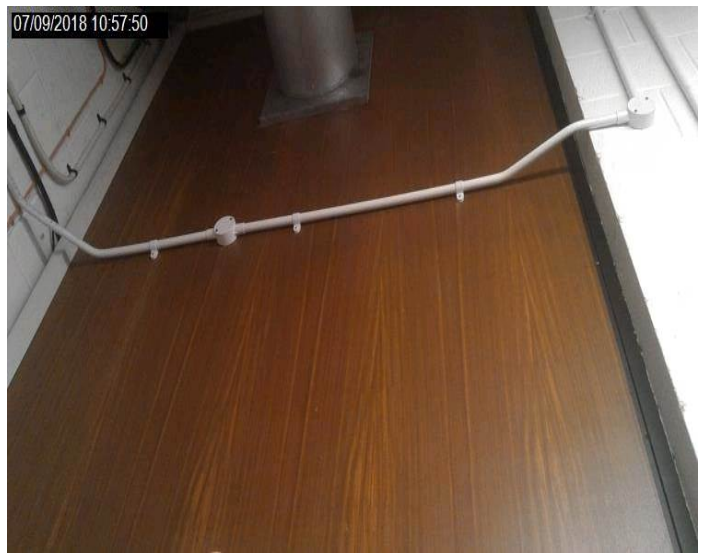
<b>Location:</b>	1.32	<b>Block:</b>	Birmingham City University	<b>Floor Level:</b> Ground Floor
<b>Sample No.:</b>	DU002314	<b>Portal Ref No.:</b>	334

<b>Item:</b>	Insulating board door header			
<b>Asbestos Content:</b>		<b>Result Based on:</b>		
No Asbestos Detected		Analysis of sample using PLM		
<b>Sample Analysed By:</b>	Reg 13(1)	<b>Extent:</b>	6 m <sup>2</sup>	
<b>Comments:</b> Behind timber panel

<b>Material Assessment Total Score: 0</b>		<b>Likelihood of Disturbance Assessment Total Score: 0</b>		<b>Management Assessment</b>  <b>Licensable:</b> Yes  <b>Recommendations:</b> Not Applicable  <b>Reinspection Interval:</b> Not Applicable  <b>Overall Risk Category:</b> E0
<b>Product Type:</b>	0 Not Applicable	<b>Location:</b>	0 Not Applicable	
<b>Condition:</b>	0 Not Applicable	<b>Accessibility:</b>	0 Not Applicable	
<b>Surface Treatment:</b>	0 Not Applicable			
<b>Asbestos Type:</b>	0 Not Applicable	<b>Extent Score:</b>	0 Not Applicable

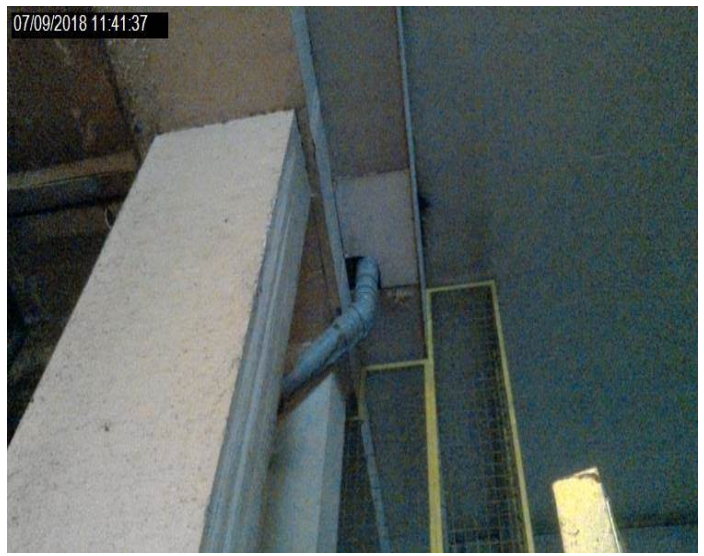
<b>Location:</b>	Roadway	<b>Block:</b>	Birmingham City University	<b>Floor Level:</b> E - External
<b>Sample No.:</b>	DU002315	<b>Portal Ref No.:</b>	338

<b>Item:</b>	Insulating board panel			
<b>Asbestos Content:</b>		<b>Result Based on:</b>		
No Asbestos Detected		Analysis of sample using PLM		
<b>Sample Analysed By:</b>	Reg 13(1)	<b>Extent:</b>	1 m <sup>2</sup>	
<b>Comments:</b> Glasroc sampled to prove negative

<b>Material Assessment Total Score:</b> 0		<b>Likelihood of Disturbance Assessment Total Score:</b> 0		<b>Management Assessment</b>  <b>Licensable:</b> Yes  <b>Recommendations:</b> Not Applicable  <b>Reinspection Interval:</b> Not Applicable  <b>Overall Risk Category:</b> E0
<b>Product Type:</b>	0 Not Applicable	<b>Location:</b>	0 Not Applicable	
<b>Condition:</b>	0 Not Applicable	<b>Accessibility:</b>	0 Not Applicable	
<b>Surface Treatment:</b>	0 Not Applicable			
<b>Asbestos Type:</b>	0 Not Applicable	<b>Extent Score:</b>	0 Not Applicable

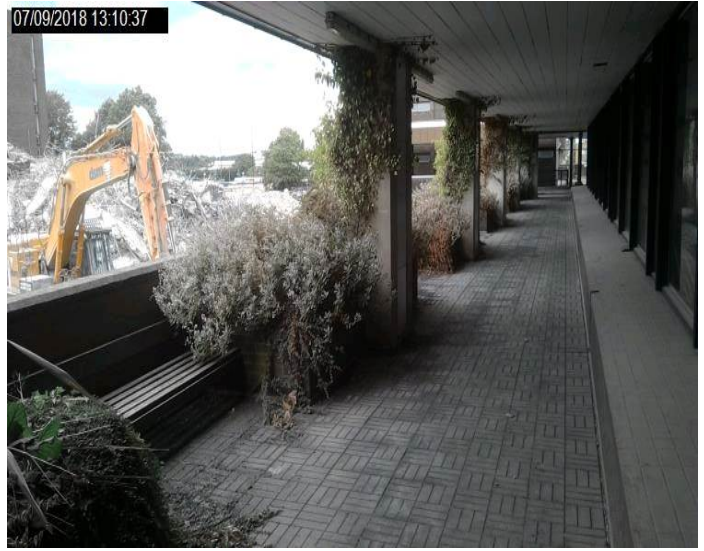
<b>Location:</b>	Walkway off level 2	<b>Block:</b>	Birmingham City University	<b>Floor Level:</b> E - External
<b>Sample No.:</b>	DU002318	<b>Portal Ref No.:</b>	341

<b>Item:</b>	Insulating board panels to risers			
<b>Asbestos Content:</b>		<b>Result Based on:</b>		
No Asbestos Detected		Analysis of sample using PLM		
<b>Sample Analysed By:</b>	Reg 13(1)	<b>Extent:</b>	45 m <sup>2</sup>	
<b>Comments:</b> 13 x risers, mixture of timber and insulating board

<b>Material Assessment Total Score: 0</b>		<b>Likelihood of Disturbance Assessment Total Score: 0</b>		<b>Management Assessment</b>  <b>Licensable:</b> Yes  <b>Recommendations:</b> Not Applicable  <b>Reinspection Interval:</b> Not Applicable  <b>Overall Risk Category:</b> E0
<b>Product Type:</b>	0 Not Applicable	<b>Location:</b>	0 Not Applicable	
<b>Condition:</b>	0 Not Applicable	<b>Accessibility:</b>	0 Not Applicable	
<b>Surface Treatment:</b>	0 Not Applicable			
<b>Asbestos Type:</b>	0 Not Applicable	<b>Extent Score:</b>	0 Not Applicable

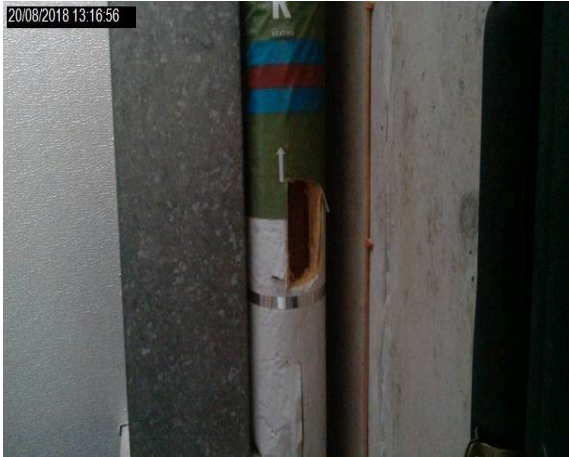
Intrusion 01 - Metal pipework beneath glass fibre insulation

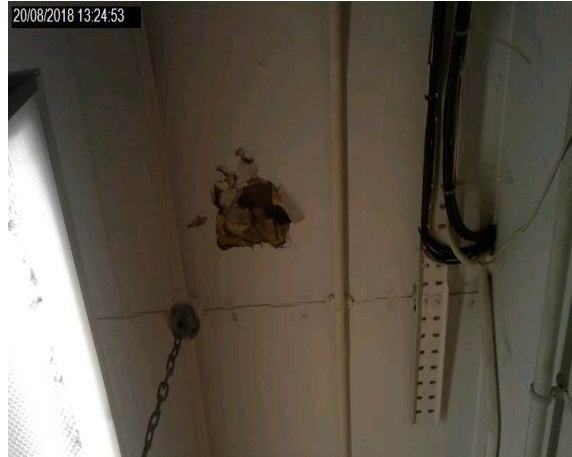
Intrusion 02 - Foam panels to concrete

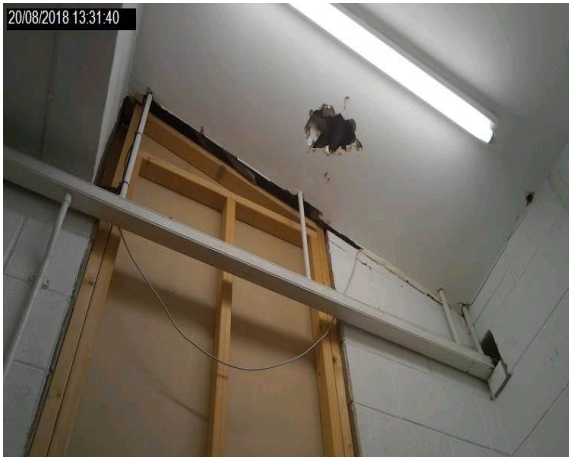
Intrusion 03 - Plaster to plasterboard to glass fibre insulation to timber panel

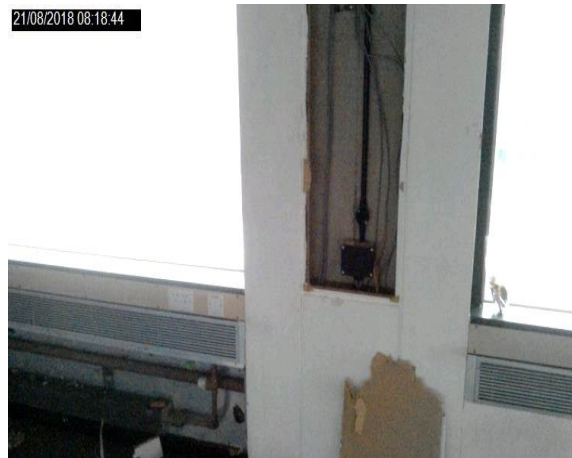
Intrusion 04 - Concrete pillar behind riser panel

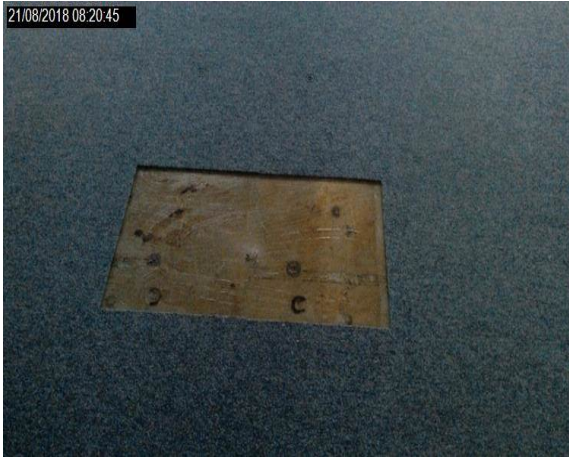
Intrusion 05 - Carpet tiles to concrete

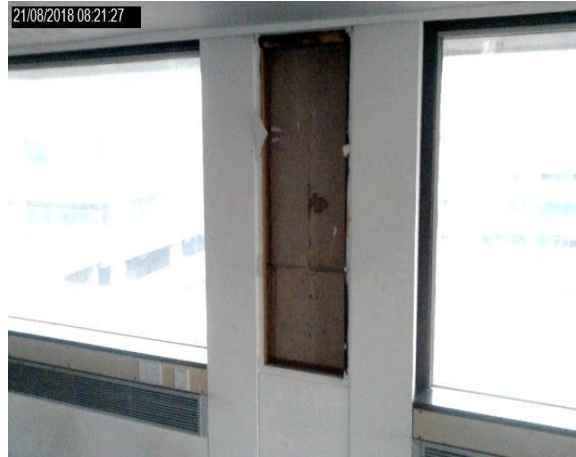
Intrusion 06 - Concrete pillar behind riser panels

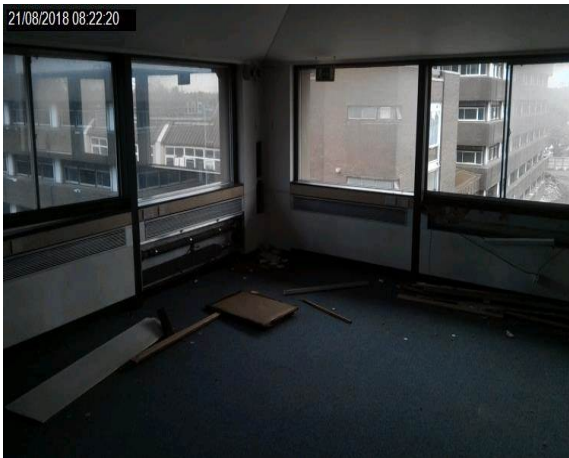
Intrusion 07 - Low level timber panels to wall void heaters

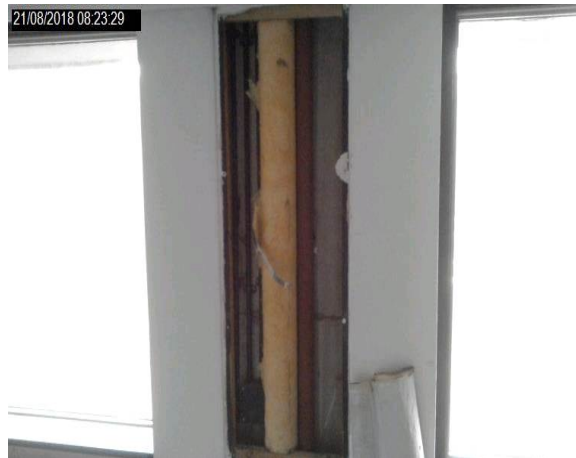
Intrusion 08 - Glass fibre insulation to metal pipework

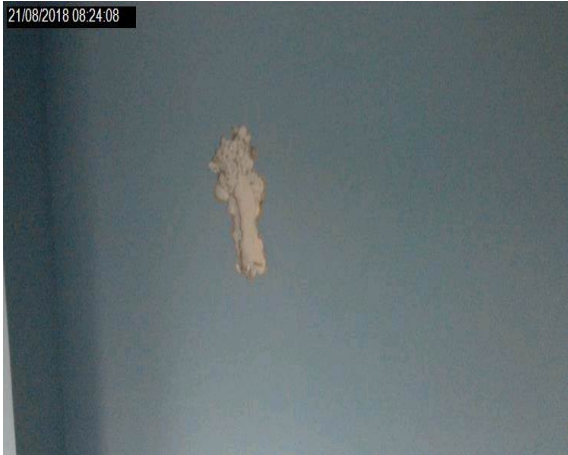
Intrusion 09 - Plasterboard to plaster to concrete

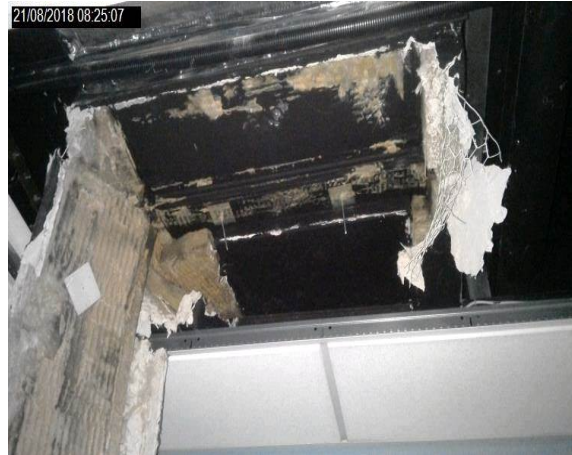
Intrusion 10 - Glassfibre insulation to metal ducting

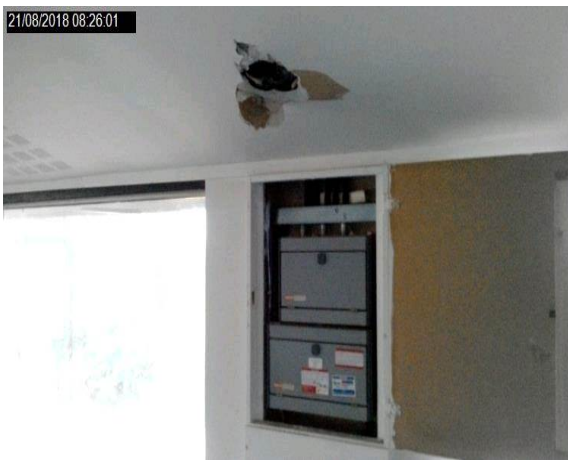
Intrusion 11 - Timber panels to modern electrics, plaster to plasterboard ceiling

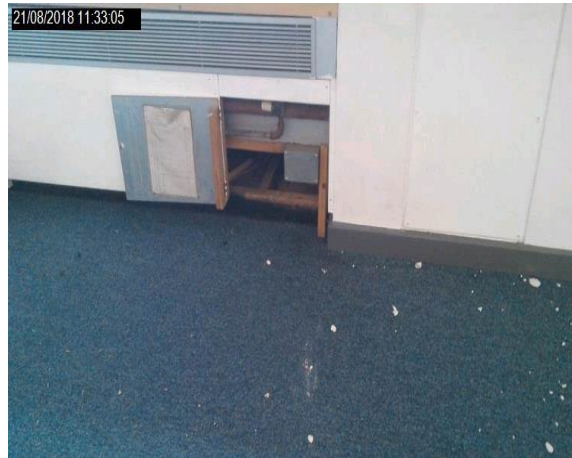
Intrusion 18 - Timber panel to timber shuttering to perimeter of building

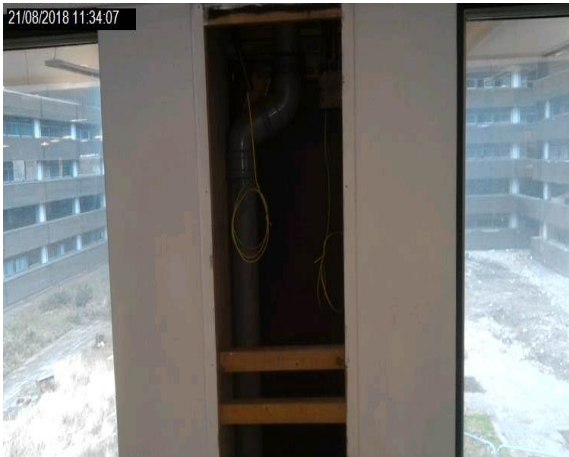
Intrusion 19 - Plastic pipework internally to riser

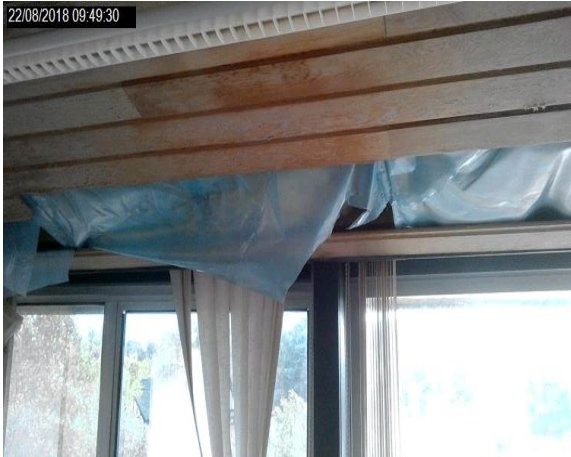
Intrusion 30 - Timber shuttering to underside of external wall; wall void

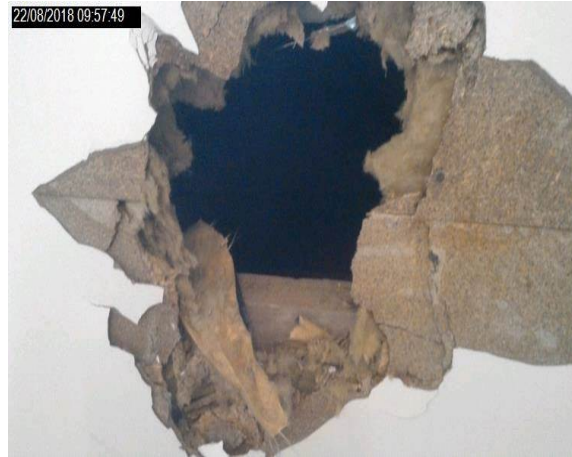
Intrusion 31 - Metal cladding within wall void

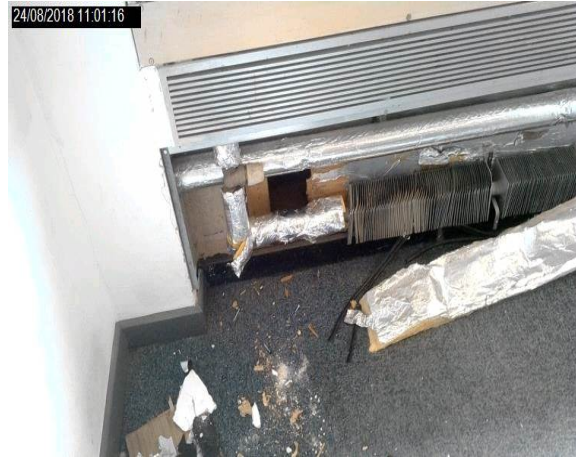
Intrusion 39 - Accessed wall void

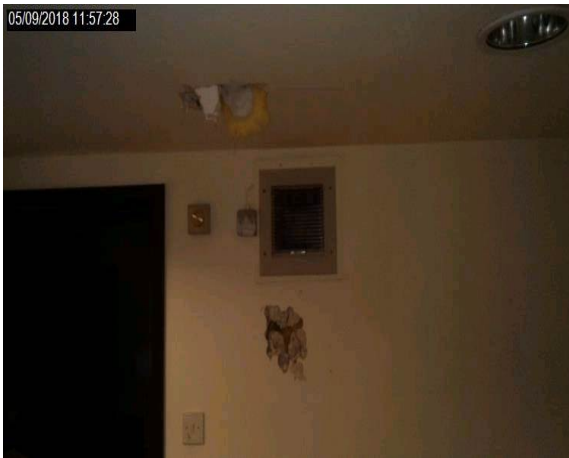
Intrusion 44 - Modern damp proof

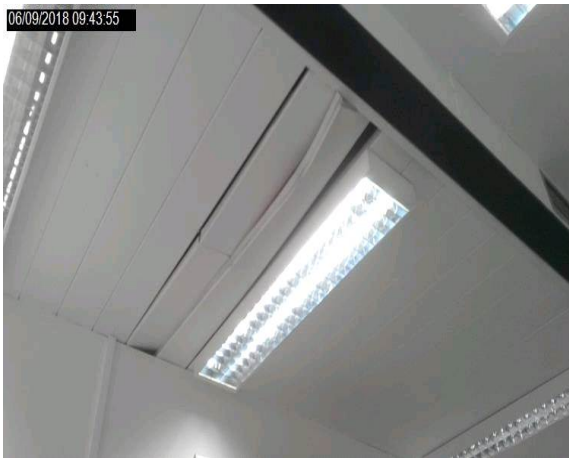
Intrusion 48 - Foam insulation panels behind plasterboard to concrete

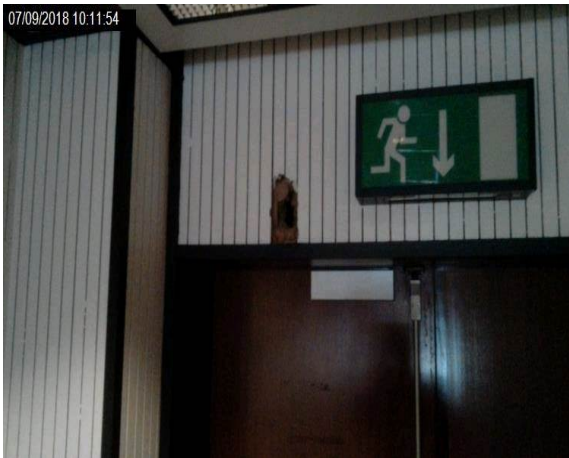
Intrusion 56 - Insulating board panel to rear of redundant door

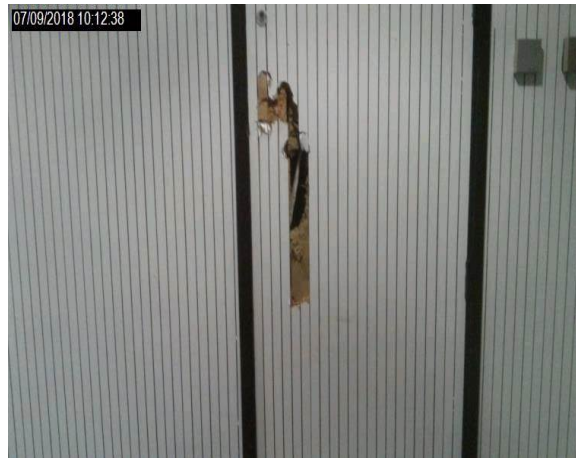
Intrusion 57 - Fibreglass panels to concrete riser
