Report No.: J102748
Nature of Work: Demolition Survey
Issue Date: 31/10/2018
Client Name: WYG Engineering Ltd
Geneva Building, Lake View Drive, Sherwood Business Park,
Annesley, Nottingham, NG15 0ED
Site Address: Baker Building, Former City North Campus, Birmingham City
University, Perry Barr, B42 2US

A demolition survey in line with HSG264 Asbestos: The Survey Guide was carried out internally and externally to the property.

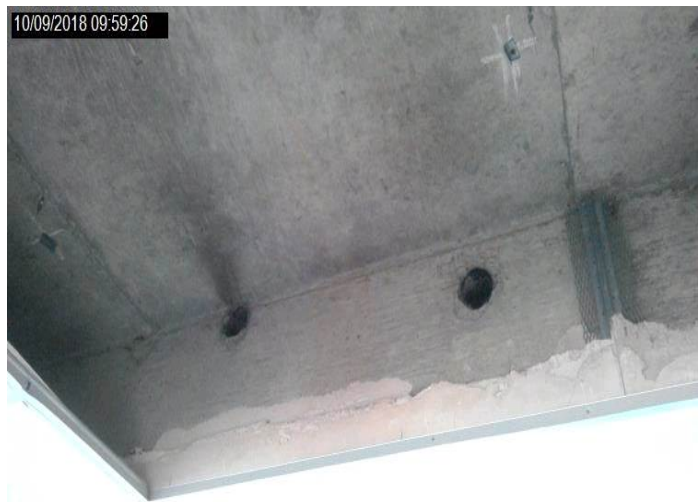
Location:	NBA814	Block:	Birmingham City University	Floor Level: 8th Floor
Sample No.:	DU002319	Portal Ref No.:	1

Item:	Asbestos Reinforced plastic pipe sleeve			
Asbestos Content:	Result Based on:			
Chrysotile	Analysis of sample using PLM			
Sample Analysed By:	[REDACTED]	Extent:	6 units	
Comments: Wall which runs parallel to the corridor

Material Assessment Total Score: 3		Likelihood of Disturbance Assessment Total Score: 3		Management Assessment Licensable: No Recommendations: Program removal Reinspection Interval: Not Applicable Overall Risk Category: D6
Product Type:	1 (Asbestos reinforced plastic)	Location:	2 (Rooms up to 100 sq m)	
Condition:	1 (Minor scratches)	Accessibility:	0 (Usually inaccessible or unlikely to be disturbed)	
Surface Treatment:	0 (Composite material)			
Asbestos Type:	1 (Chrysotile)	Extent Score:	1 (<10 sq m or 10m pipe run)

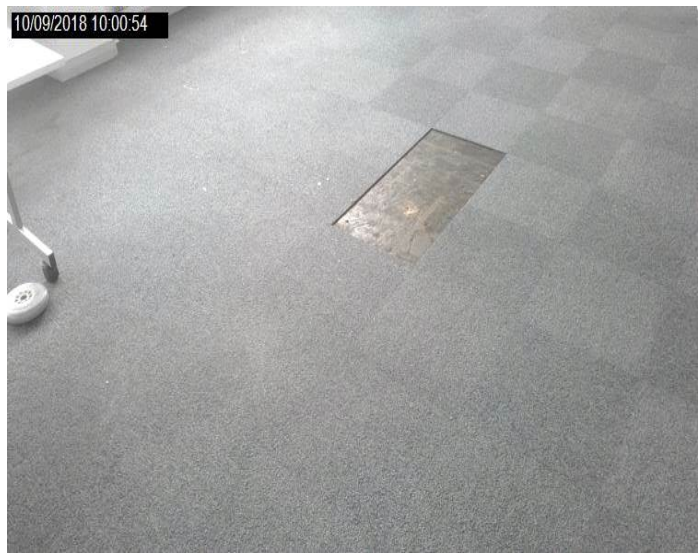
Location:	NBA814	Block:	Birmingham City University	Floor Level: 8th Floor
Sample No.:	DU002320	Portal Ref No.:	2

Item:	Asbestos Bitumen adhesive			
Asbestos Content:	Result Based on:			
Chrysotile	Analysis of sample using PLM			
Sample Analysed By:	Reg 13(1)	Extent:	48 m ²	
Comments:

Material Assessment Total Score: 3		Likelihood of Disturbance Assessment Total Score: 5		Management Assessment Licensable: No Recommendations: Program removal Reinspection Interval: Not Applicable Overall Risk Category: C8
Product Type:	1 (Asbestos bitumen)	Location:	2 (Rooms up to 100 sq m)	
Condition:	1 (Minor scratches)	Accessibility:	1 (Occasionally likely to be disturbed)	
Surface Treatment:	0 (Composite material)			
Asbestos Type:	1 (Chrysotile)	Extent Score:	2 (>10 - <50 sq m or >10m - <50m pipe run)

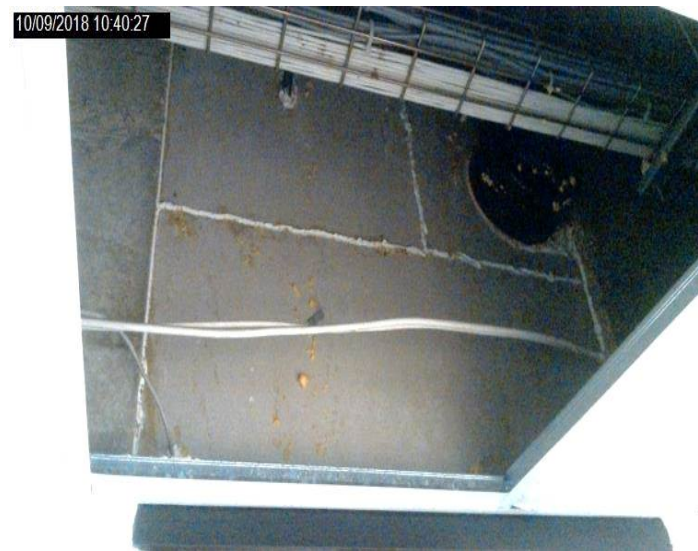
Location:	NBA817B Service duct	Block:	Birmingham City University	Floor Level: 8th Floor
Sample No.:	DU002322	Portal Ref No.:	8

Item:	Insulating board door header			
Asbestos Content:		Result Based on:		
No Asbestos Detected		Analysis of sample using PLM		
Sample Analysed By:	Reg 13(1)	Extent:	1 m ²	
Comments:

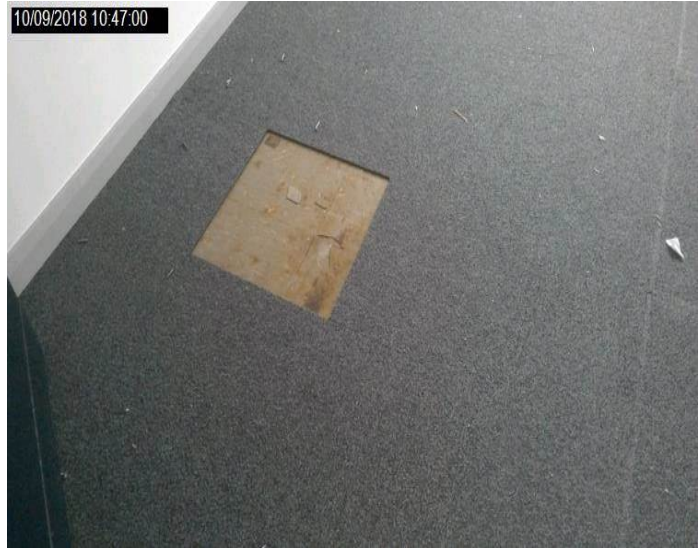
Location:	NBA818	Block:	Birmingham City University	Floor Level: 8th Floor
Sample No.:	DU002324	Portal Ref No.:	11

Item:	Asbestos Vinyl			
Asbestos Content:	Result Based on:			
Chrysotile in vinyl only	Analysis of sample using PLM			
Sample Analysed By:	Reg 13(1)	Extent:	10 m ²	
Comments:

Material Assessment Total Score: 3		Likelihood of Disturbance Assessment Total Score: 4		Management Assessment Licensable: No Recommendations: Program removal Reinspection Interval: Not Applicable Overall Risk Category: C7
Product Type:	1 (Asbestos vinyl)	Location:	2 (Rooms up to 100 sq m)	
Condition:	1 (Minor scratches)	Accessibility:	1 (Occasionally likely to be disturbed)	
Surface Treatment:	0 (Composite material)			
Asbestos Type:	1 (Chrysotile)	Extent Score:	1 (<10 sq m or 10m pipe run)

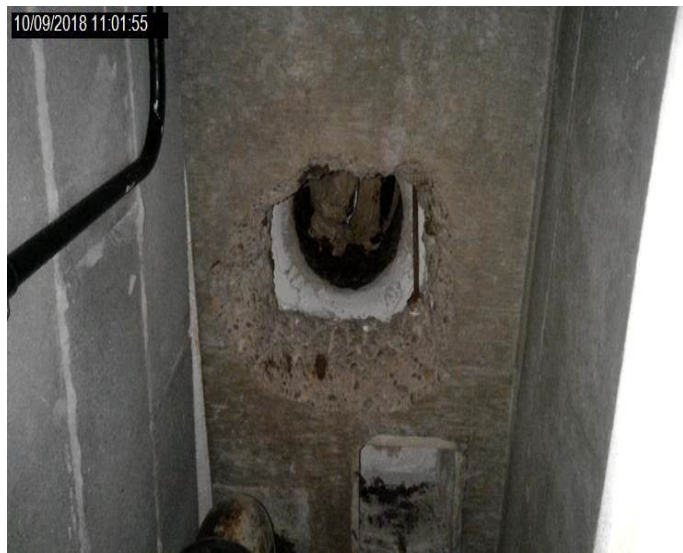
Location:	NBA819A Service duct	Block:	Birmingham City University	Floor Level: 8th Floor
Sample No.:	DU002325	Portal Ref No.:	12

Item:	Asbestos Insulating board			
Asbestos Content:	Result Based on:			
Chrysotile	Analysis of sample using PLM			
Sample Analysed By: Reg 13(1)	Extent:	4 m ²		
Comments: Where former pipework openings pass through to the roof covering, difficult to determine the extent

Material Assessment Total Score: 5		Likelihood of Disturbance Assessment Total Score: 3		Management Assessment Licensable: Yes Recommendations: Program removal Reinspection Interval: Not Applicable Overall Risk Category: C8
Product Type:	2 (Asbestos insulating board)	Location:	2 (Rooms up to 100 sq m)	
Condition:	1 (Minor scratches)	Accessibility:	0 (Usually inaccessible or unlikely to be disturbed)	
Surface Treatment:	1 (Encapsulated asbestos insulating board)			
Asbestos Type:	1 (Chrysotile)	Extent Score:	1 (<10 sq m or 10m pipe run)

Room NBA819A service duct 8th floor, insulating board ceiling panels identified unsure of the absolute extent of the item therefore I recommend further investigative works by way of core hole investigation either side of the room by a licensed contractor to establish the true extent of the item

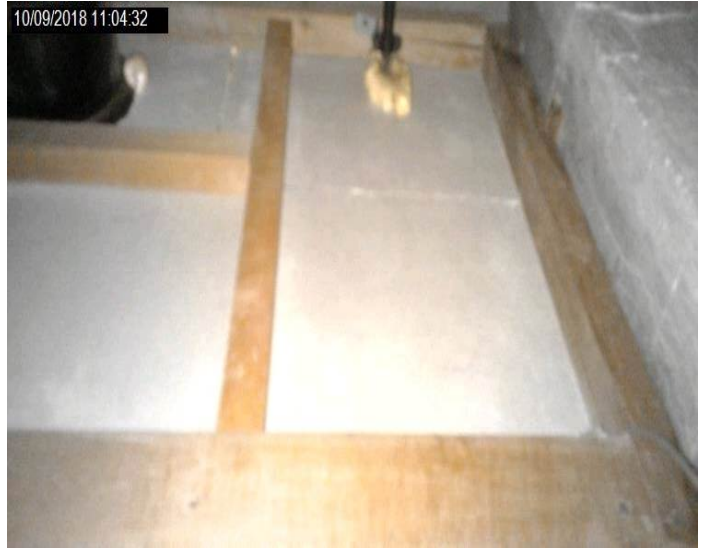
Location:	NBA819A Service duct	Block:	Birmingham City University	Floor Level: 8th Floor
Sample No.:	As DU002322	Portal Ref No.:	13

Item:	Insulating board door header			
Asbestos Content:		Result Based on:		
No Asbestos Detected		Strongly presumed		
Sample Analysed By:	Not applicable	Extent:	1 m ²	
Comments:

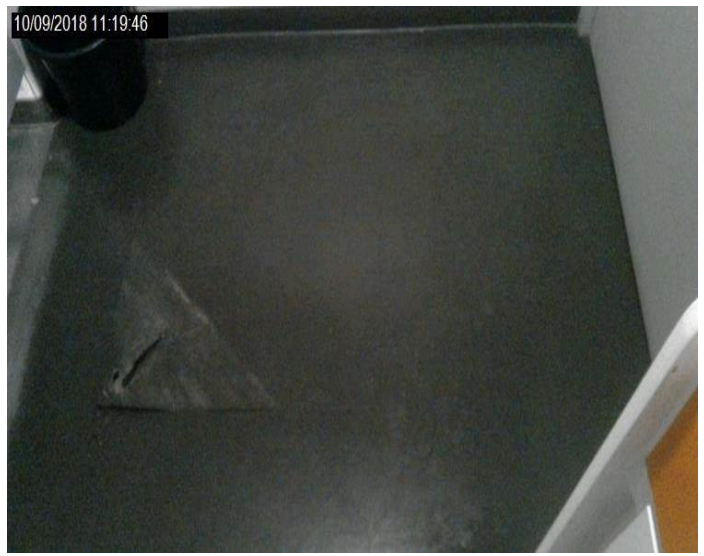
Location:	NBA819	Block:	Birmingham City University	Floor Level: 8th Floor
Sample No.:	DU002327	Portal Ref No.:	17

Item:	Vinyl			
Asbestos Content:		Result Based on:		
No Asbestos Detected in vinyl or adhesive		Analysis of sample using PLM		
Sample Analysed By:	Reg 13(1)	Extent:	10 m ²	
Comments:

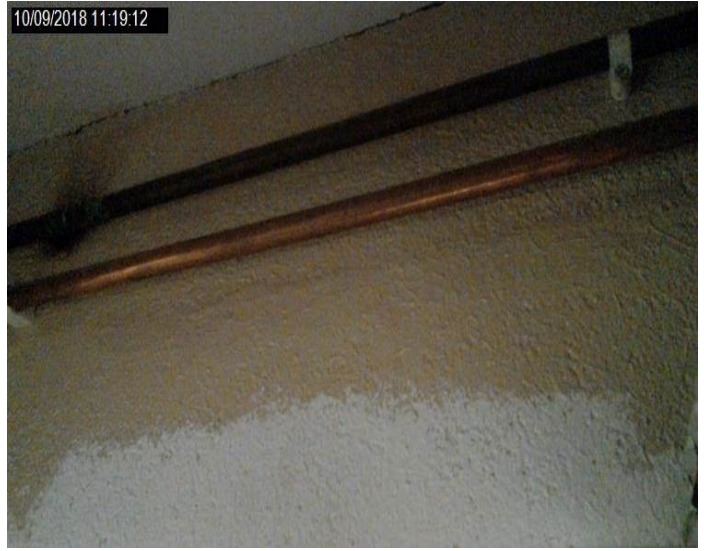
Location:	NBA819	Block:	Birmingham City University	Floor Level: 8th Floor
Sample No.:	DU002326	Portal Ref No.:	18

Item:	Textured coating to block wall			
Asbestos Content:		Result Based on:		
No Asbestos Detected		Analysis of sample using PLM		
Sample Analysed By:	Reg 13(1)	Extent:	20 m ²	
Comments:

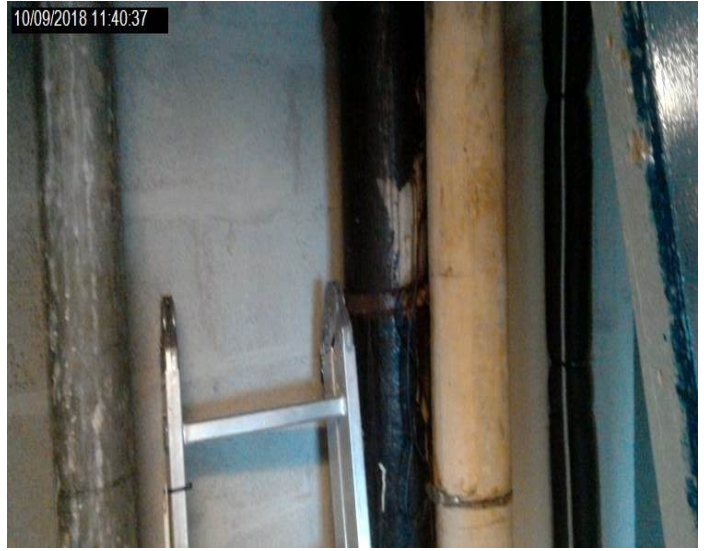
Location:	NBA820E Service duct	Block:	Birmingham City University	Floor Level: 8th Floor
Sample No.:	As DU002323	Portal Ref No.:	20

Item:	Asbestos Reinforced plastic downpipe			
Asbestos Content:	Result Based on:			
Chrysotile	Strongly presumed			
Sample Analysed By:	Not applicable	Extent:	3 linear metres	
Comments:

Material Assessment Total Score: 3		Likelihood of Disturbance Assessment Total Score: 4		Management Assessment Licensable: No Recommendations: Program removal Reinspection Interval: Not Applicable Overall Risk Category: C7
Product Type:	1 (Asbestos reinforced plastic)	Location:	2 (Rooms up to 100 sq m)	
Condition:	1 (Minor scratches)	Accessibility:	1 (Occasionally likely to be disturbed)	
Surface Treatment:	0 (Composite material)			
Asbestos Type:	1 (Chrysotile)	Extent Score:	1 (<10 sq m or 10m pipe run)

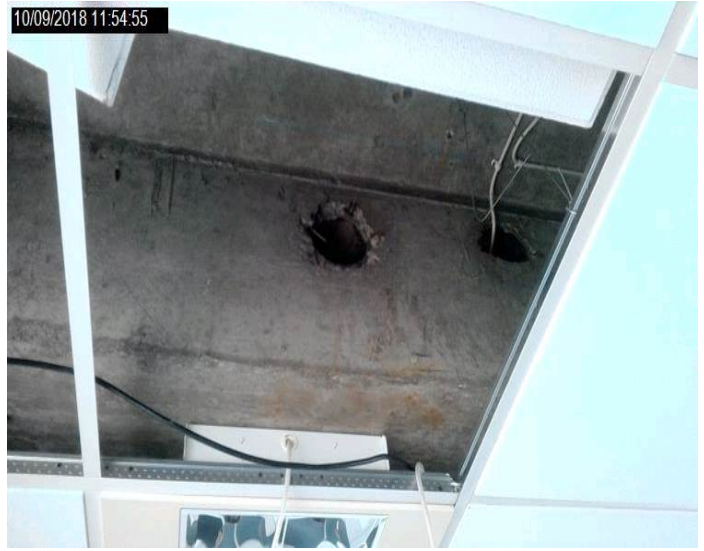
Location:	NBA811	Block:	Birmingham City University	Floor Level: 8th Floor
Sample No.:	DU002328	Portal Ref No.:	23

Item:	Asbestos Reinforced plastic pipe sleeve			
Asbestos Content:	Result Based on:			
Chrysotile	Analysis of sample using PLM			
Sample Analysed By: Reg 13(1)	Extent:	10 units		
Comments: Within concrete structure, beams across room within ceiling

Material Assessment Total Score: 3		Likelihood of Disturbance Assessment Total Score: 3		Management Assessment Licensable: No Recommendations: Program removal Reinspection Interval: Not Applicable Overall Risk Category: D6
Product Type:	1 (Asbestos reinforced plastic)	Location:	2 (Rooms up to 100 sq m)	
Condition:	1 (Minor scratches)	Accessibility:	0 (Usually inaccessible or unlikely to be disturbed)	
Surface Treatment:	0 (Composite material)			
Asbestos Type:	1 (Chrysotile)	Extent Score:	1 (<10 sq m or 10m pipe run)

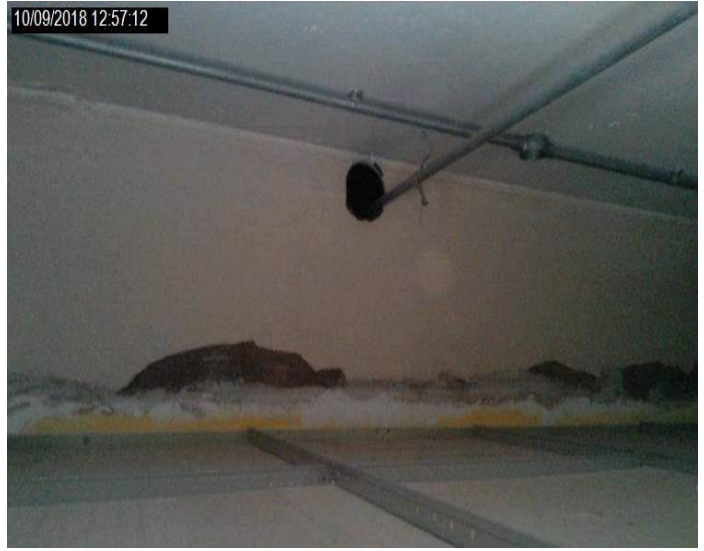
Location:	NBA808A	Block:	Birmingham City University	Floor Level: 8th Floor
Sample No.:	As DU002328	Portal Ref No.:	24

Item:	Asbestos Reinforced plastic pipe sleeve			
Asbestos Content:	Result Based on:			
Chrysotile	Strongly presumed			
Sample Analysed By:	Not applicable	Extent:	3 units	
Comments: Within concrete structure, beams across room within ceiling

Material Assessment Total Score: 3		Likelihood of Disturbance Assessment Total Score: 3		Management Assessment Licensable: No Recommendations: Program removal Reinspection Interval: Not Applicable Overall Risk Category: D6
Product Type:	1 (Asbestos reinforced plastic)	Location:	2 (Rooms up to 100 sq m)	
Condition:	1 (Minor scratches)	Accessibility:	0 (Usually inaccessible or unlikely to be disturbed)	
Surface Treatment:	0 (Composite material)			
Asbestos Type:	1 (Chrysotile)	Extent Score:	1 (<10 sq m or 10m pipe run)

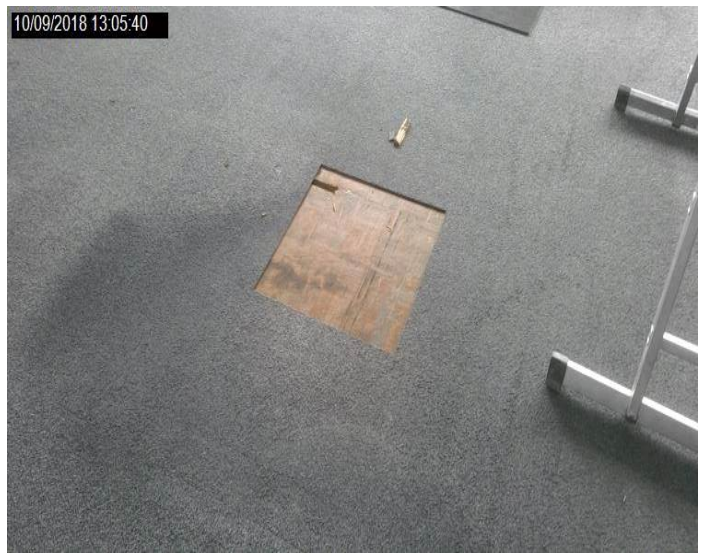
Location:	NBA806A	Block:	Birmingham City University	Floor Level: 8th Floor
Sample No.:	DU002329	Portal Ref No.:	26

Item:	Bitumen adhesive to parquet flooring			
Asbestos Content:	Result Based on:			
No Asbestos Detected	Analysis of sample using PLM			
Sample Analysed By:	Reg 13(1)	Extent:	35 m ²	
Comments:

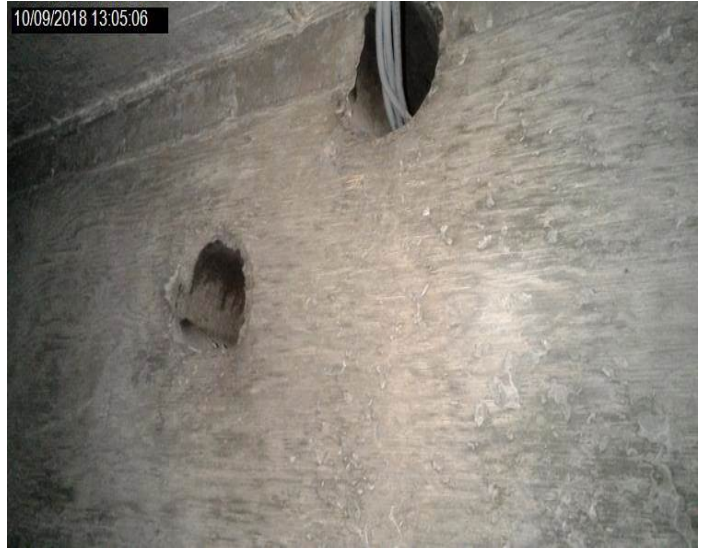
Location:	NBA806A	Block:	Birmingham City University	Floor Level: 8th Floor
Sample No.:	As DU002328	Portal Ref No.:	27

Item:	Asbestos Reinforced plastic sleeve			
Asbestos Content:	Result Based on:			
Chrysotile	Strongly presumed			
Sample Analysed By:	Not applicable	Extent:	10 units	
Comments: Within concrete structure, beams across room within ceiling

Material Assessment Total Score: 3		Likelihood of Disturbance Assessment Total Score: 3		Management Assessment Licensable: No Recommendations: Program removal Reinspection Interval: Not Applicable Overall Risk Category: D6
Product Type:	1 (Asbestos reinforced plastic)	Location:	2 (Rooms up to 100 sq m)	
Condition:	1 (Minor scratches)	Accessibility:	0 (Usually inaccessible or unlikely to be disturbed)	
Surface Treatment:	0 (Composite material)			
Asbestos Type:	1 (Chrysotile)	Extent Score:	1 (<10 sq m or 10m pipe run)

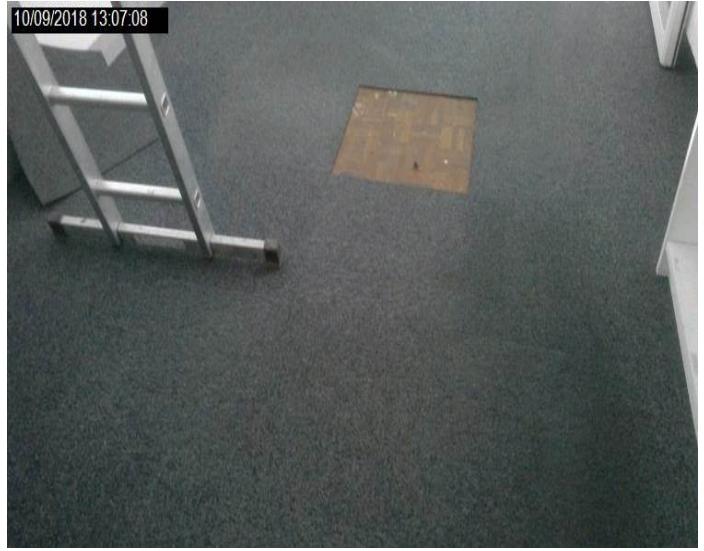
Location:	NBA806B	Block:	Birmingham City University	Floor Level: 8th Floor
Sample No.:	As DU002329	Portal Ref No.:	28

Item:	Bitumen adhesive to parquet flooring			
Asbestos Content:		Result Based on:		
No Asbestos Detected		Strongly presumed		
Sample Analysed By:	Not applicable	Extent:	12 m ²	
Comments:

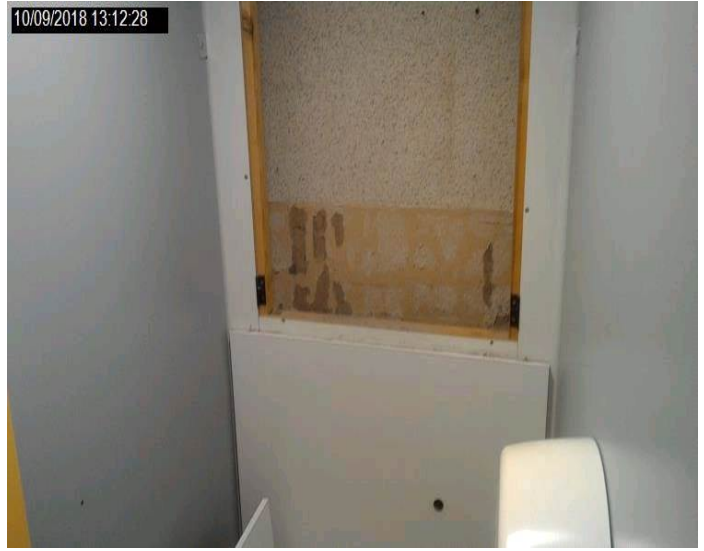
Location:	NBA820	Block:	Birmingham City University	Floor Level: 8th Floor
Sample No.:	As DU002326	Portal Ref No.:	30

Item:	Textured coating to block wall			
Asbestos Content:		Result Based on:		
No Asbestos Detected		Strongly presumed		
Sample Analysed By:	Not applicable	Extent:	20 m ²	
Comments:

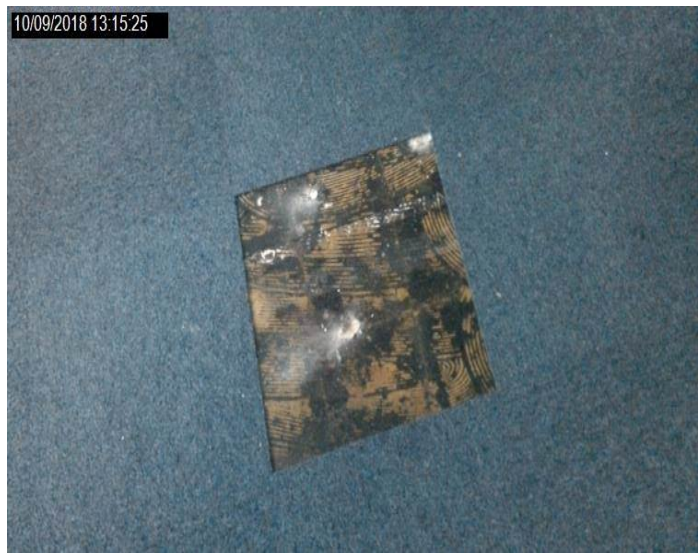
Location:	NBA822	Block:	Birmingham City University	Floor Level: 8th Floor
Sample No.:	DU002330	Portal Ref No.:	31

Item:	Asbestos Bitumen adhesive			
Asbestos Content:	Result Based on:			
Chrysotile	Analysis of sample using PLM			
Sample Analysed By:	Reg 13(1)	Extent:	15 m ²	
Comments:

Material Assessment Total Score: 3		Likelihood of Disturbance Assessment Total Score: 5		Management Assessment Licensable: No Recommendations: Program removal Reinspection Interval: Not Applicable Overall Risk Category: C8
Product Type:	1 (Asbestos bitumen)	Location:	2 (Rooms up to 100 sq m)	
Condition:	1 (Minor scratches)	Accessibility:	1 (Occasionally likely to be disturbed)	
Surface Treatment:	0 (Composite material)			
Asbestos Type:	1 (Chrysotile)	Extent Score:	2 (>10 - <50 sq m or >10m - <50m pipe run)

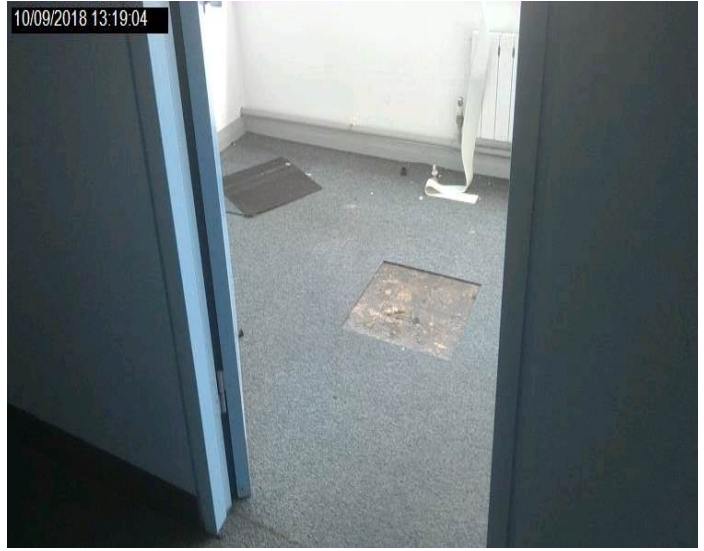
Location:	NBA821	Block:	Birmingham City University	Floor Level: 8th Floor
Sample No.:	As DU002330	Portal Ref No.:	32

Item:	Asbestos Bitumen adhesive			
Asbestos Content:	Result Based on:			
Chrysotile	Strongly presumed			
Sample Analysed By:	Not applicable	Extent:	12 m ²	
Comments:

Material Assessment Total Score: 3		Likelihood of Disturbance Assessment Total Score: 5		Management Assessment Licensable: No Recommendations: Program removal Reinspection Interval: Not Applicable Overall Risk Category: C8
Product Type:	1 (Asbestos bitumen)	Location:	2 (Rooms up to 100 sq m)	
Condition:	1 (Minor scratches)	Accessibility:	1 (Occasionally likely to be disturbed)	
Surface Treatment:	0 (Composite material)			
Asbestos Type:	1 (Chrysotile)	Extent Score:	2 (>10 - <50 sq m or >10m - <50m pipe run)

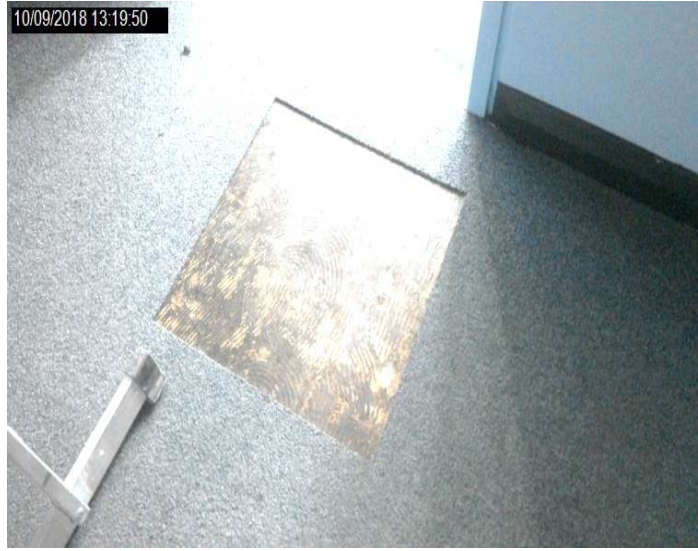
Location:	NBA821A	Block:	Birmingham City University	Floor Level: 8th Floor
Sample No.:	As DU002330	Portal Ref No.:	33

Item:	Asbestos Bitumen adhesive			
Asbestos Content:	Result Based on:			
Chrysotile	Strongly presumed			
Sample Analysed By:	Not applicable	Extent:	8 m ²	
Comments:

Material Assessment Total Score: 3		Likelihood of Disturbance Assessment Total Score: 4		Management Assessment Licensable: No Recommendations: Program removal Reinspection Interval: Not Applicable Overall Risk Category: C7
Product Type:	1 (Asbestos bitumen)	Location:	2 (Rooms up to 100 sq m)	
Condition:	1 (Minor scratches)	Accessibility:	1 (Occasionally likely to be disturbed)	
Surface Treatment:	0 (Composite material)			
Asbestos Type:	1 (Chrysotile)	Extent Score:	1 (<10 sq m or 10m pipe run)

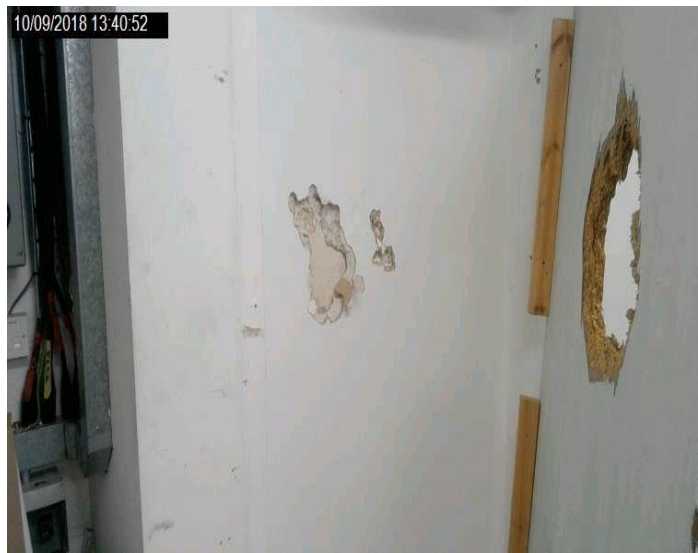
Location:	NBA899 Lifts	Block:	Birmingham City University	Floor Level: 8th Floor
Sample No.:	DU002331	Portal Ref No.:	34

Item:	Textured coating to blockwork			
Asbestos Content:		Result Based on:		
No Asbestos Detected		Analysis of sample using PLM		
Sample Analysed By:	Reg 13(1)	Extent:	25 m ²	
Comments: Behind plasterboard to right and corner of lift lobby

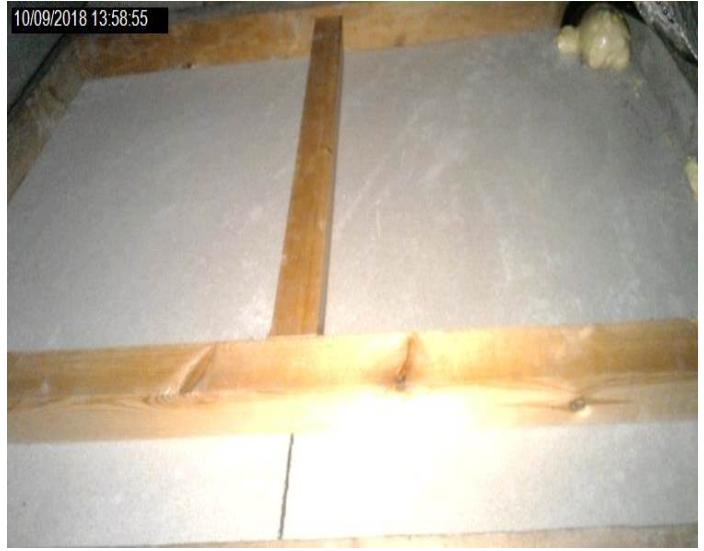
Location:	NBA809A Service duct	Block:	Birmingham City University	Floor Level: 8th Floor
Sample No.:	As DU002322	Portal Ref No.:	38

Item:	Insulating board door header			
Asbestos Content:		Result Based on:		
No Asbestos Detected		Strongly presumed		
Sample Analysed By:	Not applicable	Extent:	1 m ²	
Comments:

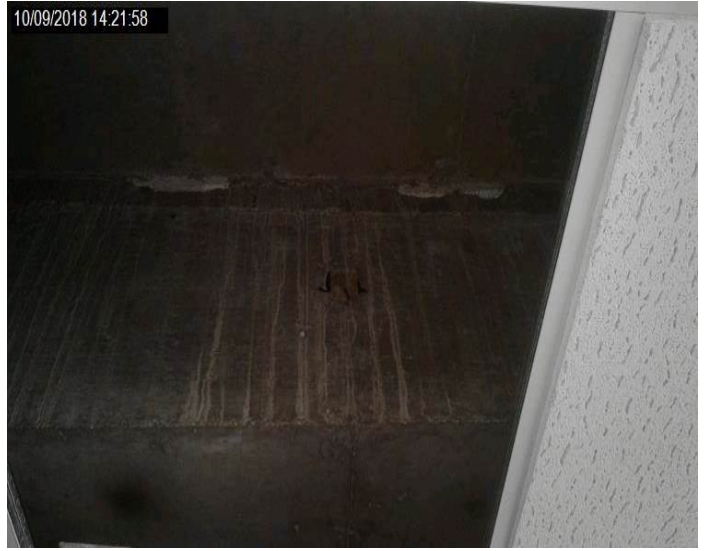
Location:	NBA805	Block:	Birmingham City University	Floor Level: 8th Floor
Sample No.:	As DU002328	Portal Ref No.:	44

Item:	Asbestos Reinforced plastic sleeve			
Asbestos Content:	Result Based on:			
Chrysotile	Strongly presumed			
Sample Analysed By:	Not applicable	Extent:	12 units	
Comments: Within concrete structure, beams across room within ceiling

Material Assessment Total Score: 3		Likelihood of Disturbance Assessment Total Score: 3		Management Assessment Licensable: No Recommendations: Program removal Reinspection Interval: Not Applicable Overall Risk Category: D6
Product Type:	1 (Asbestos reinforced plastic)	Location:	2 (Rooms up to 100 sq m)	
Condition:	1 (Minor scratches)	Accessibility:	0 (Usually inaccessible or unlikely to be disturbed)	
Surface Treatment:	0 (Composite material)			
Asbestos Type:	1 (Chrysotile)	Extent Score:	1 (<10 sq m or 10m pipe run)

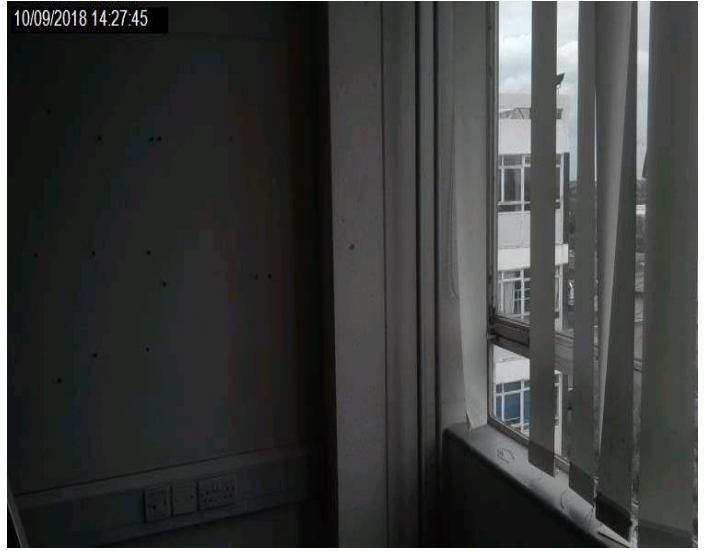
Location:	NBA827	Block:	Birmingham City University	Floor Level: 8th Floor
Sample No.:	DU002336	Portal Ref No.:	47

Item:	Textured coating to section of wall timber boxing			
Asbestos Content:		Result Based on:		
No Asbestos Detected		Analysis of sample using PLM		
Sample Analysed By:	Reg 13(1)	Extent:	3 m ²	
Comments: To section of the wall adjacent the external window

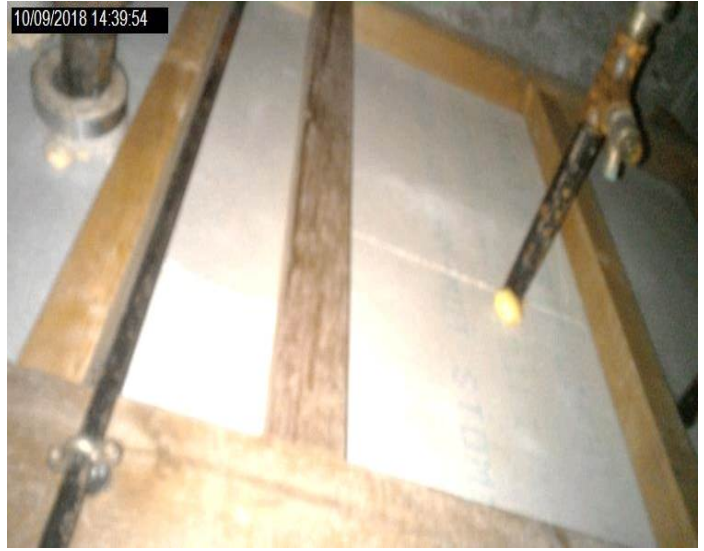
Location:	NBA826C Service duct	Block:	Birmingham City University	Floor Level: 8th Floor
Sample No.:	As DU002322	Portal Ref No.:	48

Item:	Insulating board door header			
Asbestos Content:		Result Based on:		
No Asbestos Detected		Strongly presumed		
Sample Analysed By:	Not applicable	Extent:	2 m ²	
Comments:

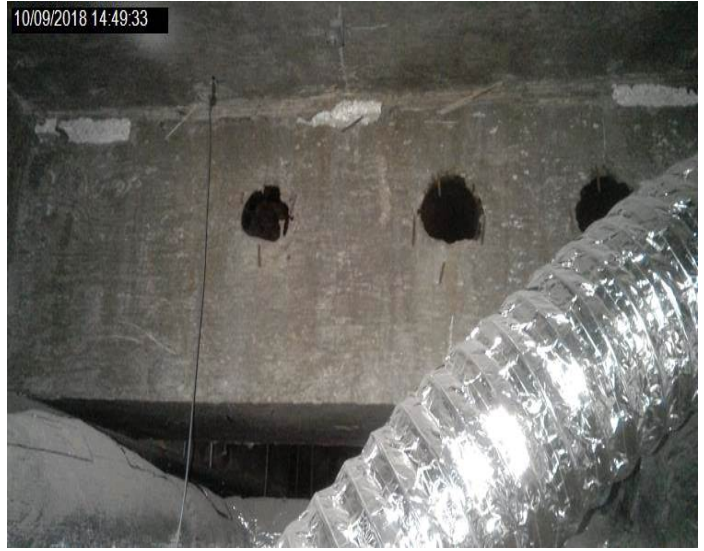
Location:	NBA830	Block:	Birmingham City University	Floor Level: 8th Floor
Sample No.:	As DU002328	Portal Ref No.:	51

Item:	Asbestos Reinforced plastic sleeve			
Asbestos Content:	Result Based on:			
Chrysotile	Strongly presumed			
Sample Analysed By:	Not applicable	Extent:	16 units	
Comments: Within concrete structure, beams across room within ceiling

Material Assessment Total Score: 3		Likelihood of Disturbance Assessment Total Score: 3		Management Assessment Licensable: No Recommendations: Program removal Reinspection Interval: Not Applicable Overall Risk Category: D6
Product Type:	1 (Asbestos reinforced plastic)	Location:	2 (Rooms up to 100 sq m)	
Condition:	1 (Minor scratches)	Accessibility:	0 (Usually inaccessible or unlikely to be disturbed)	
Surface Treatment:	0 (Composite material)			
Asbestos Type:	1 (Chrysotile)	Extent Score:	1 (<10 sq m or 10m pipe run)

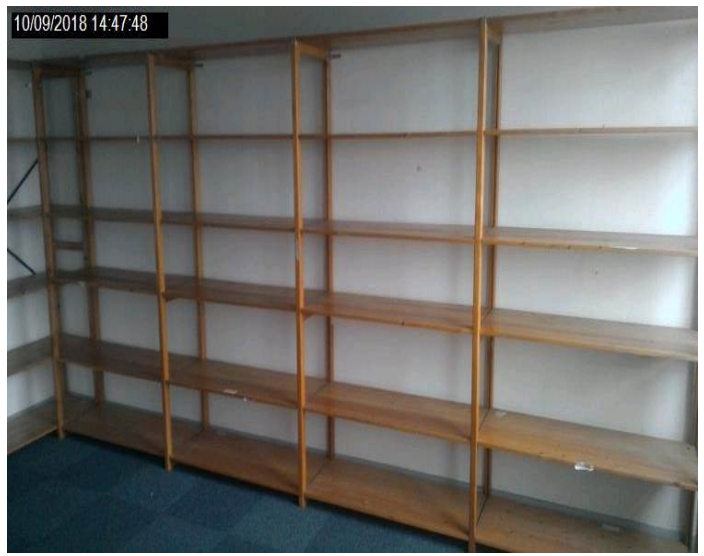
Location:	NBA830	Block:	Birmingham City University	Floor Level: 8th Floor
Sample No.:	DU002337	Portal Ref No.:	52

Item:	Textured coating to block			
Asbestos Content:		Result Based on:		
No Asbestos Detected		Analysis of sample using PLM		
Sample Analysed By:	Reg 13(1)	Extent:	90 m ²	
Comments: To all external facing walls

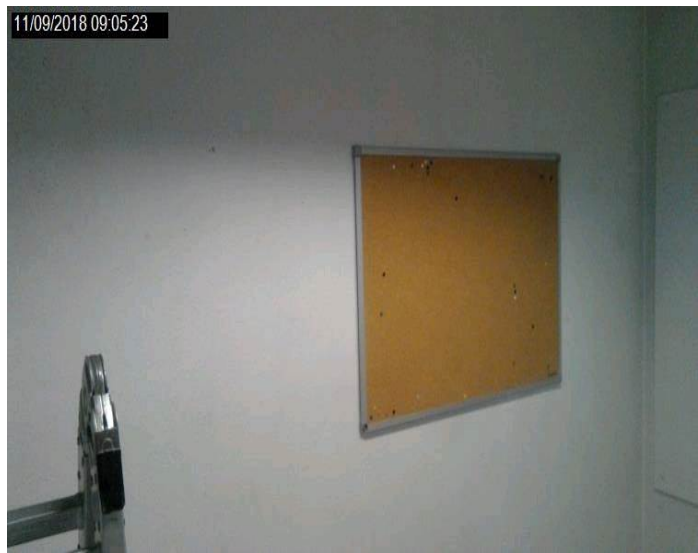
Location:	NBA830B	Block:	Birmingham City University	Floor Level: 8th Floor
Sample No.:	As DU002337	Portal Ref No.:	54

Item:	Textured coating to block			
Asbestos Content:		Result Based on:		
No Asbestos Detected		Strongly presumed		
Sample Analysed By:	Not applicable	Extent:	16 m ²	
Comments: To all external facing walls

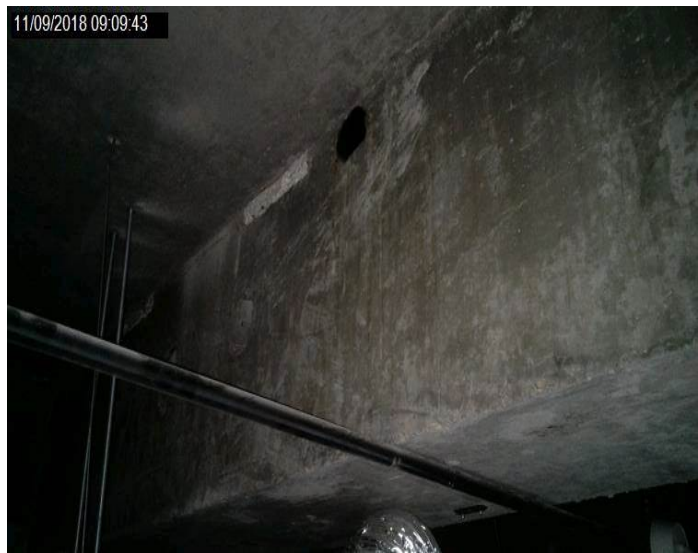
Location:	NBA830A	Block:	Birmingham City University	Floor Level: 8th Floor
Sample No.:	As DU002328	Portal Ref No.:	55

Item:	Asbestos Reinforced plastic sleeve			
Asbestos Content:	Result Based on:			
Chrysotile	Strongly presumed			
Sample Analysed By:	Not applicable	Extent:	4 units	
Comments: Within concrete structure, beams across room within ceiling

Material Assessment Total Score: 3		Likelihood of Disturbance Assessment Total Score: 3		Management Assessment Licensable: No Recommendations: Program removal Reinspection Interval: Not Applicable Overall Risk Category: D6
Product Type:	1 (Asbestos reinforced plastic)	Location:	2 (Rooms up to 100 sq m)	
Condition:	1 (Minor scratches)	Accessibility:	0 (Usually inaccessible or unlikely to be disturbed)	
Surface Treatment:	0 (Composite material)			
Asbestos Type:	1 (Chrysotile)	Extent Score:	1 (<10 sq m or 10m pipe run)

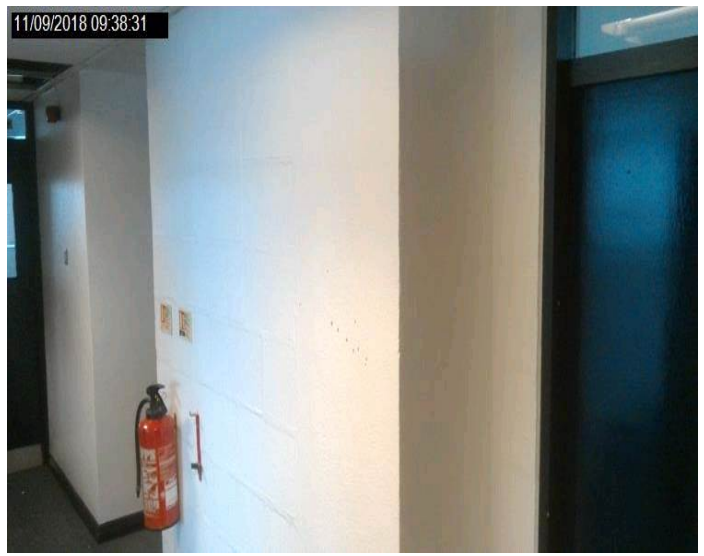
Location:	NBA899A Corridor	Block:	Birmingham City University	Floor Level: 8th Floor
Sample No.:	DU002339	Portal Ref No.:	60

Item:	Textured coating to wall and concrete pillars			
Asbestos Content:		Result Based on:		
No Asbestos Detected		Analysis of sample using PLM		
Sample Analysed By:	Reg 13(1)	Extent:	30 m ²	
Comments: The entire wall area of the corridor isn't textured coated

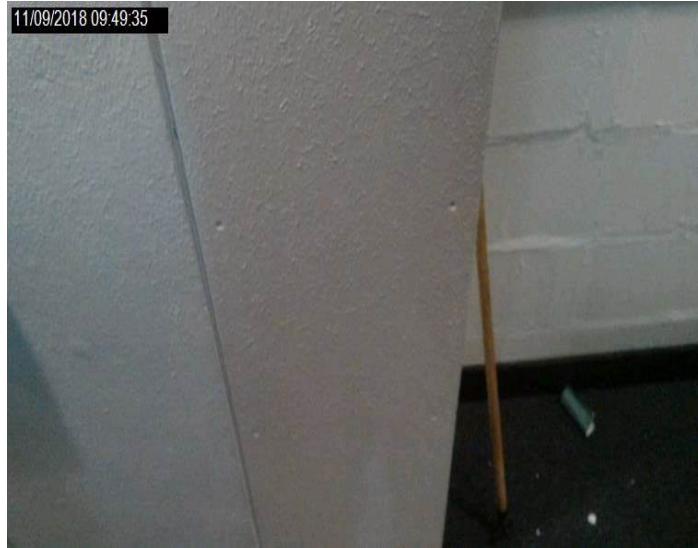
Location:	NBA899B Corridor	Block:	Birmingham City University	Floor Level: 8th Floor
Sample No.:	As DU002339	Portal Ref No.:	63

Item:	Textured coating to wall and concrete pillars			
Asbestos Content:		Result Based on:		
No Asbestos Detected		Strongly presumed		
Sample Analysed By:	Not applicable	Extent:	10 m ²	
Comments: The entire wall area of the corridor isn't textured coated

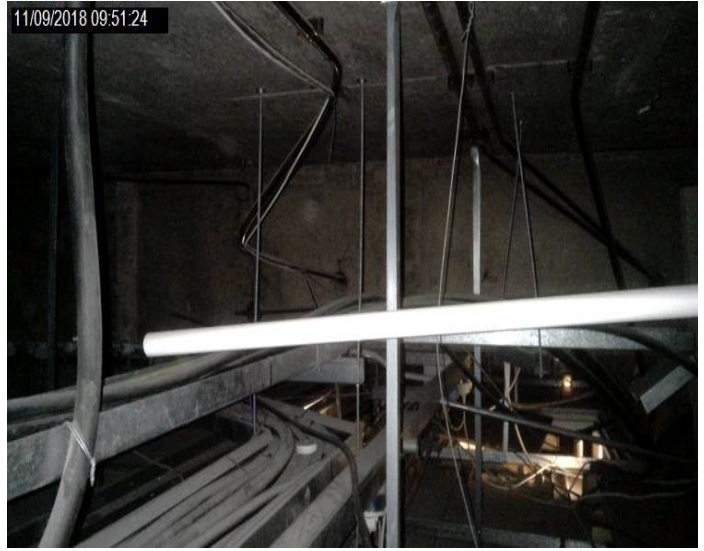
Location:	NBA899B Corridor	Block:	Birmingham City University	Floor Level: 8th Floor
Sample No.:	As DU002328	Portal Ref No.:	64

Item:	Asbestos Reinforced plastic sleeve			
Asbestos Content:	Result Based on:			
Chrysotile	Strongly presumed			
Sample Analysed By:	Not applicable	Extent:	2 units	
Comments: Within concrete structure, beams across room within ceiling

Material Assessment Total Score: 3		Likelihood of Disturbance Assessment Total Score: 3		Management Assessment Licensable: No Recommendations: Program removal Reinspection Interval: Not Applicable Overall Risk Category: D6
Product Type:	1 (Asbestos reinforced plastic)	Location:	2 (Rooms up to 100 sq m)	
Condition:	1 (Minor scratches)	Accessibility:	0 (Usually inaccessible or unlikely to be disturbed)	
Surface Treatment:	0 (Composite material)			
Asbestos Type:	1 (Chrysotile)	Extent Score:	1 (<10 sq m or 10m pipe run)

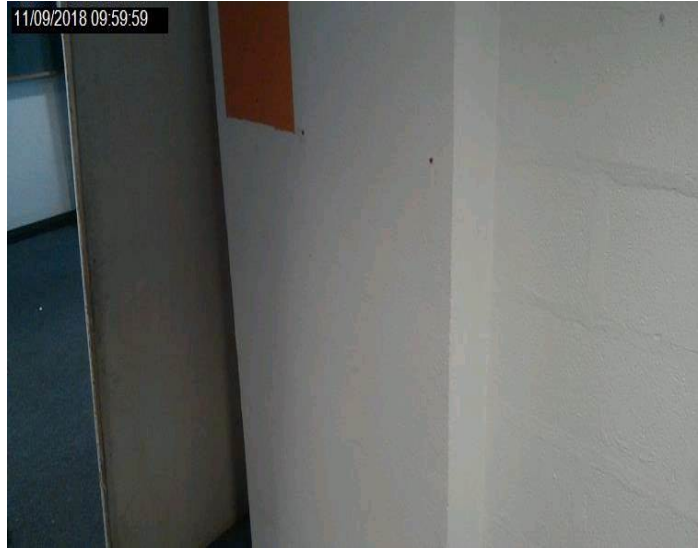
Location:	NBA899C Corridor	Block:	Birmingham City University	Floor Level: 8th Floor
Sample No.:	As DU002339	Portal Ref No.:	67

Item:	Textured coating to wall and concrete pillars			
Asbestos Content:		Result Based on:		
No Asbestos Detected		Strongly presumed		
Sample Analysed By:	Not applicable	Extent:	16 m ²	
Comments: The entire wall area of the corridor isn't textured coated

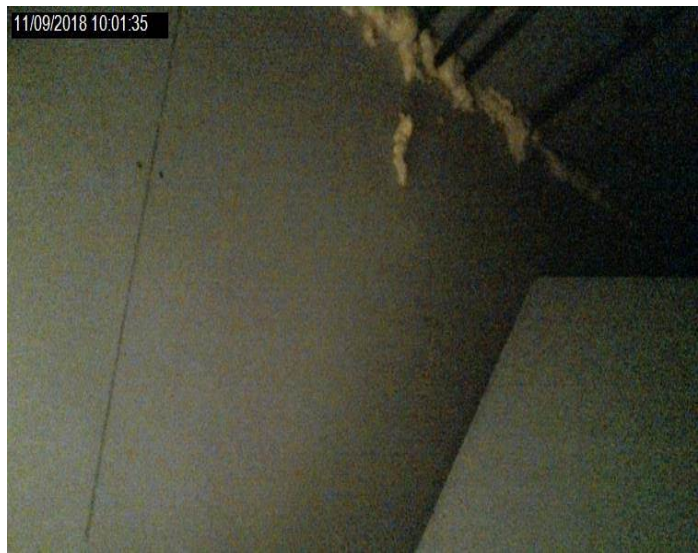
Location:	NBA899C Corridor	Block:	Birmingham City University	Floor Level: 8th Floor
Sample No.:	As DU002341	Portal Ref No.:	69

Item:	Insulating board door header			
Asbestos Content:		Result Based on:		
No Asbestos Detected		Strongly presumed		
Sample Analysed By:	Not applicable	Extent:	4 m ²	
Comments: Firebreak half way down the corridor

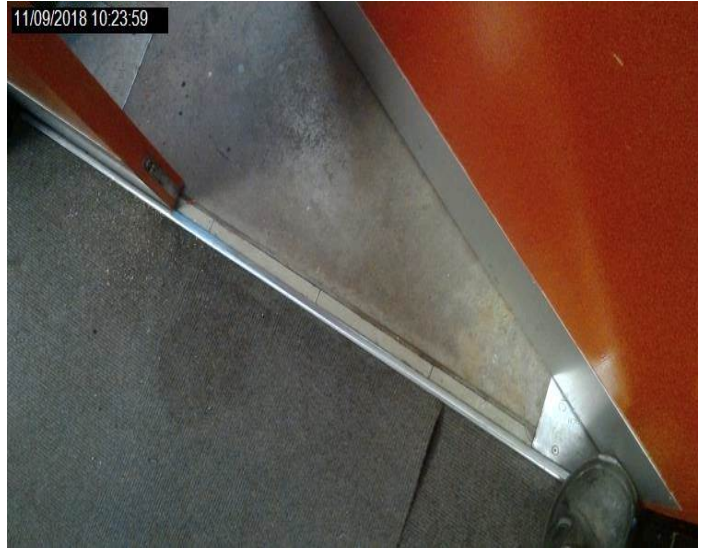
Location:	NBA899C Corridor	Block:	Birmingham City University	Floor Level: 8th Floor
Sample No.:	DU002342	Portal Ref No.:	70

Item:	Asbestos Thermoplastic floor tiles with bitumen adhesive			
Asbestos Content:	Chrysotile in tile and adhesive			
Result Based on:	Analysis of sample using PLM			
Sample Analysed By:	Reg 13(1)	Extent:	2 linear metres	
Comments: Outside stairwell doors NBA800 stairs

Material Assessment Total Score: 3		Likelihood of Disturbance Assessment Total Score: 4		Management Assessment Licensable: No Recommendations: Program removal Reinspection Interval: Not Applicable Overall Risk Category: C7
Product Type:	1 (Asbestos thermoplastic)	Location:	2 (Rooms up to 100 sq m)	
Condition:	1 (Minor scratches)	Accessibility:	1 (Occasionally likely to be disturbed)	
Surface Treatment:	0 (Composite material)			
Asbestos Type:	1 (Chrysotile)	Extent Score:	1 (<10 sq m or 10m pipe run)

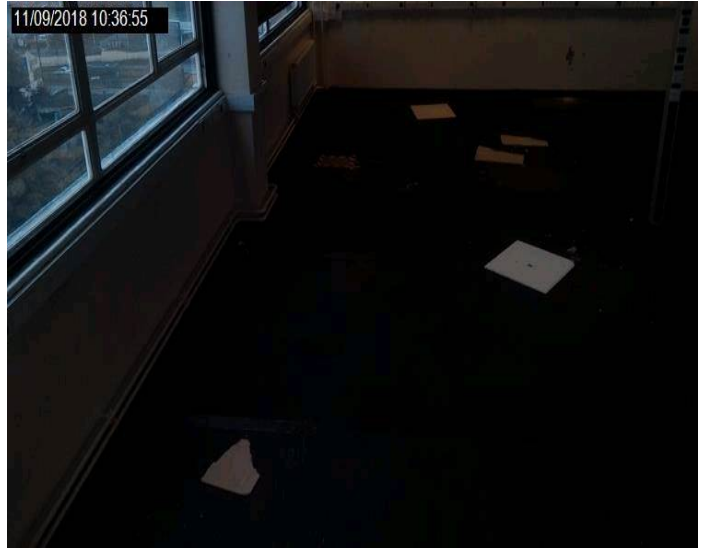
Location:	NBA728	Block:	Birmingham City University	Floor Level: 7th Floor
Sample No.:	DU002344	Portal Ref No.:	72

Item:	Bitumen adhesive to parquet flooring			
Asbestos Content:		Result Based on:		
No Asbestos Detected		Analysis of sample using PLM		
Sample Analysed By:	Reg 13(1)	Extent:	50 m ²	
Comments:

Material Assessment Total Score: 0		Likelihood of Disturbance Assessment Total Score: 0		Management Assessment Licensable: No Recommendations: Not Applicable Reinspection Interval: Not Applicable Overall Risk Category: E0
Product Type:	0 Not Applicable	Location:	0 Not Applicable	
Condition:	0 Not Applicable	Accessibility:	0 Not Applicable	
Surface Treatment:	0 Not Applicable			
Asbestos Type:	0 Not Applicable	Extent Score:	0 Not Applicable

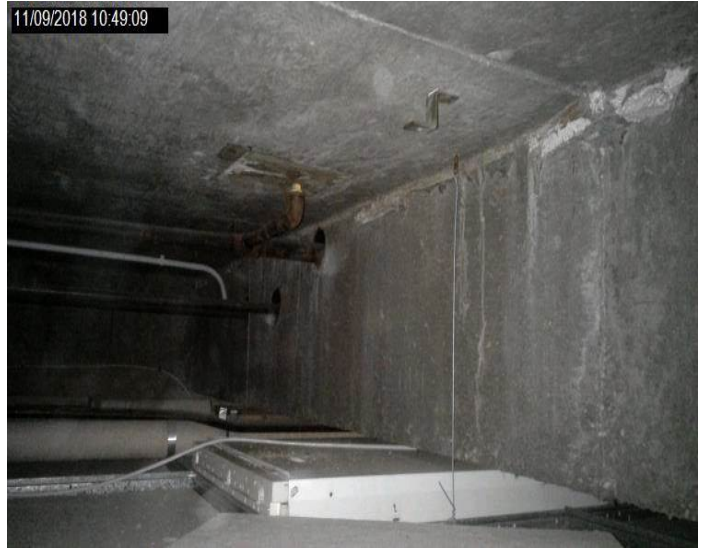
Location:	NBA702	Block:	Birmingham City University	Floor Level: 7th Floor
Sample No.:	As DU002343	Portal Ref No.:	76

Item:	Asbestos Reinforced plastic pipe sleeve			
Asbestos Content:	Result Based on:			
Chrysotile	Strongly presumed			
Sample Analysed By:	Not applicable	Extent:	16 units	
Comments: Structural columns

Material Assessment Total Score: 3		Likelihood of Disturbance Assessment Total Score: 3		Management Assessment Licensable: No Recommendations: Program removal Reinspection Interval: Not Applicable Overall Risk Category: D6
Product Type:	1 (Asbestos reinforced plastic)	Location:	2 (Rooms up to 100 sq m)	
Condition:	1 (Minor scratches)	Accessibility:	0 (Usually inaccessible or unlikely to be disturbed)	
Surface Treatment:	0 (Composite material)			
Asbestos Type:	1 (Chrysotile)	Extent Score:	1 (<10 sq m or 10m pipe run)

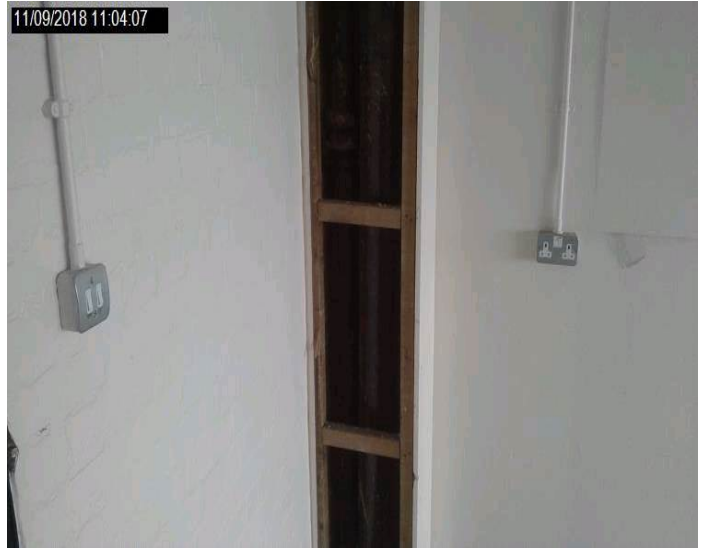
Location:	NBA704	Block:	Birmingham City University	Floor Level: 7th Floor
Sample No.:	DU002345	Portal Ref No.:	81

Item:	Asbestos Reinforced plastic downpipe			
Asbestos Content:	Result Based on:			
Chrysotile	Analysis of sample using PLM			
Sample Analysed By:	Reg 13(1)	Extent:	3 linear metres	
Comments:

Material Assessment Total Score: 3		Likelihood of Disturbance Assessment Total Score: 4		Management Assessment Licensable: No Recommendations: Program removal Reinspection Interval: Not Applicable Overall Risk Category: C7
Product Type:	1 (Asbestos reinforced plastic)	Location:	2 (Rooms up to 100 sq m)	
Condition:	1 (Minor scratches)	Accessibility:	1 (Occasionally likely to be disturbed)	
Surface Treatment:	0 (Composite material)			
Asbestos Type:	1 (Chrysotile)	Extent Score:	1 (<10 sq m or 10m pipe run)

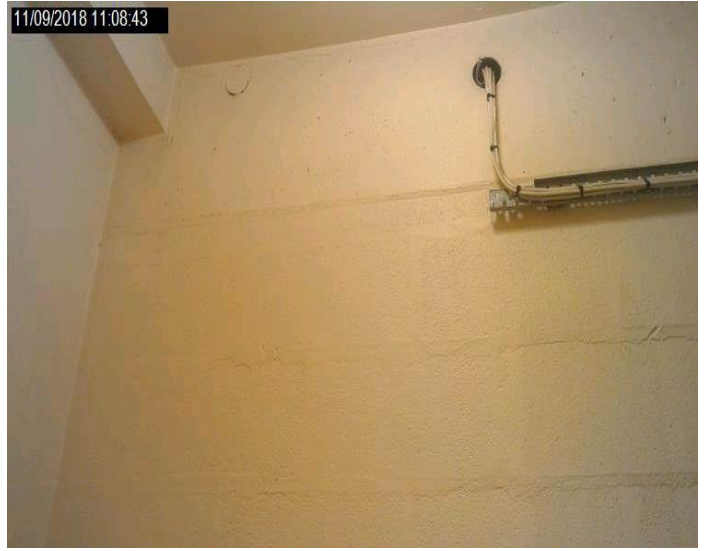
Location:	NBA704A	Block:	Birmingham City University	Floor Level: 7th Floor
Sample No.:	As DU002343	Portal Ref No.:	82

Item:	Asbestos Reinforced plastic sleeve			
Asbestos Content:	Result Based on:			
Chrysotile	Strongly presumed			
Sample Analysed By:	Not applicable	Extent:	2 units	
Comments: Structural columns

Material Assessment Total Score: 3		Likelihood of Disturbance Assessment Total Score: 3		Management Assessment Licensable: No Recommendations: Program removal Reinspection Interval: Not Applicable Overall Risk Category: D6
Product Type:	1 (Asbestos reinforced plastic)	Location:	2 (Rooms up to 100 sq m)	
Condition:	1 (Minor scratches)	Accessibility:	0 (Usually inaccessible or unlikely to be disturbed)	
Surface Treatment:	0 (Composite material)			
Asbestos Type:	1 (Chrysotile)	Extent Score:	1 (<10 sq m or 10m pipe run)

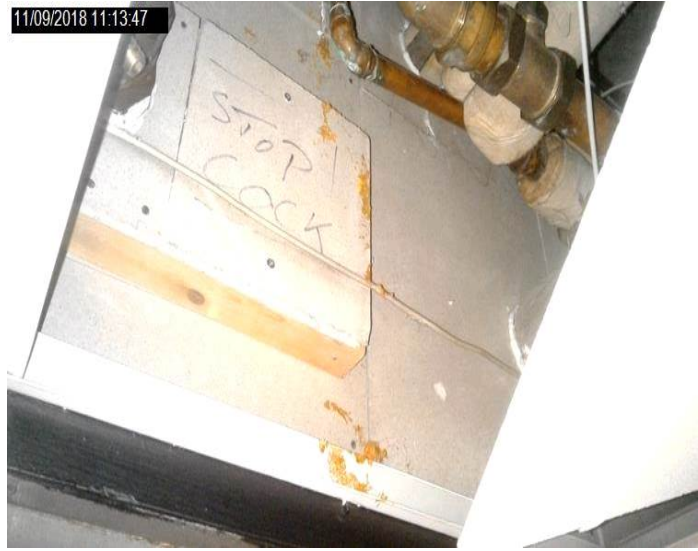
Location:	NBA727A Service duct	Block:	Birmingham City University	Floor Level: 7th Floor
Sample No.:	DU002346	Portal Ref No.:	83

Item:	Insulating board door header			
Asbestos Content:		Result Based on:		
No Asbestos Detected		Analysis of sample using PLM		
Sample Analysed By:	Reg 13(1)	Extent:	2 m ²	
Comments:

Material Assessment Total Score: 0		Likelihood of Disturbance Assessment Total Score: 0		Management Assessment Licensable: Yes Recommendations: Not Applicable Reinspection Interval: Not Applicable Overall Risk Category: E0
Product Type:	0 Not Applicable	Location:	0 Not Applicable	
Condition:	0 Not Applicable	Accessibility:	0 Not Applicable	
Surface Treatment:	0 Not Applicable			
Asbestos Type:	0 Not Applicable	Extent Score:	0 Not Applicable

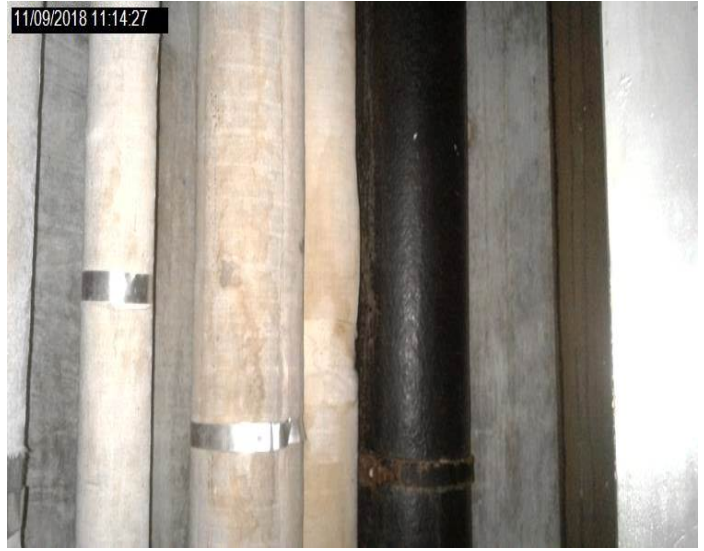
Location:	NBA727A Service duct	Block:	Birmingham City University	Floor Level: 7th Floor
Sample No.:	As DU002345	Portal Ref No.:	84

Item:	Asbestos Reinforced plastic downpipe			
Asbestos Content:	Result Based on:			
Chrysotile	Strongly presumed			
Sample Analysed By:	Not applicable	Extent:	3 linear metres	
Comments:

Material Assessment Total Score: 3		Likelihood of Disturbance Assessment Total Score: 4		Management Assessment Licensable: No Recommendations: Program removal Reinspection Interval: Not Applicable Overall Risk Category: C7
Product Type:	1 (Asbestos reinforced plastic)	Location:	2 (Rooms up to 100 sq m)	
Condition:	1 (Minor scratches)	Accessibility:	1 (Occasionally likely to be disturbed)	
Surface Treatment:	0 (Composite material)			
Asbestos Type:	1 (Chrysotile)	Extent Score:	1 (<10 sq m or 10m pipe run)

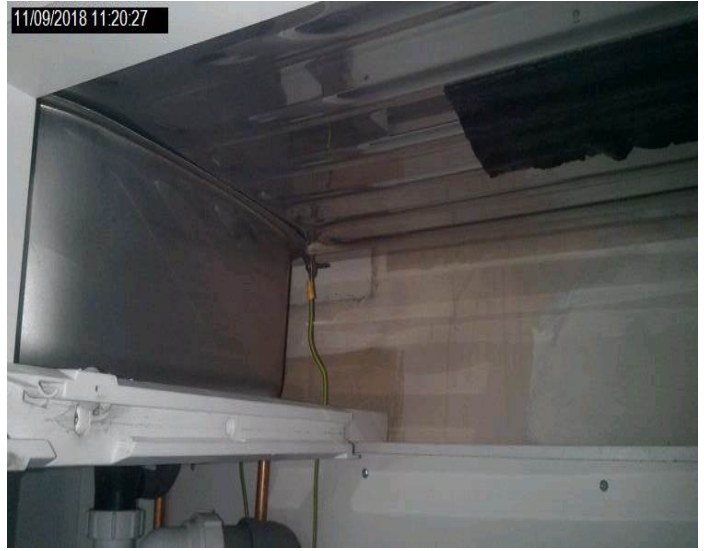
Location:	NBA727	Block:	Birmingham City University	Floor Level: 7th Floor
Sample No.:	DU002347	Portal Ref No.:	86

Item:	Bitumen sink pads			
Asbestos Content:		Result Based on:		
No Asbestos Detected		Analysis of sample using PLM		
Sample Analysed By:	Reg 13(1)	Extent:	2 units	
Comments:

Material Assessment Total Score: 0		Likelihood of Disturbance Assessment Total Score: 0		Management Assessment Licensable: No Recommendations: Not Applicable Reinspection Interval: Not Applicable Overall Risk Category: E0
Product Type:	0 Not Applicable	Location:	0 Not Applicable	
Condition:	0 Not Applicable	Accessibility:	0 Not Applicable	
Surface Treatment:	0 Not Applicable			
Asbestos Type:	0 Not Applicable	Extent Score:	0 Not Applicable
