Report No.: J102748
Nature of Work: Demolition Survey
Issue Date: 31/10/2018
Client Name: WYG Engineering Ltd
Geneva Building, Lake View Drive, Sherwood Business Park,
Annesley, Nottingham, NG15 0ED
Site Address: Baker Building, Former City North Campus, Birmingham City
University, Perry Barr, B42 2US

A demolition survey in line with HSG264 Asbestos: The Survey Guide was carried out internally and externally to the property.

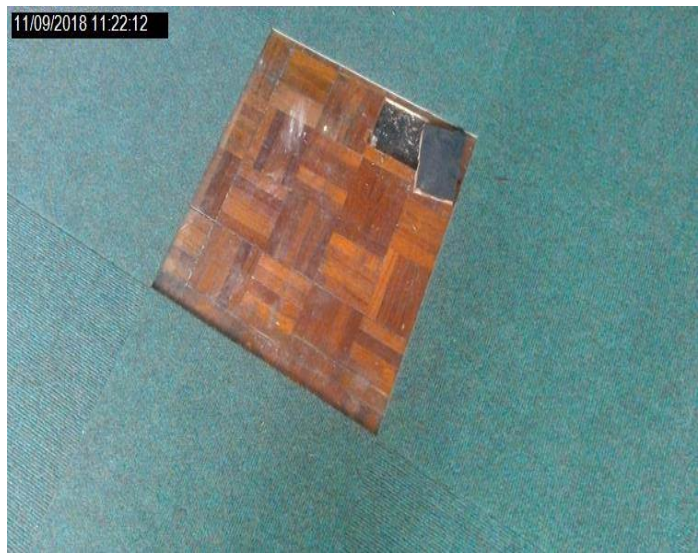
Location:	NBA727	Block:	Birmingham City University	Floor Level: 7th Floor
Sample No.:	DU002348	Portal Ref No.:	87

Item:	Bitumen adhesive beneath parquet			
Asbestos Content:			Result Based on:	
No Asbestos Detected		Analysis of sample using PLM		
Sample Analysed By:	Reg 13(1)	Extent:	20 m ²	
Comments:

Material Assessment Total Score: 0		Likelihood of Disturbance Assessment Total Score: 0		Management Assessment Licensable: No Recommendations: Not Applicable Reinspection Interval: Not Applicable Overall Risk Category: E0
Product Type:	0 Not Applicable	Location:	0 Not Applicable	
Condition:	0 Not Applicable	Accessibility:	0 Not Applicable	
Surface Treatment:	0 Not Applicable			
Asbestos Type:	0 Not Applicable	Extent Score:	0 Not Applicable

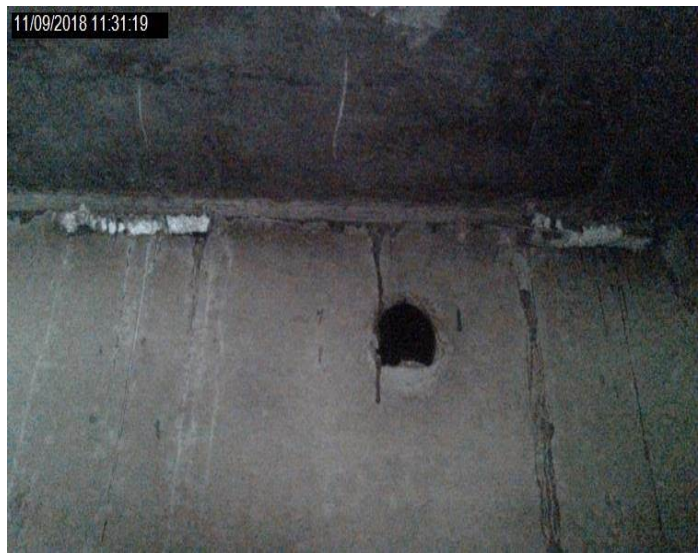
Location:	NBA706	Block:	Birmingham City University	Floor Level: 7th Floor
Sample No.:	As DU002343	Portal Ref No.:	90

Item:	Asbestos Reinforced plastic pipe sleeve			
Asbestos Content:	Result Based on:			
Chrysotile	Strongly presumed			
Sample Analysed By:	Not applicable	Extent:	16 units	
Comments: Structural columns

Material Assessment Total Score: 3		Likelihood of Disturbance Assessment Total Score: 3		Management Assessment Licensable: No Recommendations: Program removal Reinspection Interval: Not Applicable Overall Risk Category: D6
Product Type:	1 (Asbestos reinforced plastic)	Location:	2 (Rooms up to 100 sq m)	
Condition:	1 (Minor scratches)	Accessibility:	0 (Usually inaccessible or unlikely to be disturbed)	
Surface Treatment:	0 (Composite material)			
Asbestos Type:	1 (Chrysotile)	Extent Score:	1 (<10 sq m or 10m pipe run)

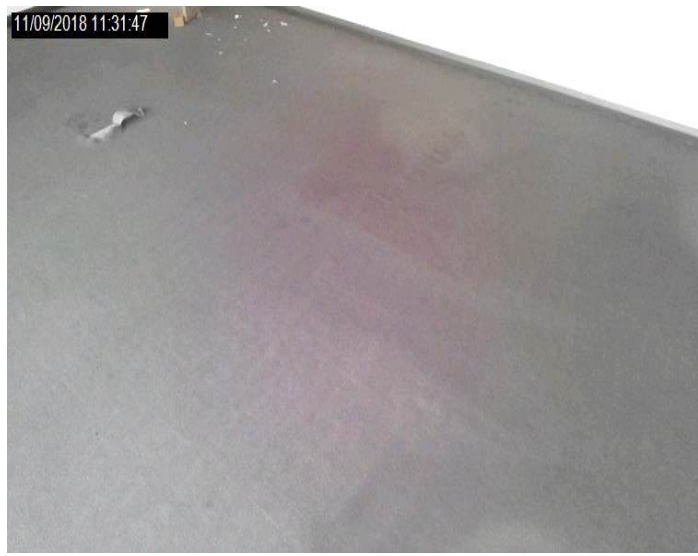
Location:	NBA706	Block:	Birmingham City University	Floor Level: 7th Floor
Sample No.:	As DU002348	Portal Ref No.:	91

Item:	Bitumen adhesive to parquet flooring			
Asbestos Content:		Result Based on:		
No Asbestos Detected		Strongly presumed		
Sample Analysed By:	Not applicable	Extent:	50 m ²	
Comments:

Material Assessment Total Score: 0		Likelihood of Disturbance Assessment Total Score: 0		Management Assessment Licensable: No Recommendations: Not Applicable Reinspection Interval: Not Applicable Overall Risk Category: E0
Product Type:	0 Not Applicable	Location:	0 Not Applicable	
Condition:	0 Not Applicable	Accessibility:	0 Not Applicable	
Surface Treatment:	0 Not Applicable			
Asbestos Type:	0 Not Applicable	Extent Score:	0 Not Applicable

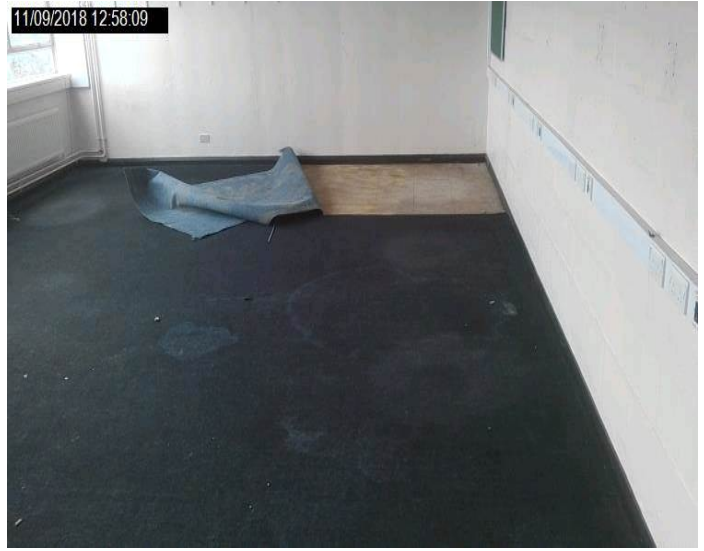
Location:	NBA725	Block:	Birmingham City University	Floor Level: 7th Floor
Sample No.:	As DU002348	Portal Ref No.:	93

Item:	Bitumen adhesive to rear of parquet			
Asbestos Content:		Result Based on:		
No Asbestos Detected		Strongly presumed		
Sample Analysed By:	Not applicable	Extent:	50 m ²	
Comments:

Material Assessment Total Score: 0		Likelihood of Disturbance Assessment Total Score: 0		Management Assessment Licensable: No Recommendations: Not Applicable Reinspection Interval: Not Applicable Overall Risk Category: E0
Product Type:	0 Not Applicable	Location:	0 Not Applicable	
Condition:	0 Not Applicable	Accessibility:	0 Not Applicable	
Surface Treatment:	0 Not Applicable			
Asbestos Type:	0 Not Applicable	Extent Score:	0 Not Applicable

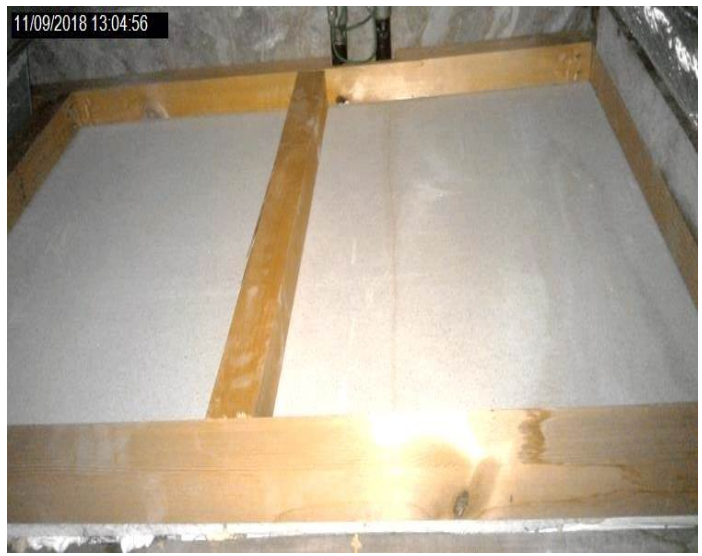
Location:	NBA707A Service duct	Block:	Birmingham City University	Floor Level: 7th Floor
Sample No.:	As DU002346	Portal Ref No.:	94

Item:	Insulating board door header			
Asbestos Content:		Result Based on:		
No Asbestos Detected		Strongly presumed		
Sample Analysed By:	Not applicable	Extent:	1 m ²	
Comments:

Material Assessment Total Score: 0		Likelihood of Disturbance Assessment Total Score: 0		Management Assessment Licensable: Yes Recommendations: Not Applicable Reinspection Interval: Not Applicable Overall Risk Category: E0
Product Type:	0 Not Applicable	Location:	0 Not Applicable	
Condition:	0 Not Applicable	Accessibility:	0 Not Applicable	
Surface Treatment:	0 Not Applicable			
Asbestos Type:	0 Not Applicable	Extent Score:	0 Not Applicable

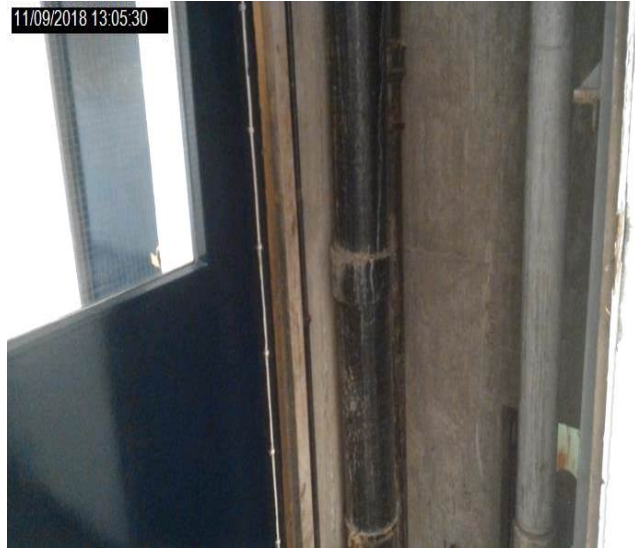
Location:	NBA707A Service duct	Block:	Birmingham City University	Floor Level: 7th Floor
Sample No.:	As DU002345	Portal Ref No.:	95

Item:	Asbestos Reinforced plastic downpipe			
Asbestos Content:	Result Based on:			
Chrysotile	Strongly presumed			
Sample Analysed By:	Not applicable	Extent:	3 linear metres	
Comments:

Material Assessment Total Score: 3		Likelihood of Disturbance Assessment Total Score: 4		Management Assessment Licensable: No Recommendations: Program removal Reinspection Interval: Not Applicable Overall Risk Category: C7
Product Type:	1 (Asbestos reinforced plastic)	Location:	2 (Rooms up to 100 sq m)	
Condition:	1 (Minor scratches)	Accessibility:	1 (Occasionally likely to be disturbed)	
Surface Treatment:	0 (Composite material)			
Asbestos Type:	1 (Chrysotile)	Extent Score:	1 (<10 sq m or 10m pipe run)

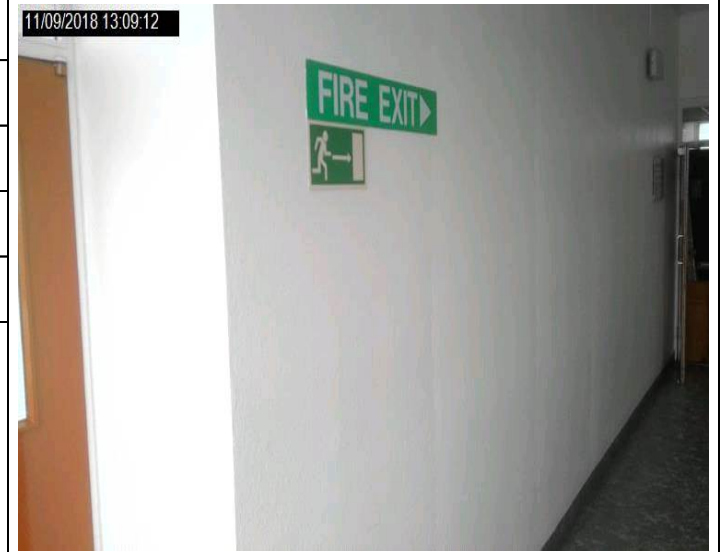
Location:	NBA799 Stairwell	Block:	Birmingham City University		Floor Level: 7th Floor
Sample No.:	DU002349	Portal Ref No.:	96	11/09/2018 13:09:12	
Item:	Textured coating to concrete				
Asbestos Content:		Result Based on:			
No Asbestos Detected		Analysis of sample using PLM			
Sample Analysed By:	Reg 13(1)	Extent:	50 m ²		
Comments:

Material Assessment Total Score: 0		Likelihood of Disturbance Assessment Total Score: 0		Management Assessment Licensable: No Recommendations: Not Applicable Reinspection Interval: Not Applicable Overall Risk Category: E0
Product Type:	0 Not Applicable	Location:	0 Not Applicable	
Condition:	0 Not Applicable	Accessibility:	0 Not Applicable	
Surface Treatment:	0 Not Applicable			
Asbestos Type:	0 Not Applicable	Extent Score:	0 Not Applicable

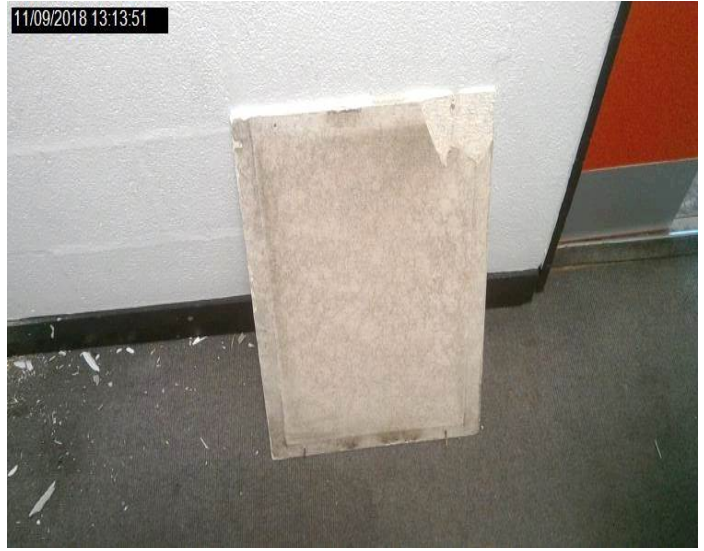
Location:	NBA899B Corridor	Block:	Birmingham City University	Floor Level: 8th Floor
Sample No.:	DU002350	Portal Ref No.:	97

Item:	Asbestos Insulating board panel to dry riser			
Asbestos Content:	Result Based on:			
Chrysotile Amosite	Analysis of sample using PLM			
Sample Analysed By: Reg 13(1)	Extent:	1 m ²		
Comments: Adjacent to stairwell and lift

Material Assessment Total Score: 6		Likelihood of Disturbance Assessment Total Score: 4		Management Assessment Licensable: Yes Recommendations: Program removal Reinspection Interval: Not Applicable Overall Risk Category: C10
Product Type:	2 (Asbestos insulating board)	Location:	2 (Rooms up to 100 sq m)	
Condition:	1 (Minor scratches)	Accessibility:	1 (Occasionally likely to be disturbed)	
Surface Treatment:	1 (Encapsulated asbestos insulating board)			
Asbestos Type:	2 (Chrysotile Amosite)	Extent Score:	1 (<10 sq m or 10m pipe run)

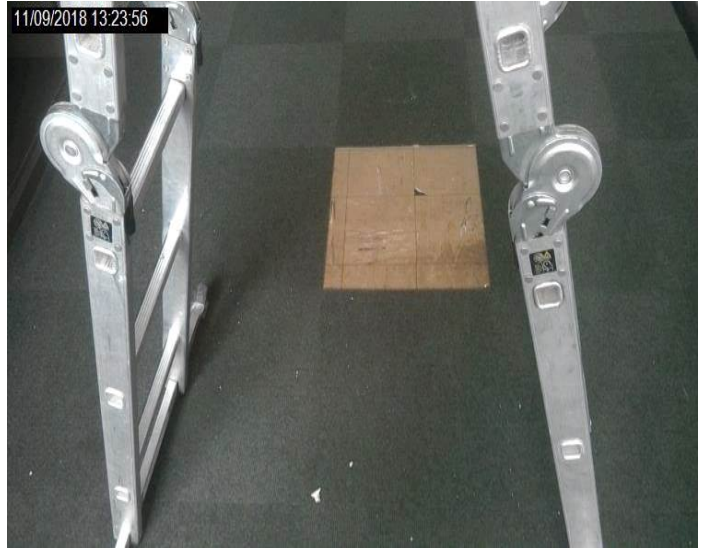
Location:	NBA722	Block:	Birmingham City University	Floor Level: 7th Floor
Sample No.:	DU002352	Portal Ref No.:	101

Item:	Asbestos Thermoplastic floor tile to bitumen adhesive			
Asbestos Content:	Result Based on:			
Chrysotile in tile and adhesive	Analysis of sample using PLM			
Sample Analysed By: Reg 13(1)	Extent:	12 m ²		
Comments: Beneath carpet tiles

Material Assessment Total Score: 3		Likelihood of Disturbance Assessment Total Score: 4		Management Assessment Licensable: No Recommendations: Program removal Reinspection Interval: Not Applicable Overall Risk Category: C7
Product Type:	1 (Asbestos thermoplastic)	Location:	2 (Rooms up to 100 sq m)	
Condition:	1 (Minor scratches)	Accessibility:	0 (Usually inaccessible or unlikely to be disturbed)	
Surface Treatment:	0 (Composite material)			
Asbestos Type:	1 (Chrysotile)	Extent Score:	2 (>10 - <50 sq m or >10m - <50m pipe run)

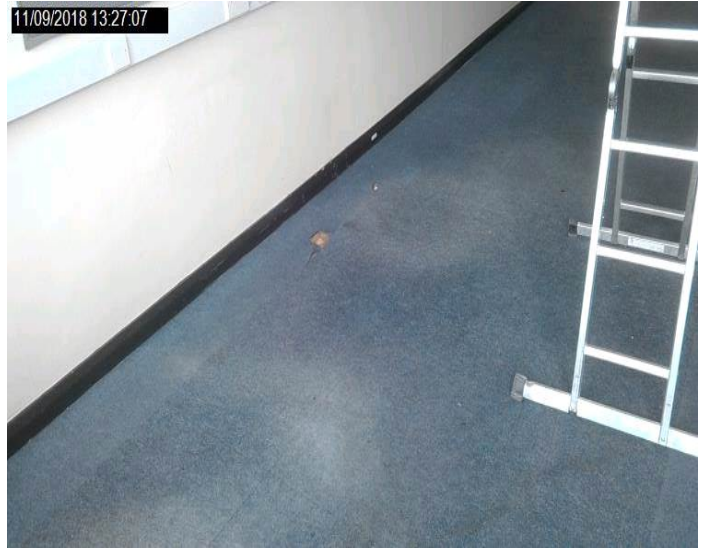
Location:	NBA708	Block:	Birmingham City University	Floor Level: 7th Floor
Sample No.:	As DU002348	Portal Ref No.:	103

Item:	Bitumen adhesive to parquet flooring			
Asbestos Content:		Result Based on:		
No Asbestos Detected		Strongly presumed		
Sample Analysed By:	Not applicable	Extent:	25 m ²	
Comments:

Material Assessment Total Score: 0		Likelihood of Disturbance Assessment Total Score: 0		Management Assessment Licensable: No Recommendations: Not Applicable Reinspection Interval: Not Applicable Overall Risk Category: E0
Product Type:	0 Not Applicable	Location:	0 Not Applicable	
Condition:	0 Not Applicable	Accessibility:	0 Not Applicable	
Surface Treatment:	0 Not Applicable			
Asbestos Type:	0 Not Applicable	Extent Score:	0 Not Applicable

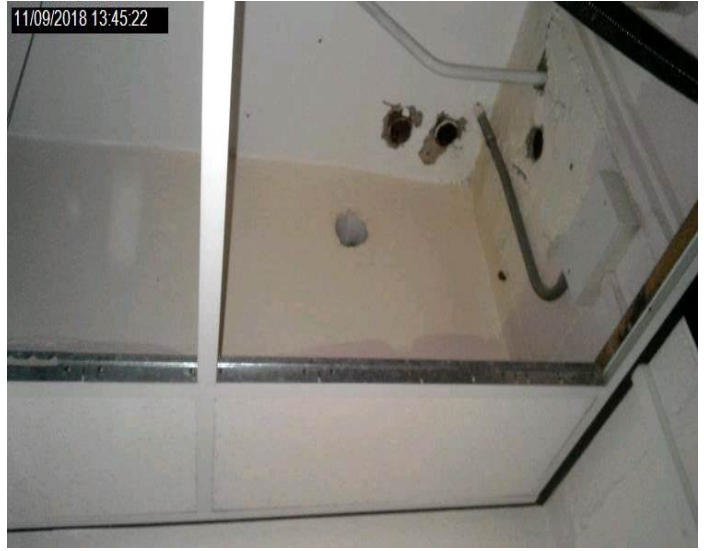
Location:	NBA709	Block:	Birmingham City University	Floor Level: 7th Floor
Sample No.:	As DU002353	Portal Ref No.:	107

Item:	Asbestos Reinforced plastic sleeve			
Asbestos Content:	Result Based on:			
Chrysotile	Strongly presumed			
Sample Analysed By:	Not applicable	Extent:	1 unit	
Comments: Structural columns

Material Assessment Total Score: 3		Likelihood of Disturbance Assessment Total Score: 3		Management Assessment Licensable: No Recommendations: Program removal Reinspection Interval: Not Applicable Overall Risk Category: D6
Product Type:	1 (Asbestos reinforced plastic)	Location:	2 (Rooms up to 100 sq m)	
Condition:	1 (Minor scratches)	Accessibility:	0 (Usually inaccessible or unlikely to be disturbed)	
Surface Treatment:	0 (Composite material)			
Asbestos Type:	1 (Chrysotile)	Extent Score:	1 (<10 sq m or 10m pipe run)

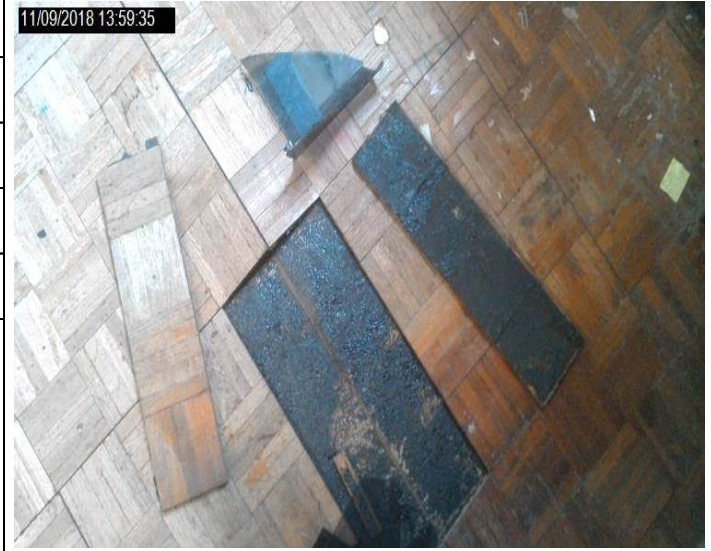
Location:	NBA712	Block:	Birmingham City University	Floor Level: 7th Floor
Sample No.:	As DU002354	Portal Ref No.:	113

Item:	Bitumen adhesive to parquet			
Asbestos Content:		Result Based on:		
No Asbestos Detected		Strongly presumed		
Sample Analysed By:	Not applicable	Extent:	10 m ²	
Comments:

Material Assessment Total Score: 0		Likelihood of Disturbance Assessment Total Score: 0		Management Assessment Licensable: No Recommendations: Not Applicable Reinspection Interval: Not Applicable Overall Risk Category: E0
Product Type:	0 Not Applicable	Location:	0 Not Applicable	
Condition:	0 Not Applicable	Accessibility:	0 Not Applicable	
Surface Treatment:	0 Not Applicable			
Asbestos Type:	0 Not Applicable	Extent Score:	0 Not Applicable

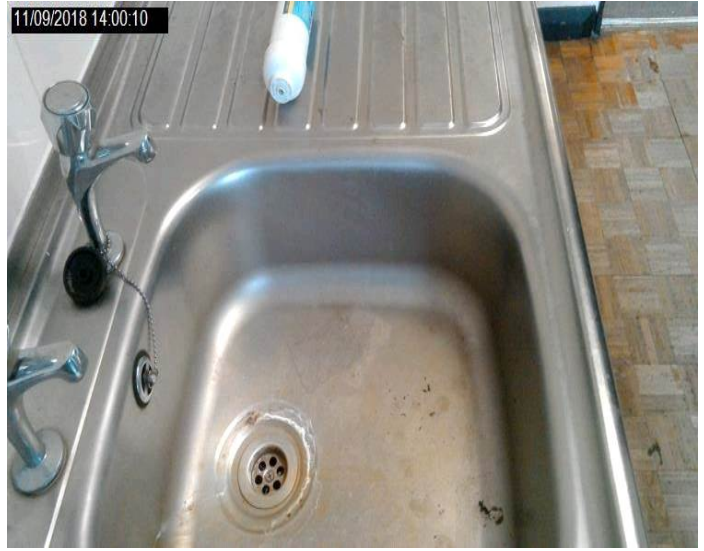
Location:	NBA712	Block:	Birmingham City University	Floor Level: 7th Floor
Sample No.:	DU002356	Portal Ref No.:	114

Item:	Bitumen sink pad			
Asbestos Content:		Result Based on:		
No Asbestos Detected		Analysis of sample using PLM		
Sample Analysed By:	Reg 13(1)	Extent:	2 units	
Comments:

Material Assessment Total Score: 0		Likelihood of Disturbance Assessment Total Score: 0		Management Assessment Licensable: No Recommendations: Not Applicable Reinspection Interval: Not Applicable Overall Risk Category: E0
Product Type:	0 Not Applicable	Location:	0 Not Applicable	
Condition:	0 Not Applicable	Accessibility:	0 Not Applicable	
Surface Treatment:	0 Not Applicable			
Asbestos Type:	0 Not Applicable	Extent Score:	0 Not Applicable

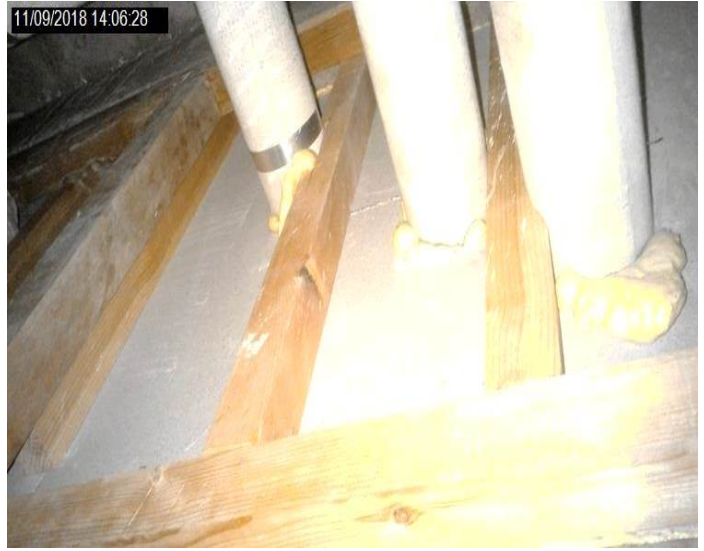
Location:	NBA713A Service duct	Block:	Birmingham City University	Floor Level: 7th Floor
Sample No.:	DU002357	Portal Ref No.:	116

Item:	Insulating board door header			
Asbestos Content:		Result Based on:		
No Asbestos Detected		Analysis of sample using PLM		
Sample Analysed By:	Reg 13(1)	Extent:	4 m ²	
Comments:

Material Assessment Total Score: 0		Likelihood of Disturbance Assessment Total Score: 0		Management Assessment Licensable: Yes Recommendations: Not Applicable Reinspection Interval: Not Applicable Overall Risk Category: E0
Product Type:	0 Not Applicable	Location:	0 Not Applicable	
Condition:	0 Not Applicable	Accessibility:	0 Not Applicable	
Surface Treatment:	0 Not Applicable			
Asbestos Type:	0 Not Applicable	Extent Score:	0 Not Applicable

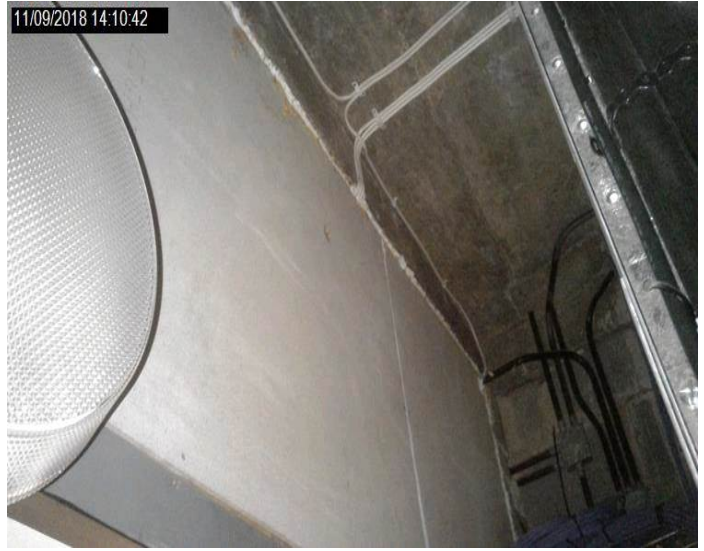
Location:	NBA720B Service duct	Block:	Birmingham City University	Floor Level: 7th Floor
Sample No.:	As DU002357	Portal Ref No.:	118

Item:	Insulating board door header			
Asbestos Content:		Result Based on:		
No Asbestos Detected		Strongly presumed		
Sample Analysed By:	Not applicable	Extent:	4 m ²	
Comments:

Material Assessment Total Score: 0		Likelihood of Disturbance Assessment Total Score: 0		Management Assessment Licensable: Yes Recommendations: Not Applicable Reinspection Interval: Not Applicable Overall Risk Category: E0
Product Type:	0 Not Applicable	Location:	0 Not Applicable	
Condition:	0 Not Applicable	Accessibility:	0 Not Applicable	
Surface Treatment:	0 Not Applicable			
Asbestos Type:	0 Not Applicable	Extent Score:	0 Not Applicable

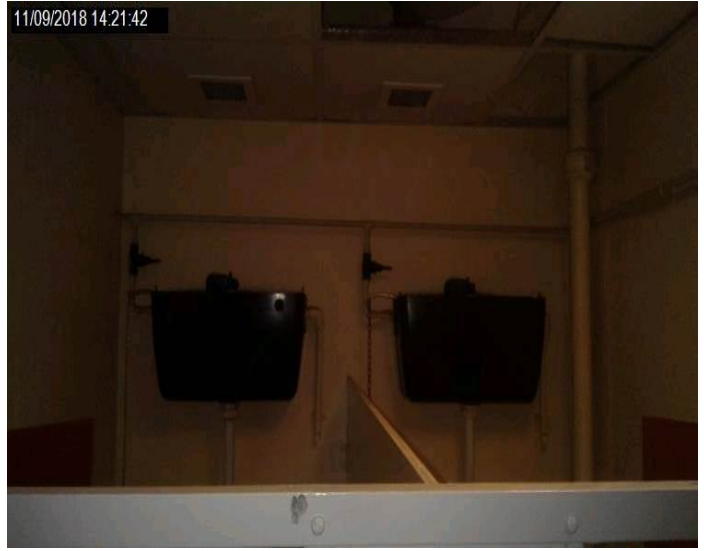
Location:	NBA721	Block:	Birmingham City University	Floor Level: 7th Floor
Sample No.:	DU002358	Portal Ref No.:	119

Item:	Asbestos Reinforced plastic cistern			
Asbestos Content:	Result Based on:			
Amosite	Analysis of sample using PLM			
Sample Analysed By:	Reg 13(1)	Extent:	2 units	
Comments:

Material Assessment Total Score: 4		Likelihood of Disturbance Assessment Total Score: 4		Management Assessment Licensable: No Recommendations: Program removal Reinspection Interval: Not Applicable Overall Risk Category: C8
Product Type:	1 (Asbestos reinforced plastic)	Location:	2 (Rooms up to 100 sq m)	
Condition:	1 (Minor scratches)	Accessibility:	1 (Occasionally likely to be disturbed)	
Surface Treatment:	0 (Composite material)			
Asbestos Type:	2 (Amosite)	Extent Score:	1 (<10 sq m or 10m pipe run)

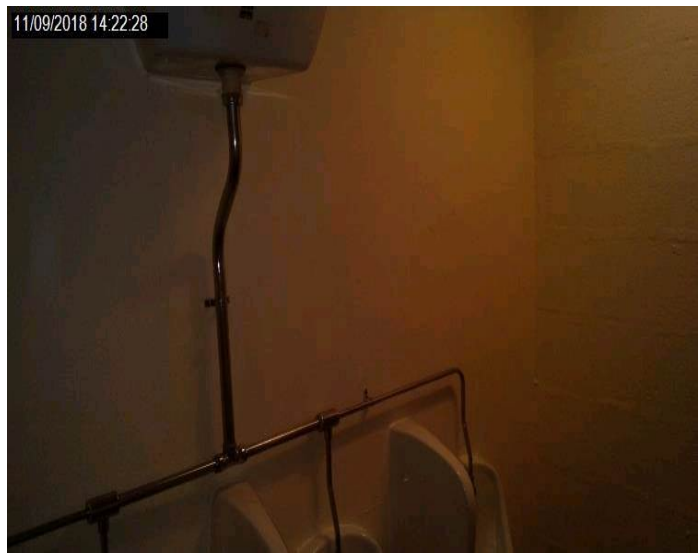
Location:	NBA721	Block:	Birmingham City University	Floor Level: 7th Floor
Sample No.:	DU002359	Portal Ref No.:	120

Item:	Textured coating to one wall			
Asbestos Content:		Result Based on:		
No Asbestos Detected		Analysis of sample using PLM		
Sample Analysed By:	Reg 13(1)	Extent:	30 m ²	
Comments: Right-hand side on entering

Material Assessment Total Score: 0		Likelihood of Disturbance Assessment Total Score: 0		Management Assessment Licensable: No Recommendations: Not Applicable Reinspection Interval: Not Applicable Overall Risk Category: E0
Product Type:	0 Not Applicable	Location:	0 Not Applicable	
Condition:	0 Not Applicable	Accessibility:	0 Not Applicable	
Surface Treatment:	0 Not Applicable			
Asbestos Type:	0 Not Applicable	Extent Score:	0 Not Applicable

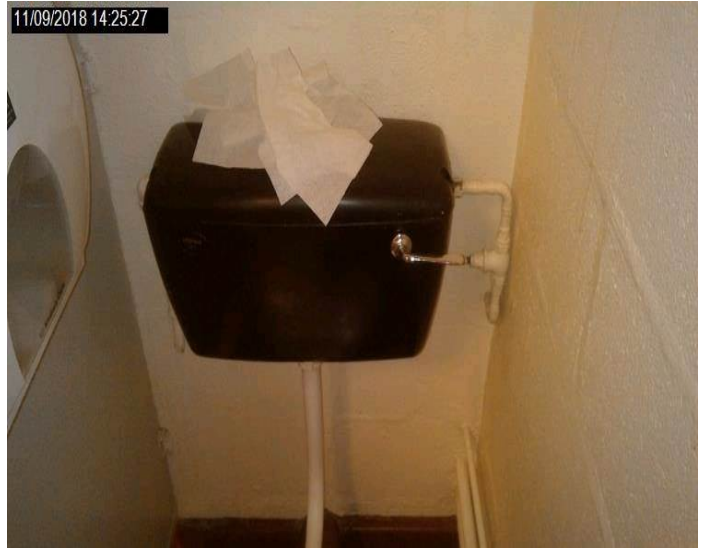
Location:	NBA719	Block:	Birmingham City University	Floor Level: 7th Floor
Sample No.:	As DU002358	Portal Ref No.:	121

Item:	Asbestos Reinforced plastic cistern			
Asbestos Content:	Result Based on:			
Amosite	Strongly presumed			
Sample Analysed By:	Not applicable	Extent:	1 unit	
Comments:

Material Assessment Total Score: 4		Likelihood of Disturbance Assessment Total Score: 4		Management Assessment Licensable: No Recommendations: Program removal Reinspection Interval: Not Applicable Overall Risk Category: C8
Product Type:	1 (Asbestos reinforced plastic)	Location:	2 (Rooms up to 100 sq m)	
Condition:	1 (Minor scratches)	Accessibility:	1 (Occasionally likely to be disturbed)	
Surface Treatment:	0 (Composite material)			
Asbestos Type:	2 (Amosite)	Extent Score:	1 (<10 sq m or 10m pipe run)

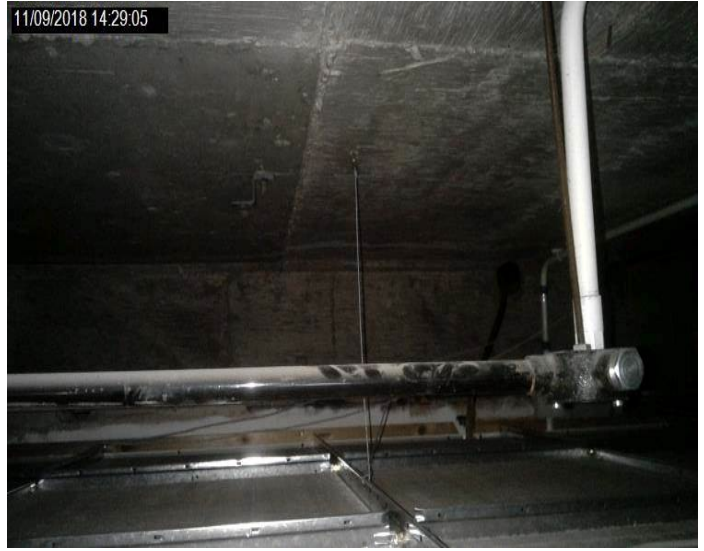
Location:	NBA713	Block:	Birmingham City University	Floor Level: 7th Floor
Sample No.:	As DU002353	Portal Ref No.:	122

Item:	Asbestos Reinforced plastic pipe sleeve			
Asbestos Content:	Result Based on:			
Chrysotile	Strongly presumed			
Sample Analysed By:	Not applicable	Extent:	5 units	
Comments: Structural columns

Material Assessment Total Score: 3		Likelihood of Disturbance Assessment Total Score: 3		Management Assessment Licensable: No Recommendations: Program removal Reinspection Interval: Not Applicable Overall Risk Category: D6
Product Type:	1 (Asbestos reinforced plastic)	Location:	2 (Rooms up to 100 sq m)	
Condition:	1 (Minor scratches)	Accessibility:	0 (Usually inaccessible or unlikely to be disturbed)	
Surface Treatment:	0 (Composite material)			
Asbestos Type:	1 (Chrysotile)	Extent Score:	1 (<10 sq m or 10m pipe run)

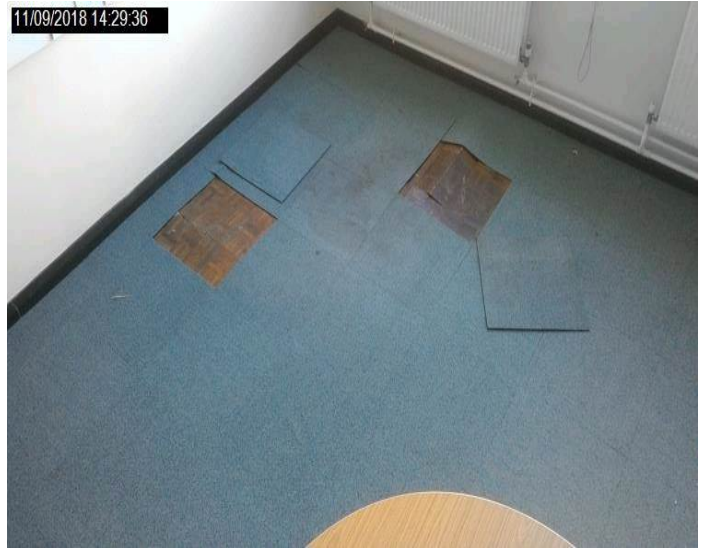
Location:	NBA713	Block:	Birmingham City University	Floor Level: 7th Floor
Sample No.:	As DU002354	Portal Ref No.:	123

Item:	Bitumen adhesive to parquet flooring			
Asbestos Content:			Result Based on:	
No Asbestos Detected		Strongly presumed		
Sample Analysed By:	Not applicable	Extent:	20 m ²	
Comments:

Material Assessment Total Score: 0		Likelihood of Disturbance Assessment Total Score: 0		Management Assessment Licensable: No Recommendations: Not Applicable Reinspection Interval: Not Applicable Overall Risk Category: E0
Product Type:	0 Not Applicable	Location:	0 Not Applicable	
Condition:	0 Not Applicable	Accessibility:	0 Not Applicable	
Surface Treatment:	0 Not Applicable			
Asbestos Type:	0 Not Applicable	Extent Score:	0 Not Applicable

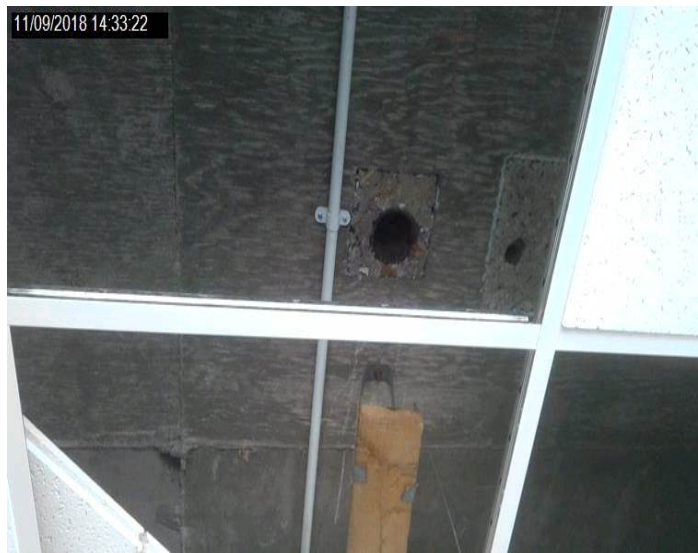
Location:	NBA714	Block:	Birmingham City University	Floor Level: 7th Floor
Sample No.:	As DU002353	Portal Ref No.:	124

Item:	Asbestos Reinforced plastic pipe sleeve			
Asbestos Content:	Result Based on:			
Chrysotile	Strongly presumed			
Sample Analysed By:	Not applicable	Extent:	6 units	
Comments: Structural columns, through ceiling also

Material Assessment Total Score: 3		Likelihood of Disturbance Assessment Total Score: 3		Management Assessment Licensable: No Recommendations: Program removal Reinspection Interval: Not Applicable Overall Risk Category: D6
Product Type:	1 (Asbestos reinforced plastic)	Location:	2 (Rooms up to 100 sq m)	
Condition:	1 (Minor scratches)	Accessibility:	0 (Usually inaccessible or unlikely to be disturbed)	
Surface Treatment:	0 (Composite material)			
Asbestos Type:	1 (Chrysotile)	Extent Score:	1 (<10 sq m or 10m pipe run)

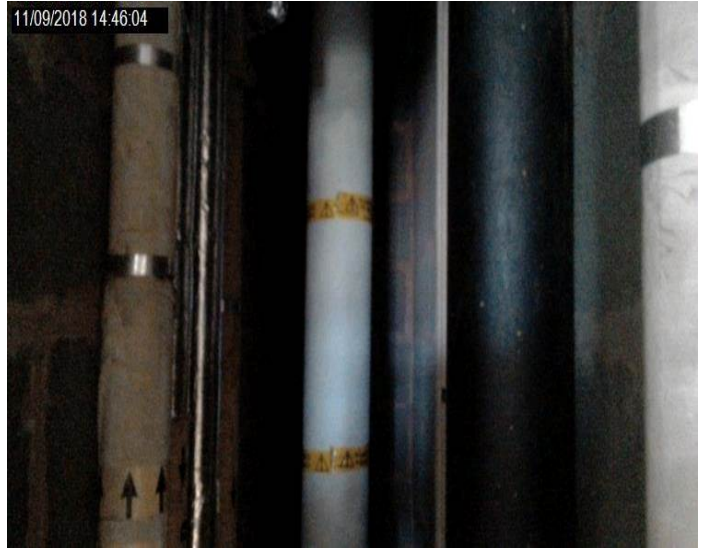
Location:	NBA719A Service duct	Block:	Birmingham City University	Floor Level: 7th Floor
Sample No.:	DU002361	Portal Ref No.:	127

Item:	Asbestos Cement flue pipe			
Asbestos Content:	Result Based on:			
Chrysotile	Analysis of sample using PLM			
Sample Analysed By: Reg 13(1)	Extent:	4 linear metres		
Comments: Textile rope present internally to the flue pipe (redundant)

Material Assessment Total Score: 4		Likelihood of Disturbance Assessment Total Score: 4		Management Assessment Licensable: No Recommendations: Program removal Reinspection Interval: Not Applicable Overall Risk Category: C8
Product Type:	1 (Asbestos cement)	Location:	2 (Rooms up to 100 sq m)	
Condition:	1 (Minor scratches)	Accessibility:	1 (Occasionally likely to be disturbed)	
Surface Treatment:	1 (Encapsulated asbestos cement)			
Asbestos Type:	1 (Chrysotile)	Extent Score:	1 (<10 sq m or 10m pipe run)

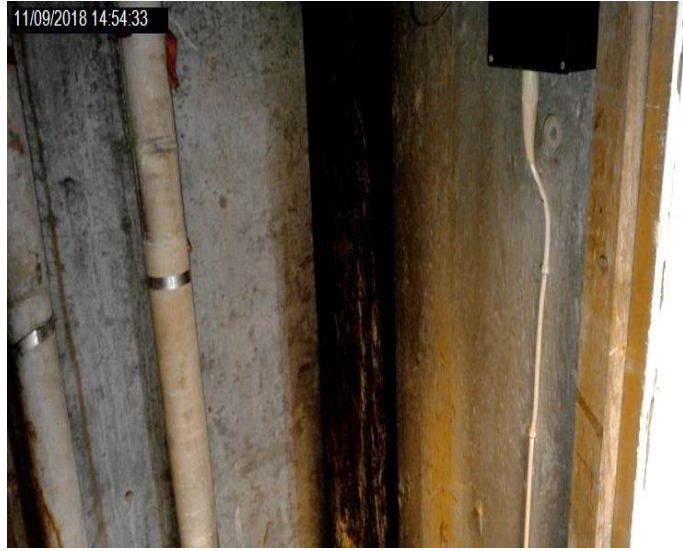
Location:	NBA714A Service duct	Block:	Birmingham City University	Floor Level: 7th Floor
Sample No.:	As DU002345	Portal Ref No.:	128

Item:	Asbestos Reinforced plastic downpipe			
Asbestos Content:	Result Based on:			
Chrysotile	Strongly presumed			
Sample Analysed By:	Not applicable	Extent:	3 linear metres	
Comments:

Material Assessment Total Score: 3		Likelihood of Disturbance Assessment Total Score: 4		Management Assessment Licensable: No Recommendations: Program removal Reinspection Interval: Not Applicable Overall Risk Category: C7
Product Type:	1 (Asbestos reinforced plastic)	Location:	2 (Rooms up to 100 sq m)	
Condition:	1 (Minor scratches)	Accessibility:	1 (Occasionally likely to be disturbed)	
Surface Treatment:	0 (Composite material)			
Asbestos Type:	1 (Chrysotile)	Extent Score:	1 (<10 sq m or 10m pipe run)

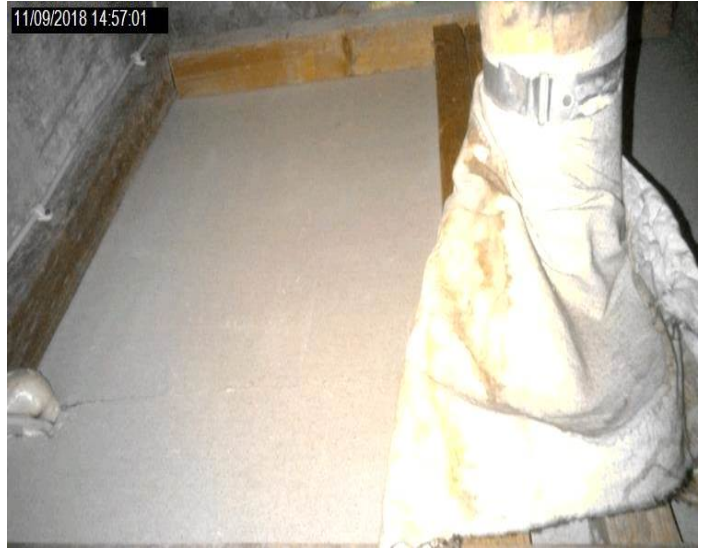
Location:	NBA714A Service duct	Block:	Birmingham City University	Floor Level: 7th Floor
Sample No.:	As DU002357	Portal Ref No.:	129

Item:	Insulating board door header			
Asbestos Content:		Result Based on:		
No Asbestos Detected		Strongly presumed		
Sample Analysed By:	Not applicable	Extent:	2 m ²	
Comments:

Material Assessment Total Score: 0		Likelihood of Disturbance Assessment Total Score: 0		Management Assessment Licensable: Yes Recommendations: Not Applicable Reinspection Interval: Not Applicable Overall Risk Category: E0
Product Type:	0 Not Applicable	Location:	0 Not Applicable	
Condition:	0 Not Applicable	Accessibility:	0 Not Applicable	
Surface Treatment:	0 Not Applicable			
Asbestos Type:	0 Not Applicable	Extent Score:	0 Not Applicable

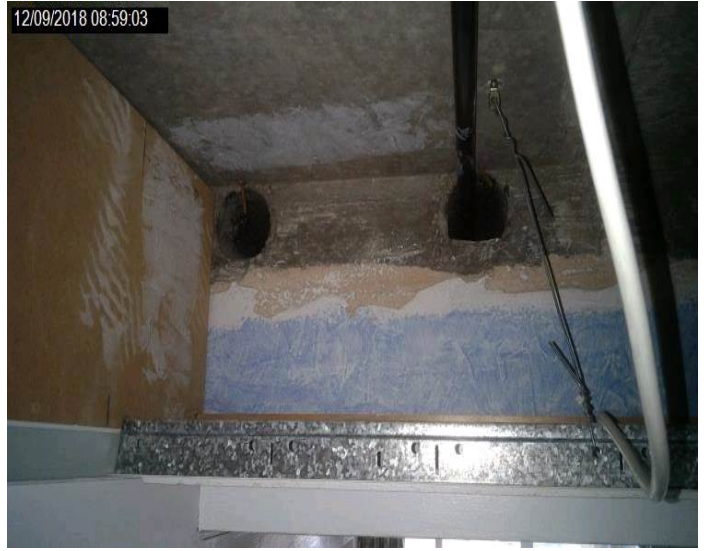
Location:	NBA715 Lecture room	Block:	Birmingham City University	Floor Level: 7th Floor
Sample No.:	As DU002353	Portal Ref No.:	130

Item:	Asbestos Reinforced plastic pipe sleeve			
Asbestos Content:	Result Based on:			
Chrysotile	Strongly presumed			
Sample Analysed By:	Not applicable	Extent:	16 units	
Comments: Structural columns

Material Assessment Total Score: 3		Likelihood of Disturbance Assessment Total Score: 3		Management Assessment Licensable: No Recommendations: Program removal Reinspection Interval: Not Applicable Overall Risk Category: D6
Product Type:	1 (Asbestos reinforced plastic)	Location:	2 (Rooms up to 100 sq m)	
Condition:	1 (Minor scratches)	Accessibility:	0 (Usually inaccessible or unlikely to be disturbed)	
Surface Treatment:	0 (Composite material)			
Asbestos Type:	1 (Chrysotile)	Extent Score:	1 (<10 sq m or 10m pipe run)

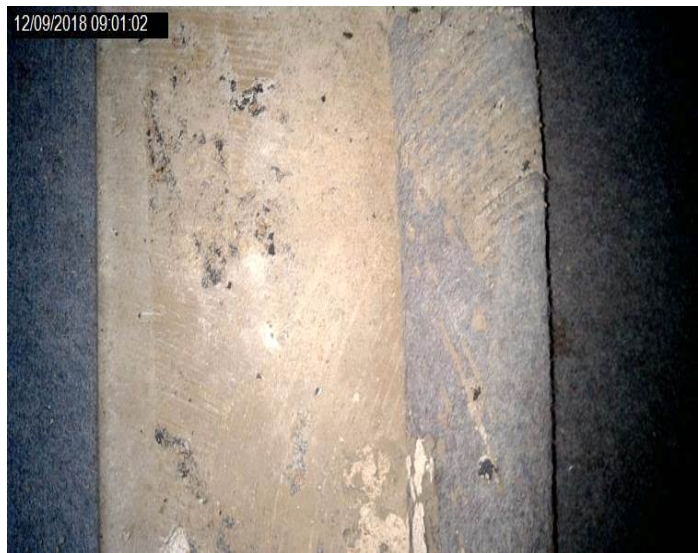
Location:	NBA715 Lecture room	Block:	Birmingham City University	Floor Level: 7th Floor
Sample No.:	DU002363	Portal Ref No.:	131

Item:	Asbestos Bitumen adhesive to concrete			
Asbestos Content:	Result Based on:			
Chrysotile	Analysis of sample using PLM			
Sample Analysed By: Reg 13(1)	Extent:	25 m ²		
Comments: Beneath carpet, to front section of room

Material Assessment Total Score: 3		Likelihood of Disturbance Assessment Total Score: 5		Management Assessment Licensable: No Recommendations: Program removal Reinspection Interval: Not Applicable Overall Risk Category: C8
Product Type:	1 (Asbestos bitumen)	Location:	2 (Rooms up to 100 sq m)	
Condition:	1 (Minor scratches)	Accessibility:	1 (Occasionally likely to be disturbed)	
Surface Treatment:	0 (Composite material)			
Asbestos Type:	1 (Chrysotile)	Extent Score:	2 (>10 - <50 sq m or >10m - <50m pipe run)

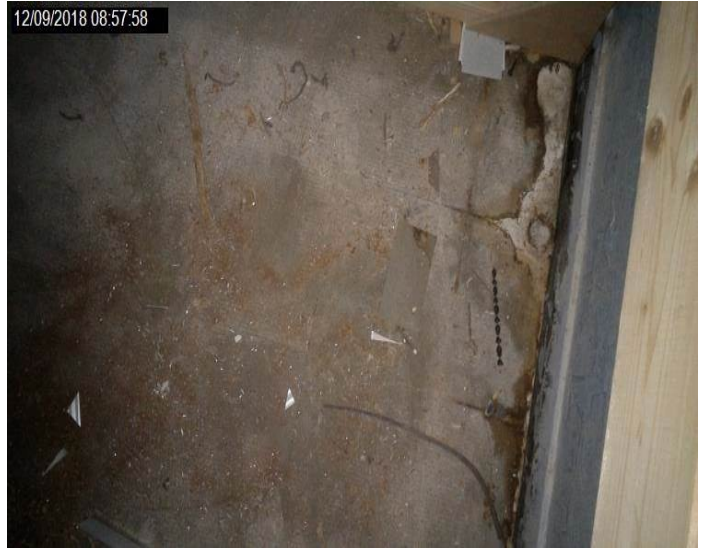
Location:	NBA715 Lecture room	Block:	Birmingham City University	Floor Level: 7th Floor
Sample No.:	DU002362	Portal Ref No.:	132

Item:	Asbestos Thermoplastic floor tiles with bitumen adhesive			
Asbestos Content:	Result Based on:			
Chrysotile in tile and adhesive	Analysis of sample using PLM			
Sample Analysed By: Reg 13(1)	Extent:	60 m ²		
Comments: Beneath raised timber floor

Material Assessment Total Score: 3		Likelihood of Disturbance Assessment Total Score: 5		Management Assessment Licensable: No Recommendations: Program removal Reinspection Interval: Not Applicable Overall Risk Category: C8
Product Type:	1 (Asbestos thermoplastic)	Location:	2 (Rooms up to 100 sq m)	
Condition:	1 (Minor scratches)	Accessibility:	0 (Usually inaccessible or unlikely to be disturbed)	
Surface Treatment:	0 (Composite material)			
Asbestos Type:	1 (Chrysotile)	Extent Score:	3 (>50 sq m or >50m pipe run)

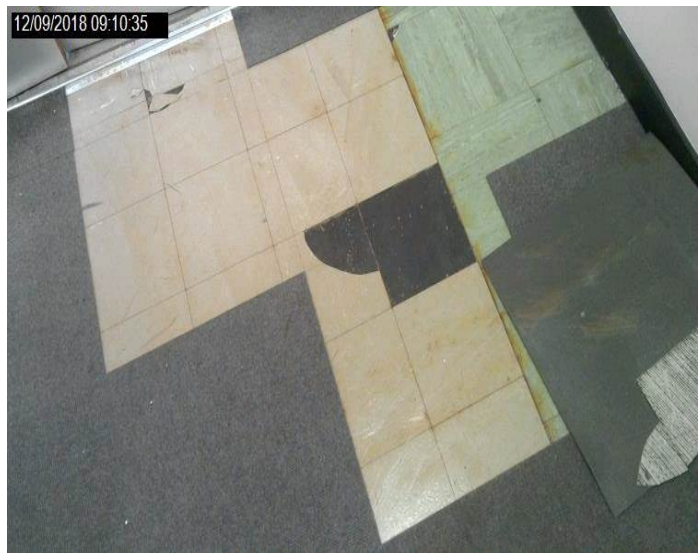
Location:	NBA799A Corridor	Block:	Birmingham City University	Floor Level: 7th Floor
Sample No.:	DU002364	Portal Ref No.:	134

Item:	Asbestos Thermoplastic floor tiles with bitumen adhesive			
Asbestos Content:	Result Based on:			
Chrysotile in tile and adhesive	Analysis of sample using PLM			
Sample Analysed By: Reg 13(1)	Extent:	16 m ²		
Comments: Composite sample green and beige

Material Assessment Total Score: 3		Likelihood of Disturbance Assessment Total Score: 4		Management Assessment Licensable: No Recommendations: Program removal Reinspection Interval: Not Applicable Overall Risk Category: C7
Product Type:	1 (Asbestos thermoplastic)	Location:	2 (Rooms up to 100 sq m)	
Condition:	1 (Minor scratches)	Accessibility:	0 (Usually inaccessible or unlikely to be disturbed)	
Surface Treatment:	0 (Composite material)			
Asbestos Type:	1 (Chrysotile)	Extent Score:	2 (>10 - <50 sq m or >10m - <50m pipe run)

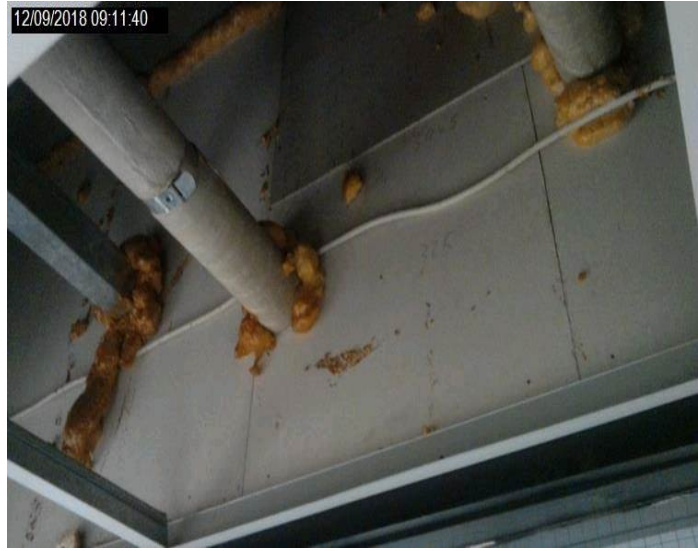
Location:	NBA799A Corridor	Block:	Birmingham City University	Floor Level: 7th Floor
Sample No.:	DU002365	Portal Ref No.:	135

Item:	Insulating board door header			
Asbestos Content:		Result Based on:		
No Asbestos Detected		Analysis of sample using PLM		
Sample Analysed By:	Reg 13(1)	Extent:	4 m ²	
Comments: Above double doors

Material Assessment Total Score: 0		Likelihood of Disturbance Assessment Total Score: 0		Management Assessment Licensable: Yes Recommendations: Not Applicable Reinspection Interval: Not Applicable Overall Risk Category: E0
Product Type:	0 Not Applicable	Location:	0 Not Applicable	
Condition:	0 Not Applicable	Accessibility:	0 Not Applicable	
Surface Treatment:	0 Not Applicable			
Asbestos Type:	0 Not Applicable	Extent Score:	0 Not Applicable

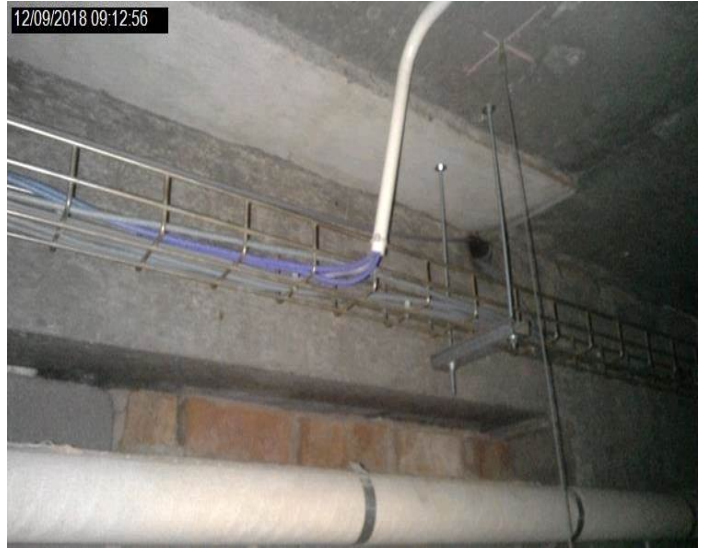
Location:	NBA799A Corridor	Block:	Birmingham City University	Floor Level: 7th Floor
Sample No.:	As DU002353	Portal Ref No.:	136

Item:	Asbestos Reinforced plastic sleeve			
Asbestos Content:	Result Based on:			
Chrysotile	Strongly presumed			
Sample Analysed By:	Not applicable	Extent:	4 units	
Comments: Structural columns

Material Assessment Total Score: 3		Likelihood of Disturbance Assessment Total Score: 3		Management Assessment Licensable: No Recommendations: Program removal Reinspection Interval: Not Applicable Overall Risk Category: D6
Product Type:	1 (Asbestos reinforced plastic)	Location:	2 (Rooms up to 100 sq m)	
Condition:	1 (Minor scratches)	Accessibility:	0 (Usually inaccessible or unlikely to be disturbed)	
Surface Treatment:	0 (Composite material)			
Asbestos Type:	1 (Chrysotile)	Extent Score:	1 (<10 sq m or 10m pipe run)

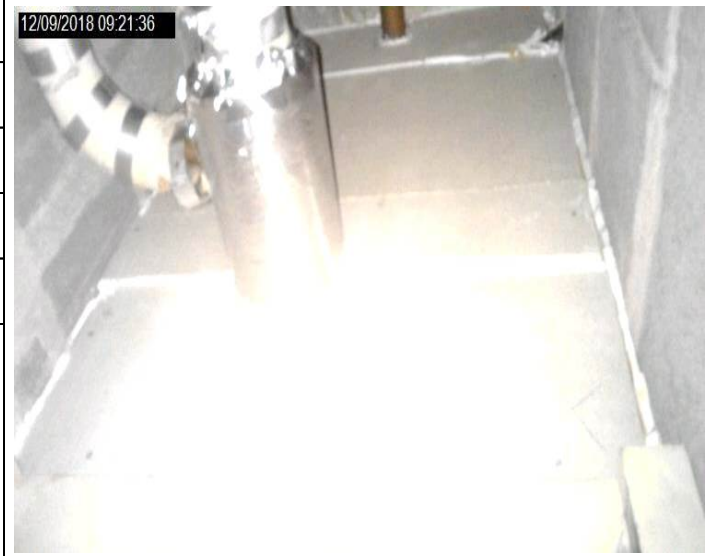
Location:	NBA799B Corridor	Block:	Birmingham City University	Floor Level: 7th Floor
Sample No.:	As DU002365	Portal Ref No.:	139

Item:	Insulating board door header			
Asbestos Content:		Result Based on:		
No Asbestos Detected		Strongly presumed		
Sample Analysed By:	Not applicable	Extent:	6 m ²	
Comments: Above door to NBA719A service duct, also above double doors

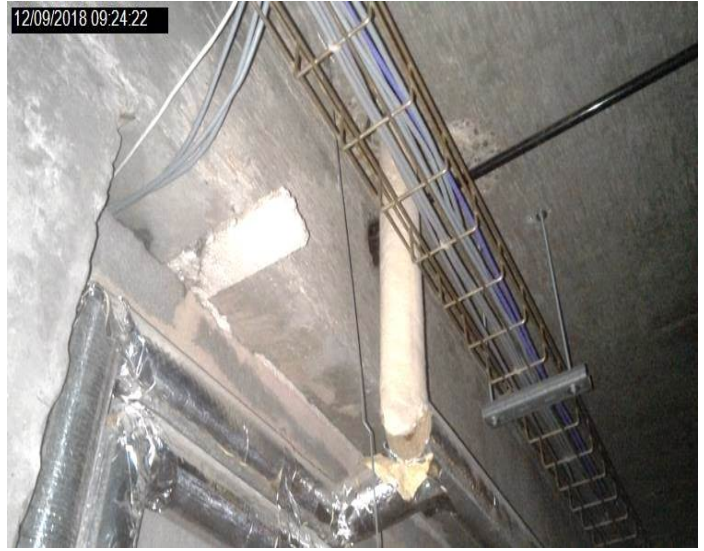
Location:	NBA799B Corridor	Block:	Birmingham City University	Floor Level: 7th Floor
Sample No.:	As DU002353	Portal Ref No.:	140

Item:	Asbestos Reinforced plastic sleeve			
Asbestos Content:	Result Based on:			
Chrysotile	Strongly presumed			
Sample Analysed By:	Not applicable	Extent:	6 units	
Comments: Structural columns

Material Assessment Total Score: 3		Likelihood of Disturbance Assessment Total Score: 3		Management Assessment Licensable: No Recommendations: Program removal Reinspection Interval: Not Applicable Overall Risk Category: D6
Product Type:	1 (Asbestos reinforced plastic)	Location:	2 (Rooms up to 100 sq m)	
Condition:	1 (Minor scratches)	Accessibility:	0 (Usually inaccessible or unlikely to be disturbed)	
Surface Treatment:	0 (Composite material)			
Asbestos Type:	1 (Chrysotile)	Extent Score:	1 (<10 sq m or 10m pipe run)

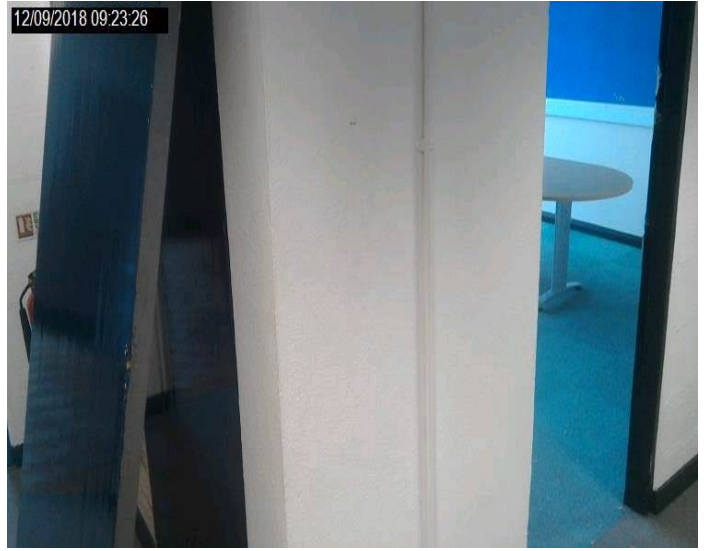
Location:	NBA799B Corridor	Block:	Birmingham City University	Floor Level: 7th Floor
Sample No.:	As DU002366	Portal Ref No.:	141

Item:	Textured coating to concrete			
Asbestos Content:		Result Based on:		
No Asbestos Detected		Strongly presumed		
Sample Analysed By:	Not applicable	Extent:	10 m ²	
Comments: Sections of walls

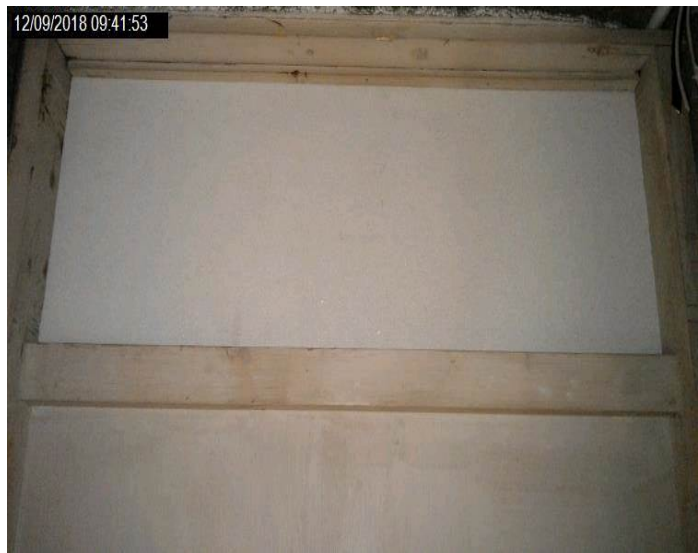
Location:	NBA799C Corridor	Block:	Birmingham City University	Floor Level: 7th Floor
Sample No.:	DU002369	Portal Ref No.:	143

Item:	Insulating board door headers			
Asbestos Content:		Result Based on:		
No Asbestos Detected		Analysis of sample using PLM		
Sample Analysed By:	Reg 13(1)	Extent:	3 m ²	
Comments: Above doors to NBA708, 722 and 723

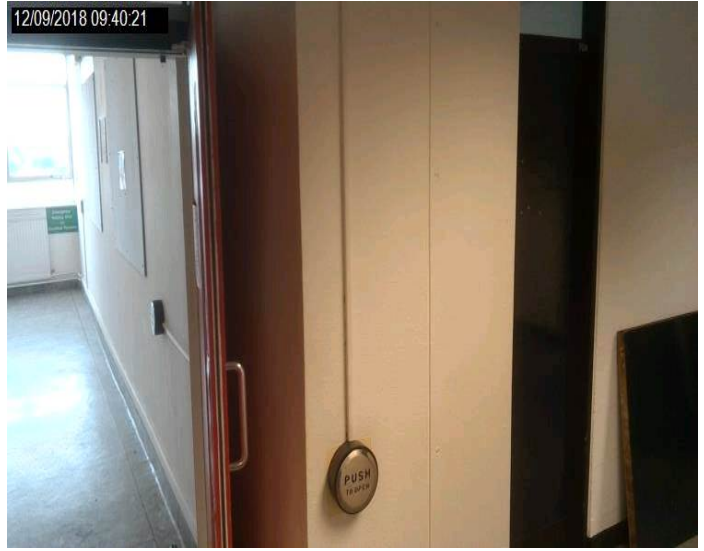
Location:	NBA799C Corridor	Block:	Birmingham City University	Floor Level: 7th Floor
Sample No.:	As DU002366	Portal Ref No.:	145

Item:	Textured coating to concrete			
Asbestos Content:		Result Based on:		
No Asbestos Detected		Strongly presumed		
Sample Analysed By:	Not applicable	Extent:	18 m ²	
Comments: Sections of walls

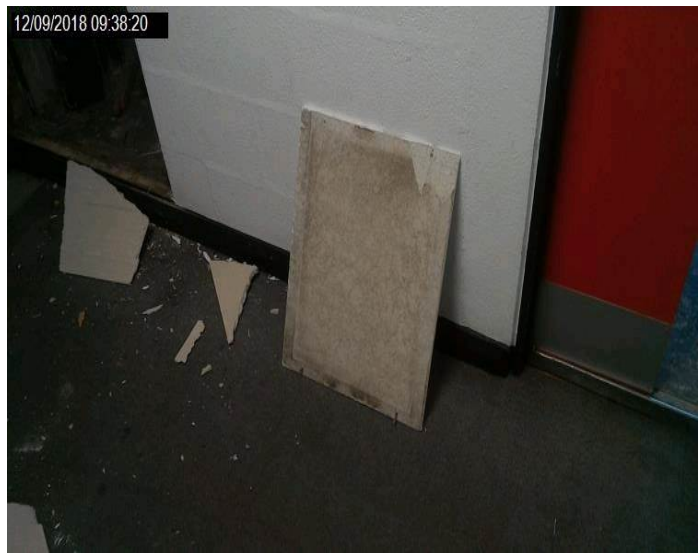
Location:	NBA799C Corridor	Block:	Birmingham City University	Floor Level: 7th Floor
Sample No.:	DU002368	Portal Ref No.:	146

Item:	Asbestos Insulating board panel to dry riser			
Asbestos Content:	Result Based on:			
Chrysotile Amosite	Analysis of sample using PLM			
Sample Analysed By: Reg 13(1)	Extent:	1 m ²		
Comments:

Material Assessment Total Score: 8		Likelihood of Disturbance Assessment Total Score: 4		Management Assessment Licensable: Yes Recommendations: Program removal Reinspection Interval: Not Applicable Overall Risk Category: B12
Product Type:	2 (Asbestos insulating board)	Location:	2 (Rooms up to 100 sq m)	
Condition:	2 (Local damage)	Accessibility:	1 (Occasionally likely to be disturbed)	
Surface Treatment:	2 (Unencapsulated asbestos insulating board)			
Asbestos Type:	2 (Chrysotile Amosite)	Extent Score:	1 (<10 sq m or 10m pipe run)

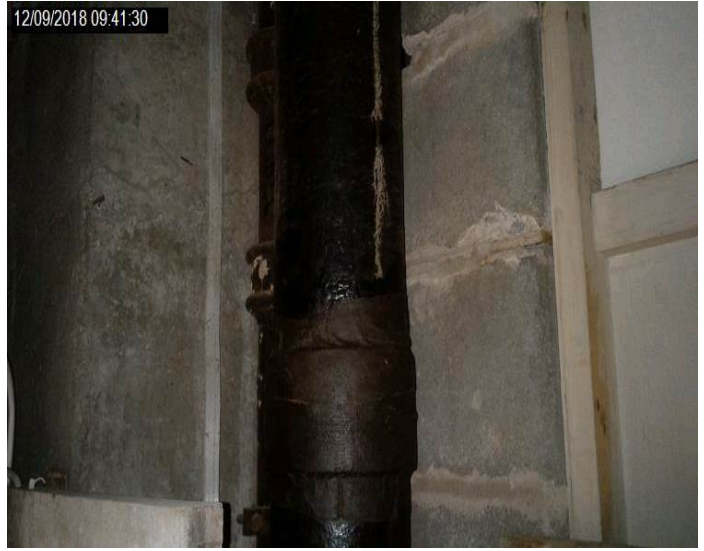
Location:	NBA799C Corridor	Block:	Birmingham City University	Floor Level: 7th Floor
Sample No.:	As DU002345	Portal Ref No.:	147

Item:	Asbestos Reinforced plastic downpipe			
Asbestos Content:	Result Based on:			
Chrysotile	Strongly presumed			
Sample Analysed By:	Not applicable	Extent:	3 linear metres	
Comments:

Material Assessment Total Score: 3		Likelihood of Disturbance Assessment Total Score: 4		Management Assessment Licensable: No Recommendations: Program removal Reinspection Interval: Not Applicable Overall Risk Category: C7
Product Type:	1 (Asbestos reinforced plastic)	Location:	2 (Rooms up to 100 sq m)	
Condition:	1 (Minor scratches)	Accessibility:	1 (Occasionally likely to be disturbed)	
Surface Treatment:	0 (Composite material)			
Asbestos Type:	1 (Chrysotile)	Extent Score:	1 (<10 sq m or 10m pipe run)
