Report No.: J102748
Nature of Work: Demolition Survey
Issue Date: 31/10/2018
Client Name: WYG Engineering Ltd
Geneva Building, Lake View Drive, Sherwood Business Park,
Annesley, Nottingham, NG15 0ED
Site Address: Baker Building, Former City North Campus, Birmingham City
University, Perry Barr, B42 2US

A demolition survey in line with HSG264 Asbestos: The Survey Guide was carried out internally and externally to the property.

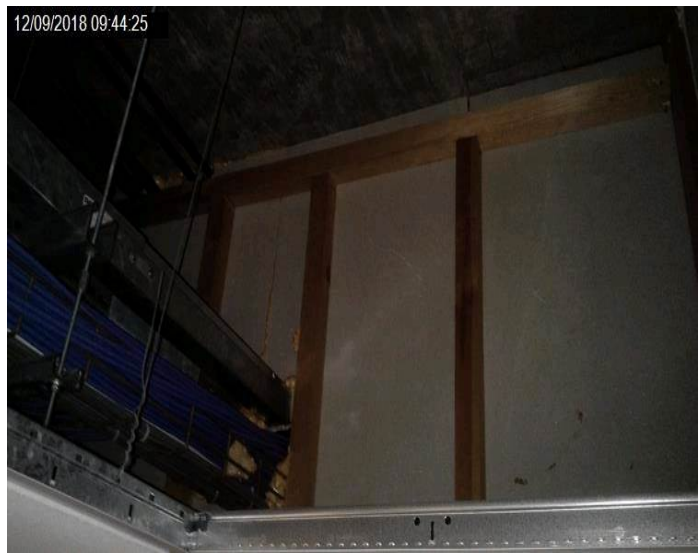
Location:	NBA799C Corridor	Block:	Birmingham City University	Floor Level: 7th Floor
Sample No.:	As DU002365	Portal Ref No.:	148

Item:	Insulating board door header			
Asbestos Content:		Result Based on:		
No Asbestos Detected		Strongly presumed		
Sample Analysed By:	Not applicable	Extent:	4 m ²	
Comments: Above double doors

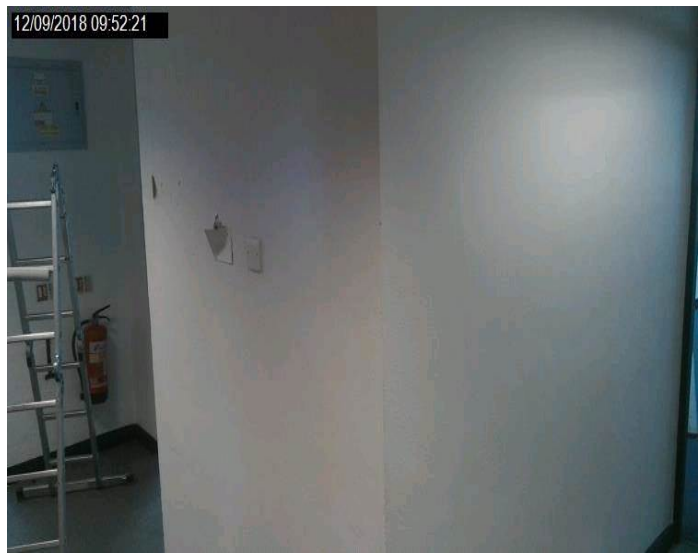
Location:	NBA799D Corridor	Block:	Birmingham City University	Floor Level: 7th Floor
Sample No.:	As DU002366	Portal Ref No.:	151

Item:	Textured coating to concrete			
Asbestos Content:		Result Based on:		
No Asbestos Detected		Strongly presumed		
Sample Analysed By:	Not applicable	Extent:	30 m ²	
Comments: Sections of walls

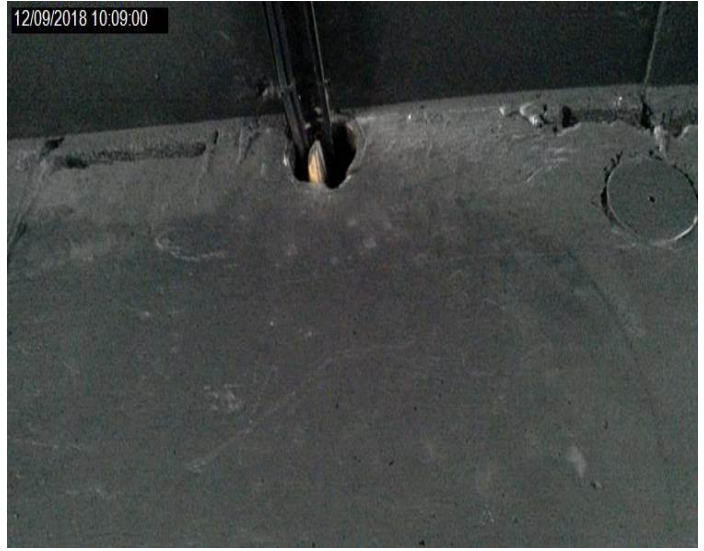
Location:	NBA614	Block:	Birmingham City University	Floor Level: 6th Floor
Sample No.:	DU002370	Portal Ref No.:	154

Item:	Asbestos Reinforced plastic sleeve			
Asbestos Content:	Result Based on:			
Chrysotile	Analysis of sample using PLM			
Sample Analysed By:	Mrs S Williams	Extent:	12 units	
Comments:

Material Assessment Total Score: 3		Likelihood of Disturbance Assessment Total Score: 3		Management Assessment Licensable: No Recommendations: Program removal Reinspection Interval: Not Applicable Overall Risk Category: D6
Product Type:	1 (Asbestos reinforced plastic)	Location:	2 (Rooms up to 100 sq m)	
Condition:	1 (Minor scratches)	Accessibility:	0 (Usually inaccessible or unlikely to be disturbed)	
Surface Treatment:	0 (Composite material)			
Asbestos Type:	1 (Chrysotile)	Extent Score:	1 (<10 sq m or 10m pipe run)

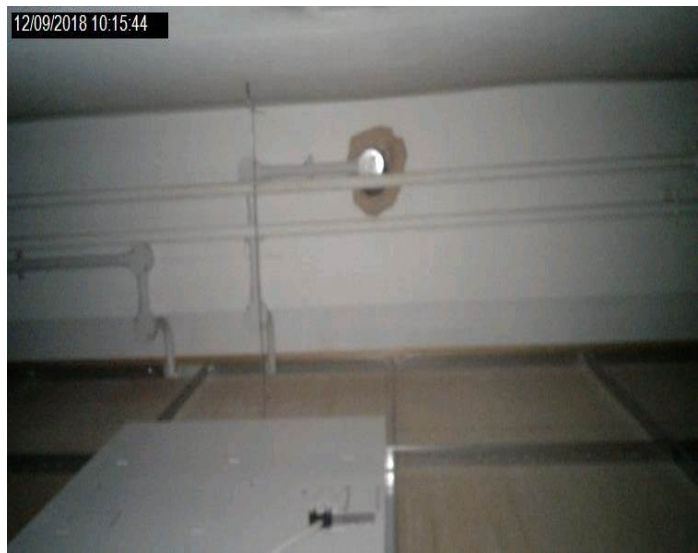
Location:	NBA613	Block:	Birmingham City University	Floor Level: 6th Floor
Sample No.:	As DU002370	Portal Ref No.:	157

Item:	Asbestos Reinforced plastic sleeve			
Asbestos Content:	Result Based on:			
Chrysotile	Strongly presumed			
Sample Analysed By:	Not applicable	Extent:	2 units	
Comments:

Material Assessment Total Score: 3		Likelihood of Disturbance Assessment Total Score: 3		Management Assessment Licensable: No Recommendations: Program removal Reinspection Interval: Not Applicable Overall Risk Category: D6
Product Type:	1 (Asbestos reinforced plastic)	Location:	2 (Rooms up to 100 sq m)	
Condition:	1 (Minor scratches)	Accessibility:	0 (Usually inaccessible or unlikely to be disturbed)	
Surface Treatment:	0 (Composite material)			
Asbestos Type:	1 (Chrysotile)	Extent Score:	1 (<10 sq m or 10m pipe run)

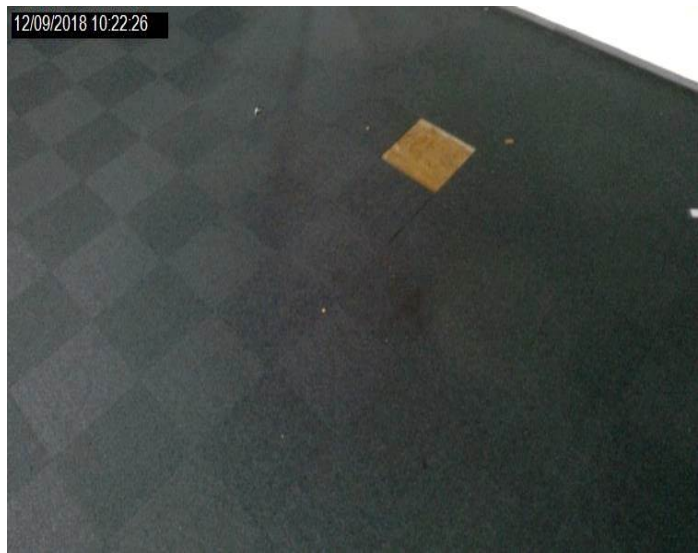
Location:	NBA612	Block:	Birmingham City University	Floor Level: 6th Floor
Sample No.:	As DU002371	Portal Ref No.:	162

Item:	Bitumen adhesive			
Asbestos Content:		Result Based on:		
No Asbestos Detected		Strongly presumed		
Sample Analysed By:	Not applicable	Extent:	50 m ²	
Comments: To underside of timber parquet flooring

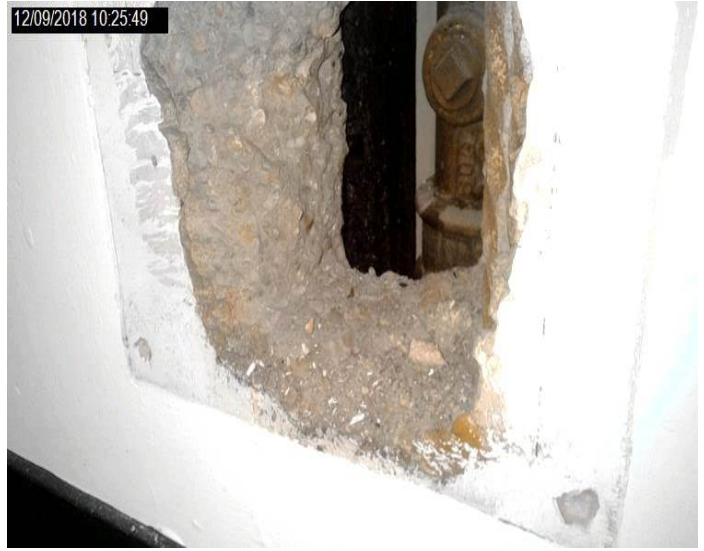
Location:	NBA612	Block:	Birmingham City University	Floor Level: 6th Floor
Sample No.:	DU002373	Portal Ref No.:	163

Item:	Asbestos Reinforced plastic downpipe			
Asbestos Content:	Result Based on:			
Chrysotile	Analysis of sample using PLM			
Sample Analysed By: Reg 13(1)	Extent:	3 linear metres		
Comments: Internally to small opening low level adjacent to entrance door

Material Assessment Total Score: 3		Likelihood of Disturbance Assessment Total Score: 3		Management Assessment Licensable: No Recommendations: Program removal Reinspection Interval: Not Applicable Overall Risk Category: D6
Product Type:	1 (Asbestos reinforced plastic)	Location:	2 (Rooms up to 100 sq m)	
Condition:	1 (Minor scratches)	Accessibility:	0 (Usually inaccessible or unlikely to be disturbed)	
Surface Treatment:	0 (Composite material)			
Asbestos Type:	1 (Chrysotile)	Extent Score:	1 (<10 sq m or 10m pipe run)

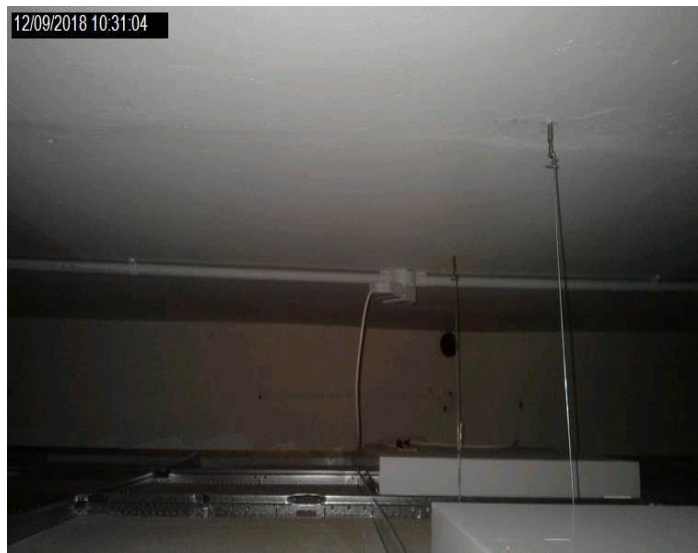
Location:	NBA611	Block:	Birmingham City University	Floor Level: 6th Floor
Sample No.:	As DU002370	Portal Ref No.:	164

Item:	Asbestos Reinforced plastic sleeve			
Asbestos Content:	Result Based on:			
Chrysotile	Strongly presumed			
Sample Analysed By:	Not applicable	Extent:	4 units	
Comments:

Material Assessment Total Score: 3		Likelihood of Disturbance Assessment Total Score: 3		Management Assessment Licensable: No Recommendations: Program removal Reinspection Interval: Not Applicable Overall Risk Category: D6
Product Type:	1 (Asbestos reinforced plastic)	Location:	2 (Rooms up to 100 sq m)	
Condition:	1 (Minor scratches)	Accessibility:	0 (Usually inaccessible or unlikely to be disturbed)	
Surface Treatment:	0 (Composite material)			
Asbestos Type:	1 (Chrysotile)	Extent Score:	1 (<10 sq m or 10m pipe run)

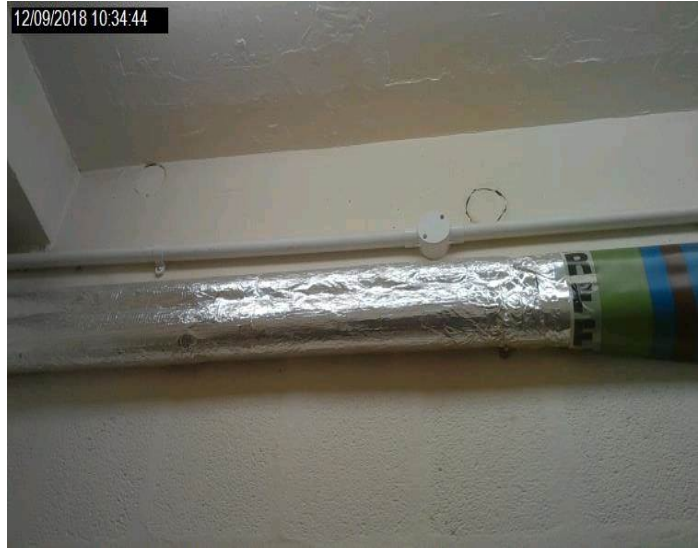
Location:	NBA610	Block:	Birmingham City University	Floor Level: 6th Floor
Sample No.:	As DU002370	Portal Ref No.:	166

Item:	Asbestos Reinforced plastic pipe sleeve			
Asbestos Content:	Result Based on:			
Chrysotile	Strongly presumed			
Sample Analysed By:	Not applicable	Extent:	2 units	
Comments:

Material Assessment Total Score: 3		Likelihood of Disturbance Assessment Total Score: 3		Management Assessment Licensable: No Recommendations: Program removal Reinspection Interval: Not Applicable Overall Risk Category: D6
Product Type:	1 (Asbestos reinforced plastic)	Location:	2 (Rooms up to 100 sq m)	
Condition:	1 (Minor scratches)	Accessibility:	0 (Usually inaccessible or unlikely to be disturbed)	
Surface Treatment:	0 (Composite material)			
Asbestos Type:	1 (Chrysotile)	Extent Score:	1 (<10 sq m or 10m pipe run)

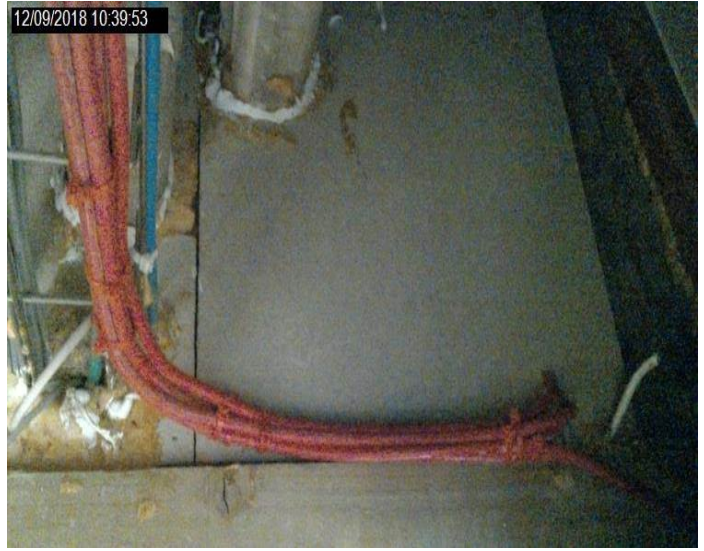
Location:	NBA615A Service duct	Block:	Birmingham City University	Floor Level: 6th Floor
Sample No.:	DU002374	Portal Ref No.:	167

Item:	Insulating board door header			
Asbestos Content:		Result Based on:		
No Asbestos Detected		Analysis of sample using PLM		
Sample Analysed By:	Reg 13(1)	Extent:	2 m ²	
Comments:

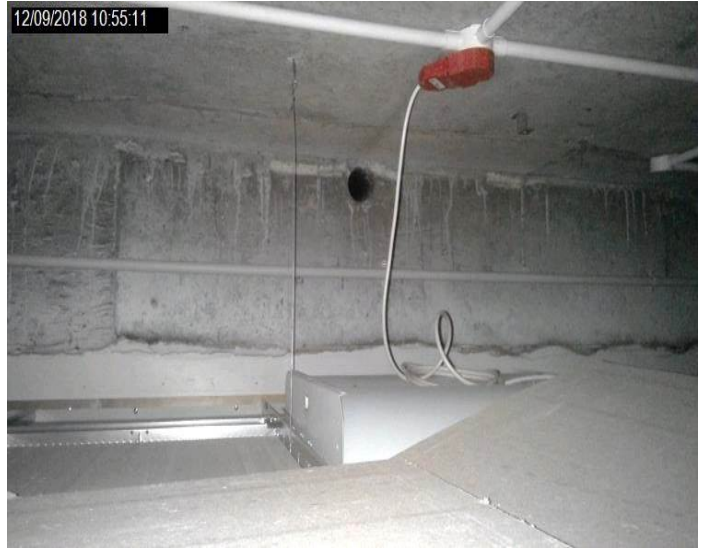
Location:	NBA609A	Block:	Birmingham City University	Floor Level: 6th Floor
Sample No.:	As DU002370	Portal Ref No.:	175

Item:	Asbestos Reinforced plastic sleeve			
Asbestos Content:	Result Based on:			
Chrysotile	Strongly presumed			
Sample Analysed By:	Not applicable	Extent:	12 units	
Comments:

Material Assessment Total Score: 3		Likelihood of Disturbance Assessment Total Score: 3		Management Assessment Licensable: No Recommendations: Program removal Reinspection Interval: Not Applicable Overall Risk Category: D6
Product Type:	1 (Asbestos reinforced plastic)	Location:	2 (Rooms up to 100 sq m)	
Condition:	1 (Minor scratches)	Accessibility:	0 (Usually inaccessible or unlikely to be disturbed)	
Surface Treatment:	0 (Composite material)			
Asbestos Type:	1 (Chrysotile)	Extent Score:	1 (<10 sq m or 10m pipe run)

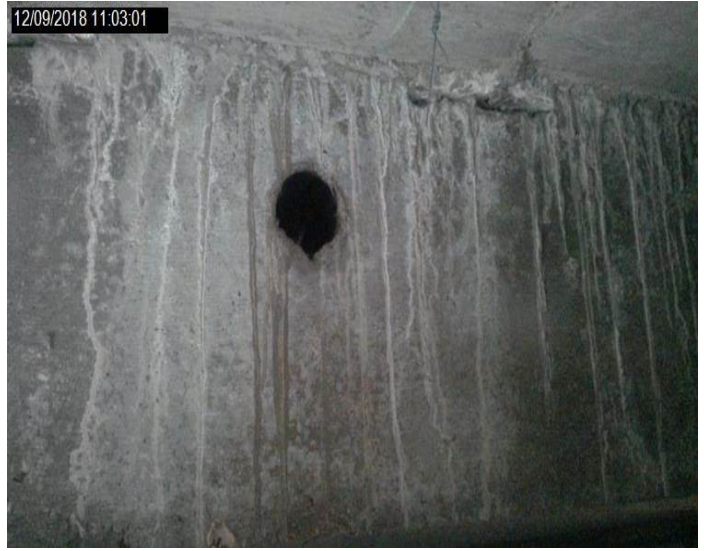
Location:	NBA609	Block:	Birmingham City University	Floor Level: 6th Floor
Sample No.:	As DU002370	Portal Ref No.:	179

Item:	Asbestos Reinforced plastic sleeve			
Asbestos Content:	Result Based on:			
Chrysotile	Strongly presumed			
Sample Analysed By:	Not applicable	Extent:	6 units	
Comments:

Material Assessment Total Score: 3		Likelihood of Disturbance Assessment Total Score: 3		Management Assessment Licensable: No Recommendations: Program removal Reinspection Interval: Not Applicable Overall Risk Category: D6
Product Type:	1 (Asbestos reinforced plastic)	Location:	2 (Rooms up to 100 sq m)	
Condition:	1 (Minor scratches)	Accessibility:	0 (Usually inaccessible or unlikely to be disturbed)	
Surface Treatment:	0 (Composite material)			
Asbestos Type:	1 (Chrysotile)	Extent Score:	1 (<10 sq m or 10m pipe run)

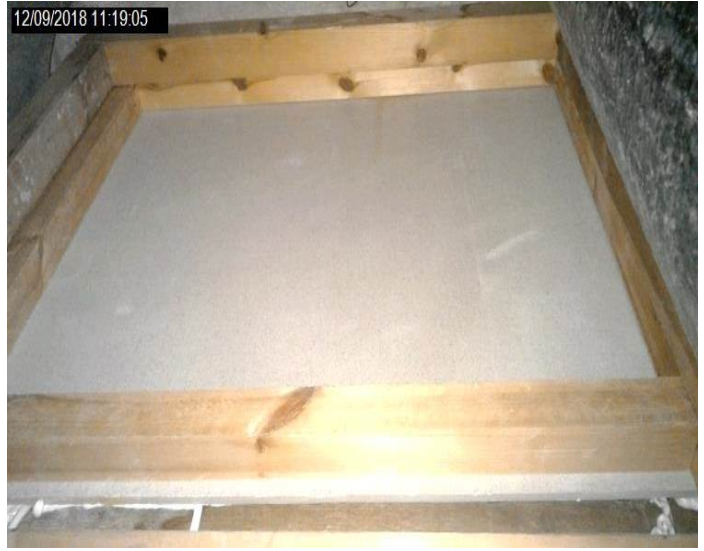
Location:	NBA608A Service duct	Block:	Birmingham City University	Floor Level: 6th Floor
Sample No.:	DU002377	Portal Ref No.:	182

Item:	Insulating board door header			
Asbestos Content:		Result Based on:		
No Asbestos Detected		Analysis of sample using PLM		
Sample Analysed By:	Reg 13(1)	Extent:	1 m ²	
Comments:

Material Assessment Total Score: 0		Likelihood of Disturbance Assessment Total Score: 0		Management Assessment Licensable: Yes Recommendations: Not Applicable Reinspection Interval: Not Applicable Overall Risk Category: E0
Product Type:	0 Not Applicable	Location:	0 Not Applicable	
Condition:	0 Not Applicable	Accessibility:	0 Not Applicable	
Surface Treatment:	0 Not Applicable			
Asbestos Type:	0 Not Applicable	Extent Score:	0 Not Applicable

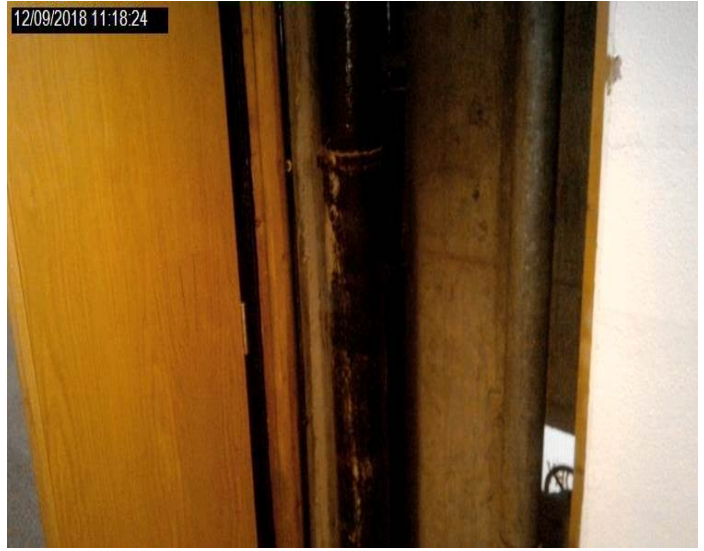
Location:	NBA608A Service duct	Block:	Birmingham City University	Floor Level: 6th Floor
Sample No.:	As DU002373	Portal Ref No.:	183

Item:	Asbestos Reinforced plastic downpipe			
Asbestos Content:	Result Based on:			
Chrysotile	Strongly presumed			
Sample Analysed By:	Not applicable	Extent:	3 linear metres	
Comments:

Material Assessment Total Score: 3		Likelihood of Disturbance Assessment Total Score: 4		Management Assessment Licensable: No Recommendations: Program removal Reinspection Interval: Not Applicable Overall Risk Category: C7
Product Type:	1 (Asbestos reinforced plastic)	Location:	2 (Rooms up to 100 sq m)	
Condition:	1 (Minor scratches)	Accessibility:	1 (Occasionally likely to be disturbed)	
Surface Treatment:	0 (Composite material)			
Asbestos Type:	1 (Chrysotile)	Extent Score:	1 (<10 sq m or 10m pipe run)

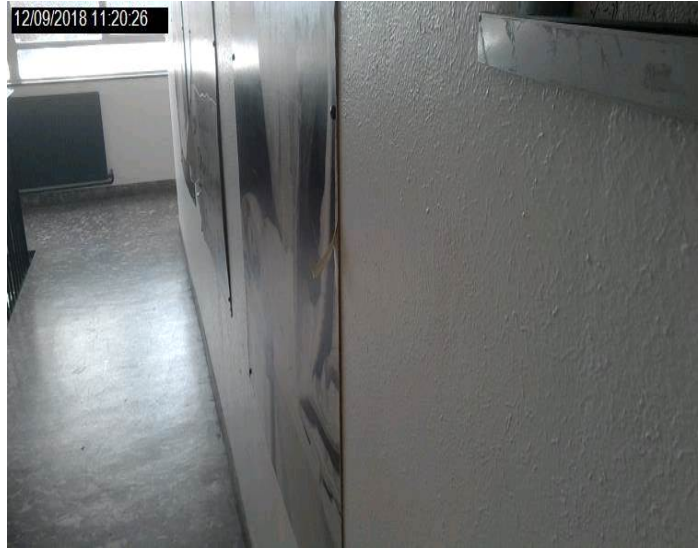
Location:	NBA699 Stairwell	Block:	Birmingham City University	Floor Level: 6th Floor
Sample No.:	DU002378	Portal Ref No.:	184

Item:	Textured coating to concrete			
Asbestos Content:		Result Based on:		
No Asbestos Detected		Analysis of sample using PLM		
Sample Analysed By:	Reg 13(1)	Extent:	75 m ²	
Comments:

Material Assessment Total Score: 0		Likelihood of Disturbance Assessment Total Score: 0		Management Assessment Licensable: No Recommendations: Not Applicable Reinspection Interval: Not Applicable Overall Risk Category: E0
Product Type:	0 Not Applicable	Location:	0 Not Applicable	
Condition:	0 Not Applicable	Accessibility:	0 Not Applicable	
Surface Treatment:	0 Not Applicable			
Asbestos Type:	0 Not Applicable	Extent Score:	0 Not Applicable

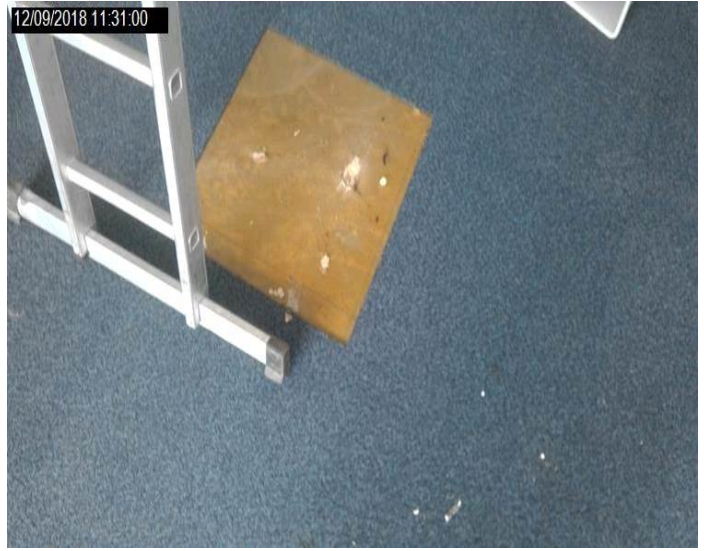
Location:	NBA620	Block:	Birmingham City University	Floor Level: 6th Floor
Sample No.:	As DU002379	Portal Ref No.:	187

Item:	Asbestos Bitumen adhesive			
Asbestos Content:	Result Based on:			
Chrysotile	Strongly presumed			
Sample Analysed By:	Not applicable	Extent:	12 m ²	
Comments:

Material Assessment Total Score: 3		Likelihood of Disturbance Assessment Total Score: 4		Management Assessment Licensable: No Recommendations: Program removal Reinspection Interval: Not Applicable Overall Risk Category: C7
Product Type:	1 (Asbestos bitumen)	Location:	2 (Rooms up to 100 sq m)	
Condition:	1 (Minor scratches)	Accessibility:	0 (Usually inaccessible or unlikely to be disturbed)	
Surface Treatment:	0 (Composite material)			
Asbestos Type:	1 (Chrysotile)	Extent Score:	2 (>10 - <50 sq m or >10m - <50m pipe run)

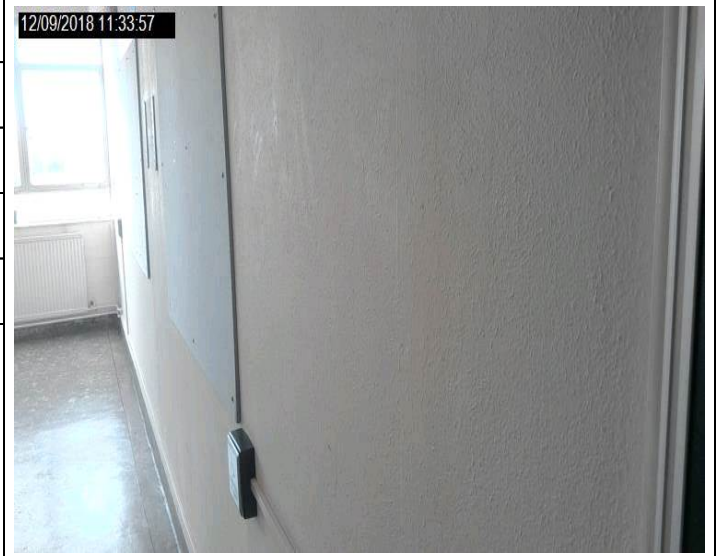
Location:	NBA699A Lift lobby	Block:	Birmingham City University		Floor Level: 6th Floor
Sample No.:	As DU002378	Portal Ref No.:	188

Item:	Textured coating to concrete walls				
Asbestos Content:		Result Based on:			
No Asbestos Detected		Strongly presumed			
Sample Analysed By:	Not applicable	Extent:	50 m ²		
Comments:

Material Assessment Total Score: 0		Likelihood of Disturbance Assessment Total Score: 0		Management Assessment Licensable: No Recommendations: Not Applicable Reinspection Interval: Not Applicable Overall Risk Category: E0
Product Type:	0 Not Applicable	Location:	0 Not Applicable	
Condition:	0 Not Applicable	Accessibility:	0 Not Applicable	
Surface Treatment:	0 Not Applicable			
Asbestos Type:	0 Not Applicable	Extent Score:	0 Not Applicable

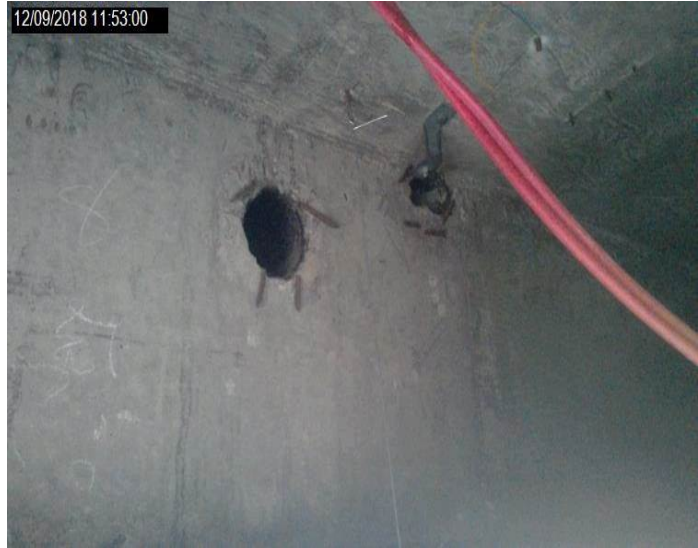
Location:	NBA605	Block:	Birmingham City University	Floor Level: 6th Floor
Sample No.:	As DU002380	Portal Ref No.:	193

Item:	Asbestos Reinforced plastic sleeve			
Asbestos Content:	Result Based on:			
Chrysotile	Strongly presumed			
Sample Analysed By:	Not applicable	Extent:	12 units	
Comments:

Material Assessment Total Score: 3		Likelihood of Disturbance Assessment Total Score: 3		Management Assessment Licensable: No Recommendations: Program removal Reinspection Interval: Not Applicable Overall Risk Category: D6
Product Type:	1 (Asbestos reinforced plastic)	Location:	2 (Rooms up to 100 sq m)	
Condition:	1 (Minor scratches)	Accessibility:	0 (Usually inaccessible or unlikely to be disturbed)	
Surface Treatment:	0 (Composite material)			
Asbestos Type:	1 (Chrysotile)	Extent Score:	1 (<10 sq m or 10m pipe run)

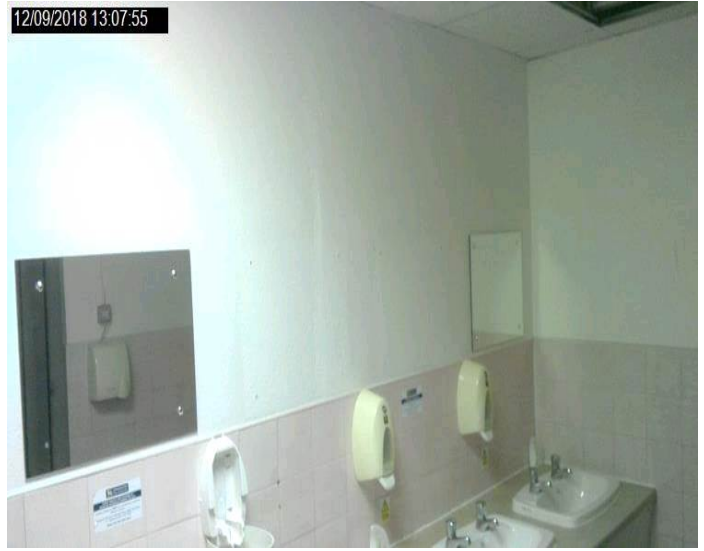
Location:	NBA620A	Block:	Birmingham City University	Floor Level: 6th Floor
Sample No.:	DU002382	Portal Ref No.:	198

Item:	Textured coating to one wall			
Asbestos Content:		Result Based on:		
No Asbestos Detected		Analysis of sample using PLM		
Sample Analysed By:	Reg 13(1)	Extent:	25 m ²	
Comments: Right-hand side on entering

Material Assessment Total Score: 0		Likelihood of Disturbance Assessment Total Score: 0		Management Assessment Licensable: No Recommendations: Not Applicable Reinspection Interval: Not Applicable Overall Risk Category: E0
Product Type:	0 Not Applicable	Location:	0 Not Applicable	
Condition:	0 Not Applicable	Accessibility:	0 Not Applicable	
Surface Treatment:	0 Not Applicable			
Asbestos Type:	0 Not Applicable	Extent Score:	0 Not Applicable

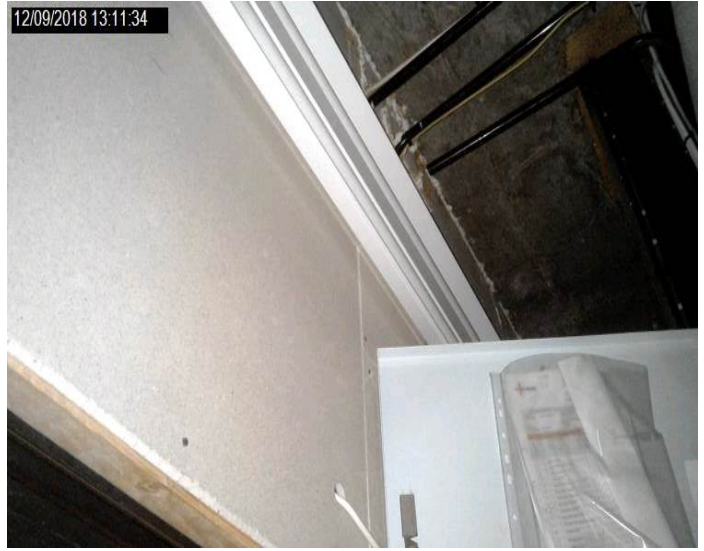
Location:	NBA621B Service duct	Block:	Birmingham City University	Floor Level: 6th Floor
Sample No.:	DU002383	Portal Ref No.:	199

Item:	Insulating board door header			
Asbestos Content:		Result Based on:		
No Asbestos Detected		Analysis of sample using PLM		
Sample Analysed By:	Reg 13(1)	Extent:	4 m ²	
Comments:

Material Assessment Total Score: 0		Likelihood of Disturbance Assessment Total Score: 0		Management Assessment Licensable: Yes Recommendations: Not Applicable Reinspection Interval: Not Applicable Overall Risk Category: E0
Product Type:	0 Not Applicable	Location:	0 Not Applicable	
Condition:	0 Not Applicable	Accessibility:	0 Not Applicable	
Surface Treatment:	0 Not Applicable			
Asbestos Type:	0 Not Applicable	Extent Score:	0 Not Applicable

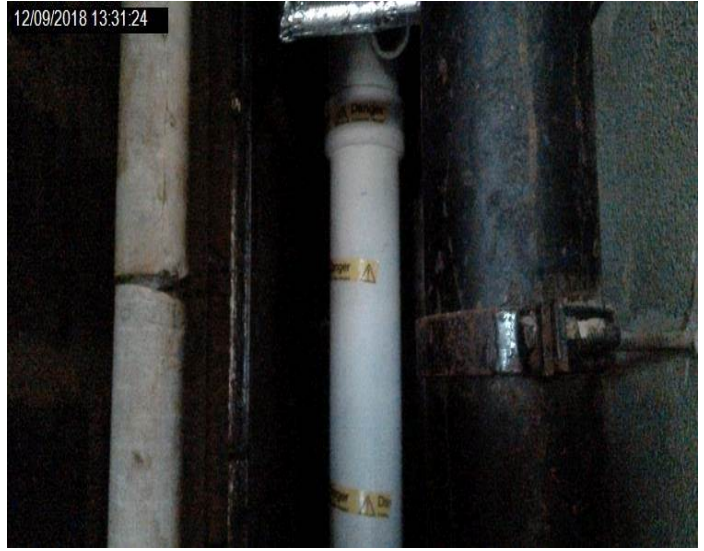
Location:	NBA619A Service duct	Block:	Birmingham City University	Floor Level: 6th Floor
Sample No.:	DU002384	Portal Ref No.:	204

Item:	Asbestos Cement flue pipe			
Asbestos Content:	Result Based on:			
Chrysotile	Analysis of sample using PLM			
Sample Analysed By:	Reg 13(1)	Extent:	4 linear metres	
Comments:

Material Assessment Total Score: 4		Likelihood of Disturbance Assessment Total Score: 4		Management Assessment Licensable: No Recommendations: Program removal Reinspection Interval: Not Applicable Overall Risk Category: C8
Product Type:	1 (Asbestos cement)	Location:	2 (Rooms up to 100 sq m)	
Condition:	1 (Minor scratches)	Accessibility:	1 (Occasionally likely to be disturbed)	
Surface Treatment:	1 (Encapsulated asbestos cement)			
Asbestos Type:	1 (Chrysotile)	Extent Score:	1 (<10 sq m or 10m pipe run)

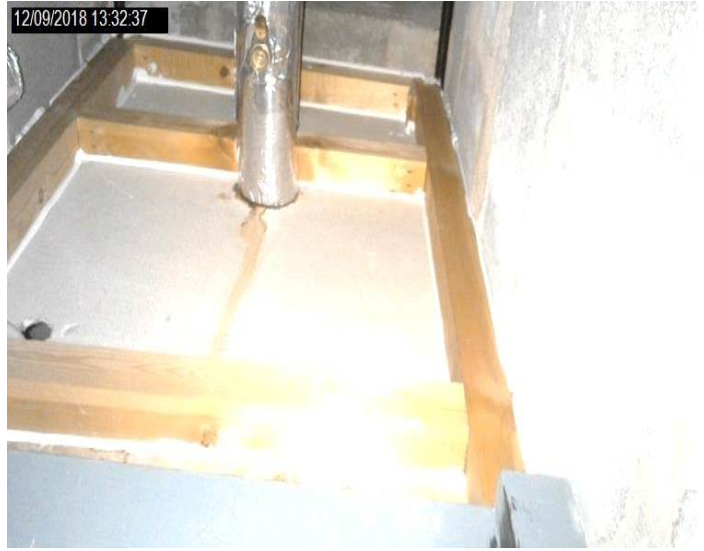
Location:	NBA619A Service duct	Block:	Birmingham City University	Floor Level: 6th Floor
Sample No.:	DU002385	Portal Ref No.:	205

Item:	Insulating board door header			
Asbestos Content:		Result Based on:		
No Asbestos Detected		Analysis of sample using PLM		
Sample Analysed By:	Reg 13(1)	Extent:	1 m ²	
Comments:

Material Assessment Total Score: 0		Likelihood of Disturbance Assessment Total Score: 0		Management Assessment Licensable: Yes Recommendations: Not Applicable Reinspection Interval: Not Applicable Overall Risk Category: E0
Product Type:	0 Not Applicable	Location:	0 Not Applicable	
Condition:	0 Not Applicable	Accessibility:	0 Not Applicable	
Surface Treatment:	0 Not Applicable			
Asbestos Type:	0 Not Applicable	Extent Score:	0 Not Applicable

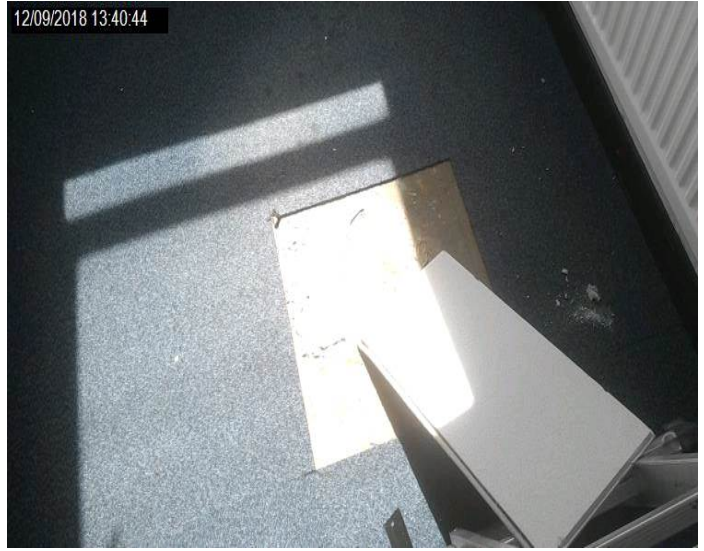
Location:	NBA622	Block:	Birmingham City University	Floor Level: 6th Floor
Sample No.:	DU002386	Portal Ref No.:	207

Item:	Asbestos Thermoplastic floor tiles with bitumen adhesive			
Asbestos Content:	Result Based on:			
Chrysotile in tile and adhesive	Analysis of sample using PLM			
Sample Analysed By:	Reg 13(1)	Extent:	10 m ²	
Comments:

Material Assessment Total Score: 3		Likelihood of Disturbance Assessment Total Score: 3		Management Assessment Licensable: No Recommendations: Program removal Reinspection Interval: Not Applicable Overall Risk Category: D6
Product Type:	1 (Asbestos thermoplastic)	Location:	2 (Rooms up to 100 sq m)	
Condition:	1 (Minor scratches)	Accessibility:	0 (Usually inaccessible or unlikely to be disturbed)	
Surface Treatment:	0 (Composite material)			
Asbestos Type:	1 (Chrysotile)	Extent Score:	1 (<10 sq m or 10m pipe run)

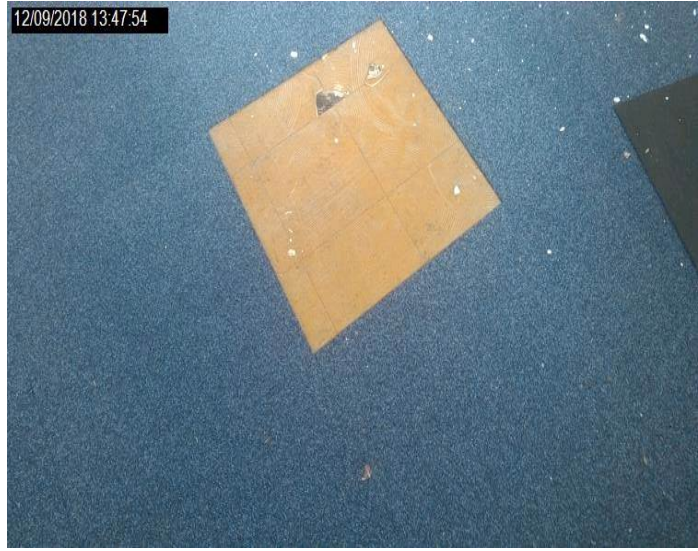
Location:	NBA623	Block:	Birmingham City University	Floor Level: 6th Floor
Sample No.:	DU002388	Portal Ref No.:	211

Item:	Asbestos Thermoplastic floor tiles with bitumen adhesive			
Asbestos Content:	Result Based on:			
Chrysotile in tile and adhesive	Analysis of sample using PLM			
Sample Analysed By:	Reg 13(1)	Extent:	18 m ²	
Comments:

Material Assessment Total Score: 3		Likelihood of Disturbance Assessment Total Score: 4		Management Assessment Licensable: No Recommendations: Program removal Reinspection Interval: Not Applicable Overall Risk Category: C7
Product Type:	1 (Asbestos thermoplastic)	Location:	2 (Rooms up to 100 sq m)	
Condition:	1 (Minor scratches)	Accessibility:	0 (Usually inaccessible or unlikely to be disturbed)	
Surface Treatment:	0 (Composite material)			
Asbestos Type:	1 (Chrysotile)	Extent Score:	2 (>10 - <50 sq m or >10m - <50m pipe run)

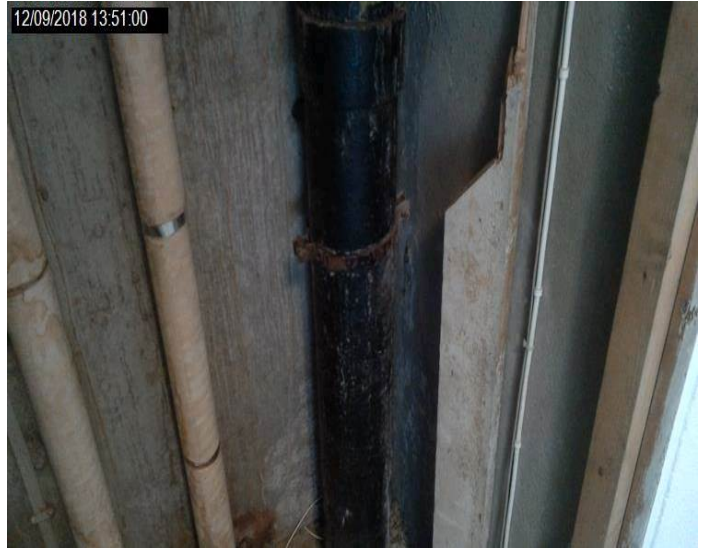
Location:	NBA602A Service duct	Block:	Birmingham City University	Floor Level: 6th Floor
Sample No.:	As DU002373	Portal Ref No.:	212

Item:	Asbestos Reinforced plastic downpipe			
Asbestos Content:	Result Based on:			
Chrysotile	Strongly presumed			
Sample Analysed By:	Not applicable	Extent:	3 linear metres	
Comments:

Material Assessment Total Score: 3		Likelihood of Disturbance Assessment Total Score: 4		Management Assessment Licensable: No Recommendations: Program removal Reinspection Interval: Not Applicable Overall Risk Category: C7
Product Type:	1 (Asbestos reinforced plastic)	Location:	2 (Rooms up to 100 sq m)	
Condition:	1 (Minor scratches)	Accessibility:	1 (Occasionally likely to be disturbed)	
Surface Treatment:	0 (Composite material)			
Asbestos Type:	1 (Chrysotile)	Extent Score:	1 (<10 sq m or 10m pipe run)

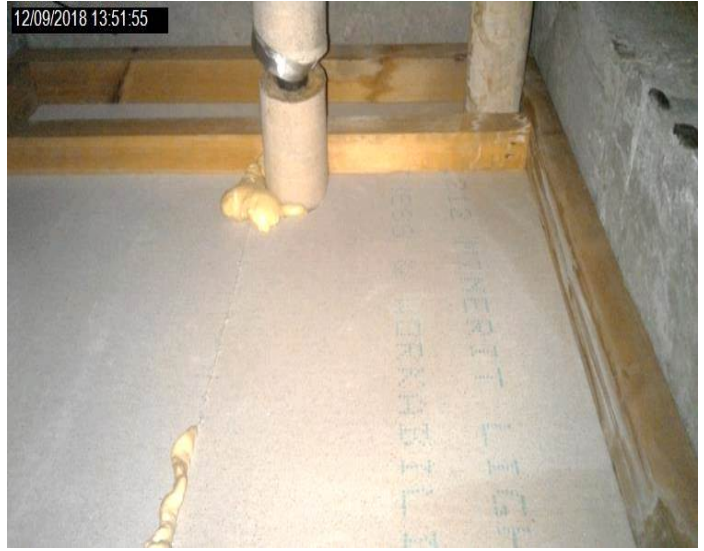
Location:	NBA602A Service duct	Block:	Birmingham City University	Floor Level: 6th Floor
Sample No.:	As DU002385	Portal Ref No.:	213

Item:	Insulating board door header			
Asbestos Content:		Result Based on:		
No Asbestos Detected		Strongly presumed		
Sample Analysed By:	Not applicable	Extent:	1 m ²	
Comments:

Material Assessment Total Score: 0		Likelihood of Disturbance Assessment Total Score: 0		Management Assessment Licensable: Yes Recommendations: Not Applicable Reinspection Interval: Not Applicable Overall Risk Category: E0
Product Type:	0 Not Applicable	Location:	0 Not Applicable	
Condition:	0 Not Applicable	Accessibility:	0 Not Applicable	
Surface Treatment:	0 Not Applicable			
Asbestos Type:	0 Not Applicable	Extent Score:	0 Not Applicable

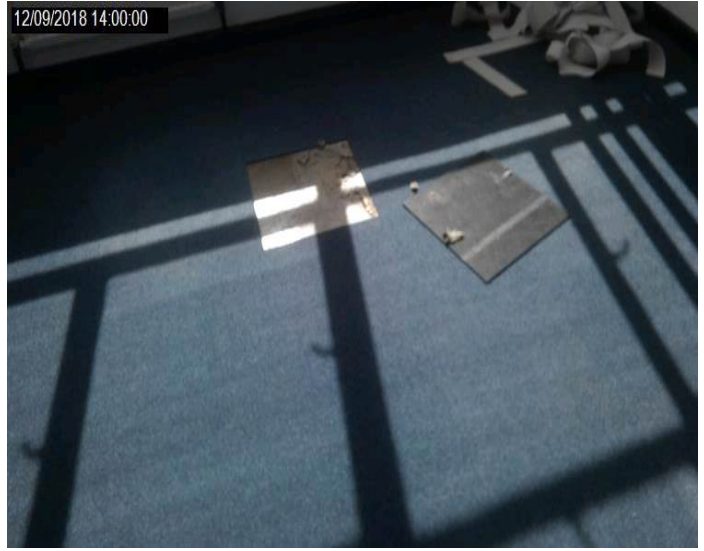
Location:	NBA624	Block:	Birmingham City University	Floor Level: 6th Floor
Sample No.:	As DU002388	Portal Ref No.:	216

Item:	Asbestos Thermoplastic floor tiles with bitumen adhesive			
Asbestos Content:	Result Based on:			
Chrysotile in tile and adhesive	Strongly presumed			
Sample Analysed By:	Not applicable	Extent:	16 m ²	
Comments:

Material Assessment Total Score: 3		Likelihood of Disturbance Assessment Total Score: 4		Management Assessment Licensable: No Recommendations: Program removal Reinspection Interval: Not Applicable Overall Risk Category: C7
Product Type:	1 (Asbestos thermoplastic)	Location:	2 (Rooms up to 100 sq m)	
Condition:	1 (Minor scratches)	Accessibility:	0 (Usually inaccessible or unlikely to be disturbed)	
Surface Treatment:	0 (Composite material)			
Asbestos Type:	1 (Chrysotile)	Extent Score:	2 (>10 - <50 sq m or >10m - <50m pipe run)

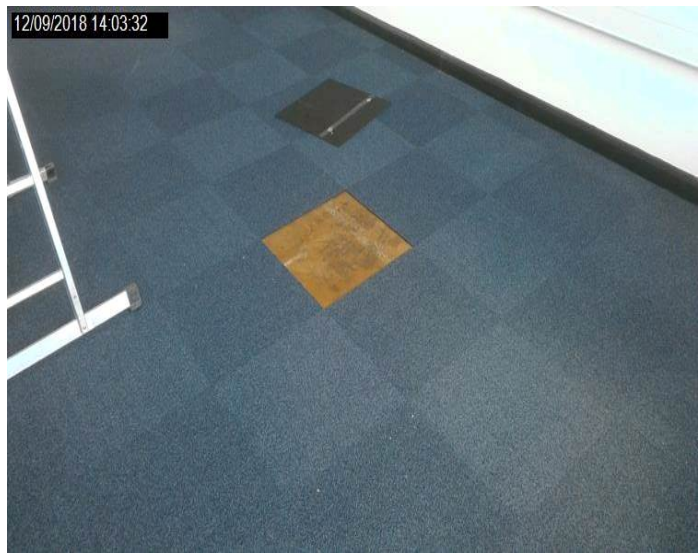
Location:	NBA601	Block:	Birmingham City University	Floor Level: 6th Floor
Sample No.:	As DU002389	Portal Ref No.:	219

Item:	Asbestos Bitumen adhesive			
Asbestos Content:	Result Based on:			
Chrysotile	Strongly presumed			
Sample Analysed By:	Not applicable	Extent:	22 m ²	
Comments:

Material Assessment Total Score: 3		Likelihood of Disturbance Assessment Total Score: 4		Management Assessment Licensable: No Recommendations: Program removal Reinspection Interval: Not Applicable Overall Risk Category: C7
Product Type:	1 (Asbestos bitumen)	Location:	2 (Rooms up to 100 sq m)	
Condition:	1 (Minor scratches)	Accessibility:	0 (Usually inaccessible or unlikely to be disturbed)	
Surface Treatment:	0 (Composite material)			
Asbestos Type:	1 (Chrysotile)	Extent Score:	2 (>10 - <50 sq m or >10m - <50m pipe run)

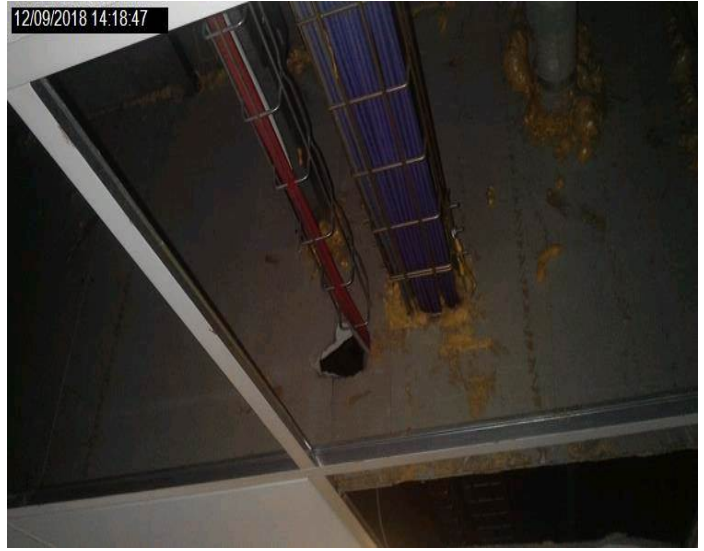
Location:	NBA699A Corridor	Block:	Birmingham City University	Floor Level: 6th Floor
Sample No.:	DU002392	Portal Ref No.:	221

Item:	Insulating board firebreak			
Asbestos Content:		Result Based on:		
No Asbestos Detected		Analysis of sample using PLM		
Sample Analysed By:	Reg 13(1)	Extent:	4 m ²	
Comments: See plan for location

Material Assessment Total Score: 0		Likelihood of Disturbance Assessment Total Score: 0		Management Assessment Licensable: Yes Recommendations: Not Applicable Reinspection Interval: Not Applicable Overall Risk Category: E0
Product Type:	0 Not Applicable	Location:	0 Not Applicable	
Condition:	0 Not Applicable	Accessibility:	0 Not Applicable	
Surface Treatment:	0 Not Applicable			
Asbestos Type:	0 Not Applicable	Extent Score:	0 Not Applicable

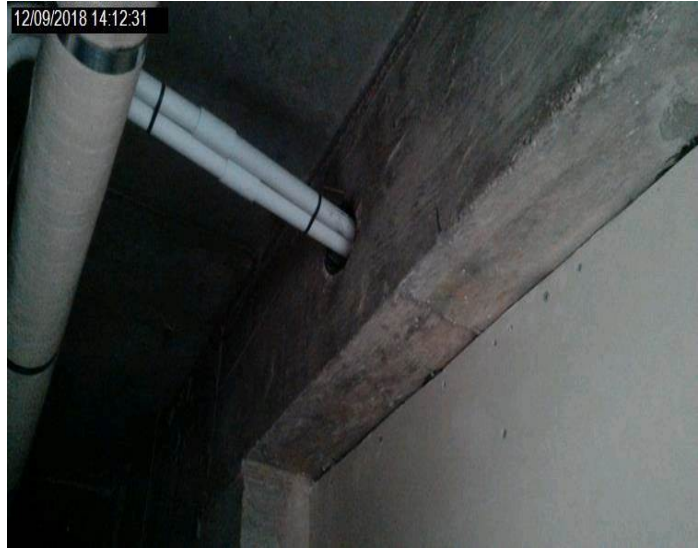
Location:	NBA699A Corridor	Block:	Birmingham City University	Floor Level: 6th Floor
Sample No.:	As DU002387	Portal Ref No.:	222

Item:	Asbestos Reinforced plastic sleeve			
Asbestos Content:	Result Based on:			
Chrysotile	Strongly presumed			
Sample Analysed By:	Not applicable	Extent:	16 units	
Comments: Structural columns

Material Assessment Total Score: 3		Likelihood of Disturbance Assessment Total Score: 3		Management Assessment Licensable: No Recommendations: Program removal Reinspection Interval: Not Applicable Overall Risk Category: D6
Product Type:	1 (Asbestos reinforced plastic)	Location:	2 (Rooms up to 100 sq m)	
Condition:	1 (Minor scratches)	Accessibility:	0 (Usually inaccessible or unlikely to be disturbed)	
Surface Treatment:	0 (Composite material)			
Asbestos Type:	1 (Chrysotile)	Extent Score:	1 (<10 sq m or 10m pipe run)

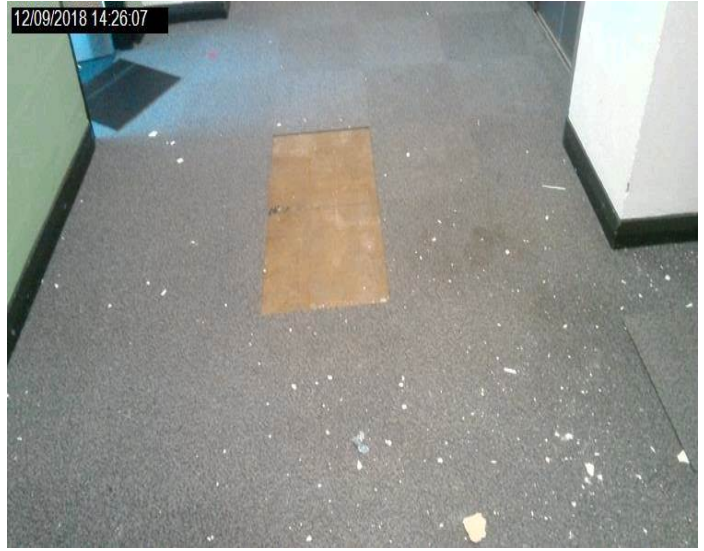
Location:	NBA699B Corridor	Block:	Birmingham City University	Floor Level: 6th Floor
Sample No.:	As DU002391	Portal Ref No.:	224

Item:	Asbestos Bitumen adhesive			
Asbestos Content:	Result Based on:			
Chrysotile	Strongly presumed			
Sample Analysed By:	Not applicable	Extent:	30 m ²	
Comments:

Material Assessment Total Score: 3		Likelihood of Disturbance Assessment Total Score: 4		Management Assessment Licensable: No Recommendations: Program removal Reinspection Interval: Not Applicable Overall Risk Category: C7
Product Type:	1 (Asbestos bitumen)	Location:	2 (Rooms up to 100 sq m)	
Condition:	1 (Minor scratches)	Accessibility:	0 (Usually inaccessible or unlikely to be disturbed)	
Surface Treatment:	0 (Composite material)			
Asbestos Type:	1 (Chrysotile)	Extent Score:	2 (>10 - <50 sq m or >10m - <50m pipe run)

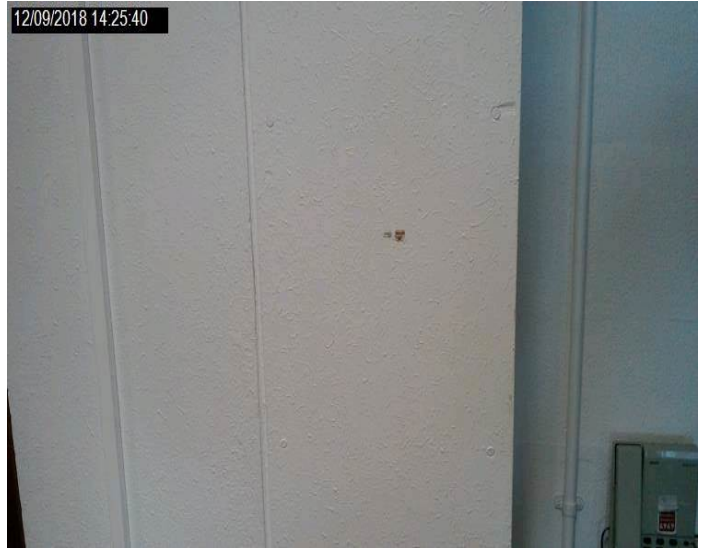
Location:	NBA699B Corridor	Block:	Birmingham City University	Floor Level: 6th Floor
Sample No.:	As DU002390	Portal Ref No.:	227

Item:	Textured coating to concrete			
Asbestos Content:		Result Based on:		
No Asbestos Detected		Strongly presumed		
Sample Analysed By:	Not applicable	Extent:	16 m ²	
Comments: Sections of walls

Material Assessment Total Score: 0		Likelihood of Disturbance Assessment Total Score: 0		Management Assessment Licensable: No Recommendations: Not Applicable Reinspection Interval: Not Applicable Overall Risk Category: E0
Product Type:	0 Not Applicable	Location:	0 Not Applicable	
Condition:	0 Not Applicable	Accessibility:	0 Not Applicable	
Surface Treatment:	0 Not Applicable			
Asbestos Type:	0 Not Applicable	Extent Score:	0 Not Applicable

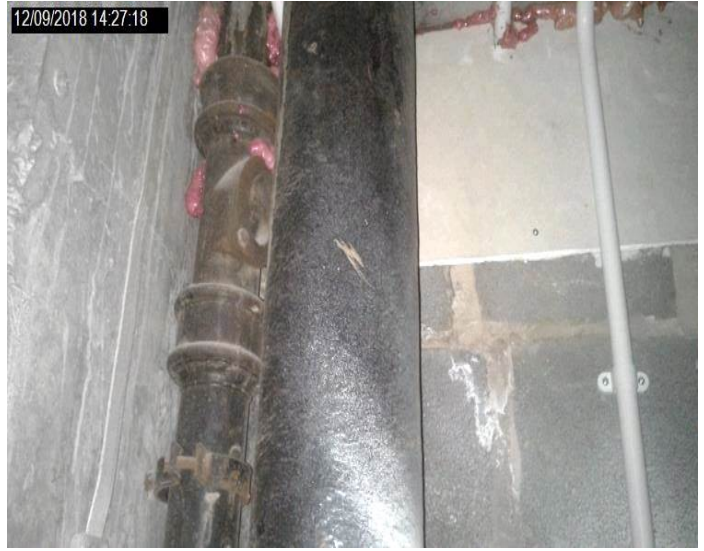
Location:	NBA699B Corridor	Block:	Birmingham City University	Floor Level: 6th Floor
Sample No.:	As DU002373	Portal Ref No.:	228

Item:	Asbestos Reinforced plastic downpipe			
Asbestos Content:	Result Based on:			
Chrysotile	Strongly presumed			
Sample Analysed By:	Not applicable	Extent:	3 linear metres	
Comments: Internally to timber boxing

Material Assessment Total Score: 3		Likelihood of Disturbance Assessment Total Score: 3		Management Assessment Licensable: No Recommendations: Program removal Reinspection Interval: Not Applicable Overall Risk Category: D6
Product Type:	1 (Asbestos reinforced plastic)	Location:	2 (Rooms up to 100 sq m)	
Condition:	1 (Minor scratches)	Accessibility:	0 (Usually inaccessible or unlikely to be disturbed)	
Surface Treatment:	0 (Composite material)			
Asbestos Type:	1 (Chrysotile)	Extent Score:	1 (<10 sq m or 10m pipe run)

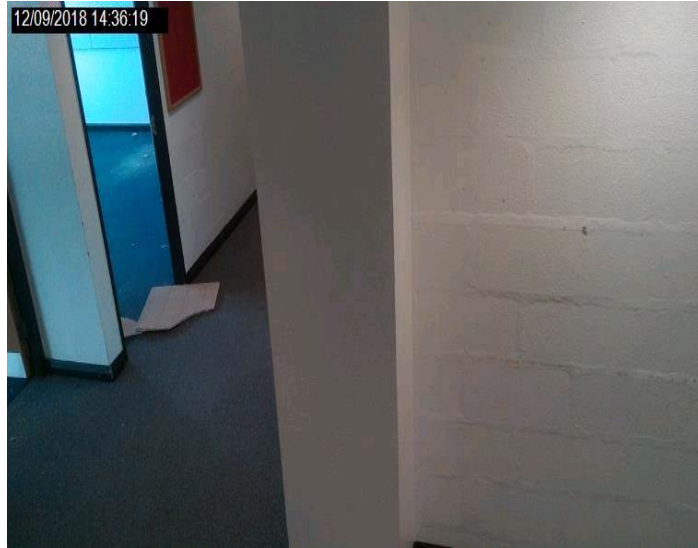
Location:	NBA699C Corridor	Block:	Birmingham City University	Floor Level: 6th Floor
Sample No.:	As DU002390	Portal Ref No.:	232

Item:	Textured coating to concrete			
Asbestos Content:		Result Based on:		
No Asbestos Detected		Strongly presumed		
Sample Analysed By:	Not applicable	Extent:	30 m ²	
Comments: Sections of walls

Material Assessment Total Score: 0		Likelihood of Disturbance Assessment Total Score: 0		Management Assessment Licensable: No Recommendations: Not Applicable Reinspection Interval: Not Applicable Overall Risk Category: E0
Product Type:	0 Not Applicable	Location:	0 Not Applicable	
Condition:	0 Not Applicable	Accessibility:	0 Not Applicable	
Surface Treatment:	0 Not Applicable			
Asbestos Type:	0 Not Applicable	Extent Score:	0 Not Applicable

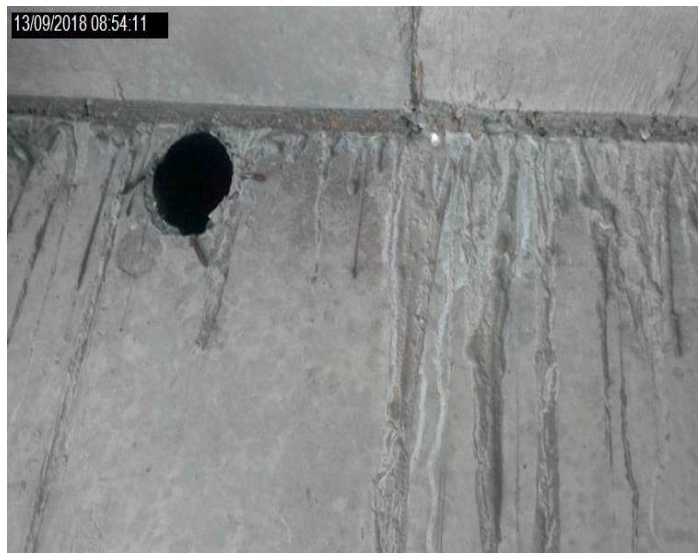
Location:	NBA529	Block:	Birmingham City University	Floor Level: 5th Floor
Sample No.:	DU002395	Portal Ref No.:	233

Item:	Asbestos Reinforced plastic sleeve			
Asbestos Content:	Result Based on:			
Chrysotile	Analysis of sample using PLM			
Sample Analysed By:	Reg 13(1)	Extent:	10 units	
Comments:

Material Assessment Total Score: 3		Likelihood of Disturbance Assessment Total Score: 3		Management Assessment Licensable: No Recommendations: Program removal Reinspection Interval: Not Applicable Overall Risk Category: D6
Product Type:	1 (Asbestos reinforced plastic)	Location:	2 (Rooms up to 100 sq m)	
Condition:	1 (Minor scratches)	Accessibility:	0 (Usually inaccessible or unlikely to be disturbed)	
Surface Treatment:	0 (Composite material)			
Asbestos Type:	1 (Chrysotile)	Extent Score:	1 (<10 sq m or 10m pipe run)

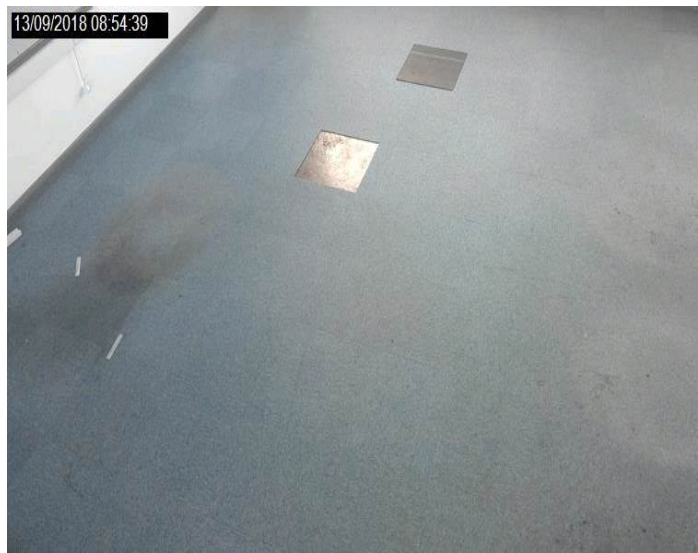
Location:	NBA529	Block:	Birmingham City University	Floor Level: 5th Floor
Sample No.:	DU002396	Portal Ref No.:	235

Item:	Asbestos Bitumen adhesive			
Asbestos Content:	Result Based on:			
Chrysotile	Analysis of sample using PLM			
Sample Analysed By:	Reg 13(1)	Extent:	30 m ²	
Comments:

Material Assessment Total Score: 3		Likelihood of Disturbance Assessment Total Score: 4		Management Assessment Licensable: No Recommendations: Program removal Reinspection Interval: Not Applicable Overall Risk Category: C7
Product Type:	1 (Asbestos bitumen)	Location:	2 (Rooms up to 100 sq m)	
Condition:	1 (Minor scratches)	Accessibility:	0 (Usually inaccessible or unlikely to be disturbed)	
Surface Treatment:	0 (Composite material)			
Asbestos Type:	1 (Chrysotile)	Extent Score:	2 (>10 - <50 sq m or >10m - <50m pipe run)

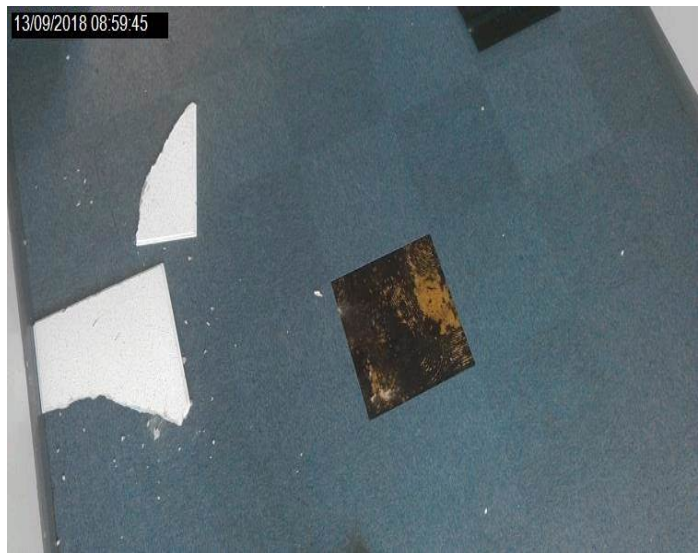
Location:	NBA530	Block:	Birmingham City University	Floor Level: 5th Floor
Sample No.:	As DU002396	Portal Ref No.:	238

Item:	Asbestos Bitumen adhesive			
Asbestos Content:	Result Based on:			
Chrysotile	Strongly presumed			
Sample Analysed By:	Not applicable	Extent:	18 m ²	
Comments:

Material Assessment Total Score: 3		Likelihood of Disturbance Assessment Total Score: 4		Management Assessment Licensable: No Recommendations: Program removal Reinspection Interval: Not Applicable Overall Risk Category: C7
Product Type:	1 (Asbestos bitumen)	Location:	2 (Rooms up to 100 sq m)	
Condition:	1 (Minor scratches)	Accessibility:	0 (Usually inaccessible or unlikely to be disturbed)	
Surface Treatment:	0 (Composite material)			
Asbestos Type:	1 (Chrysotile)	Extent Score:	2 (>10 - <50 sq m or >10m - <50m pipe run)

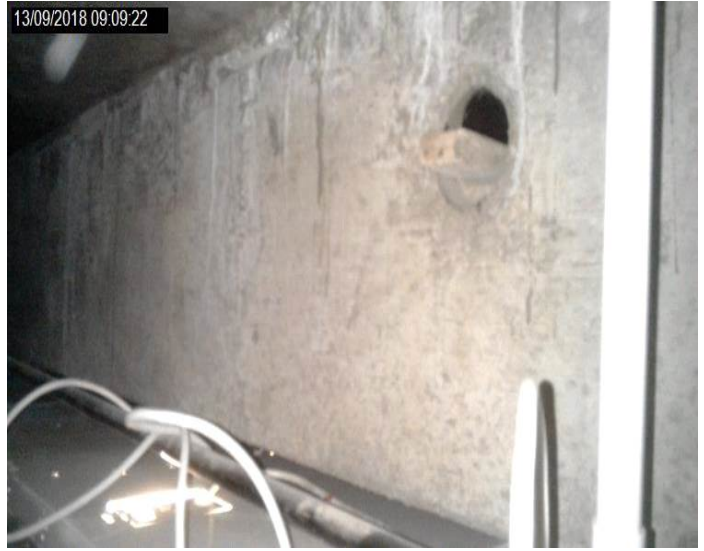
Location:	NBA502	Block:	Birmingham City University	Floor Level: 5th Floor
Sample No.:	As DU002395	Portal Ref No.:	242

Item:	Asbestos Reinforced plastic sleeve			
Asbestos Content:	Result Based on:			
Chrysotile	Strongly presumed			
Sample Analysed By:	Not applicable	Extent:	12 units	
Comments:

Material Assessment Total Score: 3		Likelihood of Disturbance Assessment Total Score: 3		Management Assessment Licensable: No Recommendations: Program removal Reinspection Interval: Not Applicable Overall Risk Category: D6
Product Type:	1 (Asbestos reinforced plastic)	Location:	2 (Rooms up to 100 sq m)	
Condition:	1 (Minor scratches)	Accessibility:	0 (Usually inaccessible or unlikely to be disturbed)	
Surface Treatment:	0 (Composite material)			
Asbestos Type:	1 (Chrysotile)	Extent Score:	1 (<10 sq m or 10m pipe run)
