Report No.: J102748
Nature of Work: Demolition Survey
Issue Date: 31/10/2018
Client Name: WYG Engineering Ltd
Geneva Building, Lake View Drive, Sherwood Business Park,
Annesley, Nottingham, NG15 0ED
Site Address: Baker Building, Former City North Campus, Birmingham City
University, Perry Barr, B42 2US

A demolition survey in line with HSG264 Asbestos: The Survey Guide was carried out internally and externally to the property.

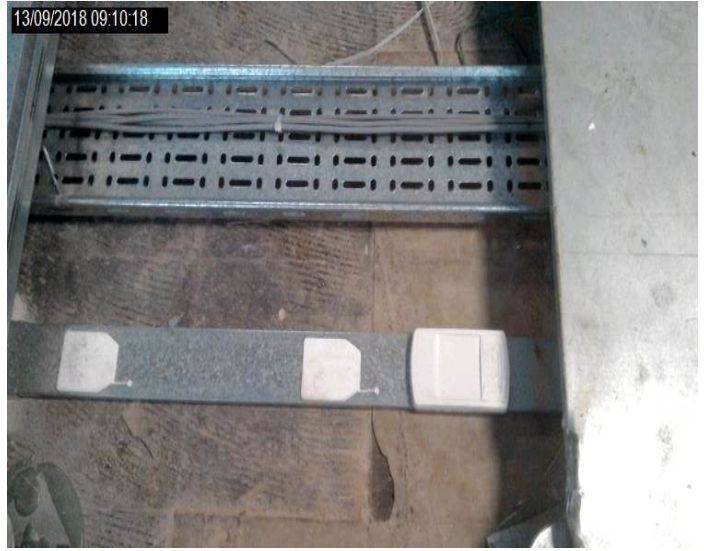
Location:	NBA502	Block:	Birmingham City University	Floor Level: 5th Floor
Sample No.:	DU002397	Portal Ref No.:	244

Item:	Asbestos Thermoplastic floor tiles to concrete			
Asbestos Content:	Result Based on:			
Chrysotile in tile and adhesive	Analysis of sample using PLM			
Sample Analysed By: Reg 13(1)	Extent:	70 m ²		
Comments:

Material Assessment Total Score: 3		Likelihood of Disturbance Assessment Total Score: 5		Management Assessment Licensable: No Recommendations: Program removal Reinspection Interval: Not Applicable Overall Risk Category: C8
Product Type:	1 (Asbestos thermoplastic)	Location:	2 (Rooms up to 100 sq m)	
Condition:	1 (Minor scratches)	Accessibility:	0 (Usually inaccessible or unlikely to be disturbed)	
Surface Treatment:	0 (Composite material)			
Asbestos Type:	1 (Chrysotile)	Extent Score:	3 (>50 sq m or >50m pipe run)

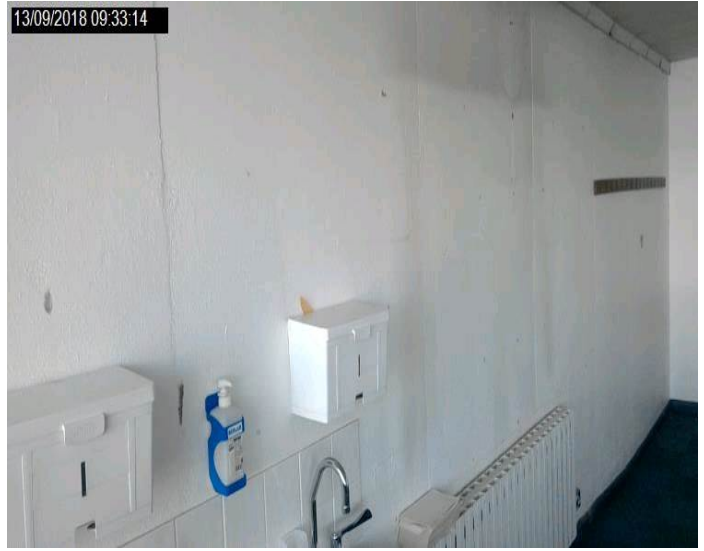
Location:	NBA505	Block:	Birmingham City University	Floor Level: 5th Floor
Sample No.:	DU002398	Portal Ref No.:	248

Item:	Textured coating to block			
Asbestos Content:	Result Based on:			
No Asbestos Detected	Analysis of sample using PLM			
Sample Analysed By:	Reg 13(1)	Extent:	25 m ²	
Comments:

Material Assessment Total Score: 0		Likelihood of Disturbance Assessment Total Score: 0		Management Assessment Licensable: No Recommendations: Not Applicable Reinspection Interval: Not Applicable Overall Risk Category: E0
Product Type:	0 Not Applicable	Location:	0 Not Applicable	
Condition:	0 Not Applicable	Accessibility:	0 Not Applicable	
Surface Treatment:	0 Not Applicable			
Asbestos Type:	0 Not Applicable	Extent Score:	0 Not Applicable

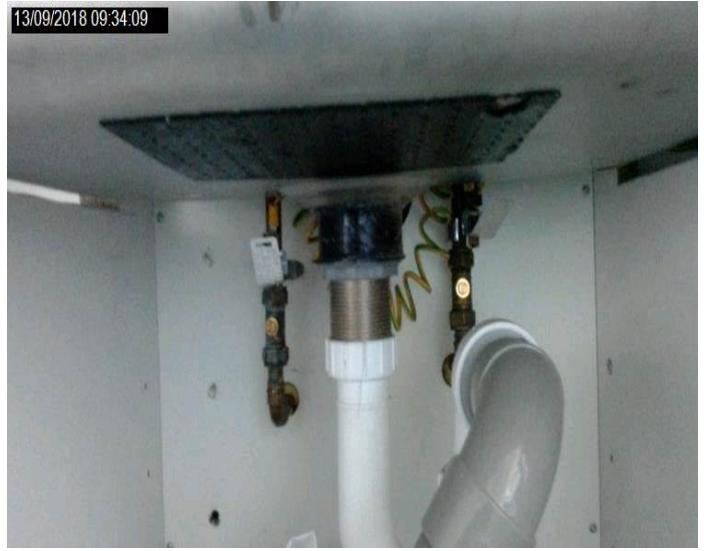
Location:	NBA505	Block:	Birmingham City University	Floor Level: 5th Floor
Sample No.:	DU002399	Portal Ref No.:	249

Item:	Bitumen sink pad			
Asbestos Content:		Result Based on:		
No Asbestos Detected		Analysis of sample using PLM		
Sample Analysed By:	Reg 13(1)	Extent:	2 units	
Comments:

Material Assessment Total Score: 0		Likelihood of Disturbance Assessment Total Score: 0		Management Assessment Licensable: No Recommendations: Not Applicable Reinspection Interval: Not Applicable Overall Risk Category: E0
Product Type:	0 Not Applicable	Location:	0 Not Applicable	
Condition:	0 Not Applicable	Accessibility:	0 Not Applicable	
Surface Treatment:	0 Not Applicable			
Asbestos Type:	0 Not Applicable	Extent Score:	0 Not Applicable

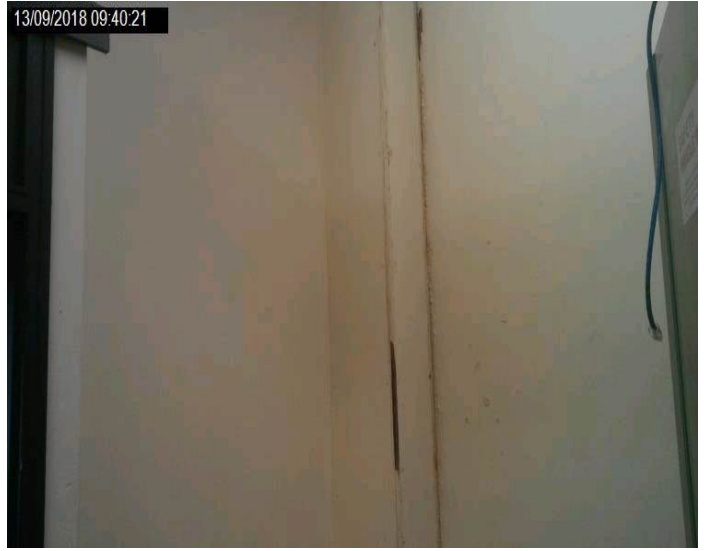
Location:	NBA504	Block:	Birmingham City University	Floor Level: 5th Floor
Sample No.:	DU002400	Portal Ref No.:	250

Item:	Asbestos Reinforced plastic downpipe			
Asbestos Content:	Result Based on:			
Chrysotile	Analysis of sample using PLM			
Sample Analysed By: Reg 13(1)	Extent:	4 linear metres		
Comments: Internally to timber boxing, visible from room NBA502

Material Assessment Total Score: 3		Likelihood of Disturbance Assessment Total Score: 3		Management Assessment Licensable: No Recommendations: Program removal Reinspection Interval: Not Applicable Overall Risk Category: D6
Product Type:	1 (Asbestos reinforced plastic)	Location:	2 (Rooms up to 100 sq m)	
Condition:	1 (Minor scratches)	Accessibility:	0 (Usually inaccessible or unlikely to be disturbed)	
Surface Treatment:	0 (Composite material)			
Asbestos Type:	1 (Chrysotile)	Extent Score:	1 (<10 sq m or 10m pipe run)

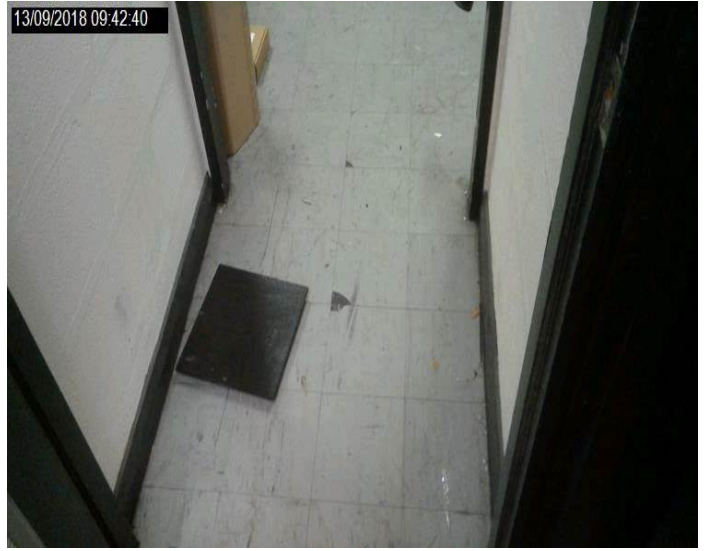
Location:	NBA504	Block:	Birmingham City University	Floor Level: 5th Floor
Sample No.:	DU002401	Portal Ref No.:	251

Item:	Asbestos Thermoplastic floor tiles with bitumen adhesive			
Asbestos Content:	Result Based on:			
Chrysotile in tile and adhesive	Analysis of sample using PLM			
Sample Analysed By: Reg 13(1)	Extent:	14 m ²		
Comments:

Material Assessment Total Score: 3		Likelihood of Disturbance Assessment Total Score: 7		Management Assessment Licensable: No Recommendations: Program removal Reinspection Interval: Not Applicable Overall Risk Category: C10
Product Type:	1 (Asbestos thermoplastic)	Location:	2 (Rooms up to 100 sq m)	
Condition:	1 (Minor scratches)	Accessibility:	3 (Routinely disturbed)	
Surface Treatment:	0 (Composite material)			
Asbestos Type:	1 (Chrysotile)	Extent Score:	2 (>10 - <50 sq m or >10m - <50m pipe run)

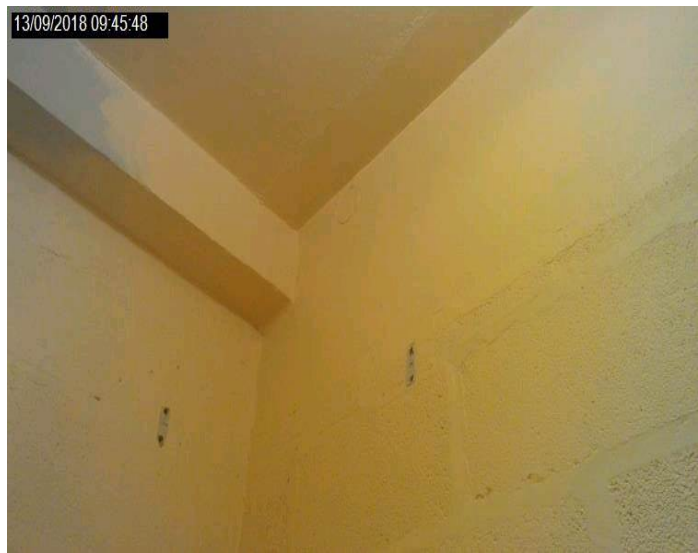
Location:	NBA505B	Block:	Birmingham City University	Floor Level: 5th Floor
Sample No.:	As DU002395	Portal Ref No.:	252

Item:	Asbestos Reinforced plastic sleeve			
Asbestos Content:	Result Based on:			
Chrysotile	Strongly presumed			
Sample Analysed By:	Not applicable	Extent:	1 unit	
Comments:

Material Assessment Total Score: 3		Likelihood of Disturbance Assessment Total Score: 3		Management Assessment Licensable: No Recommendations: Program removal Reinspection Interval: Not Applicable Overall Risk Category: D6
Product Type:	1 (Asbestos reinforced plastic)	Location:	2 (Rooms up to 100 sq m)	
Condition:	1 (Minor scratches)	Accessibility:	0 (Usually inaccessible or unlikely to be disturbed)	
Surface Treatment:	0 (Composite material)			
Asbestos Type:	1 (Chrysotile)	Extent Score:	1 (<10 sq m or 10m pipe run)

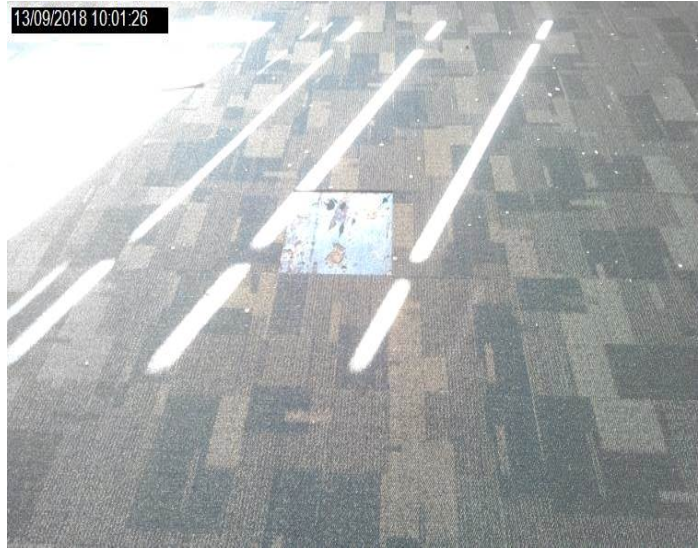
Location:	NBA527	Block:	Birmingham City University	Floor Level: 5th Floor
Sample No.:	As DU002396	Portal Ref No.:	256

Item:	Asbestos Bitumen adhesive			
Asbestos Content:	Result Based on:			
Chrysotile	Strongly presumed			
Sample Analysed By:	Not applicable	Extent:	30 m ²	
Comments:

Material Assessment Total Score: 3		Likelihood of Disturbance Assessment Total Score: 4		Management Assessment Licensable: No Recommendations: Program removal Reinspection Interval: Not Applicable Overall Risk Category: C7
Product Type:	1 (Asbestos bitumen)	Location:	2 (Rooms up to 100 sq m)	
Condition:	1 (Minor scratches)	Accessibility:	0 (Usually inaccessible or unlikely to be disturbed)	
Surface Treatment:	0 (Composite material)			
Asbestos Type:	1 (Chrysotile)	Extent Score:	2 (>10 - <50 sq m or >10m - <50m pipe run)

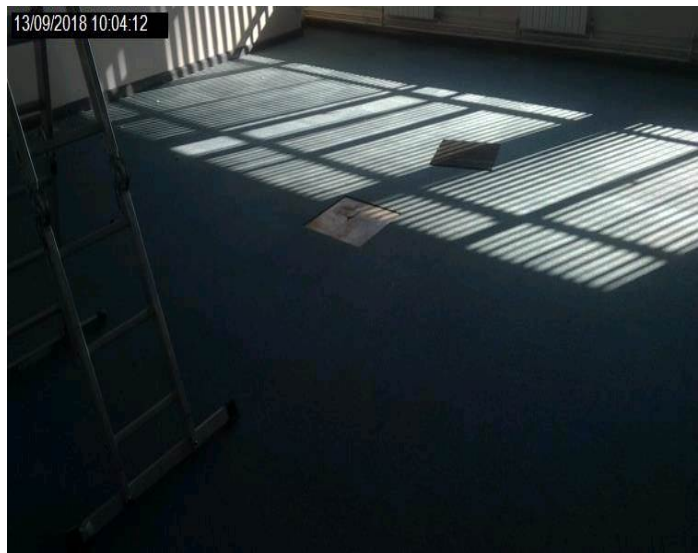
Location:	NBA526	Block:	Birmingham City University	Floor Level: 5th Floor
Sample No.:	DU002402	Portal Ref No.:	257

Item:	Asbestos Thermoplastic floor tiles with bitumen adhesive			
Asbestos Content:	Result Based on:			
Chrysotile in tile and adhesive	Analysis of sample using PLM			
Sample Analysed By: Reg 13(1)	Extent:	30 m ²		
Comments:

Material Assessment Total Score: 3		Likelihood of Disturbance Assessment Total Score: 4		Management Assessment Licensable: No Recommendations: Program removal Reinspection Interval: Not Applicable Overall Risk Category: C7
Product Type:	1 (Asbestos thermoplastic)	Location:	2 (Rooms up to 100 sq m)	
Condition:	1 (Minor scratches)	Accessibility:	0 (Usually inaccessible or unlikely to be disturbed)	
Surface Treatment:	0 (Composite material)			
Asbestos Type:	1 (Chrysotile)	Extent Score:	2 (>10 - <50 sq m or >10m - <50m pipe run)

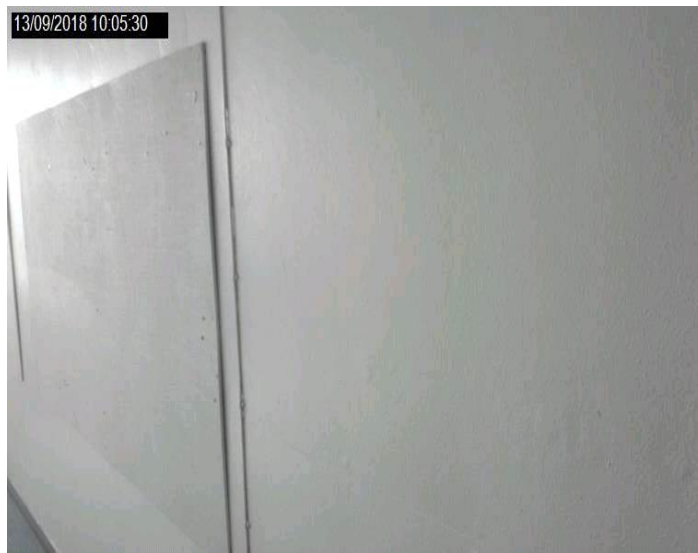
Location:	NBA526	Block:	Birmingham City University	Floor Level: 5th Floor
Sample No.:	As DU002398	Portal Ref No.:	258

Item:	Textured coating to block			
Asbestos Content:		Result Based on:		
No Asbestos Detected		Strongly presumed		
Sample Analysed By:	Not applicable	Extent:	25 m ²	
Comments: Right-hand wall on entering the room

Material Assessment Total Score: 0		Likelihood of Disturbance Assessment Total Score: 0		Management Assessment Licensable: No Recommendations: Not Applicable Reinspection Interval: Not Applicable Overall Risk Category: E0
Product Type:	0 Not Applicable	Location:	0 Not Applicable	
Condition:	0 Not Applicable	Accessibility:	0 Not Applicable	
Surface Treatment:	0 Not Applicable			
Asbestos Type:	0 Not Applicable	Extent Score:	0 Not Applicable

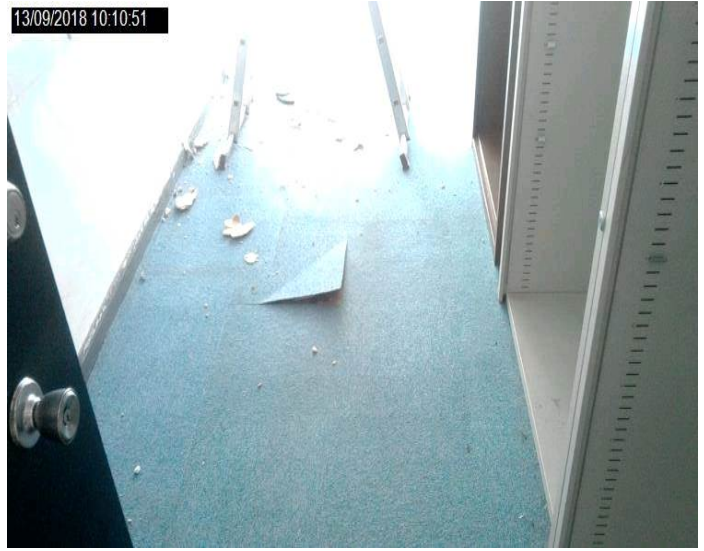
Location:	NBA526A	Block:	Birmingham City University	Floor Level: 5th Floor
Sample No.:	As DU002402	Portal Ref No.:	259

Item:	Asbestos Thermoplastic floor tiles with bitumen adhesive			
Asbestos Content:	Result Based on:			
Chrysotile in tile and adhesive	Strongly presumed			
Sample Analysed By:	Not applicable	Extent:	18 m ²	
Comments:

Material Assessment Total Score: 3		Likelihood of Disturbance Assessment Total Score: 4		Management Assessment Licensable: No Recommendations: Program removal Reinspection Interval: Not Applicable Overall Risk Category: C7
Product Type:	1 (Asbestos thermoplastic)	Location:	2 (Rooms up to 100 sq m)	
Condition:	1 (Minor scratches)	Accessibility:	0 (Usually inaccessible or unlikely to be disturbed)	
Surface Treatment:	0 (Composite material)			
Asbestos Type:	1 (Chrysotile)	Extent Score:	2 (>10 - <50 sq m or >10m - <50m pipe run)

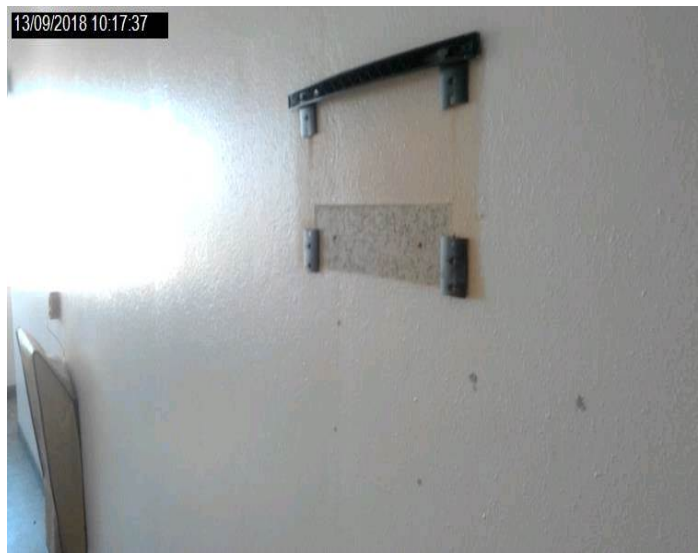
Location:	NBA599 Stairwell	Block:	Birmingham City University	Floor Level: 5th Floor
Sample No.:	As DU002398	Portal Ref No.:	260

Item:	Textured coating to concrete			
Asbestos Content:		Result Based on:		
No Asbestos Detected		Strongly presumed		
Sample Analysed By:	Not applicable	Extent:	100 m ²	
Comments: To all walls

Material Assessment Total Score: 0		Likelihood of Disturbance Assessment Total Score: 0		Management Assessment Licensable: No Recommendations: Not Applicable Reinspection Interval: Not Applicable Overall Risk Category: E0
Product Type:	0 Not Applicable	Location:	0 Not Applicable	
Condition:	0 Not Applicable	Accessibility:	0 Not Applicable	
Surface Treatment:	0 Not Applicable			
Asbestos Type:	0 Not Applicable	Extent Score:	0 Not Applicable

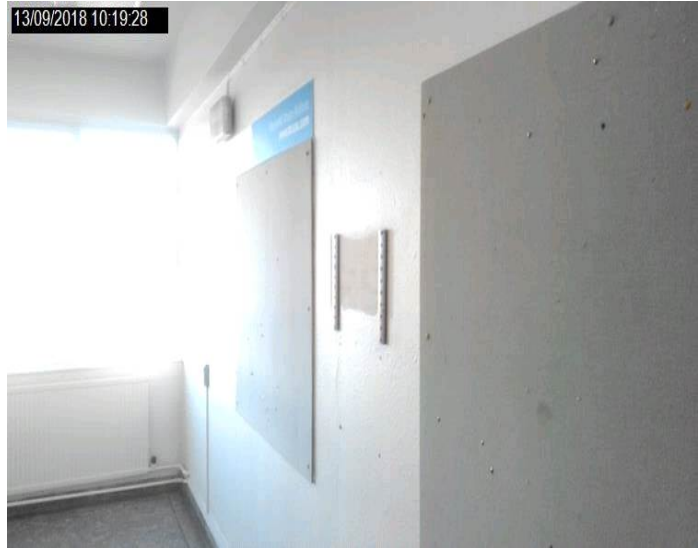
Location:	NBA599A Lift lobby	Block:	Birmingham City University	Floor Level: 5th Floor
Sample No.:	DU002403	Portal Ref No.:	261

Item:	Textured coating to concrete walls			
Asbestos Content:		Result Based on:		
No Asbestos Detected		Analysis of sample using PLM		
Sample Analysed By:	Reg 13(1)	Extent:	60 m ²	
Comments:

Material Assessment Total Score: 0		Likelihood of Disturbance Assessment Total Score: 0		Management Assessment Licensable: No Recommendations: Not Applicable Reinspection Interval: Not Applicable Overall Risk Category: E0
Product Type:	0 Not Applicable	Location:	0 Not Applicable	
Condition:	0 Not Applicable	Accessibility:	0 Not Applicable	
Surface Treatment:	0 Not Applicable			
Asbestos Type:	0 Not Applicable	Extent Score:	0 Not Applicable

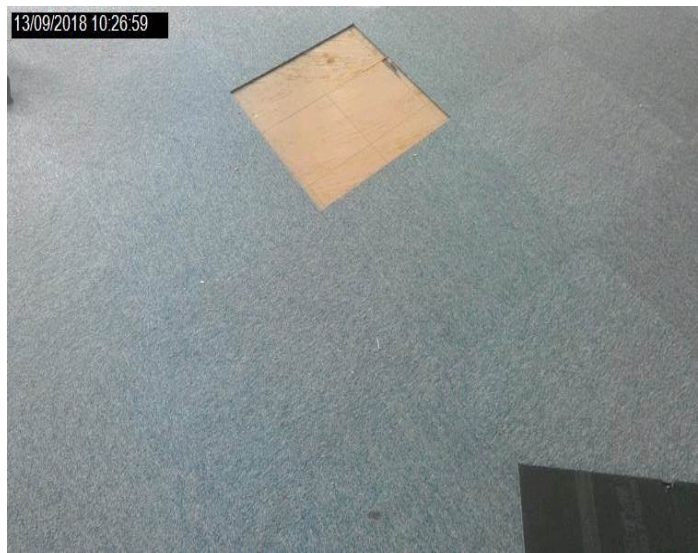
Location:	NBA524	Block:	Birmingham City University	Floor Level: 5th Floor
Sample No.:	DU002404	Portal Ref No.:	262

Item:	Asbestos Thermoplastic floor tiles with bitumen adhesive			
Asbestos Content:	Result Based on:			
Chrysotile	Analysis of sample using PLM			
Sample Analysed By:	Reg 13(1)	Extent:	20 m ²	
Comments:

Material Assessment Total Score: 3		Likelihood of Disturbance Assessment Total Score: 4		Management Assessment Licensable: No Recommendations: Program removal Reinspection Interval: Not Applicable Overall Risk Category: C7
Product Type:	1 (Asbestos thermoplastic)	Location:	2 (Rooms up to 100 sq m)	
Condition:	1 (Minor scratches)	Accessibility:	0 (Usually inaccessible or unlikely to be disturbed)	
Surface Treatment:	0 (Composite material)			
Asbestos Type:	1 (Chrysotile)	Extent Score:	2 (>10 - <50 sq m or >10m - <50m pipe run)

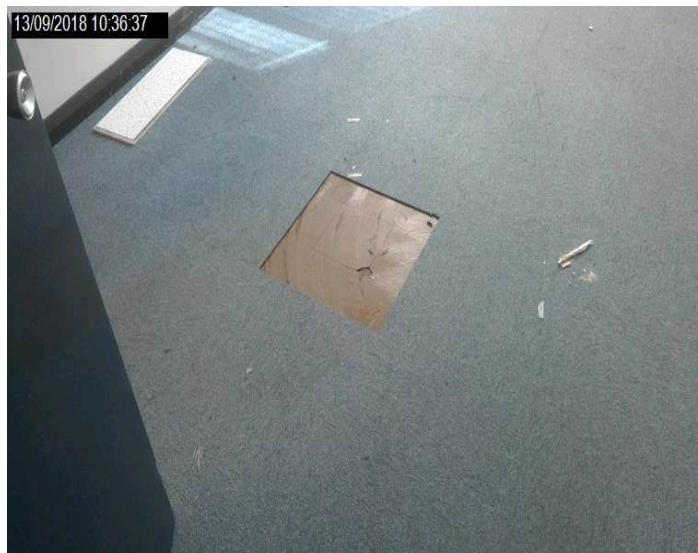
Location:	NBA523	Block:	Birmingham City University	Floor Level: 5th Floor
Sample No.:	DU002405	Portal Ref No.:	264

Item:	Asbestos Thermoplastic floor tiles with bitumen adhesive			
Asbestos Content:	Result Based on:			
Chrysotile in tile and adhesive	Analysis of sample using PLM			
Sample Analysed By: Reg 13(1)	Extent:	14 m ²		
Comments:

Material Assessment Total Score: 3		Likelihood of Disturbance Assessment Total Score: 4		Management Assessment Licensable: No Recommendations: Program removal Reinspection Interval: Not Applicable Overall Risk Category: C7
Product Type:	1 (Asbestos thermoplastic)	Location:	2 (Rooms up to 100 sq m)	
Condition:	1 (Minor scratches)	Accessibility:	0 (Usually inaccessible or unlikely to be disturbed)	
Surface Treatment:	0 (Composite material)			
Asbestos Type:	1 (Chrysotile)	Extent Score:	2 (>10 - <50 sq m or >10m - <50m pipe run)

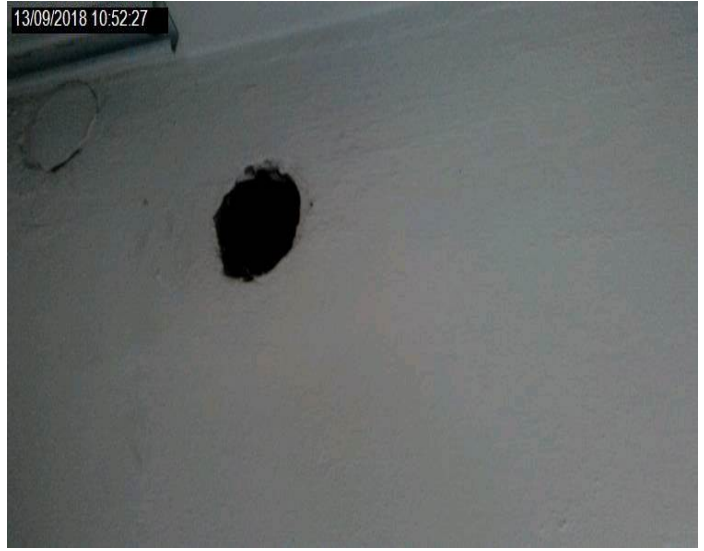
Location:	NBA508	Block:	Birmingham City University	Floor Level: 5th Floor
Sample No.:	As DU002395	Portal Ref No.:	266

Item:	Asbestos Reinforced plastic sleeve			
Asbestos Content:	Result Based on:			
Chrysotile	Strongly presumed			
Sample Analysed By:	Not applicable	Extent:	16 units	
Comments: To structural concrete

Material Assessment Total Score: 3		Likelihood of Disturbance Assessment Total Score: 3		Management Assessment Licensable: No Recommendations: Program removal Reinspection Interval: Not Applicable Overall Risk Category: D6
Product Type:	1 (Asbestos reinforced plastic)	Location:	2 (Rooms up to 100 sq m)	
Condition:	1 (Minor scratches)	Accessibility:	0 (Usually inaccessible or unlikely to be disturbed)	
Surface Treatment:	0 (Composite material)			
Asbestos Type:	1 (Chrysotile)	Extent Score:	1 (<10 sq m or 10m pipe run)

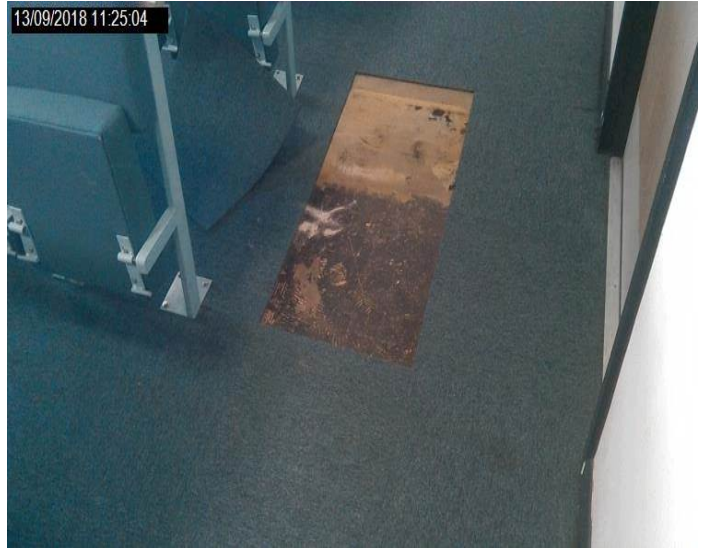
Location:	NBA508	Block:	Birmingham City University	Floor Level: 5th Floor
Sample No.:	DU002406	Portal Ref No.:	267

<p>13/09/2018 11:25:04</p>
Item:	Asbestos Bitumen adhesive			
Asbestos Content:	Result Based on:			
Chrysotile	Analysis of sample using PLM			
Sample Analysed By: Reg 13(1)	Extent:	100 m ²		
Comments: To raised seating area of theatre only

Material Assessment Total Score: 3		Likelihood of Disturbance Assessment Total Score: 5		Management Assessment Licensable: No Recommendations: Program removal Reinspection Interval: Not Applicable Overall Risk Category: C8
Product Type:	1 (Asbestos bitumen)	Location:	2 (Rooms up to 100 sq m)	
Condition:	1 (Minor scratches)	Accessibility:	0 (Usually inaccessible or unlikely to be disturbed)	
Surface Treatment:	0 (Composite material)			
Asbestos Type:	1 (Chrysotile)	Extent Score:	3 (>50 sq m or >50m pipe run)

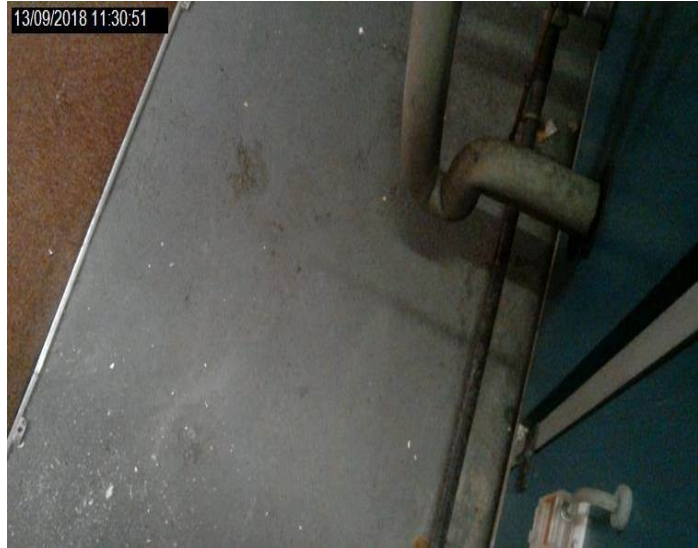
Location:	NBA510A Plant room	Block:	Birmingham City University	Floor Level: 5th Floor
Sample No.:	As DU002406	Portal Ref No.:	268

Item:	Asbestos Bitumen adhesive			
Asbestos Content:	Result Based on:			
Chrysotile	Strongly presumed			
Sample Analysed By:	Not applicable	Extent:	12 m ²	
Comments:

Material Assessment Total Score: 3		Likelihood of Disturbance Assessment Total Score: 7		Management Assessment Licensable: No Recommendations: Program removal Reinspection Interval: Not Applicable Overall Risk Category: C10
Product Type:	1 (Asbestos bitumen)	Location:	2 (Rooms up to 100 sq m)	
Condition:	1 (Minor scratches)	Accessibility:	3 (Routinely disturbed)	
Surface Treatment:	0 (Composite material)			
Asbestos Type:	1 (Chrysotile)	Extent Score:	2 (>10 - <50 sq m or >10m - <50m pipe run)

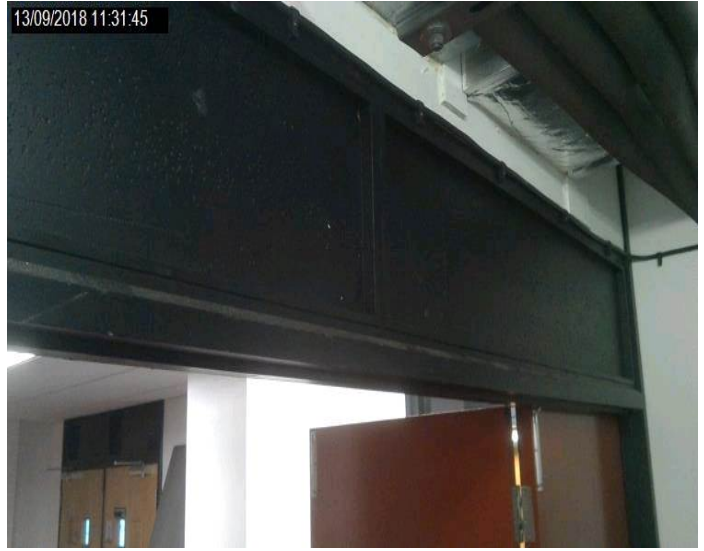
Location:	NBA510A Plant room	Block:	Birmingham City University	Floor Level: 5th Floor
Sample No.:	DU002407	Portal Ref No.:	269

Item:	Compressed plasterboard door header			
Asbestos Content:		Result Based on:		
No Asbestos Detected		Analysis of sample using PLM		
Sample Analysed By:	Reg 13(1)	Extent:	2 m ²	
Comments:

Material Assessment Total Score: 0		Likelihood of Disturbance Assessment Total Score: 0		Management Assessment Licensable: Yes Recommendations: Not Applicable Reinspection Interval: Not Applicable Overall Risk Category: E0
Product Type:	0 Not Applicable	Location:	0 Not Applicable	
Condition:	0 Not Applicable	Accessibility:	0 Not Applicable	
Surface Treatment:	0 Not Applicable			
Asbestos Type:	0 Not Applicable	Extent Score:	0 Not Applicable

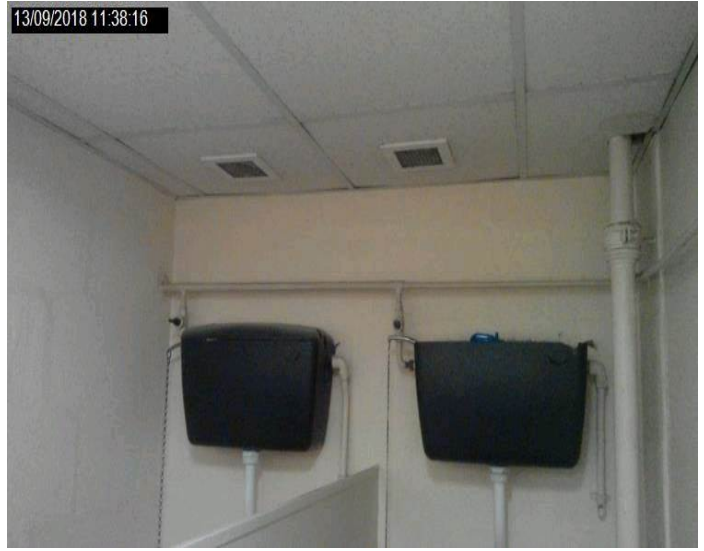
Location:	NBA522	Block:	Birmingham City University	Floor Level: 5th Floor
Sample No.:	DU002408	Portal Ref No.:	272

Item:	Asbestos Reinforced plastic cistern			
Asbestos Content:	Result Based on:			
Amosite	Analysis of sample using PLM			
Sample Analysed By:	Reg 13(1)	Extent:	2 units	
Comments:

Material Assessment Total Score: 4		Likelihood of Disturbance Assessment Total Score: 4		Management Assessment Licensable: No Recommendations: Program removal Reinspection Interval: Not Applicable Overall Risk Category: C8
Product Type:	1 (Asbestos reinforced plastic)	Location:	2 (Rooms up to 100 sq m)	
Condition:	1 (Minor scratches)	Accessibility:	1 (Occasionally likely to be disturbed)	
Surface Treatment:	0 (Composite material)			
Asbestos Type:	2 (Amosite)	Extent Score:	1 (<10 sq m or 10m pipe run)

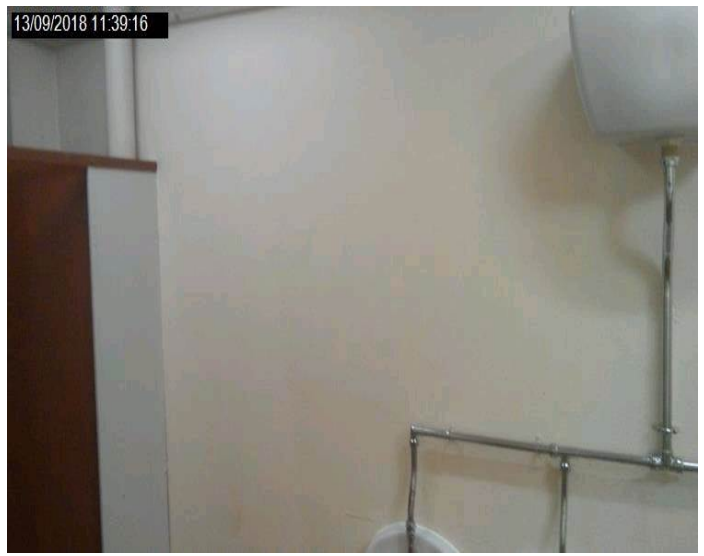
Location:	NBA522	Block:	Birmingham City University	Floor Level: 5th Floor
Sample No.:	DU002409	Portal Ref No.:	273

Item:	Textured coating to one wall			
Asbestos Content:		Result Based on:		
No Asbestos Detected		Analysis of sample using PLM		
Sample Analysed By:	Reg 13(1)	Extent:	25 m ²	
Comments: Right-hand side on entering

Material Assessment Total Score: 0		Likelihood of Disturbance Assessment Total Score: 0		Management Assessment Licensable: No Recommendations: Not Applicable Reinspection Interval: Not Applicable Overall Risk Category: E0
Product Type:	0 Not Applicable	Location:	0 Not Applicable	
Condition:	0 Not Applicable	Accessibility:	0 Not Applicable	
Surface Treatment:	0 Not Applicable			
Asbestos Type:	0 Not Applicable	Extent Score:	0 Not Applicable

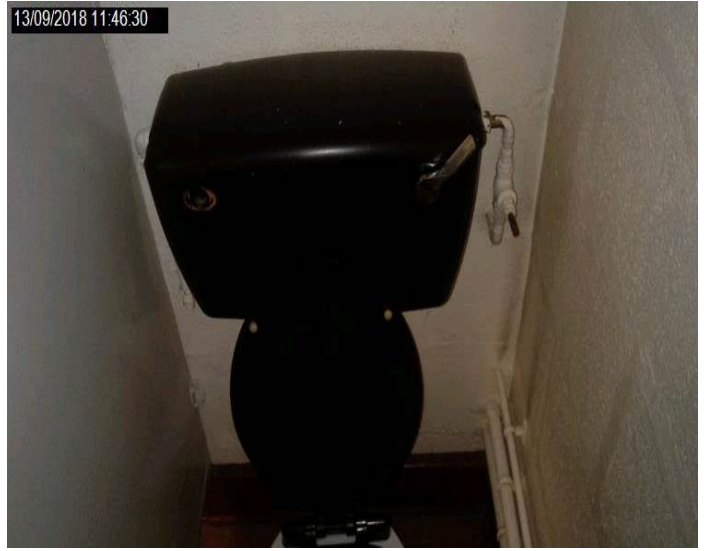
Location:	NBA520	Block:	Birmingham City University	Floor Level: 5th Floor
Sample No.:	As DU002408	Portal Ref No.:	274

Item:	Asbestos Reinforced plastic cistern			
Asbestos Content:	Result Based on:			
Amosite	Strongly presumed			
Sample Analysed By:	Not applicable	Extent:	1 unit	
Comments:

Material Assessment Total Score: 4		Likelihood of Disturbance Assessment Total Score: 4		Management Assessment Licensable: No Recommendations: Program removal Reinspection Interval: Not Applicable Overall Risk Category: C8
Product Type:	1 (Asbestos reinforced plastic)	Location:	2 (Rooms up to 100 sq m)	
Condition:	1 (Minor scratches)	Accessibility:	1 (Occasionally likely to be disturbed)	
Surface Treatment:	0 (Composite material)			
Asbestos Type:	2 (Amosite)	Extent Score:	1 (<10 sq m or 10m pipe run)

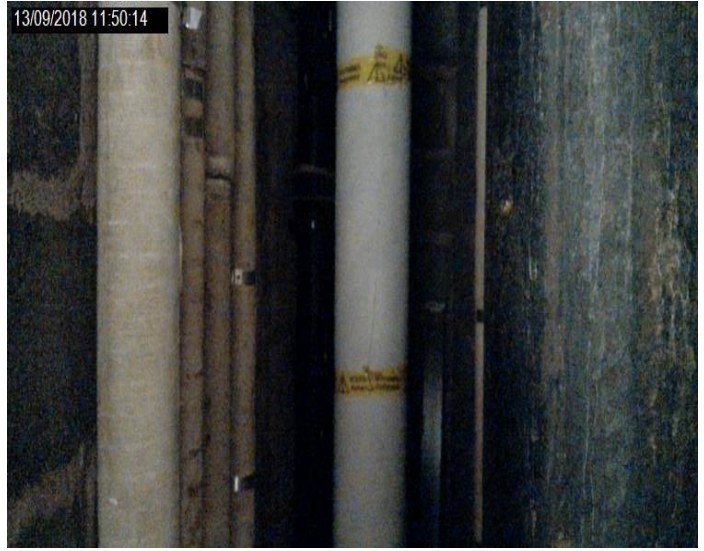
Location:	NBA519 Service duct	Block:	Birmingham City University	Floor Level: 5th Floor
Sample No.:	DU002410	Portal Ref No.:	275

Item:	Asbestos Cement flue pipe			
Asbestos Content:	Result Based on:			
Chrysotile	Analysis of sample using PLM			
Sample Analysed By: Reg 13(1)	Extent:	4 linear metres		
Comments:

Material Assessment Total Score: 4		Likelihood of Disturbance Assessment Total Score: 4		Management Assessment Licensable: No Recommendations: Program removal Reinspection Interval: Not Applicable Overall Risk Category: C8
Product Type:	1 (Asbestos cement)	Location:	2 (Rooms up to 100 sq m)	
Condition:	1 (Minor scratches)	Accessibility:	1 (Occasionally likely to be disturbed)	
Surface Treatment:	1 (Encapsulated asbestos cement)			
Asbestos Type:	1 (Chrysotile)	Extent Score:	1 (<10 sq m or 10m pipe run)

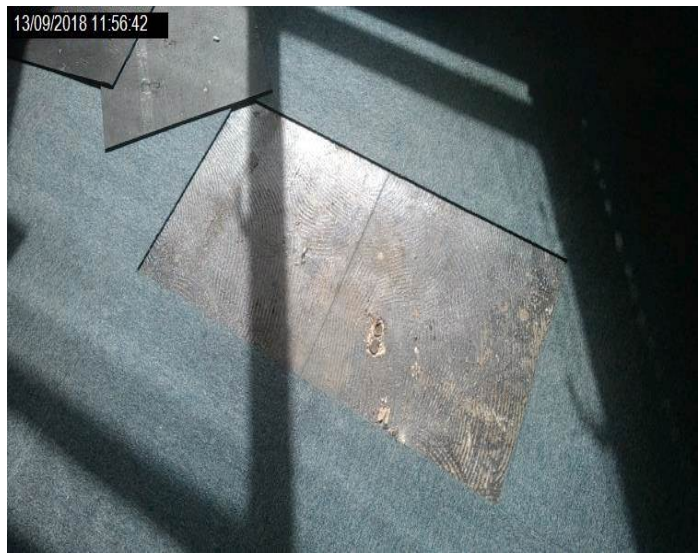
Location:	NBA517	Block:	Birmingham City University	Floor Level: 5th Floor
Sample No.:	As DU002406	Portal Ref No.:	277

Item:	Asbestos Bitumen adhesive			
Asbestos Content:	Result Based on:			
Chrysotile	Strongly presumed			
Sample Analysed By:	Not applicable	Extent:	14 m ²	
Comments:

Material Assessment Total Score: 3		Likelihood of Disturbance Assessment Total Score: 4		Management Assessment Licensable: No Recommendations: Program removal Reinspection Interval: Not Applicable Overall Risk Category: C7
Product Type:	1 (Asbestos bitumen)	Location:	2 (Rooms up to 100 sq m)	
Condition:	1 (Minor scratches)	Accessibility:	0 (Usually inaccessible or unlikely to be disturbed)	
Surface Treatment:	0 (Composite material)			
Asbestos Type:	1 (Chrysotile)	Extent Score:	2 (>10 - <50 sq m or >10m - <50m pipe run)

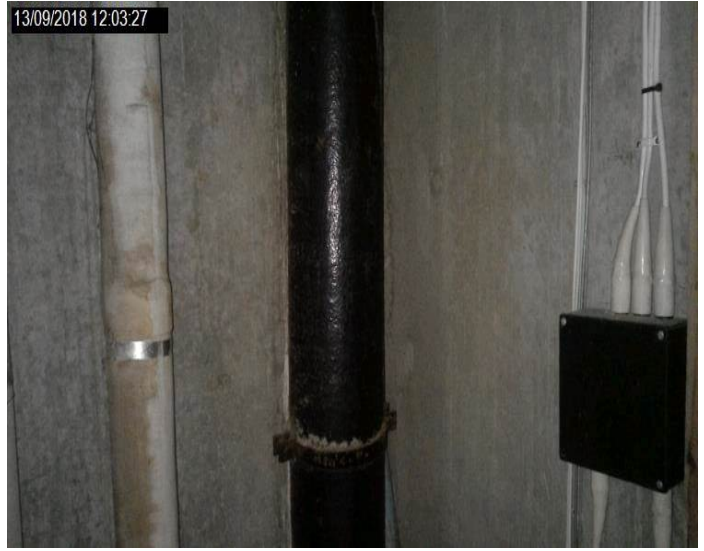
Location:	NBA510A Service duct	Block:	Birmingham City University	Floor Level: 5th Floor
Sample No.:	As DU002400	Portal Ref No.:	280

Item:	Asbestos Reinforced plastic downpipe			
Asbestos Content:	Result Based on:			
Chrysotile	Strongly presumed			
Sample Analysed By:	Not applicable	Extent:	3 linear metres	
Comments:

Material Assessment Total Score: 3		Likelihood of Disturbance Assessment Total Score: 4		Management Assessment Licensable: No Recommendations: Program removal Reinspection Interval: Not Applicable Overall Risk Category: C7
Product Type:	1 (Asbestos reinforced plastic)	Location:	2 (Rooms up to 100 sq m)	
Condition:	1 (Minor scratches)	Accessibility:	1 (Occasionally likely to be disturbed)	
Surface Treatment:	0 (Composite material)			
Asbestos Type:	1 (Chrysotile)	Extent Score:	1 (<10 sq m or 10m pipe run)

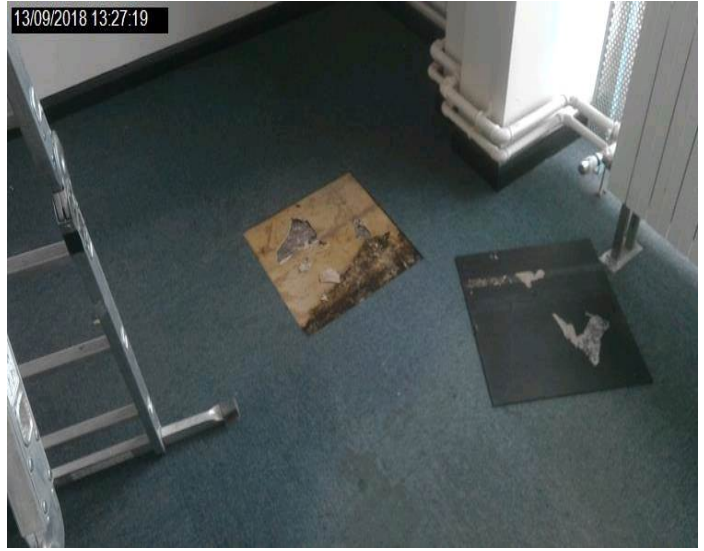
Location:	NBA514	Block:	Birmingham City University	Floor Level: 5th Floor
Sample No.:	DU002412	Portal Ref No.:	283

Item:	Asbestos Bitumen adhesive			
Asbestos Content:	Result Based on:			
Chrysotile	Analysis of sample using PLM			
Sample Analysed By:	Reg 13(1)	Extent:	14 m ²	
Comments:

Material Assessment Total Score: 3		Likelihood of Disturbance Assessment Total Score: 4		Management Assessment Licensable: No Recommendations: Program removal Reinspection Interval: Not Applicable Overall Risk Category: C7
Product Type:	1 (Asbestos bitumen)	Location:	2 (Rooms up to 100 sq m)	
Condition:	1 (Minor scratches)	Accessibility:	0 (Usually inaccessible or unlikely to be disturbed)	
Surface Treatment:	0 (Composite material)			
Asbestos Type:	1 (Chrysotile)	Extent Score:	2 (>10 - <50 sq m or >10m - <50m pipe run)

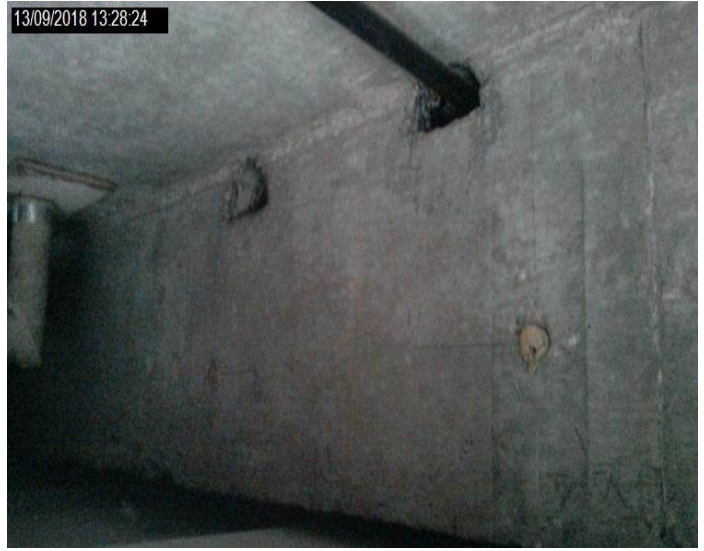
Location:	NBA514	Block:	Birmingham City University	Floor Level: 5th Floor
Sample No.:	As DU002395	Portal Ref No.:	284

Item:	Asbestos Reinforced plastic sleeve			
Asbestos Content:	Result Based on:			
Chrysotile	Strongly presumed			
Sample Analysed By:	Not applicable	Extent:	4 units	
Comments:

Material Assessment Total Score: 3		Likelihood of Disturbance Assessment Total Score: 3		Management Assessment Licensable: No Recommendations: Program removal Reinspection Interval: Not Applicable Overall Risk Category: D6
Product Type:	1 (Asbestos reinforced plastic)	Location:	2 (Rooms up to 100 sq m)	
Condition:	1 (Minor scratches)	Accessibility:	0 (Usually inaccessible or unlikely to be disturbed)	
Surface Treatment:	0 (Composite material)			
Asbestos Type:	1 (Chrysotile)	Extent Score:	1 (<10 sq m or 10m pipe run)

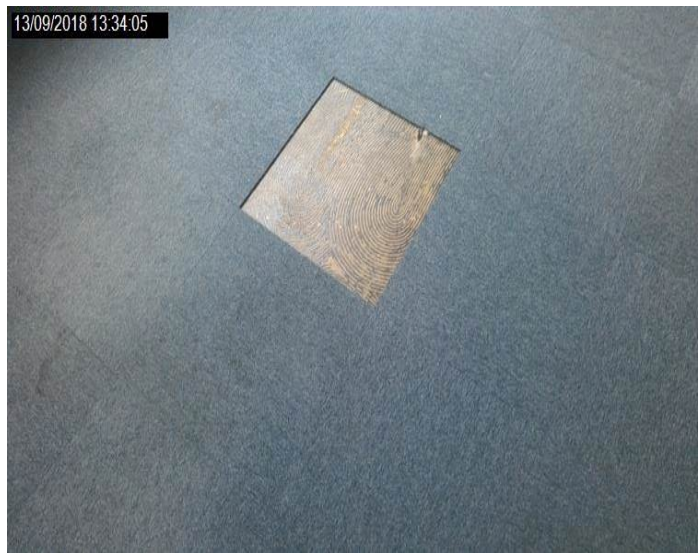
Location:	NBA512	Block:	Birmingham City University	Floor Level: 5th Floor
Sample No.:	As DU002412	Portal Ref No.:	286

Item:	Asbestos Bitumen adhesive			
Asbestos Content:	Result Based on:			
Chrysotile	Strongly presumed			
Sample Analysed By:	Not applicable	Extent:	22 m ²	
Comments:

Material Assessment Total Score: 3		Likelihood of Disturbance Assessment Total Score: 4		Management Assessment Licensable: No Recommendations: Program removal Reinspection Interval: Not Applicable Overall Risk Category: C7
Product Type:	1 (Asbestos bitumen)	Location:	2 (Rooms up to 100 sq m)	
Condition:	1 (Minor scratches)	Accessibility:	0 (Usually inaccessible or unlikely to be disturbed)	
Surface Treatment:	0 (Composite material)			
Asbestos Type:	1 (Chrysotile)	Extent Score:	2 (>10 - <50 sq m or >10m - <50m pipe run)

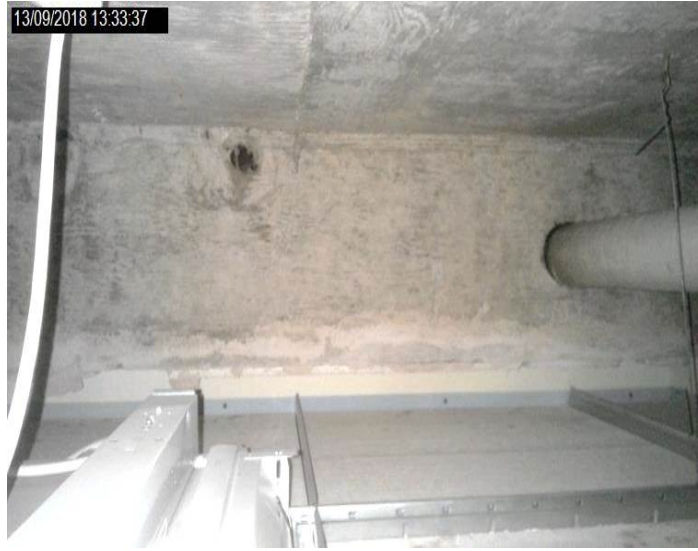
Location:	NBA512	Block:	Birmingham City University	Floor Level: 5th Floor
Sample No.:	As DU002395	Portal Ref No.:	287

Item:	Asbestos Reinforced plastic sleeve			
Asbestos Content:	Result Based on:			
Chrysotile	Strongly presumed			
Sample Analysed By:	Not applicable	Extent:	3 units	
Comments:

Material Assessment Total Score: 3		Likelihood of Disturbance Assessment Total Score: 3		Management Assessment Licensable: No Recommendations: Program removal Reinspection Interval: Not Applicable Overall Risk Category: D6
Product Type:	1 (Asbestos reinforced plastic)	Location:	2 (Rooms up to 100 sq m)	
Condition:	1 (Minor scratches)	Accessibility:	0 (Usually inaccessible or unlikely to be disturbed)	
Surface Treatment:	0 (Composite material)			
Asbestos Type:	1 (Chrysotile)	Extent Score:	1 (<10 sq m or 10m pipe run)

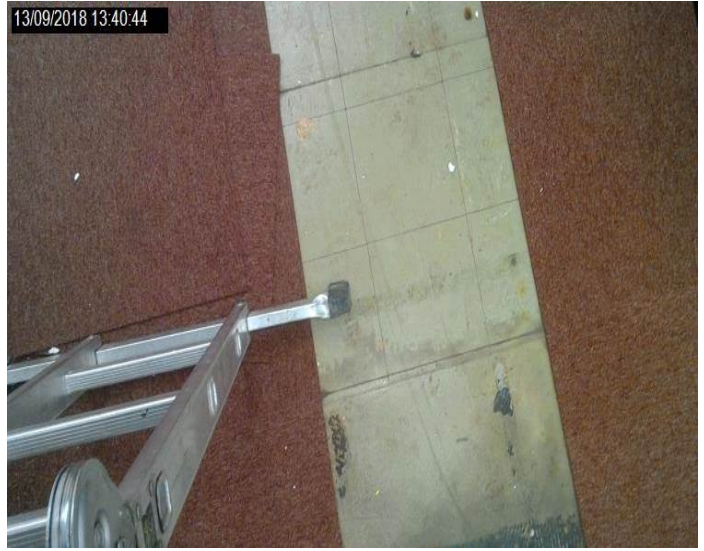
Location:	NBA599A Corridor	Block:	Birmingham City University	Floor Level: 5th Floor
Sample No.:	DU002413	Portal Ref No.:	291

Item:	Asbestos Thermoplastic floor tiles with bitumen adhesive			
Asbestos Content:	Result Based on:			
Chrysotile in tile and adhesive	Analysis of sample using PLM			
Sample Analysed By: Reg 13(1)	Extent:	6 m ²		
Comments:

Material Assessment Total Score: 3		Likelihood of Disturbance Assessment Total Score: 4		Management Assessment Licensable: No Recommendations: Program removal Reinspection Interval: Not Applicable Overall Risk Category: C7
Product Type:	1 (Asbestos thermoplastic)	Location:	2 (Rooms up to 100 sq m)	
Condition:	1 (Minor scratches)	Accessibility:	1 (Occasionally likely to be disturbed)	
Surface Treatment:	0 (Composite material)			
Asbestos Type:	1 (Chrysotile)	Extent Score:	1 (<10 sq m or 10m pipe run)

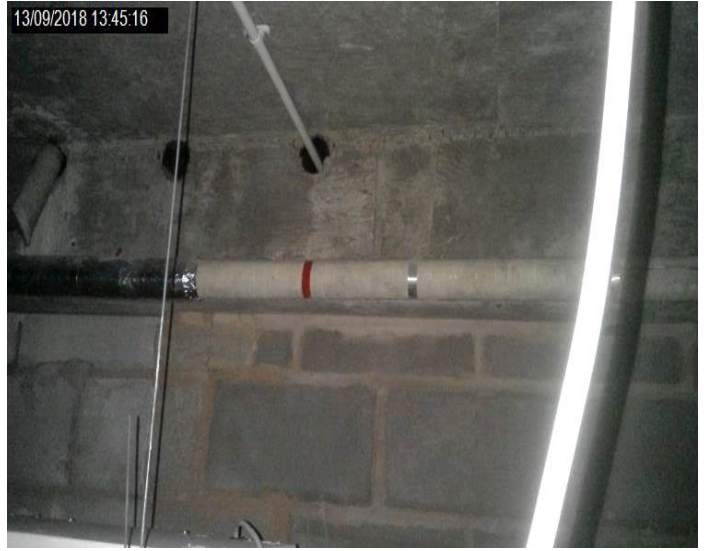
Location:	NBA599B Corridor	Block:	Birmingham City University	Floor Level: 5th Floor
Sample No.:	As DU002395	Portal Ref No.:	293

Item:	Asbestos Reinforced plastic sleeve			
Asbestos Content:	Result Based on:			
Chrysotile	Strongly presumed			
Sample Analysed By:	Not applicable	Extent:	8 units	
Comments: Structural columns

Material Assessment Total Score: 3		Likelihood of Disturbance Assessment Total Score: 3		Management Assessment Licensable: No Recommendations: Program removal Reinspection Interval: Not Applicable Overall Risk Category: D6
Product Type:	1 (Asbestos reinforced plastic)	Location:	2 (Rooms up to 100 sq m)	
Condition:	1 (Minor scratches)	Accessibility:	0 (Usually inaccessible or unlikely to be disturbed)	
Surface Treatment:	0 (Composite material)			
Asbestos Type:	1 (Chrysotile)	Extent Score:	1 (<10 sq m or 10m pipe run)

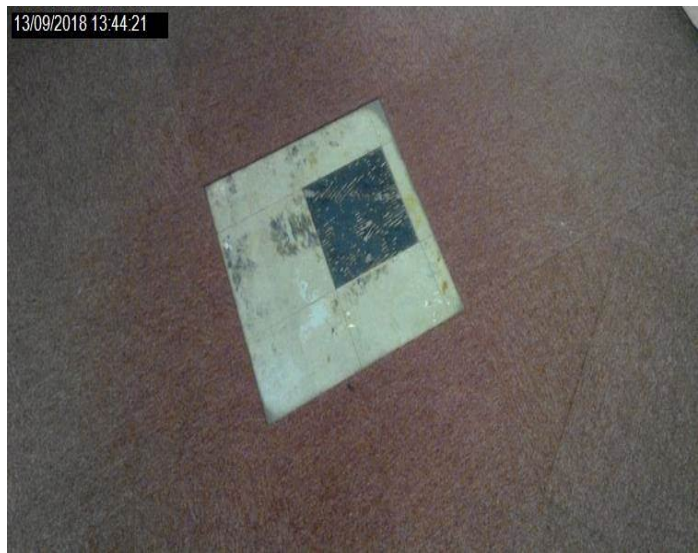
Location:	NBA599B Corridor	Block:	Birmingham City University	Floor Level: 5th Floor
Sample No.:	As DU002413	Portal Ref No.:	294

Item:	Asbestos Thermoplastic floor tiles with bitumen adhesive			
Asbestos Content:	Result Based on:			
Chrysotile in tile and adhesive	Strongly presumed			
Sample Analysed By:	Not applicable	Extent:	35 m ²	
Comments:

Material Assessment Total Score: 3		Likelihood of Disturbance Assessment Total Score: 5		Management Assessment Licensable: No Recommendations: Program removal Reinspection Interval: Not Applicable Overall Risk Category: C8
Product Type:	1 (Asbestos thermoplastic)	Location:	2 (Rooms up to 100 sq m)	
Condition:	1 (Minor scratches)	Accessibility:	1 (Occasionally likely to be disturbed)	
Surface Treatment:	0 (Composite material)			
Asbestos Type:	1 (Chrysotile)	Extent Score:	2 (>10 - <50 sq m or >10m - <50m pipe run)

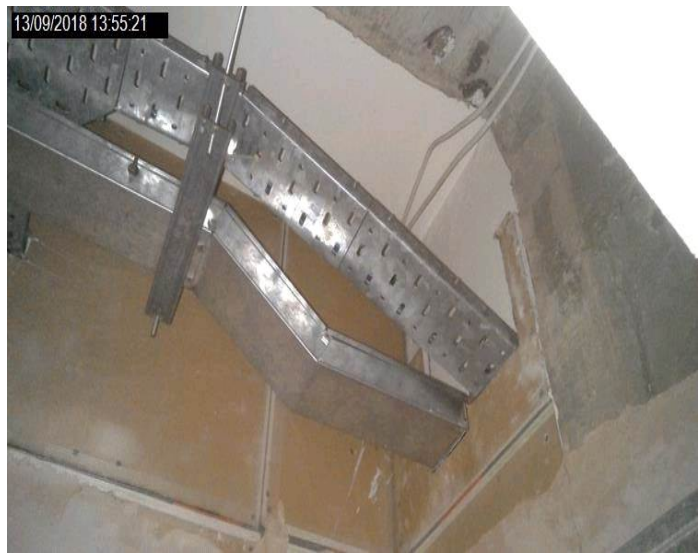
Location:	NBA599C Corridor	Block:	Birmingham City University	Floor Level: 5th Floor
Sample No.:	As DU002395	Portal Ref No.:	296

Item:	Asbestos Reinforced plastic sleeve			
Asbestos Content:	Result Based on:			
Chrysotile	Strongly presumed			
Sample Analysed By:	Not applicable	Extent:	2 units	
Comments: Structural columns, from service duct

Material Assessment Total Score: 3		Likelihood of Disturbance Assessment Total Score: 3		Management Assessment Licensable: No Recommendations: Program removal Reinspection Interval: Not Applicable Overall Risk Category: D6
Product Type:	1 (Asbestos reinforced plastic)	Location:	2 (Rooms up to 100 sq m)	
Condition:	1 (Minor scratches)	Accessibility:	0 (Usually inaccessible or unlikely to be disturbed)	
Surface Treatment:	0 (Composite material)			
Asbestos Type:	1 (Chrysotile)	Extent Score:	1 (<10 sq m or 10m pipe run)

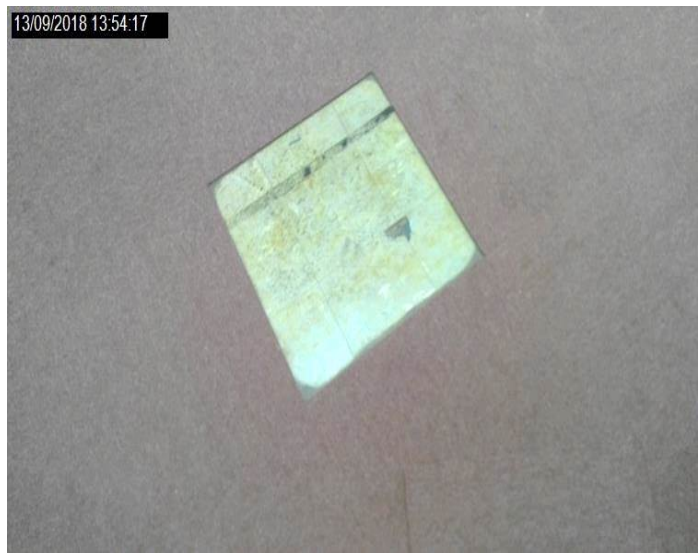
Location:	NBA599C Corridor	Block:	Birmingham City University	Floor Level: 5th Floor
Sample No.:	DU002415	Portal Ref No.:	297

Item:	Asbestos Thermoplastic floor tiles with bitumen adhesive			
Asbestos Content:	Result Based on:			
Chrysotile in tile and adhesive	Analysis of sample using PLM			
Sample Analysed By: Reg 13(1)	Extent:	30 m ²		
Comments:

Material Assessment Total Score: 3		Likelihood of Disturbance Assessment Total Score: 5		Management Assessment Licensable: No Recommendations: Program removal Reinspection Interval: Not Applicable Overall Risk Category: C8
Product Type:	1 (Asbestos thermoplastic)	Location:	2 (Rooms up to 100 sq m)	
Condition:	1 (Minor scratches)	Accessibility:	1 (Occasionally likely to be disturbed)	
Surface Treatment:	0 (Composite material)			
Asbestos Type:	1 (Chrysotile)	Extent Score:	2 (>10 - <50 sq m or >10m - <50m pipe run)

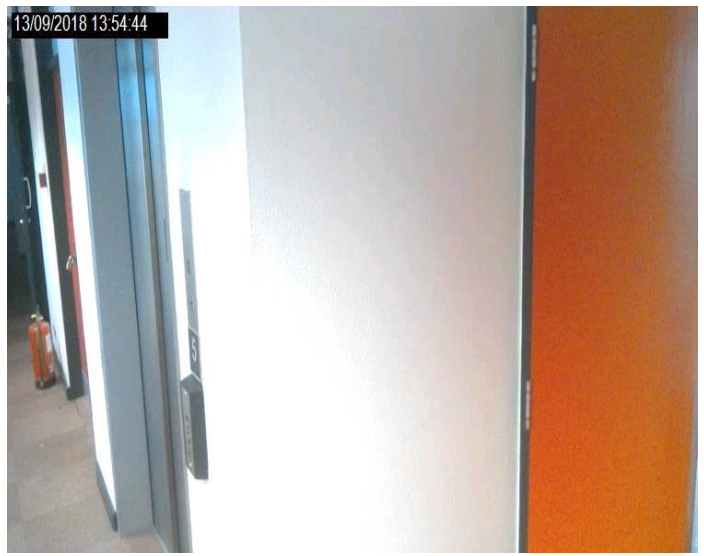
Location:	NBA599C Corridor	Block:	Birmingham City University	Floor Level: 5th Floor
Sample No.:	As DU002414	Portal Ref No.:	298

Item:	Textured coating to concrete sections			
Asbestos Content:		Result Based on:		
No Asbestos Detected		Strongly presumed		
Sample Analysed By:	Not applicable	Extent:	20 m ²	
Comments:

Material Assessment Total Score: 0		Likelihood of Disturbance Assessment Total Score: 0		Management Assessment Licensable: No Recommendations: Not Applicable Reinspection Interval: Not Applicable Overall Risk Category: E0
Product Type:	0 Not Applicable	Location:	0 Not Applicable	
Condition:	0 Not Applicable	Accessibility:	0 Not Applicable	
Surface Treatment:	0 Not Applicable			
Asbestos Type:	0 Not Applicable	Extent Score:	0 Not Applicable

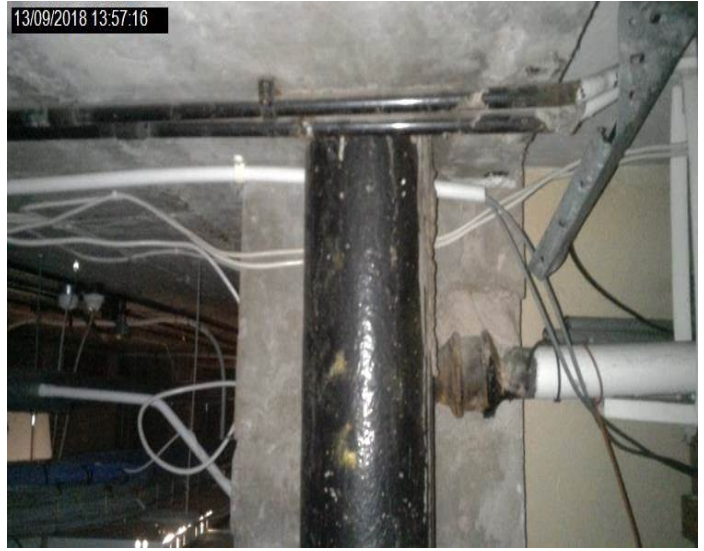
Location:	NBA599C Corridor	Block:	Birmingham City University	Floor Level: 5th Floor
Sample No.:	As DU002400	Portal Ref No.:	299

Item:	Asbestos Reinforced plastic downpipe			
Asbestos Content:	Result Based on:			
Chrysotile	Strongly presumed			
Sample Analysed By:	Not applicable	Extent:	4 linear metres	
Comments: Adjacent to lift

Material Assessment Total Score: 3		Likelihood of Disturbance Assessment Total Score: 3		Management Assessment Licensable: No Recommendations: Program removal Reinspection Interval: Not Applicable Overall Risk Category: D6
Product Type:	1 (Asbestos reinforced plastic)	Location:	2 (Rooms up to 100 sq m)	
Condition:	1 (Minor scratches)	Accessibility:	0 (Usually inaccessible or unlikely to be disturbed)	
Surface Treatment:	0 (Composite material)			
Asbestos Type:	1 (Chrysotile)	Extent Score:	1 (<10 sq m or 10m pipe run)

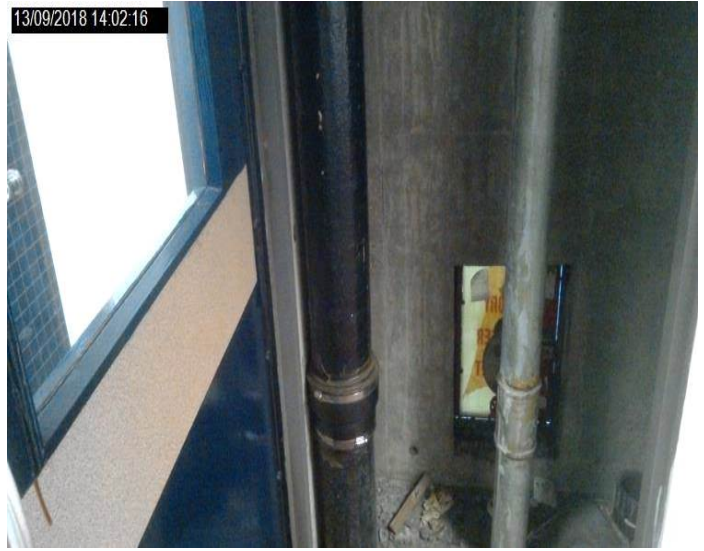
Location:	NBA505C Service duct	Block:	Birmingham City University	Floor Level: 5th Floor
Sample No.:	As DU002400	Portal Ref No.:	300

Item:	Asbestos Reinforced plastic downpipe			
Asbestos Content:	Result Based on:			
Chrysotile	Strongly presumed			
Sample Analysed By:	Not applicable	Extent:	4 linear metres	
Comments:

Material Assessment Total Score: 3		Likelihood of Disturbance Assessment Total Score: 4		Management Assessment Licensable: No Recommendations: Program removal Reinspection Interval: Not Applicable Overall Risk Category: C7
Product Type:	1 (Asbestos reinforced plastic)	Location:	2 (Rooms up to 100 sq m)	
Condition:	1 (Minor scratches)	Accessibility:	1 (Occasionally likely to be disturbed)	
Surface Treatment:	0 (Composite material)			
Asbestos Type:	1 (Chrysotile)	Extent Score:	1 (<10 sq m or 10m pipe run)
