Report No.: J102748
Nature of Work: Demolition Survey
Issue Date: 31/10/2018
Client Name: WYG Engineering Ltd
Geneva Building, Lake View Drive, Sherwood Business Park,
Annesley, Nottingham, NG15 0ED
Site Address: Baker Building, Former City North Campus, Birmingham City
University, Perry Barr, B42 2US

A demolition survey in line with HSG264 Asbestos: The Survey Guide was carried out internally and externally to the property.

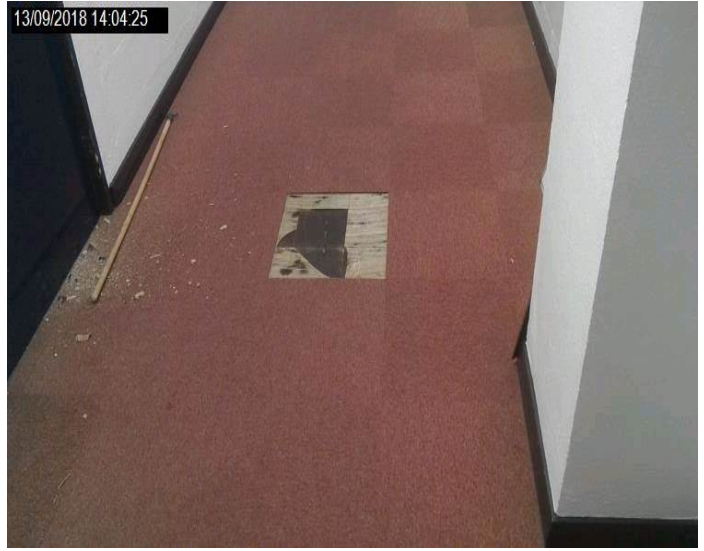
Location:	NBA599D Corridor	Block:	Birmingham City University	Floor Level: 5th Floor
Sample No.:	As DU002415	Portal Ref No.:	302

Item:	Asbestos Thermoplastic floor tiles with bitumen adhesive			
Asbestos Content:	Result Based on:			
Chrysotile in tile and adhesive	Strongly presumed			
Sample Analysed By:	Not applicable	Extent:	45 m ²	
Comments:

Material Assessment Total Score: 3		Likelihood of Disturbance Assessment Total Score: 5		Management Assessment Licensable: No Recommendations: Program removal Reinspection Interval: Not Applicable Overall Risk Category: C8
Product Type:	1 (Asbestos thermoplastic)	Location:	2 (Rooms up to 100 sq m)	
Condition:	1 (Minor scratches)	Accessibility:	1 (Occasionally likely to be disturbed)	
Surface Treatment:	0 (Composite material)			
Asbestos Type:	1 (Chrysotile)	Extent Score:	2 (>10 - <50 sq m or >10m - <50m pipe run)

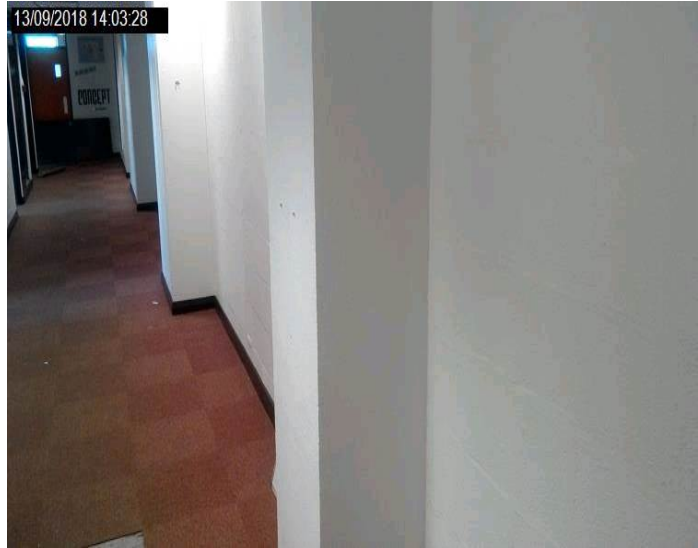
Location:	NBA599D Corridor	Block:	Birmingham City University	Floor Level: 5th Floor
Sample No.:	As DU002414	Portal Ref No.:	303

Item:	Textured coating to concrete sections			
Asbestos Content:		Result Based on:		
No Asbestos Detected		Strongly presumed		
Sample Analysed By:	Not applicable	Extent:	25 m ²	
Comments:

Material Assessment Total Score: 0		Likelihood of Disturbance Assessment Total Score: 0		Management Assessment Licensable: No Recommendations: Not Applicable Reinspection Interval: Not Applicable Overall Risk Category: E0
Product Type:	0 Not Applicable	Location:	0 Not Applicable	
Condition:	0 Not Applicable	Accessibility:	0 Not Applicable	
Surface Treatment:	0 Not Applicable			
Asbestos Type:	0 Not Applicable	Extent Score:	0 Not Applicable

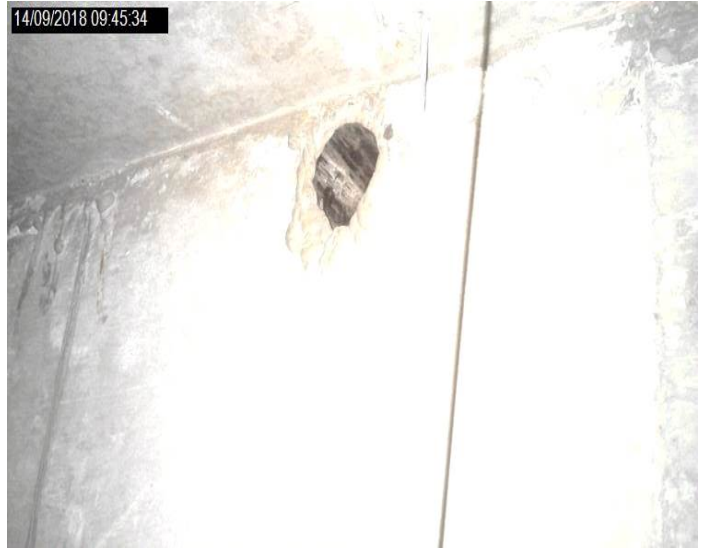
Location:	NBA401	Block:	Birmingham City University	Floor Level: 4th Floor
Sample No.:	DU002421	Portal Ref No.:	304

Item:	Asbestos Reinforced plastic sleeve			
Asbestos Content:	Result Based on:			
Chrysotile	Analysis of sample using PLM			
Sample Analysed By: Reg 13(1)	Extent:	20 units		
Comments:

Material Assessment Total Score: 3		Likelihood of Disturbance Assessment Total Score: 3		Management Assessment Licensable: No Recommendations: Program removal Reinspection Interval: Not Applicable Overall Risk Category: D6
Product Type:	1 (Asbestos reinforced plastic)	Location:	2 (Rooms up to 100 sq m)	
Condition:	1 (Minor scratches)	Accessibility:	0 (Usually inaccessible or unlikely to be disturbed)	
Surface Treatment:	0 (Composite material)			
Asbestos Type:	1 (Chrysotile)	Extent Score:	1 (<10 sq m or 10m pipe run)

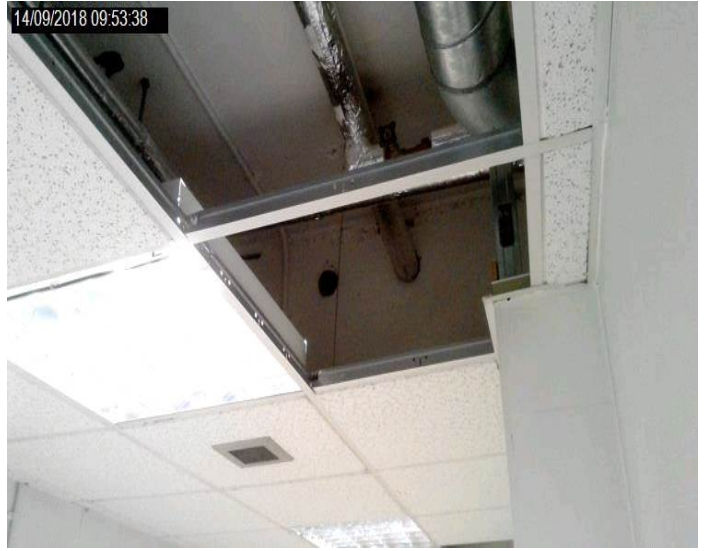
Location:	NBA401B	Block:	Birmingham City University	Floor Level: 4th Floor
Sample No.:	As DU002421	Portal Ref No.:	310

Item:	Asbestos Reinforced plastic sleeve			
Asbestos Content:	Result Based on:			
Chrysotile	Strongly presumed			
Sample Analysed By:	Not applicable	Extent:	9 units	
Comments:

Material Assessment Total Score: 3		Likelihood of Disturbance Assessment Total Score: 3		Management Assessment Licensable: No Recommendations: Program removal Reinspection Interval: Not Applicable Overall Risk Category: D6
Product Type:	1 (Asbestos reinforced plastic)	Location:	2 (Rooms up to 100 sq m)	
Condition:	1 (Minor scratches)	Accessibility:	0 (Usually inaccessible or unlikely to be disturbed)	
Surface Treatment:	0 (Composite material)			
Asbestos Type:	1 (Chrysotile)	Extent Score:	1 (<10 sq m or 10m pipe run)

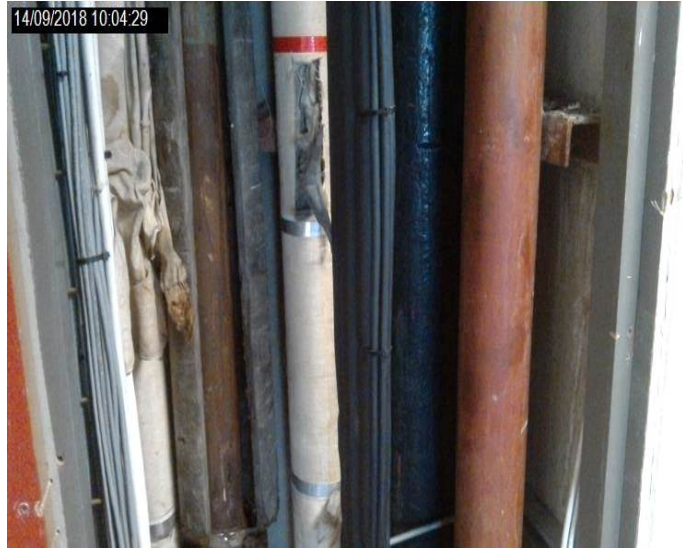
Location:	NBA424A Service duct	Block:	Birmingham City University	Floor Level: 4th Floor
Sample No.:	DU002423	Portal Ref No.:	313

Item:	Asbestos Reinforced plastic downpipe			
Asbestos Content:	Result Based on:			
Chrysotile	Analysis of sample using PLM			
Sample Analysed By: Reg 13(1)	Extent:	3 linear metres		
Comments:

Material Assessment Total Score: 3		Likelihood of Disturbance Assessment Total Score: 4		Management Assessment Licensable: No Recommendations: Program removal Reinspection Interval: Not Applicable Overall Risk Category: C7
Product Type:	1 (Asbestos reinforced plastic)	Location:	2 (Rooms up to 100 sq m)	
Condition:	1 (Minor scratches)	Accessibility:	1 (Occasionally likely to be disturbed)	
Surface Treatment:	0 (Composite material)			
Asbestos Type:	1 (Chrysotile)	Extent Score:	1 (<10 sq m or 10m pipe run)

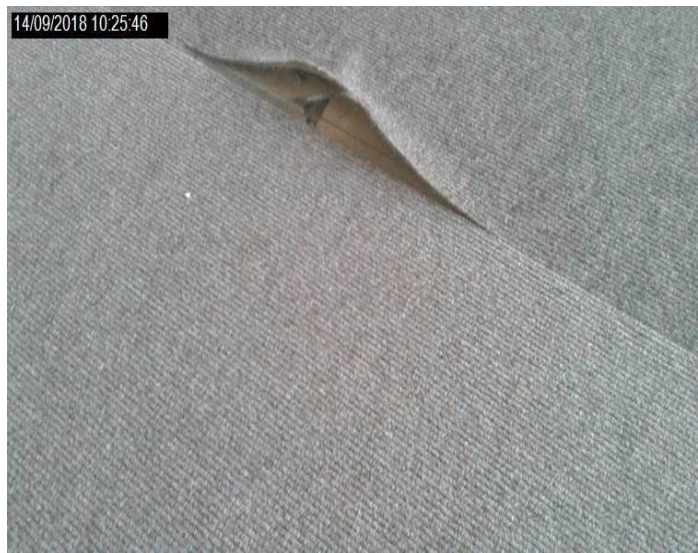
Location:	NBA423	Block:	Birmingham City University	Floor Level: 4th Floor
Sample No.:	DU002425	Portal Ref No.:	322

Item:	Asbestos Thermoplastic floor tiles with bitumen adhesive			
Asbestos Content:	Result Based on:			
Chrysotile in tile and adhesive	Analysis of sample using PLM			
Sample Analysed By: Reg 13(1)	Extent:	80 m ²		
Comments:

Material Assessment Total Score: 3		Likelihood of Disturbance Assessment Total Score: 5		Management Assessment Licensable: No Recommendations: Program removal Reinspection Interval: Not Applicable Overall Risk Category: C8
Product Type:	1 (Asbestos thermoplastic)	Location:	2 (Rooms up to 100 sq m)	
Condition:	1 (Minor scratches)	Accessibility:	0 (Usually inaccessible or unlikely to be disturbed)	
Surface Treatment:	0 (Composite material)			
Asbestos Type:	1 (Chrysotile)	Extent Score:	3 (>50 sq m or >50m pipe run)

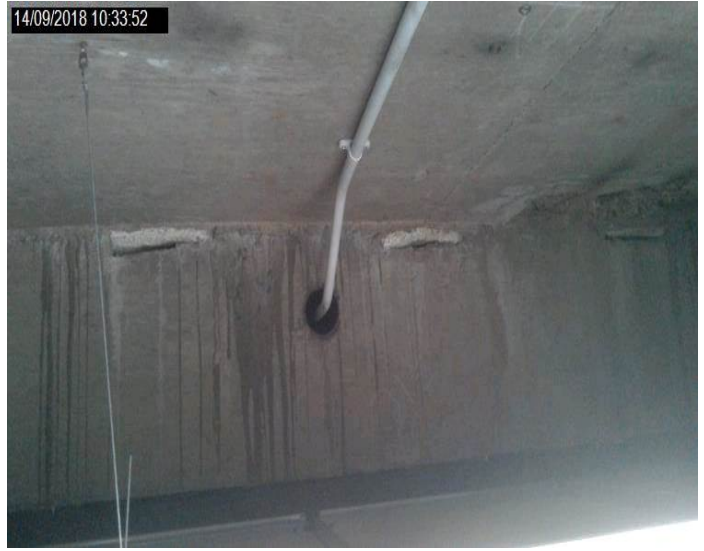
Location:	NBA405	Block:	Birmingham City University	Floor Level: 4th Floor
Sample No.:	As DU002421	Portal Ref No.:	327

Item:	Asbestos Reinforced plastic sleeve			
Asbestos Content:	Result Based on:			
Chrysotile	Strongly presumed			
Sample Analysed By:	Not applicable	Extent:	6 units	
Comments:

Material Assessment Total Score: 3		Likelihood of Disturbance Assessment Total Score: 3		Management Assessment Licensable: No Recommendations: Program removal Reinspection Interval: Not Applicable Overall Risk Category: D6
Product Type:	1 (Asbestos reinforced plastic)	Location:	2 (Rooms up to 100 sq m)	
Condition:	1 (Minor scratches)	Accessibility:	0 (Usually inaccessible or unlikely to be disturbed)	
Surface Treatment:	0 (Composite material)			
Asbestos Type:	1 (Chrysotile)	Extent Score:	1 (<10 sq m or 10m pipe run)

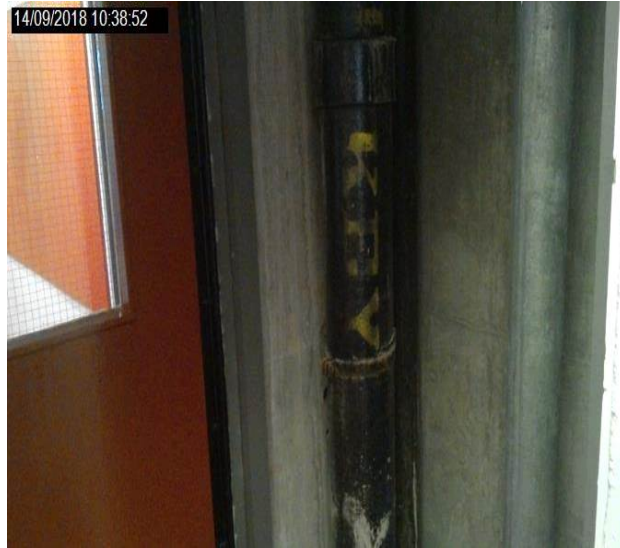
Location:	NBA405A Service duct	Block:	Birmingham City University	Floor Level: 4th Floor
Sample No.:	As DU002423	Portal Ref No.:	328

Item:	Asbestos Reinforced plastic downpipe			
Asbestos Content:	Result Based on:			
Chrysotile	Strongly presumed			
Sample Analysed By:	Not applicable	Extent:	4 linear metres	
Comments:

Material Assessment Total Score: 3		Likelihood of Disturbance Assessment Total Score: 4		Management Assessment Licensable: No Recommendations: Program removal Reinspection Interval: Not Applicable Overall Risk Category: C7
Product Type:	1 (Asbestos reinforced plastic)	Location:	2 (Rooms up to 100 sq m)	
Condition:	1 (Minor scratches)	Accessibility:	1 (Occasionally likely to be disturbed)	
Surface Treatment:	0 (Composite material)			
Asbestos Type:	1 (Chrysotile)	Extent Score:	1 (<10 sq m or 10m pipe run)

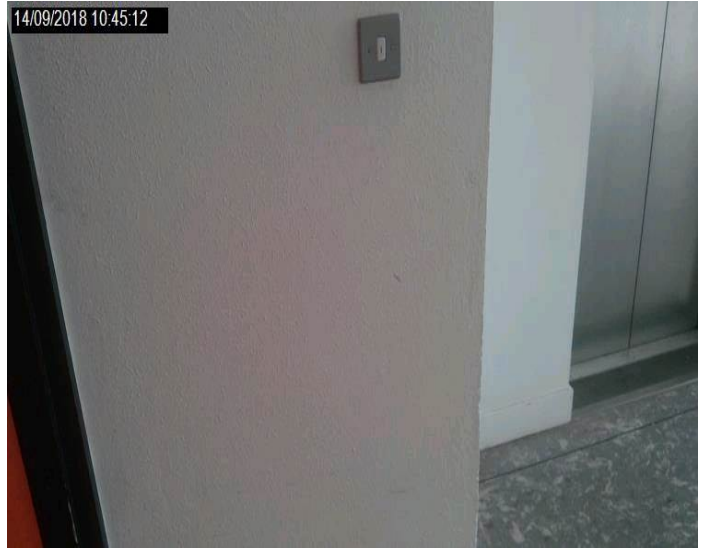
Location:	NBA499 Lift Lobby	Block:	Birmingham City University	Floor Level: 4th Floor
Sample No.:	As DU002427	Portal Ref No.:	330

Item:	Textured coating to concrete			
Asbestos Content:		Result Based on:		
No Asbestos Detected		Strongly presumed		
Sample Analysed By:	Not applicable	Extent:	80 m ²	
Comments: To all walls

Material Assessment Total Score: 0		Likelihood of Disturbance Assessment Total Score: 0		Management Assessment Licensable: No Recommendations: Not Applicable Reinspection Interval: Not Applicable Overall Risk Category: E0
Product Type:	0 Not Applicable	Location:	0 Not Applicable	
Condition:	0 Not Applicable	Accessibility:	0 Not Applicable	
Surface Treatment:	0 Not Applicable			
Asbestos Type:	0 Not Applicable	Extent Score:	0 Not Applicable

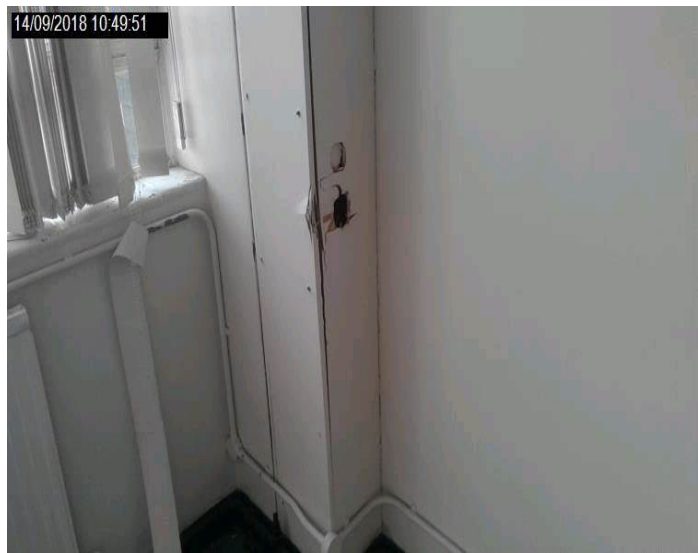
Location:	NBA422	Block:	Birmingham City University	Floor Level: 4th Floor
Sample No.:	As DU002423	Portal Ref No.:	332

Item:	Asbestos Reinforced plastic downpipe			
Asbestos Content:	Result Based on:			
Chrysotile	Strongly presumed			
Sample Analysed By:	Not applicable	Extent:	4 linear metres	
Comments:

Material Assessment Total Score: 3		Likelihood of Disturbance Assessment Total Score: 3		Management Assessment Licensable: No Recommendations: Program removal Reinspection Interval: Not Applicable Overall Risk Category: D6
Product Type:	1 (Asbestos reinforced plastic)	Location:	2 (Rooms up to 100 sq m)	
Condition:	1 (Minor scratches)	Accessibility:	0 (Usually inaccessible or unlikely to be disturbed)	
Surface Treatment:	0 (Composite material)			
Asbestos Type:	1 (Chrysotile)	Extent Score:	1 (<10 sq m or 10m pipe run)

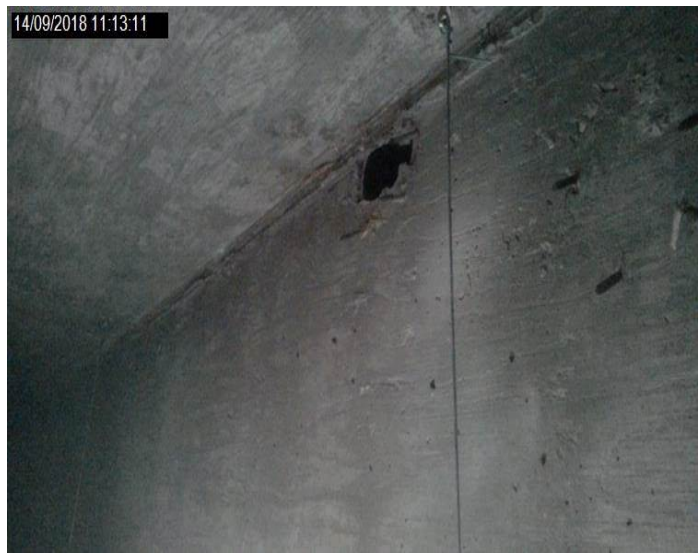
Location:	NBA406	Block:	Birmingham City University	Floor Level: 4th Floor
Sample No.:	As DU002421	Portal Ref No.:	335

Item:	Asbestos Reinforced plastic sleeve			
Asbestos Content:	Result Based on:			
Chrysotile	Strongly presumed			
Sample Analysed By:	Not applicable	Extent:	4 units	
Comments:

Material Assessment Total Score: 3		Likelihood of Disturbance Assessment Total Score: 3		Management Assessment Licensable: No Recommendations: Program removal Reinspection Interval: Not Applicable Overall Risk Category: D6
Product Type:	1 (Asbestos reinforced plastic)	Location:	2 (Rooms up to 100 sq m)	
Condition:	1 (Minor scratches)	Accessibility:	0 (Usually inaccessible or unlikely to be disturbed)	
Surface Treatment:	0 (Composite material)			
Asbestos Type:	1 (Chrysotile)	Extent Score:	1 (<10 sq m or 10m pipe run)

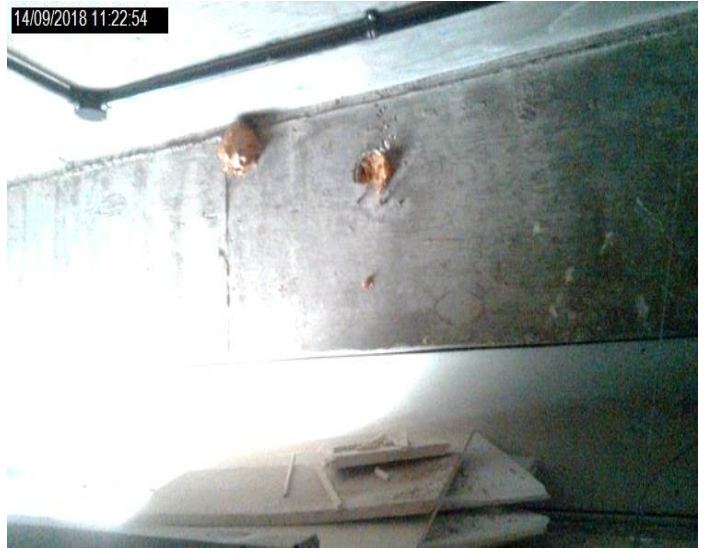
Location:	NBA407A	Block:	Birmingham City University	Floor Level: 4th Floor
Sample No.:	DU002428	Portal Ref No.:	336

Item:	Asbestos Reinforced plastic sleeve			
Asbestos Content:	Result Based on:			
Chrysotile	Analysis of sample using PLM			
Sample Analysed By:	Reg 13(1)	Extent:	2 units	
Comments:

Material Assessment Total Score: 3		Likelihood of Disturbance Assessment Total Score: 4		Management Assessment Licensable: No Recommendations: Program removal Reinspection Interval: Not Applicable Overall Risk Category: C7
Product Type:	1 (Asbestos reinforced plastic)	Location:	2 (Rooms up to 100 sq m)	
Condition:	1 (Minor scratches)	Accessibility:	1 (Occasionally likely to be disturbed)	
Surface Treatment:	0 (Composite material)			
Asbestos Type:	1 (Chrysotile)	Extent Score:	1 (<10 sq m or 10m pipe run)

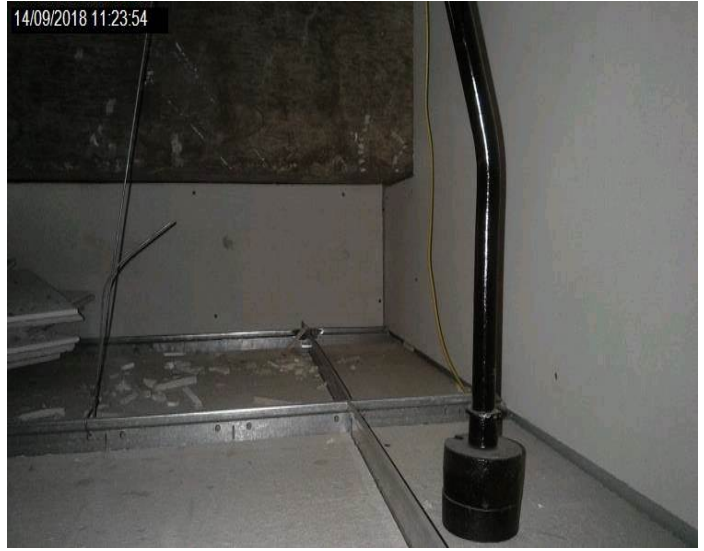
Location:	NBA407A	Block:	Birmingham City University	Floor Level: 4th Floor
Sample No.:	DU002429	Portal Ref No.:	337

Item:	Fibreboard wall panelling			
Asbestos Content:		Result Based on:		
No Asbestos Detected		Analysis of sample using PLM		
Sample Analysed By:	Reg 13(1)	Extent:	16 m ²	
Comments: Extends above and below the ceiling tiles

Material Assessment Total Score: 0		Likelihood of Disturbance Assessment Total Score: 0		Management Assessment Licensable: No Recommendations: Not Applicable Reinspection Interval: Not Applicable Overall Risk Category: E0
Product Type:	0 Not Applicable	Location:	0 Not Applicable	
Condition:	0 Not Applicable	Accessibility:	0 Not Applicable	
Surface Treatment:	0 Not Applicable			
Asbestos Type:	0 Not Applicable	Extent Score:	0 Not Applicable

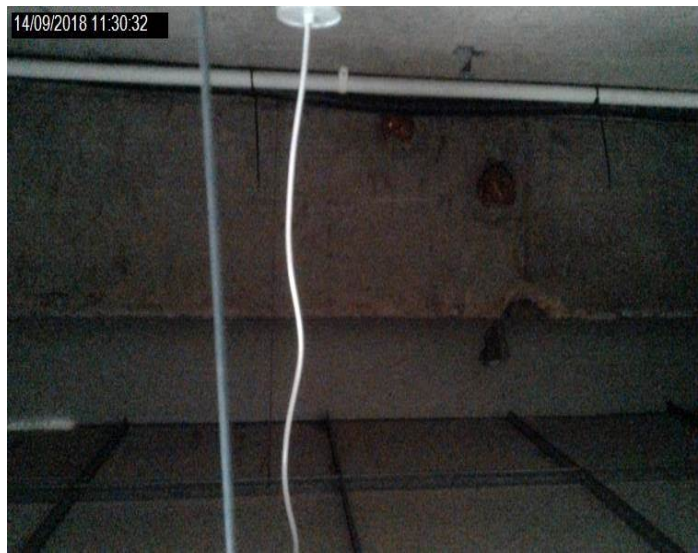
Location:	NBA409	Block:	Birmingham City University	Floor Level: 4th Floor
Sample No.:	As DU002428	Portal Ref No.:	342

Item:	Asbestos Reinforced plastic sleeve			
Asbestos Content:	Result Based on:			
Chrysotile	Strongly presumed			
Sample Analysed By:	Not applicable	Extent:	2 units	
Comments:

Material Assessment Total Score: 3		Likelihood of Disturbance Assessment Total Score: 4		Management Assessment Licensable: No Recommendations: Program removal Reinspection Interval: Not Applicable Overall Risk Category: C7
Product Type:	1 (Asbestos reinforced plastic)	Location:	2 (Rooms up to 100 sq m)	
Condition:	1 (Minor scratches)	Accessibility:	1 (Occasionally likely to be disturbed)	
Surface Treatment:	0 (Composite material)			
Asbestos Type:	1 (Chrysotile)	Extent Score:	1 (<10 sq m or 10m pipe run)

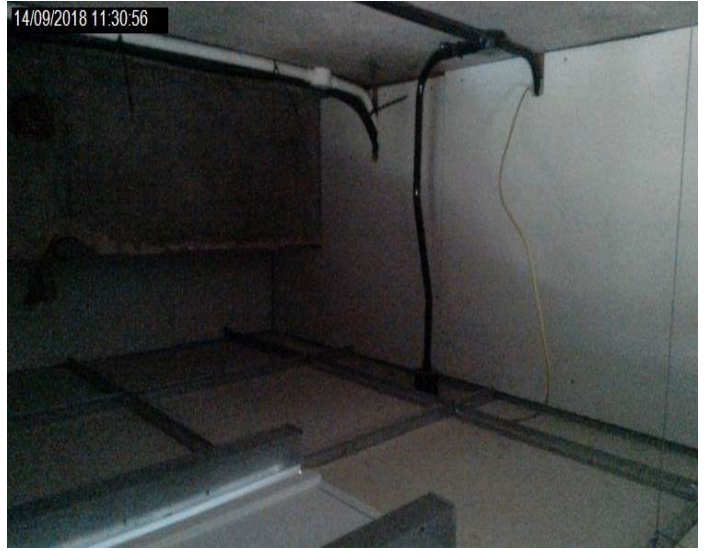
Location:	NBA409	Block:	Birmingham City University	Floor Level: 4th Floor
Sample No.:	As DU002429	Portal Ref No.:	343

Item:	Fibreboard wall panelling			
Asbestos Content:		Result Based on:		
No Asbestos Detected		Strongly presumed		
Sample Analysed By:	Not applicable	Extent:	20 m ²	
Comments: Extends above and below the ceiling tiles

Material Assessment Total Score: 0		Likelihood of Disturbance Assessment Total Score: 0		Management Assessment Licensable: No Recommendations: Not Applicable Reinspection Interval: Not Applicable Overall Risk Category: E0
Product Type:	0 Not Applicable	Location:	0 Not Applicable	
Condition:	0 Not Applicable	Accessibility:	0 Not Applicable	
Surface Treatment:	0 Not Applicable			
Asbestos Type:	0 Not Applicable	Extent Score:	0 Not Applicable

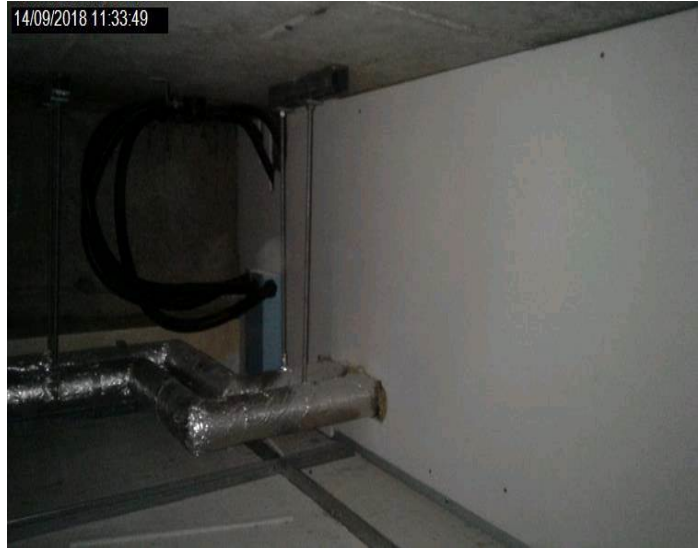
Location:	NBA410	Block:	Birmingham City University	Floor Level: 4th Floor
Sample No.:	As DU002429	Portal Ref No.:	346

Item:	Fibreboard wall panelling			
Asbestos Content:		Result Based on:		
No Asbestos Detected		Strongly presumed		
Sample Analysed By:	Not applicable	Extent:	25 m ²	
Comments: Extends above and below the ceiling tiles

Material Assessment Total Score: 0		Likelihood of Disturbance Assessment Total Score: 0		Management Assessment Licensable: No Recommendations: Not Applicable Reinspection Interval: Not Applicable Overall Risk Category: E0
Product Type:	0 Not Applicable	Location:	0 Not Applicable	
Condition:	0 Not Applicable	Accessibility:	0 Not Applicable	
Surface Treatment:	0 Not Applicable			
Asbestos Type:	0 Not Applicable	Extent Score:	0 Not Applicable

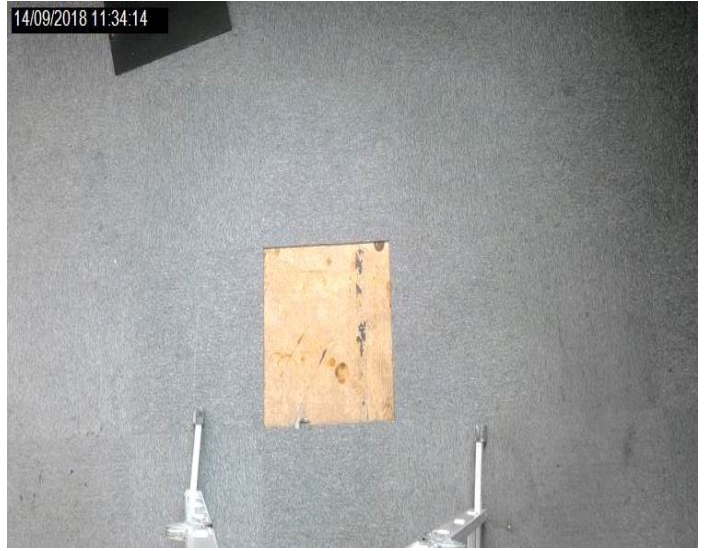
Location:	NBA410	Block:	Birmingham City University	Floor Level: 4th Floor
Sample No.:	As DU002430	Portal Ref No.:	347

Item:	Asbestos Bitumen adhesive			
Asbestos Content:	Result Based on:			
Chrysotile	Strongly presumed			
Sample Analysed By:	Not applicable	Extent:	14 m ²	
Comments:

Material Assessment Total Score: 3		Likelihood of Disturbance Assessment Total Score: 5		Management Assessment Licensable: No Recommendations: Program removal Reinspection Interval: Not Applicable Overall Risk Category: C8
Product Type:	1 (Asbestos bitumen)	Location:	2 (Rooms up to 100 sq m)	
Condition:	1 (Minor scratches)	Accessibility:	1 (Occasionally likely to be disturbed)	
Surface Treatment:	0 (Composite material)			
Asbestos Type:	1 (Chrysotile)	Extent Score:	2 (>10 - <50 sq m or >10m - <50m pipe run)

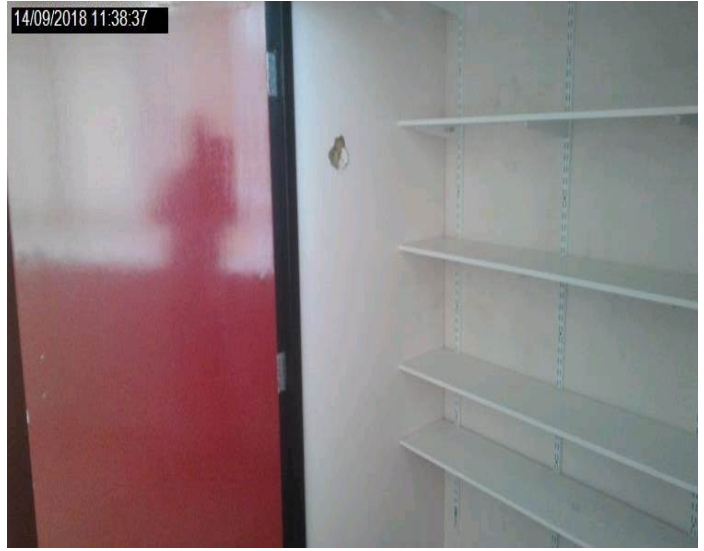
Location:	NBA410A	Block:	Birmingham City University	Floor Level: 4th Floor
Sample No.:	As DU002429	Portal Ref No.:	349

Item:	Fibreboard wall panelling			
Asbestos Content:		Result Based on:		
No Asbestos Detected		Strongly presumed		
Sample Analysed By:	Not applicable	Extent:	16 m ²	
Comments: Extends above and below the ceiling tiles

Material Assessment Total Score: 0		Likelihood of Disturbance Assessment Total Score: 0		Management Assessment Licensable: No Recommendations: Not Applicable Reinspection Interval: Not Applicable Overall Risk Category: E0
Product Type:	0 Not Applicable	Location:	0 Not Applicable	
Condition:	0 Not Applicable	Accessibility:	0 Not Applicable	
Surface Treatment:	0 Not Applicable			
Asbestos Type:	0 Not Applicable	Extent Score:	0 Not Applicable

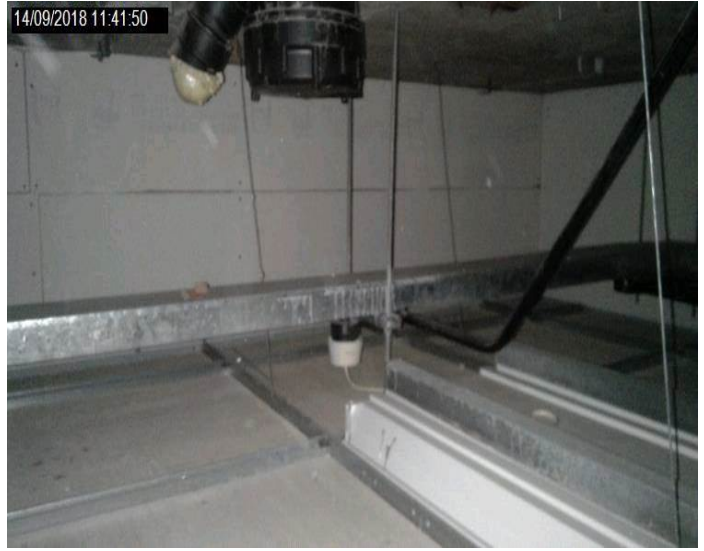
Location:	NBA407	Block:	Birmingham City University	Floor Level: 4th Floor
Sample No.:	As DU002429	Portal Ref No.:	352

Item:	Fibreboard wall panelling			
Asbestos Content:		Result Based on:		
No Asbestos Detected		Strongly presumed		
Sample Analysed By:	Not applicable	Extent:	60 m ²	
Comments: Extends above and below the ceiling tiles, labelled as modern board

Material Assessment Total Score: 0		Likelihood of Disturbance Assessment Total Score: 0		Management Assessment Licensable: No Recommendations: Not Applicable Reinspection Interval: Not Applicable Overall Risk Category: E0
Product Type:	0 Not Applicable	Location:	0 Not Applicable	
Condition:	0 Not Applicable	Accessibility:	0 Not Applicable	
Surface Treatment:	0 Not Applicable			
Asbestos Type:	0 Not Applicable	Extent Score:	0 Not Applicable

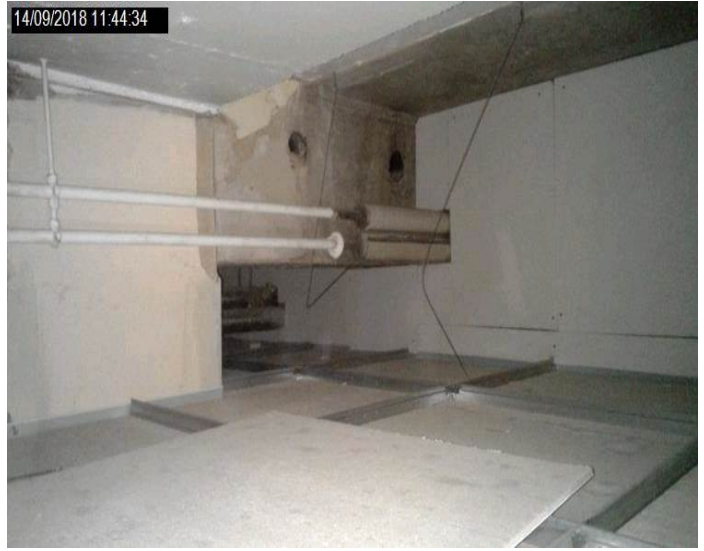
Location:	NBA411	Block:	Birmingham City University	Floor Level: 4th Floor
Sample No.:	As DU002428	Portal Ref No.:	354

Item:	Asbestos Reinforced plastic sleeve			
Asbestos Content:	Result Based on:			
Chrysotile	Strongly presumed			
Sample Analysed By:	Not applicable	Extent:	4 units	
Comments:

Material Assessment Total Score: 3		Likelihood of Disturbance Assessment Total Score: 4		Management Assessment Licensable: No Recommendations: Program removal Reinspection Interval: Not Applicable Overall Risk Category: C7
Product Type:	1 (Asbestos reinforced plastic)	Location:	2 (Rooms up to 100 sq m)	
Condition:	1 (Minor scratches)	Accessibility:	1 (Occasionally likely to be disturbed)	
Surface Treatment:	0 (Composite material)			
Asbestos Type:	1 (Chrysotile)	Extent Score:	1 (<10 sq m or 10m pipe run)

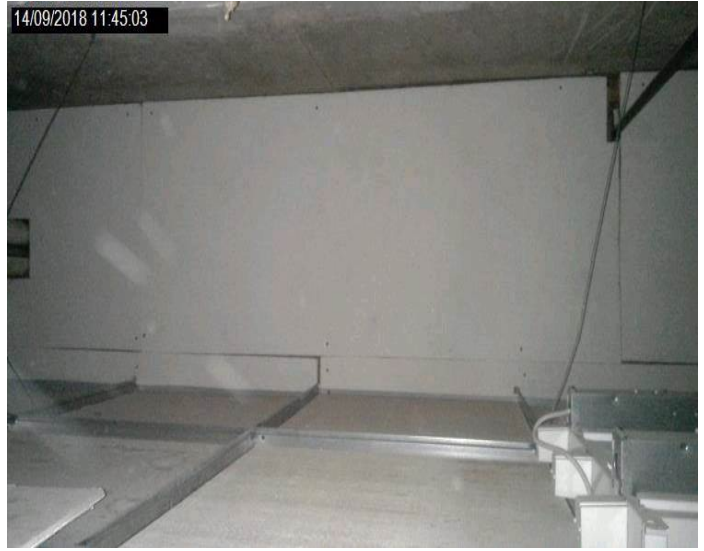
Location:	NBA411	Block:	Birmingham City University	Floor Level: 4th Floor
Sample No.:	As DU002429	Portal Ref No.:	355

Item:	Fibreboard wall panelling			
Asbestos Content:		Result Based on:		
No Asbestos Detected		Strongly presumed		
Sample Analysed By:	Not applicable	Extent:	40 m ²	
Comments: Extends above and below the ceiling tiles, labelled as modern board

Material Assessment Total Score: 0		Likelihood of Disturbance Assessment Total Score: 0		Management Assessment Licensable: No Recommendations: Not Applicable Reinspection Interval: Not Applicable Overall Risk Category: E0
Product Type:	0 Not Applicable	Location:	0 Not Applicable	
Condition:	0 Not Applicable	Accessibility:	0 Not Applicable	
Surface Treatment:	0 Not Applicable			
Asbestos Type:	0 Not Applicable	Extent Score:	0 Not Applicable

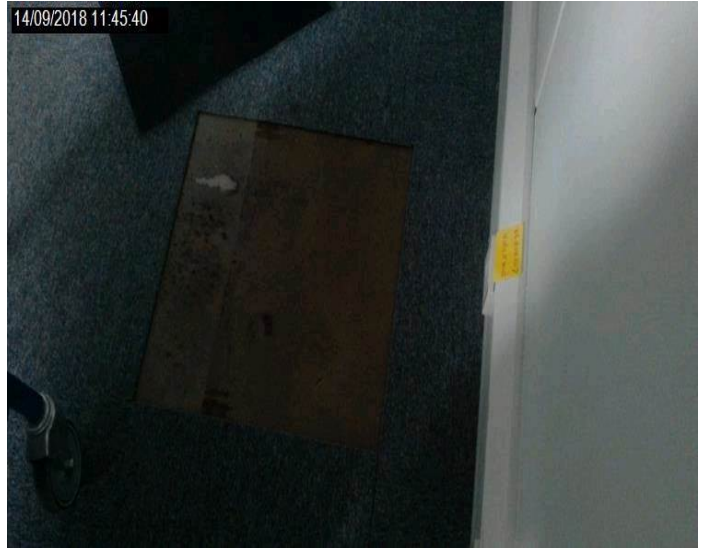
Location:	NBA411	Block:	Birmingham City University	Floor Level: 4th Floor
Sample No.:	As DU002430	Portal Ref No.:	356

Item:	Asbestos Bitumen adhesive			
Asbestos Content:	Result Based on:			
Chrysotile	Strongly presumed			
Sample Analysed By:	Not applicable	Extent:	16 m ²	
Comments:

Material Assessment Total Score: 3		Likelihood of Disturbance Assessment Total Score: 5		Management Assessment Licensable: No Recommendations: Program removal Reinspection Interval: Not Applicable Overall Risk Category: C8
Product Type:	1 (Asbestos bitumen)	Location:	2 (Rooms up to 100 sq m)	
Condition:	1 (Minor scratches)	Accessibility:	1 (Occasionally likely to be disturbed)	
Surface Treatment:	0 (Composite material)			
Asbestos Type:	1 (Chrysotile)	Extent Score:	2 (>10 - <50 sq m or >10m - <50m pipe run)

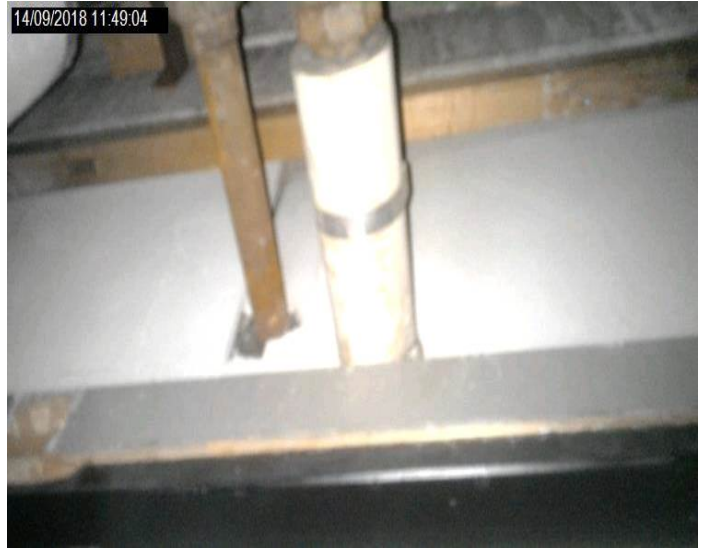
Location:	NBA412B Service duct	Block:	Birmingham City University	Floor Level: 4th Floor
Sample No.:	DU002431	Portal Ref No.:	357

Item:	Insulating board door header			
Asbestos Content:		Result Based on:		
No Asbestos Detected		Analysis of sample using PLM		
Sample Analysed By:	Reg 13(1)	Extent:	2 m ²	
Comments:

Material Assessment Total Score: 0		Likelihood of Disturbance Assessment Total Score: 0		Management Assessment Licensable: Yes Recommendations: Not Applicable Reinspection Interval: Not Applicable Overall Risk Category: E0
Product Type:	0 Not Applicable	Location:	0 Not Applicable	
Condition:	0 Not Applicable	Accessibility:	0 Not Applicable	
Surface Treatment:	0 Not Applicable			
Asbestos Type:	0 Not Applicable	Extent Score:	0 Not Applicable

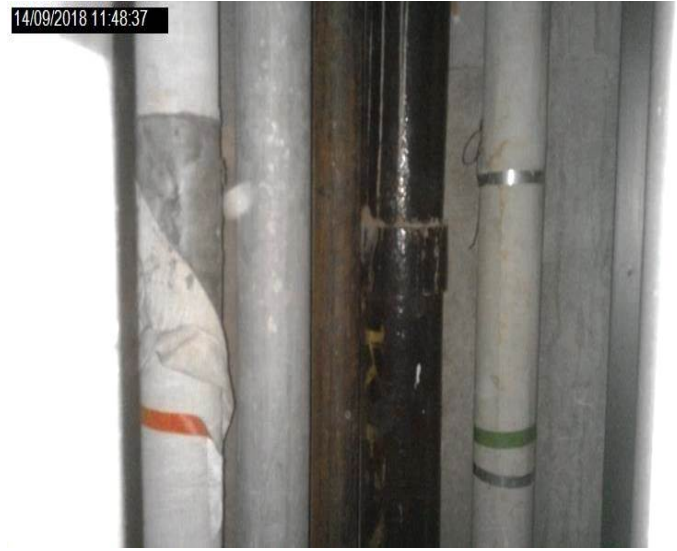
Location:	NBA412B Service duct	Block:	Birmingham City University		Floor Level: 4th Floor
Sample No.:	As DU002423	Portal Ref No.:	358

Item:	Asbestos Reinforced plastic downpipe				
Asbestos Content:	Result Based on:				
Chrysotile	Strongly presumed				
Sample Analysed By:	Not applicable	Extent:	4 linear metres		
Comments:

Material Assessment Total Score: 3		Likelihood of Disturbance Assessment Total Score: 4		Management Assessment Licensable: No Recommendations: Program removal Reinspection Interval: Not Applicable Overall Risk Category: C7
Product Type:	1 (Asbestos reinforced plastic)	Location:	2 (Rooms up to 100 sq m)	
Condition:	1 (Minor scratches)	Accessibility:	1 (Occasionally likely to be disturbed)	
Surface Treatment:	0 (Composite material)			
Asbestos Type:	1 (Chrysotile)	Extent Score:	1 (<10 sq m or 10m pipe run)

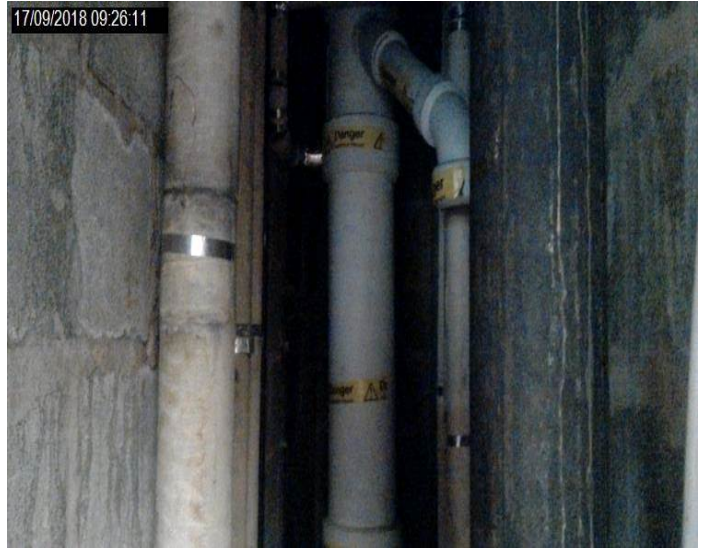
Location:	NBA417A Service duct	Block:	Birmingham City University	Floor Level: 4th Floor
Sample No.:	DU002434	Portal Ref No.:	363

Item:	Asbestos Cement flue pipe			
Asbestos Content:	Result Based on:			
Chrysotile	Analysis of sample using PLM			
Sample Analysed By: Reg 13(1)	Extent:	4 linear metres		
Comments: Textile rope seal internally to smaller flue

Material Assessment Total Score: 4		Likelihood of Disturbance Assessment Total Score: 4		Management Assessment Licensable: No Recommendations: Program removal Reinspection Interval: Not Applicable Overall Risk Category: C8
Product Type:	1 (Asbestos cement)	Location:	2 (Rooms up to 100 sq m)	
Condition:	1 (Minor scratches)	Accessibility:	1 (Occasionally likely to be disturbed)	
Surface Treatment:	1 (Encapsulated asbestos cement)			
Asbestos Type:	1 (Chrysotile)	Extent Score:	1 (<10 sq m or 10m pipe run)

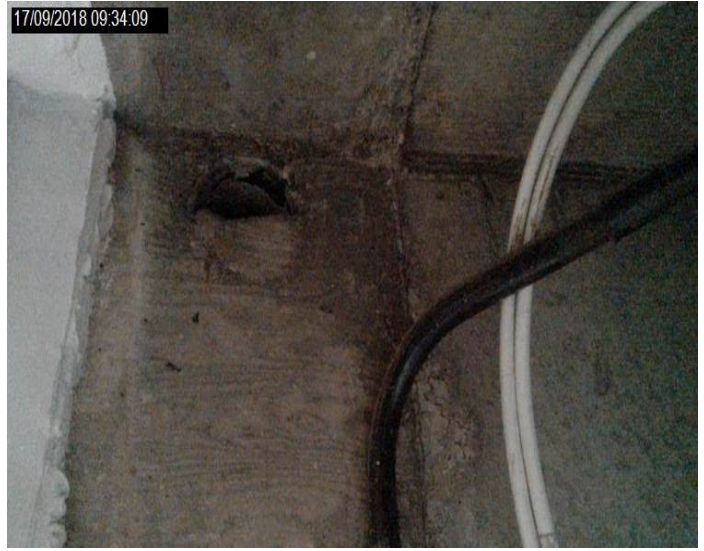
Location:	NBA412	Block:	Birmingham City University	Floor Level: 4th Floor
Sample No.:	DU002435	Portal Ref No.:	365

Item:	Asbestos Reinforced plastic sleeve			
Asbestos Content:	Result Based on:			
Chrysotile	Analysis of sample using PLM			
Sample Analysed By:	Reg 13(1)	Extent:	3 units	
Comments:

Material Assessment Total Score: 3		Likelihood of Disturbance Assessment Total Score: 3		Management Assessment Licensable: No Recommendations: Program removal Reinspection Interval: Not Applicable Overall Risk Category: D6
Product Type:	1 (Asbestos reinforced plastic)	Location:	2 (Rooms up to 100 sq m)	
Condition:	1 (Minor scratches)	Accessibility:	0 (Usually inaccessible or unlikely to be disturbed)	
Surface Treatment:	0 (Composite material)			
Asbestos Type:	1 (Chrysotile)	Extent Score:	1 (<10 sq m or 10m pipe run)

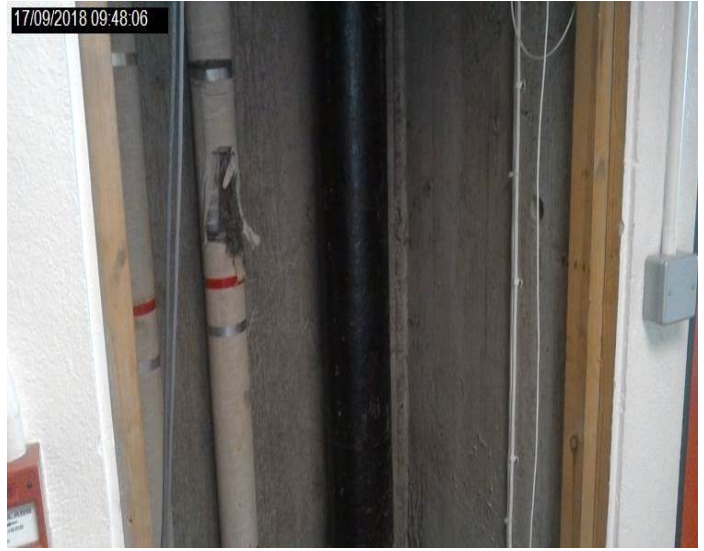
Location:	NBA412A Service duct	Block:	Birmingham City University	Floor Level: 4th Floor
Sample No.:	As DU002423	Portal Ref No.:	368

Item:	Asbestos Reinforced plastic downpipe			
Asbestos Content:	Result Based on:			
Chrysotile	Strongly presumed			
Sample Analysed By:	Not applicable	Extent:	3 linear metres	
Comments:

Material Assessment Total Score: 3		Likelihood of Disturbance Assessment Total Score: 4		Management Assessment Licensable: No Recommendations: Program removal Reinspection Interval: Not Applicable Overall Risk Category: C7
Product Type:	1 (Asbestos reinforced plastic)	Location:	2 (Rooms up to 100 sq m)	
Condition:	1 (Minor scratches)	Accessibility:	1 (Occasionally likely to be disturbed)	
Surface Treatment:	0 (Composite material)			
Asbestos Type:	1 (Chrysotile)	Extent Score:	1 (<10 sq m or 10m pipe run)

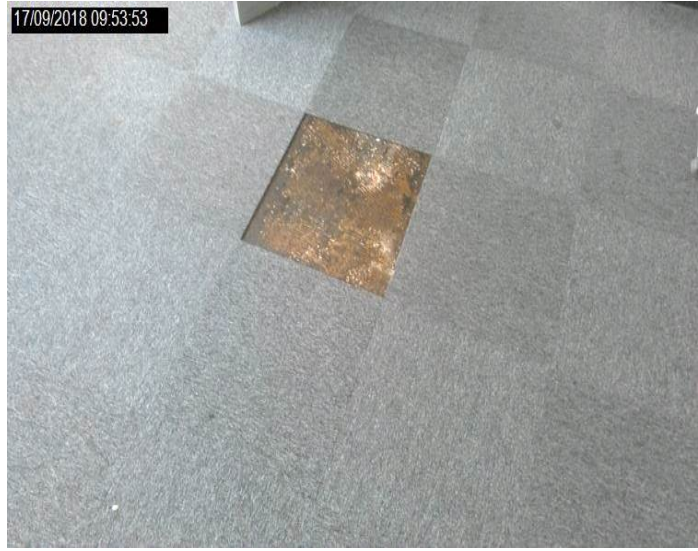
Location:	NBA413	Block:	Birmingham City University	Floor Level: 4th Floor
Sample No.:	As DU002436	Portal Ref No.:	369

Item:	Asbestos Bitumen adhesive			
Asbestos Content:	Result Based on:			
Chrysotile	Strongly presumed			
Sample Analysed By:	Not applicable	Extent:	24 m ²	
Comments:

Material Assessment Total Score: 3		Likelihood of Disturbance Assessment Total Score: 4		Management Assessment Licensable: No Recommendations: Program removal Reinspection Interval: Not Applicable Overall Risk Category: C7
Product Type:	1 (Asbestos bitumen)	Location:	2 (Rooms up to 100 sq m)	
Condition:	1 (Minor scratches)	Accessibility:	0 (Usually inaccessible or unlikely to be disturbed)	
Surface Treatment:	0 (Composite material)			
Asbestos Type:	1 (Chrysotile)	Extent Score:	2 (>10 - <50 sq m or >10m - <50m pipe run)

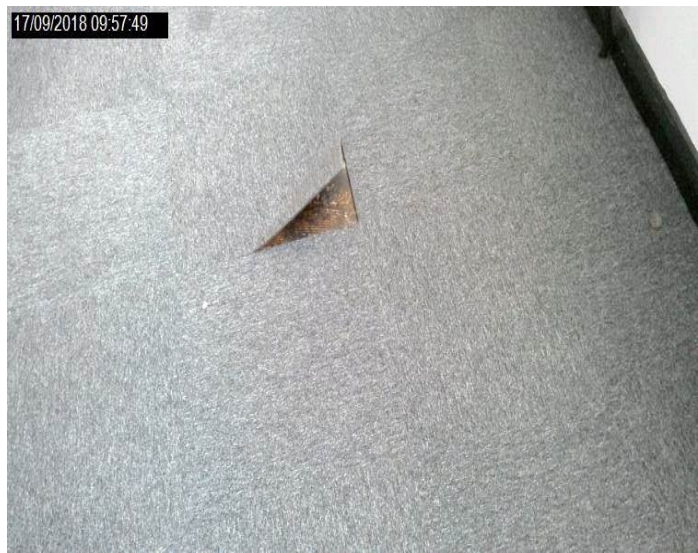
Location:	NBA414	Block:	Birmingham City University	Floor Level: 4th Floor
Sample No.:	As DU002436	Portal Ref No.:	371

Item:	Asbestos Bitumen adhesive			
Asbestos Content:	Result Based on:			
Chrysotile	Strongly presumed			
Sample Analysed By:	Not applicable	Extent:	20 m ²	
Comments:

Material Assessment Total Score: 3		Likelihood of Disturbance Assessment Total Score: 4		Management Assessment Licensable: No Recommendations: Program removal Reinspection Interval: Not Applicable Overall Risk Category: C7
Product Type:	1 (Asbestos bitumen)	Location:	2 (Rooms up to 100 sq m)	
Condition:	1 (Minor scratches)	Accessibility:	0 (Usually inaccessible or unlikely to be disturbed)	
Surface Treatment:	0 (Composite material)			
Asbestos Type:	1 (Chrysotile)	Extent Score:	2 (>10 - <50 sq m or >10m - <50m pipe run)

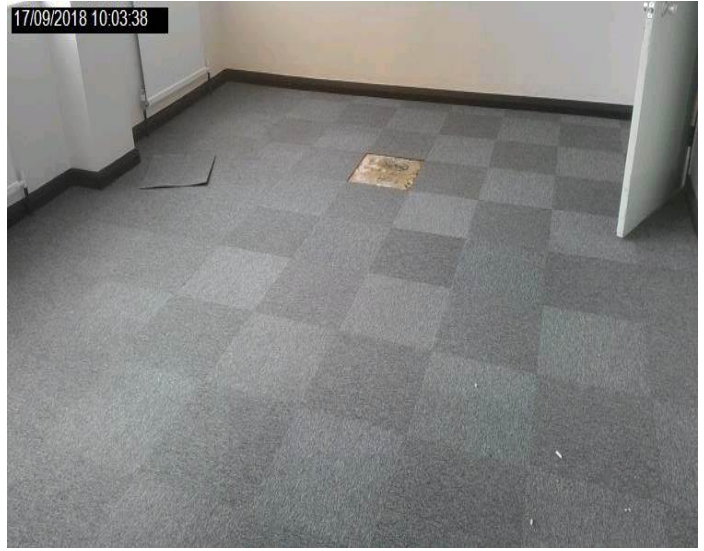
Location:	NBA415	Block:	Birmingham City University	Floor Level: 4th Floor
Sample No.:	As DU002436	Portal Ref No.:	374

Item:	Asbestos Bitumen adhesive			
Asbestos Content:	Result Based on:			
Chrysotile	Strongly presumed			
Sample Analysed By:	Not applicable	Extent:	25 m ²	
Comments:

Material Assessment Total Score: 3		Likelihood of Disturbance Assessment Total Score: 4		Management Assessment Licensable: No Recommendations: Program removal Reinspection Interval: Not Applicable Overall Risk Category: C7
Product Type:	1 (Asbestos bitumen)	Location:	2 (Rooms up to 100 sq m)	
Condition:	1 (Minor scratches)	Accessibility:	0 (Usually inaccessible or unlikely to be disturbed)	
Surface Treatment:	0 (Composite material)			
Asbestos Type:	1 (Chrysotile)	Extent Score:	2 (>10 - <50 sq m or >10m - <50m pipe run)

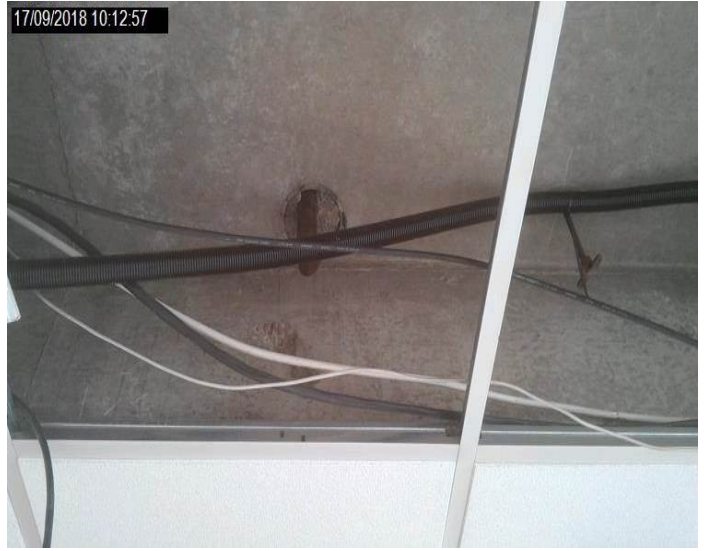
Location:	NBA499A Corridor	Block:	Birmingham City University	Floor Level: 4th Floor
Sample No.:	As DU002435	Portal Ref No.:	376

Item:	Asbestos Reinforced plastic sleeve			
Asbestos Content:	Result Based on:			
Chrysotile	Strongly presumed			
Sample Analysed By:	Not applicable	Extent:	16 units	
Comments: Structural columns between rooms and corridor, sleeve also seen to pass through the ceiling

Material Assessment Total Score: 3		Likelihood of Disturbance Assessment Total Score: 3		Management Assessment Licensable: No Recommendations: Program removal Reinspection Interval: Not Applicable Overall Risk Category: D6
Product Type:	1 (Asbestos reinforced plastic)	Location:	2 (Rooms up to 100 sq m)	
Condition:	1 (Minor scratches)	Accessibility:	0 (Usually inaccessible or unlikely to be disturbed)	
Surface Treatment:	0 (Composite material)			
Asbestos Type:	1 (Chrysotile)	Extent Score:	1 (<10 sq m or 10m pipe run)

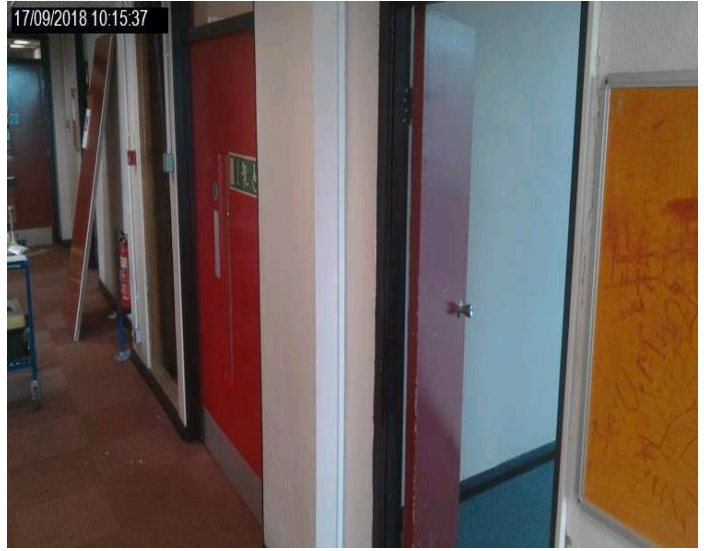
Location:	NBA499A Corridor	Block:	Birmingham City University	Floor Level: 4th Floor
Sample No.:	DU002438	Portal Ref No.:	377

Item:	Textured coating to concrete			
Asbestos Content:		Result Based on:		
No Asbestos Detected		Analysis of sample using PLM		
Sample Analysed By:	Reg 13(1)	Extent:	20 m ²	
Comments:

Material Assessment Total Score: 0		Likelihood of Disturbance Assessment Total Score: 0		Management Assessment Licensable: No Recommendations: Not Applicable Reinspection Interval: Not Applicable Overall Risk Category: E0
Product Type:	0 Not Applicable	Location:	0 Not Applicable	
Condition:	0 Not Applicable	Accessibility:	0 Not Applicable	
Surface Treatment:	0 Not Applicable			
Asbestos Type:	0 Not Applicable	Extent Score:	0 Not Applicable

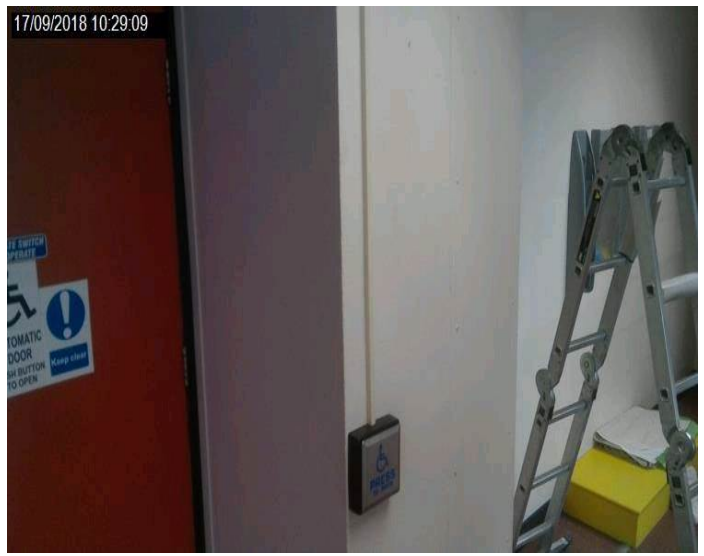
Location:	NBA499B Corridor	Block:	Birmingham City University	Floor Level: 4th Floor
Sample No.:	As DU002438	Portal Ref No.:	381

Item:	Textured coating to concrete sections			
Asbestos Content:		Result Based on:		
No Asbestos Detected		Strongly presumed		
Sample Analysed By:	Not applicable	Extent:	18 m ²	
Comments: To concrete sections

Material Assessment Total Score: 0		Likelihood of Disturbance Assessment Total Score: 0		Management Assessment Licensable: No Recommendations: Not Applicable Reinspection Interval: Not Applicable Overall Risk Category: E0
Product Type:	0 Not Applicable	Location:	0 Not Applicable	
Condition:	0 Not Applicable	Accessibility:	0 Not Applicable	
Surface Treatment:	0 Not Applicable			
Asbestos Type:	0 Not Applicable	Extent Score:	0 Not Applicable

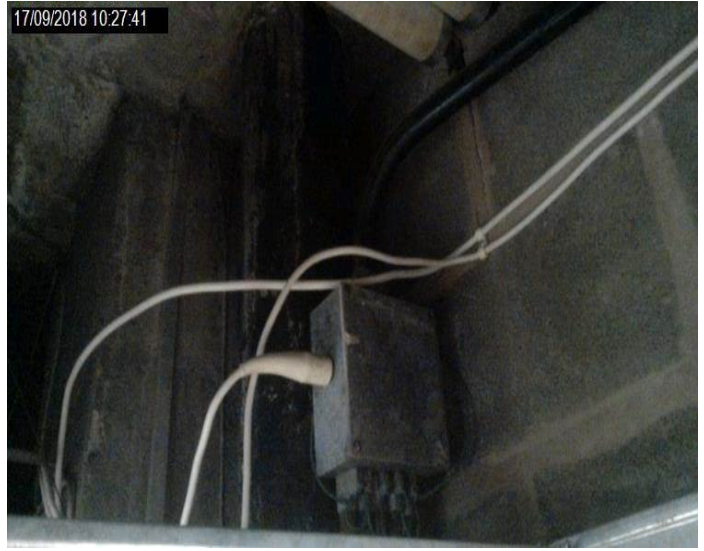
Location:	NBA499B Corridor	Block:	Birmingham City University	Floor Level: 4th Floor
Sample No.:	As DU002423	Portal Ref No.:	382

Item:	Asbestos Reinforced plastic downpipe			
Asbestos Content:	Result Based on:			
Chrysotile	Strongly presumed			
Sample Analysed By:	Not applicable	Extent:	3 linear metres	
Comments: Adjacent to lift

Material Assessment Total Score: 3		Likelihood of Disturbance Assessment Total Score: 3		Management Assessment Licensable: No Recommendations: Program removal Reinspection Interval: Not Applicable Overall Risk Category: D6
Product Type:	1 (Asbestos reinforced plastic)	Location:	2 (Rooms up to 100 sq m)	
Condition:	1 (Minor scratches)	Accessibility:	0 (Usually inaccessible or unlikely to be disturbed)	
Surface Treatment:	0 (Composite material)			
Asbestos Type:	1 (Chrysotile)	Extent Score:	1 (<10 sq m or 10m pipe run)

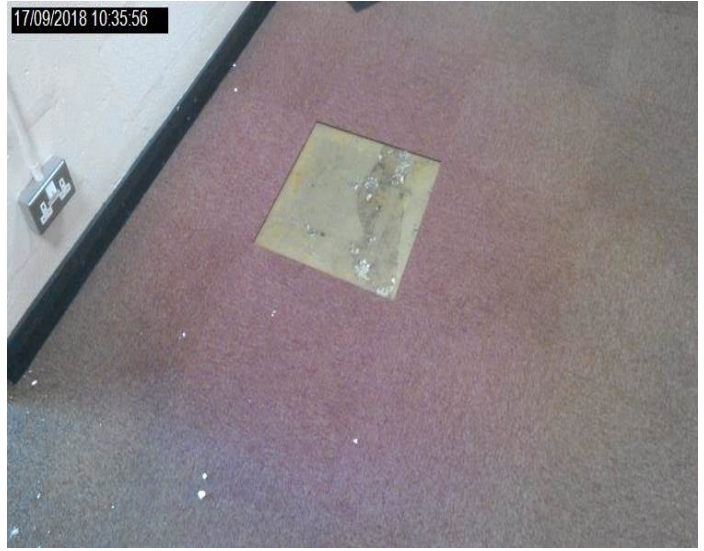
Location:	NBA499C Corridor	Block:	Birmingham City University	Floor Level: 4th Floor
Sample No.:	As DU002437	Portal Ref No.:	384

Item:	Asbestos Bitumen adhesive			
Asbestos Content:	Result Based on:			
Chrysotile	Strongly presumed			
Sample Analysed By:	Not applicable	Extent:	40 m ²	
Comments:

Material Assessment Total Score: 3		Likelihood of Disturbance Assessment Total Score: 5		Management Assessment Licensable: No Recommendations: Program removal Reinspection Interval: Not Applicable Overall Risk Category: C8
Product Type:	1 (Asbestos bitumen)	Location:	2 (Rooms up to 100 sq m)	
Condition:	1 (Minor scratches)	Accessibility:	1 (Occasionally likely to be disturbed)	
Surface Treatment:	0 (Composite material)			
Asbestos Type:	1 (Chrysotile)	Extent Score:	2 (>10 - <50 sq m or >10m - <50m pipe run)

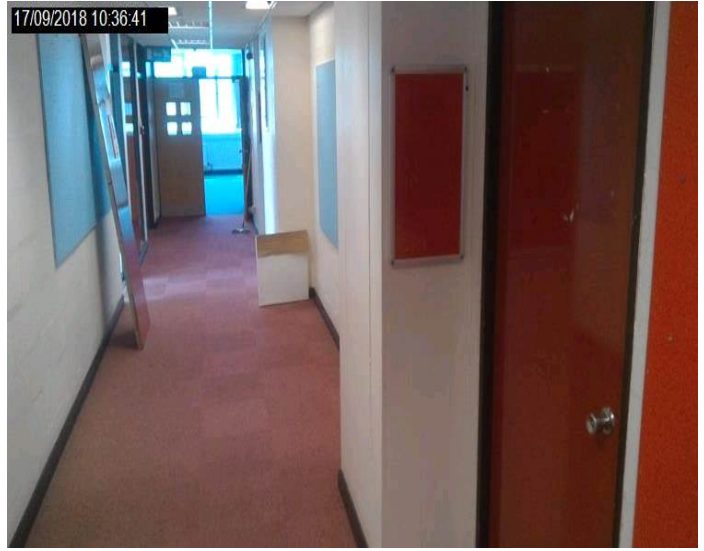
Location:	NBA499C Corridor	Block:	Birmingham City University	Floor Level: 4th Floor
Sample No.:	As DU002438	Portal Ref No.:	385

Item:	Textured coating to concrete sections			
Asbestos Content:		Result Based on:		
No Asbestos Detected		Strongly presumed		
Sample Analysed By:	Not applicable	Extent:	30 m ²	
Comments:

Material Assessment Total Score: 0		Likelihood of Disturbance Assessment Total Score: 0		Management Assessment Licensable: No Recommendations: Not Applicable Reinspection Interval: Not Applicable Overall Risk Category: E0
Product Type:	0 Not Applicable	Location:	0 Not Applicable	
Condition:	0 Not Applicable	Accessibility:	0 Not Applicable	
Surface Treatment:	0 Not Applicable			
Asbestos Type:	0 Not Applicable	Extent Score:	0 Not Applicable
