Report No.: J102748
Nature of Work: Demolition Survey
Issue Date: 31/10/2018
Client Name: WYG Engineering Ltd
Geneva Building, Lake View Drive, Sherwood Business Park,
Annesley, Nottingham, NG15 0ED
Site Address: Baker Building, Former City North Campus, Birmingham City
University, Perry Barr, B42 2US

A demolition survey in line with HSG264 Asbestos: The Survey Guide was carried out internally and externally to the property.

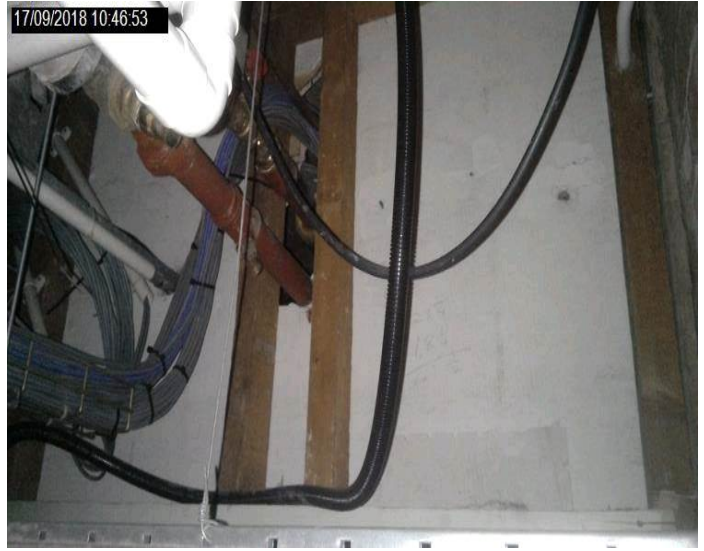
Location:	NBA499C Corridor	Block:	Birmingham City University	Floor Level: 4th Floor
Sample No.:	DU002440	Portal Ref No.:	386

Item:	Asbestos Insulating board firebreak			
Asbestos Content:	Result Based on:			
Chrysotile Amosite	Analysis of sample using PLM			
Sample Analysed By: Reg 13(1)	Extent:	2 m ²		
Comments: Within ceiling void adjacent to stairwell NBA400, item in poor condition

Material Assessment Total Score: 8		Likelihood of Disturbance Assessment Total Score: 4		Management Assessment Licensable: Yes Recommendations: Program removal Reinspection Interval: Not Applicable Overall Risk Category: B12
Product Type:	2 (Asbestos insulating board)	Location:	2 (Rooms up to 100 sq m)	
Condition:	2 (Local damage)	Accessibility:	1 (Occasionally likely to be disturbed)	
Surface Treatment:	2 (Unencapsulated asbestos insulating board)			
Asbestos Type:	2 (Chrysotile Amosite)	Extent Score:	1 (<10 sq m or 10m pipe run)

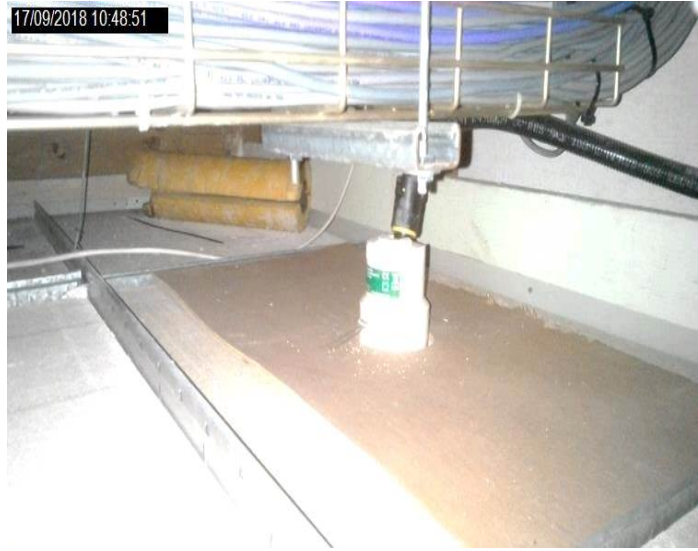
Location:	NBA499C Corridor	Block:	Birmingham City University	Floor Level: 4th Floor
Sample No.:	DU002441	Portal Ref No.:	387

Item:	Asbestos Insulating board debris			
Asbestos Content:	Result Based on:			
Chrysotile Amosite	Analysis of sample using PLM			
Sample Analysed By: Reg 13(1)	Extent:	1 m ²		
Comments: Associated debris from badly damaged firebreak

Material Assessment Total Score: 9		Likelihood of Disturbance Assessment Total Score: 5		Management Assessment Licensable: Yes Recommendations: Program removal Reinspection Interval: Not Applicable Overall Risk Category: B14
Product Type:	2 (Asbestos insulating board)	Location:	2 (Rooms up to 100 sq m)	
Condition:	3 (Significant damage)	Accessibility:	2 (Easily disturbed)	
Surface Treatment:	2 (Unencapsulated asbestos insulating board)			
Asbestos Type:	2 (Chrysotile Amosite)	Extent Score:	1 (<10 sq m or 10m pipe run)

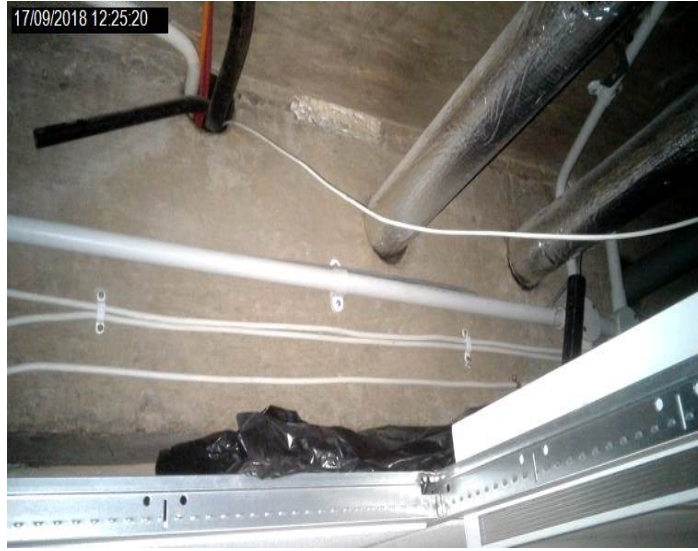
Location:	NBA325	Block:	Birmingham City University	Floor Level: 3rd Floor
Sample No.:	DU002442	Portal Ref No.:	388

Item:	Asbestos Reinforced plastic sleeve			
Asbestos Content:	Result Based on:			
Chrysotile	Analysis of sample using PLM			
Sample Analysed By: Reg 13(1)	Extent:	12 units		
Comments: Through the structural concrete

Material Assessment Total Score: 3		Likelihood of Disturbance Assessment Total Score: 3		Management Assessment Licensable: No Recommendations: Program removal Reinspection Interval: Not Applicable Overall Risk Category: D6
Product Type:	1 (Asbestos reinforced plastic)	Location:	2 (Rooms up to 100 sq m)	
Condition:	1 (Minor scratches)	Accessibility:	0 (Usually inaccessible or unlikely to be disturbed)	
Surface Treatment:	0 (Composite material)			
Asbestos Type:	1 (Chrysotile)	Extent Score:	1 (<10 sq m or 10m pipe run)

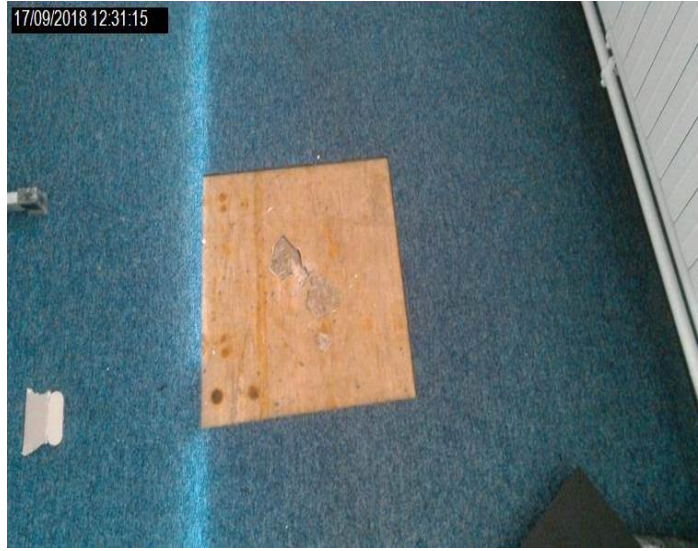
Location:	NBA325A	Block:	Birmingham City University	Floor Level: 3rd Floor
Sample No.:	As DU002443	Portal Ref No.:	391

Item:	Asbestos Bitumen adhesive			
Asbestos Content:	Result Based on:			
Chrysotile	Strongly presumed			
Sample Analysed By:	Not applicable	Extent:	8 m ²	
Comments:

Material Assessment Total Score: 3		Likelihood of Disturbance Assessment Total Score: 3		Management Assessment Licensable: No Recommendations: Program removal Reinspection Interval: Not Applicable Overall Risk Category: D6
Product Type:	1 (Asbestos bitumen)	Location:	2 (Rooms up to 100 sq m)	
Condition:	1 (Minor scratches)	Accessibility:	0 (Usually inaccessible or unlikely to be disturbed)	
Surface Treatment:	0 (Composite material)			
Asbestos Type:	1 (Chrysotile)	Extent Score:	1 (<10 sq m or 10m pipe run)

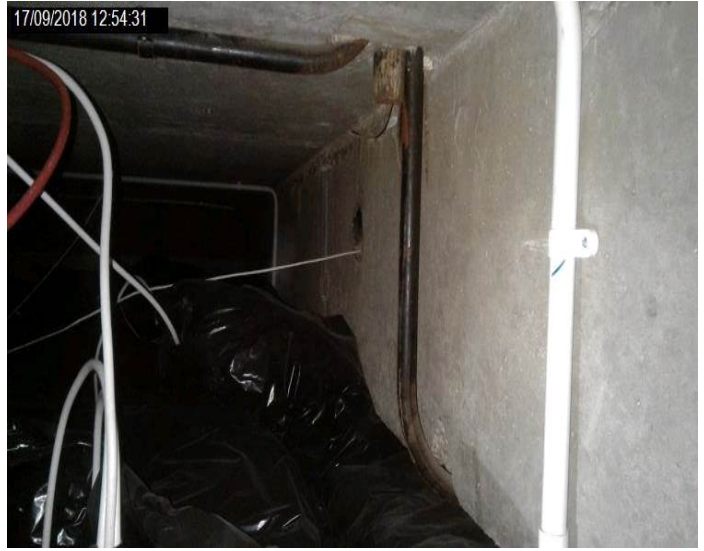
Location:	NBA301	Block:	Birmingham City University	Floor Level: 3rd Floor
Sample No.:	As DU002442	Portal Ref No.:	395

Item:	Asbestos Reinforced plastic sleeve			
Asbestos Content:	Result Based on:			
Chrysotile	Strongly presumed			
Sample Analysed By:	Not applicable	Extent:	12 units	
Comments: Through the structural concrete

Material Assessment Total Score: 3		Likelihood of Disturbance Assessment Total Score: 3		Management Assessment Licensable: No Recommendations: Program removal Reinspection Interval: Not Applicable Overall Risk Category: D6
Product Type:	1 (Asbestos reinforced plastic)	Location:	2 (Rooms up to 100 sq m)	
Condition:	1 (Minor scratches)	Accessibility:	0 (Usually inaccessible or unlikely to be disturbed)	
Surface Treatment:	0 (Composite material)			
Asbestos Type:	1 (Chrysotile)	Extent Score:	1 (<10 sq m or 10m pipe run)

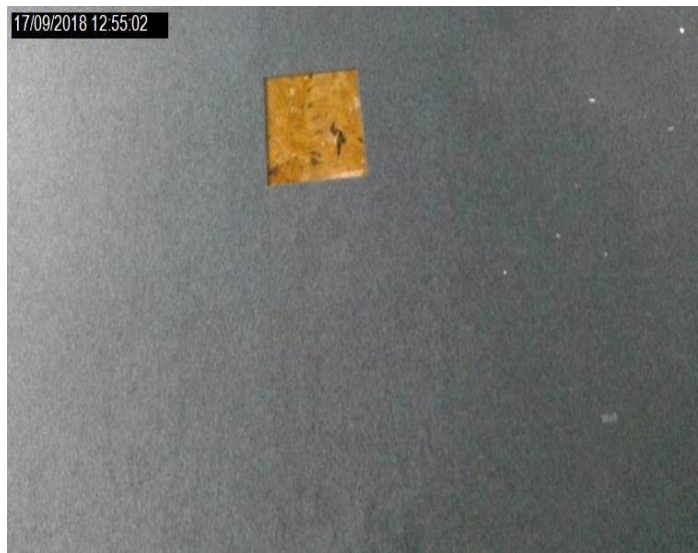
Location:	NBA301	Block:	Birmingham City University	Floor Level: 3rd Floor
Sample No.:	DU002444	Portal Ref No.:	396

Item:	Asbestos Thermoplastic floor tiles with bitumen adhesive			
Asbestos Content:	Result Based on:			
Chrysotile in tile and adhesive		Analysis of sample using PLM		
Sample Analysed By:	Reg 13(1)	Extent:	50 m ²	
Comments:

Material Assessment Total Score: 3		Likelihood of Disturbance Assessment Total Score: 5		Management Assessment Licensable: No Recommendations: Program removal Reinspection Interval: Not Applicable Overall Risk Category: C8
Product Type:	1 (Asbestos thermoplastic)	Location:	2 (Rooms up to 100 sq m)	
Condition:	1 (Minor scratches)	Accessibility:	0 (Usually inaccessible or unlikely to be disturbed)	
Surface Treatment:	0 (Composite material)			
Asbestos Type:	1 (Chrysotile)	Extent Score:	3 (>50 sq m or >50m pipe run)

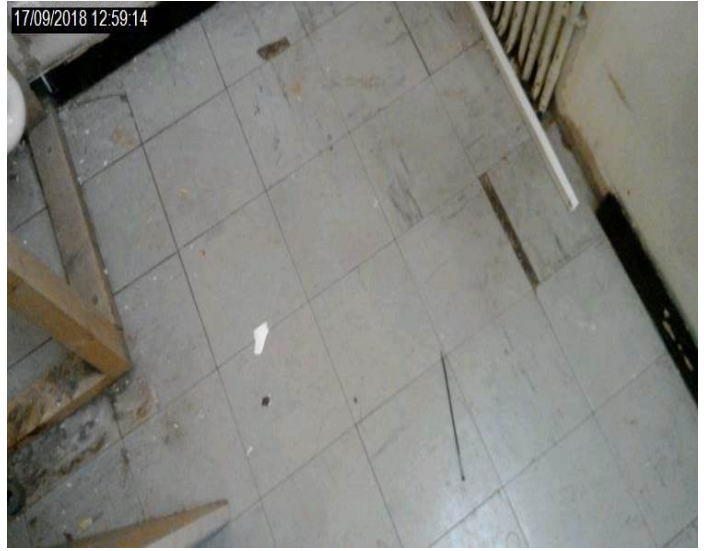
Location:	NBA326A	Block:	Birmingham City University	Floor Level: 3rd Floor
Sample No.:	DU002445	Portal Ref No.:	397

Item:	Asbestos Thermoplastic floor tiles with bitumen adhesive			
Asbestos Content:	Result Based on:			
Chrysotile in tile and adhesive	Analysis of sample using PLM			
Sample Analysed By: Reg 13(1)	Extent:	4 m ²		
Comments:

Material Assessment Total Score: 3		Likelihood of Disturbance Assessment Total Score: 3		Management Assessment Licensable: No Recommendations: Program removal Reinspection Interval: Not Applicable Overall Risk Category: D6
Product Type:	1 (Asbestos thermoplastic)	Location:	2 (Rooms up to 100 sq m)	
Condition:	1 (Minor scratches)	Accessibility:	0 (Usually inaccessible or unlikely to be disturbed)	
Surface Treatment:	0 (Composite material)			
Asbestos Type:	1 (Chrysotile)	Extent Score:	1 (<10 sq m or 10m pipe run)

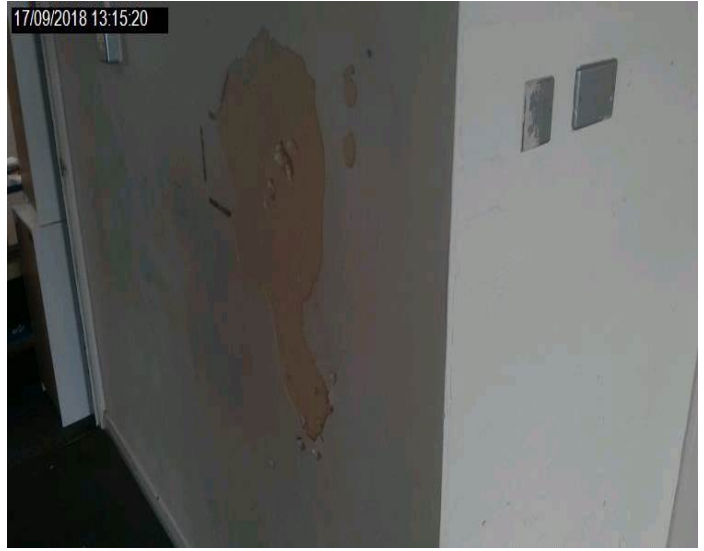
Location:	NBA303	Block:	Birmingham City University	Floor Level: 3rd Floor
Sample No.:	DU002447	Portal Ref No.:	399

Item:	Textured coating to concrete			
Asbestos Content:		Result Based on:		
No Asbestos Detected		Analysis of sample using PLM		
Sample Analysed By:	Reg 13(1)	Extent:	20 m ²	
Comments: Behind paint to concrete

Material Assessment Total Score: 0		Likelihood of Disturbance Assessment Total Score: 0		Management Assessment Licensable: No Recommendations: Not Applicable Reinspection Interval: Not Applicable Overall Risk Category: E0
Product Type:	0 Not Applicable	Location:	0 Not Applicable	
Condition:	0 Not Applicable	Accessibility:	0 Not Applicable	
Surface Treatment:	0 Not Applicable			
Asbestos Type:	0 Not Applicable	Extent Score:	0 Not Applicable

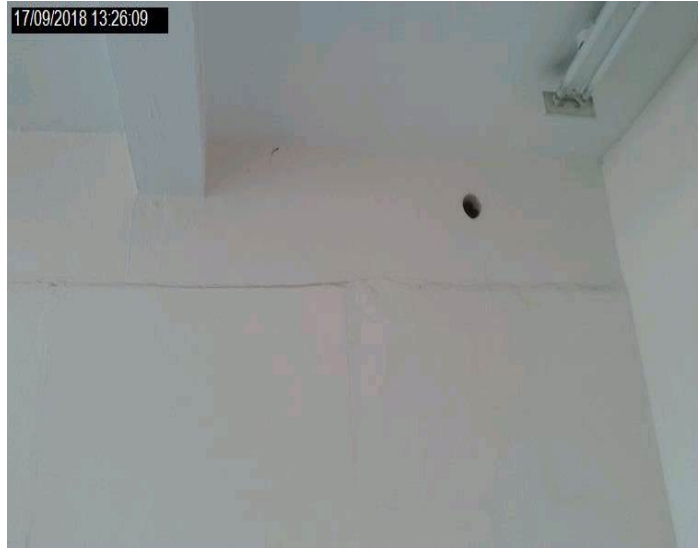
Location:	NBA303	Block:	Birmingham City University	Floor Level: 3rd Floor
Sample No.:	As DU002442	Portal Ref No.:	400

Item:	Asbestos Reinforced plastic sleeve			
Asbestos Content:	Result Based on:			
Chrysotile	Strongly presumed			
Sample Analysed By:	Not applicable	Extent:	3 units	
Comments: Through the structural concrete

Material Assessment Total Score: 3		Likelihood of Disturbance Assessment Total Score: 3		Management Assessment Licensable: No Recommendations: Program removal Reinspection Interval: Not Applicable Overall Risk Category: D6
Product Type:	1 (Asbestos reinforced plastic)	Location:	2 (Rooms up to 100 sq m)	
Condition:	1 (Minor scratches)	Accessibility:	0 (Usually inaccessible or unlikely to be disturbed)	
Surface Treatment:	0 (Composite material)			
Asbestos Type:	1 (Chrysotile)	Extent Score:	1 (<10 sq m or 10m pipe run)

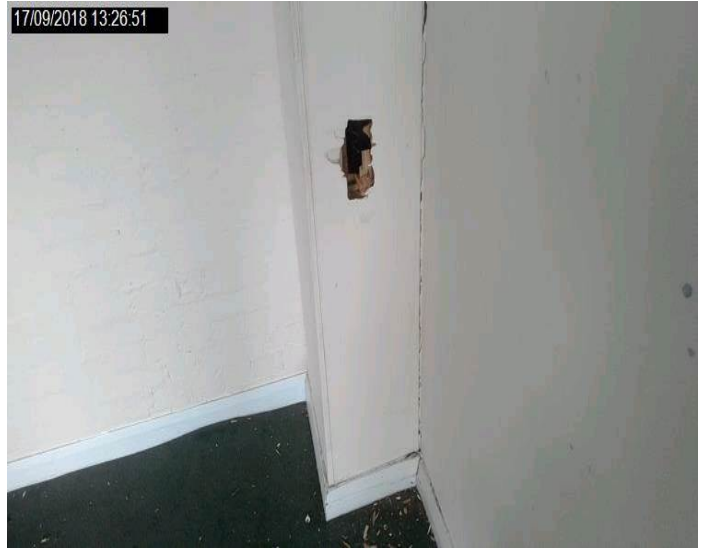
Location:	NBA303	Block:	Birmingham City University	Floor Level: 3rd Floor
Sample No.:	As DU002446	Portal Ref No.:	401

Item:	Asbestos Reinforced plastic downpipe			
Asbestos Content:	Result Based on:			
Chrysotile	Strongly presumed			
Sample Analysed By:	Not applicable	Extent:	3 linear metres	
Comments:

Material Assessment Total Score: 3		Likelihood of Disturbance Assessment Total Score: 4		Management Assessment Licensable: No Recommendations: Program removal Reinspection Interval: Not Applicable Overall Risk Category: C7
Product Type:	1 (Asbestos reinforced plastic)	Location:	2 (Rooms up to 100 sq m)	
Condition:	1 (Minor scratches)	Accessibility:	1 (Occasionally likely to be disturbed)	
Surface Treatment:	0 (Composite material)			
Asbestos Type:	1 (Chrysotile)	Extent Score:	1 (<10 sq m or 10m pipe run)

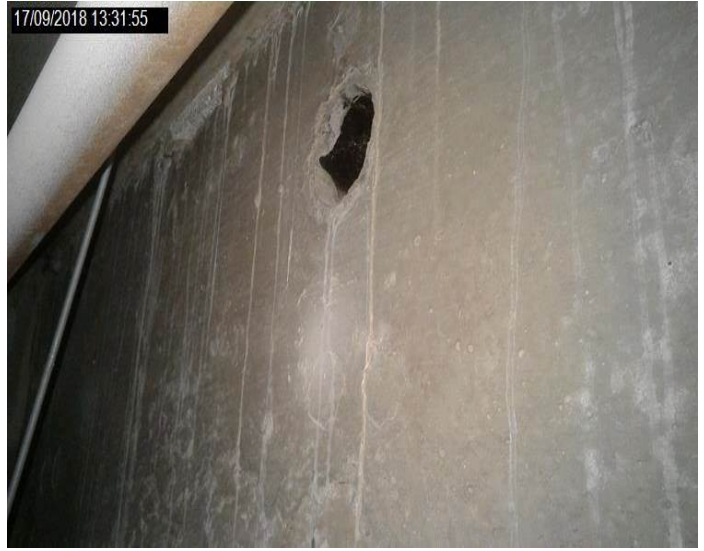
Location:	NBA303B	Block:	Birmingham City University	Floor Level: 3rd Floor
Sample No.:	As DU002442	Portal Ref No.:	404

Item:	Asbestos Reinforced plastic sleeve			
Asbestos Content:	Result Based on:			
Chrysotile	Strongly presumed			
Sample Analysed By:	Not applicable	Extent:	2 units	
Comments: Through the structural concrete

Material Assessment Total Score: 3		Likelihood of Disturbance Assessment Total Score: 3		Management Assessment Licensable: No Recommendations: Program removal Reinspection Interval: Not Applicable Overall Risk Category: D6
Product Type:	1 (Asbestos reinforced plastic)	Location:	2 (Rooms up to 100 sq m)	
Condition:	1 (Minor scratches)	Accessibility:	0 (Usually inaccessible or unlikely to be disturbed)	
Surface Treatment:	0 (Composite material)			
Asbestos Type:	1 (Chrysotile)	Extent Score:	1 (<10 sq m or 10m pipe run)

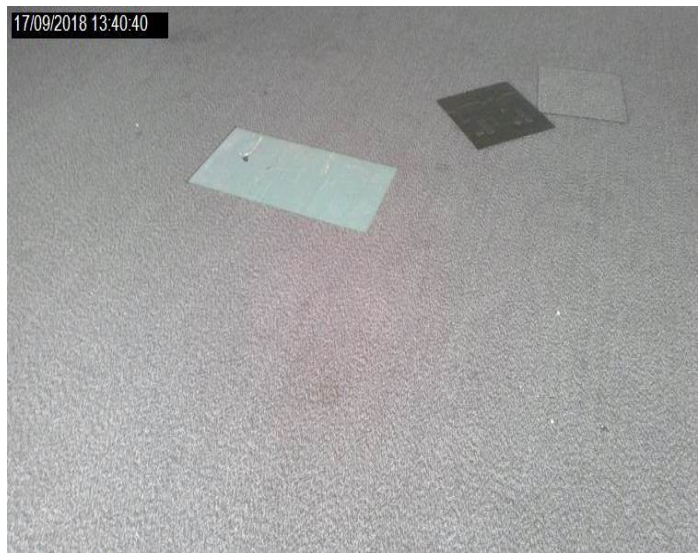
Location:	NBA323	Block:	Birmingham City University	Floor Level: 3rd Floor
Sample No.:	DU002450	Portal Ref No.:	407

Item:	Asbestos Thermoplastic floor tiles with bitumen adhesive			
Asbestos Content:	Result Based on:			
Chrysotile in tile and adhesive	Analysis of sample using PLM			
Sample Analysed By:	Reg 13(1)	Extent:	50 m ²	
Comments:

Material Assessment Total Score: 3		Likelihood of Disturbance Assessment Total Score: 5		Management Assessment Licensable: No Recommendations: Program removal Reinspection Interval: Not Applicable Overall Risk Category: C8
Product Type:	1 (Asbestos thermoplastic)	Location:	2 (Rooms up to 100 sq m)	
Condition:	1 (Minor scratches)	Accessibility:	0 (Usually inaccessible or unlikely to be disturbed)	
Surface Treatment:	0 (Composite material)			
Asbestos Type:	1 (Chrysotile)	Extent Score:	3 (>50 sq m or >50m pipe run)

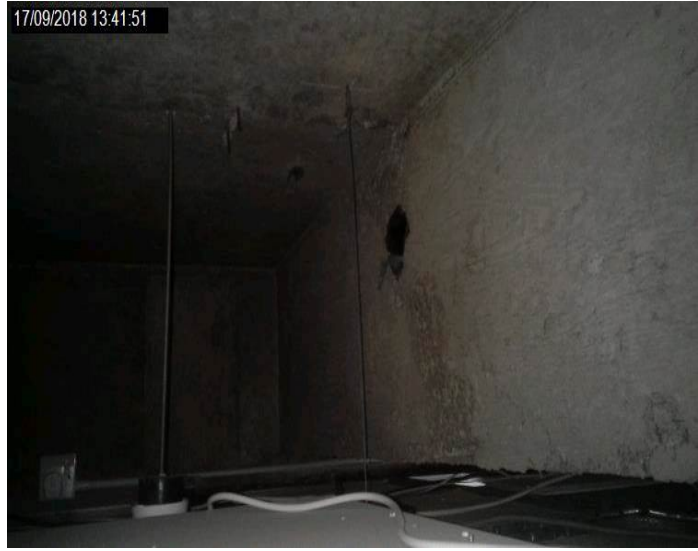
Location:	NBA323	Block:	Birmingham City University	Floor Level: 3rd Floor
Sample No.:	As DU002442	Portal Ref No.:	408

Item:	Asbestos Reinforced plastic sleeve			
Asbestos Content:	Result Based on:			
Chrysotile	Strongly presumed			
Sample Analysed By:	Not applicable	Extent:	1 unit	
Comments: Through the structural concrete

Material Assessment Total Score: 3		Likelihood of Disturbance Assessment Total Score: 3		Management Assessment Licensable: No Recommendations: Program removal Reinspection Interval: Not Applicable Overall Risk Category: D6
Product Type:	1 (Asbestos reinforced plastic)	Location:	2 (Rooms up to 100 sq m)	
Condition:	1 (Minor scratches)	Accessibility:	0 (Usually inaccessible or unlikely to be disturbed)	
Surface Treatment:	0 (Composite material)			
Asbestos Type:	1 (Chrysotile)	Extent Score:	1 (<10 sq m or 10m pipe run)

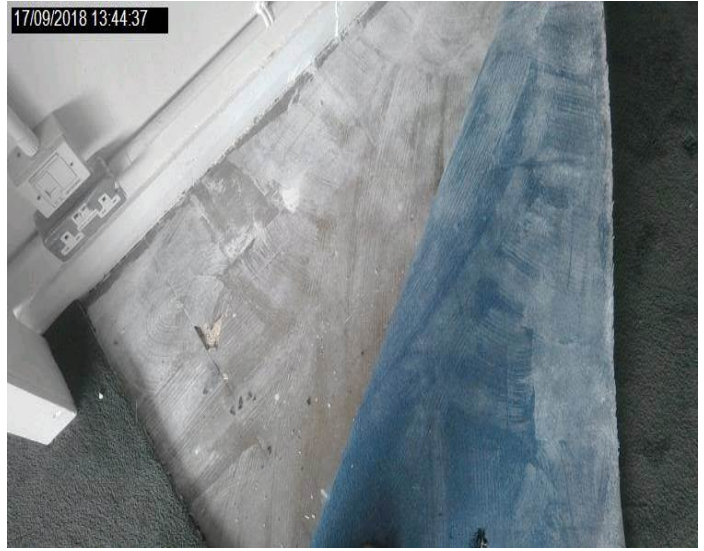
Location:	NBA305	Block:	Birmingham City University	Floor Level: 3rd Floor
Sample No.:	DU002451	Portal Ref No.:	412

Item:	Asbestos Thermoplastic floor tiles with bitumen adhesive			
Asbestos Content:	Result Based on:			
Chrysotile in tile and adhesive	Analysis of sample using PLM			
Sample Analysed By: Reg 13(1)	Extent:	40 m ²		
Comments:

Material Assessment Total Score: 3		Likelihood of Disturbance Assessment Total Score: 5		Management Assessment Licensable: No Recommendations: Program removal Reinspection Interval: Not Applicable Overall Risk Category: C8
Product Type:	1 (Asbestos thermoplastic)	Location:	2 (Rooms up to 100 sq m)	
Condition:	1 (Minor scratches)	Accessibility:	1 (Occasionally likely to be disturbed)	
Surface Treatment:	0 (Composite material)			
Asbestos Type:	1 (Chrysotile)	Extent Score:	2 (>10 - <50 sq m or >10m - <50m pipe run)

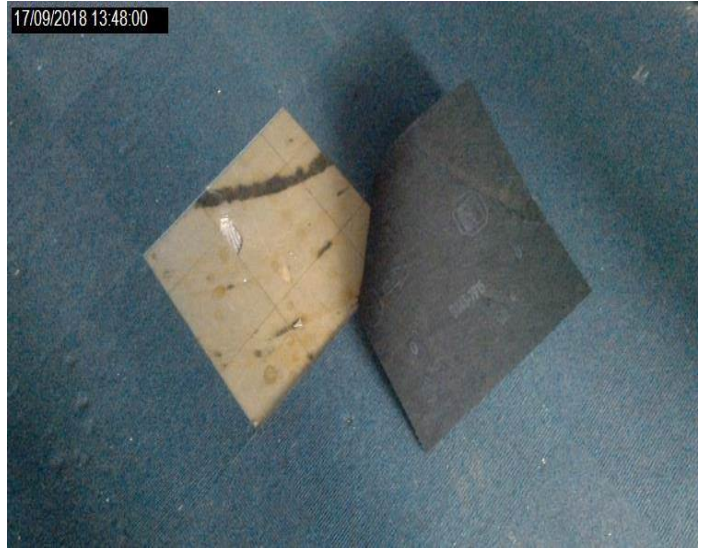
Location:	NBA306	Block:	Birmingham City University	Floor Level: 3rd Floor
Sample No.:	DU002452	Portal Ref No.:	414

Item:	Asbestos Thermoplastic floor tiles with bitumen adhesive			
Asbestos Content:	Result Based on:			
Chrysotile in tile and adhesive		Analysis of sample using PLM		
Sample Analysed By:	Reg 13(1)	Extent:	12 units	
Comments:

Material Assessment Total Score: 3		Likelihood of Disturbance Assessment Total Score: 5		Management Assessment Licensable: No Recommendations: Program removal Reinspection Interval: Not Applicable Overall Risk Category: C8
Product Type:	1 (Asbestos thermoplastic)	Location:	2 (Rooms up to 100 sq m)	
Condition:	1 (Minor scratches)	Accessibility:	1 (Occasionally likely to be disturbed)	
Surface Treatment:	0 (Composite material)			
Asbestos Type:	1 (Chrysotile)	Extent Score:	2 (>10 - <50 sq m or >10m - <50m pipe run)

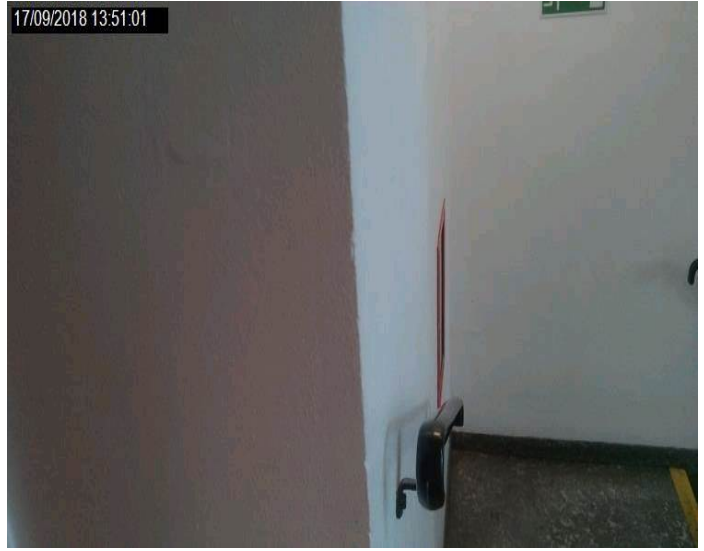
Location:	NBA300A Stairwell	Block:	Birmingham City University	Floor Level: 3rd Floor
Sample No.:	DU002453	Portal Ref No.:	415

Item:	Textured coating to concrete			
Asbestos Content:		Result Based on:		
No Asbestos Detected		Analysis of sample using PLM		
Sample Analysed By:	Reg 13(1)	Extent:	100 m ²	
Comments: To all walls

Material Assessment Total Score: 0		Likelihood of Disturbance Assessment Total Score: 0		Management Assessment Licensable: No Recommendations: Not Applicable Reinspection Interval: Not Applicable Overall Risk Category: E0
Product Type:	0 Not Applicable	Location:	0 Not Applicable	
Condition:	0 Not Applicable	Accessibility:	0 Not Applicable	
Surface Treatment:	0 Not Applicable			
Asbestos Type:	0 Not Applicable	Extent Score:	0 Not Applicable

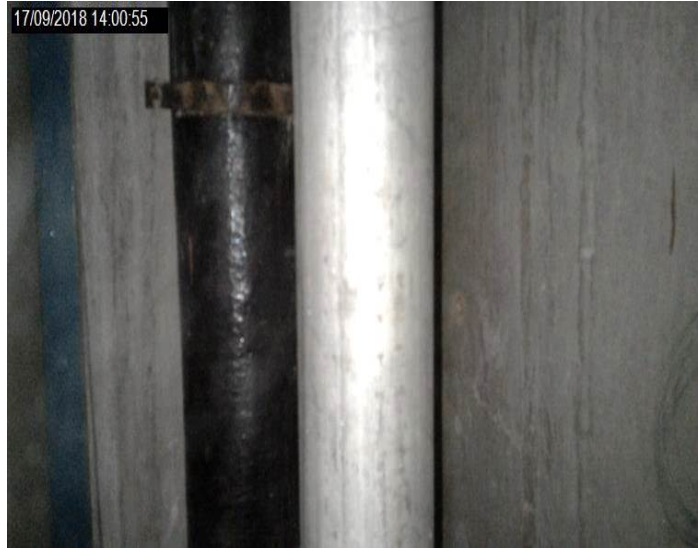
Location:	NBA306A Service duct	Block:	Birmingham City University	Floor Level: 3rd Floor
Sample No.:	As DU002446	Portal Ref No.:	417

Item:	Asbestos Reinforced plastic downpipe			
Asbestos Content:	Result Based on:			
Chrysotile	Strongly presumed			
Sample Analysed By:	Not applicable	Extent:	3 linear metres	
Comments:

Material Assessment Total Score: 3		Likelihood of Disturbance Assessment Total Score: 4		Management Assessment Licensable: No Recommendations: Program removal Reinspection Interval: Not Applicable Overall Risk Category: C7
Product Type:	1 (Asbestos reinforced plastic)	Location:	2 (Rooms up to 100 sq m)	
Condition:	1 (Minor scratches)	Accessibility:	1 (Occasionally likely to be disturbed)	
Surface Treatment:	0 (Composite material)			
Asbestos Type:	1 (Chrysotile)	Extent Score:	1 (<10 sq m or 10m pipe run)

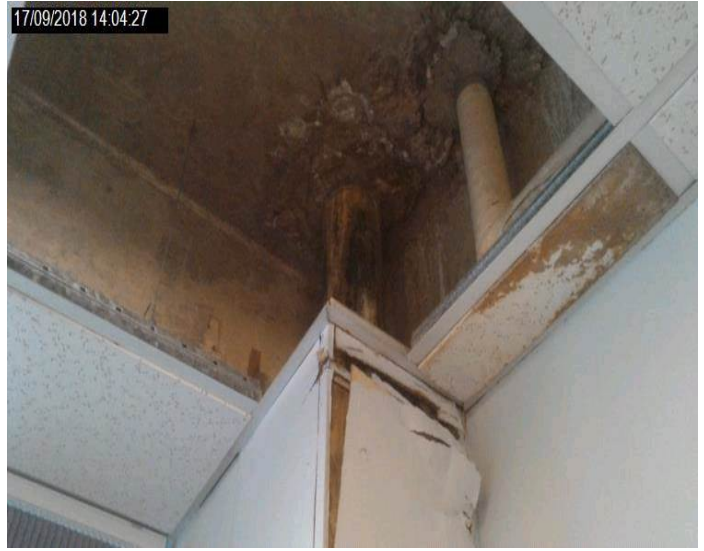
Location:	NBA322	Block:	Birmingham City University	Floor Level: 3rd Floor
Sample No.:	As DU002446	Portal Ref No.:	418

Item:	Asbestos Reinforced plastic downpipe			
Asbestos Content:	Result Based on:			
Chrysotile	Strongly presumed			
Sample Analysed By:	Not applicable	Extent:	3 linear metres	
Comments: Through the structural concrete

Material Assessment Total Score: 3		Likelihood of Disturbance Assessment Total Score: 3		Management Assessment Licensable: No Recommendations: Program removal Reinspection Interval: Not Applicable Overall Risk Category: D6
Product Type:	1 (Asbestos reinforced plastic)	Location:	2 (Rooms up to 100 sq m)	
Condition:	1 (Minor scratches)	Accessibility:	0 (Usually inaccessible or unlikely to be disturbed)	
Surface Treatment:	0 (Composite material)			
Asbestos Type:	1 (Chrysotile)	Extent Score:	1 (<10 sq m or 10m pipe run)

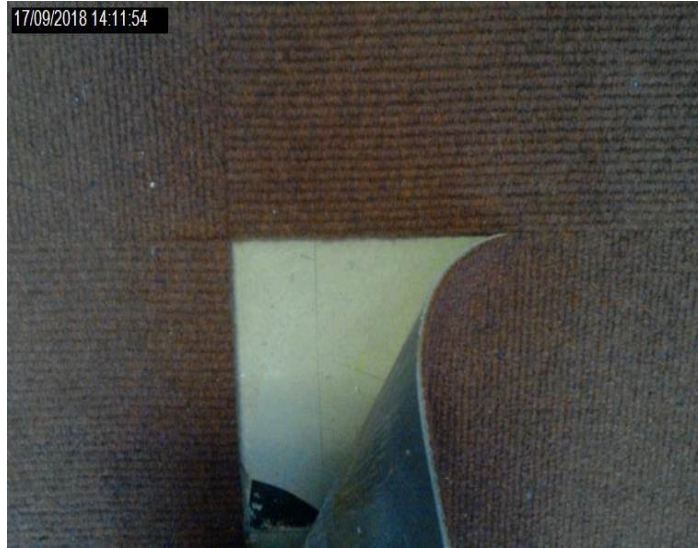
Location:	NBA320	Block:	Birmingham City University	Floor Level: 3rd Floor
Sample No.:	DU002455	Portal Ref No.:	423

Item:	Asbestos Thermoplastic floor tiles with bitumen adhesive			
Asbestos Content:	Result Based on:			
Chrysotile in tile and adhesive	Analysis of sample using PLM			
Sample Analysed By:	Reg 13(1)	Extent:	14 m ²	
Comments:

Material Assessment Total Score: 3		Likelihood of Disturbance Assessment Total Score: 5		Management Assessment Licensable: No Recommendations: Program removal Reinspection Interval: Not Applicable Overall Risk Category: C8
Product Type:	1 (Asbestos thermoplastic)	Location:	2 (Rooms up to 100 sq m)	
Condition:	1 (Minor scratches)	Accessibility:	1 (Occasionally likely to be disturbed)	
Surface Treatment:	0 (Composite material)			
Asbestos Type:	1 (Chrysotile)	Extent Score:	2 (>10 - <50 sq m or >10m - <50m pipe run)

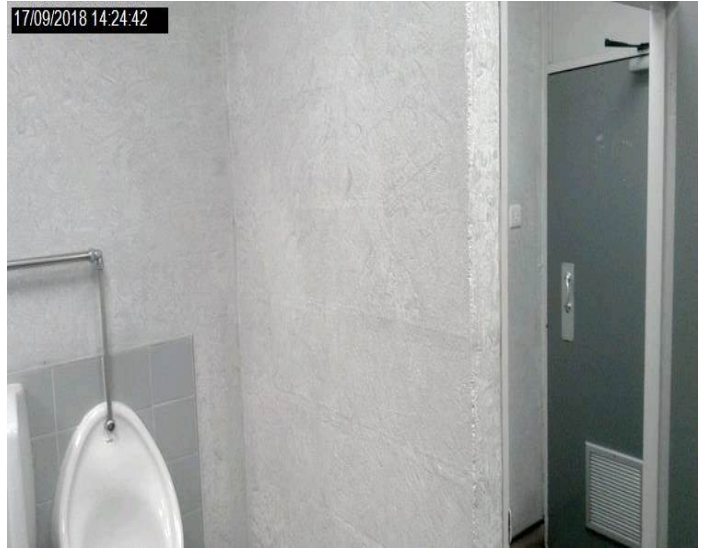
Location:	NBA319	Block:	Birmingham City University	Floor Level: 3rd Floor
Sample No.:	DU002456	Portal Ref No.:	427

Item:	Textured coating			
Asbestos Content:	Result Based on:			
No Asbestos Detected	Analysis of sample using PLM			
Sample Analysed By: Reg 13(1)	Extent:	45 m ²		
Comments: All walls

Material Assessment Total Score: 0		Likelihood of Disturbance Assessment Total Score: 0		Management Assessment Licensable: No Recommendations: Not Applicable Reinspection Interval: Not Applicable Overall Risk Category: E0
Product Type:	0 Not Applicable	Location:	0 Not Applicable	
Condition:	0 Not Applicable	Accessibility:	0 Not Applicable	
Surface Treatment:	0 Not Applicable			
Asbestos Type:	0 Not Applicable	Extent Score:	0 Not Applicable

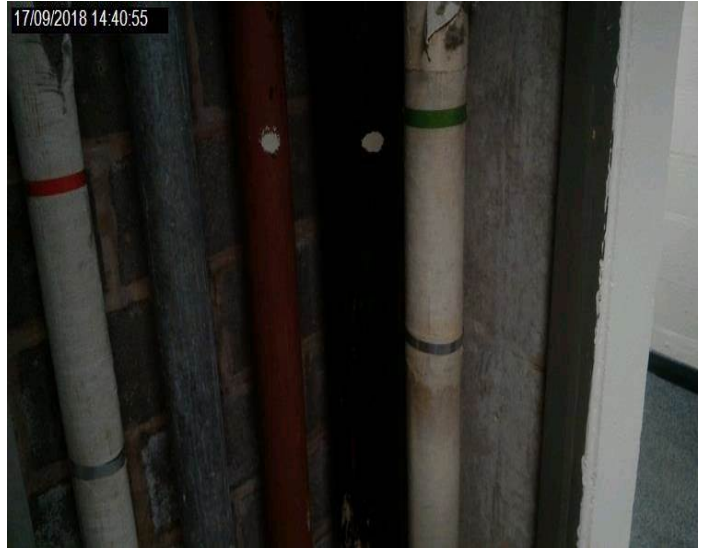
Location:	NBA312B Service duct	Block:	Birmingham City University	Floor Level: 3rd Floor
Sample No.:	As DU002446	Portal Ref No.:	433

Item:	Asbestos Reinforced plastic downpipe			
Asbestos Content:	Result Based on:			
Chrysotile	Strongly presumed			
Sample Analysed By:	Not applicable	Extent:	3 linear metres	
Comments:

Material Assessment Total Score: 3		Likelihood of Disturbance Assessment Total Score: 4		Management Assessment Licensable: No Recommendations: Program removal Reinspection Interval: Not Applicable Overall Risk Category: C7
Product Type:	1 (Asbestos reinforced plastic)	Location:	2 (Rooms up to 100 sq m)	
Condition:	1 (Minor scratches)	Accessibility:	1 (Occasionally likely to be disturbed)	
Surface Treatment:	0 (Composite material)			
Asbestos Type:	1 (Chrysotile)	Extent Score:	1 (<10 sq m or 10m pipe run)

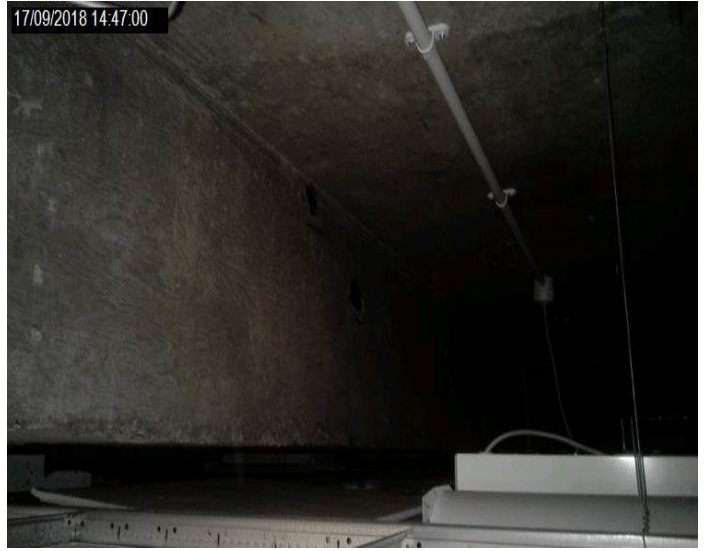
Location:	NBA307	Block:	Birmingham City University	Floor Level: 3rd Floor
Sample No.:	As DU002442	Portal Ref No.:	435

Item:	Asbestos Reinforced plastic sleeve			
Asbestos Content:	Result Based on:			
Chrysotile	Strongly presumed			
Sample Analysed By:	Not applicable	Extent:	6 units	
Comments: Through the structural concrete

Material Assessment Total Score: 3		Likelihood of Disturbance Assessment Total Score: 3		Management Assessment Licensable: No Recommendations: Program removal Reinspection Interval: Not Applicable Overall Risk Category: D6
Product Type:	1 (Asbestos reinforced plastic)	Location:	2 (Rooms up to 100 sq m)	
Condition:	1 (Minor scratches)	Accessibility:	0 (Usually inaccessible or unlikely to be disturbed)	
Surface Treatment:	0 (Composite material)			
Asbestos Type:	1 (Chrysotile)	Extent Score:	1 (<10 sq m or 10m pipe run)

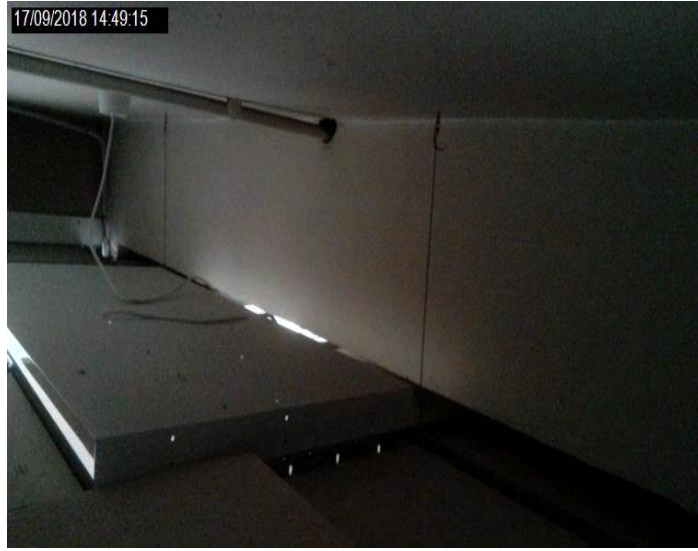
Location:	NBA308	Block:	Birmingham City University	Floor Level: 3rd Floor
Sample No.:	As DU002442	Portal Ref No.:	437

Item:	Asbestos Reinforced plastic sleeve			
Asbestos Content:	Result Based on:			
Chrysotile	Strongly presumed			
Sample Analysed By:	Not applicable	Extent:	1 unit	
Comments: Through the structural concrete

Material Assessment Total Score: 3		Likelihood of Disturbance Assessment Total Score: 3		Management Assessment Licensable: No Recommendations: Program removal Reinspection Interval: Not Applicable Overall Risk Category: D6
Product Type:	1 (Asbestos reinforced plastic)	Location:	2 (Rooms up to 100 sq m)	
Condition:	1 (Minor scratches)	Accessibility:	0 (Usually inaccessible or unlikely to be disturbed)	
Surface Treatment:	0 (Composite material)			
Asbestos Type:	1 (Chrysotile)	Extent Score:	1 (<10 sq m or 10m pipe run)

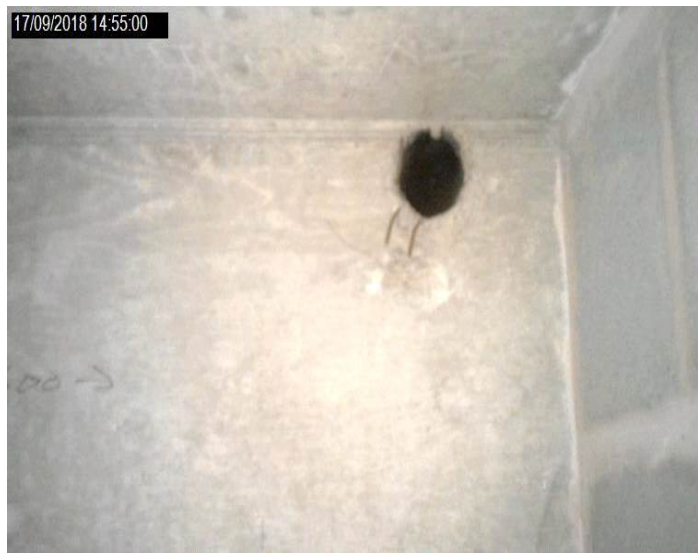
Location:	NBA399B Corridor	Block:	Birmingham City University	Floor Level: 3rd Floor
Sample No.:	As DU002442	Portal Ref No.:	440

Item:	Asbestos Reinforced plastic sleeve			
Asbestos Content:	Result Based on:			
Chrysotile	Strongly presumed			
Sample Analysed By:	Not applicable	Extent:	1 unit	
Comments: Through the structural concrete

Material Assessment Total Score: 3		Likelihood of Disturbance Assessment Total Score: 3		Management Assessment Licensable: No Recommendations: Program removal Reinspection Interval: Not Applicable Overall Risk Category: D6
Product Type:	1 (Asbestos reinforced plastic)	Location:	2 (Rooms up to 100 sq m)	
Condition:	1 (Minor scratches)	Accessibility:	0 (Usually inaccessible or unlikely to be disturbed)	
Surface Treatment:	0 (Composite material)			
Asbestos Type:	1 (Chrysotile)	Extent Score:	1 (<10 sq m or 10m pipe run)

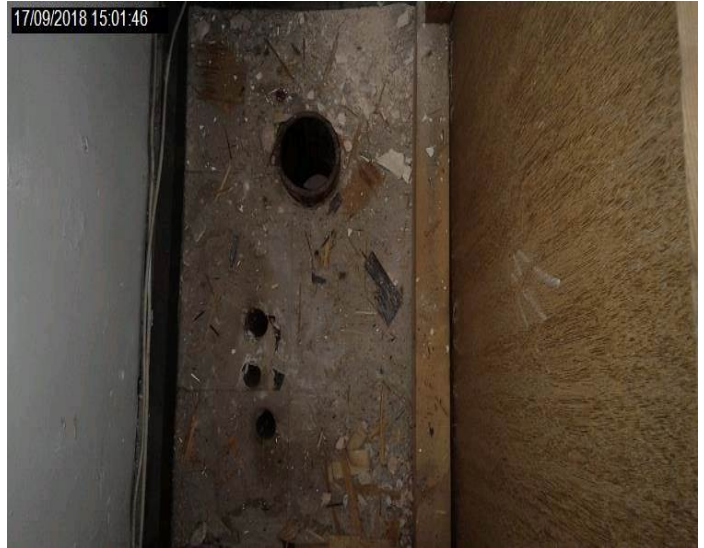
Location:	NBA309	Block:	Birmingham City University	Floor Level: 3rd Floor
Sample No.:	DU002458	Portal Ref No.:	443

Item:	Asbestos Thermoplastic floor tiles			
Asbestos Content:	Result Based on:			
Chrysotile in tile and adhesive	Analysis of sample using PLM			
Sample Analysed By: Reg 13(1)	Extent:	1 m ²		
Comments: Within timber boxing to corner of room

Material Assessment Total Score: 3		Likelihood of Disturbance Assessment Total Score: 4		Management Assessment Licensable: No Recommendations: Program removal Reinspection Interval: Not Applicable Overall Risk Category: C7
Product Type:	1 (Asbestos thermoplastic)	Location:	2 (Rooms up to 100 sq m)	
Condition:	1 (Minor scratches)	Accessibility:	1 (Occasionally likely to be disturbed)	
Surface Treatment:	0 (Composite material)			
Asbestos Type:	1 (Chrysotile)	Extent Score:	1 (<10 sq m or 10m pipe run)

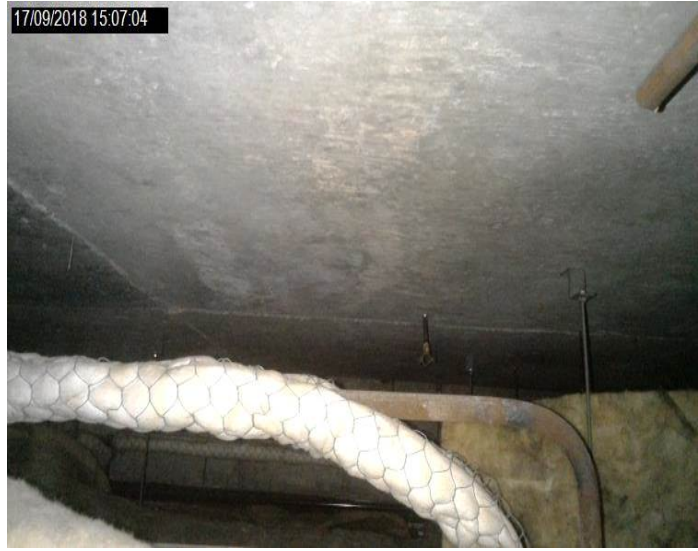
Location:	NBA310A	Block:	Birmingham City University	Floor Level: 3rd Floor
Sample No.:	As DU002442	Portal Ref No.:	444

Item:	Asbestos Reinforced plastic sleeve			
Asbestos Content:	Result Based on:			
Chrysotile	Strongly presumed			
Sample Analysed By:	Not applicable	Extent:	2 units	
Comments: Through the structural concrete

Material Assessment Total Score: 3		Likelihood of Disturbance Assessment Total Score: 3		Management Assessment Licensable: No Recommendations: Program removal Reinspection Interval: Not Applicable Overall Risk Category: D6
Product Type:	1 (Asbestos reinforced plastic)	Location:	2 (Rooms up to 100 sq m)	
Condition:	1 (Minor scratches)	Accessibility:	0 (Usually inaccessible or unlikely to be disturbed)	
Surface Treatment:	0 (Composite material)			
Asbestos Type:	1 (Chrysotile)	Extent Score:	1 (<10 sq m or 10m pipe run)

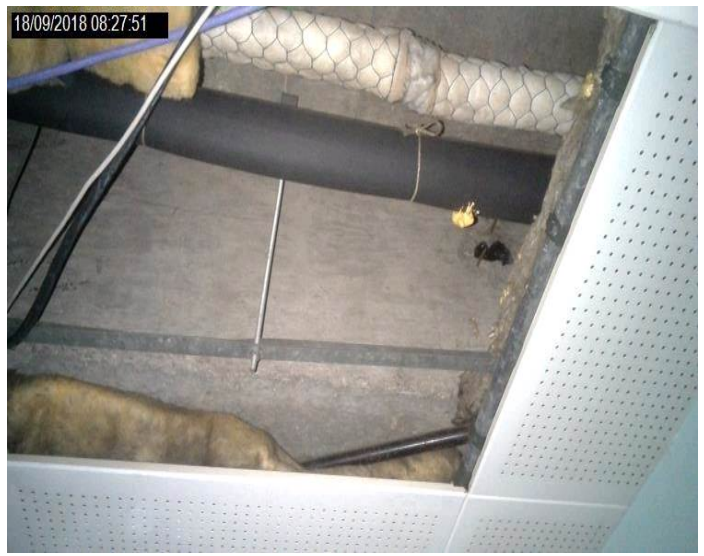
Location:	NBA399C Corridor	Block:	Birmingham City University	Floor Level: 3rd Floor
Sample No.:	As DU002442	Portal Ref No.:	446

Item:	Asbestos Reinforced plastic sleeve			
Asbestos Content:	Result Based on:			
Chrysotile	Strongly presumed			
Sample Analysed By:	Not applicable	Extent:	2 units	
Comments: Through the structural concrete

Material Assessment Total Score: 3		Likelihood of Disturbance Assessment Total Score: 3		Management Assessment Licensable: No Recommendations: Program removal Reinspection Interval: Not Applicable Overall Risk Category: D6
Product Type:	1 (Asbestos reinforced plastic)	Location:	2 (Rooms up to 100 sq m)	
Condition:	1 (Minor scratches)	Accessibility:	0 (Usually inaccessible or unlikely to be disturbed)	
Surface Treatment:	0 (Composite material)			
Asbestos Type:	1 (Chrysotile)	Extent Score:	1 (<10 sq m or 10m pipe run)

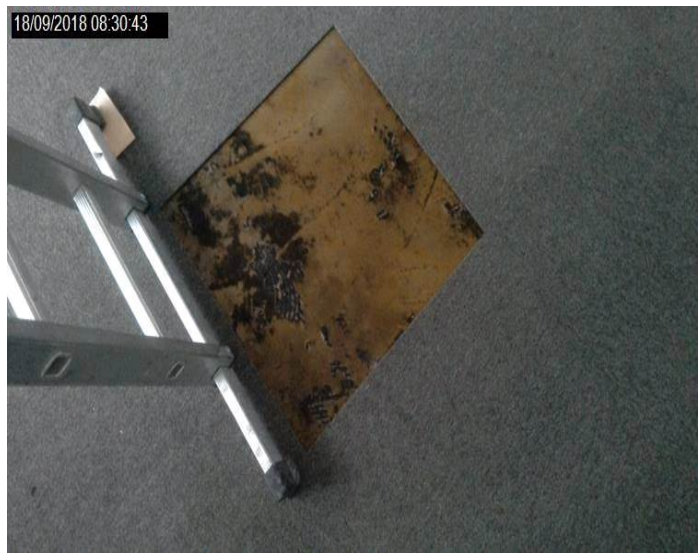
Location:	NBA310B	Block:	Birmingham City University	Floor Level: 3rd Floor
Sample No.:	As DU002454	Portal Ref No.:	449

Item:	Asbestos Bitumen adhesive			
Asbestos Content:	Result Based on:			
Chrysotile	Strongly presumed			
Sample Analysed By:	Not applicable	Extent:	12 m ²	
Comments:

Material Assessment Total Score: 3		Likelihood of Disturbance Assessment Total Score: 5		Management Assessment Licensable: No Recommendations: Program removal Reinspection Interval: Not Applicable Overall Risk Category: C8
Product Type:	1 (Asbestos bitumen)	Location:	2 (Rooms up to 100 sq m)	
Condition:	1 (Minor scratches)	Accessibility:	1 (Occasionally likely to be disturbed)	
Surface Treatment:	0 (Composite material)			
Asbestos Type:	1 (Chrysotile)	Extent Score:	2 (>10 - <50 sq m or >10m - <50m pipe run)

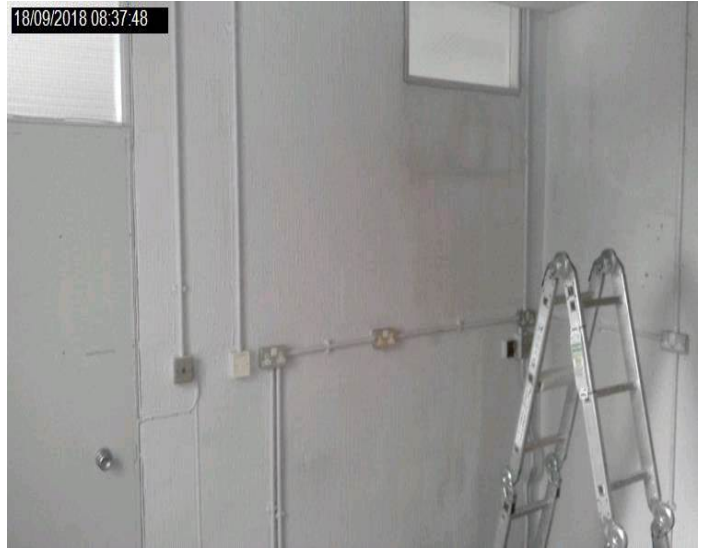
Location:	NBA311	Block:	Birmingham City University	Floor Level: 3rd Floor
Sample No.:	DU002460	Portal Ref No.:	450

Item:	Textured coating to block walls			
Asbestos Content:		Result Based on:		
No Asbestos Detected		Analysis of sample using PLM		
Sample Analysed By:	Reg 13(1)	Extent:	64 m ²	
Comments:

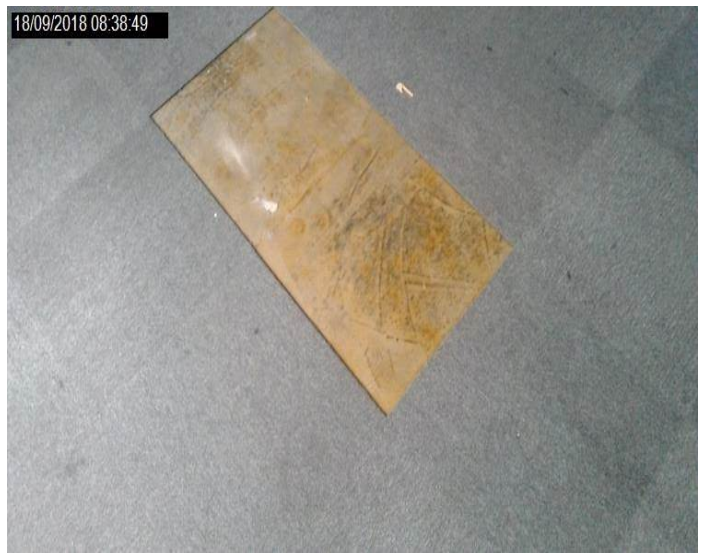
Location:	NBA311	Block:	Birmingham City University	Floor Level: 3rd Floor
Sample No.:	DU002461	Portal Ref No.:	451

Item:	Asbestos Bitumen adhesive			
Asbestos Content:	Result Based on:			
Chrysotile	Analysis of sample using PLM			
Sample Analysed By:	Reg 13(1)	Extent:	14 m ²	
Comments:

Material Assessment Total Score: 3		Likelihood of Disturbance Assessment Total Score: 4		Management Assessment Licensable: No Recommendations: Program removal Reinspection Interval: Not Applicable Overall Risk Category: C7
Product Type:	1 (Asbestos bitumen)	Location:	2 (Rooms up to 100 sq m)	
Condition:	1 (Minor scratches)	Accessibility:	0 (Usually inaccessible or unlikely to be disturbed)	
Surface Treatment:	0 (Composite material)			
Asbestos Type:	1 (Chrysotile)	Extent Score:	2 (>10 - <50 sq m or >10m - <50m pipe run)

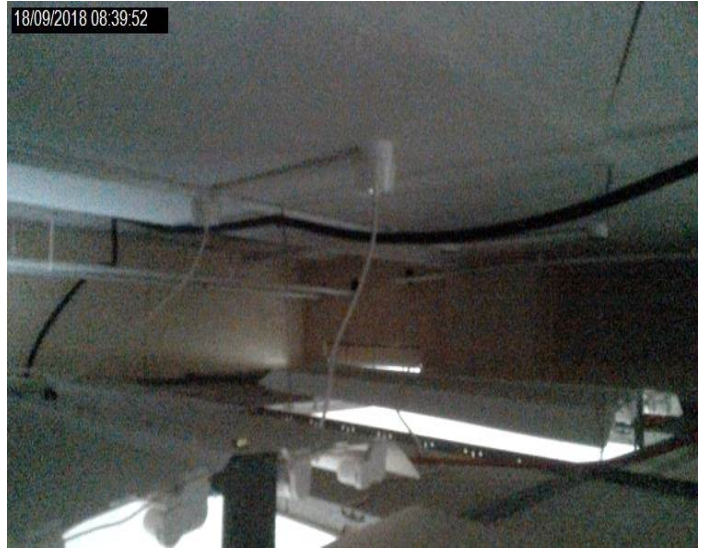
Location:	NBA311	Block:	Birmingham City University	Floor Level: 3rd Floor
Sample No.:	As DU002442	Portal Ref No.:	452

Item:	Asbestos Reinforced plastic sleeve			
Asbestos Content:	Result Based on:			
Chrysotile	Strongly presumed			
Sample Analysed By:	Not applicable	Extent:	5 units	
Comments: Through the structural concrete

Material Assessment Total Score: 3		Likelihood of Disturbance Assessment Total Score: 3		Management Assessment Licensable: No Recommendations: Program removal Reinspection Interval: Not Applicable Overall Risk Category: D6
Product Type:	1 (Asbestos reinforced plastic)	Location:	2 (Rooms up to 100 sq m)	
Condition:	1 (Minor scratches)	Accessibility:	0 (Usually inaccessible or unlikely to be disturbed)	
Surface Treatment:	0 (Composite material)			
Asbestos Type:	1 (Chrysotile)	Extent Score:	1 (<10 sq m or 10m pipe run)

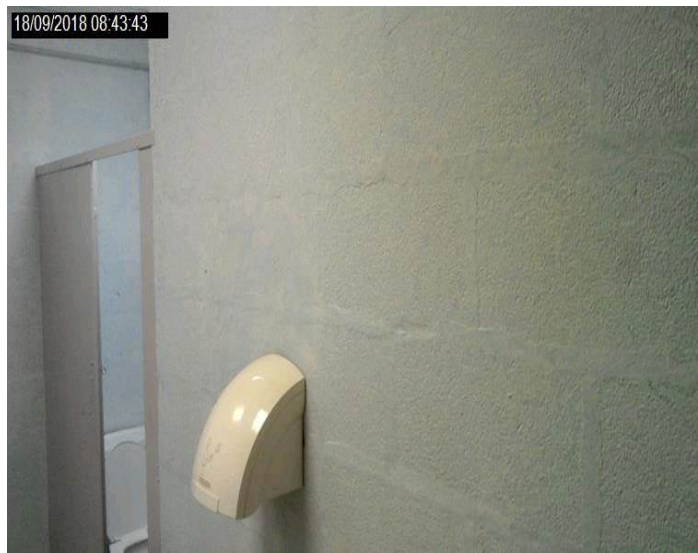
Location:	NBA318	Block:	Birmingham City University	Floor Level: 3rd Floor
Sample No.:	As DU002456	Portal Ref No.:	453

Item:	Textured coating			
Asbestos Content:		Result Based on:		
No Asbestos Detected		Strongly presumed		
Sample Analysed By:	Not applicable	Extent:	28 m ²	
Comments: All walls

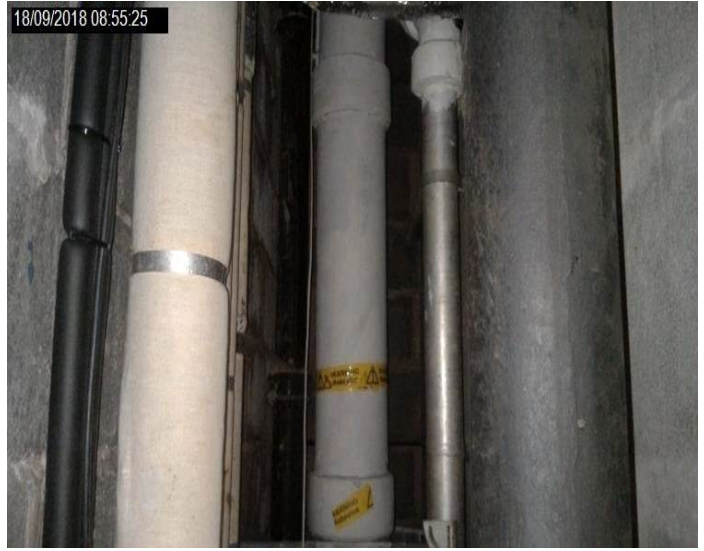
Location:	NBA317 Service duct	Block:	Birmingham City University	Floor Level: 3rd Floor
Sample No.:	DU002463	Portal Ref No.:	456

Item:	Asbestos Cement flue pipe			
Asbestos Content:	Result Based on:			
Chrysotile Crocidolite	Analysis of sample using PLM			
Sample Analysed By: Reg 13(1)	Extent:	4 linear metres		
Comments: Textile rope seal internally to smaller flue, connects to former female WC dispenser unit

Material Assessment Total Score: 6		Likelihood of Disturbance Assessment Total Score: 4		Management Assessment Licensable: No Recommendations: Program removal Reinspection Interval: Not Applicable Overall Risk Category: C10
Product Type:	1 (Asbestos cement)	Location:	2 (Rooms up to 100 sq m)	
Condition:	1 (Minor scratches)	Accessibility:	1 (Occasionally likely to be disturbed)	
Surface Treatment:	1 (Encapsulated asbestos cement)			
Asbestos Type:	3 (Chrysotile Crocidolite)	Extent Score:	1 (<10 sq m or 10m pipe run)

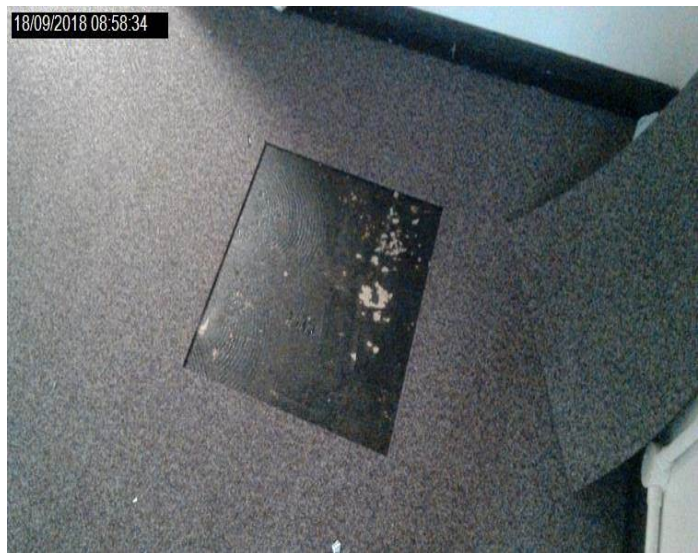
Location:	NBA316	Block:	Birmingham City University	Floor Level: 3rd Floor
Sample No.:	As DU002461	Portal Ref No.:	457

Item:	Asbestos Bitumen adhesive			
Asbestos Content:	Result Based on:			
Chrysotile	Strongly presumed			
Sample Analysed By:	Not applicable	Extent:	12 m ²	
Comments:

Material Assessment Total Score: 3		Likelihood of Disturbance Assessment Total Score: 4		Management Assessment Licensable: No Recommendations: Program removal Reinspection Interval: Not Applicable Overall Risk Category: C7
Product Type:	1 (Asbestos bitumen)	Location:	2 (Rooms up to 100 sq m)	
Condition:	1 (Minor scratches)	Accessibility:	0 (Usually inaccessible or unlikely to be disturbed)	
Surface Treatment:	0 (Composite material)			
Asbestos Type:	1 (Chrysotile)	Extent Score:	2 (>10 - <50 sq m or >10m - <50m pipe run)

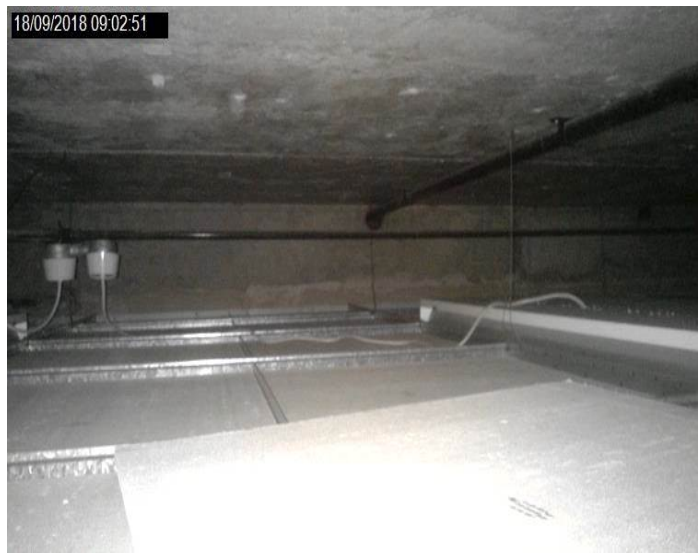
Location:	NBA312	Block:	Birmingham City University	Floor Level: 3rd Floor
Sample No.:	As DU002442	Portal Ref No.:	459

Item:	Asbestos Reinforced plastic sleeve			
Asbestos Content:	Result Based on:			
Chrysotile	Strongly presumed			
Sample Analysed By:	Not applicable	Extent:	6 units	
Comments: Through the structural concrete

Material Assessment Total Score: 3		Likelihood of Disturbance Assessment Total Score: 3		Management Assessment Licensable: No Recommendations: Program removal Reinspection Interval: Not Applicable Overall Risk Category: D6
Product Type:	1 (Asbestos reinforced plastic)	Location:	2 (Rooms up to 100 sq m)	
Condition:	1 (Minor scratches)	Accessibility:	0 (Usually inaccessible or unlikely to be disturbed)	
Surface Treatment:	0 (Composite material)			
Asbestos Type:	1 (Chrysotile)	Extent Score:	1 (<10 sq m or 10m pipe run)

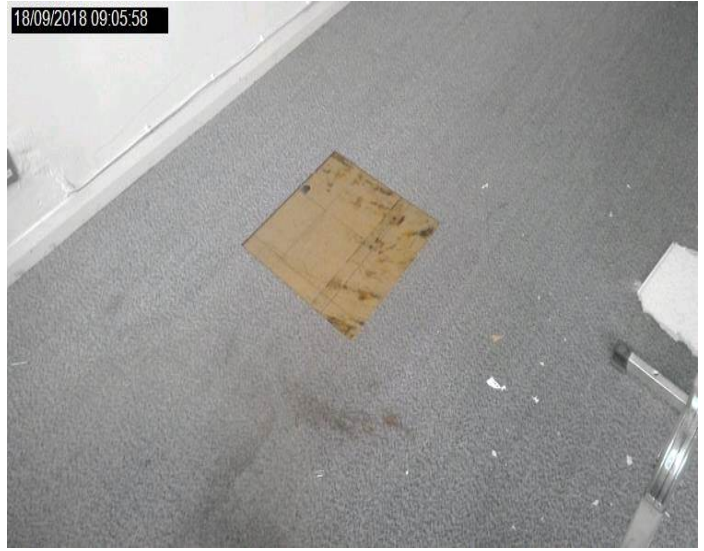
Location:	NBA315	Block:	Birmingham City University	Floor Level: 3rd Floor
Sample No.:	DU002464	Portal Ref No.:	461

Item:	Asbestos Thermoplastic floor tiles with bitumen adhesive			
Asbestos Content:	Result Based on:			
Chrysotile in tile and adhesive	Analysis of sample using PLM			
Sample Analysed By: Reg 13(1)	Extent:	14 m ²		
Comments:

Material Assessment Total Score: 3		Likelihood of Disturbance Assessment Total Score: 4		Management Assessment Licensable: No Recommendations: Program removal Reinspection Interval: Not Applicable Overall Risk Category: C7
Product Type:	1 (Asbestos thermoplastic)	Location:	2 (Rooms up to 100 sq m)	
Condition:	1 (Minor scratches)	Accessibility:	0 (Usually inaccessible or unlikely to be disturbed)	
Surface Treatment:	0 (Composite material)			
Asbestos Type:	1 (Chrysotile)	Extent Score:	2 (>10 - <50 sq m or >10m - <50m pipe run)
