Report No.: J102748
Nature of Work: Demolition Survey
Issue Date: 31/10/2018
Client Name: WYG Engineering Ltd
Geneva Building, Lake View Drive, Sherwood Business Park,
Annesley, Nottingham, NG15 0ED
Site Address: Baker Building, Former City North Campus, Birmingham City
University, Perry Barr, B42 2US

A demolition survey in line with HSG264 Asbestos: The Survey Guide was carried out internally and externally to the property.

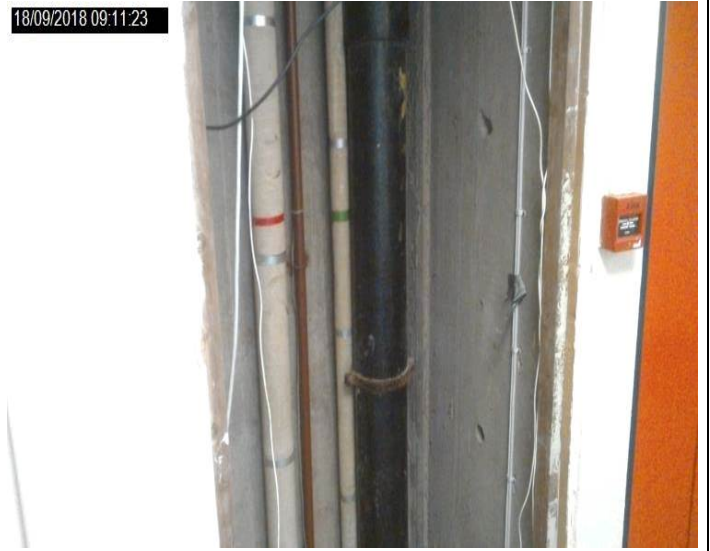
Location:	NBA312A Service duct	Block:	Birmingham City University		Floor Level: 3rd Floor
Sample No.:	As DU002446	Portal Ref No.:	462

Item:	Asbestos Reinforced plastic downpipe				
Asbestos Content:	Result Based on:				
Chrysotile	Strongly presumed				
Sample Analysed By:	Not applicable	Extent:	3 linear metres		
Comments:

Material Assessment Total Score: 3		Likelihood of Disturbance Assessment Total Score: 4		Management Assessment Licensable: No Recommendations: Program removal Reinspection Interval: Not Applicable Overall Risk Category: C7
Product Type:	1 (Asbestos reinforced plastic)	Location:	2 (Rooms up to 100 sq m)	
Condition:	1 (Minor scratches)	Accessibility:	1 (Occasionally likely to be disturbed)	
Surface Treatment:	0 (Composite material)			
Asbestos Type:	1 (Chrysotile)	Extent Score:	1 (<10 sq m or 10m pipe run)

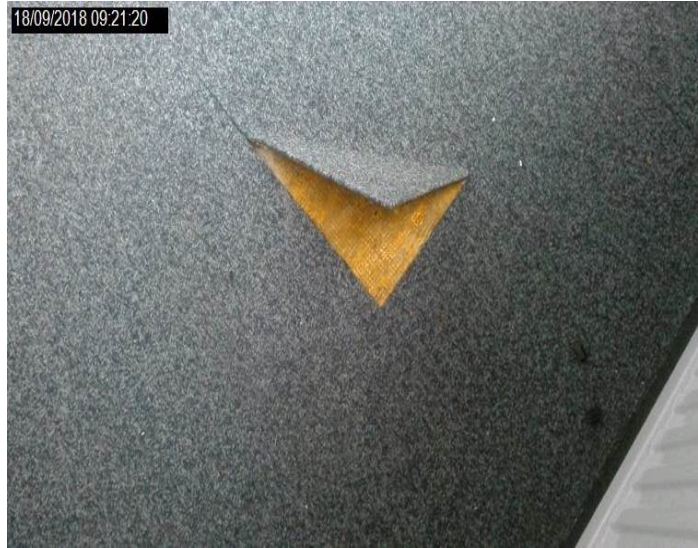
Location:	NBA313C	Block:	Birmingham City University	Floor Level: 3rd Floor
Sample No.:	As DU002461	Portal Ref No.:	465

Item:	Asbestos Bitumen adhesive			
Asbestos Content:	Result Based on:			
Chrysotile	Strongly presumed			
Sample Analysed By:	Not applicable	Extent:	10 m ²	
Comments: Sporadic amounts throughout

Material Assessment Total Score: 3		Likelihood of Disturbance Assessment Total Score: 3		Management Assessment Licensable: No Recommendations: Program removal Reinspection Interval: Not Applicable Overall Risk Category: D6
Product Type:	1 (Asbestos bitumen)	Location:	2 (Rooms up to 100 sq m)	
Condition:	1 (Minor scratches)	Accessibility:	0 (Usually inaccessible or unlikely to be disturbed)	
Surface Treatment:	0 (Composite material)			
Asbestos Type:	1 (Chrysotile)	Extent Score:	1 (<10 sq m or 10m pipe run)

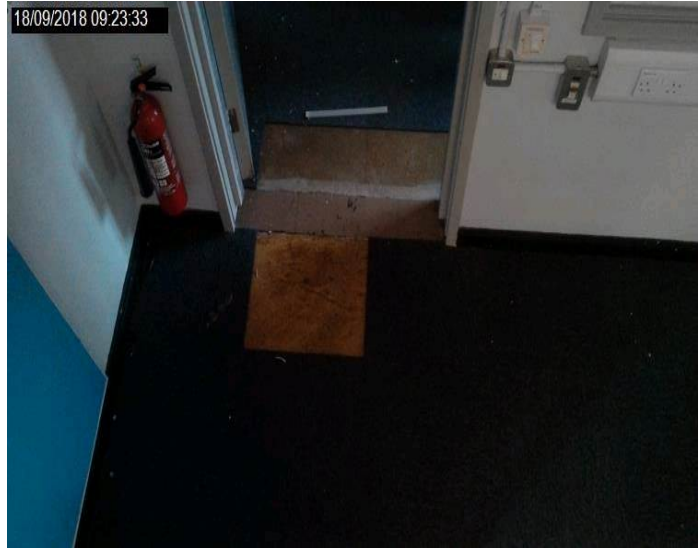
Location:	NBA313B	Block:	Birmingham City University	Floor Level: 3rd Floor
Sample No.:	DU002465	Portal Ref No.:	467

Item:	Asbestos Thermoplastic floor tiles with bitumen adhesive			
Asbestos Content:	Result Based on:			
Chrysotile in tile and adhesive		Analysis of sample using PLM		
Sample Analysed By:	Reg 13(1)	Extent:	1 linear metres	
Comments: To the door opening only

Material Assessment Total Score: 3		Likelihood of Disturbance Assessment Total Score: 4		Management Assessment Licensable: No Recommendations: Program removal Reinspection Interval: Not Applicable Overall Risk Category: C7
Product Type:	1 (Asbestos thermoplastic)	Location:	2 (Rooms up to 100 sq m)	
Condition:	1 (Minor scratches)	Accessibility:	1 (Occasionally likely to be disturbed)	
Surface Treatment:	0 (Composite material)			
Asbestos Type:	1 (Chrysotile)	Extent Score:	1 (<10 sq m or 10m pipe run)

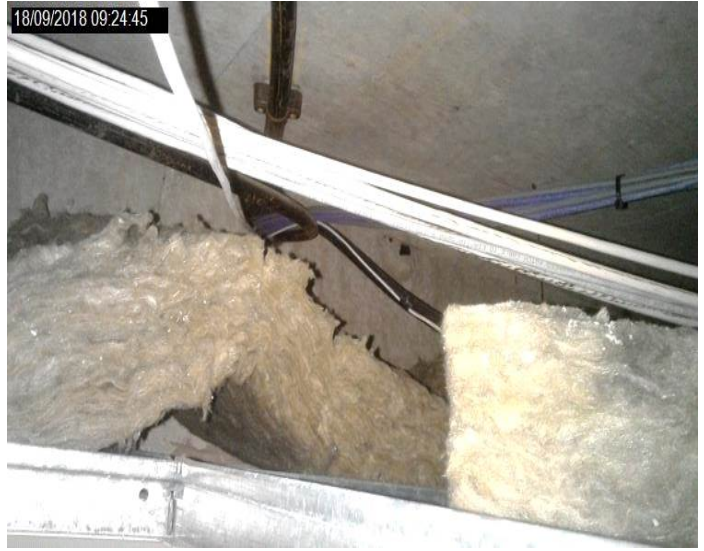
Location:	NBA313B	Block:	Birmingham City University	Floor Level: 3rd Floor
Sample No.:	As DU002442	Portal Ref No.:	468

Item:	Asbestos Reinforced plastic sleeve			
Asbestos Content:	Result Based on:			
Chrysotile	Strongly presumed			
Sample Analysed By:	Not applicable	Extent:	3 units	
Comments: Through the structural concrete, to corridor wall

Material Assessment Total Score: 3		Likelihood of Disturbance Assessment Total Score: 3		Management Assessment Licensable: No Recommendations: Program removal Reinspection Interval: Not Applicable Overall Risk Category: D6
Product Type:	1 (Asbestos reinforced plastic)	Location:	2 (Rooms up to 100 sq m)	
Condition:	1 (Minor scratches)	Accessibility:	0 (Usually inaccessible or unlikely to be disturbed)	
Surface Treatment:	0 (Composite material)			
Asbestos Type:	1 (Chrysotile)	Extent Score:	1 (<10 sq m or 10m pipe run)

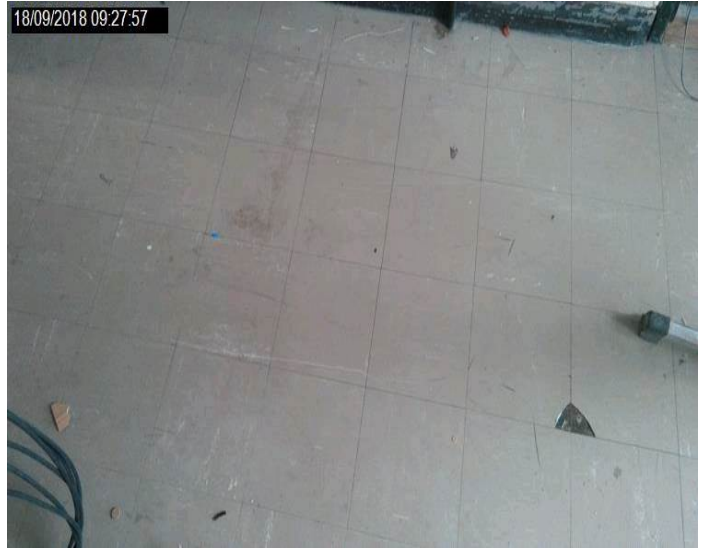
Location:	NBA313A	Block:	Birmingham City University	Floor Level: 3rd Floor
Sample No.:	DU002466	Portal Ref No.:	470

Item:	Asbestos Thermoplastic floor tiles with bitumen adhesive			
Asbestos Content:	Result Based on:			
Chrysotile in tile and adhesive	Analysis of sample using PLM			
Sample Analysed By: Reg 13(1)	Extent:	8 m ²		
Comments:

Material Assessment Total Score: 3		Likelihood of Disturbance Assessment Total Score: 4		Management Assessment Licensable: No Recommendations: Program removal Reinspection Interval: Not Applicable Overall Risk Category: C7
Product Type:	1 (Asbestos thermoplastic)	Location:	2 (Rooms up to 100 sq m)	
Condition:	1 (Minor scratches)	Accessibility:	1 (Occasionally likely to be disturbed)	
Surface Treatment:	0 (Composite material)			
Asbestos Type:	1 (Chrysotile)	Extent Score:	1 (<10 sq m or 10m pipe run)

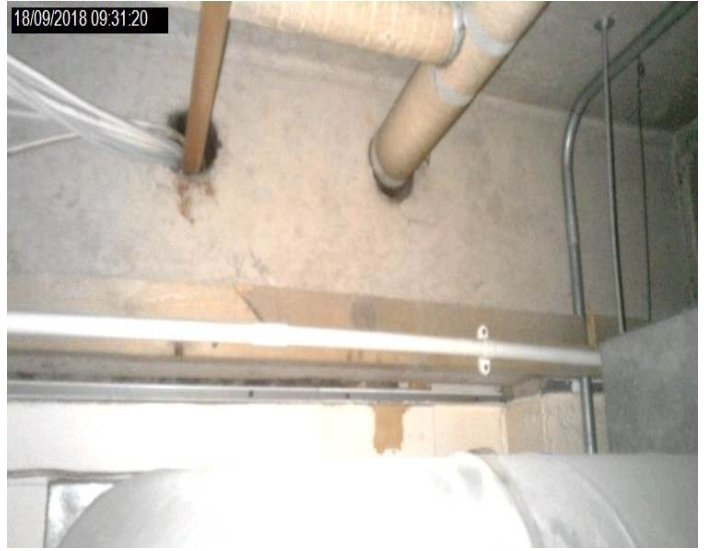
Location:	NBA313A	Block:	Birmingham City University	Floor Level: 3rd Floor
Sample No.:	As DU002442	Portal Ref No.:	471

Item:	Asbestos Reinforced plastic sleeve			
Asbestos Content:	Result Based on:			
Chrysotile	Strongly presumed			
Sample Analysed By:	Not applicable	Extent:	4 units	
Comments: Through the structural concrete, to corridor wall

Material Assessment Total Score: 3		Likelihood of Disturbance Assessment Total Score: 3		Management Assessment Licensable: No Recommendations: Program removal Reinspection Interval: Not Applicable Overall Risk Category: D6
Product Type:	1 (Asbestos reinforced plastic)	Location:	2 (Rooms up to 100 sq m)	
Condition:	1 (Minor scratches)	Accessibility:	0 (Usually inaccessible or unlikely to be disturbed)	
Surface Treatment:	0 (Composite material)			
Asbestos Type:	1 (Chrysotile)	Extent Score:	1 (<10 sq m or 10m pipe run)

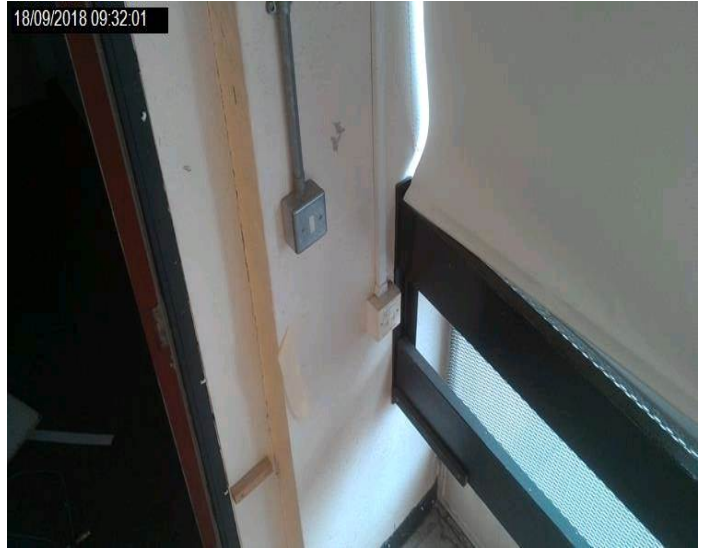
Location:	NBA313A	Block:	Birmingham City University	Floor Level: 3rd Floor
Sample No.:	DU002467	Portal Ref No.:	472

Item:	Textured coating to concrete section			
Asbestos Content:	Result Based on:			
No Asbestos Detected	Analysis of sample using PLM			
Sample Analysed By:	██████████	Extent:	3 m ²	
Comments:

Material Assessment Total Score: 0		Likelihood of Disturbance Assessment Total Score: 0		Management Assessment Licensable: No Recommendations: Not Applicable Reinspection Interval: Not Applicable Overall Risk Category: E0
Product Type:	0 Not Applicable	Location:	0 Not Applicable	
Condition:	0 Not Applicable	Accessibility:	0 Not Applicable	
Surface Treatment:	0 Not Applicable			
Asbestos Type:	0 Not Applicable	Extent Score:	0 Not Applicable

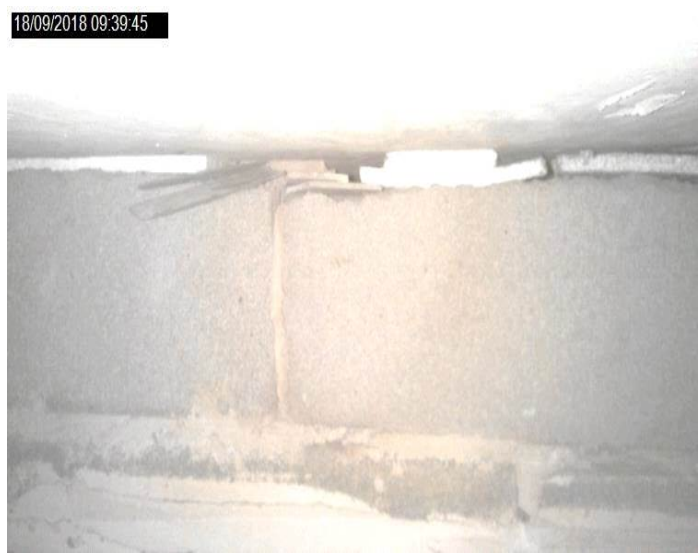
Location:	NBA314A	Block:	Birmingham City University	Floor Level: 3rd Floor
Sample No.:	DU002468	Portal Ref No.:	474	18/09/2018 09:39:45
Item:	Asbestos Cement roof tile packers			
Asbestos Content:	Result Based on:

Chrysotile	Analysis of sample using PLM			
Sample Analysed By: Reg 13(1)	Extent:	1 m ²		
Comments: To the top of the adjoining wall to room NBA314

Material Assessment Total Score: 6		Likelihood of Disturbance Assessment Total Score: 3		Management Assessment Licensable: No Recommendations: Program removal Reinspection Interval: Not Applicable Overall Risk Category: C9
Product Type:	1 (Asbestos cement)	Location:	2 (Rooms up to 100 sq m)	
Condition:	3 (Significant damage)	Accessibility:	0 (Usually inaccessible or unlikely to be disturbed)	
Surface Treatment:	1 (Unencapsulated asbestos cement)			
Asbestos Type:	1 (Chrysotile)	Extent Score:	1 (<10 sq m or 10m pipe run)

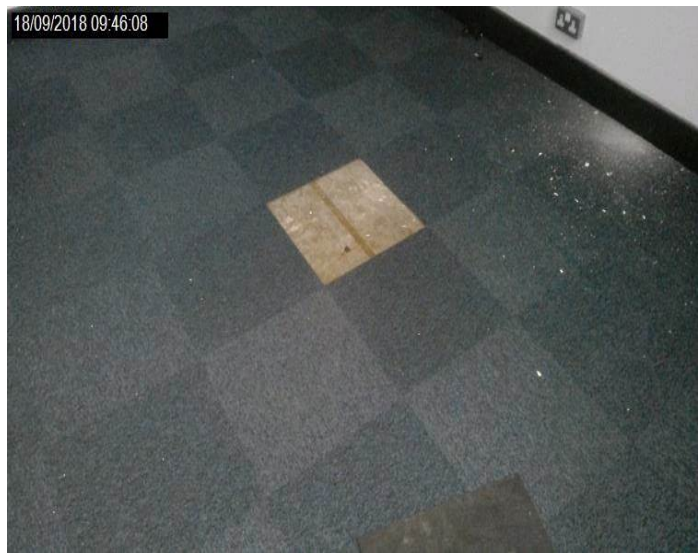
Location:	NBA314	Block:	Birmingham City University	Floor Level: 3rd Floor
Sample No.:	DU002469	Portal Ref No.:	475

Item:	Asbestos Thermoplastic floor tiles			
Asbestos Content:	Result Based on:			
Chrysotile in tile and adhesive	Analysis of sample using PLM			
Sample Analysed By: Reg 13(1)	Extent:	25 m ²		
Comments: Throughout all rooms

Material Assessment Total Score: 3		Likelihood of Disturbance Assessment Total Score: 4		Management Assessment Licensable: No Recommendations: Program removal Reinspection Interval: Not Applicable Overall Risk Category: C7
Product Type:	1 (Asbestos thermoplastic)	Location:	2 (Rooms up to 100 sq m)	
Condition:	1 (Minor scratches)	Accessibility:	0 (Usually inaccessible or unlikely to be disturbed)	
Surface Treatment:	0 (Composite material)			
Asbestos Type:	1 (Chrysotile)	Extent Score:	2 (>10 - <50 sq m or >10m - <50m pipe run)

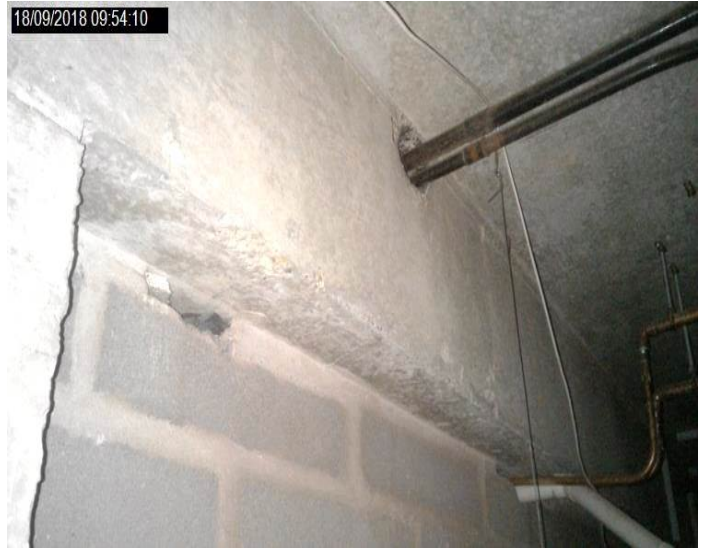
Location:	NBA399D Corridor	Block:	Birmingham City University	Floor Level: 3rd Floor
Sample No.:	As DU002442	Portal Ref No.:	478

Item:	Asbestos Reinforced plastic sleeve			
Asbestos Content:	Result Based on:			
Chrysotile	Strongly presumed			
Sample Analysed By:	Not applicable	Extent:	18 units	
Comments: Passes through wall section separating the rooms and the corridor

Material Assessment Total Score: 3		Likelihood of Disturbance Assessment Total Score: 3		Management Assessment Licensable: No Recommendations: Program removal Reinspection Interval: Not Applicable Overall Risk Category: D6
Product Type:	1 (Asbestos reinforced plastic)	Location:	2 (Rooms up to 100 sq m)	
Condition:	1 (Minor scratches)	Accessibility:	0 (Usually inaccessible or unlikely to be disturbed)	
Surface Treatment:	0 (Composite material)			
Asbestos Type:	1 (Chrysotile)	Extent Score:	1 (<10 sq m or 10m pipe run)

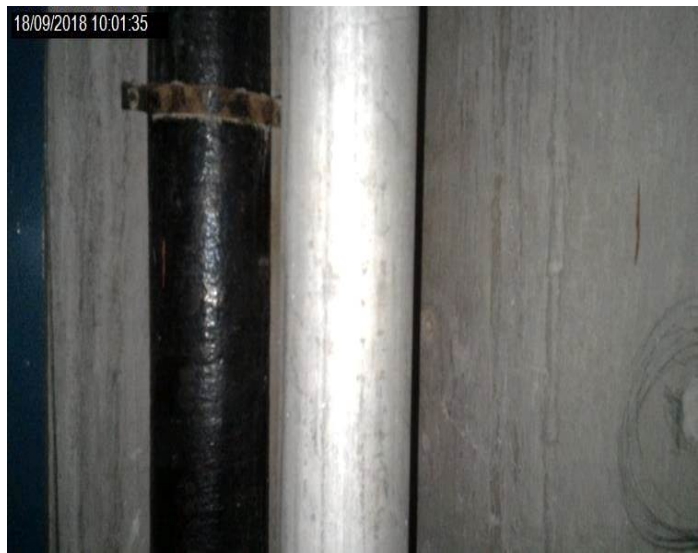
Location:	NBA399E Corridor	Block:	Birmingham City University	Floor Level: 3rd Floor
Sample No.:	As DU002446	Portal Ref No.:	481

Item:	Asbestos Reinforced plastic downpipe			
Asbestos Content:	Result Based on:			
Chrysotile	Strongly presumed			
Sample Analysed By:	Not applicable	Extent:	3 linear metres	
Comments: Internally to timber boxing

Material Assessment Total Score: 3		Likelihood of Disturbance Assessment Total Score: 3		Management Assessment Licensable: No Recommendations: Program removal Reinspection Interval: Not Applicable Overall Risk Category: D6
Product Type:	1 (Asbestos reinforced plastic)	Location:	2 (Rooms up to 100 sq m)	
Condition:	1 (Minor scratches)	Accessibility:	0 (Usually inaccessible or unlikely to be disturbed)	
Surface Treatment:	0 (Composite material)			
Asbestos Type:	1 (Chrysotile)	Extent Score:	1 (<10 sq m or 10m pipe run)

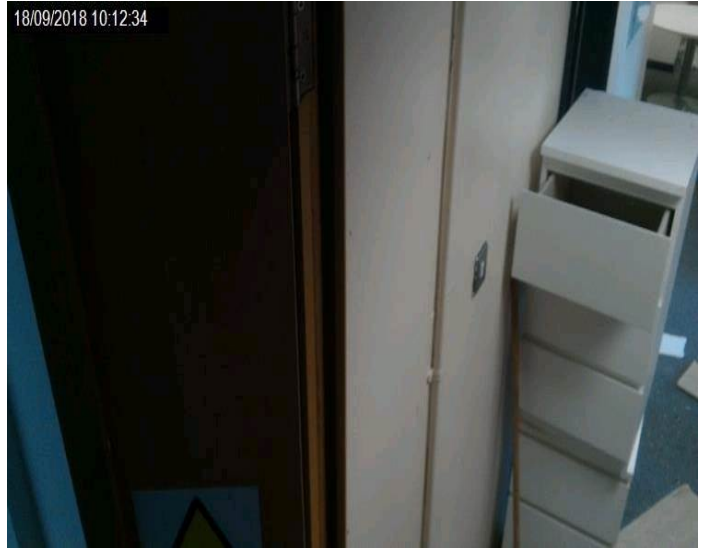
Location:	NBA399F Corridor	Block:	Birmingham City University	Floor Level: 3rd Floor
Sample No.:	As DU002467	Portal Ref No.:	483

Item:	Textured coating to concrete sections			
Asbestos Content:		Result Based on:		
No Asbestos Detected		Strongly presumed		
Sample Analysed By:	Not applicable	Extent:	30 m ²	
Comments: To concrete sections

Material Assessment Total Score: 0		Likelihood of Disturbance Assessment Total Score: 0		Management Assessment Licensable: No Recommendations: Not Applicable Reinspection Interval: Not Applicable Overall Risk Category: E0
Product Type:	0 Not Applicable	Location:	0 Not Applicable	
Condition:	0 Not Applicable	Accessibility:	0 Not Applicable	
Surface Treatment:	0 Not Applicable			
Asbestos Type:	0 Not Applicable	Extent Score:	0 Not Applicable

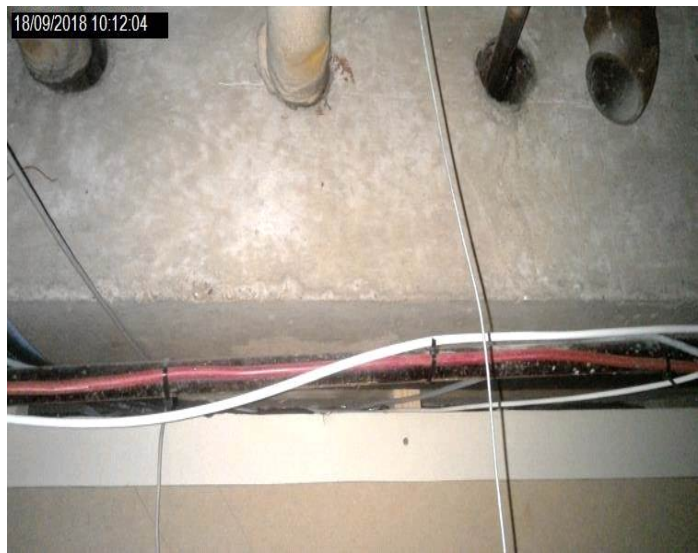
Location:	NBA399F Corridor	Block:	Birmingham City University	Floor Level: 3rd Floor
Sample No.:	As DU002442	Portal Ref No.:	484

Item:	Asbestos Reinforced plastic sleeve			
Asbestos Content:	Result Based on:			
Chrysotile	Strongly presumed			
Sample Analysed By:	Not applicable	Extent:	5 units	
Comments: Passes through wall section separating the rooms and the corridor

Material Assessment Total Score: 3		Likelihood of Disturbance Assessment Total Score: 3		Management Assessment Licensable: No Recommendations: Program removal Reinspection Interval: Not Applicable Overall Risk Category: D6
Product Type:	1 (Asbestos reinforced plastic)	Location:	2 (Rooms up to 100 sq m)	
Condition:	1 (Minor scratches)	Accessibility:	0 (Usually inaccessible or unlikely to be disturbed)	
Surface Treatment:	0 (Composite material)			
Asbestos Type:	1 (Chrysotile)	Extent Score:	1 (<10 sq m or 10m pipe run)

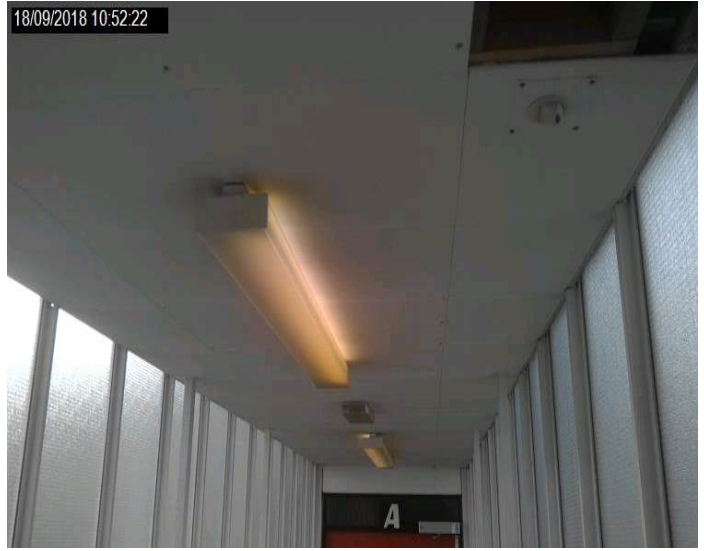
Location:	To Attwood walkway	Block:	Birmingham City University	Floor Level: 2nd Floor
Sample No.:	DU002471	Portal Ref No.:	486

Item:	Insulating board suspended tiles			
Asbestos Content:		Result Based on:		
No Asbestos Detected		Analysis of sample using PLM		
Sample Analysed By:	Reg 13(1)	Extent:	18 m ²	
Comments: Includes firebreak above doors

Material Assessment Total Score: 0		Likelihood of Disturbance Assessment Total Score: 0		Management Assessment Licensable: Yes Recommendations: Not Applicable Reinspection Interval: Not Applicable Overall Risk Category: E0
Product Type:	0 Not Applicable	Location:	0 Not Applicable	
Condition:	0 Not Applicable	Accessibility:	0 Not Applicable	
Surface Treatment:	0 Not Applicable			
Asbestos Type:	0 Not Applicable	Extent Score:	0 Not Applicable

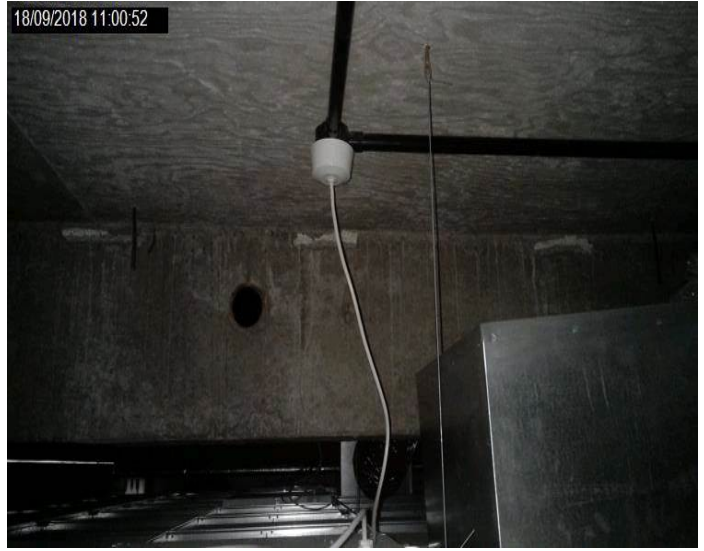
Location:	NBA225	Block:	Birmingham City University	Floor Level: 2nd Floor
Sample No.:	DU002472	Portal Ref No.:	487

Item:	Asbestos Reinforced plastic sleeve			
Asbestos Content:	Result Based on:			
Chrysotile	Analysis of sample using PLM			
Sample Analysed By:	Reg 13(1)	Extent:	12 units	
Comments:

Material Assessment Total Score: 3		Likelihood of Disturbance Assessment Total Score: 4		Management Assessment Licensable: No Recommendations: Program removal Reinspection Interval: Not Applicable Overall Risk Category: C7
Product Type:	1 (Asbestos reinforced plastic)	Location:	2 (Rooms up to 100 sq m)	
Condition:	1 (Minor scratches)	Accessibility:	1 (Occasionally likely to be disturbed)	
Surface Treatment:	0 (Composite material)			
Asbestos Type:	1 (Chrysotile)	Extent Score:	1 (<10 sq m or 10m pipe run)

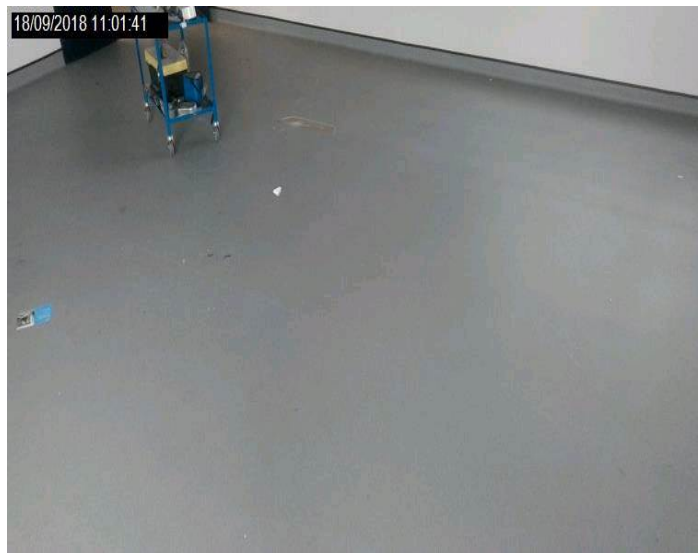
Location:	NBA225	Block:	Birmingham City University	Floor Level: 2nd Floor
Sample No.:	DU002473	Portal Ref No.:	488

Item:	Asbestos Bitumen adhesive			
Asbestos Content:	Result Based on:			
Chrysotile	Analysis of sample using PLM			
Sample Analysed By: Reg 13(1)	Extent:	50 m ²		
Comments:

Material Assessment Total Score: 3		Likelihood of Disturbance Assessment Total Score: 5		Management Assessment Licensable: No Recommendations: Program removal Reinspection Interval: Not Applicable Overall Risk Category: C8
Product Type:	1 (Asbestos bitumen)	Location:	2 (Rooms up to 100 sq m)	
Condition:	1 (Minor scratches)	Accessibility:	0 (Usually inaccessible or unlikely to be disturbed)	
Surface Treatment:	0 (Composite material)			
Asbestos Type:	1 (Chrysotile)	Extent Score:	3 (>50 sq m or >50m pipe run)

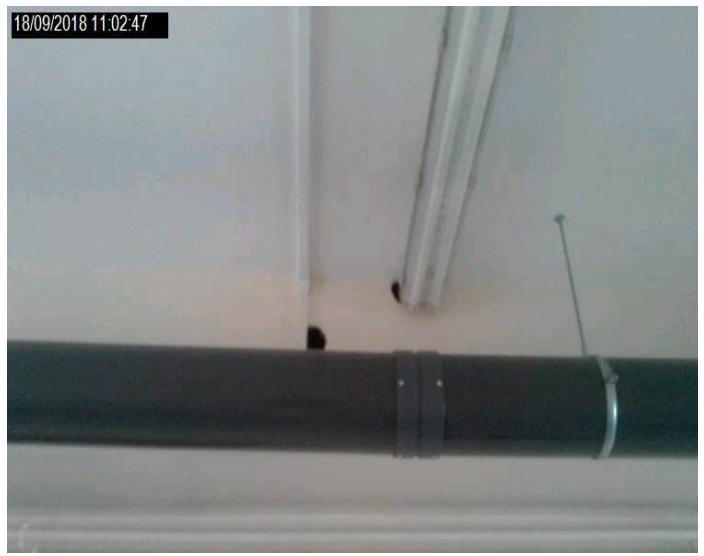
Location:	NBA226	Block:	Birmingham City University	Floor Level: 2nd Floor
Sample No.:	As DU002472	Portal Ref No.:	489

Item:	Asbestos Reinforced plastic sleeve			
Asbestos Content:	Result Based on:			
Chrysotile	Strongly presumed			
Sample Analysed By:	Not applicable	Extent:	4 units	
Comments:

Material Assessment Total Score: 3		Likelihood of Disturbance Assessment Total Score: 4		Management Assessment Licensable: No Recommendations: Program removal Reinspection Interval: Not Applicable Overall Risk Category: C7
Product Type:	1 (Asbestos reinforced plastic)	Location:	2 (Rooms up to 100 sq m)	
Condition:	1 (Minor scratches)	Accessibility:	1 (Occasionally likely to be disturbed)	
Surface Treatment:	0 (Composite material)			
Asbestos Type:	1 (Chrysotile)	Extent Score:	1 (<10 sq m or 10m pipe run)

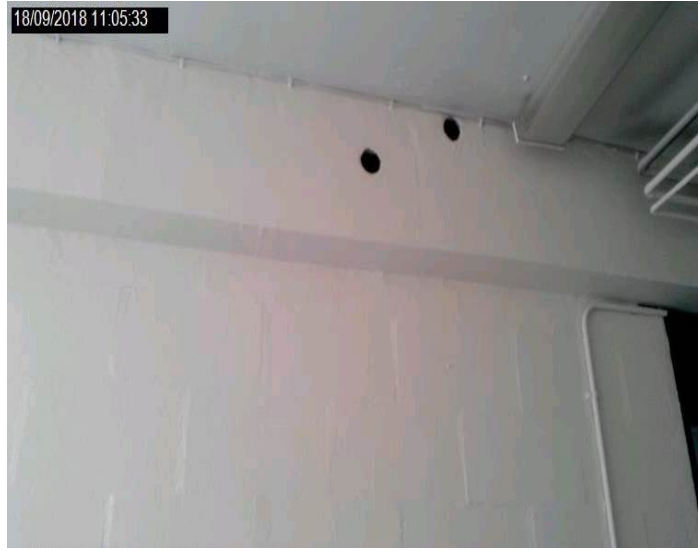
Location:	NBA201D	Block:	Birmingham City University	Floor Level: 2nd Floor
Sample No.:	As DU002472	Portal Ref No.:	490

Item:	Asbestos Reinforced plastic sleeve			
Asbestos Content:	Result Based on:			
Chrysotile	Strongly presumed			
Sample Analysed By:	Not applicable	Extent:	4 units	
Comments:

Material Assessment Total Score: 3		Likelihood of Disturbance Assessment Total Score: 4		Management Assessment Licensable: No Recommendations: Program removal Reinspection Interval: Not Applicable Overall Risk Category: C7
Product Type:	1 (Asbestos reinforced plastic)	Location:	2 (Rooms up to 100 sq m)	
Condition:	1 (Minor scratches)	Accessibility:	1 (Occasionally likely to be disturbed)	
Surface Treatment:	0 (Composite material)			
Asbestos Type:	1 (Chrysotile)	Extent Score:	1 (<10 sq m or 10m pipe run)

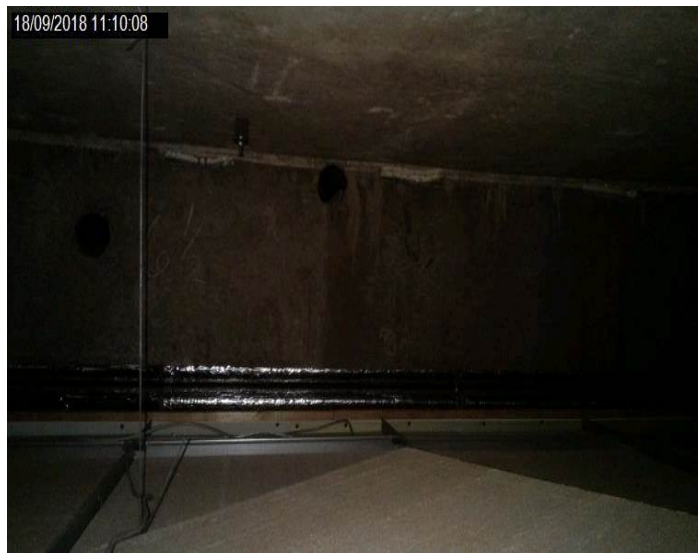
Location:	NBA201A	Block:	Birmingham City University	Floor Level: 2nd Floor
Sample No.:	As DU002472	Portal Ref No.:	491

Item:	Asbestos Reinforced plastic sleeve			
Asbestos Content:	Result Based on:			
Chrysotile	Strongly presumed			
Sample Analysed By:	Not applicable	Extent:	6 units	
Comments: To structural columns

Material Assessment Total Score: 3		Likelihood of Disturbance Assessment Total Score: 4		Management Assessment Licensable: No Recommendations: Program removal Reinspection Interval: Not Applicable Overall Risk Category: C7
Product Type:	1 (Asbestos reinforced plastic)	Location:	2 (Rooms up to 100 sq m)	
Condition:	1 (Minor scratches)	Accessibility:	1 (Occasionally likely to be disturbed)	
Surface Treatment:	0 (Composite material)			
Asbestos Type:	1 (Chrysotile)	Extent Score:	1 (<10 sq m or 10m pipe run)
