Location:	NBA201A	Block:	Birmingham City University	Floor Level: 2nd Floor
Sample No.:	DU002474	Portal Ref No.:	492

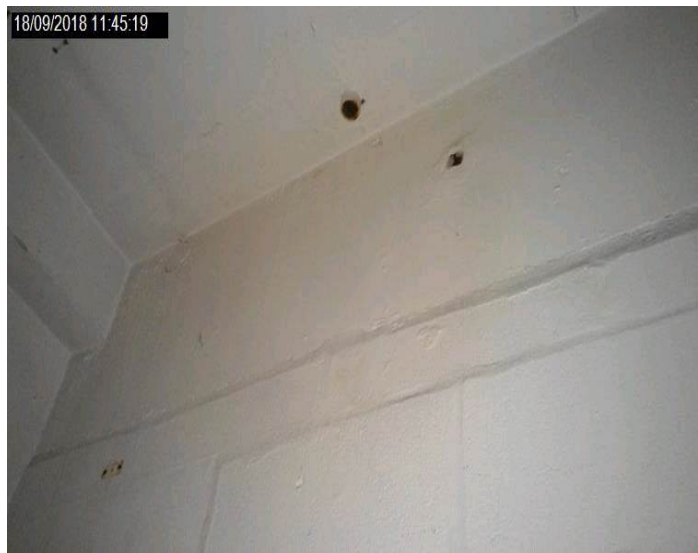
Location:	NBA202	Block:	Birmingham City University	Floor Level: 2nd Floor
Sample No.:	As DU002472	Portal Ref No.:	504

Item:	Asbestos Reinforced plastic sleeve			
Asbestos Content:	Result Based on:			
Chrysotile	Strongly presumed			
Sample Analysed By:	Not applicable	Extent:	2 units	
Comments:

Material Assessment Total Score: 3		Likelihood of Disturbance Assessment Total Score: 3		Management Assessment Licensable: No Recommendations: Program removal Reinspection Interval: Not Applicable Overall Risk Category: D6
Product Type:	1 (Asbestos reinforced plastic)	Location:	2 (Rooms up to 100 sq m)	
Condition:	1 (Minor scratches)	Accessibility:	0 (Usually inaccessible or unlikely to be disturbed)	
Surface Treatment:	0 (Composite material)			
Asbestos Type:	1 (Chrysotile)	Extent Score:	1 (<10 sq m or 10m pipe run)

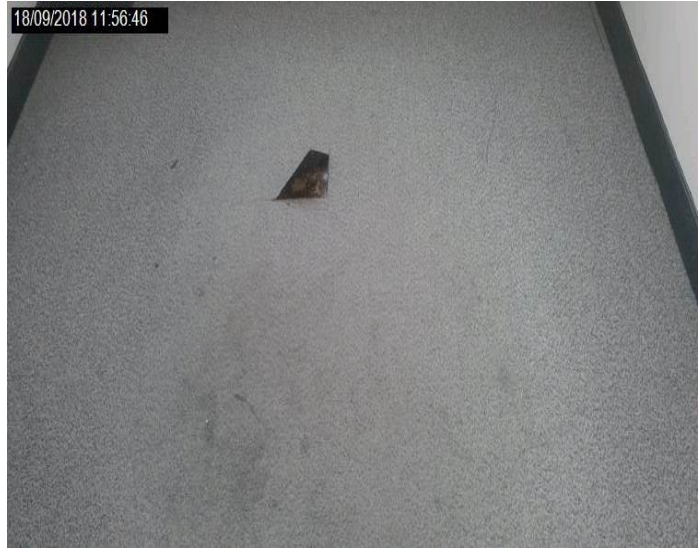
Location:	NBA204A	Block:	Birmingham City University	Floor Level: 2nd Floor
Sample No.:	As DU002477	Portal Ref No.:	508

Item:	Asbestos Bitumen adhesive			
Asbestos Content:	Result Based on:			
Chrysotile	Strongly presumed			
Sample Analysed By:	Not applicable	Extent:	12 m ²	
Comments:

Material Assessment Total Score: 3		Likelihood of Disturbance Assessment Total Score: 4		Management Assessment Licensable: No Recommendations: Program removal Reinspection Interval: Not Applicable Overall Risk Category: C7
Product Type:	1 (Asbestos bitumen)	Location:	2 (Rooms up to 100 sq m)	
Condition:	1 (Minor scratches)	Accessibility:	0 (Usually inaccessible or unlikely to be disturbed)	
Surface Treatment:	0 (Composite material)			
Asbestos Type:	1 (Chrysotile)	Extent Score:	2 (>10 - <50 sq m or >10m - <50m pipe run)

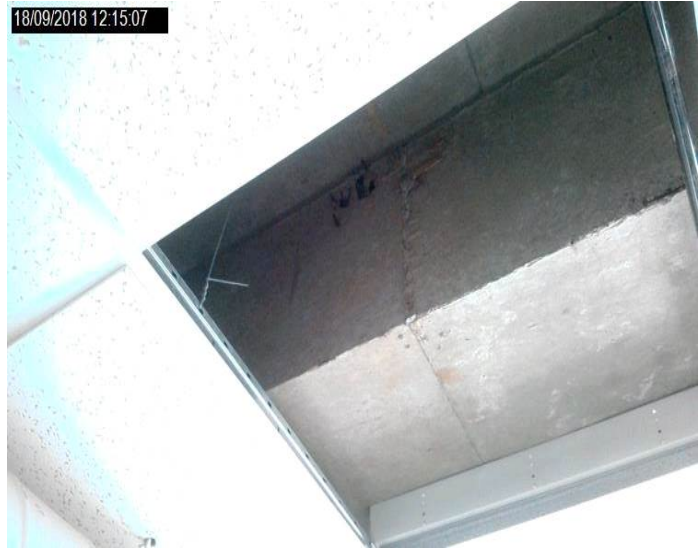
Location:	NBA223B	Block:	Birmingham City University	Floor Level: 2nd Floor
Sample No.:	As DU002472	Portal Ref No.:	514

Item:	Asbestos Reinforced plastic sleeve			
Asbestos Content:	Result Based on:			
Chrysotile	Strongly presumed			
Sample Analysed By:	Not applicable	Extent:	1 unit	
Comments:

Material Assessment Total Score: 3		Likelihood of Disturbance Assessment Total Score: 4		Management Assessment Licensable: No Recommendations: Program removal Reinspection Interval: Not Applicable Overall Risk Category: C7
Product Type:	1 (Asbestos reinforced plastic)	Location:	2 (Rooms up to 100 sq m)	
Condition:	1 (Minor scratches)	Accessibility:	1 (Occasionally likely to be disturbed)	
Surface Treatment:	0 (Composite material)			
Asbestos Type:	1 (Chrysotile)	Extent Score:	1 (<10 sq m or 10m pipe run)

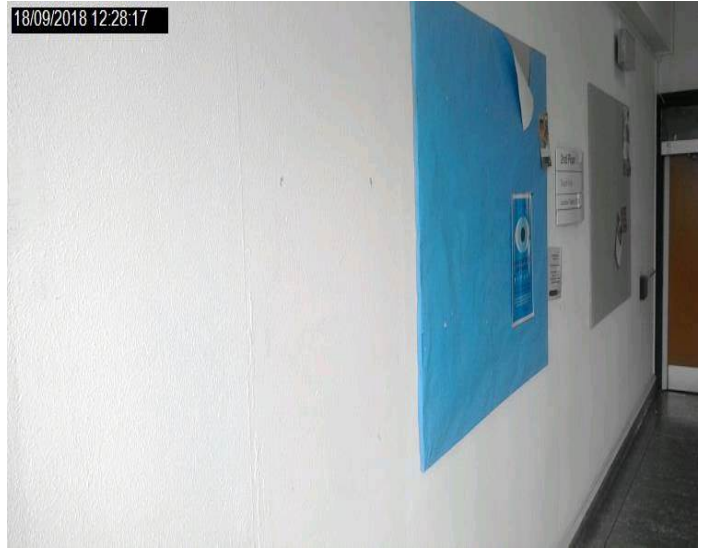
Location:	NBA299 Lift Lobby	Block:	Birmingham City University	Floor Level: 2nd Floor
Sample No.:	As DU002480	Portal Ref No.:	522

Item:	Textured coating to concrete			
Asbestos Content:		Result Based on:		
No Asbestos Detected		Strongly presumed		
Sample Analysed By:	Not applicable	Extent:	50 m ²	
Comments: To all walls

Material Assessment Total Score: 0		Likelihood of Disturbance Assessment Total Score: 0		Management Assessment Licensable: No Recommendations: Not Applicable Reinspection Interval: Not Applicable Overall Risk Category: E0
Product Type:	0 Not Applicable	Location:	0 Not Applicable	
Condition:	0 Not Applicable	Accessibility:	0 Not Applicable	
Surface Treatment:	0 Not Applicable			
Asbestos Type:	0 Not Applicable	Extent Score:	0 Not Applicable

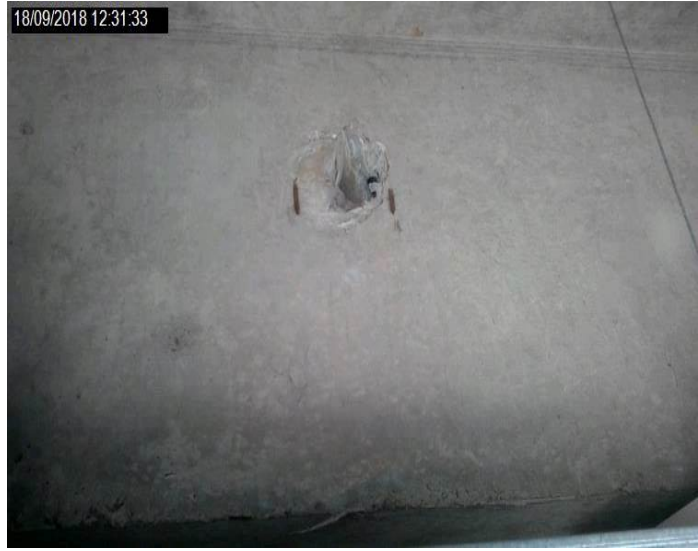
Location:	NBA222	Block:	Birmingham City University	Floor Level: 2nd Floor
Sample No.:	As DU002472	Portal Ref No.:	523

Item:	Asbestos Reinforced plastic sleeve			
Asbestos Content:	Result Based on:			
Chrysotile	Strongly presumed			
Sample Analysed By:	Not applicable	Extent:	1 unit	
Comments: To structural columns

Material Assessment Total Score: 3		Likelihood of Disturbance Assessment Total Score: 4		Management Assessment Licensable: No Recommendations: Program removal Reinspection Interval: Not Applicable Overall Risk Category: C7
Product Type:	1 (Asbestos reinforced plastic)	Location:	2 (Rooms up to 100 sq m)	
Condition:	1 (Minor scratches)	Accessibility:	1 (Occasionally likely to be disturbed)	
Surface Treatment:	0 (Composite material)			
Asbestos Type:	1 (Chrysotile)	Extent Score:	1 (<10 sq m or 10m pipe run)

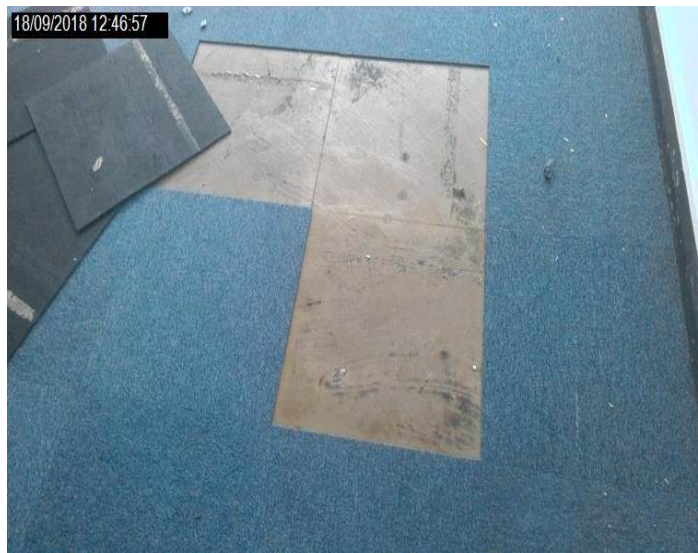
Location:	NBA219	Block:	Birmingham City University	Floor Level: 2nd Floor
Sample No.:	As DU002477	Portal Ref No.:	529

Item:	Asbestos Bitumen adhesive			
Asbestos Content:	Result Based on:			
Chrysotile	Strongly presumed			
Sample Analysed By:	Not applicable	Extent:	12 m ²	
Comments:

Material Assessment Total Score: 3		Likelihood of Disturbance Assessment Total Score: 4		Management Assessment Licensable: No Recommendations: Program removal Reinspection Interval: Not Applicable Overall Risk Category: C7
Product Type:	1 (Asbestos bitumen)	Location:	2 (Rooms up to 100 sq m)	
Condition:	1 (Minor scratches)	Accessibility:	0 (Usually inaccessible or unlikely to be disturbed)	
Surface Treatment:	0 (Composite material)			
Asbestos Type:	1 (Chrysotile)	Extent Score:	2 (>10 - <50 sq m or >10m - <50m pipe run)

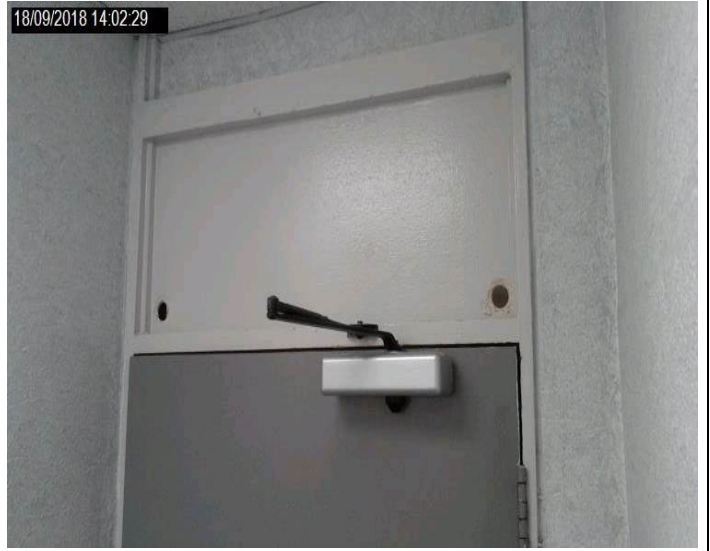
Location:	NBA218	Block:	Birmingham City University	Floor Level: 2nd Floor
Sample No.:	DU002486	Portal Ref No.:	534

Item:	Insulating board door header			
Asbestos Content:		Result Based on:		
No Asbestos Detected		Analysis of sample using PLM		
Sample Analysed By:	Reg 13(1)	Extent:	1 m ²	
Comments:

Material Assessment Total Score: 0		Likelihood of Disturbance Assessment Total Score: 0		Management Assessment Licensable: Yes Recommendations: Not Applicable Reinspection Interval: Not Applicable Overall Risk Category: E0
Product Type:	0 Not Applicable	Location:	0 Not Applicable	
Condition:	0 Not Applicable	Accessibility:	0 Not Applicable	
Surface Treatment:	0 Not Applicable			
Asbestos Type:	0 Not Applicable	Extent Score:	0 Not Applicable

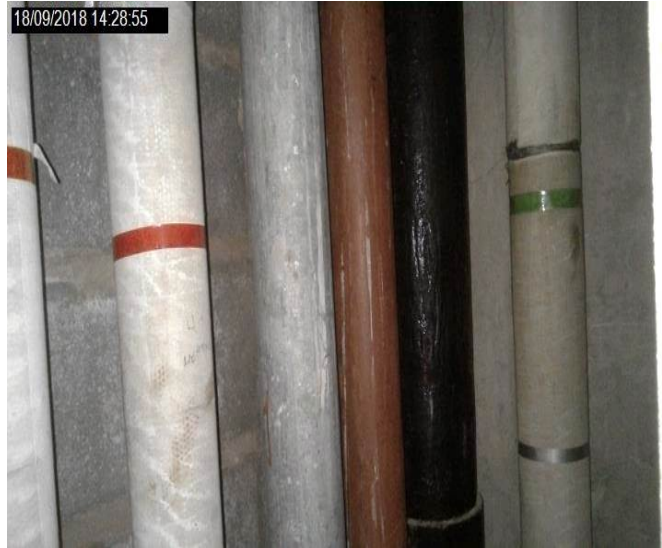
Location:	NBA210D Service duct	Block:	Birmingham City University	Floor Level: 2nd Floor
Sample No.:	As DU002476	Portal Ref No.:	539

Item:	Asbestos Reinforced plastic downpipe			
Asbestos Content:	Result Based on:			
Chrysotile	Strongly presumed			
Sample Analysed By:	Not applicable	Extent:	3 linear metres	
Comments:

Material Assessment Total Score: 3		Likelihood of Disturbance Assessment Total Score: 4		Management Assessment Licensable: No Recommendations: Program removal Reinspection Interval: Not Applicable Overall Risk Category: C7
Product Type:	1 (Asbestos reinforced plastic)	Location:	2 (Rooms up to 100 sq m)	
Condition:	1 (Minor scratches)	Accessibility:	1 (Occasionally likely to be disturbed)	
Surface Treatment:	0 (Composite material)			
Asbestos Type:	1 (Chrysotile)	Extent Score:	1 (<10 sq m or 10m pipe run)

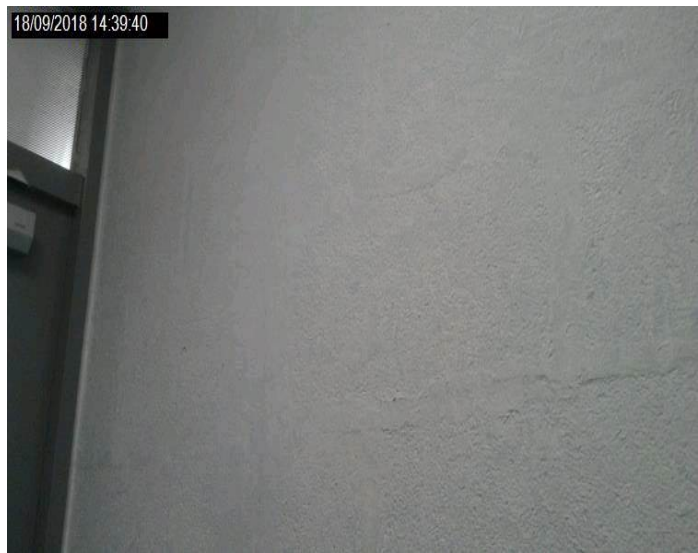
Location:	NBA217	Block:	Birmingham City University	Floor Level: 2nd Floor
Sample No.:	As DU002485	Portal Ref No.:	541

Item:	Textured coating to blockwork			
Asbestos Content:		Result Based on:		
No Asbestos Detected		Strongly presumed		
Sample Analysed By:	Not applicable	Extent:	12 m ²	
Comments: All walls

Material Assessment Total Score: 0		Likelihood of Disturbance Assessment Total Score: 0		Management Assessment Licensable: No Recommendations: Not Applicable Reinspection Interval: Not Applicable Overall Risk Category: E0
Product Type:	0 Not Applicable	Location:	0 Not Applicable	
Condition:	0 Not Applicable	Accessibility:	0 Not Applicable	
Surface Treatment:	0 Not Applicable			
Asbestos Type:	0 Not Applicable	Extent Score:	0 Not Applicable

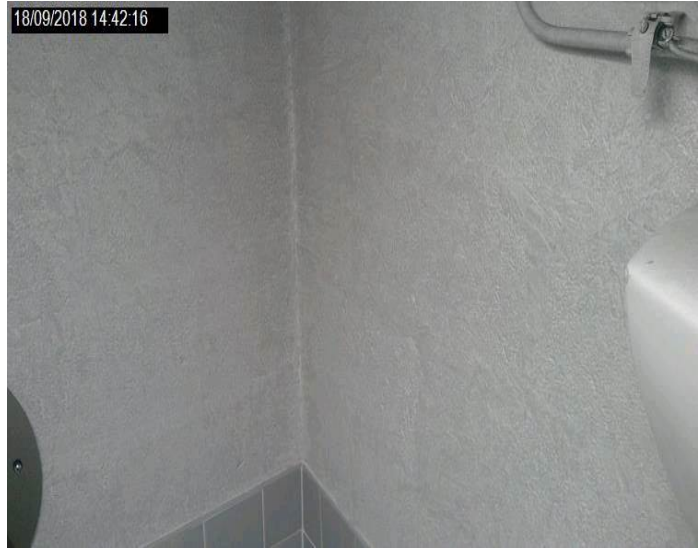
Location:	NBA216	Block:	Birmingham City University	Floor Level: 2nd Floor
Sample No.:	As DU002485	Portal Ref No.:	542

Item:	Textured coating			
Asbestos Content:		Result Based on:		
No Asbestos Detected		Strongly presumed		
Sample Analysed By:	Not applicable	Extent:	24 m ²	
Comments: All walls

Material Assessment Total Score: 0		Likelihood of Disturbance Assessment Total Score: 0		Management Assessment Licensable: No Recommendations: Not Applicable Reinspection Interval: Not Applicable Overall Risk Category: E0
Product Type:	0 Not Applicable	Location:	0 Not Applicable	
Condition:	0 Not Applicable	Accessibility:	0 Not Applicable	
Surface Treatment:	0 Not Applicable			
Asbestos Type:	0 Not Applicable	Extent Score:	0 Not Applicable

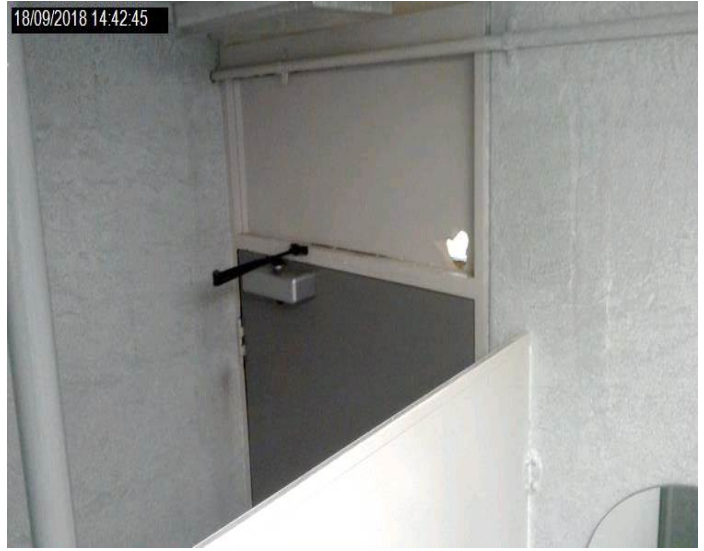
Location:	NBA216	Block:	Birmingham City University	Floor Level: 2nd Floor
Sample No.:	DU002487	Portal Ref No.:	543

Item:	Insulating board door header			
Asbestos Content:		Result Based on:		
No Asbestos Detected		Analysis of sample using PLM		
Sample Analysed By:	Reg 13(1)	Extent:	1 m ²	
Comments:

Material Assessment Total Score: 0		Likelihood of Disturbance Assessment Total Score: 0		Management Assessment Licensable: Yes Recommendations: Not Applicable Reinspection Interval: Not Applicable Overall Risk Category: E0
Product Type:	0 Not Applicable	Location:	0 Not Applicable	
Condition:	0 Not Applicable	Accessibility:	0 Not Applicable	
Surface Treatment:	0 Not Applicable			
Asbestos Type:	0 Not Applicable	Extent Score:	0 Not Applicable

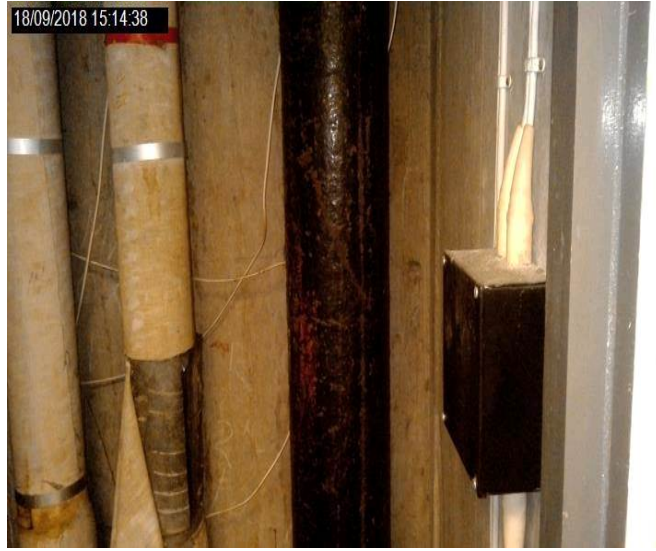
Location:	NBA210A Service duct	Block:	Birmingham City University	Floor Level: 2nd Floor
Sample No.:	As DU002476	Portal Ref No.:	551

Item:	Asbestos Reinforced plastic downpipe			
Asbestos Content:	Result Based on:			
Chrysotile	Strongly presumed			
Sample Analysed By:	Not applicable	Extent:	3 linear metres	
Comments:

Material Assessment Total Score: 3		Likelihood of Disturbance Assessment Total Score: 4		Management Assessment Licensable: No Recommendations: Program removal Reinspection Interval: Not Applicable Overall Risk Category: C7
Product Type:	1 (Asbestos reinforced plastic)	Location:	2 (Rooms up to 100 sq m)	
Condition:	1 (Minor scratches)	Accessibility:	1 (Occasionally likely to be disturbed)	
Surface Treatment:	0 (Composite material)			
Asbestos Type:	1 (Chrysotile)	Extent Score:	1 (<10 sq m or 10m pipe run)

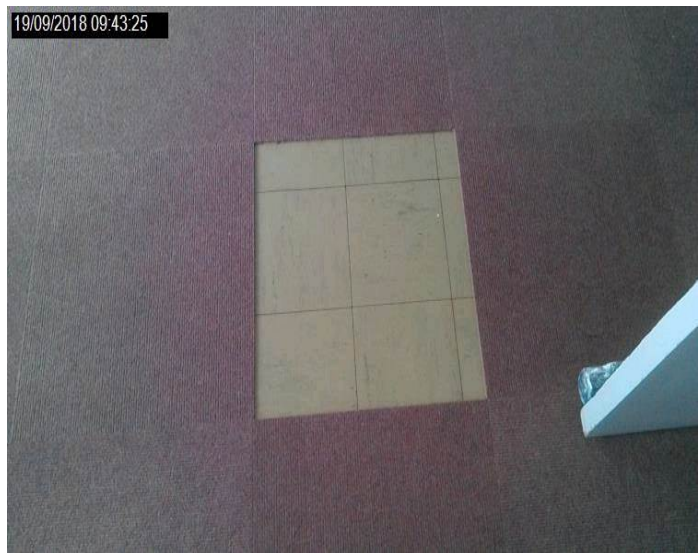
Location:	NBA213A	Block:	Birmingham City University	Floor Level: 2nd Floor
Sample No.:	As DU002491	Portal Ref No.:	556

Item:	Asbestos Thermoplastic floor tiles			
Asbestos Content:	Result Based on:			
Chrysotile in tile and adhesive	Strongly presumed			
Sample Analysed By:	Not applicable	Extent:	10 m ²	
Comments:

Material Assessment Total Score: 3		Likelihood of Disturbance Assessment Total Score: 3		Management Assessment Licensable: No Recommendations: Program removal Reinspection Interval: Not Applicable Overall Risk Category: D6
Product Type:	1 (Asbestos thermoplastic)	Location:	2 (Rooms up to 100 sq m)	
Condition:	1 (Minor scratches)	Accessibility:	0 (Usually inaccessible or unlikely to be disturbed)	
Surface Treatment:	0 (Composite material)			
Asbestos Type:	1 (Chrysotile)	Extent Score:	1 (<10 sq m or 10m pipe run)

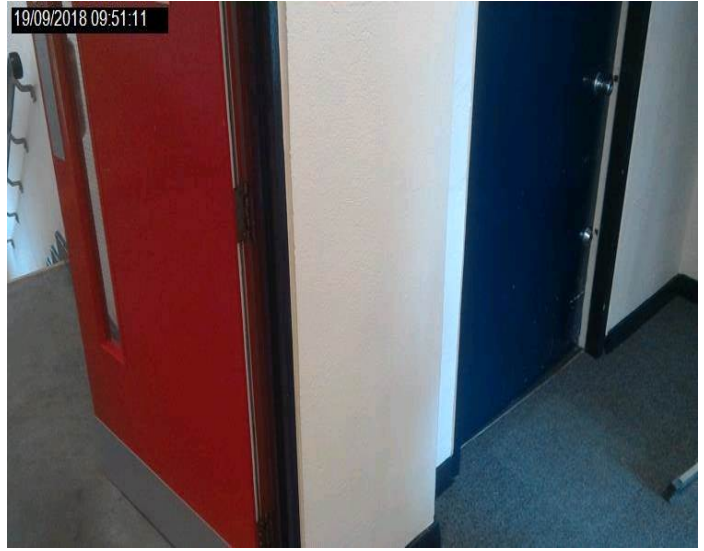
Location:	NBA299A Corridor	Block:	Birmingham City University	Floor Level: 2nd Floor
Sample No.:	DU002492	Portal Ref No.:	558

Item:	Textured coating to concrete sections			
Asbestos Content:	Result Based on:			
No Asbestos Detected	Analysis of sample using PLM			
Sample Analysed By: Reg 13(1)	Extent:	16 m ²		
Comments: To concrete sections

Material Assessment Total Score: 0		Likelihood of Disturbance Assessment Total Score: 0		Management Assessment Licensable: No Recommendations: Not Applicable Reinspection Interval: Not Applicable Overall Risk Category: E0
Product Type:	0 Not Applicable	Location:	0 Not Applicable	
Condition:	0 Not Applicable	Accessibility:	0 Not Applicable	
Surface Treatment:	0 Not Applicable			
Asbestos Type:	0 Not Applicable	Extent Score:	0 Not Applicable

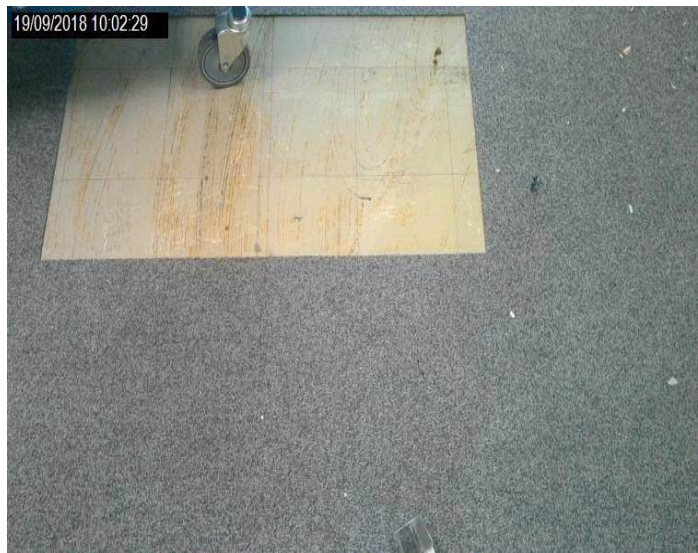
Location:	NBA299B Corridor	Block:	Birmingham City University	Floor Level: 2nd Floor
Sample No.:	As DU002493	Portal Ref No.:	560

Item:	Asbestos Thermoplastic floor tiles with bitumen adhesive			
Asbestos Content:	Result Based on:			
Chrysotile in tile and adhesive	Strongly presumed			
Sample Analysed By:	Not applicable	Extent:	35 m ²	
Comments:

Material Assessment Total Score: 3		Likelihood of Disturbance Assessment Total Score: 5		Management Assessment Licensable: No Recommendations: Program removal Reinspection Interval: Not Applicable Overall Risk Category: C8
Product Type:	1 (Asbestos thermoplastic)	Location:	2 (Rooms up to 100 sq m)	
Condition:	1 (Minor scratches)	Accessibility:	1 (Occasionally likely to be disturbed)	
Surface Treatment:	0 (Composite material)			
Asbestos Type:	1 (Chrysotile)	Extent Score:	2 (>10 - <50 sq m or >10m - <50m pipe run)

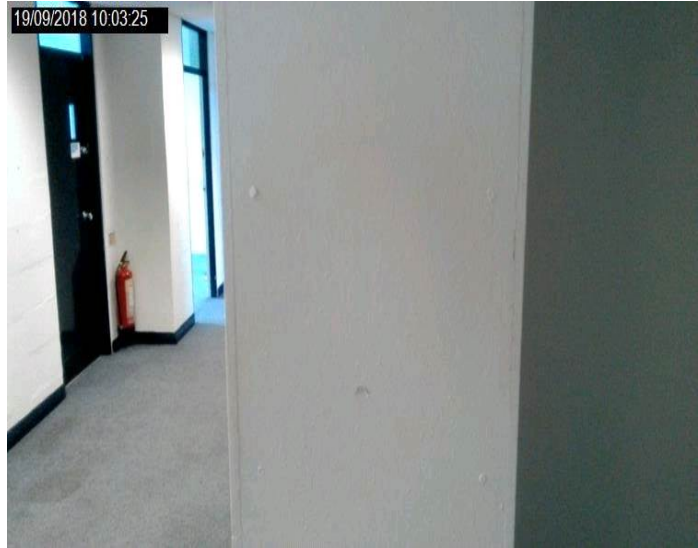
Location:	NBA299B Corridor	Block:	Birmingham City University	Floor Level: 2nd Floor
Sample No.:	As DU002492	Portal Ref No.:	561

Item:	Textured coating to concrete sections			
Asbestos Content:		Result Based on:		
No Asbestos Detected		Strongly presumed		
Sample Analysed By:	Not applicable	Extent:	16 m ²	
Comments: To concrete sections and timber boxing

Material Assessment Total Score: 0		Likelihood of Disturbance Assessment Total Score: 0		Management Assessment Licensable: No Recommendations: Not Applicable Reinspection Interval: Not Applicable Overall Risk Category: E0
Product Type:	0 Not Applicable	Location:	0 Not Applicable	
Condition:	0 Not Applicable	Accessibility:	0 Not Applicable	
Surface Treatment:	0 Not Applicable			
Asbestos Type:	0 Not Applicable	Extent Score:	0 Not Applicable

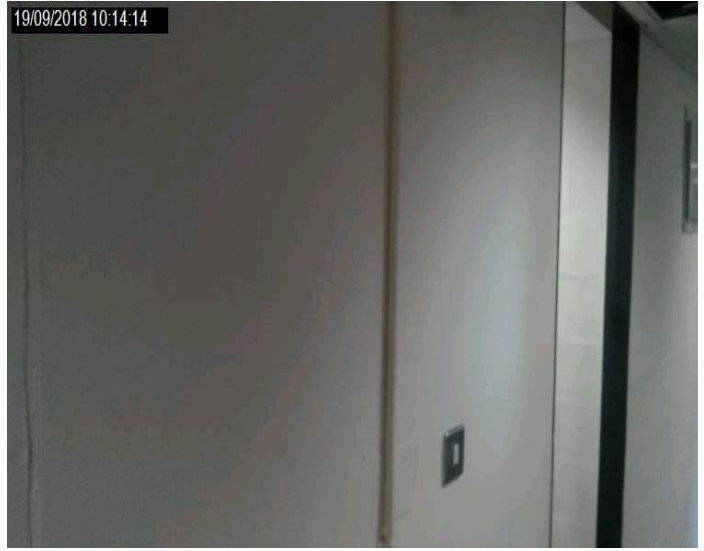
Location:	NBA299C Corridor	Block:	Birmingham City University	Floor Level: 2nd Floor
Sample No.:	As DU002492	Portal Ref No.:	564

Item:	Textured coating to concrete sections			
Asbestos Content:		Result Based on:		
No Asbestos Detected		Strongly presumed		
Sample Analysed By:	Not applicable	Extent:	25 m ²	
Comments: To concrete sections

Material Assessment Total Score: 0		Likelihood of Disturbance Assessment Total Score: 0		Management Assessment Licensable: No Recommendations: Not Applicable Reinspection Interval: Not Applicable Overall Risk Category: E0
Product Type:	0 Not Applicable	Location:	0 Not Applicable	
Condition:	0 Not Applicable	Accessibility:	0 Not Applicable	
Surface Treatment:	0 Not Applicable			
Asbestos Type:	0 Not Applicable	Extent Score:	0 Not Applicable

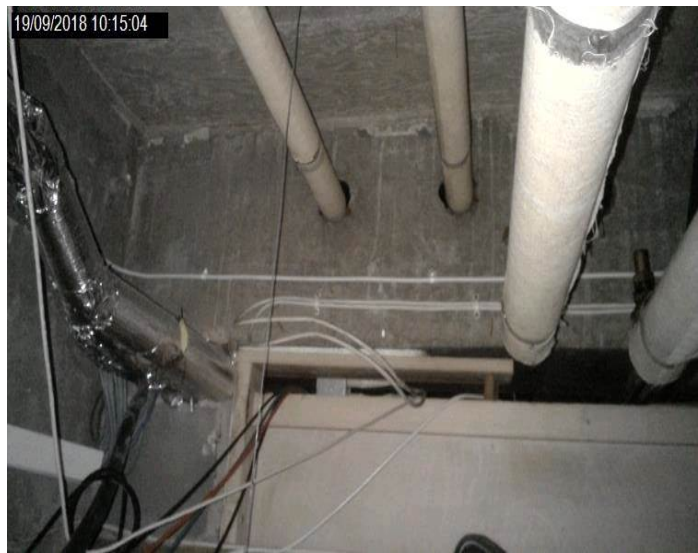
Location:	NBA299C Corridor	Block:	Birmingham City University	Floor Level: 2nd Floor
Sample No.:	As DU002484	Portal Ref No.:	565

Item:	Asbestos Reinforced plastic sleeve			
Asbestos Content:	Result Based on:			
Chrysotile	Strongly presumed			
Sample Analysed By:	Not applicable	Extent:	6 units	
Comments:

Material Assessment Total Score: 3		Likelihood of Disturbance Assessment Total Score: 3		Management Assessment Licensable: No Recommendations: Program removal Reinspection Interval: Not Applicable Overall Risk Category: D6
Product Type:	1 (Asbestos reinforced plastic)	Location:	2 (Rooms up to 100 sq m)	
Condition:	1 (Minor scratches)	Accessibility:	0 (Usually inaccessible or unlikely to be disturbed)	
Surface Treatment:	0 (Composite material)			
Asbestos Type:	1 (Chrysotile)	Extent Score:	1 (<10 sq m or 10m pipe run)

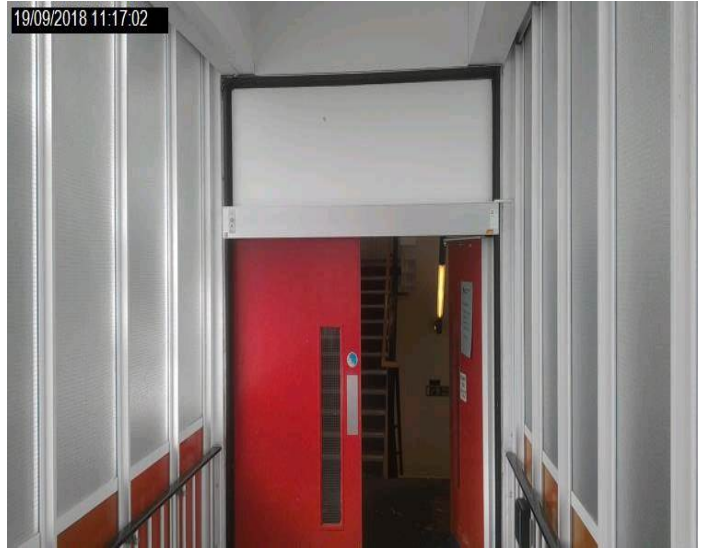
Location:	Attwood walkway	Block:	Birmingham City University	Floor Level: 1st Floor
Sample No.:	DU002494	Portal Ref No.:	566

Item:	Insulating board door header panel			
Asbestos Content:		Result Based on:		
No Asbestos Detected		Analysis of sample using PLM		
Sample Analysed By:	Reg 13(1)	Extent:	2 m ²	
Comments: Above door leading to Attwood building

Material Assessment Total Score: 0		Likelihood of Disturbance Assessment Total Score: 0		Management Assessment Licensable: Yes Recommendations: Not Applicable Reinspection Interval: Not Applicable Overall Risk Category: E0
Product Type:	0 Not Applicable	Location:	0 Not Applicable	
Condition:	0 Not Applicable	Accessibility:	0 Not Applicable	
Surface Treatment:	0 Not Applicable			
Asbestos Type:	0 Not Applicable	Extent Score:	0 Not Applicable

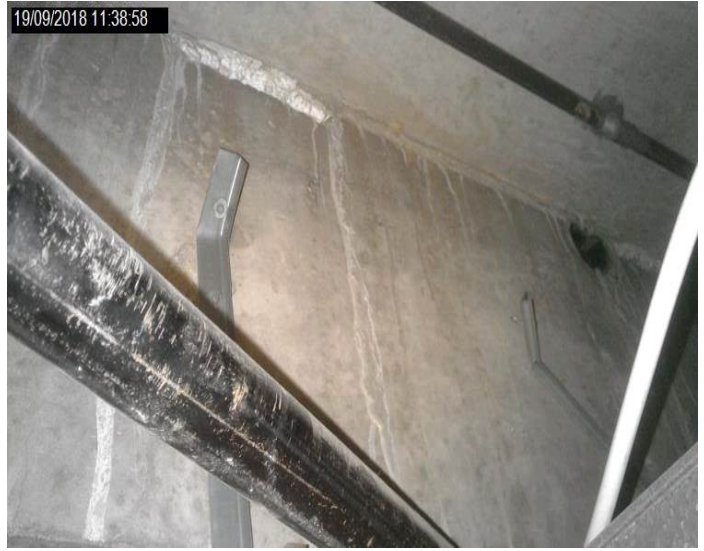
Location:	NBA102	Block:	Birmingham City University	Floor Level: 1st Floor
Sample No.:	As DU002496	Portal Ref No.:	572

Item:	Asbestos Reinforced plastic sleeve			
Asbestos Content:	Result Based on:			
Chrysotile	Strongly presumed			
Sample Analysed By:	Not applicable	Extent:	4 units	
Comments: To the structural columns

Material Assessment Total Score: 3		Likelihood of Disturbance Assessment Total Score: 4		Management Assessment Licensable: No Recommendations: Program removal Reinspection Interval: Not Applicable Overall Risk Category: C7
Product Type:	1 (Asbestos reinforced plastic)	Location:	2 (Rooms up to 100 sq m)	
Condition:	1 (Minor scratches)	Accessibility:	1 (Occasionally likely to be disturbed)	
Surface Treatment:	0 (Composite material)			
Asbestos Type:	1 (Chrysotile)	Extent Score:	1 (<10 sq m or 10m pipe run)

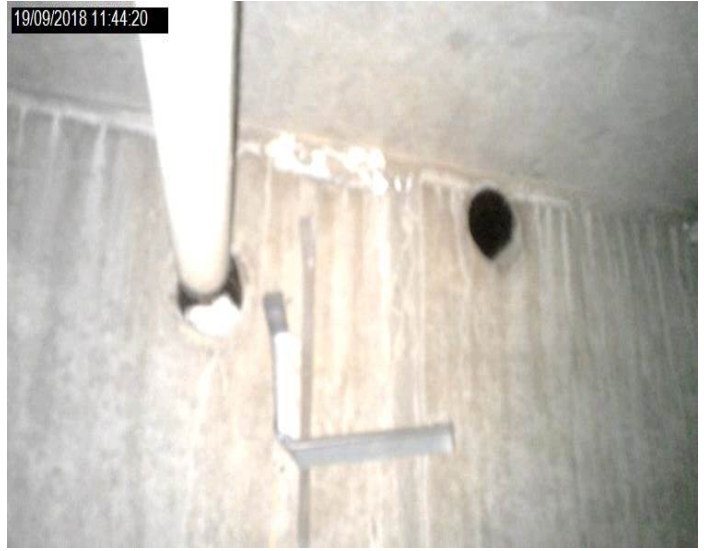
Location:	NBA199A	Block:	Birmingham City University	Floor Level: 1st Floor
Sample No.:	As DU002496	Portal Ref No.:	575

Item:	Asbestos Reinforced plastic sleeve			
Asbestos Content:	Result Based on:			
Chrysotile	Strongly presumed			
Sample Analysed By:	Not applicable	Extent:	2 units	
Comments: To the structural columns

Material Assessment Total Score: 3		Likelihood of Disturbance Assessment Total Score: 4		Management Assessment Licensable: No Recommendations: Program removal Reinspection Interval: Not Applicable Overall Risk Category: C7
Product Type:	1 (Asbestos reinforced plastic)	Location:	2 (Rooms up to 100 sq m)	
Condition:	1 (Minor scratches)	Accessibility:	1 (Occasionally likely to be disturbed)	
Surface Treatment:	0 (Composite material)			
Asbestos Type:	1 (Chrysotile)	Extent Score:	1 (<10 sq m or 10m pipe run)

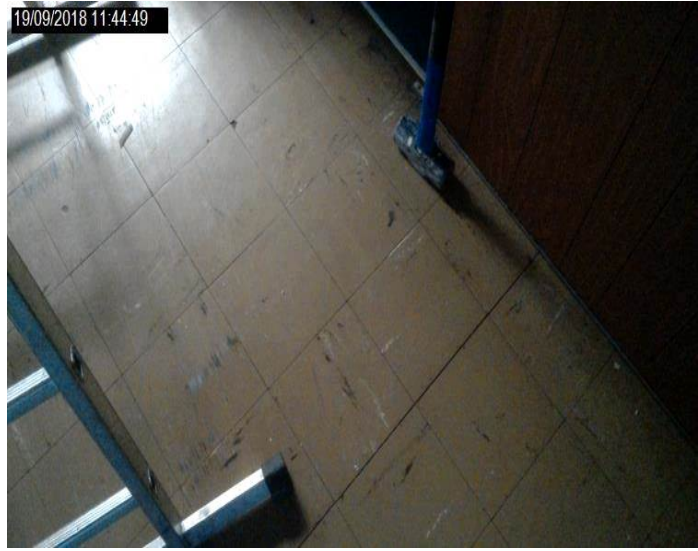
Location:	NBA199A	Block:	Birmingham City University	Floor Level: 1st Floor
Sample No.:	As DU002497	Portal Ref No.:	576

Item:	Asbestos Thermoplastic floor tiles			
Asbestos Content:	Result Based on:			
Chrysotile in tile and adhesive	Strongly presumed			
Sample Analysed By:	Not applicable	Extent:	8 m ²	
Comments:

Material Assessment Total Score: 3		Likelihood of Disturbance Assessment Total Score: 6		Management Assessment Licensable: No Recommendations: Program removal Reinspection Interval: Not Applicable Overall Risk Category: C9
Product Type:	1 (Asbestos thermoplastic)	Location:	2 (Rooms up to 100 sq m)	
Condition:	1 (Minor scratches)	Accessibility:	3 (Routinely disturbed)	
Surface Treatment:	0 (Composite material)			
Asbestos Type:	1 (Chrysotile)	Extent Score:	1 (<10 sq m or 10m pipe run)

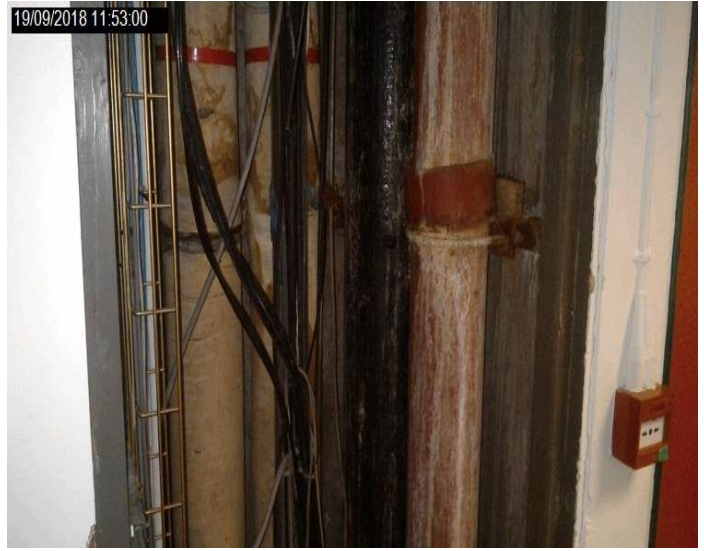
Location:	NBA129A Service duct	Block:	Birmingham City University	Floor Level: 1st Floor
Sample No.:	DU002498	Portal Ref No.:	577

Item:	Asbestos Reinforced plastic downpipe			
Asbestos Content:	Result Based on:			
Chrysotile	Analysis of sample using PLM			
Sample Analysed By:	Reg 13(1)	Extent:	3 linear metres	
Comments:

Material Assessment Total Score: 3		Likelihood of Disturbance Assessment Total Score: 4		Management Assessment Licensable: No Recommendations: Program removal Reinspection Interval: Not Applicable Overall Risk Category: C7
Product Type:	1 (Asbestos reinforced plastic)	Location:	2 (Rooms up to 100 sq m)	
Condition:	1 (Minor scratches)	Accessibility:	1 (Occasionally likely to be disturbed)	
Surface Treatment:	0 (Composite material)			
Asbestos Type:	1 (Chrysotile)	Extent Score:	1 (<10 sq m or 10m pipe run)

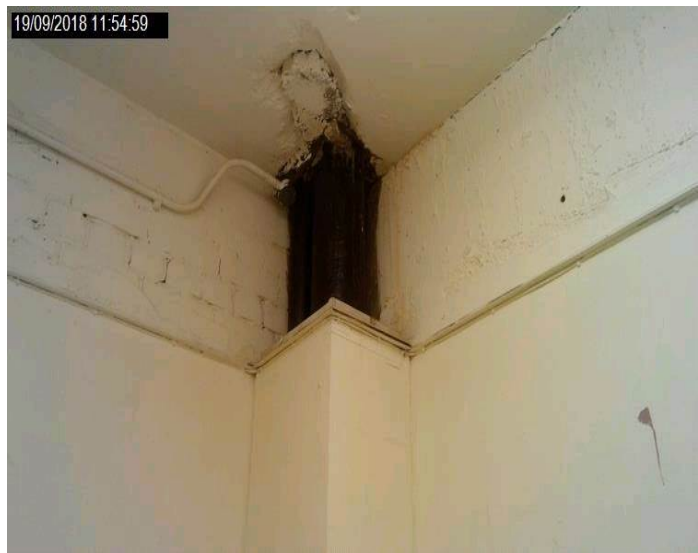
Location:	NBA105	Block:	Birmingham City University	Floor Level: 1st Floor
Sample No.:	As DU002498	Portal Ref No.:	578

Item:	Asbestos Reinforced plastic downpipe			
Asbestos Content:	Result Based on:			
Chrysotile	Strongly presumed			
Sample Analysed By:	Not applicable	Extent:	3 linear metres	
Comments: Internally to timber boxing

Material Assessment Total Score: 3		Likelihood of Disturbance Assessment Total Score: 4		Management Assessment Licensable: No Recommendations: Program removal Reinspection Interval: Not Applicable Overall Risk Category: C7
Product Type:	1 (Asbestos reinforced plastic)	Location:	2 (Rooms up to 100 sq m)	
Condition:	1 (Minor scratches)	Accessibility:	1 (Occasionally likely to be disturbed)	
Surface Treatment:	0 (Composite material)			
Asbestos Type:	1 (Chrysotile)	Extent Score:	1 (<10 sq m or 10m pipe run)

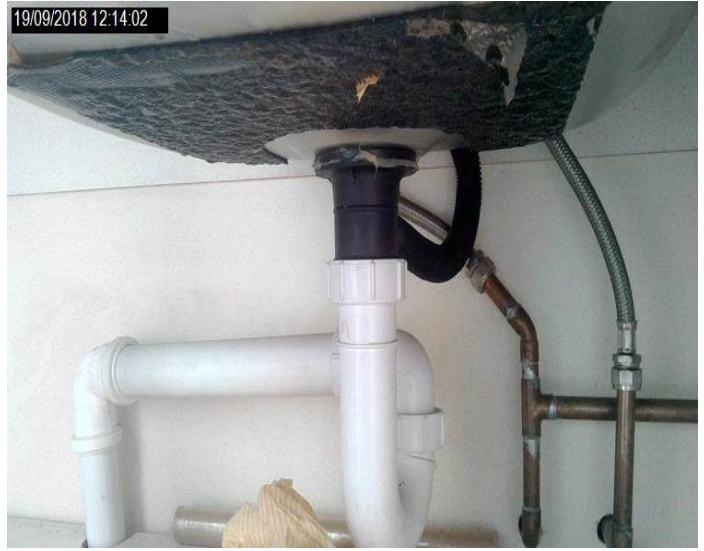
Location:	NBA127	Block:	Birmingham City University	Floor Level: 1st Floor
Sample No.:	DU002499	Portal Ref No.:	579

Item:	Bitumen sink pad			
Asbestos Content:		Result Based on:		
No Asbestos Detected		Analysis of sample using PLM		
Sample Analysed By:	Reg 13(1)	Extent:	1 unit	
Comments: sink only

Material Assessment Total Score: 0		Likelihood of Disturbance Assessment Total Score: 0		Management Assessment Licensable: No Recommendations: Not Applicable Reinspection Interval: Not Applicable Overall Risk Category: E0
Product Type:	0 Not Applicable	Location:	0 Not Applicable	
Condition:	0 Not Applicable	Accessibility:	0 Not Applicable	
Surface Treatment:	0 Not Applicable			
Asbestos Type:	0 Not Applicable	Extent Score:	0 Not Applicable

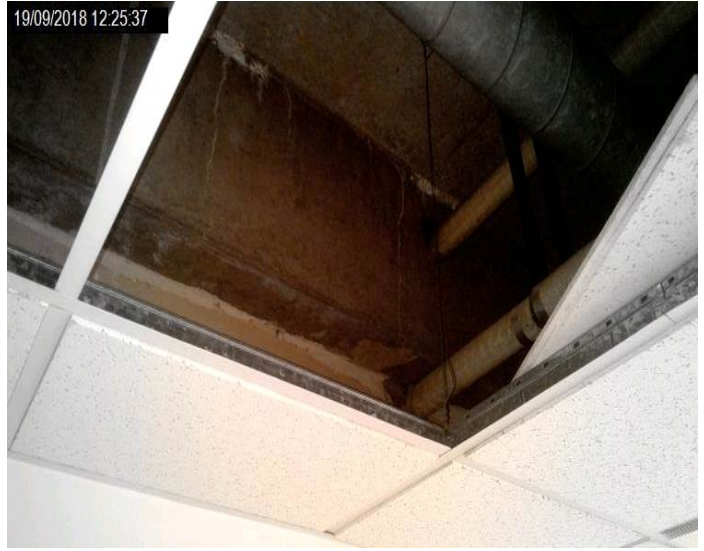
Location:	NBA111	Block:	Birmingham City University	Floor Level: 1st Floor
Sample No.:	As DU002496	Portal Ref No.:	581

Item:	Asbestos Reinforced plastic sleeve			
Asbestos Content:	Result Based on:			
Chrysotile	Strongly presumed			
Sample Analysed By:	Not applicable	Extent:	3 units	
Comments:

Material Assessment Total Score: 3		Likelihood of Disturbance Assessment Total Score: 4		Management Assessment Licensable: No Recommendations: Program removal Reinspection Interval: Not Applicable Overall Risk Category: C7
Product Type:	1 (Asbestos reinforced plastic)	Location:	2 (Rooms up to 100 sq m)	
Condition:	1 (Minor scratches)	Accessibility:	1 (Occasionally likely to be disturbed)	
Surface Treatment:	0 (Composite material)			
Asbestos Type:	1 (Chrysotile)	Extent Score:	1 (<10 sq m or 10m pipe run)

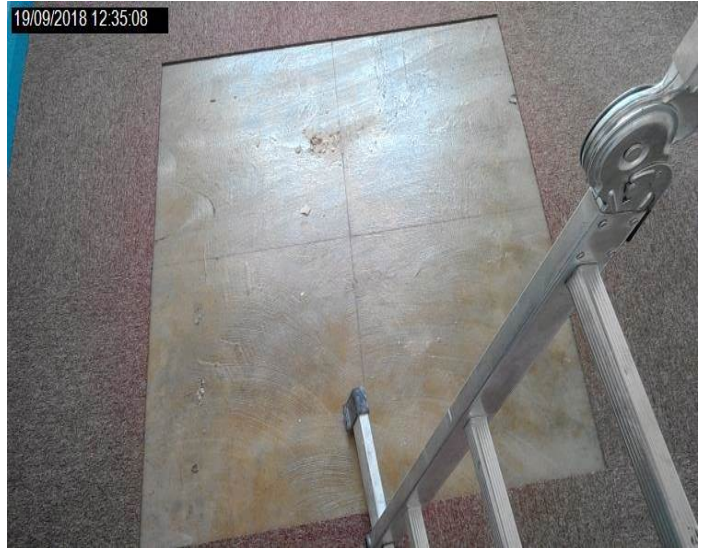
Location:	NBA109	Block:	Birmingham City University	Floor Level: 1st Floor
Sample No.:	DU002500	Portal Ref No.:	586

Item:	Asbestos Bitumen adhesive			
Asbestos Content:	Result Based on:			
Chrysotile	Analysis of sample using PLM			
Sample Analysed By: Reg 13(1)	Extent:	8 m ²		
Comments:

Material Assessment Total Score: 3		Likelihood of Disturbance Assessment Total Score: 3		Management Assessment Licensable: No Recommendations: Program removal Reinspection Interval: Not Applicable Overall Risk Category: D6
Product Type:	1 (Asbestos bitumen)	Location:	2 (Rooms up to 100 sq m)	
Condition:	1 (Minor scratches)	Accessibility:	0 (Usually inaccessible or unlikely to be disturbed)	
Surface Treatment:	0 (Composite material)			
Asbestos Type:	1 (Chrysotile)	Extent Score:	1 (<10 sq m or 10m pipe run)

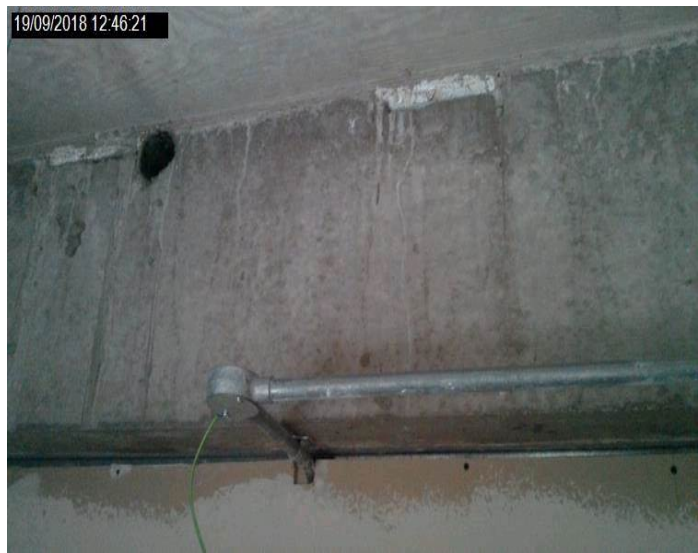
Location:	NBA108	Block:	Birmingham City University	Floor Level: 1st Floor
Sample No.:	As DU002496	Portal Ref No.:	587

Item:	Asbestos Reinforced plastic sleeve			
Asbestos Content:	Result Based on:			
Chrysotile	Strongly presumed			
Sample Analysed By:	Not applicable	Extent:	2 units	
Comments:

Material Assessment Total Score: 3		Likelihood of Disturbance Assessment Total Score: 4		Management Assessment Licensable: No Recommendations: Program removal Reinspection Interval: Not Applicable Overall Risk Category: C7
Product Type:	1 (Asbestos reinforced plastic)	Location:	2 (Rooms up to 100 sq m)	
Condition:	1 (Minor scratches)	Accessibility:	1 (Occasionally likely to be disturbed)	
Surface Treatment:	0 (Composite material)			
Asbestos Type:	1 (Chrysotile)	Extent Score:	1 (<10 sq m or 10m pipe run)

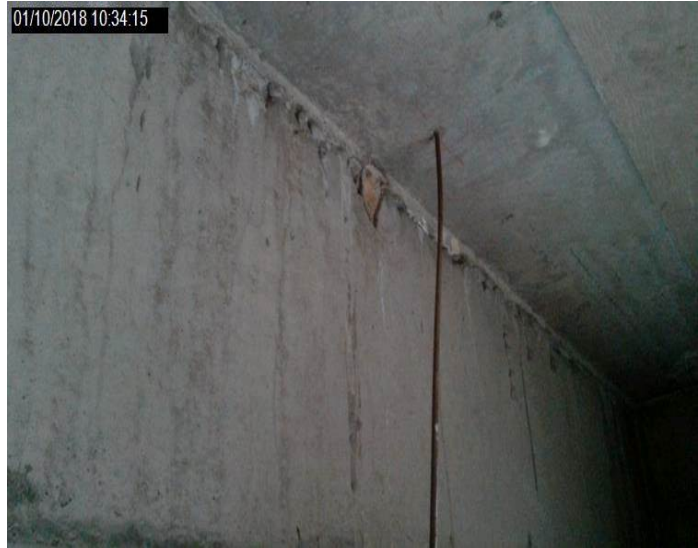
Location:	NBA107	Block:	Birmingham City University	Floor Level: 1st Floor
Sample No.:	DU002512	Portal Ref No.:	588

Item:	Asbestos Reinforced plastic sleeve			
Asbestos Content:	Result Based on:			
Chrysotile	Analysis of sample using PLM			
Sample Analysed By: Reg 13(1)	Extent:	2 units		
Comments:

Material Assessment Total Score: 3		Likelihood of Disturbance Assessment Total Score: 4		Management Assessment Licensable: No Recommendations: Program removal Reinspection Interval: Not Applicable Overall Risk Category: C7
Product Type:	1 (Asbestos reinforced plastic)	Location:	2 (Rooms up to 100 sq m)	
Condition:	1 (Minor scratches)	Accessibility:	1 (Occasionally likely to be disturbed)	
Surface Treatment:	0 (Composite material)			
Asbestos Type:	1 (Chrysotile)	Extent Score:	1 (<10 sq m or 10m pipe run)

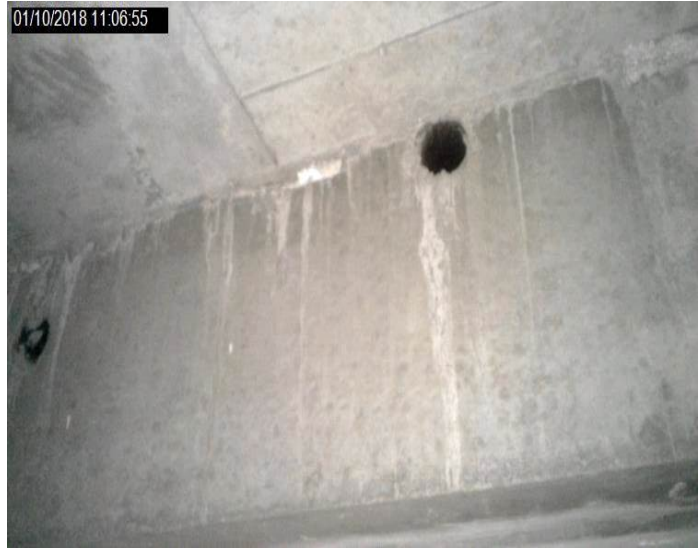
Location:	NBA199B	Block:	Birmingham City University	Floor Level: 1st Floor
Sample No.:	As DU002512	Portal Ref No.:	592

Item:	Asbestos Reinforced plastic sleeve			
Asbestos Content:	Result Based on:			
Chrysotile	Strongly presumed			
Sample Analysed By:	Not applicable	Extent:	6 units	
Comments:

Material Assessment Total Score: 3		Likelihood of Disturbance Assessment Total Score: 4		Management Assessment Licensable: No Recommendations: Program removal Reinspection Interval: Not Applicable Overall Risk Category: C7
Product Type:	1 (Asbestos reinforced plastic)	Location:	2 (Rooms up to 100 sq m)	
Condition:	1 (Minor scratches)	Accessibility:	1 (Occasionally likely to be disturbed)	
Surface Treatment:	0 (Composite material)			
Asbestos Type:	1 (Chrysotile)	Extent Score:	1 (<10 sq m or 10m pipe run)

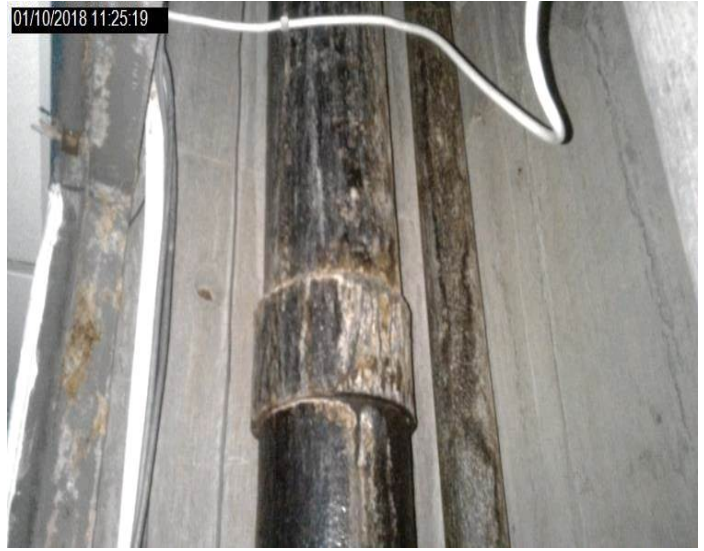
Location:	NBA112B	Block:	Birmingham City University	Floor Level: 1st Floor
Sample No.:	DU002515	Portal Ref No.:	596

Item:	Asbestos Reinforced plastic downpipe			
Asbestos Content:	Result Based on:			
Chrysotile	Analysis of sample using PLM			
Sample Analysed By: Reg 13(1)	Extent:	4 linear metres		
Comments:

Material Assessment Total Score: 3		Likelihood of Disturbance Assessment Total Score: 4		Management Assessment Licensable: No Recommendations: Program removal Reinspection Interval: Not Applicable Overall Risk Category: C7
Product Type:	1 (Asbestos reinforced plastic)	Location:	2 (Rooms up to 100 sq m)	
Condition:	1 (Minor scratches)	Accessibility:	1 (Occasionally likely to be disturbed)	
Surface Treatment:	0 (Composite material)			
Asbestos Type:	1 (Chrysotile)	Extent Score:	1 (<10 sq m or 10m pipe run)

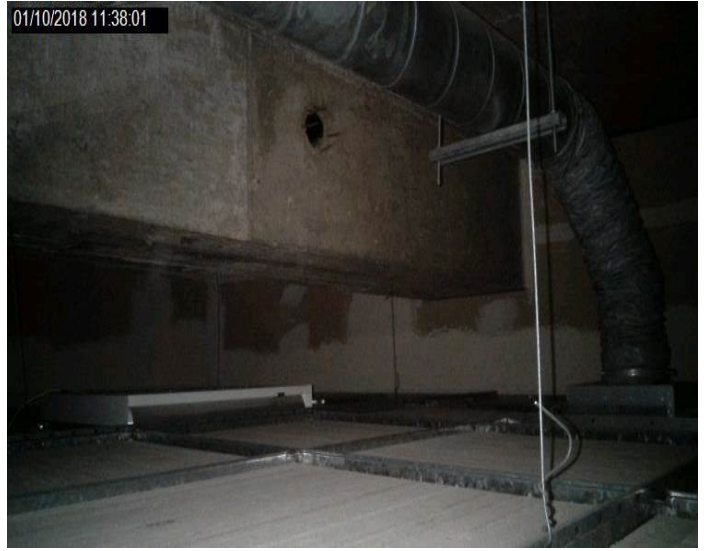
Location:	NBA125	Block:	Birmingham City University	Floor Level: 1st Floor
Sample No.:	As DU002512	Portal Ref No.:	597

Item:	Asbestos Reinforced plastic sleeve			
Asbestos Content:	Result Based on:			
Chrysotile	Strongly presumed			
Sample Analysed By:	Not applicable	Extent:	4 units	
Comments:

Material Assessment Total Score: 3		Likelihood of Disturbance Assessment Total Score: 4		Management Assessment Licensable: No Recommendations: Program removal Reinspection Interval: Not Applicable Overall Risk Category: C7
Product Type:	1 (Asbestos reinforced plastic)	Location:	2 (Rooms up to 100 sq m)	
Condition:	1 (Minor scratches)	Accessibility:	1 (Occasionally likely to be disturbed)	
Surface Treatment:	0 (Composite material)			
Asbestos Type:	1 (Chrysotile)	Extent Score:	1 (<10 sq m or 10m pipe run)

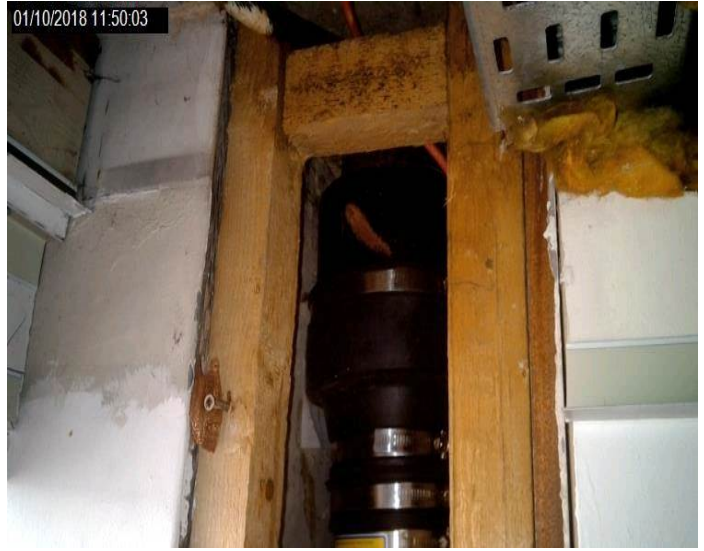
Location:	NBA124	Block:	Birmingham City University	Floor Level: 1st Floor
Sample No.:	As DU002515	Portal Ref No.:	598

Item:	Asbestos Reinforced plastic downpipe			
Asbestos Content:	Result Based on:			
Chrysotile	Strongly presumed			
Sample Analysed By:	Not applicable	Extent:	<1 linear metres	
Comments: Top section of pipework

Material Assessment Total Score: 3		Likelihood of Disturbance Assessment Total Score: 4		Management Assessment Licensable: No Recommendations: Program removal Reinspection Interval: Not Applicable Overall Risk Category: C7
Product Type:	1 (Asbestos reinforced plastic)	Location:	2 (Rooms up to 100 sq m)	
Condition:	1 (Minor scratches)	Accessibility:	1 (Occasionally likely to be disturbed)	
Surface Treatment:	0 (Composite material)			
Asbestos Type:	1 (Chrysotile)	Extent Score:	1 (<10 sq m or 10m pipe run)

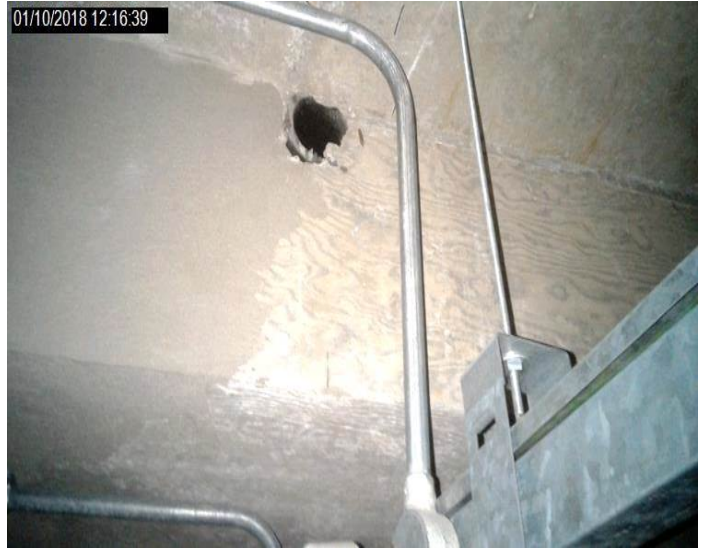
Location:	NBA116	Block:	Birmingham City University	Floor Level: 1st Floor
Sample No.:	As DU002512	Portal Ref No.:	599

Item:	Asbestos Reinforced plastic sleeve			
Asbestos Content:	Result Based on:			
Chrysotile	Strongly presumed			
Sample Analysed By:	Not applicable	Extent:	4 units	
Comments:

Material Assessment Total Score: 3		Likelihood of Disturbance Assessment Total Score: 4		Management Assessment Licensable: No Recommendations: Program removal Reinspection Interval: Not Applicable Overall Risk Category: C7
Product Type:	1 (Asbestos reinforced plastic)	Location:	2 (Rooms up to 100 sq m)	
Condition:	1 (Minor scratches)	Accessibility:	1 (Occasionally likely to be disturbed)	
Surface Treatment:	0 (Composite material)			
Asbestos Type:	1 (Chrysotile)	Extent Score:	1 (<10 sq m or 10m pipe run)

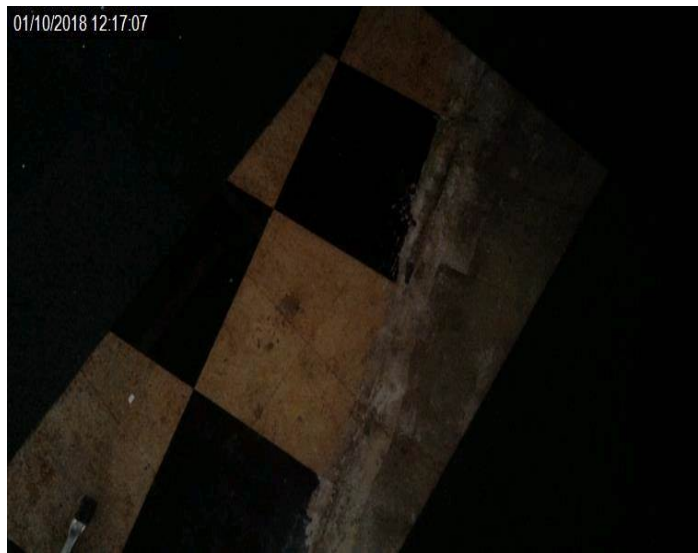
Location:	NBA116	Block:	Birmingham City University	Floor Level: 1st Floor
Sample No.:	As DU002513	Portal Ref No.:	600

Item:	Vinyl			
Asbestos Content:		Result Based on:		
No Asbestos Detected		Strongly presumed		
Sample Analysed By:	Not applicable	Extent:	10 m ²	
Comments: Beneath carpet tile, to front section of room only see plan for location

Material Assessment Total Score: 0		Likelihood of Disturbance Assessment Total Score: 0		Management Assessment Licensable: No Recommendations: Not Applicable Reinspection Interval: Not Applicable Overall Risk Category: E0
Product Type:	0 Not Applicable	Location:	0 Not Applicable	
Condition:	0 Not Applicable	Accessibility:	0 Not Applicable	
Surface Treatment:	0 Not Applicable			
Asbestos Type:	0 Not Applicable	Extent Score:	0 Not Applicable

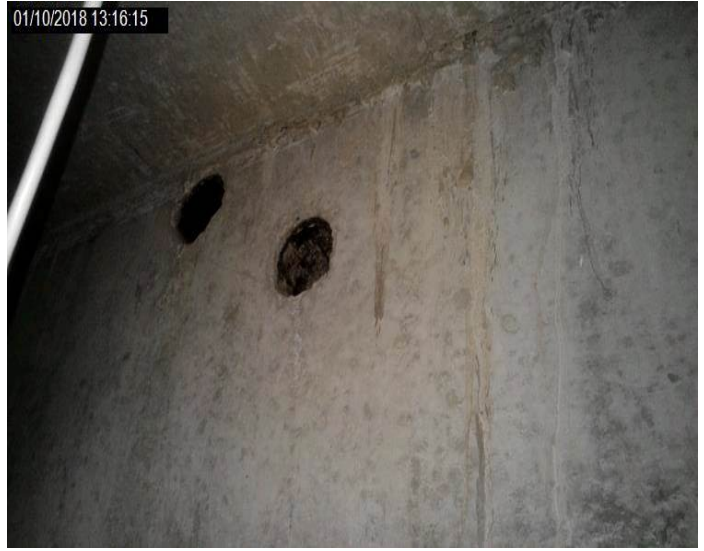
Location:	NBA131	Block:	Birmingham City University	Floor Level: 1st Floor
Sample No.:	As DU002512	Portal Ref No.:	601

Item:	Asbestos Reinforced plastic sleeve			
Asbestos Content:	Result Based on:			
Chrysotile	Strongly presumed			
Sample Analysed By:	Not applicable	Extent:	12 units	
Comments:

Material Assessment Total Score: 3		Likelihood of Disturbance Assessment Total Score: 4		Management Assessment Licensable: No Recommendations: Program removal Reinspection Interval: Not Applicable Overall Risk Category: C7
Product Type:	1 (Asbestos reinforced plastic)	Location:	2 (Rooms up to 100 sq m)	
Condition:	1 (Minor scratches)	Accessibility:	1 (Occasionally likely to be disturbed)	
Surface Treatment:	0 (Composite material)			
Asbestos Type:	1 (Chrysotile)	Extent Score:	1 (<10 sq m or 10m pipe run)
