Location:	NBA201A	Block:	Birmingham City University	Floor Level: 2nd Floor
Sample No.:	DU002474	Portal Ref No.:	492

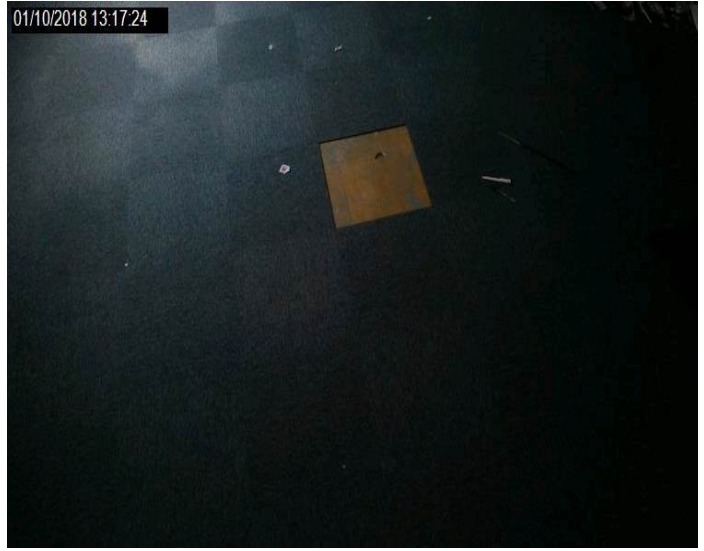
Location:	NBA131	Block:	Birmingham City University	Floor Level: 1st Floor
Sample No.:	DU002516	Portal Ref No.:	602

Item:	Asbestos Thermoplastic floor tiles			
Asbestos Content:	Result Based on:			
Chrysotile in adhesive only	Analysis of sample using PLM			
Sample Analysed By: Reg 13(1)	Extent:	36 m ²		
Comments:

Material Assessment Total Score: 3		Likelihood of Disturbance Assessment Total Score: 5		Management Assessment Licensable: No Recommendations: Program removal Reinspection Interval: Not Applicable Overall Risk Category: C8
Product Type:	1 (Asbestos thermoplastic)	Location:	2 (Rooms up to 100 sq m)	
Condition:	1 (Minor scratches)	Accessibility:	1 (Occasionally likely to be disturbed)	
Surface Treatment:	0 (Composite material)			
Asbestos Type:	1 (Chrysotile)	Extent Score:	2 (>10 - <50 sq m or >10m - <50m pipe run)

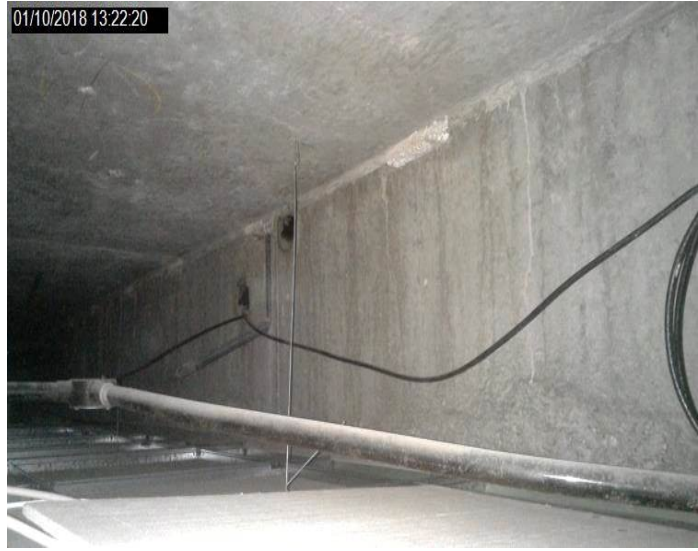
Location:	NBA132	Block:	Birmingham City University	Floor Level: 1st Floor
Sample No.:	As DU002512	Portal Ref No.:	603

Item:	Asbestos Reinforced plastic sleeve			
Asbestos Content:	Result Based on:			
Chrysotile	Strongly presumed			
Sample Analysed By:	Not applicable	Extent:	6 units	
Comments:

Material Assessment Total Score: 3		Likelihood of Disturbance Assessment Total Score: 4		Management Assessment Licensable: No Recommendations: Program removal Reinspection Interval: Not Applicable Overall Risk Category: C7
Product Type:	1 (Asbestos reinforced plastic)	Location:	2 (Rooms up to 100 sq m)	
Condition:	1 (Minor scratches)	Accessibility:	1 (Occasionally likely to be disturbed)	
Surface Treatment:	0 (Composite material)			
Asbestos Type:	1 (Chrysotile)	Extent Score:	1 (<10 sq m or 10m pipe run)

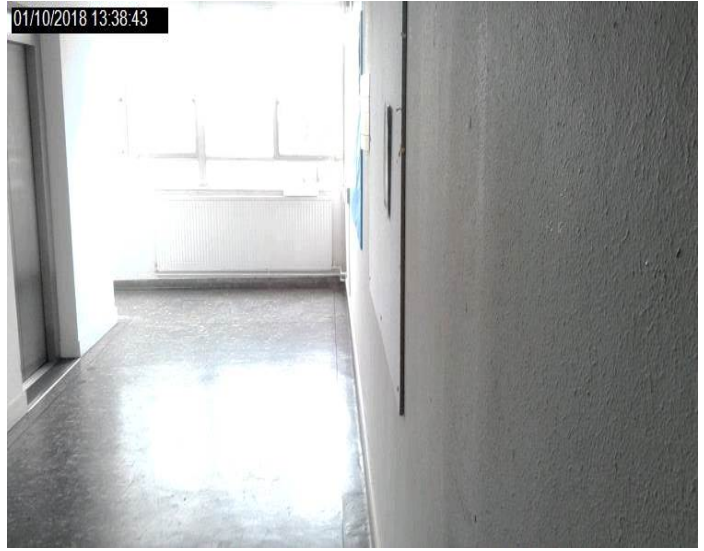
Location:	NBA199 Lift lobby	Block:	Birmingham City University	Floor Level: 1st Floor
Sample No.:	As DU002518	Portal Ref No.:	609

Item:	Textured coating to concrete			
Asbestos Content:		Result Based on:		
No Asbestos Detected		Strongly presumed		
Sample Analysed By:	Not applicable	Extent:	60 m ²	
Comments: To all walls

Material Assessment Total Score: 0		Likelihood of Disturbance Assessment Total Score: 0		Management Assessment Licensable: No Recommendations: Not Applicable Reinspection Interval: Not Applicable Overall Risk Category: E0
Product Type:	0 Not Applicable	Location:	0 Not Applicable	
Condition:	0 Not Applicable	Accessibility:	0 Not Applicable	
Surface Treatment:	0 Not Applicable			
Asbestos Type:	0 Not Applicable	Extent Score:	0 Not Applicable

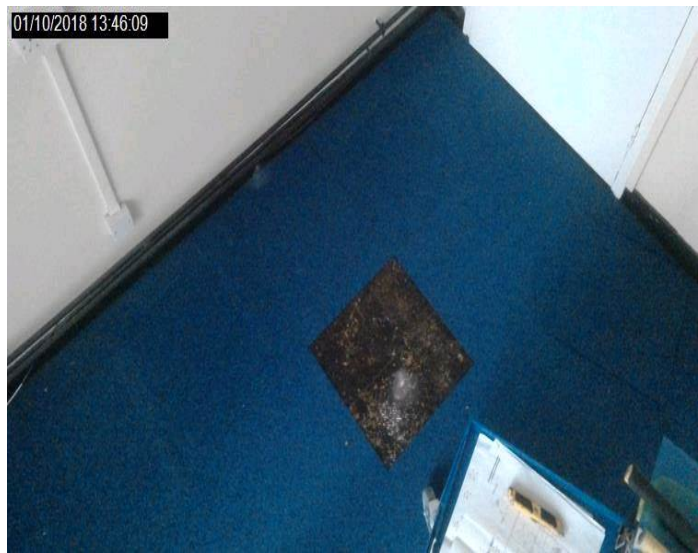
Location:	NBA114A	Block:	Birmingham City University	Floor Level: 1st Floor
Sample No.:	As DU002514	Portal Ref No.:	611

Item:	Asbestos Bitumen adhesive			
Asbestos Content:	Result Based on:			
Chrysotile	Strongly presumed			
Sample Analysed By:	Not applicable	Extent:	12 m ²	
Comments: Beneath carpet tile

Material Assessment Total Score: 3		Likelihood of Disturbance Assessment Total Score: 5		Management Assessment Licensable: No Recommendations: Program removal Reinspection Interval: Not Applicable Overall Risk Category: C8
Product Type:	1 (Asbestos bitumen)	Location:	2 (Rooms up to 100 sq m)	
Condition:	1 (Minor scratches)	Accessibility:	1 (Occasionally likely to be disturbed)	
Surface Treatment:	0 (Composite material)			
Asbestos Type:	1 (Chrysotile)	Extent Score:	2 (>10 - <50 sq m or >10m - <50m pipe run)

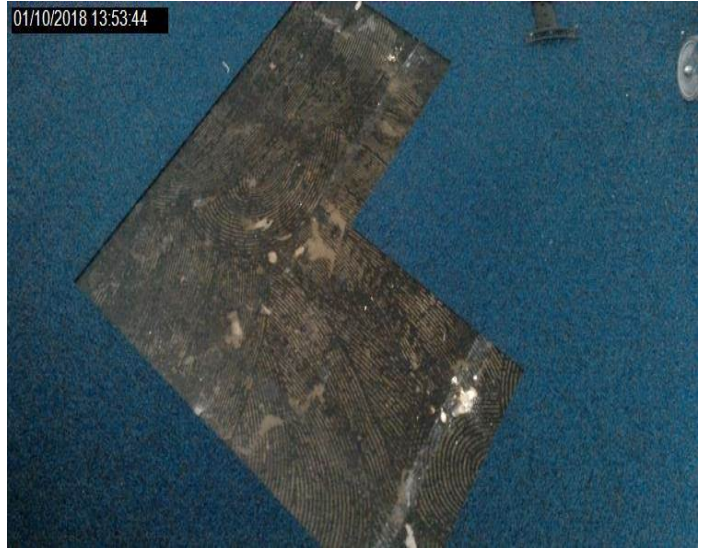
Location:	NBA114	Block:	Birmingham City University	Floor Level: 1st Floor
Sample No.:	As DU002514	Portal Ref No.:	613

Item:	Asbestos Bitumen adhesive			
Asbestos Content:	Result Based on:			
Chrysotile	Strongly presumed			
Sample Analysed By:	Not applicable	Extent:	15 m ²	
Comments: Beneath carpet tile

Material Assessment Total Score: 3		Likelihood of Disturbance Assessment Total Score: 5		Management Assessment Licensable: No Recommendations: Program removal Reinspection Interval: Not Applicable Overall Risk Category: C8
Product Type:	1 (Asbestos bitumen)	Location:	2 (Rooms up to 100 sq m)	
Condition:	1 (Minor scratches)	Accessibility:	1 (Occasionally likely to be disturbed)	
Surface Treatment:	0 (Composite material)			
Asbestos Type:	1 (Chrysotile)	Extent Score:	2 (>10 - <50 sq m or >10m - <50m pipe run)

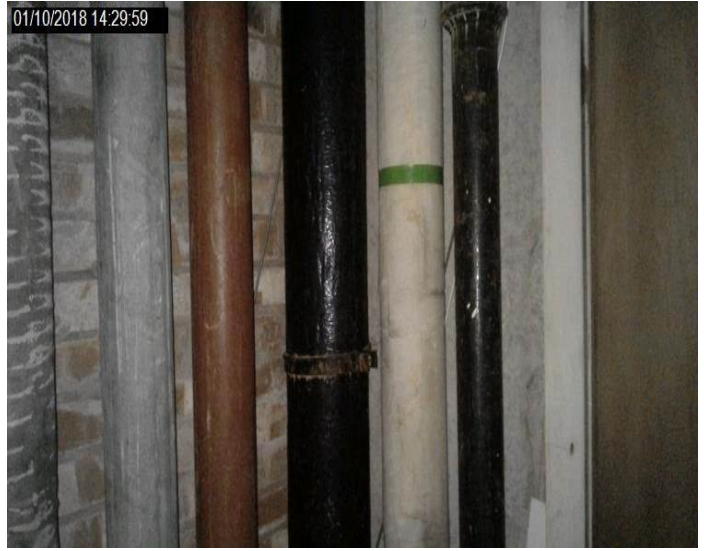
Location:	NBA113	Block:	Birmingham City University	Floor Level: 1st Floor
Sample No.:	As DU002515	Portal Ref No.:	617

Item:	Asbestos Reinforced plastic downpipe			
Asbestos Content:	Result Based on:			
Chrysotile	Strongly presumed			
Sample Analysed By:	Not applicable	Extent:	3 linear metres	
Comments:

Material Assessment Total Score: 3		Likelihood of Disturbance Assessment Total Score: 4		Management Assessment Licensable: No Recommendations: Program removal Reinspection Interval: Not Applicable Overall Risk Category: C7
Product Type:	1 (Asbestos reinforced plastic)	Location:	2 (Rooms up to 100 sq m)	
Condition:	1 (Minor scratches)	Accessibility:	1 (Occasionally likely to be disturbed)	
Surface Treatment:	0 (Composite material)			
Asbestos Type:	1 (Chrysotile)	Extent Score:	1 (<10 sq m or 10m pipe run)

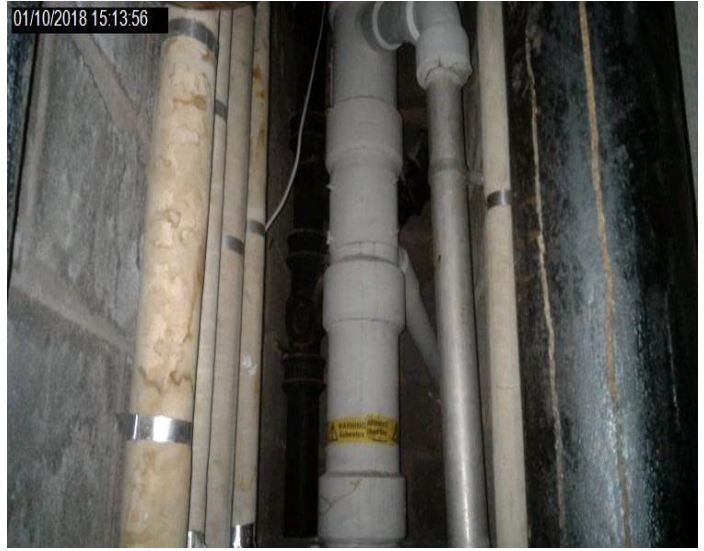
Location:	NBA141	Block:	Birmingham City University	Floor Level: 1st Floor
Sample No.:	DU002521	Portal Ref No.:	618

Item:	Asbestos Cement flue pipe			
Asbestos Content:	Result Based on:			
Chrysotile	Analysis of sample using PLM			
Sample Analysed By: Reg 13(1)	Extent:	4 linear metres		
Comments: Off shoot off the flue pipe exits through the wall unable to chase through the block wall

Material Assessment Total Score: 4		Likelihood of Disturbance Assessment Total Score: 4		Management Assessment Licensable: No Recommendations: Program removal Reinspection Interval: Not Applicable Overall Risk Category: C8
Product Type:	1 (Asbestos cement)	Location:	2 (Rooms up to 100 sq m)	
Condition:	1 (Minor scratches)	Accessibility:	1 (Occasionally likely to be disturbed)	
Surface Treatment:	1 (Encapsulated asbestos cement)			
Asbestos Type:	1 (Chrysotile)	Extent Score:	1 (<10 sq m or 10m pipe run)

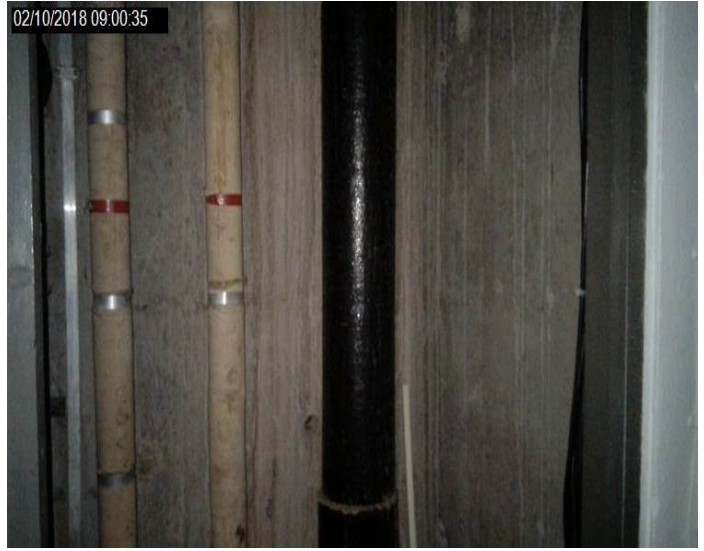
Location:	NBA134A Service duct	Block:	Birmingham City University	Floor Level: 1st Floor
Sample No.:	As DU002515	Portal Ref No.:	620

Item:	Asbestos Reinforced plastic downpipe			
Asbestos Content:	Result Based on:			
Chrysotile	Strongly presumed			
Sample Analysed By:	Not applicable	Extent:	3 linear metres	
Comments:

Material Assessment Total Score: 3		Likelihood of Disturbance Assessment Total Score: 4		Management Assessment Licensable: No Recommendations: Program removal Reinspection Interval: Not Applicable Overall Risk Category: C7
Product Type:	1 (Asbestos reinforced plastic)	Location:	2 (Rooms up to 100 sq m)	
Condition:	1 (Minor scratches)	Accessibility:	1 (Occasionally likely to be disturbed)	
Surface Treatment:	0 (Composite material)			
Asbestos Type:	1 (Chrysotile)	Extent Score:	1 (<10 sq m or 10m pipe run)

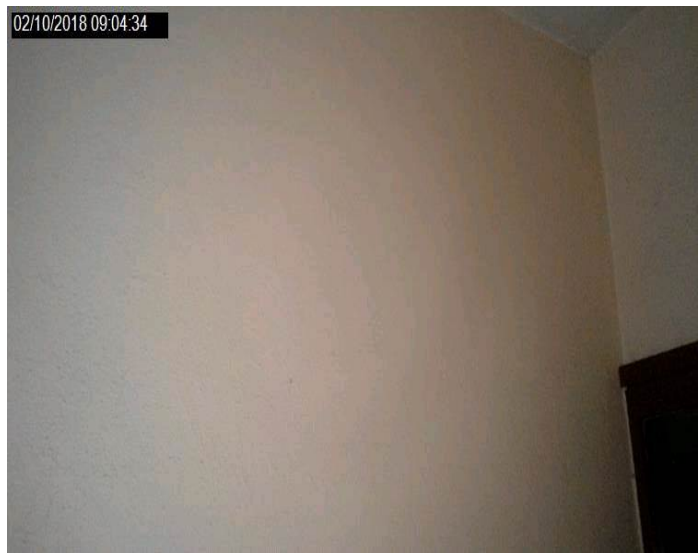
Location:	NBA100C Stairwell	Block:	Birmingham City University	Floor Level: 1st Floor
Sample No.:	DU002523	Portal Ref No.:	621

Item:	Textured coating to concrete walls			
Asbestos Content:		Result Based on:		
No Asbestos Detected		Analysis of sample using PLM		
Sample Analysed By:	Reg 13(1)	Extent:	50 m ²	
Comments: Sampled to prove negative throughout the stairwell

Material Assessment Total Score: 0		Likelihood of Disturbance Assessment Total Score: 0		Management Assessment Licensable: No Recommendations: Not Applicable Reinspection Interval: Not Applicable Overall Risk Category: E0
Product Type:	0 Not Applicable	Location:	0 Not Applicable	
Condition:	0 Not Applicable	Accessibility:	0 Not Applicable	
Surface Treatment:	0 Not Applicable			
Asbestos Type:	0 Not Applicable	Extent Score:	0 Not Applicable

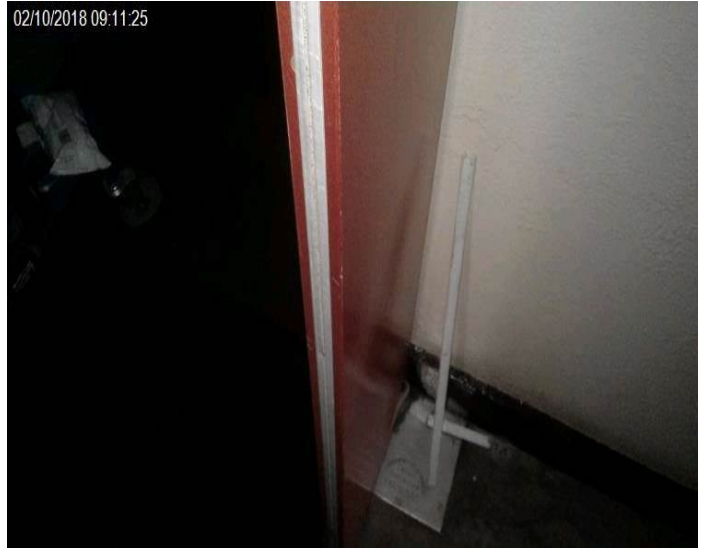
Location:	NBA100C Stairwell	Block:	Birmingham City University	Floor Level: 1st Floor
Sample No.:	DU002524	Portal Ref No.:	622

Item:	Paper within plastic casing to door			
Asbestos Content:		Result Based on:		
No Asbestos Detected		Analysis of sample using PLM		
Sample Analysed By:	Reg 13(1)	Extent:	4 linear metres	
Comments: Intumescent strip to door surround

Material Assessment Total Score: 0		Likelihood of Disturbance Assessment Total Score: 0		Management Assessment Licensable: No Recommendations: Not Applicable Reinspection Interval: Not Applicable Overall Risk Category: E0
Product Type:	0 Not Applicable	Location:	0 Not Applicable	
Condition:	0 Not Applicable	Accessibility:	0 Not Applicable	
Surface Treatment:	0 Not Applicable			
Asbestos Type:	0 Not Applicable	Extent Score:	0 Not Applicable

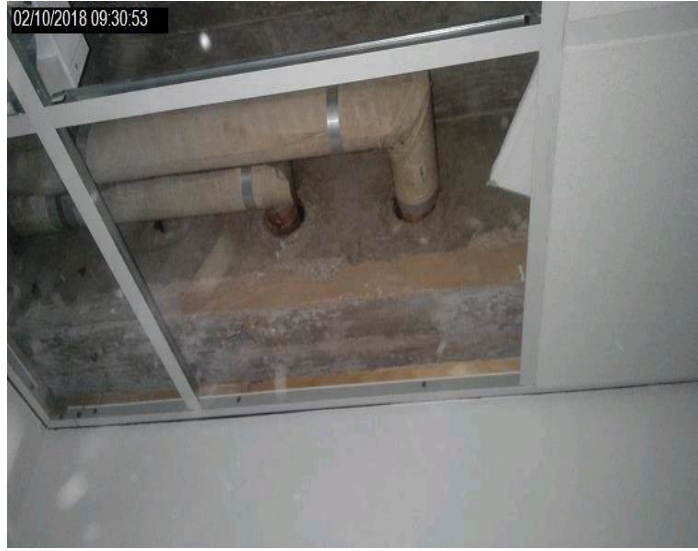
Location:	NBA135	Block:	Birmingham City University	Floor Level: 1st Floor
Sample No.:	As DU002525	Portal Ref No.:	626

Item:	Asbestos Reinforced plastic sleeve			
Asbestos Content:	Result Based on:			
Chrysotile	Strongly presumed			
Sample Analysed By:	Not applicable	Extent:	2 units	
Comments:

Material Assessment Total Score: 3		Likelihood of Disturbance Assessment Total Score: 4		Management Assessment Licensable: No Recommendations: Program removal Reinspection Interval: Not Applicable Overall Risk Category: C7
Product Type:	1 (Asbestos reinforced plastic)	Location:	2 (Rooms up to 100 sq m)	
Condition:	1 (Minor scratches)	Accessibility:	1 (Occasionally likely to be disturbed)	
Surface Treatment:	0 (Composite material)			
Asbestos Type:	1 (Chrysotile)	Extent Score:	1 (<10 sq m or 10m pipe run)

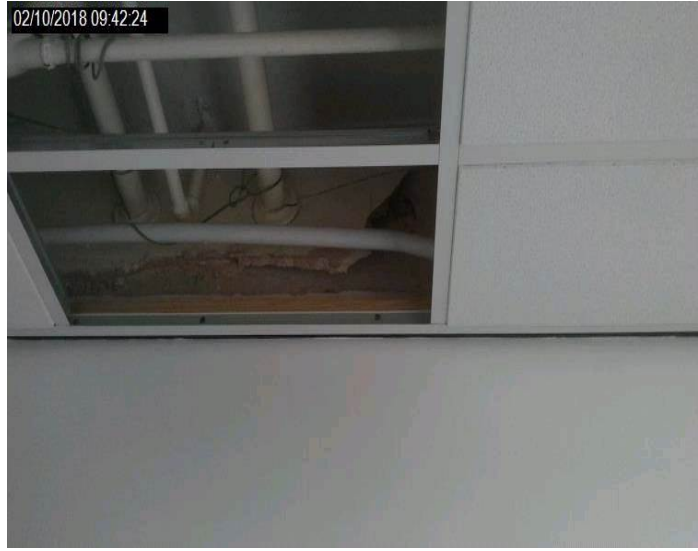
Location:	NBA136	Block:	Birmingham City University	Floor Level: 1st Floor
Sample No.:	As DU002525	Portal Ref No.:	628

Item:	Asbestos Reinforced plastic sleeve			
Asbestos Content:	Result Based on:			
Chrysotile	Strongly presumed			
Sample Analysed By:	Not applicable	Extent:	2 units	
Comments:

Material Assessment Total Score: 3		Likelihood of Disturbance Assessment Total Score: 4		Management Assessment Licensable: No Recommendations: Program removal Reinspection Interval: Not Applicable Overall Risk Category: C7
Product Type:	1 (Asbestos reinforced plastic)	Location:	2 (Rooms up to 100 sq m)	
Condition:	1 (Minor scratches)	Accessibility:	1 (Occasionally likely to be disturbed)	
Surface Treatment:	0 (Composite material)			
Asbestos Type:	1 (Chrysotile)	Extent Score:	1 (<10 sq m or 10m pipe run)

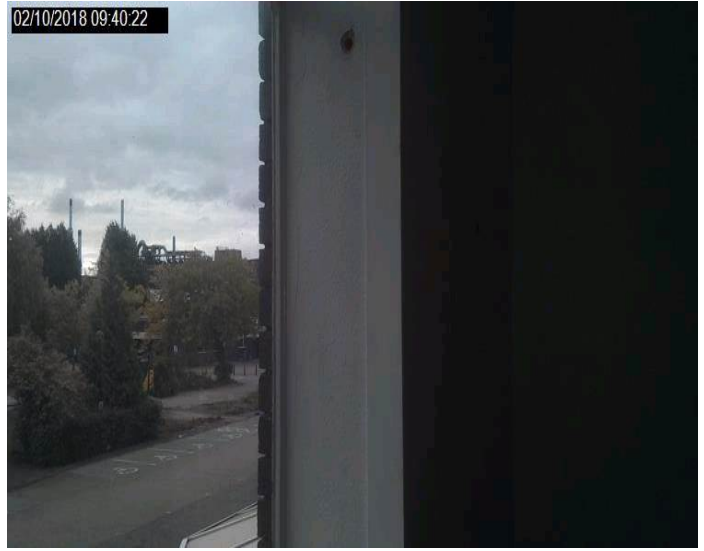
Location:	NBA136	Block:	Birmingham City University	Floor Level: 1st Floor
Sample No.:	DU002526	Portal Ref No.:	629

Item:	Textured coating to walls			
Asbestos Content:	Result Based on:			
No Asbestos Detected	Analysis of sample using PLM			
Sample Analysed By: Reg 13(1)	Extent:	10 m ²		
Comments: Above suspended tile level, and recess of window

Material Assessment Total Score: 0		Likelihood of Disturbance Assessment Total Score: 0		Management Assessment Licensable: No Recommendations: Not Applicable Reinspection Interval: Not Applicable Overall Risk Category: E0
Product Type:	0 Not Applicable	Location:	0 Not Applicable	
Condition:	0 Not Applicable	Accessibility:	0 Not Applicable	
Surface Treatment:	0 Not Applicable			
Asbestos Type:	0 Not Applicable	Extent Score:	0 Not Applicable

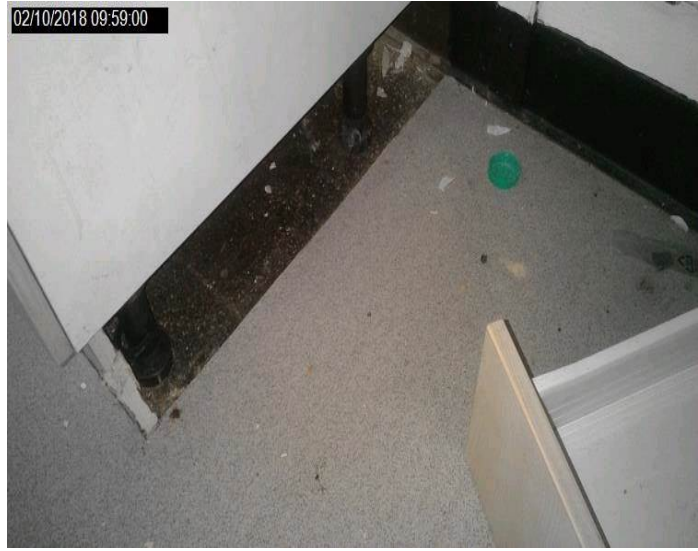
Location:	NBA139	Block:	Birmingham City University	Floor Level: 1st Floor
Sample No.:	As DU002527	Portal Ref No.:	633

Item:	Asbestos Bitumen adhesive			
Asbestos Content:	Result Based on:			
Chrysotile	Strongly presumed			
Sample Analysed By:	Not applicable	Extent:	8 m ²	
Comments:

Material Assessment Total Score: 3		Likelihood of Disturbance Assessment Total Score: 4		Management Assessment Licensable: No Recommendations: Program removal Reinspection Interval: Not Applicable Overall Risk Category: C7
Product Type:	1 (Asbestos bitumen)	Location:	2 (Rooms up to 100 sq m)	
Condition:	1 (Minor scratches)	Accessibility:	1 (Occasionally likely to be disturbed)	
Surface Treatment:	0 (Composite material)			
Asbestos Type:	1 (Chrysotile)	Extent Score:	1 (<10 sq m or 10m pipe run)

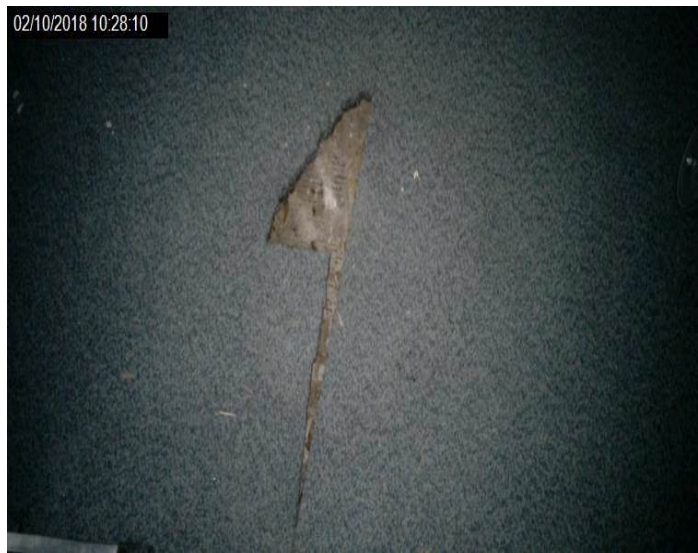
Location:	NBA199D	Block:	Birmingham City University	Floor Level: 1st Floor
Sample No.:	DU002530	Portal Ref No.:	635

Item:	Asbestos Bitumen adhesive			
Asbestos Content:	Result Based on:			
Chrysotile	Analysis of sample using PLM			
Sample Analysed By: Reg 13(1)	Extent:	12 m ²		
Comments:

Material Assessment Total Score: 3		Likelihood of Disturbance Assessment Total Score: 5		Management Assessment Licensable: No Recommendations: Program removal Reinspection Interval: Not Applicable Overall Risk Category: C8
Product Type:	1 (Asbestos bitumen)	Location:	2 (Rooms up to 100 sq m)	
Condition:	1 (Minor scratches)	Accessibility:	1 (Occasionally likely to be disturbed)	
Surface Treatment:	0 (Composite material)			
Asbestos Type:	1 (Chrysotile)	Extent Score:	2 (>10 - <50 sq m or >10m - <50m pipe run)

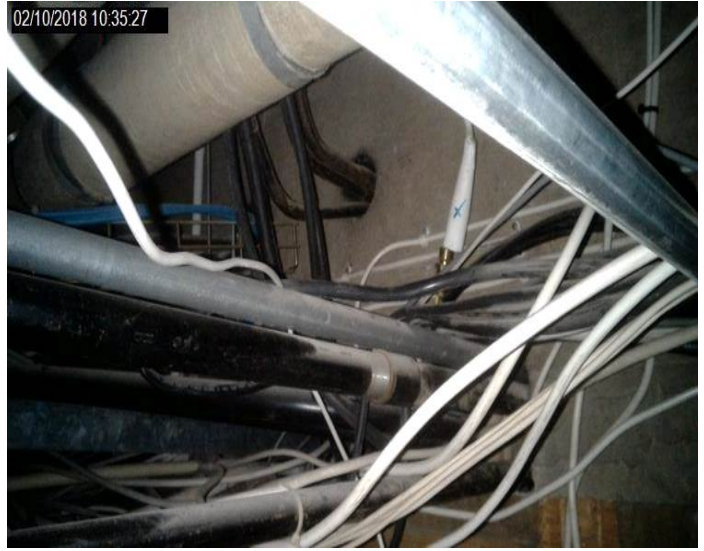
Location:	NBA199E	Block:	Birmingham City University	Floor Level: 1st Floor
Sample No.:	As DU002525	Portal Ref No.:	636

Item:	Asbestos Reinforced plastic sleeve			
Asbestos Content:	Result Based on:			
Chrysotile	Strongly presumed			
Sample Analysed By:	Not applicable	Extent:	12 units	
Comments:

Material Assessment Total Score: 3		Likelihood of Disturbance Assessment Total Score: 4		Management Assessment Licensable: No Recommendations: Program removal Reinspection Interval: Not Applicable Overall Risk Category: C7
Product Type:	1 (Asbestos reinforced plastic)	Location:	2 (Rooms up to 100 sq m)	
Condition:	1 (Minor scratches)	Accessibility:	1 (Occasionally likely to be disturbed)	
Surface Treatment:	0 (Composite material)			
Asbestos Type:	1 (Chrysotile)	Extent Score:	1 (<10 sq m or 10m pipe run)

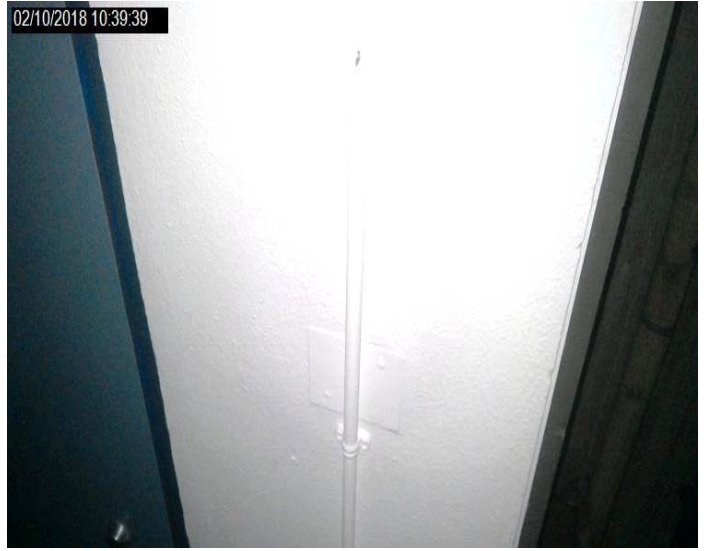
Location:	NBA199E	Block:	Birmingham City University	Floor Level: 1st Floor
Sample No.:	DU002532	Portal Ref No.:	638

Item:	Textured coating to concrete sections			
Asbestos Content:	Result Based on:			
No Asbestos Detected	Analysis of sample using PLM			
Sample Analysed By:	Reg 13(1)	Extent:	16 m ²	
Comments: To walls

Material Assessment Total Score: 0		Likelihood of Disturbance Assessment Total Score: 0		Management Assessment Licensable: No Recommendations: Not Applicable Reinspection Interval: Not Applicable Overall Risk Category: E0
Product Type:	0 Not Applicable	Location:	0 Not Applicable	
Condition:	0 Not Applicable	Accessibility:	0 Not Applicable	
Surface Treatment:	0 Not Applicable			
Asbestos Type:	0 Not Applicable	Extent Score:	0 Not Applicable

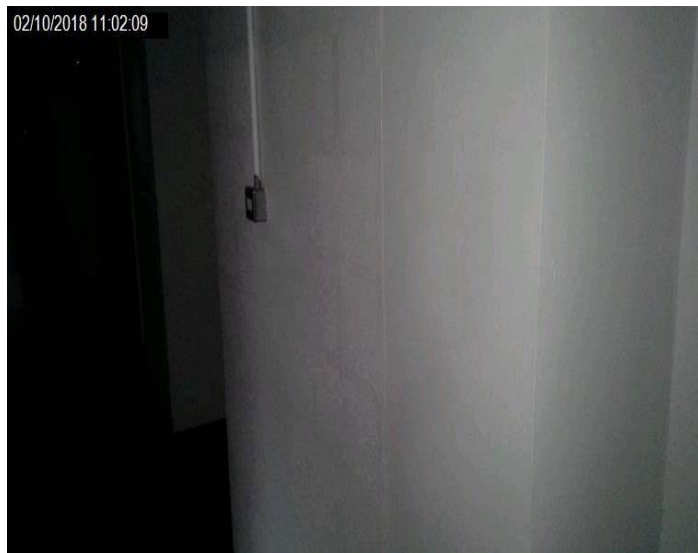
Location:	NBA199G	Block:	Birmingham City University	Floor Level: 1st Floor
Sample No.:	As DU002532	Portal Ref No.:	644

Item:	Textured coating to concrete sections			
Asbestos Content:		Result Based on:		
No Asbestos Detected		Strongly presumed		
Sample Analysed By:	Not applicable	Extent:	50 m ²	
Comments: To walls concrete sections only

Material Assessment Total Score: 0		Likelihood of Disturbance Assessment Total Score: 0		Management Assessment Licensable: No Recommendations: Not Applicable Reinspection Interval: Not Applicable Overall Risk Category: E0
Product Type:	0 Not Applicable	Location:	0 Not Applicable	
Condition:	0 Not Applicable	Accessibility:	0 Not Applicable	
Surface Treatment:	0 Not Applicable			
Asbestos Type:	0 Not Applicable	Extent Score:	0 Not Applicable

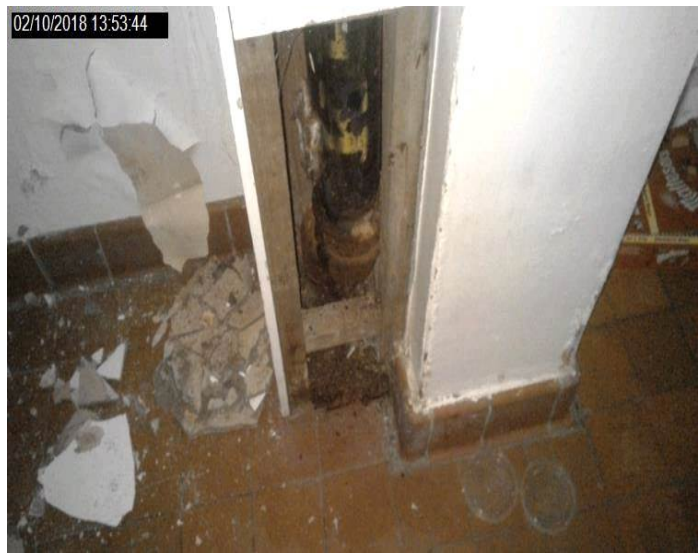
Location:	NBAG32	Block:	Birmingham City University	Floor Level: Ground Floor
Sample No.:	DU002536	Portal Ref No.:	652

Item:	Asbestos Reinforced plastic downpipe			
Asbestos Content:	Result Based on:			
Chrysotile	Analysis of sample using PLM			
Sample Analysed By: Reg 13(1)	Extent:	2 linear metres		
Comments:

Material Assessment Total Score: 3		Likelihood of Disturbance Assessment Total Score: 4		Management Assessment Licensable: No Recommendations: Program removal Reinspection Interval: Not Applicable Overall Risk Category: C7
Product Type:	1 (Asbestos reinforced plastic)	Location:	2 (Rooms up to 100 sq m)	
Condition:	1 (Minor scratches)	Accessibility:	1 (Occasionally likely to be disturbed)	
Surface Treatment:	0 (Composite material)			
Asbestos Type:	1 (Chrysotile)	Extent Score:	1 (<10 sq m or 10m pipe run)

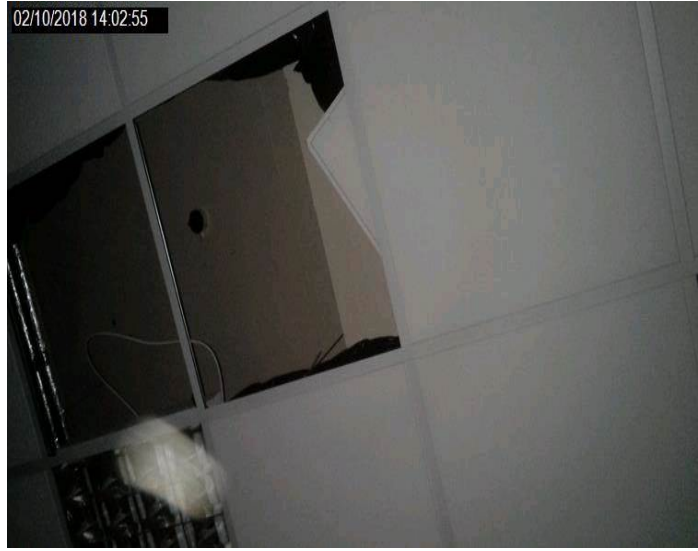
Location:	NBAG01	Block:	Birmingham City University	Floor Level: Ground Floor
Sample No.:	As DU002534	Portal Ref No.:	653

Item:	Asbestos Reinforced plastic downpipe			
Asbestos Content:	Result Based on:			
Chrysotile	Strongly presumed			
Sample Analysed By:	Not applicable	Extent:	4 units	
Comments: To the structural column

Material Assessment Total Score: 3		Likelihood of Disturbance Assessment Total Score: 4		Management Assessment Licensable: No Recommendations: Program removal Reinspection Interval: Not Applicable Overall Risk Category: C7
Product Type:	1 (Asbestos reinforced plastic)	Location:	2 (Rooms up to 100 sq m)	
Condition:	1 (Minor scratches)	Accessibility:	1 (Occasionally likely to be disturbed)	
Surface Treatment:	0 (Composite material)			
Asbestos Type:	1 (Chrysotile)	Extent Score:	1 (<10 sq m or 10m pipe run)

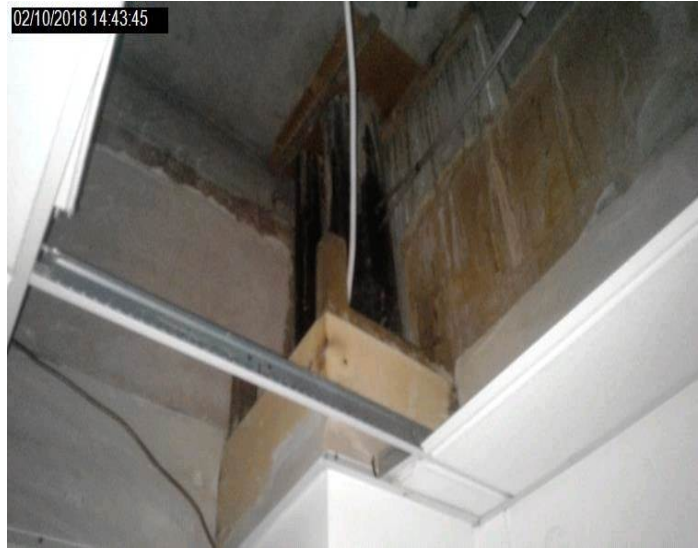
Location:	NBAG05	Block:	Birmingham City University	Floor Level: Ground Floor
Sample No.:	As DU002536	Portal Ref No.:	658

Item:	Asbestos Reinforced plastic downpipe			
Asbestos Content:	Result Based on:			
Chrysotile	Strongly presumed			
Sample Analysed By:	Not applicable	Extent:	3 linear metres	
Comments:

Material Assessment Total Score: 3		Likelihood of Disturbance Assessment Total Score: 4		Management Assessment Licensable: No Recommendations: Program removal Reinspection Interval: Not Applicable Overall Risk Category: C7
Product Type:	1 (Asbestos reinforced plastic)	Location:	2 (Rooms up to 100 sq m)	
Condition:	1 (Minor scratches)	Accessibility:	1 (Occasionally likely to be disturbed)	
Surface Treatment:	0 (Composite material)			
Asbestos Type:	1 (Chrysotile)	Extent Score:	1 (<10 sq m or 10m pipe run)

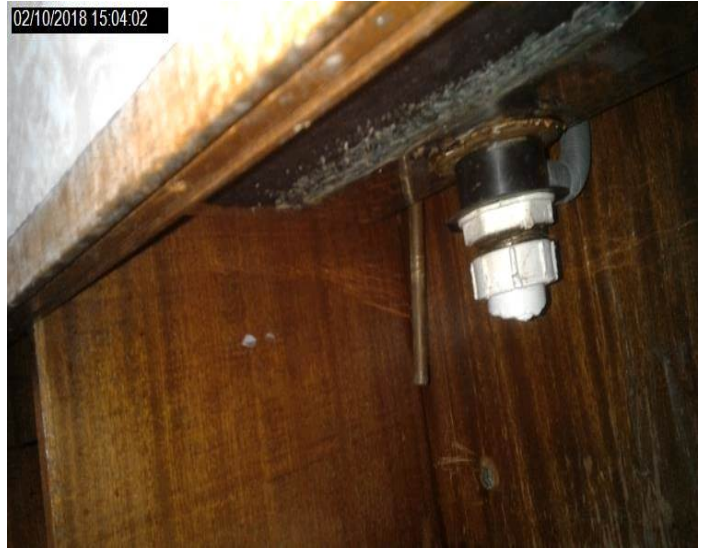
Location:	NBAG04	Block:	Birmingham City University	Floor Level: Ground Floor
Sample No.:	DU002539	Portal Ref No.:	663

Item:	Asbestos Bitumen sink pads			
Asbestos Content:	Result Based on:			
Chrysotile	Analysis of sample using PLM			
Sample Analysed By: Reg 13(1)	Extent:	2 units		
Comments: Two sinks

Material Assessment Total Score: 3		Likelihood of Disturbance Assessment Total Score: 4		Management Assessment Licensable: No Recommendations: Program removal Reinspection Interval: Not Applicable Overall Risk Category: C7
Product Type:	1 (Asbestos bitumen)	Location:	2 (Rooms up to 100 sq m)	
Condition:	1 (Minor scratches)	Accessibility:	1 (Occasionally likely to be disturbed)	
Surface Treatment:	0 (Composite material)			
Asbestos Type:	1 (Chrysotile)	Extent Score:	1 (<10 sq m or 10m pipe run)

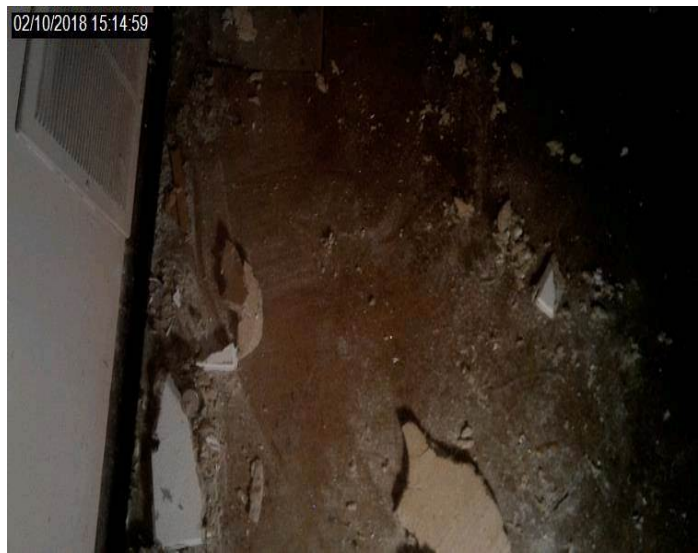
Location:	NBAG06	Block:	Birmingham City University	Floor Level: Ground Floor
Sample No.:	As DU002538	Portal Ref No.:	665

Item:	Asbestos Vinyl			
Asbestos Content:	Result Based on:			
Chrysotile in adhesive only	Strongly presumed			
Sample Analysed By:	Not applicable	Extent:	4 m ²	
Comments: Bitumen adhesive to remaining floor area

Material Assessment Total Score: 3		Likelihood of Disturbance Assessment Total Score: 5		Management Assessment Licensable: No Recommendations: Program removal Reinspection Interval: Not Applicable Overall Risk Category: C8
Product Type:	1 (Asbestos vinyl)	Location:	2 (Rooms up to 100 sq m)	
Condition:	1 (Minor scratches)	Accessibility:	2 (Easily disturbed)	
Surface Treatment:	0 (Composite material)			
Asbestos Type:	1 (Chrysotile)	Extent Score:	1 (<10 sq m or 10m pipe run)

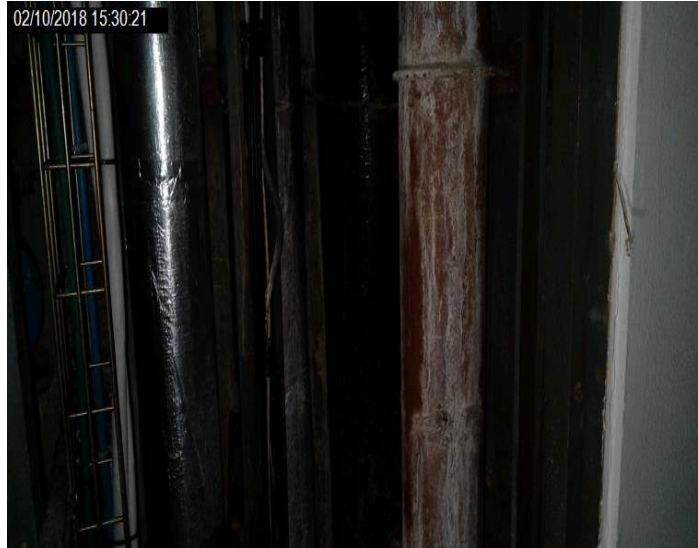
Location:	NBAG30A Service duct	Block:	Birmingham City University	Floor Level: Ground Floor
Sample No.:	As DU002536	Portal Ref No.:	667

Item:	Asbestos Reinforced plastic downpipe			
Asbestos Content:	Result Based on:			
Chrysotile	Strongly presumed			
Sample Analysed By:	Not applicable	Extent:	4 linear metres	
Comments:

Material Assessment Total Score: 3		Likelihood of Disturbance Assessment Total Score: 4		Management Assessment Licensable: No Recommendations: Program removal Reinspection Interval: Not Applicable Overall Risk Category: C7
Product Type:	1 (Asbestos reinforced plastic)	Location:	2 (Rooms up to 100 sq m)	
Condition:	1 (Minor scratches)	Accessibility:	1 (Occasionally likely to be disturbed)	
Surface Treatment:	0 (Composite material)			
Asbestos Type:	1 (Chrysotile)	Extent Score:	1 (<10 sq m or 10m pipe run)

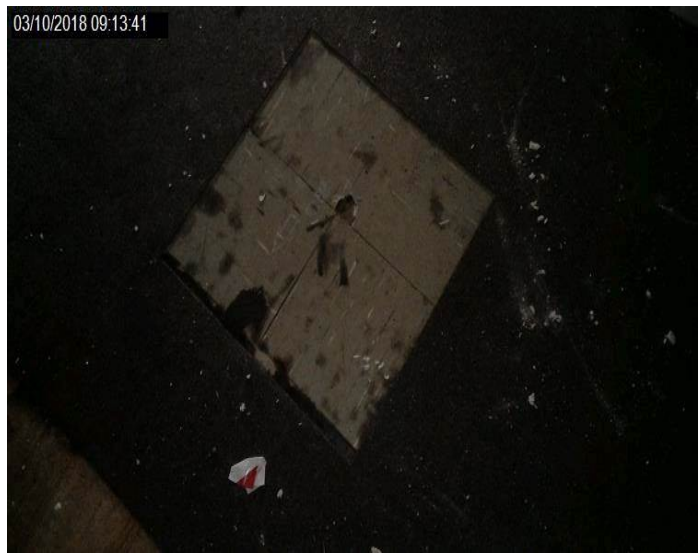
Location:	NBAG99A	Block:	Birmingham City University	Floor Level: Ground Floor
Sample No.:	DU002542	Portal Ref No.:	669

Item:	Asbestos Thermoplastic floor tiles			
Asbestos Content:	Result Based on:			
Chrysotile in adhesive only	Analysis of sample using PLM			
Sample Analysed By: Reg 13(1)	Extent:	8 m ²		
Comments: Beneath carpet tile, see plan for location

Material Assessment Total Score: 3		Likelihood of Disturbance Assessment Total Score: 3		Management Assessment Licensable: No Recommendations: Program removal Reinspection Interval: Not Applicable Overall Risk Category: D6
Product Type:	1 (Asbestos thermoplastic)	Location:	2 (Rooms up to 100 sq m)	
Condition:	1 (Minor scratches)	Accessibility:	0 (Usually inaccessible or unlikely to be disturbed)	
Surface Treatment:	0 (Composite material)			
Asbestos Type:	1 (Chrysotile)	Extent Score:	1 (<10 sq m or 10m pipe run)

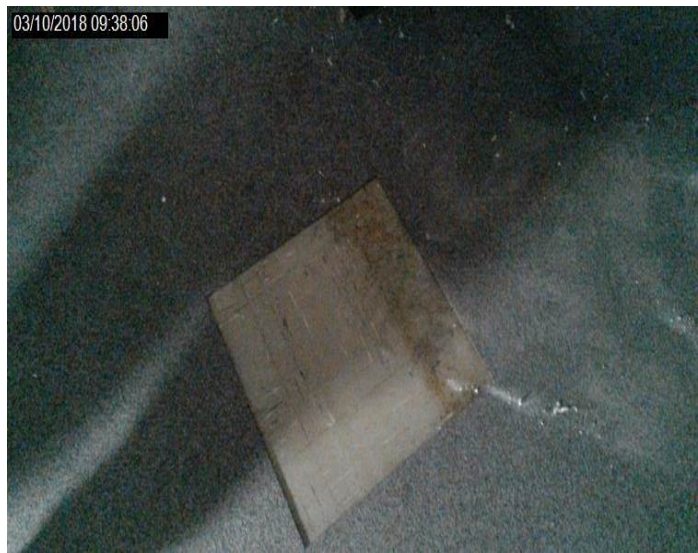
Location:	NBAG99B	Block:	Birmingham City University	Floor Level: Ground Floor
Sample No.:	As DU002542	Portal Ref No.:	673

Item:	Asbestos Thermoplastic floor tiles			
Asbestos Content:	Result Based on:			
Chrysotile in adhesive only	Strongly presumed			
Sample Analysed By:	Not applicable	Extent:	30 m ²	
Comments:

Material Assessment Total Score: 3		Likelihood of Disturbance Assessment Total Score: 4		Management Assessment Licensable: No Recommendations: Program removal Reinspection Interval: Not Applicable Overall Risk Category: C7
Product Type:	1 (Asbestos thermoplastic)	Location:	2 (Rooms up to 100 sq m)	
Condition:	1 (Minor scratches)	Accessibility:	0 (Usually inaccessible or unlikely to be disturbed)	
Surface Treatment:	0 (Composite material)			
Asbestos Type:	1 (Chrysotile)	Extent Score:	2 (>10 - <50 sq m or >10m - <50m pipe run)

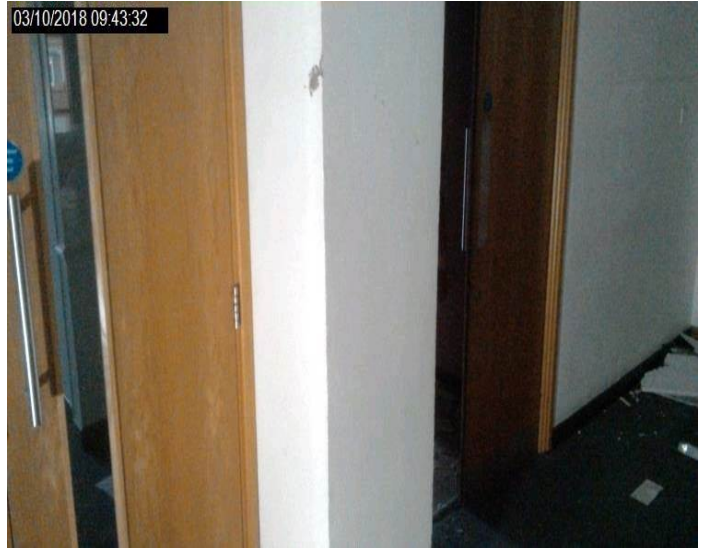
Location:	NBAG99B	Block:	Birmingham City University	Floor Level: Ground Floor
Sample No.:	DU002543	Portal Ref No.:	674

Item:	Textured coating to concrete sections			
Asbestos Content:		Result Based on:		
No Asbestos Detected		Analysis of sample using PLM		
Sample Analysed By:	Reg 13(1)	Extent:	25 m ²	
Comments: Concrete sections

Material Assessment Total Score: 0		Likelihood of Disturbance Assessment Total Score: 0		Management Assessment Licensable: No Recommendations: Not Applicable Reinspection Interval: Not Applicable Overall Risk Category: E0
Product Type:	0 Not Applicable	Location:	0 Not Applicable	
Condition:	0 Not Applicable	Accessibility:	0 Not Applicable	
Surface Treatment:	0 Not Applicable			
Asbestos Type:	0 Not Applicable	Extent Score:	0 Not Applicable

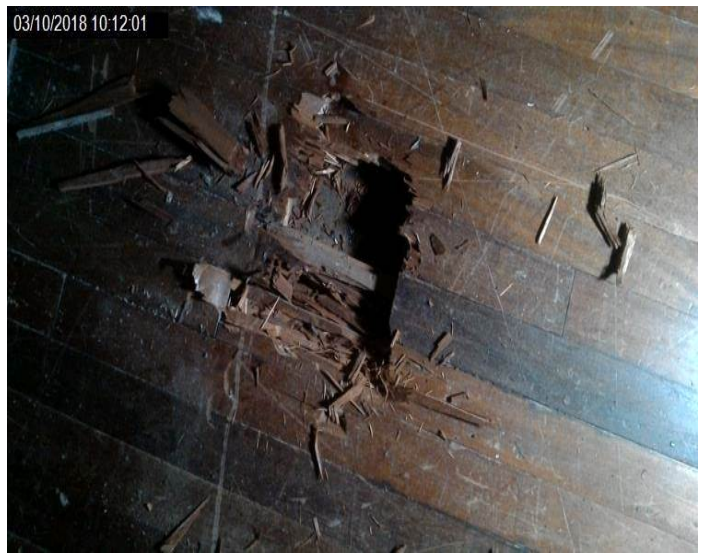
Location:	NBAG07B	Block:	Birmingham City University	Floor Level: Ground Floor
Sample No.:	DU002544	Portal Ref No.:	676

Item:	Asphalt			
Asbestos Content:		Result Based on:		
No Asbestos Detected		Analysis of sample using PLM		
Sample Analysed By:	Reg 13(1)	Extent:	45 m ²	
Comments: Beneath timber flooring

Material Assessment Total Score: 0		Likelihood of Disturbance Assessment Total Score: 0		Management Assessment Licensable: No Recommendations: Not Applicable Reinspection Interval: Not Applicable Overall Risk Category: E0
Product Type:	0 Not Applicable	Location:	0 Not Applicable	
Condition:	0 Not Applicable	Accessibility:	0 Not Applicable	
Surface Treatment:	0 Not Applicable			
Asbestos Type:	0 Not Applicable	Extent Score:	0 Not Applicable

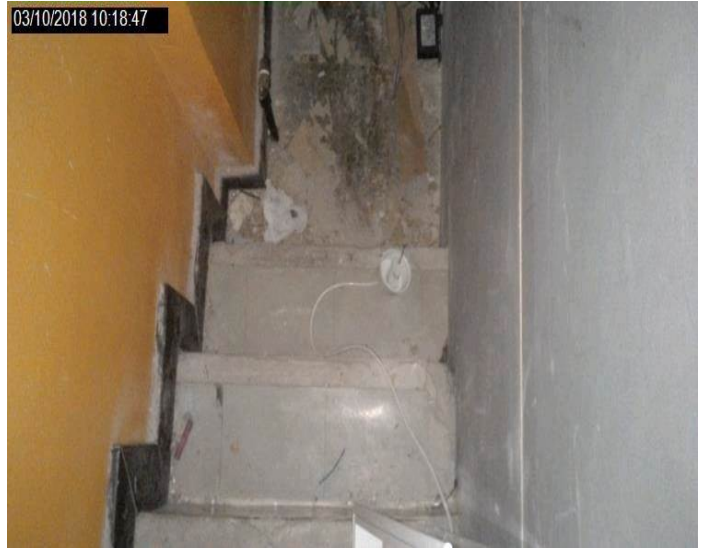
Location:	NBAG07D	Block:	Birmingham City University	Floor Level: Ground Floor
Sample No.:	DU002545	Portal Ref No.:	677

Item:	Asbestos Thermoplastic floor tiles with bitumen adhesive			
Asbestos Content:	Result Based on:			
Chrysotile in tile and adhesive	Analysis of sample using PLM			
Sample Analysed By: Reg 13(1)	Extent:	4 m ²		
Comments: Floor tiles to the step, bitumen adhesive throughout

Material Assessment Total Score: 3		Likelihood of Disturbance Assessment Total Score: 4		Management Assessment Licensable: No Recommendations: Program removal Reinspection Interval: Not Applicable Overall Risk Category: C7
Product Type:	1 (Asbestos thermoplastic)	Location:	2 (Rooms up to 100 sq m)	
Condition:	1 (Minor scratches)	Accessibility:	1 (Occasionally likely to be disturbed)	
Surface Treatment:	0 (Composite material)			
Asbestos Type:	1 (Chrysotile)	Extent Score:	1 (<10 sq m or 10m pipe run)

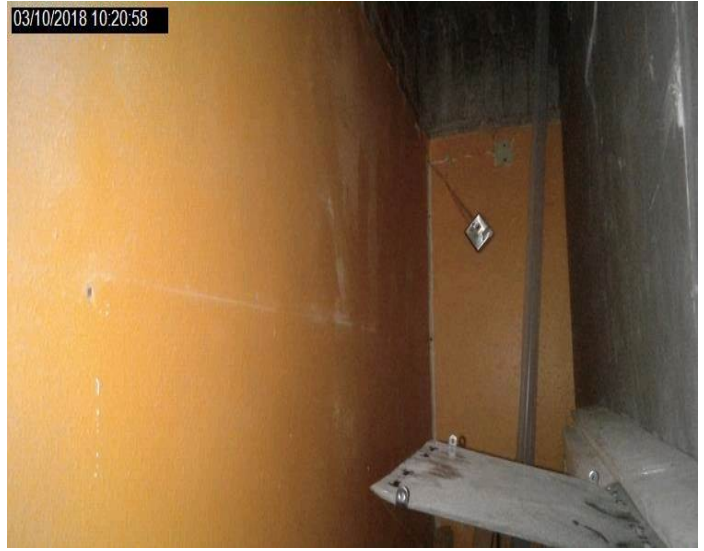
Location:	NBAG07D	Block:	Birmingham City University	Floor Level: Ground Floor
Sample No.:	DU002546	Portal Ref No.:	678

Item:	Textured coating to plaster to walls			
Asbestos Content:	Result Based on:			
No Asbestos Detected	Analysis of sample using PLM			
Sample Analysed By: Reg 13(1)	Extent:	16 m ²		
Comments:

Material Assessment Total Score: 0		Likelihood of Disturbance Assessment Total Score: 0		Management Assessment Licensable: No Recommendations: Not Applicable Reinspection Interval: Not Applicable Overall Risk Category: E0
Product Type:	0 Not Applicable	Location:	0 Not Applicable	
Condition:	0 Not Applicable	Accessibility:	0 Not Applicable	
Surface Treatment:	0 Not Applicable			
Asbestos Type:	0 Not Applicable	Extent Score:	0 Not Applicable

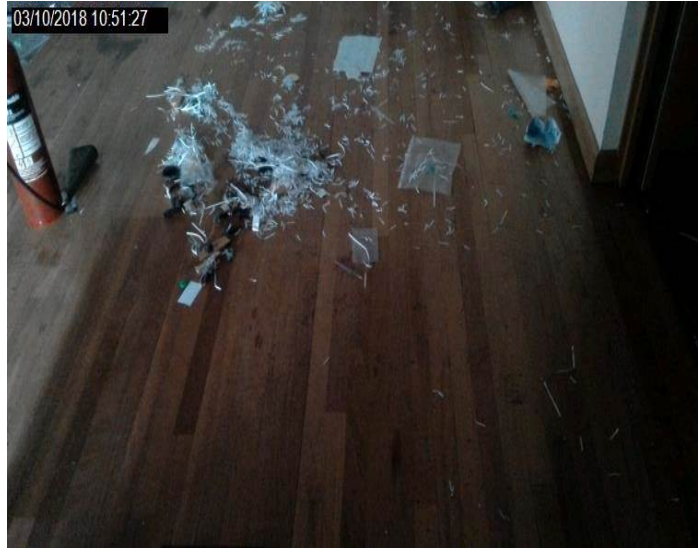
Location:	NBAG07A	Block:	Birmingham City University	Floor Level: Ground Floor
Sample No.:	As DU002544	Portal Ref No.:	680

Item:	Asphalt			
Asbestos Content:		Result Based on:		
No Asbestos Detected		Strongly presumed		
Sample Analysed By:	Not applicable	Extent:	30 m ²	
Comments: Beneath timber flooring

Material Assessment Total Score: 0		Likelihood of Disturbance Assessment Total Score: 0		Management Assessment Licensable: No Recommendations: Not Applicable Reinspection Interval: Not Applicable Overall Risk Category: E0
Product Type:	0 Not Applicable	Location:	0 Not Applicable	
Condition:	0 Not Applicable	Accessibility:	0 Not Applicable	
Surface Treatment:	0 Not Applicable			
Asbestos Type:	0 Not Applicable	Extent Score:	0 Not Applicable

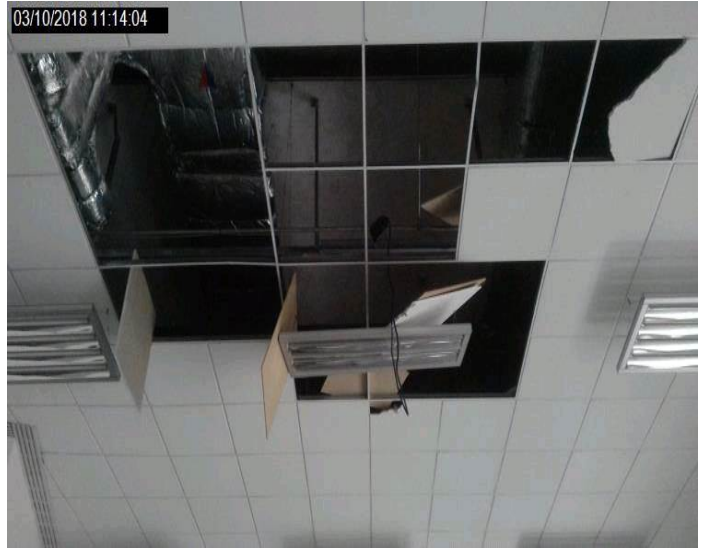
Location:	NBAG07	Block:	Birmingham City University	Floor Level: Ground Floor
Sample No.:	DU002547	Portal Ref No.:	681

Item:	Textured coating to concrete			
Asbestos Content:		Result Based on:		
No Asbestos Detected		Analysis of sample using PLM		
Sample Analysed By:	Reg 13(1)	Extent:	100 m ²	
Comments: Suspended ceiling high level above central areas Material is for acoustic values

Material Assessment Total Score: 0		Likelihood of Disturbance Assessment Total Score: 0		Management Assessment Licensable: No Recommendations: Not Applicable Reinspection Interval: Not Applicable Overall Risk Category: E0
Product Type:	0 Not Applicable	Location:	0 Not Applicable	
Condition:	0 Not Applicable	Accessibility:	0 Not Applicable	
Surface Treatment:	0 Not Applicable			
Asbestos Type:	0 Not Applicable	Extent Score:	0 Not Applicable

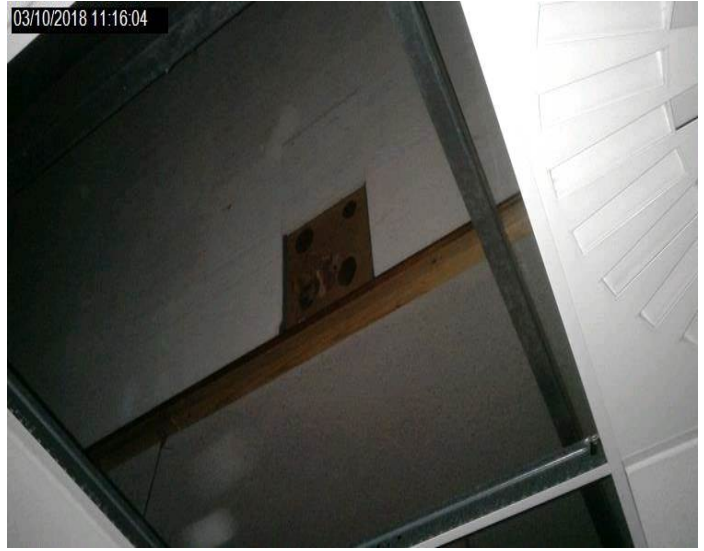
Location:	NBAG07	Block:	Birmingham City University	Floor Level: Ground Floor
Sample No.:	DU002548	Portal Ref No.:	682

Item:	Bitumen adhesive to acoustic tiles			
Asbestos Content:		Result Based on:		
No Asbestos Detected		Analysis of sample using PLM		
Sample Analysed By:	Reg 13(1)	Extent:	30 m ²	
Comments: To rear of acoustic tiles

Material Assessment Total Score: 0		Likelihood of Disturbance Assessment Total Score: 0		Management Assessment Licensable: No Recommendations: Not Applicable Reinspection Interval: Not Applicable Overall Risk Category: E0
Product Type:	0 Not Applicable	Location:	0 Not Applicable	
Condition:	0 Not Applicable	Accessibility:	0 Not Applicable	
Surface Treatment:	0 Not Applicable			
Asbestos Type:	0 Not Applicable	Extent Score:	0 Not Applicable

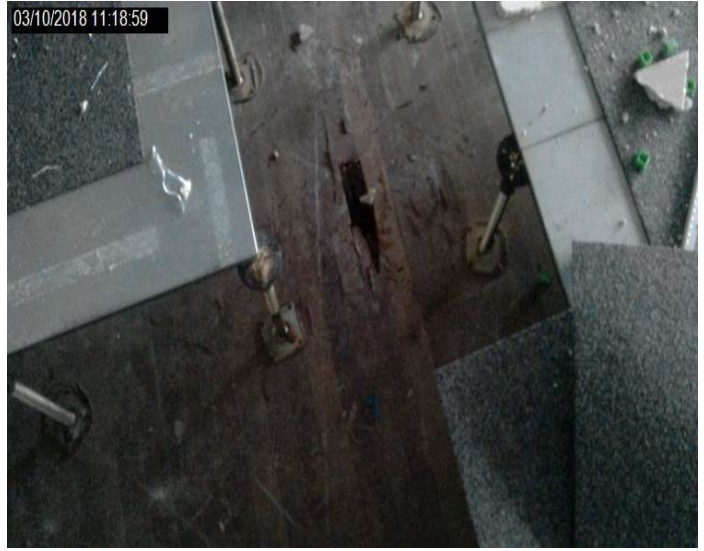
Location:	NBAG07	Block:	Birmingham City University	Floor Level: Ground Floor
Sample No.:	DU002550	Portal Ref No.:	684

Item:	Asphalt			
Asbestos Content:		Result Based on:		
No Asbestos Detected		Analysis of sample using PLM		
Sample Analysed By:	Reg 13(1)	Extent:	100 m ²	
Comments: Beneath timber flooring

Material Assessment Total Score: 0		Likelihood of Disturbance Assessment Total Score: 0		Management Assessment Licensable: No Recommendations: Not Applicable Reinspection Interval: Not Applicable Overall Risk Category: E0
Product Type:	0 Not Applicable	Location:	0 Not Applicable	
Condition:	0 Not Applicable	Accessibility:	0 Not Applicable	
Surface Treatment:	0 Not Applicable			
Asbestos Type:	0 Not Applicable	Extent Score:	0 Not Applicable

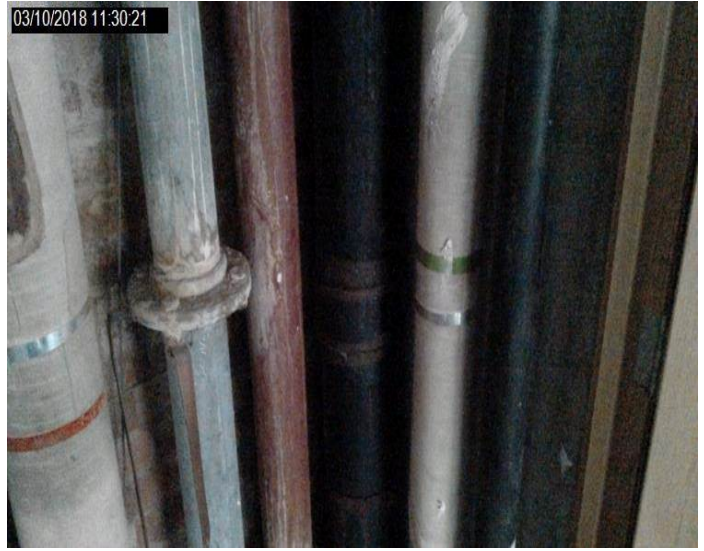
Location:	NBAG07E Service duct	Block:	Birmingham City University	Floor Level: Ground Floor
Sample No.:	As DU002536	Portal Ref No.:	690

Item:	Asbestos Reinforced plastic downpipe			
Asbestos Content:	Result Based on:			
Chrysotile	Strongly presumed			
Sample Analysed By:	Not applicable	Extent:	3 linear metres	
Comments:

Material Assessment Total Score: 3		Likelihood of Disturbance Assessment Total Score: 4		Management Assessment Licensable: No Recommendations: Program removal Reinspection Interval: Not Applicable Overall Risk Category: C7
Product Type:	1 (Asbestos reinforced plastic)	Location:	2 (Rooms up to 100 sq m)	
Condition:	1 (Minor scratches)	Accessibility:	1 (Occasionally likely to be disturbed)	
Surface Treatment:	0 (Composite material)			
Asbestos Type:	1 (Chrysotile)	Extent Score:	1 (<10 sq m or 10m pipe run)

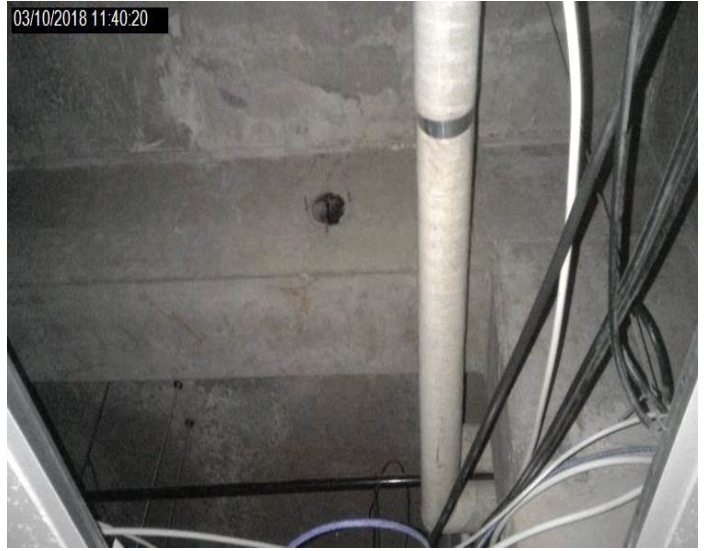
Location:	NBAG08	Block:	Birmingham City University	Floor Level: Ground Floor
Sample No.:	DU002551	Portal Ref No.:	691

Item:	Asbestos Reinforced plastic sleeve			
Asbestos Content:	Result Based on:			
Chrysotile	Analysis of sample using PLM			
Sample Analysed By: Reg 13(1)	Extent:	3 units		
Comments: To structural concrete

Material Assessment Total Score: 3		Likelihood of Disturbance Assessment Total Score: 4		Management Assessment Licensable: No Recommendations: Program removal Reinspection Interval: Not Applicable Overall Risk Category: C7
Product Type:	1 (Asbestos reinforced plastic)	Location:	2 (Rooms up to 100 sq m)	
Condition:	1 (Minor scratches)	Accessibility:	1 (Occasionally likely to be disturbed)	
Surface Treatment:	0 (Composite material)			
Asbestos Type:	1 (Chrysotile)	Extent Score:	1 (<10 sq m or 10m pipe run)
