Location:	NBA201A	Block:	Birmingham City University	Floor Level: 2nd Floor
Sample No.:	DU002474	Portal Ref No.:	492

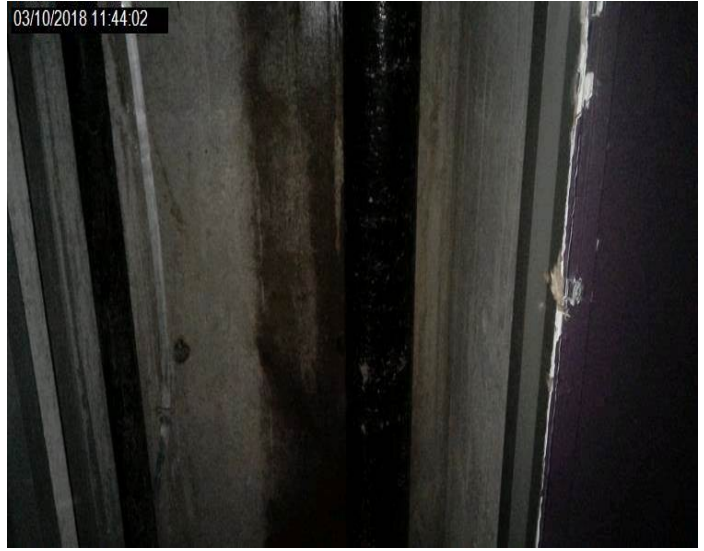
Location:	NBAG08B	Block:	Birmingham City University	Floor Level: Ground Floor
Sample No.:	As DU002536	Portal Ref No.:	692

Item:	Asbestos Reinforced plastic downpipe			
Asbestos Content:	Result Based on:			
Chrysotile	Strongly presumed			
Sample Analysed By:	Not applicable	Extent:	3 linear metres	
Comments:

Material Assessment Total Score: 3		Likelihood of Disturbance Assessment Total Score: 4		Management Assessment Licensable: No Recommendations: Program removal Reinspection Interval: Not Applicable Overall Risk Category: C7
Product Type:	1 (Asbestos reinforced plastic)	Location:	2 (Rooms up to 100 sq m)	
Condition:	1 (Minor scratches)	Accessibility:	1 (Occasionally likely to be disturbed)	
Surface Treatment:	0 (Composite material)			
Asbestos Type:	1 (Chrysotile)	Extent Score:	1 (<10 sq m or 10m pipe run)

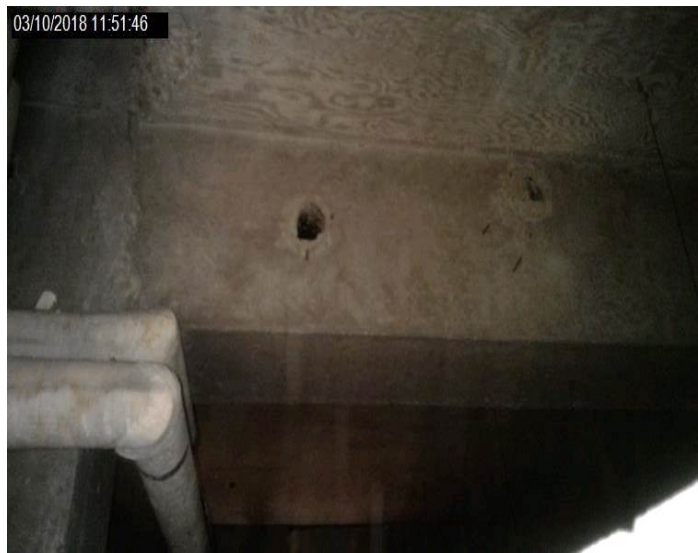
Location:	NBAG09A	Block:	Birmingham City University	Floor Level: Ground Floor
Sample No.:	As DU002551	Portal Ref No.:	693

Item:	Asbestos Reinforced plastic sleeve			
Asbestos Content:	Result Based on:			
Chrysotile	Strongly presumed			
Sample Analysed By:	Not applicable	Extent:	4 units	
Comments: To structural concrete

Material Assessment Total Score: 3		Likelihood of Disturbance Assessment Total Score: 4		Management Assessment Licensable: No Recommendations: Program removal Reinspection Interval: Not Applicable Overall Risk Category: C7
Product Type:	1 (Asbestos reinforced plastic)	Location:	2 (Rooms up to 100 sq m)	
Condition:	1 (Minor scratches)	Accessibility:	1 (Occasionally likely to be disturbed)	
Surface Treatment:	0 (Composite material)			
Asbestos Type:	1 (Chrysotile)	Extent Score:	1 (<10 sq m or 10m pipe run)

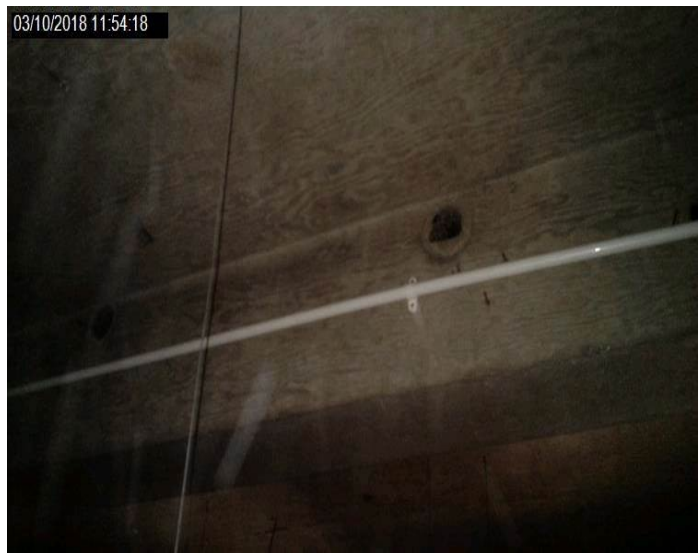
Location:	NBAG09B	Block:	Birmingham City University	Floor Level: Ground Floor
Sample No.:	As DU002551	Portal Ref No.:	694

Item:	Asbestos Reinforced plastic sleeve			
Asbestos Content:	Result Based on:			
Chrysotile	Strongly presumed			
Sample Analysed By:	Not applicable	Extent:	4 units	
Comments: To structural concrete

Material Assessment Total Score: 3		Likelihood of Disturbance Assessment Total Score: 4		Management Assessment Licensable: No Recommendations: Program removal Reinspection Interval: Not Applicable Overall Risk Category: C7
Product Type:	1 (Asbestos reinforced plastic)	Location:	2 (Rooms up to 100 sq m)	
Condition:	1 (Minor scratches)	Accessibility:	1 (Occasionally likely to be disturbed)	
Surface Treatment:	0 (Composite material)			
Asbestos Type:	1 (Chrysotile)	Extent Score:	1 (<10 sq m or 10m pipe run)

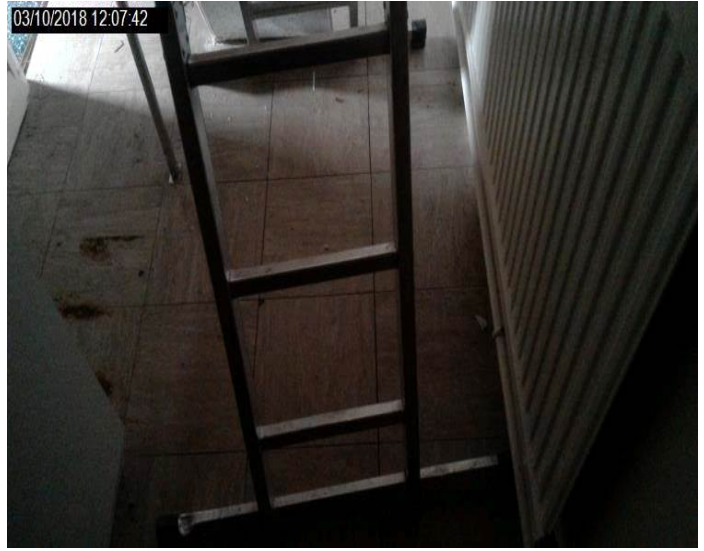
Location:	NBAG11A	Block:	Birmingham City University	Floor Level: Ground Floor
Sample No.:	DU002553	Portal Ref No.:	698

Item:	Asbestos Thermoplastic floor tiles with bitumen adhesive			
Asbestos Content:	Result Based on:			
Chrysotile in adhesive only	Analysis of sample using PLM			
Sample Analysed By: Reg 13(1)	Extent:	6 m ²		
Comments:

Material Assessment Total Score: 3		Likelihood of Disturbance Assessment Total Score: 6		Management Assessment Licensable: No Recommendations: Program removal Reinspection Interval: Not Applicable Overall Risk Category: C9
Product Type:	1 (Asbestos thermoplastic)	Location:	2 (Rooms up to 100 sq m)	
Condition:	1 (Minor scratches)	Accessibility:	3 (Routinely disturbed)	
Surface Treatment:	0 (Composite material)			
Asbestos Type:	1 (Chrysotile)	Extent Score:	1 (<10 sq m or 10m pipe run)

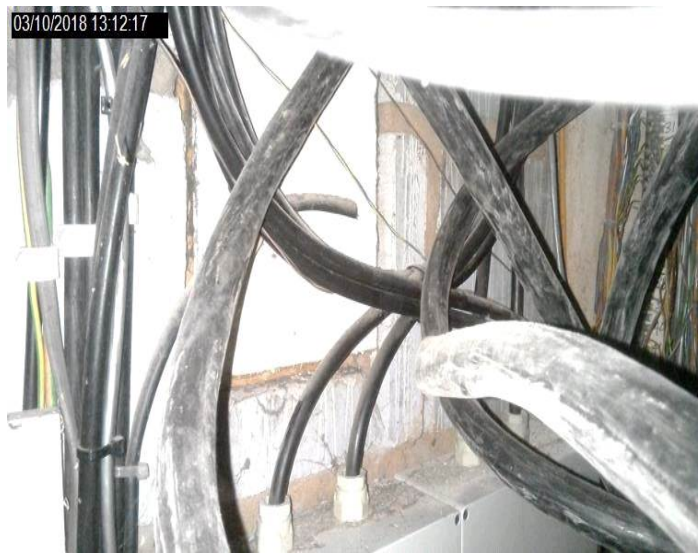
Location:	NBAG08C	Block:	Birmingham City University	Floor Level: Ground Floor
Sample No.:	DU002555	Portal Ref No.:	700

Item:	Insulating board panel			
Asbestos Content:		Result Based on:		
No Asbestos Detected		Analysis of sample using PLM		
Sample Analysed By:	Reg 13(1)	Extent:	1 m ²	
Comments: To rear electrical riser

Material Assessment Total Score: 0		Likelihood of Disturbance Assessment Total Score: 0		Management Assessment Licensable: Yes Recommendations: Not Applicable Reinspection Interval: Not Applicable Overall Risk Category: E0
Product Type:	0 Not Applicable	Location:	0 Not Applicable	
Condition:	0 Not Applicable	Accessibility:	0 Not Applicable	
Surface Treatment:	0 Not Applicable			
Asbestos Type:	0 Not Applicable	Extent Score:	0 Not Applicable

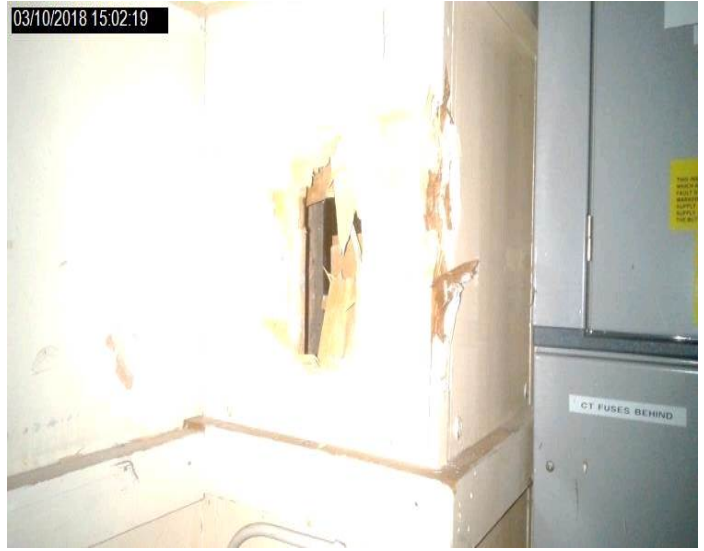
Location:	NBAG34	Block:	Birmingham City University	Floor Level: Ground Floor
Sample No.:	As DU002536	Portal Ref No.:	707

Item:	Asbestos Reinforced plastic downpipe			
Asbestos Content:	Result Based on:			
Chrysotile	Strongly presumed			
Sample Analysed By:	Not applicable	Extent:	3 linear metres	
Comments: Internally to timber boxing

Material Assessment Total Score: 3		Likelihood of Disturbance Assessment Total Score: 4		Management Assessment Licensable: No Recommendations: Program removal Reinspection Interval: Not Applicable Overall Risk Category: C7
Product Type:	1 (Asbestos reinforced plastic)	Location:	2 (Rooms up to 100 sq m)	
Condition:	1 (Minor scratches)	Accessibility:	1 (Occasionally likely to be disturbed)	
Surface Treatment:	0 (Composite material)			
Asbestos Type:	1 (Chrysotile)	Extent Score:	1 (<10 sq m or 10m pipe run)

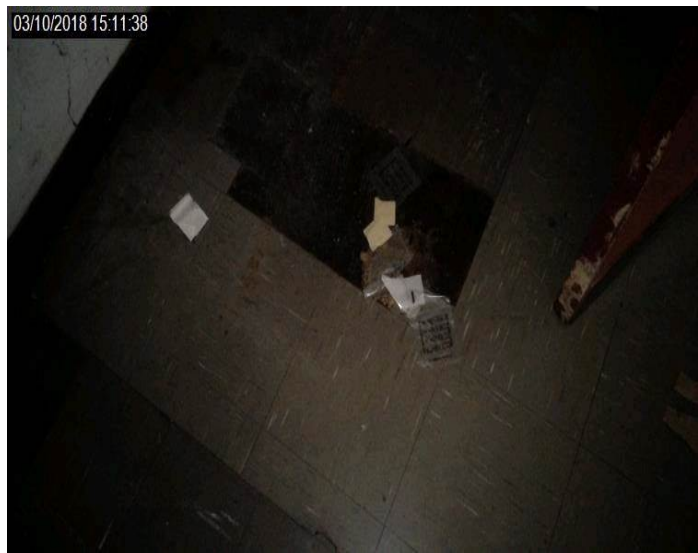
Location:	NBAG20B	Block:	Birmingham City University	Floor Level: Ground Floor
Sample No.:	DU002557	Portal Ref No.:	709

Item:	Asbestos Thermoplastic floor tiles with bitumen adhesive			
Asbestos Content:	Result Based on:			
Chrysotile in tile and adhesive	Analysis of sample using PLM			
Sample Analysed By: Reg 13(1)	Extent:	10 m ²		
Comments: Composite sample

Material Assessment Total Score: 3		Likelihood of Disturbance Assessment Total Score: 6		Management Assessment Licensable: No Recommendations: Program removal Reinspection Interval: Not Applicable Overall Risk Category: C9
Product Type:	1 (Asbestos thermoplastic)	Location:	2 (Rooms up to 100 sq m)	
Condition:	1 (Minor scratches)	Accessibility:	3 (Routinely disturbed)	
Surface Treatment:	0 (Composite material)			
Asbestos Type:	1 (Chrysotile)	Extent Score:	1 (<10 sq m or 10m pipe run)

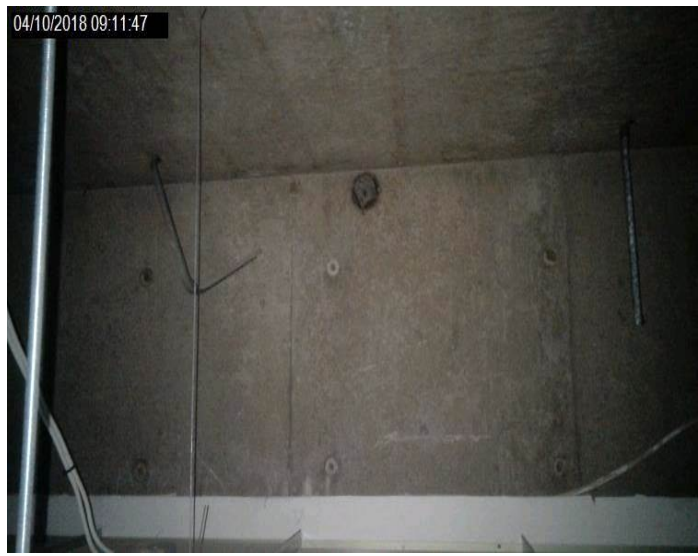
Location:	NBAG99D	Block:	Birmingham City University	Floor Level: Ground Floor
Sample No.:	As DU002551	Portal Ref No.:	714

Item:	Asbestos Reinforced plastic sleeve			
Asbestos Content:	Result Based on:			
Chrysotile	Strongly presumed			
Sample Analysed By:	Not applicable	Extent:	6 units	
Comments: To structural concrete

Material Assessment Total Score: 3		Likelihood of Disturbance Assessment Total Score: 4		Management Assessment Licensable: No Recommendations: Program removal Reinspection Interval: Not Applicable Overall Risk Category: C7
Product Type:	1 (Asbestos reinforced plastic)	Location:	2 (Rooms up to 100 sq m)	
Condition:	1 (Minor scratches)	Accessibility:	1 (Occasionally likely to be disturbed)	
Surface Treatment:	0 (Composite material)			
Asbestos Type:	1 (Chrysotile)	Extent Score:	1 (<10 sq m or 10m pipe run)

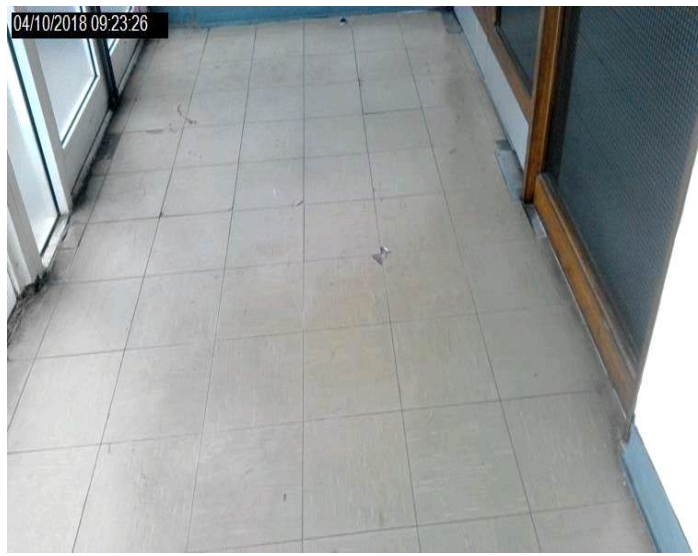
Location:	NBAG99G	Block:	Birmingham City University	Floor Level: Ground Floor
Sample No.:	DU002560	Portal Ref No.:	719

Item:	Asbestos Thermoplastic floor tiles			
Asbestos Content:	Result Based on:			
Chrysotile in tile and adhesive	Analysis of sample using PLM			
Sample Analysed By: Reg 13(1)	Extent:	10 m ²		
Comments:

Material Assessment Total Score: 3		Likelihood of Disturbance Assessment Total Score: 6		Management Assessment Licensable: No Recommendations: Program removal Reinspection Interval: Not Applicable Overall Risk Category: C9
Product Type:	1 (Asbestos thermoplastic)	Location:	2 (Rooms up to 100 sq m)	
Condition:	1 (Minor scratches)	Accessibility:	3 (Routinely disturbed)	
Surface Treatment:	0 (Composite material)			
Asbestos Type:	1 (Chrysotile)	Extent Score:	1 (<10 sq m or 10m pipe run)

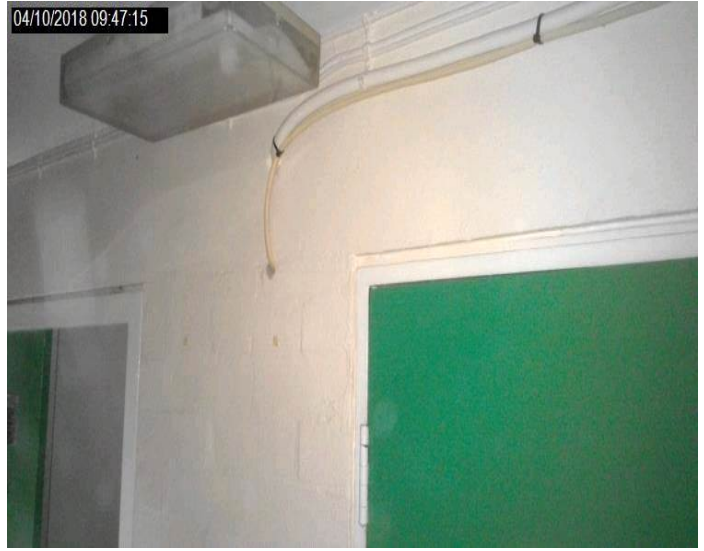
Location:	NBAB99 Corridor	Block:	Birmingham City University	Floor Level: Basement
Sample No.:	DU002561	Portal Ref No.:	720

Item:	Textured coating to brick and concrete			
Asbestos Content:	Result Based on:			
No Asbestos Detected	Analysis of sample using PLM			
Sample Analysed By:	Reg 13(1)	Extent:	25 m ²	
Comments:

Material Assessment Total Score: 0		Likelihood of Disturbance Assessment Total Score: 0		Management Assessment Licensable: No Recommendations: Not Applicable Reinspection Interval: Not Applicable Overall Risk Category: E0
Product Type:	0 Not Applicable	Location:	0 Not Applicable	
Condition:	0 Not Applicable	Accessibility:	0 Not Applicable	
Surface Treatment:	0 Not Applicable			
Asbestos Type:	0 Not Applicable	Extent Score:	0 Not Applicable

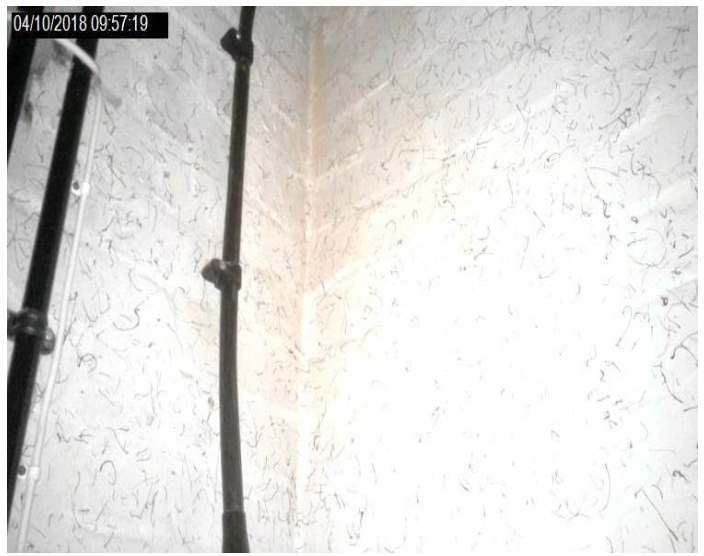
Location:	NBAB08	Block:	Birmingham City University	Floor Level: Basement
Sample No.:	DU002562	Portal Ref No.:	722

Item:	Textured coating to brick and concrete			
Asbestos Content:	Result Based on:			
No Asbestos Detected	Analysis of sample using PLM			
Sample Analysed By: Reg 13(1)	Extent:	10 m ²		
Comments: To all walls

Material Assessment Total Score: 0		Likelihood of Disturbance Assessment Total Score: 0		Management Assessment Licensable: No Recommendations: Not Applicable Reinspection Interval: Not Applicable Overall Risk Category: E0
Product Type:	0 Not Applicable	Location:	0 Not Applicable	
Condition:	0 Not Applicable	Accessibility:	0 Not Applicable	
Surface Treatment:	0 Not Applicable			
Asbestos Type:	0 Not Applicable	Extent Score:	0 Not Applicable

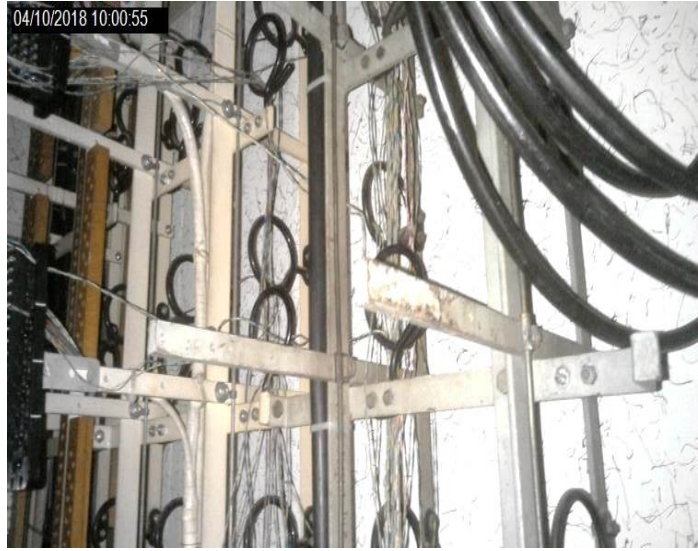
Location:	NBAB09	Block:	Birmingham City University	Floor Level: Basement
Sample No.:	As DU002562	Portal Ref No.:	723

Item:	Textured coating to brick and concrete			
Asbestos Content:			Result Based on:	
No Asbestos Detected		Strongly presumed		
Sample Analysed By:	Not applicable	Extent:	10 m ²	
Comments: To all walls

Material Assessment Total Score: 0		Likelihood of Disturbance Assessment Total Score: 0		Management Assessment Licensable: No Recommendations: Not Applicable Reinspection Interval: Not Applicable Overall Risk Category: E0
Product Type:	0 Not Applicable	Location:	0 Not Applicable	
Condition:	0 Not Applicable	Accessibility:	0 Not Applicable	
Surface Treatment:	0 Not Applicable			
Asbestos Type:	0 Not Applicable	Extent Score:	0 Not Applicable

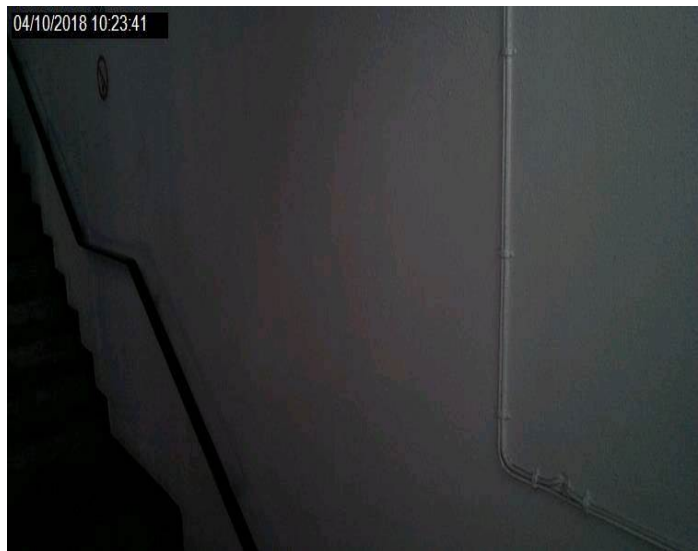
Location:	NBAB00 Stairs	Block:	Birmingham City University	Floor Level: Basement
Sample No.:	DU002563	Portal Ref No.:	728

Item:	Textured coating to brick and concrete			
Asbestos Content:		Result Based on:		
No Asbestos Detected		Analysis of sample using PLM		
Sample Analysed By:	Reg 13(1)	Extent:	75 m ²	
Comments:

Material Assessment Total Score: 0		Likelihood of Disturbance Assessment Total Score: 0		Management Assessment Licensable: No Recommendations: Not Applicable Reinspection Interval: Not Applicable Overall Risk Category: E0
Product Type:	0 Not Applicable	Location:	0 Not Applicable	
Condition:	0 Not Applicable	Accessibility:	0 Not Applicable	
Surface Treatment:	0 Not Applicable			
Asbestos Type:	0 Not Applicable	Extent Score:	0 Not Applicable

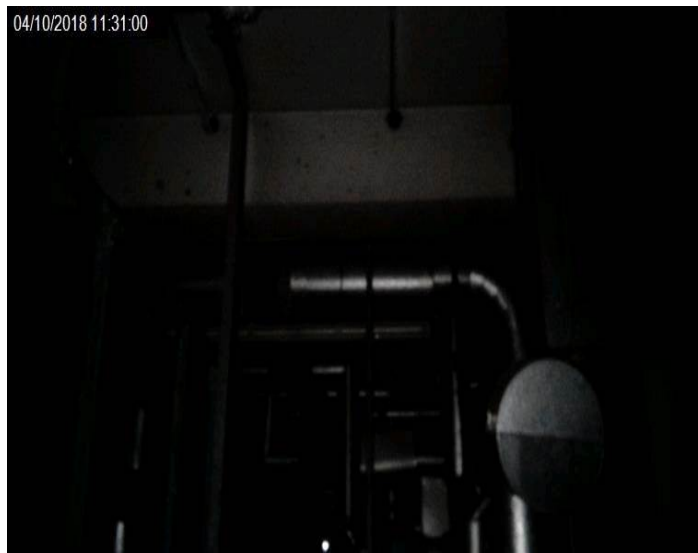
Location:	NBA02 Plant room	Block:	Birmingham City University	Floor Level: Basement
Sample No.:	DU002564	Portal Ref No.:	729

Item:	Asbestos Reinforced plastic sleeve			
Asbestos Content:	Result Based on:			
Chrysotile	Analysis of sample using PLM			
Sample Analysed By:	Reg 13(1)	Extent:	10 units	
Comments: Through structural columns

Material Assessment Total Score: 3		Likelihood of Disturbance Assessment Total Score: 4		Management Assessment Licensable: No Recommendations: Program removal Reinspection Interval: Not Applicable Overall Risk Category: C7
Product Type:	1 (Asbestos reinforced plastic)	Location:	2 (Rooms up to 100 sq m)	
Condition:	1 (Minor scratches)	Accessibility:	1 (Occasionally likely to be disturbed)	
Surface Treatment:	0 (Composite material)			
Asbestos Type:	1 (Chrysotile)	Extent Score:	1 (<10 sq m or 10m pipe run)

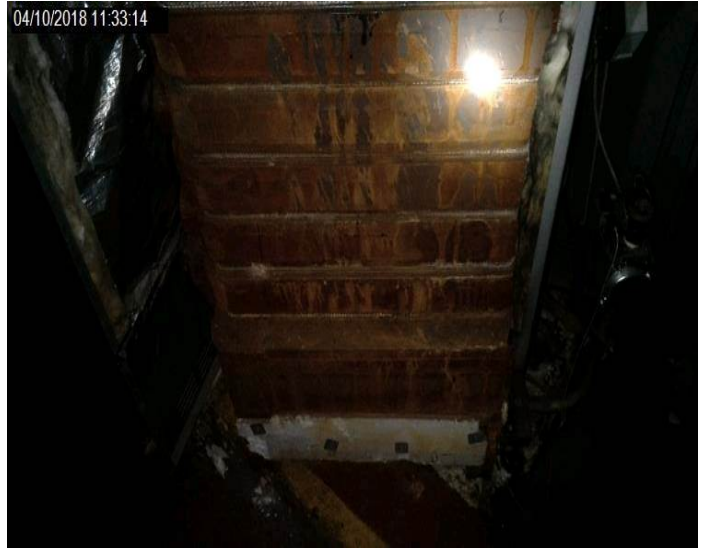
Location:	NBA02 Plant room	Block:	Birmingham City University	Floor Level: Basement
Sample No.:	DU002566	Portal Ref No.:	731

Item:	Textile rope seal to cast iron boilers			
Asbestos Content:		Result Based on:		
No Asbestos Detected		Analysis of sample using PLM		
Sample Analysed By:	Reg 13(1)	Extent:	100 linear metres	
Comments: 22 x boilers

Material Assessment Total Score: 0		Likelihood of Disturbance Assessment Total Score: 0		Management Assessment Licensable: No Recommendations: Not Applicable Reinspection Interval: Not Applicable Overall Risk Category: E0
Product Type:	0 Not Applicable	Location:	0 Not Applicable	
Condition:	0 Not Applicable	Accessibility:	0 Not Applicable	
Surface Treatment:	0 Not Applicable			
Asbestos Type:	0 Not Applicable	Extent Score:	0 Not Applicable

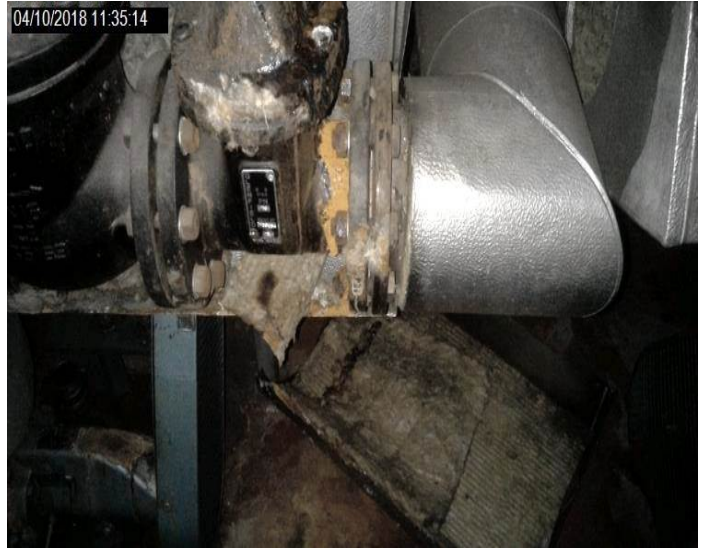
Location:	NBA02 Plant room	Block:	Birmingham City University	Floor Level: Basement
Sample No.:	DU002567	Portal Ref No.:	732

Item:	Asbestos Compressed fibre gaskets			
Asbestos Content:	Chrysotile			
Result Based on:	Analysis of sample using PLM			
Sample Analysed By:	Reg 13(1)	Extent:	16 units	
Comments: White gaskets to rear section of boiler components

Material Assessment Total Score: 5		Likelihood of Disturbance Assessment Total Score: 2		Management Assessment Licensable: No Recommendations: Program removal Reinspection Interval: Not Applicable Overall Risk Category: C7
Product Type:	2 (Compressed asbestos fibre)	Location:	1 (Large rooms or well-ventilated areas)	
Condition:	1 (Minor scratches)	Accessibility:	0 (Usually inaccessible or unlikely to be disturbed)	
Surface Treatment:	1 (Enclosed textile/paper)			
Asbestos Type:	1 (Chrysotile)	Extent Score:	1 (<10 sq m or 10m pipe run)

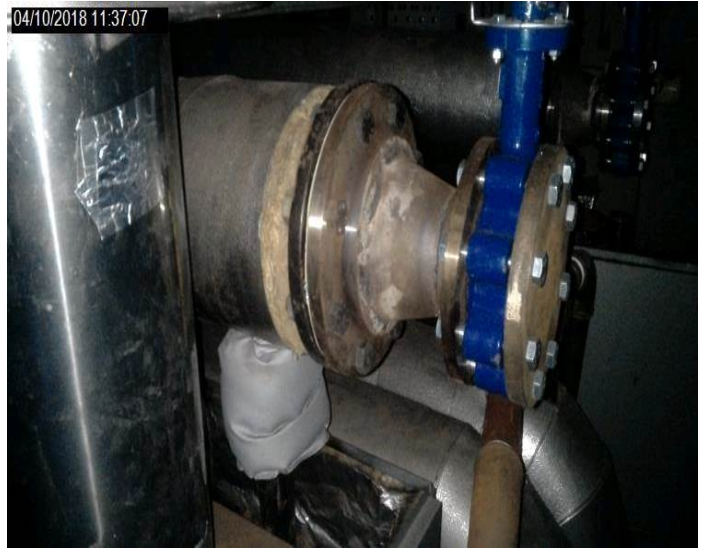
Location:	NBA02 Plant room	Block:	Birmingham City University	Floor Level: Basement
Sample No.:	DU002568	Portal Ref No.:	733

Item:	Compressed fibre gasket			
Asbestos Content:		Result Based on:		
No Asbestos Detected		Analysis of sample using PLM		
Sample Analysed By:	Reg 13(1)	Extent:	4 units	
Comments: Green gaskets to central section of boiler components

Material Assessment Total Score: 0		Likelihood of Disturbance Assessment Total Score: 0		Management Assessment Licensable: No Recommendations: Not Applicable Reinspection Interval: Not Applicable Overall Risk Category: E0
Product Type:	0 Not Applicable	Location:	0 Not Applicable	
Condition:	0 Not Applicable	Accessibility:	0 Not Applicable	
Surface Treatment:	0 Not Applicable			
Asbestos Type:	0 Not Applicable	Extent Score:	0 Not Applicable

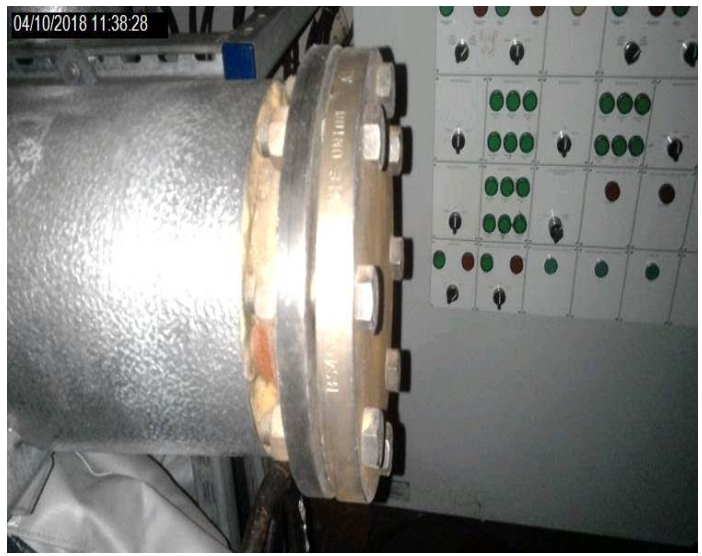
Location:	NBA02 Plant room	Block:	Birmingham City University	Floor Level: Basement
Sample No.:	DU002569	Portal Ref No.:	734

Item:	Asbestos Compressed fibre gasket			
Asbestos Content:	Chrysotile			
Result Based on:	Analysis of sample using PLM			
Sample Analysed By:	Reg 13(1)	Extent:	8 units	
Comments: Grey gaskets to right hand section of boiler components

Material Assessment Total Score: 5		Likelihood of Disturbance Assessment Total Score: 2		Management Assessment Licensable: No Recommendations: Program removal Reinspection Interval: Not Applicable Overall Risk Category: C7
Product Type:	2 (Compressed asbestos fibre)	Location:	1 (Large rooms or well-ventilated areas)	
Condition:	1 (Minor scratches)	Accessibility:	0 (Usually inaccessible or unlikely to be disturbed)	
Surface Treatment:	1 (Enclosed textile/paper)			
Asbestos Type:	1 (Chrysotile)	Extent Score:	1 (<10 sq m or 10m pipe run)

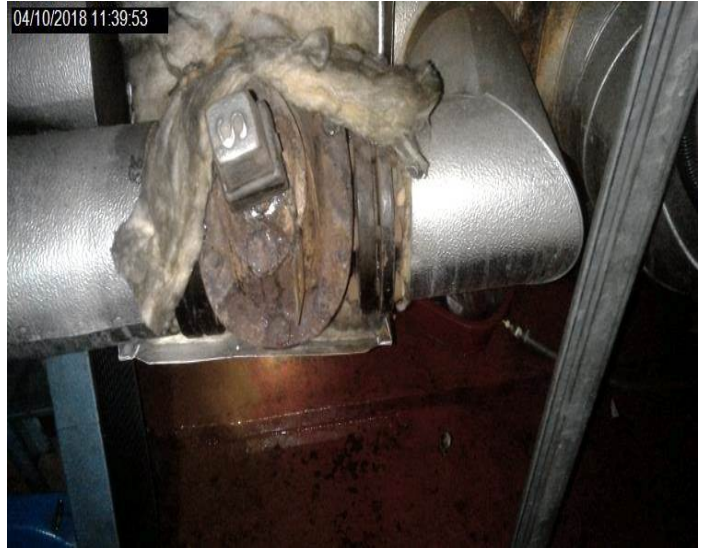
Location:	NBA02 Plant room	Block:	Birmingham City University	Floor Level: Basement
Sample No.:	DU002570	Portal Ref No.:	735

Item:	Asbestos Compressed fibre gasket			
Asbestos Content:	Chrysotile			
Result Based on:	Analysis of sample using PLM			
Sample Analysed By:	Reg 13(1)	Extent:	20 units	
Comments: Red gaskets to central section of boiler components

Material Assessment Total Score: 5		Likelihood of Disturbance Assessment Total Score: 2		Management Assessment Licensable: No Recommendations: Program removal Reinspection Interval: Not Applicable Overall Risk Category: C7
Product Type:	2 (Compressed asbestos fibre)	Location:	1 (Large rooms or well-ventilated areas)	
Condition:	1 (Minor scratches)	Accessibility:	0 (Usually inaccessible or unlikely to be disturbed)	
Surface Treatment:	1 (Enclosed textile/paper)			
Asbestos Type:	1 (Chrysotile)	Extent Score:	1 (<10 sq m or 10m pipe run)

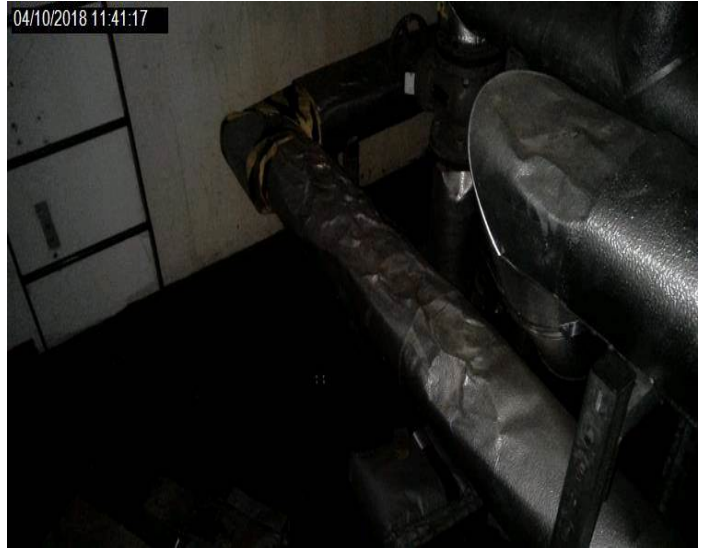
Location:	NBA02 Plant room	Block:	Birmingham City University	Floor Level: Basement
Sample No.:	DU002571	Portal Ref No.:	736

Item:	Asbestos Compressed fibre gasket			
Asbestos Content:	Result Based on:			
Chrysotile	Analysis of sample using PLM			
Sample Analysed By:	Reg 13(1)	Extent:	10 units	
Comments: White gaskets to rear section of boiler components, labelled with a warning label

Material Assessment Total Score: 5		Likelihood of Disturbance Assessment Total Score: 2		Management Assessment Licensable: No Recommendations: Program removal Reinspection Interval: Not Applicable Overall Risk Category: C7
Product Type:	2 (Compressed asbestos fibre)	Location:	1 (Large rooms or well-ventilated areas)	
Condition:	1 (Minor scratches)	Accessibility:	0 (Usually inaccessible or unlikely to be disturbed)	
Surface Treatment:	1 (Enclosed textile/paper)			
Asbestos Type:	1 (Chrysotile)	Extent Score:	1 (<10 sq m or 10m pipe run)

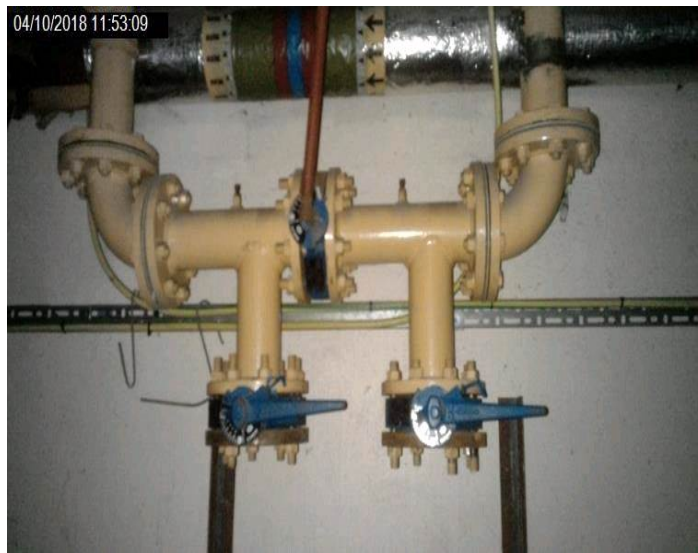
Location:	NBA02 Plant room	Block:	Birmingham City University	Floor Level: Basement
Sample No.:	DU002572	Portal Ref No.:	737

Item:	Compressed fibre gaskets			
Asbestos Content:		Result Based on:		
No Asbestos Detected		Analysis of sample using PLM		
Sample Analysed By:	Reg 13(1)	Extent:	6 units	
Comments: To yellow gas pipework

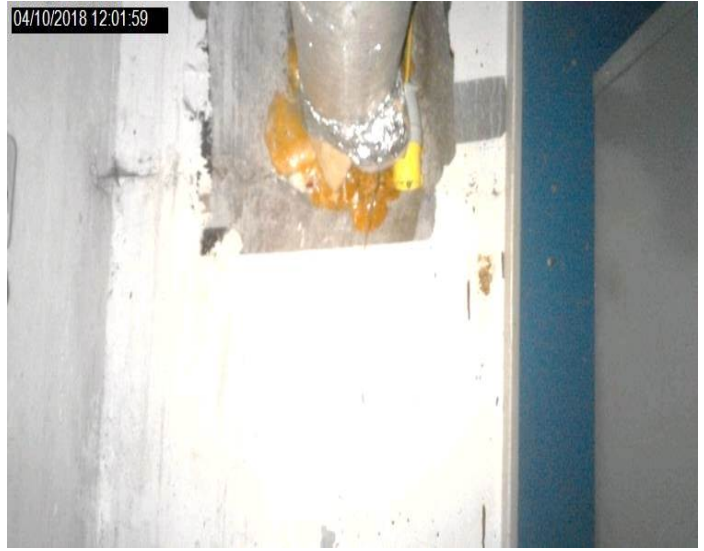
Location:	NBA02 Plant room	Block:	Birmingham City University	Floor Level: Basement
Sample No.:	DU002574	Portal Ref No.:	739

Item:	Asbestos Insulation debris			
Asbestos Content:	Result Based on:			
Amosite	Analysis of sample using PLM			
Sample Analysed By:	Reg 13(1)	Extent:	2 m ²	
Comments: Foam sealed within pipework recess see plan for location.

Material Assessment Total Score: 11		Likelihood of Disturbance Assessment Total Score: 2		Management Assessment Licensable: Yes Recommendations: Program removal Reinspection Interval: Not Applicable Overall Risk Category: B13
Product Type:	3 (Asbestos insulation)	Location:	1 (Large rooms or well-ventilated areas)	
Condition:	3 (Significant damage)	Accessibility:	0 (Usually inaccessible or unlikely to be disturbed)	
Surface Treatment:	3 (Unencapsulated insulation)			
Asbestos Type:	2 (Amosite)	Extent Score:	1 (<10 sq m or 10m pipe run)

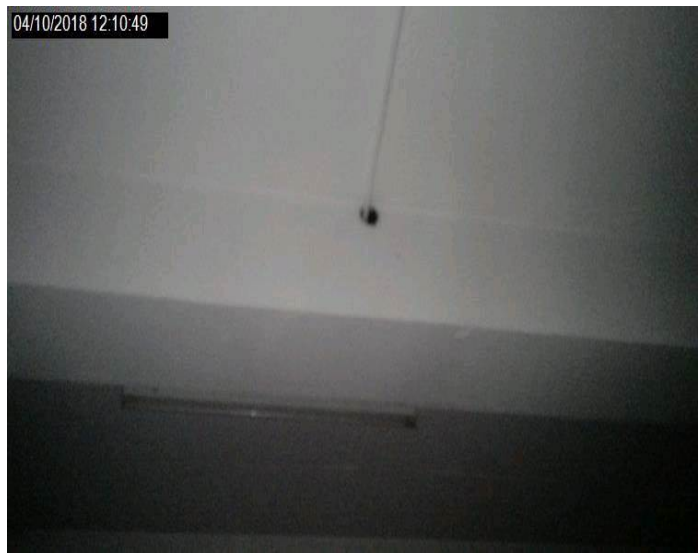
Location:	NBA03 Storage	Block:	Birmingham City University	Floor Level: Basement
Sample No.:	As DU002564	Portal Ref No.:	740

Item:	Asbestos Reinforced plastic sleeve			
Asbestos Content:	Result Based on:			
Chrysotile	Strongly presumed			
Sample Analysed By:	Not applicable	Extent:	6 units	
Comments: Through structural columns

Material Assessment Total Score: 3		Likelihood of Disturbance Assessment Total Score: 4		Management Assessment Licensable: No Recommendations: Program removal Reinspection Interval: Not Applicable Overall Risk Category: C7
Product Type:	1 (Asbestos reinforced plastic)	Location:	2 (Rooms up to 100 sq m)	
Condition:	1 (Minor scratches)	Accessibility:	1 (Occasionally likely to be disturbed)	
Surface Treatment:	0 (Composite material)			
Asbestos Type:	1 (Chrysotile)	Extent Score:	1 (<10 sq m or 10m pipe run)

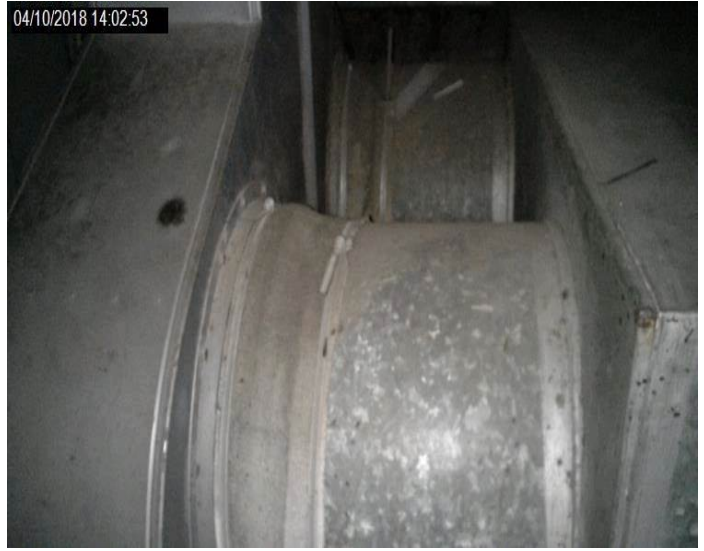
Location:	NBA903 Roof top plant room	Block:	Birmingham City University	Floor Level: E - External
Sample No.:	DU002576	Portal Ref No.:	742

Item:	Asbestos Textile wrap to ducting			
Asbestos Content:	Result Based on:			
Chrysotile	Analysis of sample using PLM			
Sample Analysed By: Reg 13(1)	Extent:	2 m ²		
Comments:

Material Assessment Total Score: 6		Likelihood of Disturbance Assessment Total Score: 4		Management Assessment Licensable: No Recommendations: Program removal Reinspection Interval: Not Applicable Overall Risk Category: C10
Product Type:	2 (Asbestos textile)	Location:	2 (Rooms up to 100 sq m)	
Condition:	1 (Minor scratches)	Accessibility:	1 (Occasionally likely to be disturbed)	
Surface Treatment:	2 (Unencapsulated textile/paper)			
Asbestos Type:	1 (Chrysotile)	Extent Score:	1 (<10 sq m or 10m pipe run)

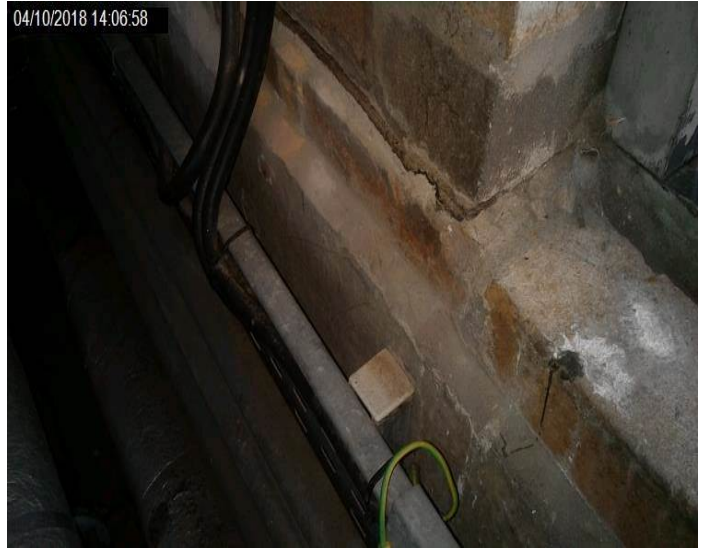
Location:	NBA903 Roof top plant room	Block:	Birmingham City University	Floor Level: E - External
Sample No.:	DU002577	Portal Ref No.:	744

Item:	Bitumen damp proof course			
Asbestos Content:		Result Based on:		
No Asbestos Detected		Analysis of sample using PLM		
Sample Analysed By:	Reg 13(1)	Extent:	16 linear metres	
Comments: To perimeter of plant room

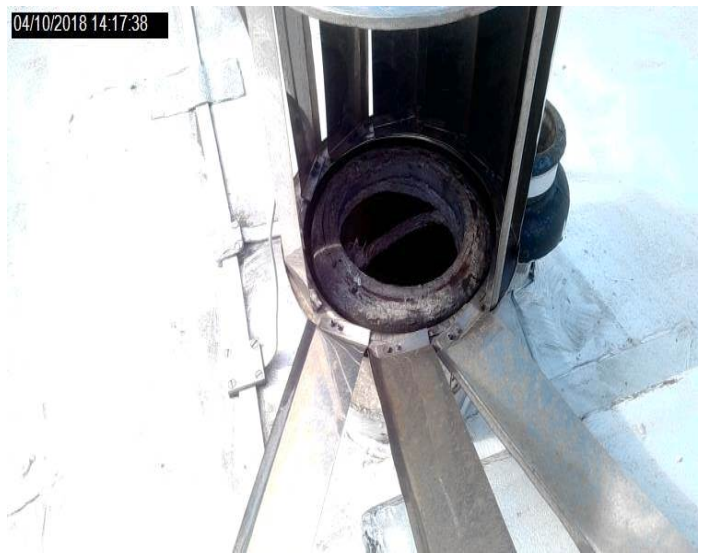
Location:	NBA905 Roof	Block:	Birmingham City University	Floor Level: E - External
Sample No.:	DU002578	Portal Ref No.:	745

Item:	Asbestos Textile rope seal to metal flue pipe			
Asbestos Content:	Result Based on:			
Chrysotile	Analysis of sample using PLM			
Sample Analysed By: Reg 13(1)	Extent:	1 linear metres		
Comments: Internally to metal flue pipe, see plan for location

Material Assessment Total Score: 6		Likelihood of Disturbance Assessment Total Score: 1		Management Assessment Licensable: No Recommendations: Program removal Reinspection Interval: Not Applicable Overall Risk Category: C7
Product Type:	2 (Asbestos textile)	Location:	0 (Outdoors)	
Condition:	1 (Minor scratches)	Accessibility:	0 (Usually inaccessible or unlikely to be disturbed)	
Surface Treatment:	2 (Unencapsulated textile/paper)			
Asbestos Type:	1 (Chrysotile)	Extent Score:	1 (<10 sq m or 10m pipe run)

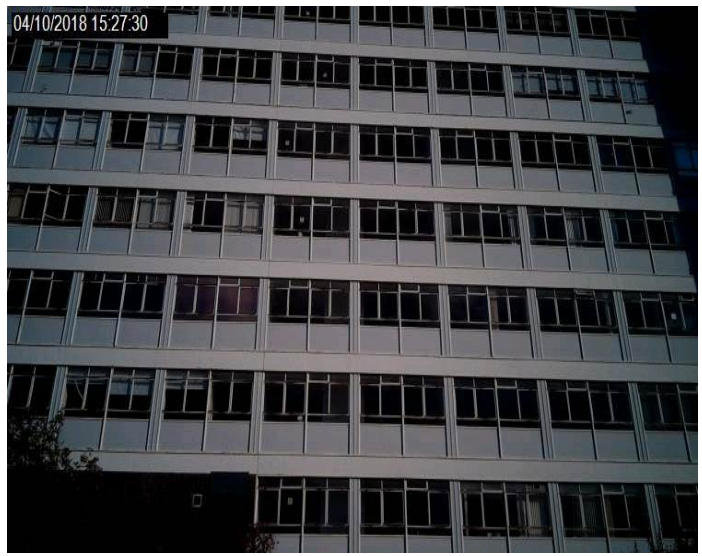
Location:	NBAEXT - External	Block:	Birmingham City University	Floor Level: E - External
Sample No.:	DU002582	Portal Ref No.:	749

Item:	Asbestos Cement panels			
Asbestos Content:	Result Based on:			
Chrysotile	Analysis of sample using PLM			
Sample Analysed By: Reg 13(1)	Extent:	308 m ²		
Comments: Beneath windows to side elevation former main reception side, includes panels painted black

Material Assessment Total Score: 4		Likelihood of Disturbance Assessment Total Score: 3		Management Assessment Licensable: No Recommendations: Program removal Reinspection Interval: Not Applicable Overall Risk Category: C7
Product Type:	1 (Asbestos cement)	Location:	0 (Outdoors)	
Condition:	1 (Minor scratches)	Accessibility:	0 (Usually inaccessible or unlikely to be disturbed)	
Surface Treatment:	1 (Encapsulated asbestos cement)			
Asbestos Type:	1 (Chrysotile)	Extent Score:	3 (>50 sq m or >50m pipe run)

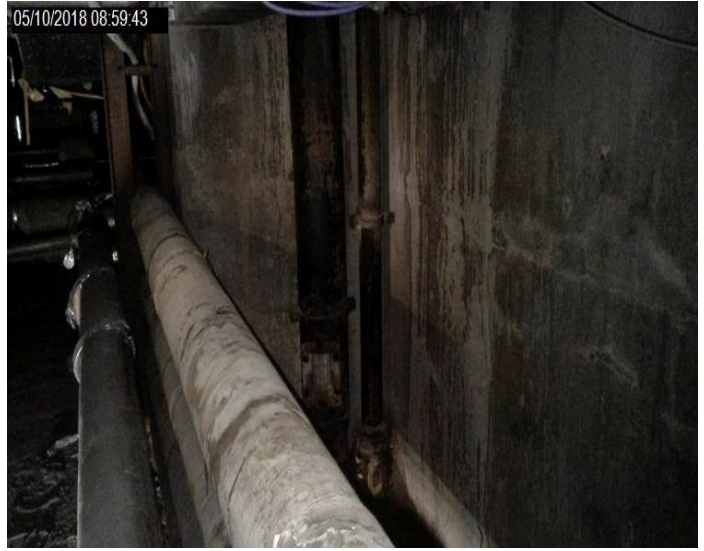
Location:	NBAB11 Service Duct	Block:	Birmingham City University	Floor Level: Basement
Sample No.:	As DU002536	Portal Ref No.:	754

Item:	Asbestos Reinforced plastic downpipe			
Asbestos Content:	Result Based on:			
Chrysotile	Strongly presumed			
Sample Analysed By:	Not applicable	Extent:	3 linear metres	
Comments:

Material Assessment Total Score: 3		Likelihood of Disturbance Assessment Total Score: 4		Management Assessment Licensable: No Recommendations: Program removal Reinspection Interval: Not Applicable Overall Risk Category: C7
Product Type:	1 (Asbestos reinforced plastic)	Location:	2 (Rooms up to 100 sq m)	
Condition:	1 (Minor scratches)	Accessibility:	1 (Occasionally likely to be disturbed)	
Surface Treatment:	0 (Composite material)			
Asbestos Type:	1 (Chrysotile)	Extent Score:	1 (<10 sq m or 10m pipe run)

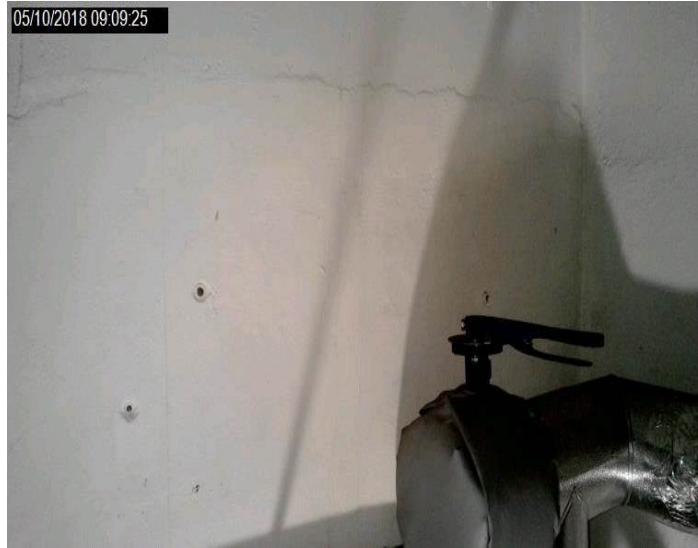
Location:	NBA02 Plant room	Block:	Birmingham City University	Floor Level: Basement
Sample No.:	DU002584	Portal Ref No.:	755

Item:	Asbestos Insulation residues to wall			
Asbestos Content:	Result Based on:			
Chrysotile Amosite	Analysis of sample using PLM			
Sample Analysed By: Reg 13(1)	Extent:	24 m ²		
Comments: Small amount of residue to concrete wall to left-hand side of duct opening, quantity face of entire wall recommend a licensed contractor carries out an environmental clean under fully controlled conditions

Material Assessment Total Score: 11		Likelihood of Disturbance Assessment Total Score: 4		Management Assessment Licensable: Yes Recommendations: Program removal Reinspection Interval: Not Applicable Overall Risk Category: B15
Product Type:	3 (Asbestos insulation)	Location:	1 (Large rooms or well-ventilated areas)	
Condition:	3 (Significant damage)	Accessibility:	1 (Occasionally likely to be disturbed)	
Surface Treatment:	3 (Unencapsulated insulation)			
Asbestos Type:	2 (Chrysotile Amosite)	Extent Score:	2 (>10 - <50 sq m or >10m - <50m pipe run)

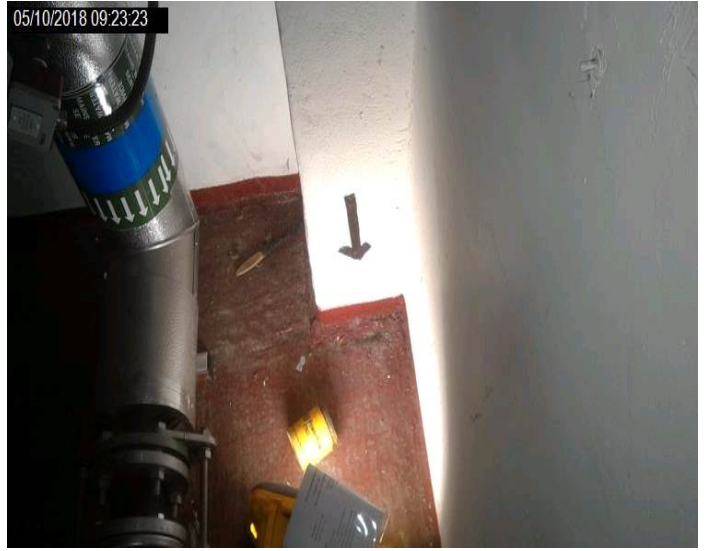
Location:	NBA02 Plant room	Block:	Birmingham City University	Floor Level: Basement
Sample No.:	DU002586	Portal Ref No.:	757

Item:	Insulation residues to corner pillar			
Asbestos Content:		Result Based on:		
No Asbestos Detected		Analysis of sample using PLM		
Sample Analysed By:	Reg 13(1)	Extent:	2 linear metres	
Comments: Small amount of residue to concrete pillar low level close to duct opening

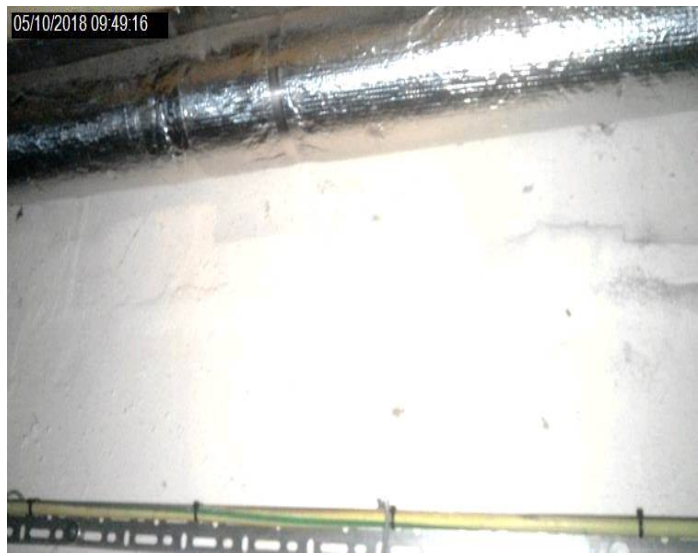
Location:	NBA02 Plant room	Block:	Birmingham City University	Floor Level: Basement
Sample No.:	DU002587	Portal Ref No.:	761

Item:	Asbestos Insulation residues to wall			
Asbestos Content:	Result Based on:			
Chrysotile Amosite	Analysis of sample using PLM			
Sample Analysed By: Reg 13(1)	Extent:	16 m ²		
<p>Comments: Small amount of residue sporadic to concrete wall to left-hand side of duct opening to B50A Service duct, quantity face of entire wall recommend a licensed contractor carries out an environmental clean under fully controlled conditions</p>

Material Assessment Total Score: 11		Likelihood of Disturbance Assessment Total Score: 4		<p>Management Assessment</p> <p>Licensable: Yes</p> <p>Recommendations: Program removal</p> <p>Reinspection Interval: Not Applicable</p> <p>Overall Risk Category: B15</p>
Product Type:	3 (Asbestos insulation)	Location:	1 (Large rooms or well-ventilated areas)	
Condition:	3 (Significant damage)	Accessibility:	1 (Occasionally likely to be disturbed)	
Surface Treatment:	3 (Unencapsulated insulation)			
Asbestos Type:	2 (Chrysotile Amosite)	Extent Score:	2 (>10 - <50 sq m or >10m - <50m pipe run)

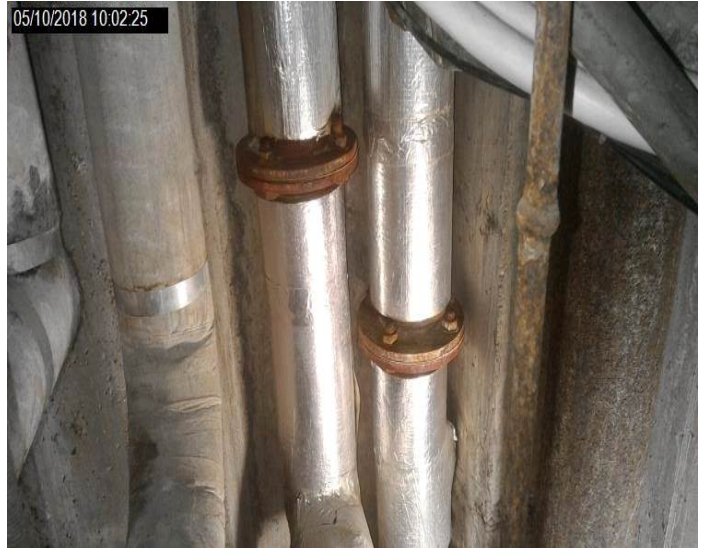
Location:	NBAB05A Service Duct	Block:	Birmingham City University	Floor Level: Basement
Sample No.:	DU002588	Portal Ref No.:	762

Item:	Asbestos Compressed fibre gasket			
Asbestos Content:	Result Based on:			
Chrysotile	Analysis of sample using PLM			
Sample Analysed By:	Reg 13(1)	Extent:	2 units	
Comments:

Material Assessment Total Score: 5		Likelihood of Disturbance Assessment Total Score: 3		Management Assessment Licensable: No Recommendations: Program removal Reinspection Interval: Not Applicable Overall Risk Category: C8
Product Type:	2 (Compressed asbestos fibre)	Location:	2 (Rooms up to 100 sq m)	
Condition:	1 (Minor scratches)	Accessibility:	0 (Usually inaccessible or unlikely to be disturbed)	
Surface Treatment:	1 (Enclosed textile/paper)			
Asbestos Type:	1 (Chrysotile)	Extent Score:	1 (<10 sq m or 10m pipe run)

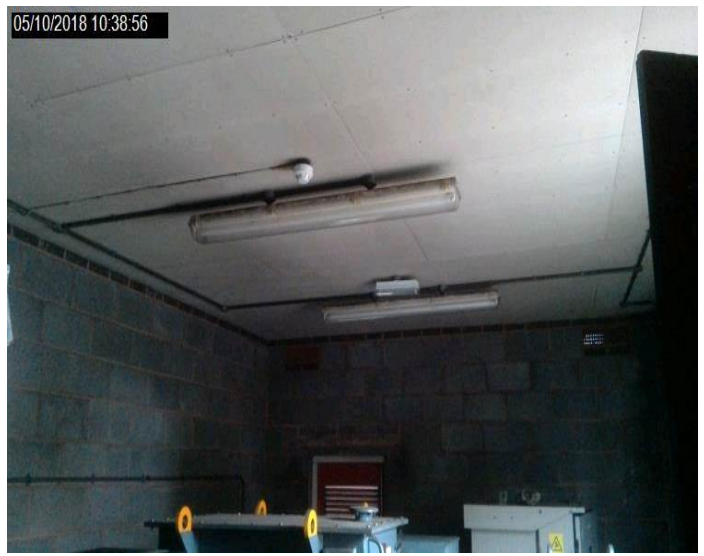
Location:	NBAG00 Sub Station No.3	Block:	Birmingham City University	Floor Level: Ground Floor
Sample No.:	DU002589	Portal Ref No.:	764

Item:	Insulating board ceiling panels			
Asbestos Content:		Result Based on:		
No Asbestos Detected		Analysis of sample using PLM		
Sample Analysed By:	Reg 13(1)	Extent:	30 m ²	
Comments:

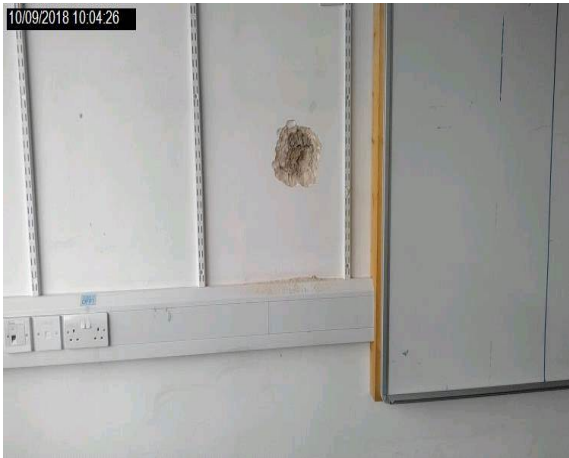
Intrusion 01 - Plaster to
compressed straw board to
concrete

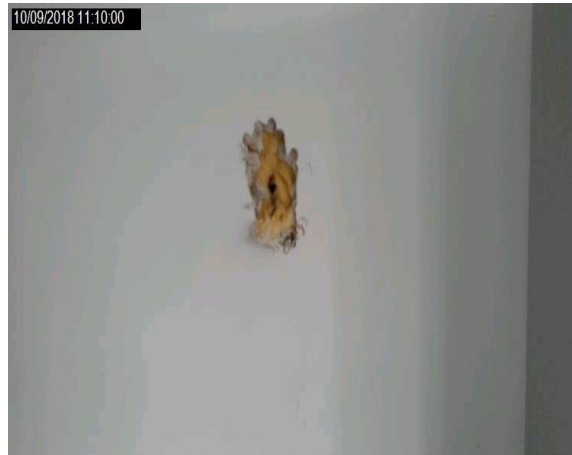
Intrusion 03 - Plaster to
plasterboard to glass fibre
insulation cavity

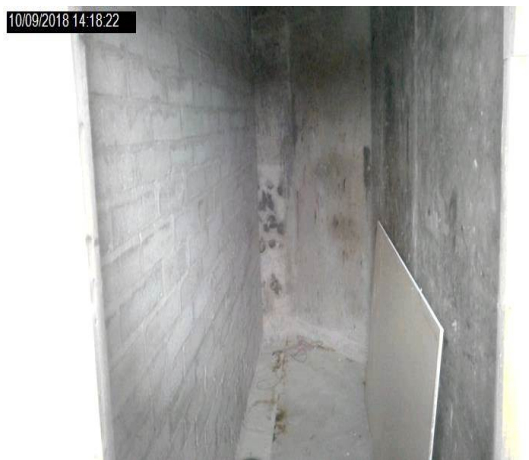
Intrusion 07 - Wall void

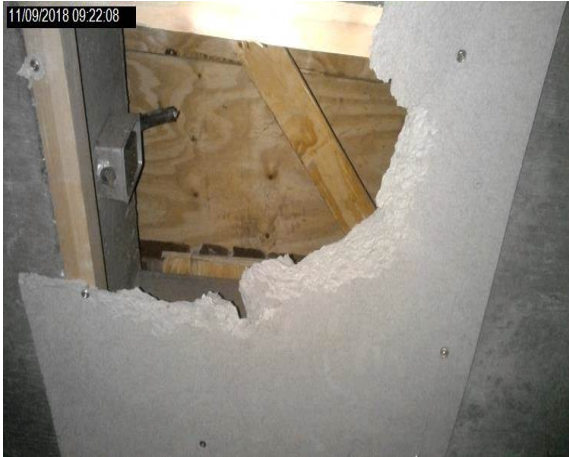
Intrusion 09 - Void opening to roof

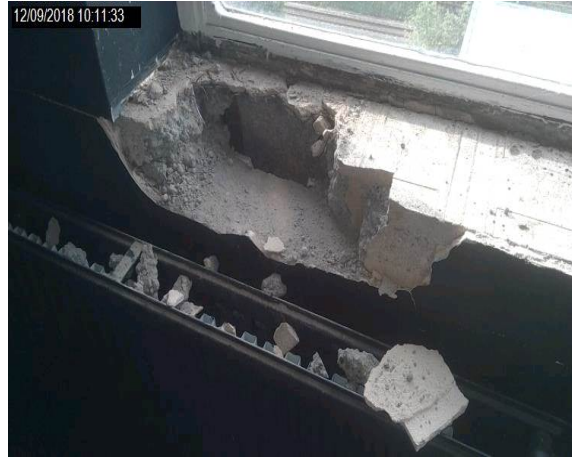
Intrusion 14 - Cement panel to underside of window

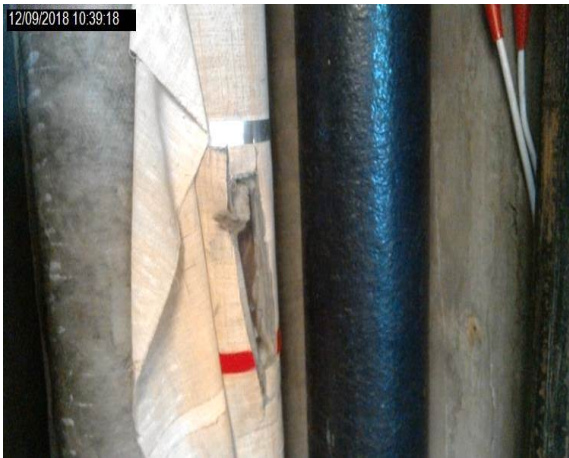
Intrusion 15 - Cloth wrap to glass fibre insulation to metal pipework

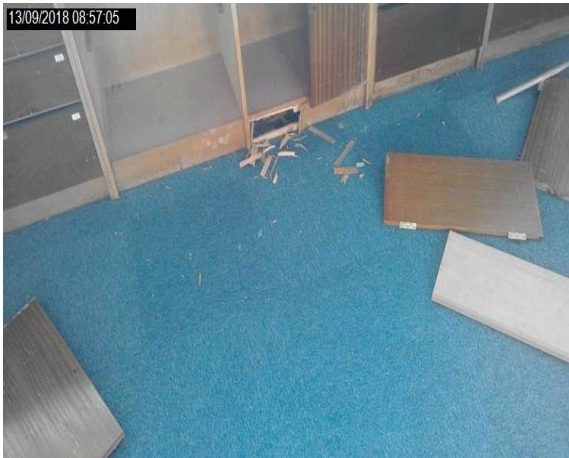
Intrusion 21 - Built in timber cupboards to bitumen adhesive to concrete

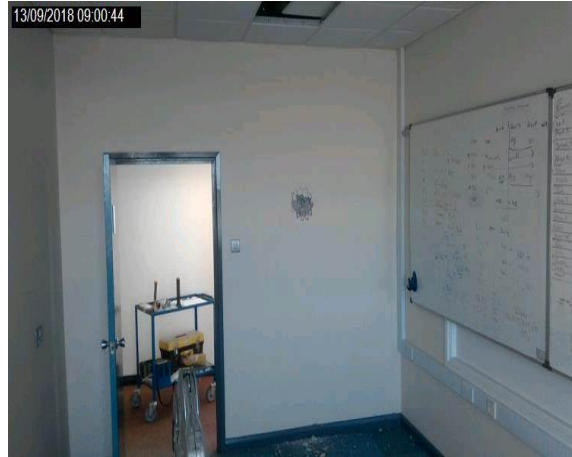
Intrusion 22 - Plaster to plasterboard
