Location:	NBA201A	Block:	Birmingham City University	Floor Level: 2nd Floor
Sample No.:	DU002474	Portal Ref No.:	492

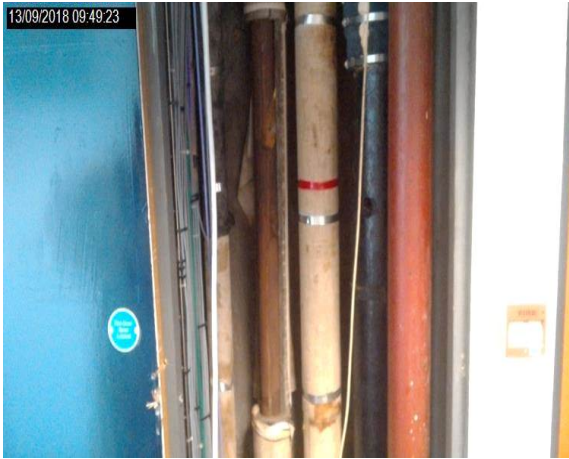
Intrusion 24 - Cloth wrap to glass fibre insulation to metal pipework

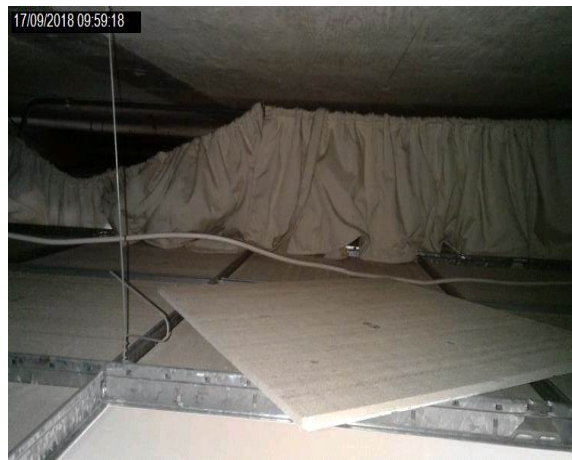
Intrusion 32 - Non suspect curtain firebreak

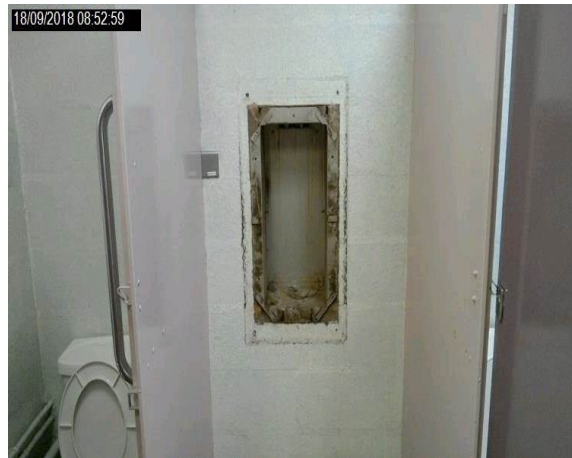
Intrusion 36 - Former female dispenser position

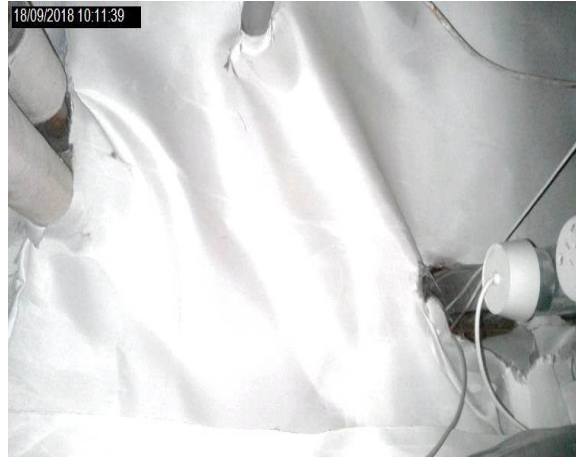
Intrusion 38 - Textile fire break modern

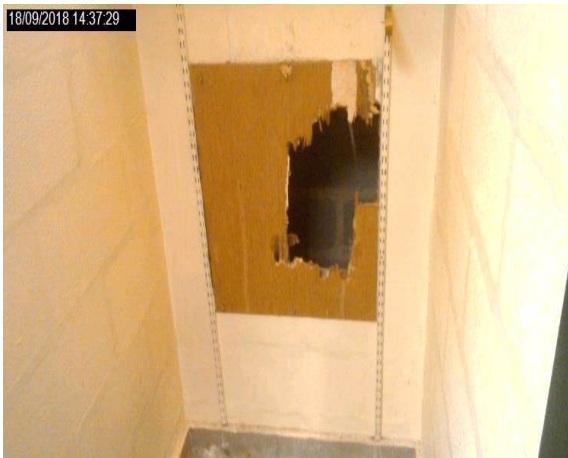
Intrusion 43 - Timber panel to block built riser

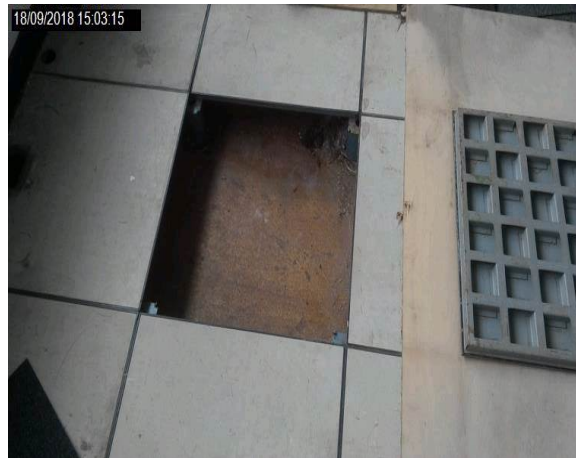
Intrusion 44 - Raised flooring

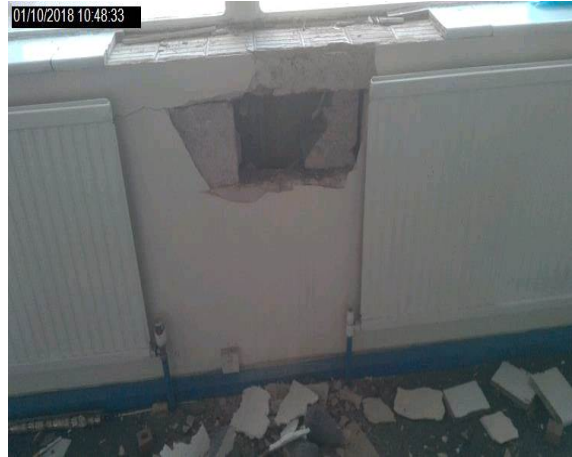
Intrusion 50 - Cement panels to underside of external windows

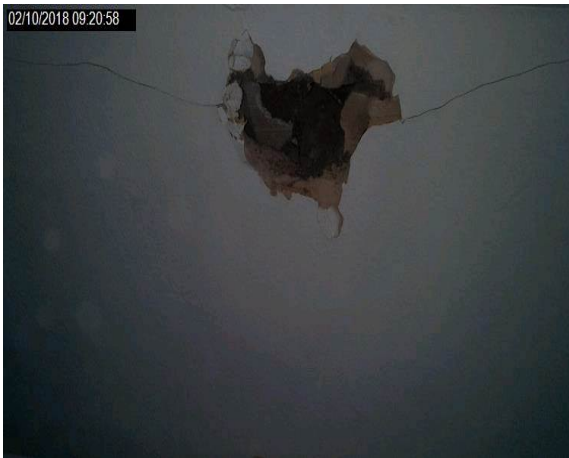
Intrusion 51 - Cement panel to underside of external window

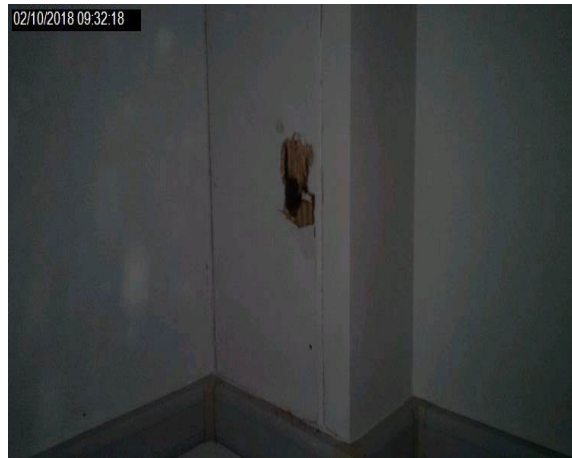
Intrusion 52 - Timber boxing to metal pipework

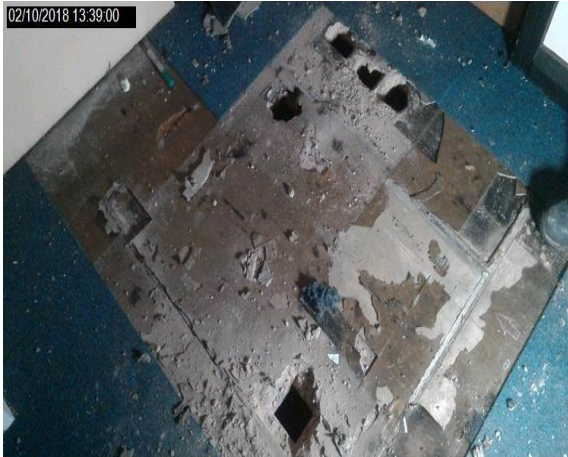
Intrusion 53 - Floor duct limited access

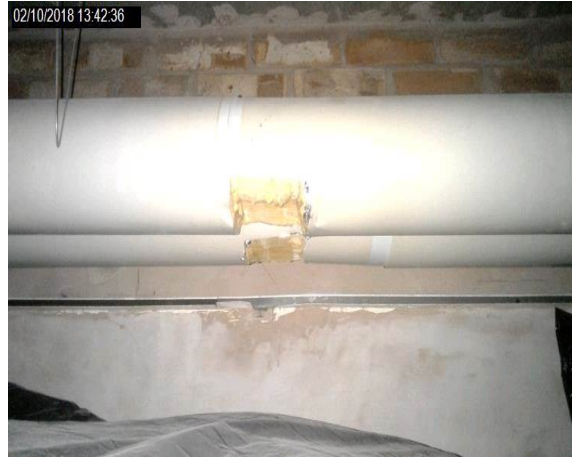
Intrusion 54 - Plastic wrap to glass fibre insulation to metal pipework

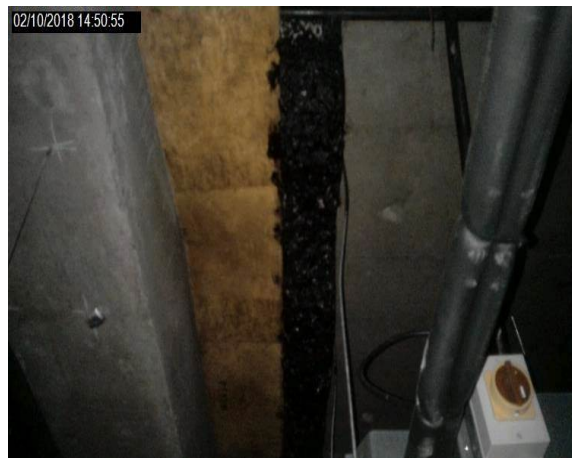
Intrusion 56 - Painted black redundant section of wall

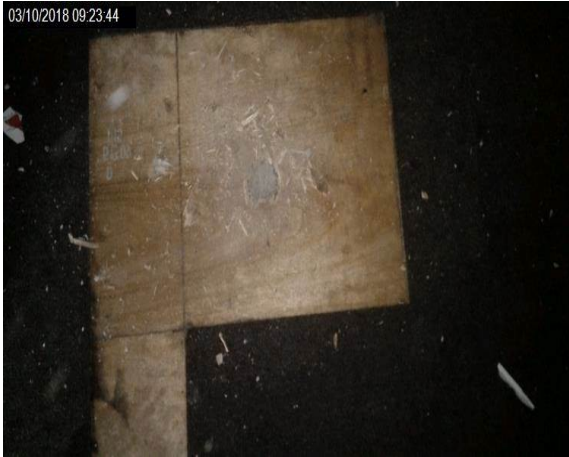
Intrusion 57 - Timber ply to concrete

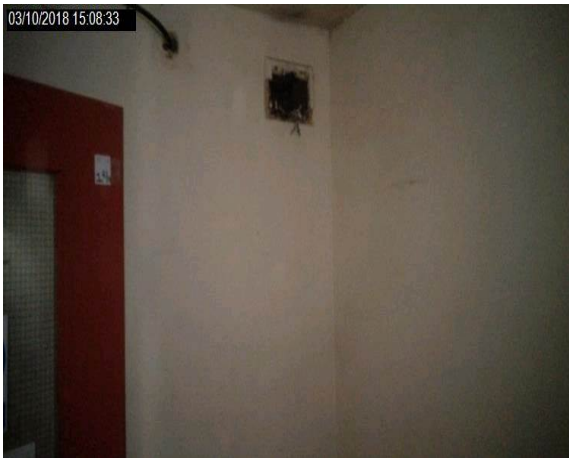
Intrusion 67 - Plaster cast vent cover to slate shuttering

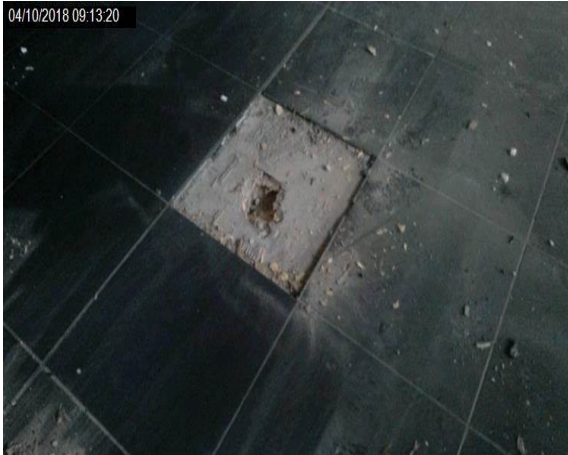
Intrusion 69 - Ceramic tile to timber ply to metal raised flooring

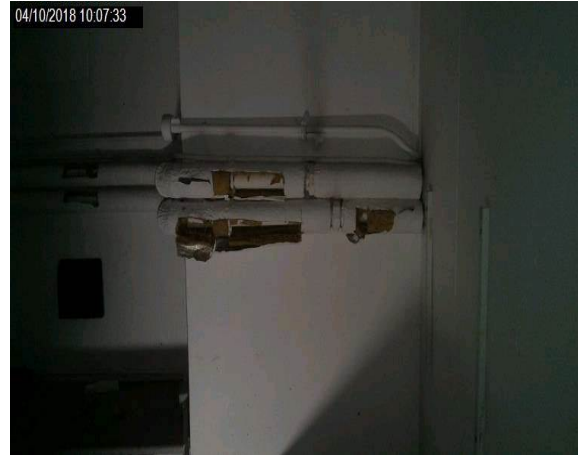
Intrusion 70 - Glass fibre to metal pipework

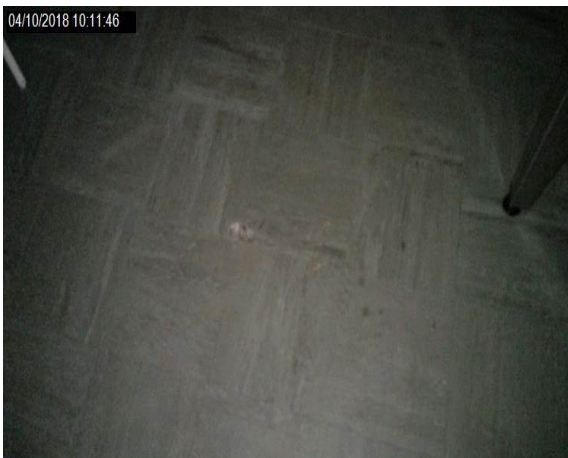
Intrusion 71 - Modern vinyl floor tiles

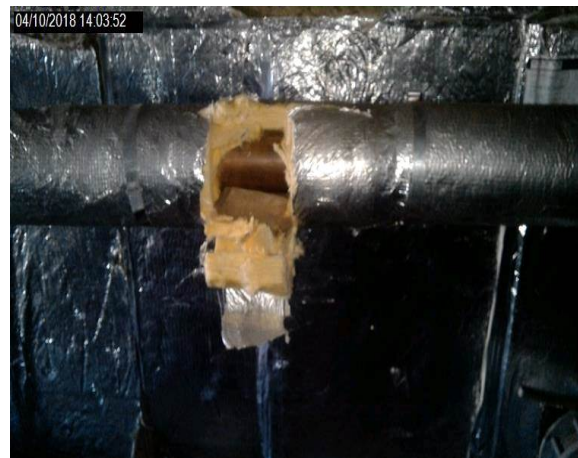
Intrusion 72 - Foil faced glass fibre insulation to metal pipework

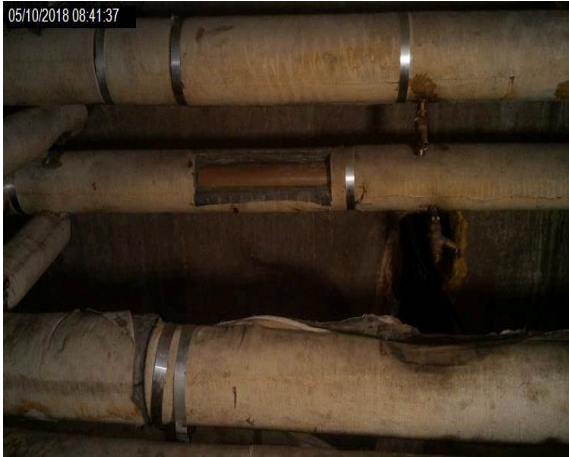
Intrusion 72 - Cloth wrap glass fibre insulation to metal pipework

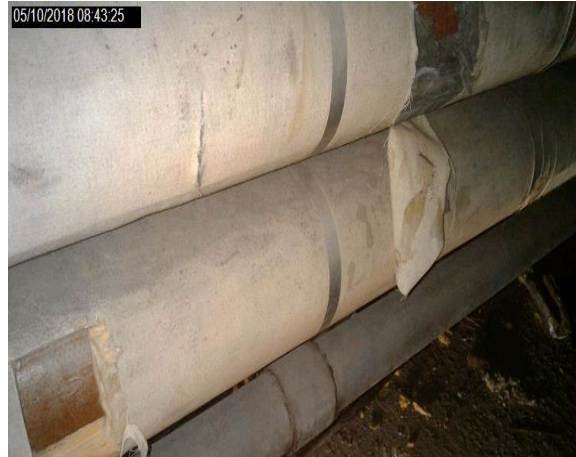
Intrusion 73 - Cloth wrap glass fibre insulation to metal pipework

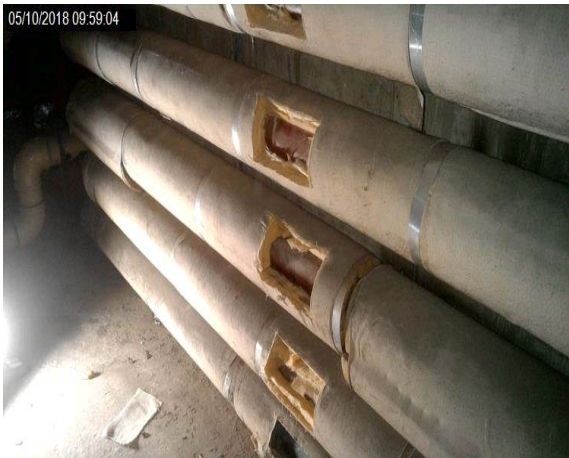
Intrusion 74 - Cloth wrap glass fibre insulation to metal pipework

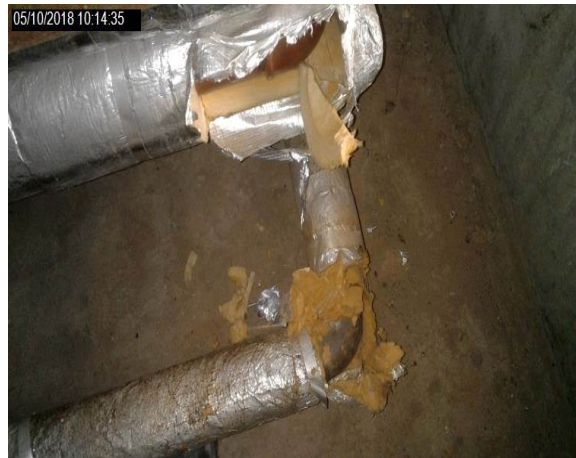
Intrusion 75 - Foil faced glass fibre insulation to metal pipework
