Report No.: J102749
Nature of Work: Demolition Survey
Issue Date: 02/11/2018
Client Name: WYG Engineering Ltd
 Geneva Building, Lake View Drive, Sherwood Business Park,
 Annesley, Nottingham, NG15 0ED
Site Address: Attwood Building, Former City North Campus, Birmingham City
 University, Perry Barr, B42 2US

1.0 Introduction & Scope of Work

A demolition survey in line with HSG264 Asbestos: The Survey Guide was carried out internally and externally to the property.

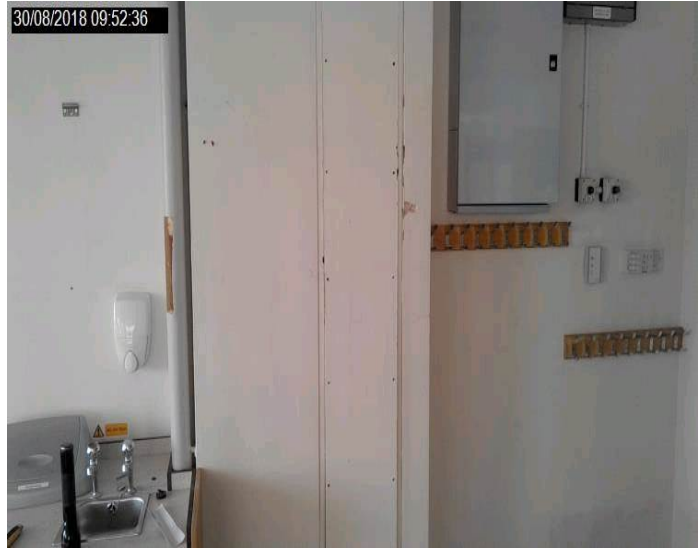
Location:	NAT200	Block:	Birmingham City University	Floor Level: 2nd Floor
Sample No.:	DU002190	Portal Ref No.:	1

Item:	Asbestos Reinforced plastic soil pipe			
Asbestos Content:	Result Based on:			
Chrysotile	Analysis of sample using PLM			
Sample Analysed By:	Reg 13(1)	Extent:	4 linear metres	
Comments: Within riser

Material Assessment Total Score: 3		Likelihood of Disturbance Assessment Total Score: 3		Management Assessment Licensable: No Recommendations: Program removal Reinspection Interval: Not Applicable Overall Risk Category: D6
Product Type:	1 (Asbestos reinforced plastic)	Location:	2 (Rooms up to 100 sq m)	
Condition:	1 (Minor scratches)	Accessibility:	0 (Usually inaccessible or unlikely to be disturbed)	
Surface Treatment:	0 (Composite material)			
Asbestos Type:	1 (Chrysotile)	Extent Score:	1 (<10 sq m or 10m pipe run)

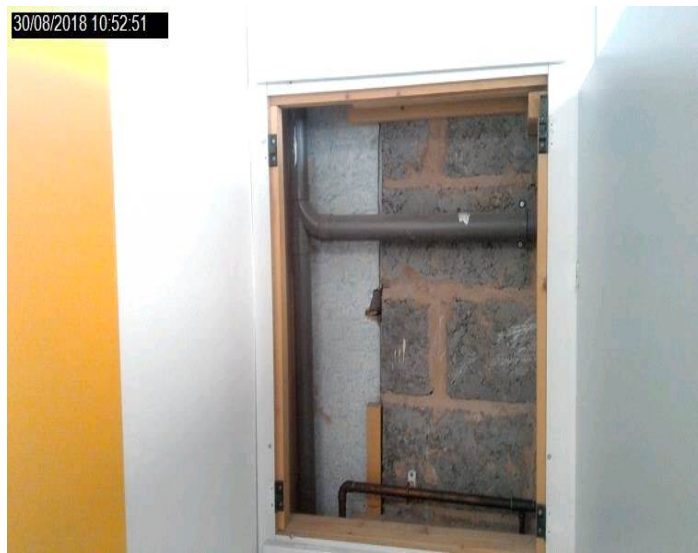
Location:	NAT213A	Block:	Birmingham City University	Floor Level: 2nd Floor
Sample No.:	DU002195	Portal Ref No.:	12

Item:	Textured coating to blockwork			
Asbestos Content:		Result Based on:		
No Asbestos Detected		Analysis of sample using PLM		
Sample Analysed By:	Reg 13(1)	Extent:	25 m ²	
Comments: To one half of the room, behind plaster to one side exposed on the other

Material Assessment Total Score: 0		Likelihood of Disturbance Assessment Total Score: 0		Management Assessment Licensable: No Recommendations: Not Applicable Reinspection Interval: Not Applicable Overall Risk Category: E0
Product Type:	0 Not Applicable	Location:	0 Not Applicable	
Condition:	0 Not Applicable	Accessibility:	0 Not Applicable	
Surface Treatment:	0 Not Applicable			
Asbestos Type:	0 Not Applicable	Extent Score:	0 Not Applicable

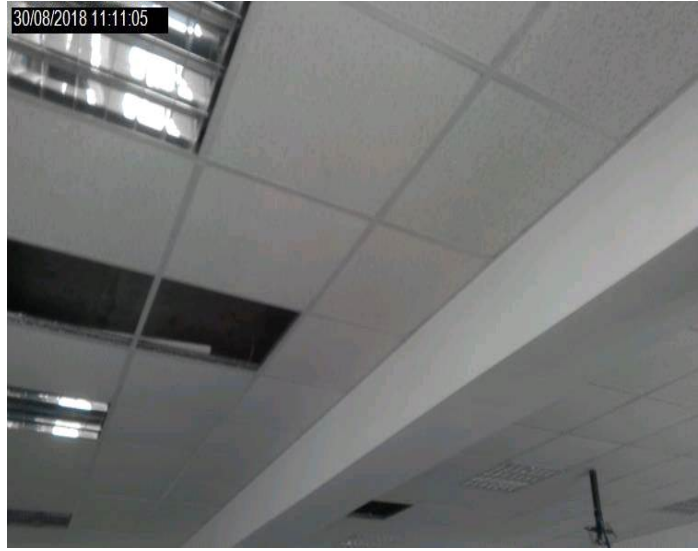
Location:	NAT224	Block:	Birmingham City University	Floor Level: 2nd Floor
Sample No.:	As DU002191	Portal Ref No.:	17

Item:	Asbestos Reinforced plastic sleeve			
Asbestos Content:	Result Based on:			
Chrysotile	Strongly presumed			
Sample Analysed By:	Not applicable	Extent:	4 units	
Comments: Through structural concrete various points within ceiling void items run parallel generally throughout the ceiling void

Material Assessment Total Score: 3		Likelihood of Disturbance Assessment Total Score: 4		Management Assessment Licensable: No Recommendations: Program removal Reinspection Interval: Not Applicable Overall Risk Category: C7
Product Type:	1 (Asbestos reinforced plastic)	Location:	2 (Rooms up to 100 sq m)	
Condition:	1 (Minor scratches)	Accessibility:	1 (Occasionally likely to be disturbed)	
Surface Treatment:	0 (Composite material)			
Asbestos Type:	1 (Chrysotile)	Extent Score:	1 (<10 sq m or 10m pipe run)

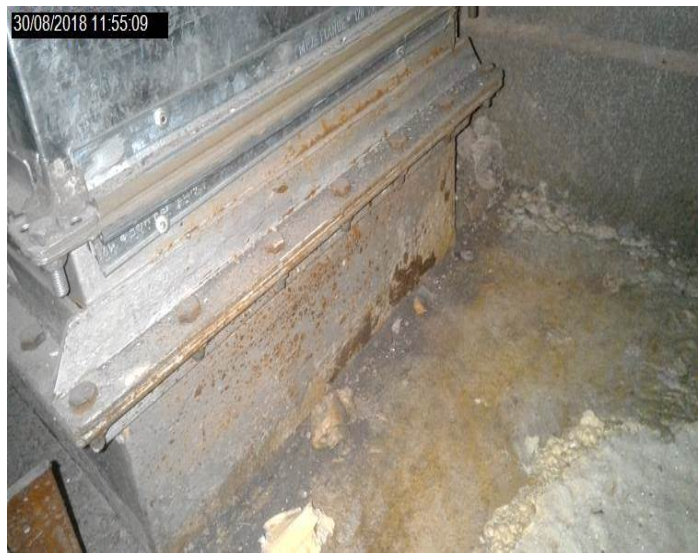
Location:	NAT223A	Block:	Birmingham City University	Floor Level: 2nd Floor
Sample No.:	DU002201	Portal Ref No.:	25

Item:	Asbestos Textile seal to metal ducting joints			
Asbestos Content:	Result Based on:			
Chrysotile	Analysis of sample using PLM			
Sample Analysed By: Reg 13(1)	Extent:	2 linear metres		
Comments: To bolted joint section only

Material Assessment Total Score: 5		Likelihood of Disturbance Assessment Total Score: 4		Management Assessment Licensable: No Recommendations: Program removal Reinspection Interval: Not Applicable Overall Risk Category: C9
Product Type:	2 (Asbestos textile)	Location:	2 (Rooms up to 100 sq m)	
Condition:	1 (Minor scratches)	Accessibility:	1 (Occasionally likely to be disturbed)	
Surface Treatment:	1 (Enclosed textile/paper)			
Asbestos Type:	1 (Chrysotile)	Extent Score:	1 (<10 sq m or 10m pipe run)

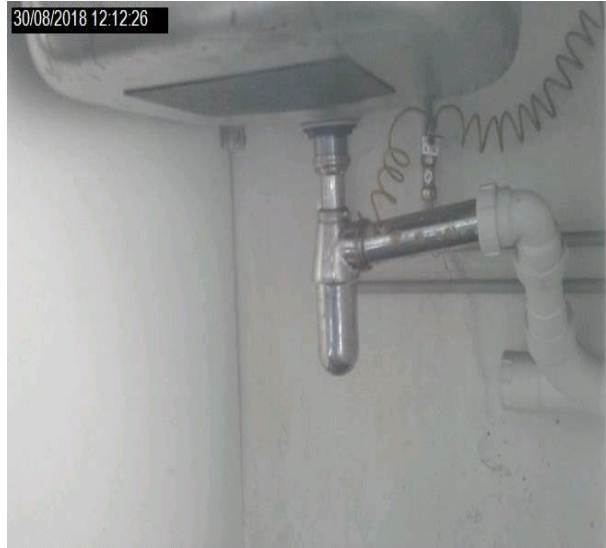
Location:	NAT204	Block:	Birmingham City University	Floor Level: 2nd Floor
Sample No.:	DU002203	Portal Ref No.:	32

Item:	Bitumen sink pads			
Asbestos Content:		Result Based on:		
No Asbestos Detected		Analysis of sample using PLM		
Sample Analysed By:	Reg 13(1)	Extent:	2 units	
Comments: Sink and drainer

Material Assessment Total Score: 0		Likelihood of Disturbance Assessment Total Score: 0		Management Assessment Licensable: No Recommendations: Not Applicable Reinspection Interval: Not Applicable Overall Risk Category: E0
Product Type:	0 Not Applicable	Location:	0 Not Applicable	
Condition:	0 Not Applicable	Accessibility:	0 Not Applicable	
Surface Treatment:	0 Not Applicable			
Asbestos Type:	0 Not Applicable	Extent Score:	0 Not Applicable

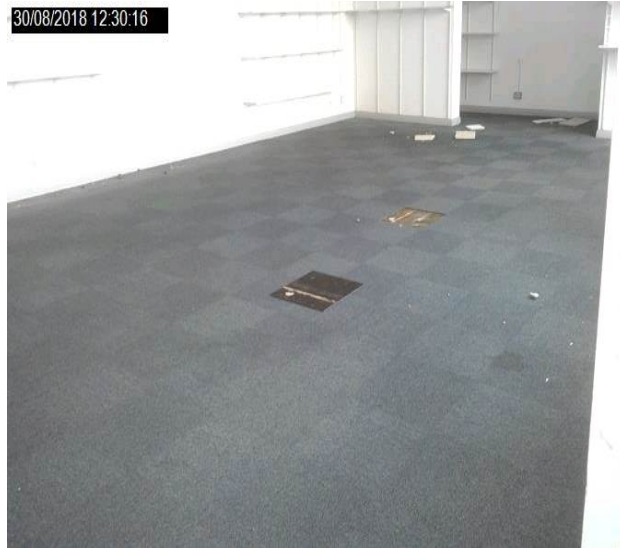
Location:	NAT219	Block:	Birmingham City University	Floor Level: 2nd Floor
Sample No.:	As DU002204	Portal Ref No.:	40

Item:	Asbestos Bitumen adhesive			
Asbestos Content:	Result Based on:			
Chrysotile	Strongly presumed			
Sample Analysed By:	Not applicable	Extent:	84 m ²	
Comments:

Material Assessment Total Score: 2		Likelihood of Disturbance Assessment Total Score: 6		Management Assessment Licensable: No Recommendations: Program removal Reinspection Interval: Not Applicable Overall Risk Category: C8
Product Type:	1 (Asbestos bitumen)	Location:	2 (Rooms up to 100 sq m)	
Condition:	0 (Perfect)	Accessibility:	1 (Occasionally likely to be disturbed)	
Surface Treatment:	0 (Composite material)			
Asbestos Type:	1 (Chrysotile)	Extent Score:	3 (>50 sq m or >50m pipe run)

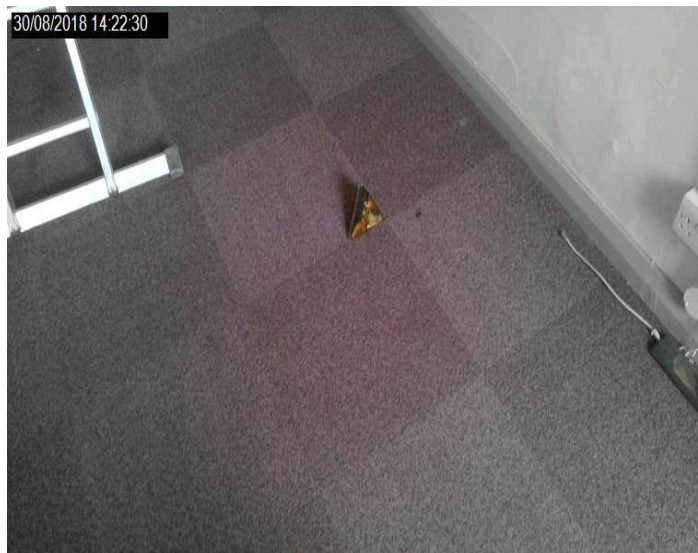
Location:	NAT217	Block:	Birmingham City University	Floor Level: 2nd Floor
Sample No.:	DU002208	Portal Ref No.:	48

Item:	Vinyl			
Asbestos Content:		Result Based on:		
No Asbestos Detected in vinyl or adhesive		Analysis of sample using PLM		
Sample Analysed By:	Reg 13(1)	Extent:	16 m ²	
Comments: To bottom section of room

Material Assessment Total Score: 0		Likelihood of Disturbance Assessment Total Score: 0		Management Assessment Licensable: No Recommendations: Not Applicable Reinspection Interval: Not Applicable Overall Risk Category: E0
Product Type:	0 Not Applicable	Location:	0 Not Applicable	
Condition:	0 Not Applicable	Accessibility:	0 Not Applicable	
Surface Treatment:	0 Not Applicable			
Asbestos Type:	0 Not Applicable	Extent Score:	0 Not Applicable

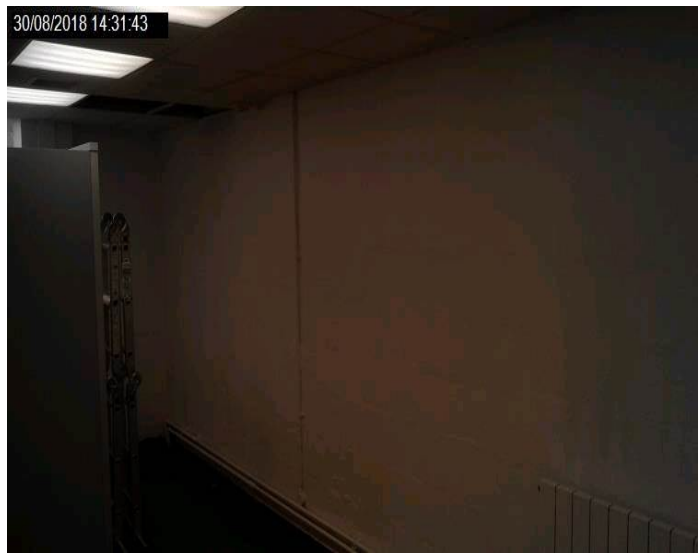
Location:	NAT225	Block:	Birmingham City University	Floor Level: 2nd Floor
Sample No.:	DU002209	Portal Ref No.:	49

Item:	Textured coating to blockwork			
Asbestos Content:		Result Based on:		
No Asbestos Detected		Analysis of sample using PLM		
Sample Analysed By:	Reg 13(1)	Extent:	40 m ²	
Comments: To both sides of room

Material Assessment Total Score: 0		Likelihood of Disturbance Assessment Total Score: 0		Management Assessment Licensable: No Recommendations: Not Applicable Reinspection Interval: Not Applicable Overall Risk Category: E0
Product Type:	0 Not Applicable	Location:	0 Not Applicable	
Condition:	0 Not Applicable	Accessibility:	0 Not Applicable	
Surface Treatment:	0 Not Applicable			
Asbestos Type:	0 Not Applicable	Extent Score:	0 Not Applicable

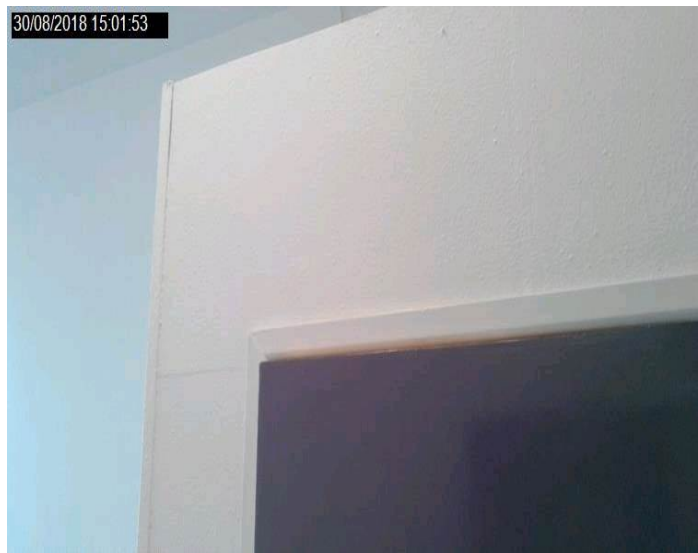
Location:	NAT299A	Block:	Birmingham City University	Floor Level: 2nd Floor
Sample No.:	DU002210	Portal Ref No.:	53

Item:	Textured coating to concrete			
Asbestos Content:	Result Based on:			
No Asbestos Detected	Analysis of sample using PLM			
Sample Analysed By: Reg 13(1)	Extent:	8 m ²		
Comments: To timber wall of built in cupboard

Material Assessment Total Score: 0		Likelihood of Disturbance Assessment Total Score: 0		Management Assessment Licensable: No Recommendations: Not Applicable Reinspection Interval: Not Applicable Overall Risk Category: E0
Product Type:	0 Not Applicable	Location:	0 Not Applicable	
Condition:	0 Not Applicable	Accessibility:	0 Not Applicable	
Surface Treatment:	0 Not Applicable			
Asbestos Type:	0 Not Applicable	Extent Score:	0 Not Applicable

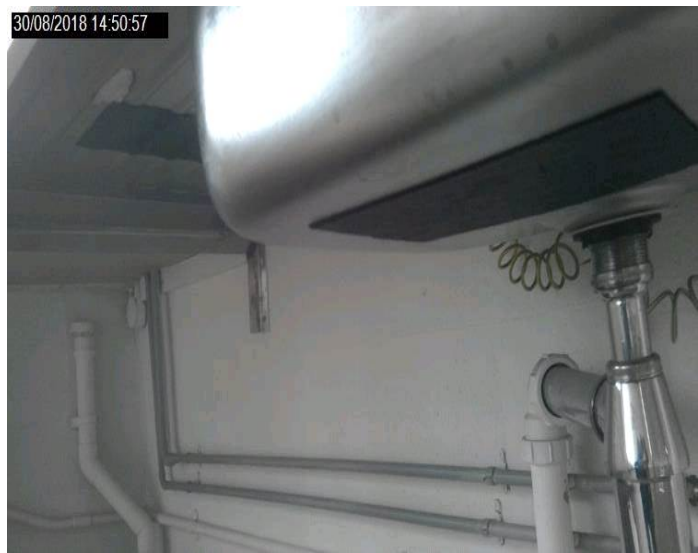
Location:	NAT209	Block:	Birmingham City University	Floor Level: 2nd Floor
Sample No.:	DU002211	Portal Ref No.:	56

Item:	Bitumen sink pad			
Asbestos Content:		Result Based on:		
No Asbestos Detected		Analysis of sample using PLM		
Sample Analysed By:	Reg 13(1)	Extent:	2 units	
Comments:

Material Assessment Total Score: 0		Likelihood of Disturbance Assessment Total Score: 0		Management Assessment Licensable: No Recommendations: Not Applicable Reinspection Interval: Not Applicable Overall Risk Category: E0
Product Type:	0 Not Applicable	Location:	0 Not Applicable	
Condition:	0 Not Applicable	Accessibility:	0 Not Applicable	
Surface Treatment:	0 Not Applicable			
Asbestos Type:	0 Not Applicable	Extent Score:	0 Not Applicable

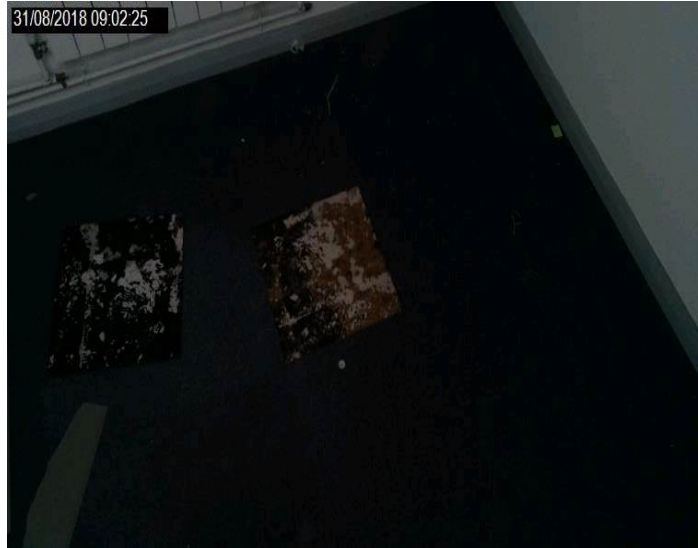
Location:	NAT205A	Block:	Birmingham City University	Floor Level: 2nd Floor
Sample No.:	As DU002204	Portal Ref No.:	60

Item:	Asbestos Bitumen adhesive			
Asbestos Content:	Result Based on:			
Chrysotile	Strongly presumed			
Sample Analysed By:	Not applicable	Extent:	12 m ²	
Comments:

Material Assessment Total Score: 2		Likelihood of Disturbance Assessment Total Score: 5		Management Assessment Licensable: No Recommendations: Program removal Reinspection Interval: Not Applicable Overall Risk Category: C7
Product Type:	1 (Asbestos bitumen)	Location:	2 (Rooms up to 100 sq m)	
Condition:	0 (Perfect)	Accessibility:	1 (Occasionally likely to be disturbed)	
Surface Treatment:	0 (Composite material)			
Asbestos Type:	1 (Chrysotile)	Extent Score:	2 (>10 - <50 sq m or >10m - <50m pipe run)

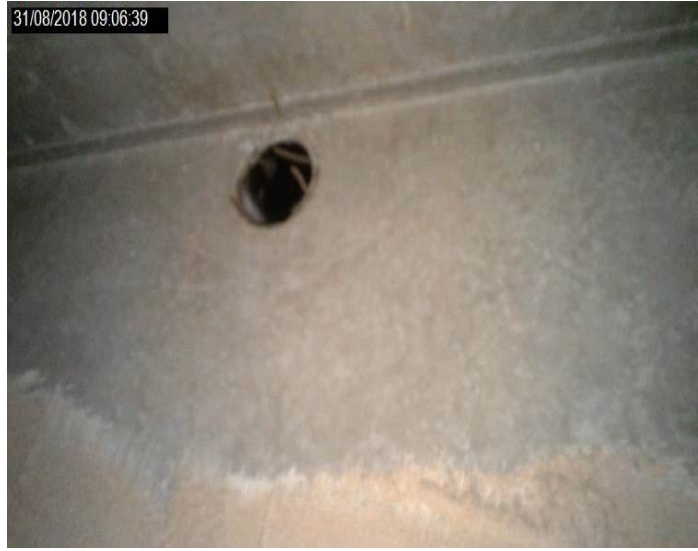
Location:	NAT205	Block:	Birmingham City University	Floor Level: 2nd Floor
Sample No.:	DU002214	Portal Ref No.:	62

Item:	Asbestos Reinforced plastic pipe sleeve			
Asbestos Content:	Result Based on:			
Chrysotile	Analysis of sample using PLM			
Sample Analysed By:	Reg 13(1)	Extent:	3 units	
Comments: Through structural concrete various points within ceiling void items run parallel generally throughout the ceiling void

Material Assessment Total Score: 3		Likelihood of Disturbance Assessment Total Score: 4		Management Assessment Licensable: No Recommendations: Program removal Reinspection Interval: Not Applicable Overall Risk Category: C7
Product Type:	1 (Asbestos reinforced plastic)	Location:	2 (Rooms up to 100 sq m)	
Condition:	1 (Minor scratches)	Accessibility:	1 (Occasionally likely to be disturbed)	
Surface Treatment:	0 (Composite material)			
Asbestos Type:	1 (Chrysotile)	Extent Score:	1 (<10 sq m or 10m pipe run)

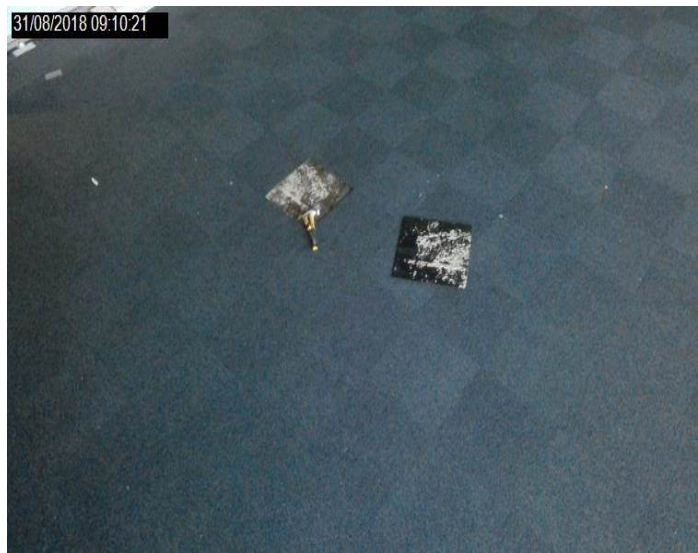
Location:	NAT213	Block:	Birmingham City University	Floor Level: 2nd Floor
Sample No.:	DU002215	Portal Ref No.:	63

Item:	Asbestos Bitumen adhesive			
Asbestos Content:	Result Based on:			
Chrysotile	Analysis of sample using PLM			
Sample Analysed By:	Reg 13(1)	Extent:	72 m ²	
Comments:

Material Assessment Total Score: 2		Likelihood of Disturbance Assessment Total Score: 6		Management Assessment Licensable: No Recommendations: Program removal Reinspection Interval: Not Applicable Overall Risk Category: C8
Product Type:	1 (Asbestos bitumen)	Location:	2 (Rooms up to 100 sq m)	
Condition:	0 (Perfect)	Accessibility:	1 (Occasionally likely to be disturbed)	
Surface Treatment:	0 (Composite material)			
Asbestos Type:	1 (Chrysotile)	Extent Score:	3 (>50 sq m or >50m pipe run)

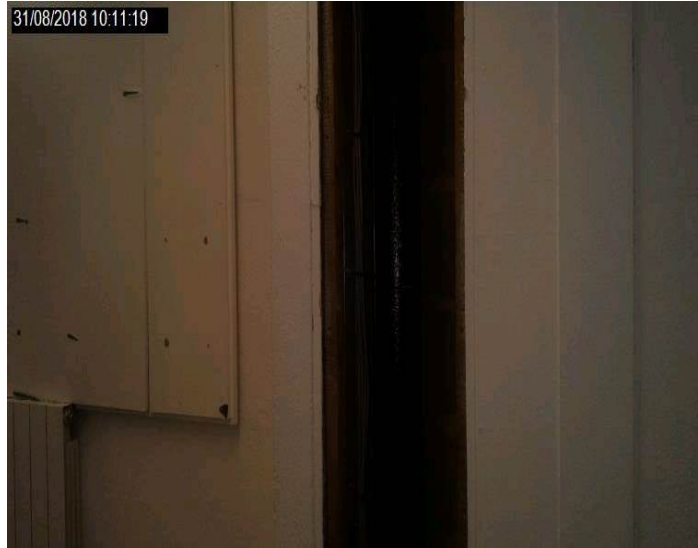
Location:	NAT299 Corridor	Block:	Birmingham City University	Floor Level: 2nd Floor
Sample No.:	DU002221	Portal Ref No.:	82

Item:	Asbestos Reinforced plastic downpipes			
Asbestos Content:	Result Based on:			
Chrysotile	Analysis of sample using PLM			
Sample Analysed By: Reg 13(1)	Extent:	36 linear metres		
Comments: 9 pipes within risers throughout this corridor see plan for location

Material Assessment Total Score: 3		Likelihood of Disturbance Assessment Total Score: 5		Management Assessment Licensable: No Recommendations: Program removal Reinspection Interval: Not Applicable Overall Risk Category: C8
Product Type:	1 (Asbestos reinforced plastic)	Location:	2 (Rooms up to 100 sq m)	
Condition:	1 (Minor scratches)	Accessibility:	1 (Occasionally likely to be disturbed)	
Surface Treatment:	0 (Composite material)			
Asbestos Type:	1 (Chrysotile)	Extent Score:	2 (>10 - <50 sq m or >10m - <50m pipe run)

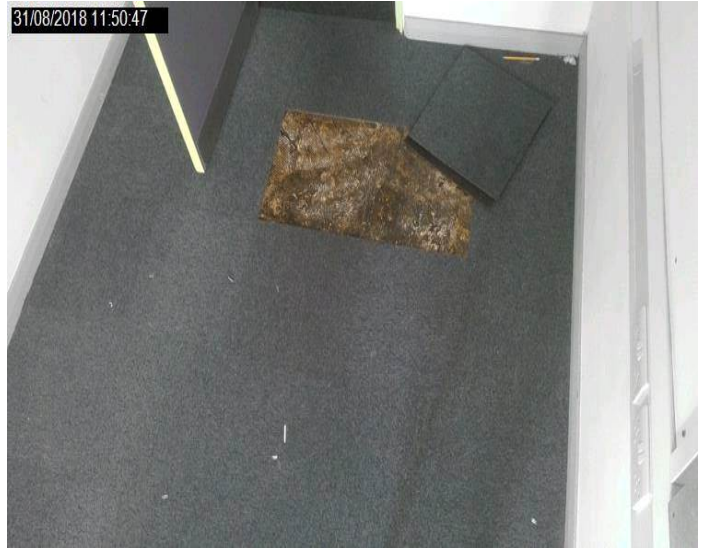
Location:	NAT101	Block:	Birmingham City University	Floor Level: 1st Floor
Sample No.:	As DU002224	Portal Ref No.:	94

Item:	Asbestos Bitumen adhesive			
Asbestos Content:	Result Based on:			
Chrysotile	Strongly presumed			
Sample Analysed By:	Not applicable	Extent:	12 m ²	
Comments:

Material Assessment Total Score: 3		Likelihood of Disturbance Assessment Total Score: 5		Management Assessment Licensable: No Recommendations: Program removal Reinspection Interval: Not Applicable Overall Risk Category: C8
Product Type:	1 (Asbestos bitumen)	Location:	2 (Rooms up to 100 sq m)	
Condition:	1 (Minor scratches)	Accessibility:	1 (Occasionally likely to be disturbed)	
Surface Treatment:	0 (Composite material)			
Asbestos Type:	1 (Chrysotile)	Extent Score:	2 (>10 - <50 sq m or >10m - <50m pipe run)	
Management Detail

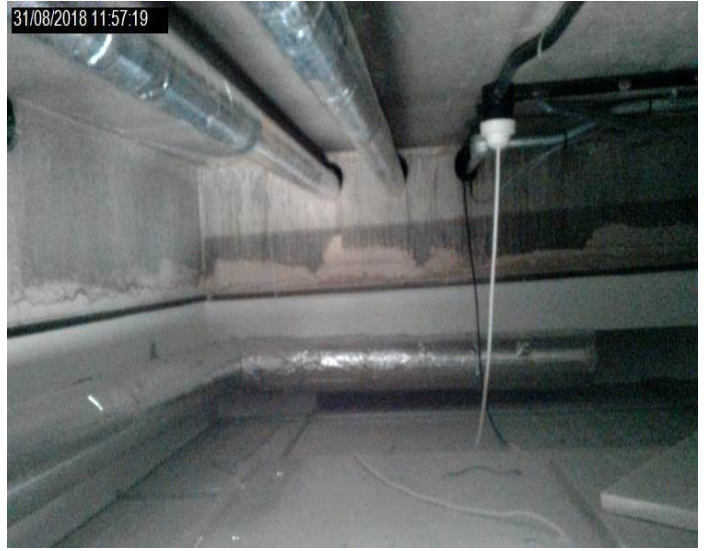
Location:	NAT103	Block:	Birmingham City University	Floor Level: 1st Floor
Sample No.:	As DU002223	Portal Ref No.:	97

Item:	Asbestos Reinforced plastic sleeve			
Asbestos Content:	Result Based on:			
Chrysotile	Strongly presumed			
Sample Analysed By:	Not applicable	Extent:	6 units	
Comments:

Material Assessment Total Score: 3		Likelihood of Disturbance Assessment Total Score: 4		Management Assessment Licensable: No Recommendations: Program removal Reinspection Interval: Not Applicable Overall Risk Category: C7
Product Type:	1 (Asbestos reinforced plastic)	Location:	2 (Rooms up to 100 sq m)	
Condition:	1 (Minor scratches)	Accessibility:	1 (Occasionally likely to be disturbed)	
Surface Treatment:	0 (Composite material)			
Asbestos Type:	1 (Chrysotile)	Extent Score:	1 (<10 sq m or 10m pipe run)

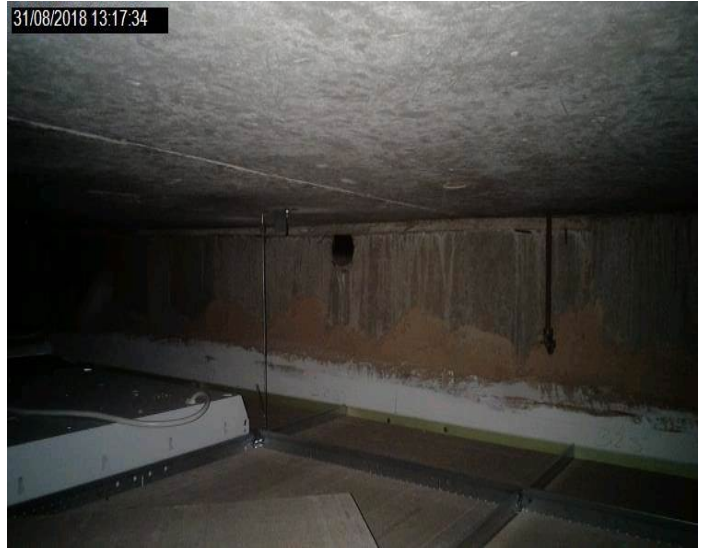
Location:	NAT104A	Block:	Birmingham City University	Floor Level: 1st Floor
Sample No.:	As DU002223	Portal Ref No.:	99

Item:	Asbestos Reinforced plastic sleeve			
Asbestos Content:	Result Based on:			
Chrysotile	Strongly presumed			
Sample Analysed By:	Not applicable	Extent:	6 units	
Comments:

Material Assessment Total Score: 3		Likelihood of Disturbance Assessment Total Score: 4		Management Assessment Licensable: No Recommendations: Program removal Reinspection Interval: Not Applicable Overall Risk Category: C7
Product Type:	1 (Asbestos reinforced plastic)	Location:	2 (Rooms up to 100 sq m)	
Condition:	1 (Minor scratches)	Accessibility:	1 (Occasionally likely to be disturbed)	
Surface Treatment:	0 (Composite material)			
Asbestos Type:	1 (Chrysotile)	Extent Score:	1 (<10 sq m or 10m pipe run)

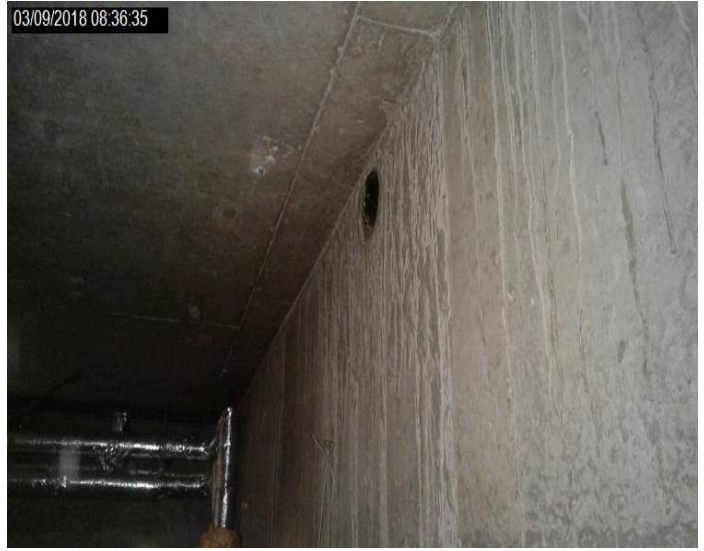
Location:	NAT138	Block:	Birmingham City University	Floor Level: 1st Floor
Sample No.:	As DU002223	Portal Ref No.:	104

Item:	Asbestos Reinforced plastic sleeve			
Asbestos Content:	Result Based on:			
Chrysotile	Strongly presumed			
Sample Analysed By:	Not applicable	Extent:	3 units	
Comments:

Material Assessment Total Score: 3		Likelihood of Disturbance Assessment Total Score: 4		Management Assessment Licensable: No Recommendations: Program removal Reinspection Interval: Not Applicable Overall Risk Category: C7
Product Type:	1 (Asbestos reinforced plastic)	Location:	2 (Rooms up to 100 sq m)	
Condition:	1 (Minor scratches)	Accessibility:	1 (Occasionally likely to be disturbed)	
Surface Treatment:	0 (Composite material)			
Asbestos Type:	1 (Chrysotile)	Extent Score:	1 (<10 sq m or 10m pipe run)

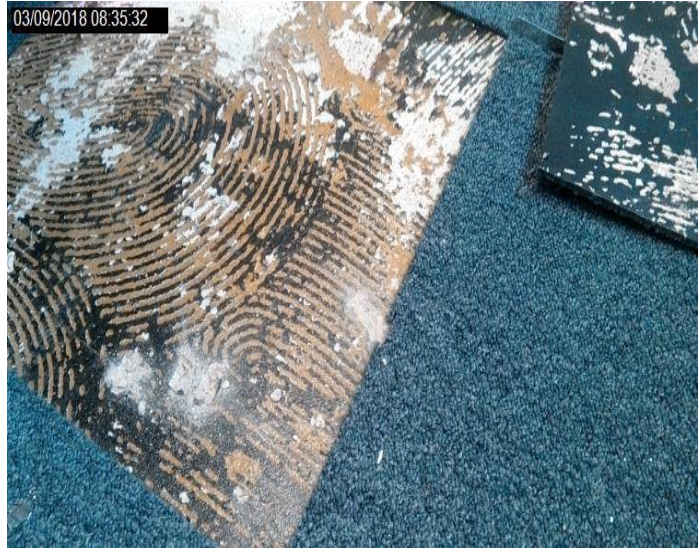
Location:	NAT138	Block:	Birmingham City University	Floor Level: 1st Floor
Sample No.:	DU002226	Portal Ref No.:	105

Item:	Asbestos Bitumen adhesive			
Asbestos Content:	Result Based on:			
Chrysotile	Analysis of sample using PLM			
Sample Analysed By:	Reg 13(1)	Extent:	18 m ²	
Comments:

Material Assessment Total Score: 3		Likelihood of Disturbance Assessment Total Score: 4		Management Assessment Licensable: No Recommendations: Program removal Reinspection Interval: Not Applicable Overall Risk Category: C7
Product Type:	1 (Asbestos bitumen)	Location:	2 (Rooms up to 100 sq m)	
Condition:	1 (Minor scratches)	Accessibility:	0 (Usually inaccessible or unlikely to be disturbed)	
Surface Treatment:	0 (Composite material)			
Asbestos Type:	1 (Chrysotile)	Extent Score:	2 (>10 - <50 sq m or >10m - <50m pipe run)

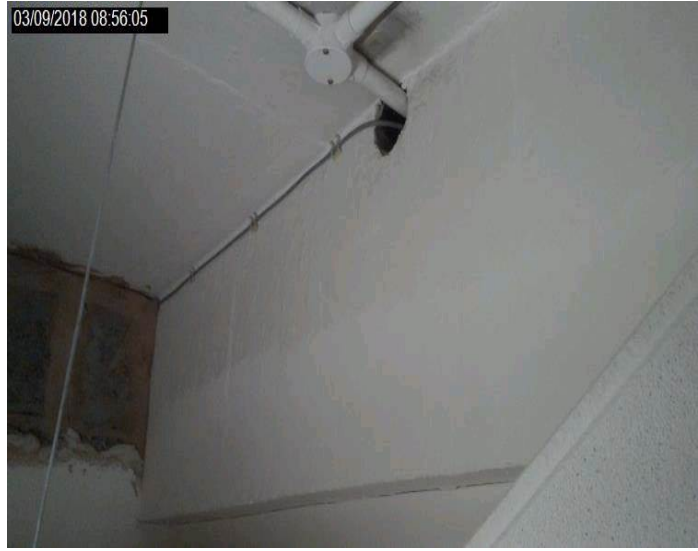
Location:	NAT105B	Block:	Birmingham City University	Floor Level: 1st Floor
Sample No.:	As DU002223	Portal Ref No.:	110

Item:	Asbestos Reinforced plastic sleeve			
Asbestos Content:	Result Based on:			
Chrysotile	Strongly presumed			
Sample Analysed By:	Not applicable	Extent:	1 unit	
Comments:

Material Assessment Total Score: 3		Likelihood of Disturbance Assessment Total Score: 4		Management Assessment Licensable: No Recommendations: Program removal Reinspection Interval: Not Applicable Overall Risk Category: C7
Product Type:	1 (Asbestos reinforced plastic)	Location:	2 (Rooms up to 100 sq m)	
Condition:	1 (Minor scratches)	Accessibility:	1 (Occasionally likely to be disturbed)	
Surface Treatment:	0 (Composite material)			
Asbestos Type:	1 (Chrysotile)	Extent Score:	1 (<10 sq m or 10m pipe run)

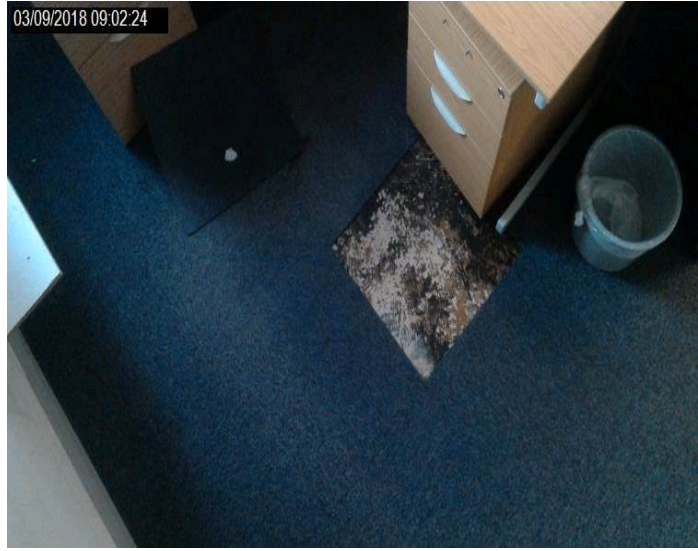
Location:	NAT105A	Block:	Birmingham City University	Floor Level: 1st Floor
Sample No.:	As DU002226	Portal Ref No.:	113

Item:	Asbestos Bitumen adhesive			
Asbestos Content:	Result Based on:			
Chrysotile	Strongly presumed			
Sample Analysed By:	Not applicable	Extent:	8 m ²	
Comments:

Material Assessment Total Score: 3		Likelihood of Disturbance Assessment Total Score: 3		Management Assessment Licensable: No Recommendations: Program removal Reinspection Interval: Not Applicable Overall Risk Category: D6
Product Type:	1 (Asbestos bitumen)	Location:	2 (Rooms up to 100 sq m)	
Condition:	1 (Minor scratches)	Accessibility:	0 (Usually inaccessible or unlikely to be disturbed)	
Surface Treatment:	0 (Composite material)			
Asbestos Type:	1 (Chrysotile)	Extent Score:	1 (<10 sq m or 10m pipe run)

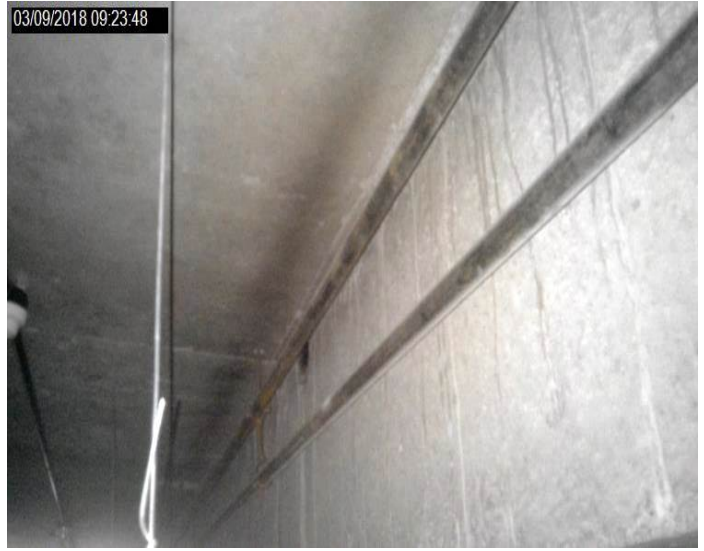
Location:	NAT135	Block:	Birmingham City University	Floor Level: 1st Floor
Sample No.:	As DU002223	Portal Ref No.:	119

Item:	Asbestos Reinforced plastic sleeve			
Asbestos Content:	Result Based on:			
Chrysotile	Strongly presumed			
Sample Analysed By:	Not applicable	Extent:	3 units	
Comments:

Material Assessment Total Score: 3		Likelihood of Disturbance Assessment Total Score: 4		Management Assessment Licensable: No Recommendations: Program removal Reinspection Interval: Not Applicable Overall Risk Category: C7
Product Type:	1 (Asbestos reinforced plastic)	Location:	2 (Rooms up to 100 sq m)	
Condition:	1 (Minor scratches)	Accessibility:	1 (Occasionally likely to be disturbed)	
Surface Treatment:	0 (Composite material)			
Asbestos Type:	1 (Chrysotile)	Extent Score:	1 (<10 sq m or 10m pipe run)

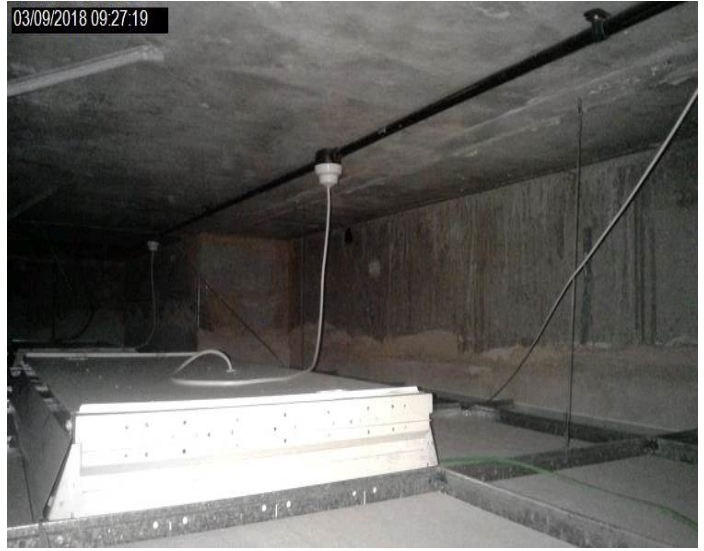
Location:	NAT134B	Block:	Birmingham City University	Floor Level: 1st Floor
Sample No.:	As DU002223	Portal Ref No.:	121

Item:	Asbestos Reinforced plastic sleeve			
Asbestos Content:	Result Based on:			
Chrysotile	Strongly presumed			
Sample Analysed By:	Not applicable	Extent:	3 units	
Comments:

Material Assessment Total Score: 3		Likelihood of Disturbance Assessment Total Score: 4		Management Assessment Licensable: No Recommendations: Program removal Reinspection Interval: Not Applicable Overall Risk Category: C7
Product Type:	1 (Asbestos reinforced plastic)	Location:	2 (Rooms up to 100 sq m)	
Condition:	1 (Minor scratches)	Accessibility:	1 (Occasionally likely to be disturbed)	
Surface Treatment:	0 (Composite material)			
Asbestos Type:	1 (Chrysotile)	Extent Score:	1 (<10 sq m or 10m pipe run)

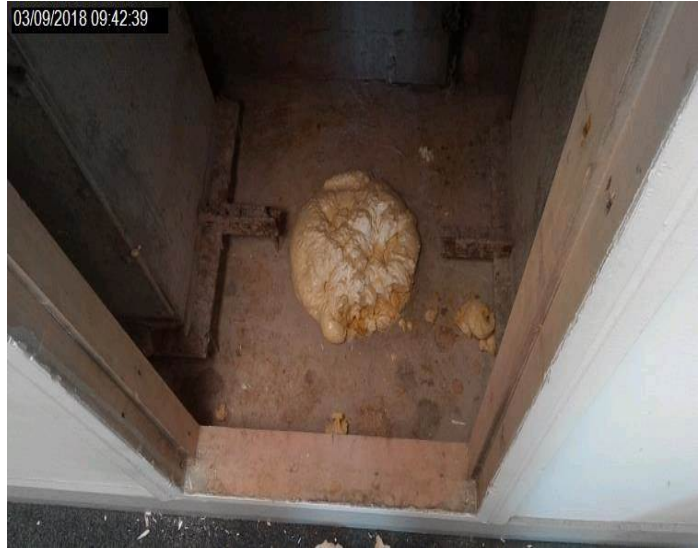
Location:	NAT134 Service Duct	Block:	Birmingham City University	Floor Level: 1st Floor
Sample No.:	DU002230	Portal Ref No.:	125

Item:	Asbestos Cement flue			
Asbestos Content:	Result Based on:			
Chrysotile	Analysis of sample using PLM			
Sample Analysed By: Reg 13(1)	Extent:	1 linear metres		
Comments: Foam sealed, continues through the floor slab

Material Assessment Total Score: 4		Likelihood of Disturbance Assessment Total Score: 4		Management Assessment Licensable: No Recommendations: Program removal Reinspection Interval: Not Applicable Overall Risk Category: C8
Product Type:	1 (Asbestos cement)	Location:	2 (Rooms up to 100 sq m)	
Condition:	1 (Minor scratches)	Accessibility:	1 (Occasionally likely to be disturbed)	
Surface Treatment:	1 (Enclosed asbestos cement)			
Asbestos Type:	1 (Chrysotile)	Extent Score:	1 (<10 sq m or 10m pipe run)

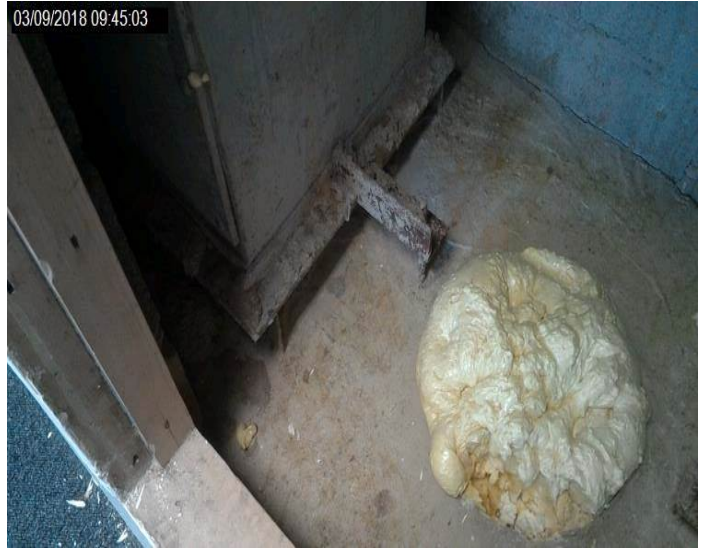
Location:	NAT134 Service Duct	Block:	Birmingham City University	Floor Level: 1st Floor
Sample No.:	DU002231	Portal Ref No.:	126

Item:	Asbestos Textile joint seal to metal ducting			
Asbestos Content:	Result Based on:			
Chrysotile	Analysis of sample using PLM			
Sample Analysed By: Reg 13(1)	Extent:	2 linear metres		
Comments: To both metal ductings

Material Assessment Total Score: 6		Likelihood of Disturbance Assessment Total Score: 4		Management Assessment Licensable: No Recommendations: Program removal Reinspection Interval: Not Applicable Overall Risk Category: C10
Product Type:	2 (Asbestos textile)	Location:	2 (Rooms up to 100 sq m)	
Condition:	1 (Minor scratches)	Accessibility:	1 (Occasionally likely to be disturbed)	
Surface Treatment:	2 (Unencapsulated textile/paper)			
Asbestos Type:	1 (Chrysotile)	Extent Score:	1 (<10 sq m or 10m pipe run)

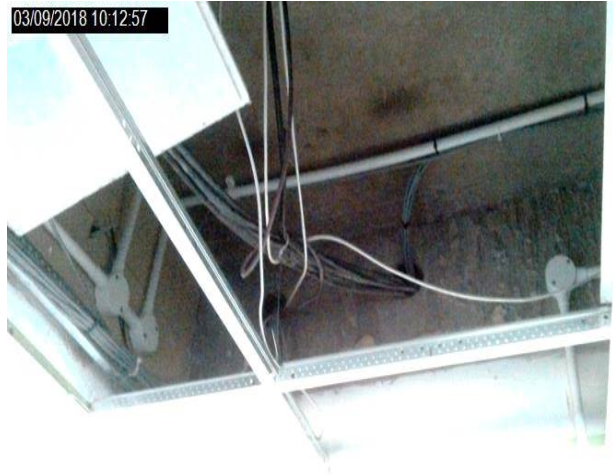
Location:	NAT106A	Block:	Birmingham City University	Floor Level: 1st Floor
Sample No.:	DU002232	Portal Ref No.:	129

Item:	Asbestos Reinforced plastic sleeve			
Asbestos Content:	Result Based on:			
Chrysotile	Analysis of sample using PLM			
Sample Analysed By: Reg 13(1)	Extent:	10 units		
Comments:

Material Assessment Total Score: 3		Likelihood of Disturbance Assessment Total Score: 4		Management Assessment Licensable: No Recommendations: Program removal Reinspection Interval: Not Applicable Overall Risk Category: C7
Product Type:	1 (Asbestos reinforced plastic)	Location:	2 (Rooms up to 100 sq m)	
Condition:	1 (Minor scratches)	Accessibility:	1 (Occasionally likely to be disturbed)	
Surface Treatment:	0 (Composite material)			
Asbestos Type:	1 (Chrysotile)	Extent Score:	1 (<10 sq m or 10m pipe run)

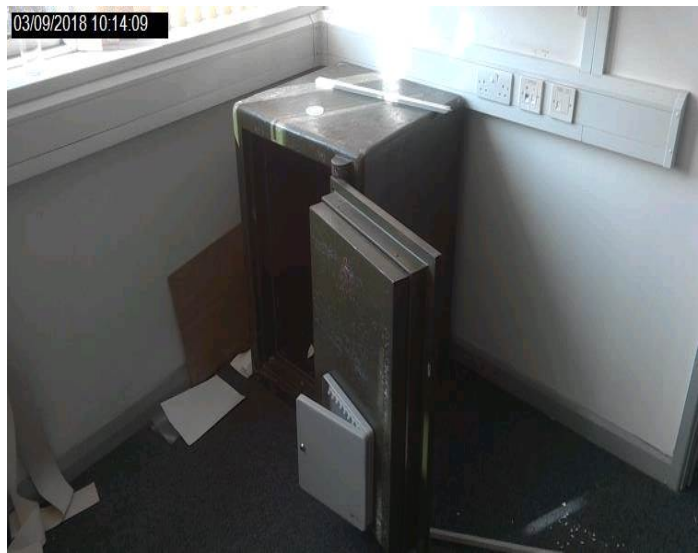
Location:	NAT106A	Block:	Birmingham City University	Floor Level: 1st Floor
Sample No.:	No sample - presumed	Portal Ref No.:	131

Item:	Asbestos Insulation lining to safe			
Asbestos Content:	Result Based on:			
Crocidolite	Presumed			
Sample Analysed By:	Not applicable	Extent:	1 unit	
Comments: No sample - presumed due to no physical access available

Material Assessment Total Score: 7		Likelihood of Disturbance Assessment Total Score: 3		Management Assessment Licensable: Yes Recommendations: Program removal Reinspection Interval: Not Applicable Overall Risk Category: C10
Product Type:	3 (Asbestos Insulation/Coating)	Location:	2 (Rooms up to 100 sq m)	
Condition:	0 (Perfect)	Accessibility:	0 (Usually inaccessible or unlikely to be disturbed)	
Surface Treatment:	1 (Enclosed insulation)			
Asbestos Type:	3 (Crocidolite)	Extent Score:	1 (<10 sq m or 10m pipe run)

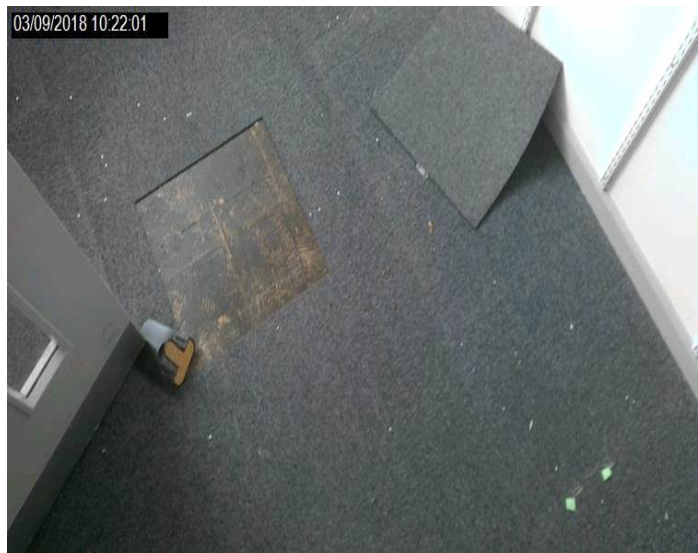
Location:	NAT107A	Block:	Birmingham City University	Floor Level: 1st Floor
Sample No.:	As DU002229	Portal Ref No.:	134

Item:	Asbestos Bitumen adhesive			
Asbestos Content:	Result Based on:			
Chrysotile	Strongly presumed			
Sample Analysed By:	Not applicable	Extent:	6 m ²	
Comments:

Material Assessment Total Score: 3		Likelihood of Disturbance Assessment Total Score: 3		Management Assessment Licensable: No Recommendations: Program removal Reinspection Interval: Not Applicable Overall Risk Category: D6
Product Type:	1 (Asbestos bitumen)	Location:	2 (Rooms up to 100 sq m)	
Condition:	1 (Minor scratches)	Accessibility:	0 (Usually inaccessible or unlikely to be disturbed)	
Surface Treatment:	0 (Composite material)			
Asbestos Type:	1 (Chrysotile)	Extent Score:	1 (<10 sq m or 10m pipe run)

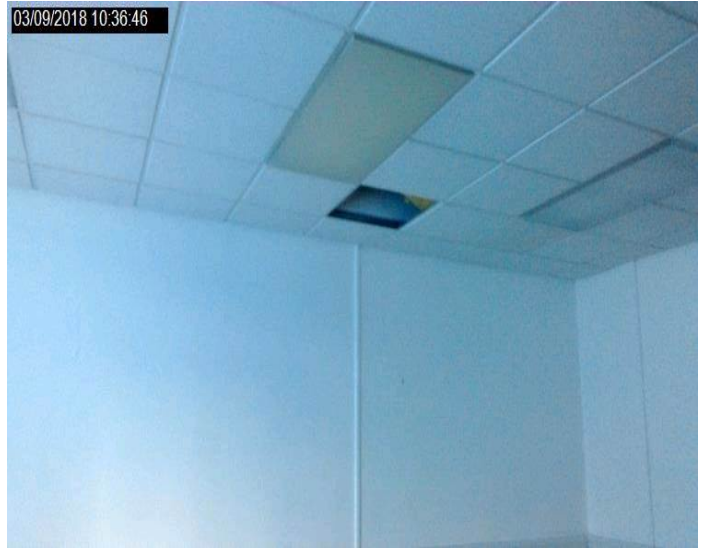
Location:	NAT105C	Block:	Birmingham City University	Floor Level: 1st Floor
Sample No.:	As DU002232	Portal Ref No.:	141

Item:	Asbestos Reinforced plastic sleeve			
Asbestos Content:	Result Based on:			
Chrysotile	Strongly presumed			
Sample Analysed By:	Not applicable	Extent:	6 units	
Comments:

Material Assessment Total Score: 3		Likelihood of Disturbance Assessment Total Score: 4		Management Assessment Licensable: No Recommendations: Program removal Reinspection Interval: Not Applicable Overall Risk Category: C7
Product Type:	1 (Asbestos reinforced plastic)	Location:	2 (Rooms up to 100 sq m)	
Condition:	1 (Minor scratches)	Accessibility:	1 (Occasionally likely to be disturbed)	
Surface Treatment:	0 (Composite material)			
Asbestos Type:	1 (Chrysotile)	Extent Score:	1 (<10 sq m or 10m pipe run)

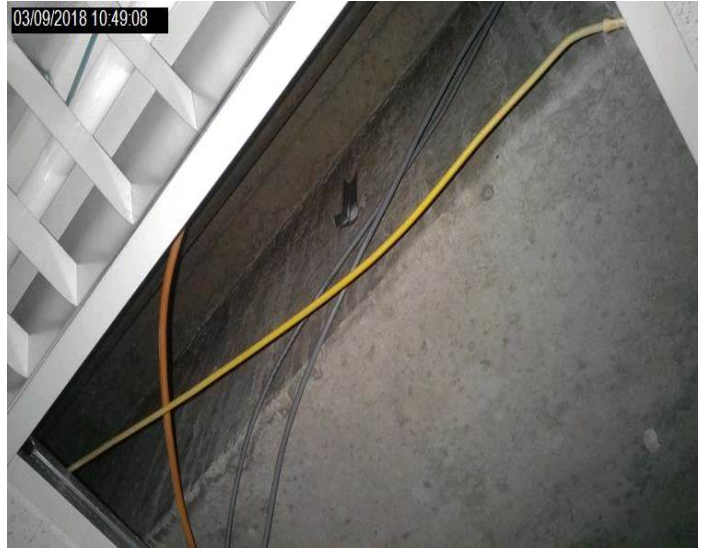
Location:	NAT132	Block:	Birmingham City University	Floor Level: 1st Floor
Sample No.:	As DU002232	Portal Ref No.:	145

Item:	Asbestos Reinforced plastic sleeve			
Asbestos Content:	Result Based on:			
Chrysotile	Strongly presumed			
Sample Analysed By:	Not applicable	Extent:	4 units	
Comments:

Material Assessment Total Score: 3		Likelihood of Disturbance Assessment Total Score: 4		Management Assessment Licensable: No Recommendations: Program removal Reinspection Interval: Not Applicable Overall Risk Category: C7
Product Type:	1 (Asbestos reinforced plastic)	Location:	2 (Rooms up to 100 sq m)	
Condition:	1 (Minor scratches)	Accessibility:	1 (Occasionally likely to be disturbed)	
Surface Treatment:	0 (Composite material)			
Asbestos Type:	1 (Chrysotile)	Extent Score:	1 (<10 sq m or 10m pipe run)

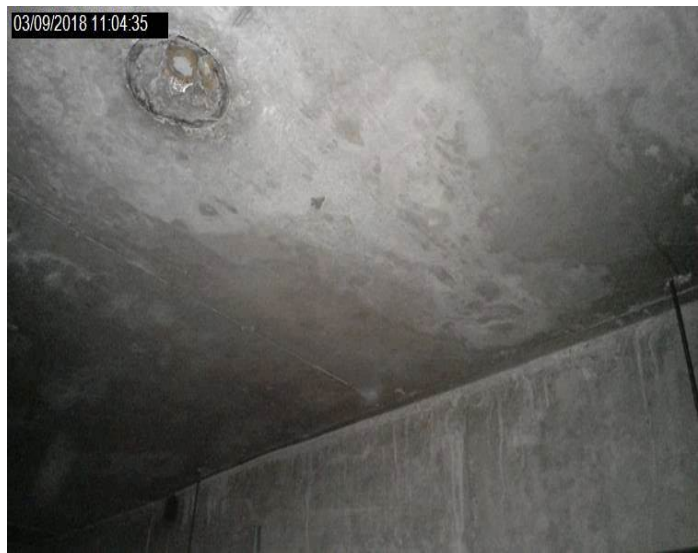
Location:	NAT128	Block:	Birmingham City University	Floor Level: 1st Floor
Sample No.:	As DU002232	Portal Ref No.:	151

Item:	Asbestos Reinforced plastic sleeve			
Asbestos Content:	Result Based on:			
Chrysotile	Strongly presumed			
Sample Analysed By:	Not applicable	Extent:	3 units	
Comments: Also passes through the ceiling

Material Assessment Total Score: 3		Likelihood of Disturbance Assessment Total Score: 4		Management Assessment Licensable: No Recommendations: Program removal Reinspection Interval: Not Applicable Overall Risk Category: C7
Product Type:	1 (Asbestos reinforced plastic)	Location:	2 (Rooms up to 100 sq m)	
Condition:	1 (Minor scratches)	Accessibility:	1 (Occasionally likely to be disturbed)	
Surface Treatment:	0 (Composite material)			
Asbestos Type:	1 (Chrysotile)	Extent Score:	1 (<10 sq m or 10m pipe run)

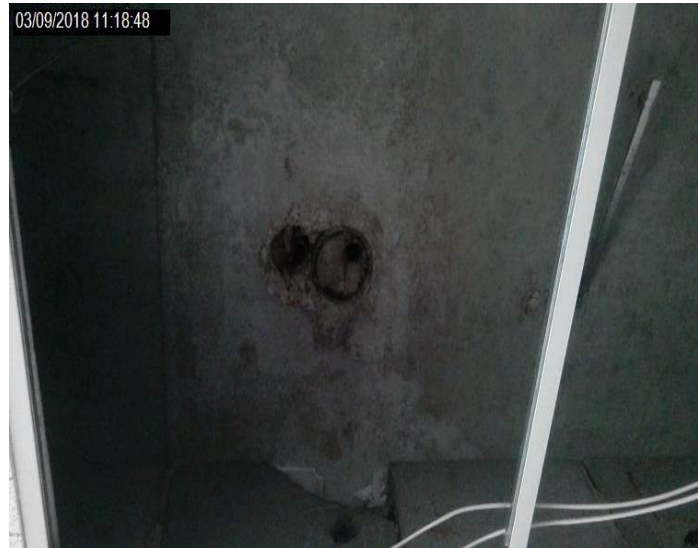
Location:	NAT127B	Block:	Birmingham City University	Floor Level: 1st Floor
Sample No.:	As DU002232	Portal Ref No.:	154

Item:	Asbestos Reinforced plastic sleeve			
Asbestos Content:	Result Based on:			
Chrysotile	Strongly presumed			
Sample Analysed By:	Not applicable	Extent:	1 unit	
Comments: Passes through the ceiling

Material Assessment Total Score: 3		Likelihood of Disturbance Assessment Total Score: 4		Management Assessment Licensable: No Recommendations: Program removal Reinspection Interval: Not Applicable Overall Risk Category: C7
Product Type:	1 (Asbestos reinforced plastic)	Location:	2 (Rooms up to 100 sq m)	
Condition:	1 (Minor scratches)	Accessibility:	1 (Occasionally likely to be disturbed)	
Surface Treatment:	0 (Composite material)			
Asbestos Type:	1 (Chrysotile)	Extent Score:	1 (<10 sq m or 10m pipe run)

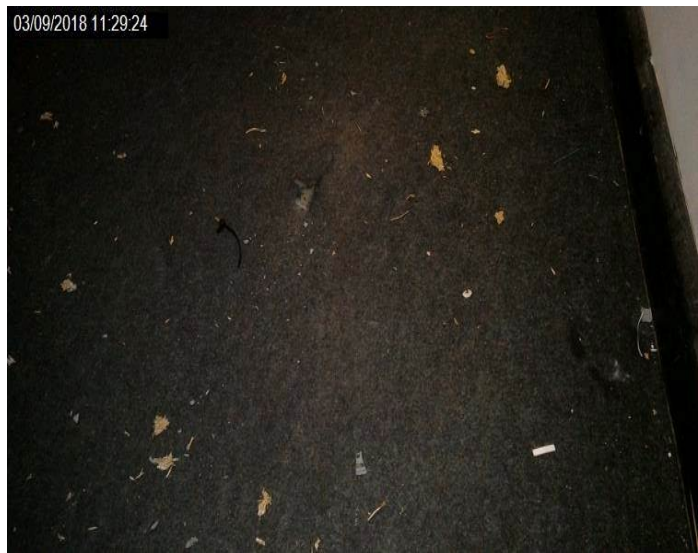
Location:	NAT199D	Block:	Birmingham City University	Floor Level: 1st Floor
Sample No.:	DU002236	Portal Ref No.:	157

Item:	Asbestos Thermoplastic floor tiles			
Asbestos Content:	Result Based on:			
Chrysotile in tile and adhesive	Analysis of sample using PLM			
Sample Analysed By: Reg 13(1)	Extent:	10 m ²		
Comments: Beneath carpet

Material Assessment Total Score: 3		Likelihood of Disturbance Assessment Total Score: 3		Management Assessment Licensable: No Recommendations: Program removal Reinspection Interval: Not Applicable Overall Risk Category: D6
Product Type:	1 (Asbestos thermoplastic)	Location:	2 (Rooms up to 100 sq m)	
Condition:	1 (Minor scratches)	Accessibility:	0 (Usually inaccessible or unlikely to be disturbed)	
Surface Treatment:	0 (Composite material)			
Asbestos Type:	1 (Chrysotile)	Extent Score:	1 (<10 sq m or 10m pipe run)

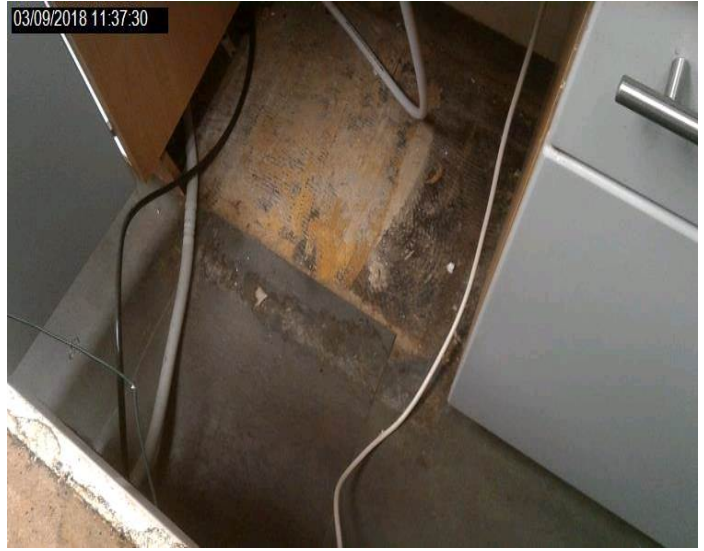
Location:	NAT110B	Block:	Birmingham City University	Floor Level: 1st Floor
Sample No.:	DU002237	Portal Ref No.:	159

Item:	Asbestos Bitumen adhesive			
Asbestos Content:	Result Based on:			
Chrysotile	Analysis of sample using PLM			
Sample Analysed By: Reg 13(1)	Extent:	10 m ²		
Comments:

Material Assessment Total Score: 3		Likelihood of Disturbance Assessment Total Score: 3		Management Assessment Licensable: No Recommendations: Program removal Reinspection Interval: Not Applicable Overall Risk Category: D6
Product Type:	1 (Asbestos bitumen)	Location:	2 (Rooms up to 100 sq m)	
Condition:	1 (Minor scratches)	Accessibility:	0 (Usually inaccessible or unlikely to be disturbed)	
Surface Treatment:	0 (Composite material)			
Asbestos Type:	1 (Chrysotile)	Extent Score:	1 (<10 sq m or 10m pipe run)

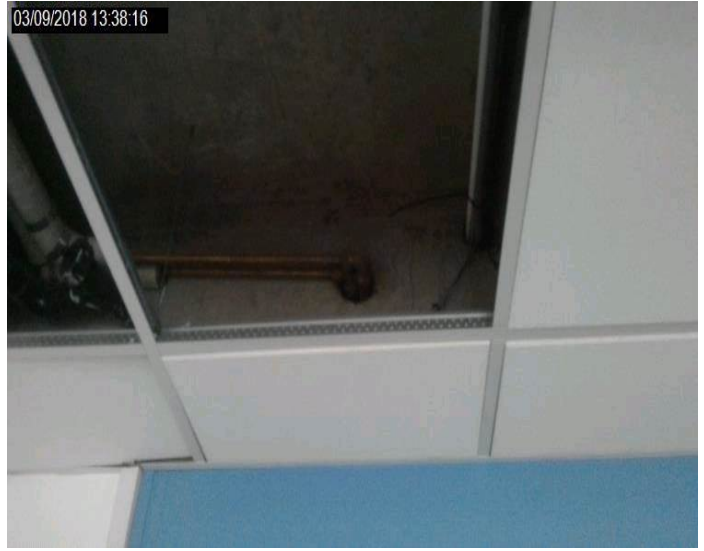
Location:	NAT110A	Block:	Birmingham City University	Floor Level: 1st Floor
Sample No.:	As DU002232	Portal Ref No.:	169

Item:	Asbestos Reinforced plastic sleeve			
Asbestos Content:	Result Based on:			
Chrysotile	Strongly presumed			
Sample Analysed By:	Not applicable	Extent:	6 units	
Comments: Through ceiling also where rooms join

Material Assessment Total Score: 3		Likelihood of Disturbance Assessment Total Score: 4		Management Assessment Licensable: No Recommendations: Program removal Reinspection Interval: Not Applicable Overall Risk Category: C7
Product Type:	1 (Asbestos reinforced plastic)	Location:	2 (Rooms up to 100 sq m)	
Condition:	1 (Minor scratches)	Accessibility:	1 (Occasionally likely to be disturbed)	
Surface Treatment:	0 (Composite material)			
Asbestos Type:	1 (Chrysotile)	Extent Score:	1 (<10 sq m or 10m pipe run)

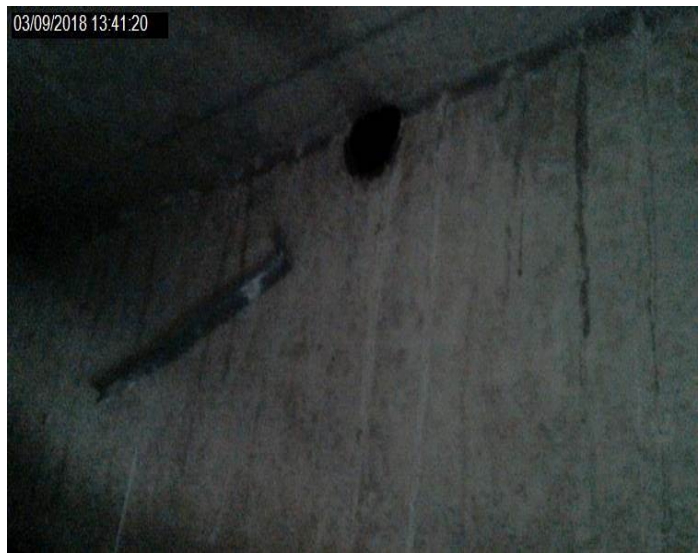
Location:	NAT137	Block:	Birmingham City University	Floor Level: 1st Floor
Sample No.:	As DU002232	Portal Ref No.:	171

Item:	Asbestos Reinforced plastic sleeve			
Asbestos Content:	Result Based on:			
Chrysotile	Strongly presumed			
Sample Analysed By:	Not applicable	Extent:	6 units	
Comments: Through ceiling also where rooms join

Material Assessment Total Score: 3		Likelihood of Disturbance Assessment Total Score: 4		Management Assessment Licensable: No Recommendations: Program removal Reinspection Interval: Not Applicable Overall Risk Category: C7
Product Type:	1 (Asbestos reinforced plastic)	Location:	2 (Rooms up to 100 sq m)	
Condition:	1 (Minor scratches)	Accessibility:	1 (Occasionally likely to be disturbed)	
Surface Treatment:	0 (Composite material)			
Asbestos Type:	1 (Chrysotile)	Extent Score:	1 (<10 sq m or 10m pipe run)
