Report No.: J102749
Nature of Work: Demolition Survey
Issue Date: 02/11/2018
Client Name: WYG Engineering Ltd
 Geneva Building, Lake View Drive, Sherwood Business Park,
 Annesley, Nottingham, NG15 0ED
Site Address: Attwood Building, Former City North Campus, Birmingham City
 University, Perry Barr, B42 2US

1.0 Introduction & Scope of Work

A demolition survey in line with HSG264 Asbestos: The Survey Guide was carried out internally and externally to the property.

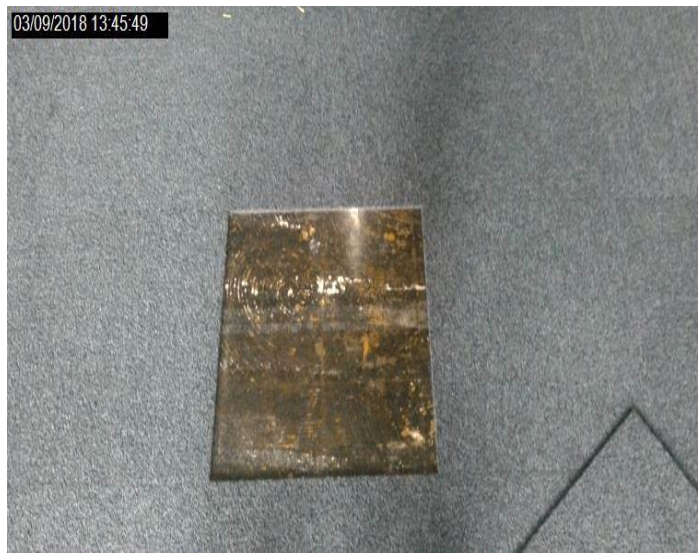
Location:	NAT110	Block:	Birmingham City University	Floor Level: 1st Floor
Sample No.:	As DU002238	Portal Ref No.:	174

Item:	Asbestos Bitumen adhesive			
Asbestos Content:	Result Based on:			
Chrysotile	Strongly presumed			
Sample Analysed By:	Not applicable	Extent:	45 m ²	
Comments:

Material Assessment Total Score: 3		Likelihood of Disturbance Assessment Total Score: 4		Management Assessment Licensable: No Recommendations: Program removal Reinspection Interval: Not Applicable Overall Risk Category: C7
Product Type:	1 (Asbestos bitumen)	Location:	2 (Rooms up to 100 sq m)	
Condition:	1 (Minor scratches)	Accessibility:	0 (Usually inaccessible or unlikely to be disturbed)	
Surface Treatment:	0 (Composite material)			
Asbestos Type:	1 (Chrysotile)	Extent Score:	2 (>10 - <50 sq m or >10m - <50m pipe run)

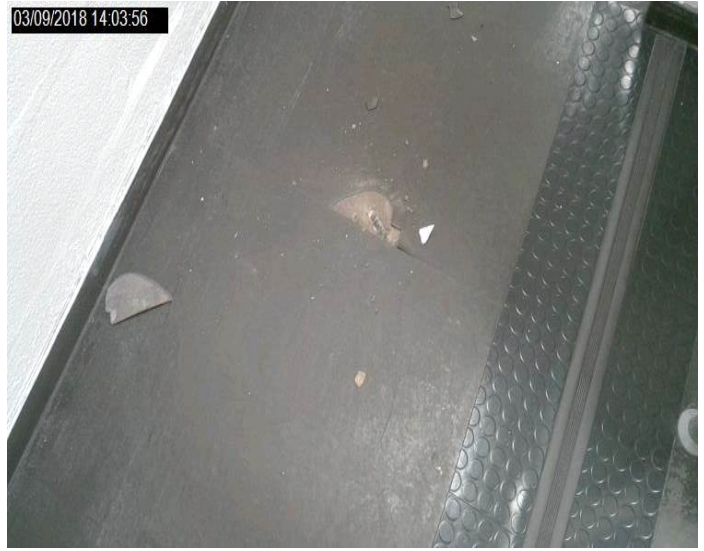
Location:	NAT121	Block:	Birmingham City University	Floor Level: 1st Floor
Sample No.:	DU002240	Portal Ref No.:	178

Item:	Asbestos Bitumen adhesive			
Asbestos Content:	Result Based on:			
Chrysotile	Analysis of sample using PLM			
Sample Analysed By:	Reg 13(1)	Extent:	14 m ²	
Comments:

Material Assessment Total Score: 3		Likelihood of Disturbance Assessment Total Score: 5		Management Assessment Licensable: No Recommendations: Program removal Reinspection Interval: Not Applicable Overall Risk Category: C8
Product Type:	1 (Asbestos bitumen)	Location:	2 (Rooms up to 100 sq m)	
Condition:	1 (Minor scratches)	Accessibility:	1 (Occasionally likely to be disturbed)	
Surface Treatment:	0 (Composite material)			
Asbestos Type:	1 (Chrysotile)	Extent Score:	2 (>10 - <50 sq m or >10m - <50m pipe run)

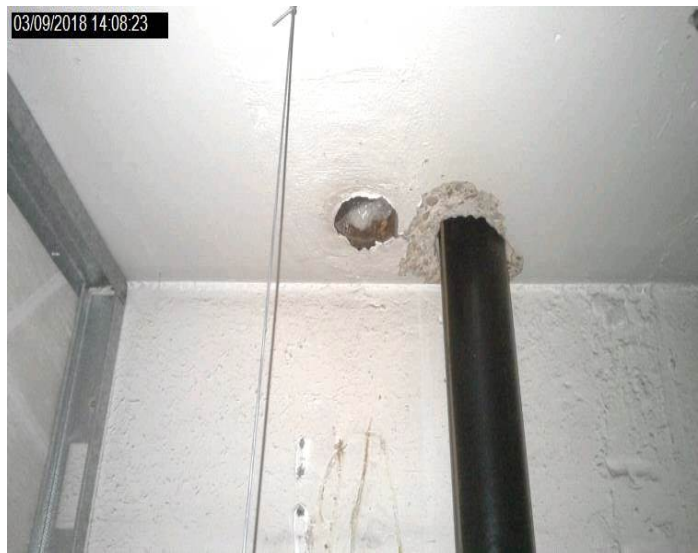
Location:	NAT121	Block:	Birmingham City University	Floor Level: 1st Floor
Sample No.:	As DU002232	Portal Ref No.:	180

Item:	Asbestos Reinforced plastic sleeve			
Asbestos Content:	Result Based on:			
Chrysotile	Strongly presumed			
Sample Analysed By:	Not applicable	Extent:	2 units	
Comments:

Material Assessment Total Score: 3		Likelihood of Disturbance Assessment Total Score: 4		Management Assessment Licensable: No Recommendations: Program removal Reinspection Interval: Not Applicable Overall Risk Category: C7
Product Type:	1 (Asbestos reinforced plastic)	Location:	2 (Rooms up to 100 sq m)	
Condition:	1 (Minor scratches)	Accessibility:	1 (Occasionally likely to be disturbed)	
Surface Treatment:	0 (Composite material)			
Asbestos Type:	1 (Chrysotile)	Extent Score:	1 (<10 sq m or 10m pipe run)

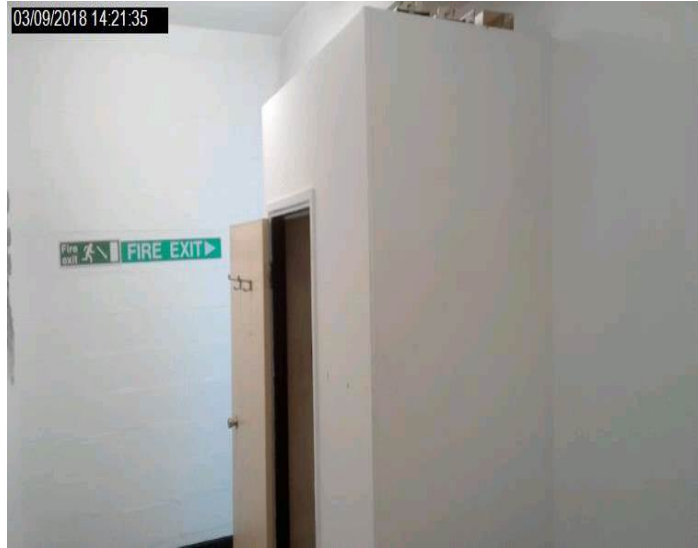
Location:	NAT118B	Block:	Birmingham City University	Floor Level: 1st Floor
Sample No.:	DU002243	Portal Ref No.:	184

Item:	Textured coating			
Asbestos Content:		Result Based on:		
No Asbestos Detected		Analysis of sample using PLM		
Sample Analysed By:	Reg 13(1)	Extent:	12 m ²	
Comments: To walls of cleaners cupboard

Material Assessment Total Score: 0		Likelihood of Disturbance Assessment Total Score: 0		Management Assessment Licensable: No Recommendations: Not Applicable Reinspection Interval: Not Applicable Overall Risk Category: E0
Product Type:	0 Not Applicable	Location:	0 Not Applicable	
Condition:	0 Not Applicable	Accessibility:	0 Not Applicable	
Surface Treatment:	0 Not Applicable			
Asbestos Type:	0 Not Applicable	Extent Score:	0 Not Applicable

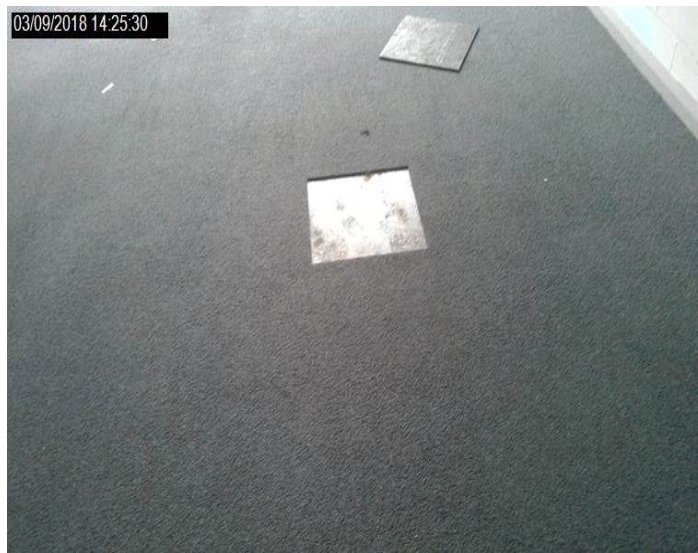
Location:	NAT113A	Block:	Birmingham City University	Floor Level: 1st Floor
Sample No.:	As DU002238	Portal Ref No.:	185

Item:	Asbestos Bitumen adhesive			
Asbestos Content:	Result Based on:			
Chrysotile	Strongly presumed			
Sample Analysed By:	Not applicable	Extent:	32 m ²	
Comments:

Material Assessment Total Score: 3		Likelihood of Disturbance Assessment Total Score: 4		Management Assessment Licensable: No Recommendations: Program removal Reinspection Interval: Not Applicable Overall Risk Category: C7
Product Type:	1 (Asbestos bitumen)	Location:	2 (Rooms up to 100 sq m)	
Condition:	1 (Minor scratches)	Accessibility:	0 (Usually inaccessible or unlikely to be disturbed)	
Surface Treatment:	0 (Composite material)			
Asbestos Type:	1 (Chrysotile)	Extent Score:	2 (>10 - <50 sq m or >10m - <50m pipe run)

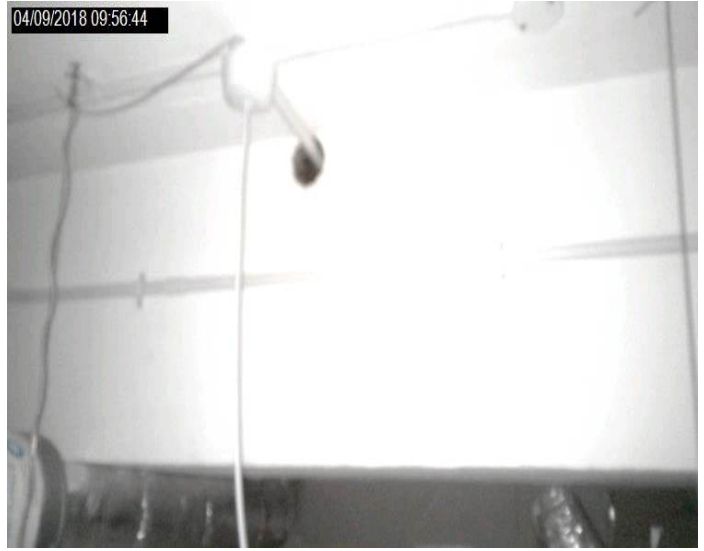
Location:	NAT116B	Block:	Birmingham City University	Floor Level: 1st Floor
Sample No.:	As DU002232	Portal Ref No.:	195

Item:	Asbestos Reinforced plastic sleeve			
Asbestos Content:	Result Based on:			
Chrysotile	Strongly presumed			
Sample Analysed By:	Not applicable	Extent:	1 unit	
Comments:

Material Assessment Total Score: 3		Likelihood of Disturbance Assessment Total Score: 4		Management Assessment Licensable: No Recommendations: Program removal Reinspection Interval: Not Applicable Overall Risk Category: C7
Product Type:	1 (Asbestos reinforced plastic)	Location:	2 (Rooms up to 100 sq m)	
Condition:	1 (Minor scratches)	Accessibility:	1 (Occasionally likely to be disturbed)	
Surface Treatment:	0 (Composite material)			
Asbestos Type:	1 (Chrysotile)	Extent Score:	1 (<10 sq m or 10m pipe run)

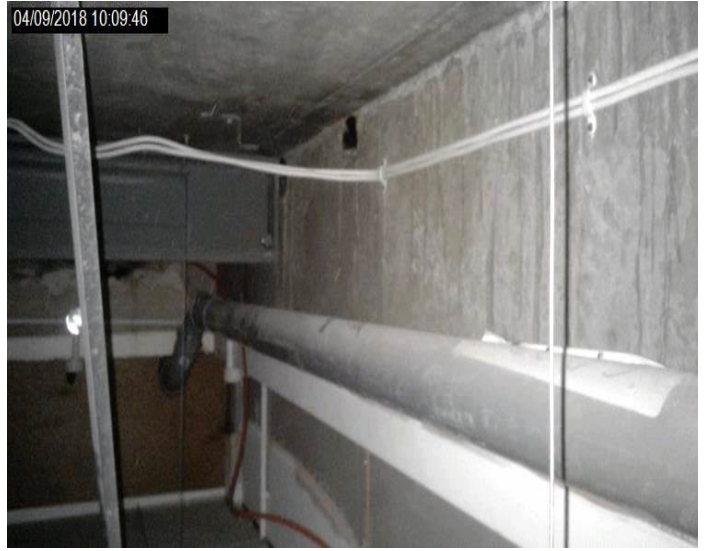
Location:	NAT114	Block:	Birmingham City University	Floor Level: 1st Floor
Sample No.:	As DU002245	Portal Ref No.:	199

Item:	Asbestos Reinforced plastic sleeve			
Asbestos Content:	Result Based on:			
Chrysotile	Strongly presumed			
Sample Analysed By:	Not applicable	Extent:	12 units	
Comments:

Material Assessment Total Score: 3		Likelihood of Disturbance Assessment Total Score: 4		Management Assessment Licensable: No Recommendations: Program removal Reinspection Interval: Not Applicable Overall Risk Category: C7
Product Type:	1 (Asbestos reinforced plastic)	Location:	2 (Rooms up to 100 sq m)	
Condition:	1 (Minor scratches)	Accessibility:	1 (Occasionally likely to be disturbed)	
Surface Treatment:	0 (Composite material)			
Asbestos Type:	1 (Chrysotile)	Extent Score:	1 (<10 sq m or 10m pipe run)

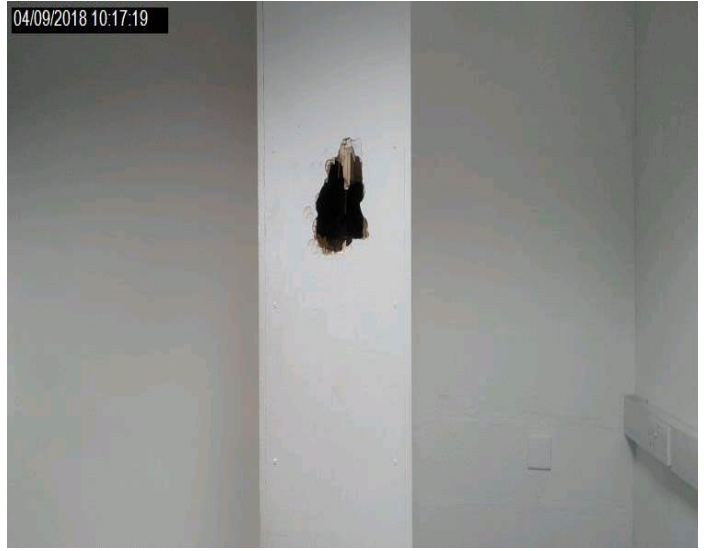
Location:	NAT116	Block:	Birmingham City University	Floor Level: 1st Floor
Sample No.:	DU002247	Portal Ref No.:	202

Item:	Asbestos Reinforced plastic downpipe			
Asbestos Content:	Result Based on:			
Chrysotile	Analysis of sample using PLM			
Sample Analysed By: Reg 13(1)	Extent:	4 linear metres		
Comments: Black pipe within timber boxing

Material Assessment Total Score: 3		Likelihood of Disturbance Assessment Total Score: 4		Management Assessment Licensable: No Recommendations: Program removal Reinspection Interval: Not Applicable Overall Risk Category: C7
Product Type:	1 (Asbestos reinforced plastic)	Location:	2 (Rooms up to 100 sq m)	
Condition:	1 (Minor scratches)	Accessibility:	1 (Occasionally likely to be disturbed)	
Surface Treatment:	0 (Composite material)			
Asbestos Type:	1 (Chrysotile)	Extent Score:	1 (<10 sq m or 10m pipe run)

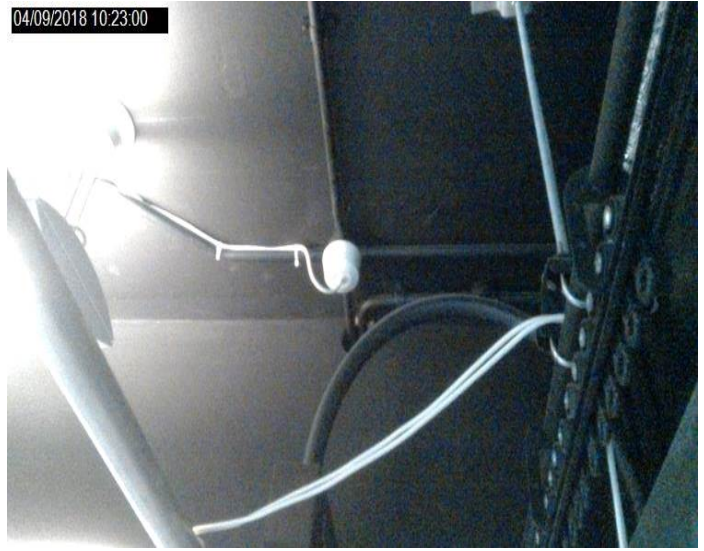
Location:	NAT114A	Block:	Birmingham City University	Floor Level: 1st Floor
Sample No.:	As DU002245	Portal Ref No.:	203

Item:	Asbestos Reinforced plastic sleeve			
Asbestos Content:	Result Based on:			
Chrysotile	Strongly presumed			
Sample Analysed By:	Not applicable	Extent:	2 units	
Comments:

Material Assessment Total Score: 3		Likelihood of Disturbance Assessment Total Score: 4		Management Assessment Licensable: No Recommendations: Program removal Reinspection Interval: Not Applicable Overall Risk Category: C7
Product Type:	1 (Asbestos reinforced plastic)	Location:	2 (Rooms up to 100 sq m)	
Condition:	1 (Minor scratches)	Accessibility:	1 (Occasionally likely to be disturbed)	
Surface Treatment:	0 (Composite material)			
Asbestos Type:	1 (Chrysotile)	Extent Score:	1 (<10 sq m or 10m pipe run)

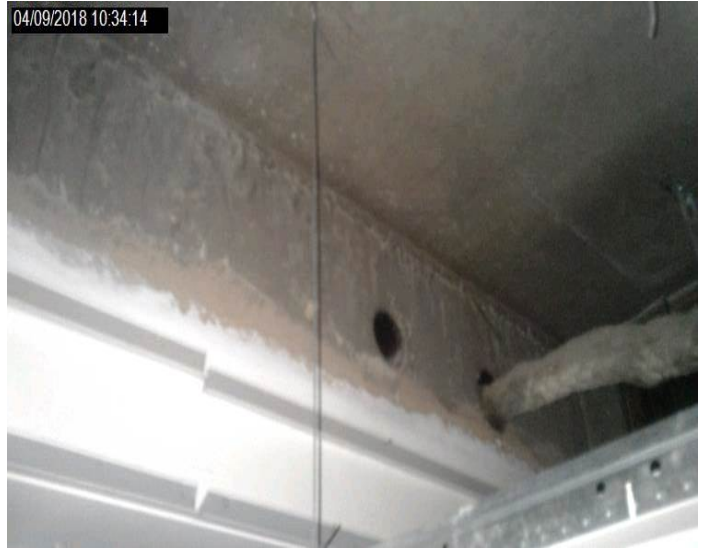
Location:	NAT113F	Block:	Birmingham City University	Floor Level: 1st Floor
Sample No.:	As DU002245	Portal Ref No.:	208

Item:	Asbestos Reinforced plastic sleeve			
Asbestos Content:	Result Based on:			
Chrysotile	Strongly presumed			
Sample Analysed By:	Not applicable	Extent:	3 units	
Comments:

Material Assessment Total Score: 3		Likelihood of Disturbance Assessment Total Score: 4		Management Assessment Licensable: No Recommendations: Program removal Reinspection Interval: Not Applicable Overall Risk Category: C7
Product Type:	1 (Asbestos reinforced plastic)	Location:	2 (Rooms up to 100 sq m)	
Condition:	1 (Minor scratches)	Accessibility:	1 (Occasionally likely to be disturbed)	
Surface Treatment:	0 (Composite material)			
Asbestos Type:	1 (Chrysotile)	Extent Score:	1 (<10 sq m or 10m pipe run)

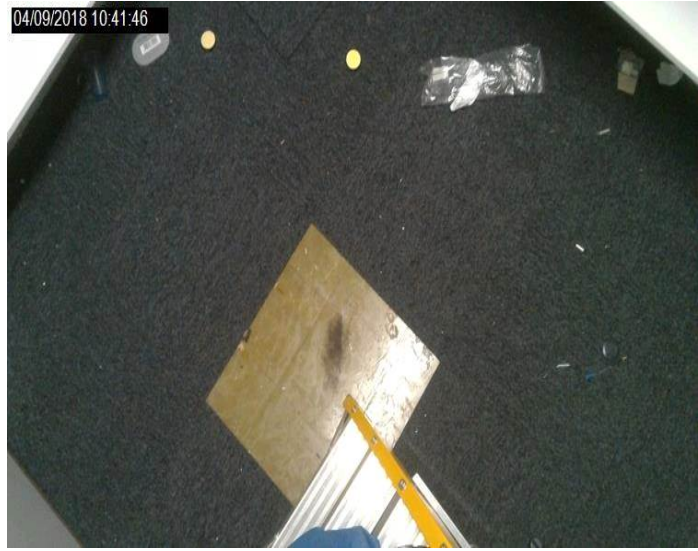
Location:	NAT113D	Block:	Birmingham City University	Floor Level: 1st Floor
Sample No.:	As DU002249	Portal Ref No.:	215

Item:	Asbestos Thermoplastic floor tiles			
Asbestos Content:	Result Based on:			
Chrysotile in tile and adhesive	Strongly presumed			
Sample Analysed By:	Not applicable	Extent:	6 m ²	
Comments:

Material Assessment Total Score: 3		Likelihood of Disturbance Assessment Total Score: 4		Management Assessment Licensable: No Recommendations: Program removal Reinspection Interval: Not Applicable Overall Risk Category: C7
Product Type:	1 (Asbestos thermoplastic)	Location:	2 (Rooms up to 100 sq m)	
Condition:	1 (Minor scratches)	Accessibility:	1 (Occasionally likely to be disturbed)	
Surface Treatment:	0 (Composite material)			
Asbestos Type:	1 (Chrysotile)	Extent Score:	1 (<10 sq m or 10m pipe run)

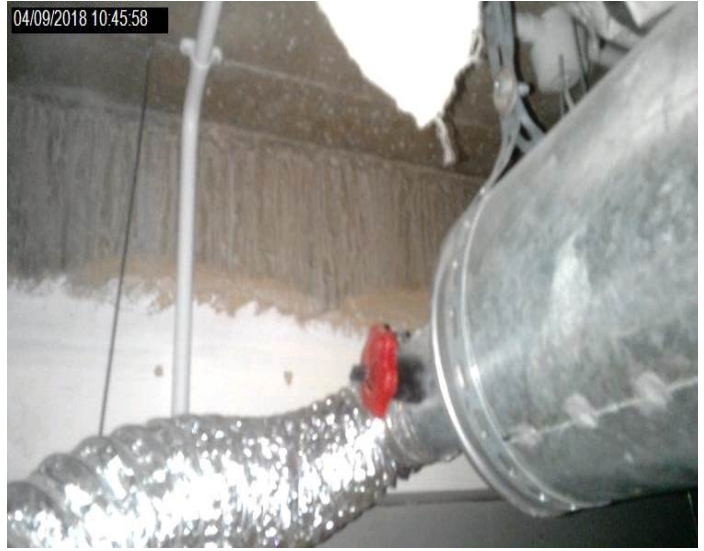
Location:	NAT113C	Block:	Birmingham City University	Floor Level: 1st Floor
Sample No.:	As DU002245	Portal Ref No.:	216

Item:	Asbestos Reinforced plastic sleeve			
Asbestos Content:	Result Based on:			
Chrysotile	Strongly presumed			
Sample Analysed By:	Not applicable	Extent:	2 units	
Comments:

Material Assessment Total Score: 3		Likelihood of Disturbance Assessment Total Score: 4		Management Assessment Licensable: No Recommendations: Program removal Reinspection Interval: Not Applicable Overall Risk Category: C7
Product Type:	1 (Asbestos reinforced plastic)	Location:	2 (Rooms up to 100 sq m)	
Condition:	1 (Minor scratches)	Accessibility:	1 (Occasionally likely to be disturbed)	
Surface Treatment:	0 (Composite material)			
Asbestos Type:	1 (Chrysotile)	Extent Score:	1 (<10 sq m or 10m pipe run)

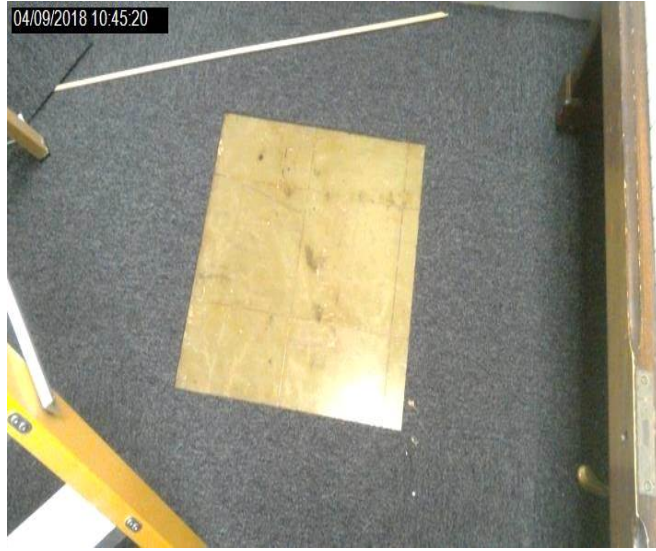
Location:	NAT113C	Block:	Birmingham City University	Floor Level: 1st Floor
Sample No.:	As DU002249	Portal Ref No.:	217

Item:	Asbestos Thermoplastic floor tiles			
Asbestos Content:	Result Based on:			
Chrysotile in tile and adhesive	Strongly presumed			
Sample Analysed By:	Not applicable	Extent:	4 m ²	
Comments:

Material Assessment Total Score: 3		Likelihood of Disturbance Assessment Total Score: 4		Management Assessment Licensable: No Recommendations: Program removal Reinspection Interval: Not Applicable Overall Risk Category: C7
Product Type:	1 (Asbestos thermoplastic)	Location:	2 (Rooms up to 100 sq m)	
Condition:	1 (Minor scratches)	Accessibility:	1 (Occasionally likely to be disturbed)	
Surface Treatment:	0 (Composite material)			
Asbestos Type:	1 (Chrysotile)	Extent Score:	1 (<10 sq m or 10m pipe run)

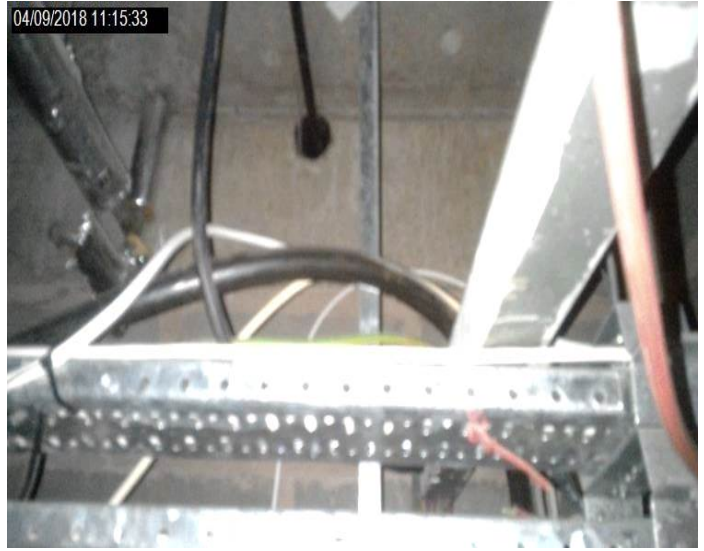
Location:	NAT199H	Block:	Birmingham City University	Floor Level: 1st Floor
Sample No.:	As DU002245	Portal Ref No.:	220

Item:	Asbestos Reinforced plastic sleeve			
Asbestos Content:	Result Based on:			
Chrysotile	Strongly presumed			
Sample Analysed By:	Not applicable	Extent:	6 units	
Comments:

Material Assessment Total Score: 3		Likelihood of Disturbance Assessment Total Score: 4		Management Assessment Licensable: No Recommendations: Program removal Reinspection Interval: Not Applicable Overall Risk Category: C7
Product Type:	1 (Asbestos reinforced plastic)	Location:	2 (Rooms up to 100 sq m)	
Condition:	1 (Minor scratches)	Accessibility:	1 (Occasionally likely to be disturbed)	
Surface Treatment:	0 (Composite material)			
Asbestos Type:	1 (Chrysotile)	Extent Score:	1 (<10 sq m or 10m pipe run)

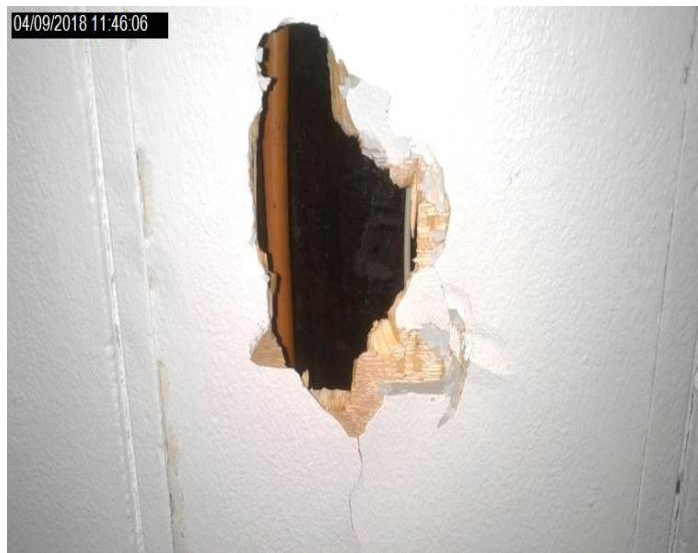
Location:	NAT199A	Block:	Birmingham City University	Floor Level: 1st Floor
Sample No.:	DU002251	Portal Ref No.:	222

Item:	Asbestos Reinforced plastic downpipe			
Asbestos Content:	Result Based on:			
Chrysotile	Analysis of sample using PLM			
Sample Analysed By: Reg 13(1)	Extent:	32 linear metres		
Comments: Black pipe within timber boxing to risers 8 in total

Material Assessment Total Score: 3		Likelihood of Disturbance Assessment Total Score: 5		Management Assessment Licensable: No Recommendations: Program removal Reinspection Interval: Not Applicable Overall Risk Category: C8
Product Type:	1 (Asbestos reinforced plastic)	Location:	2 (Rooms up to 100 sq m)	
Condition:	1 (Minor scratches)	Accessibility:	1 (Occasionally likely to be disturbed)	
Surface Treatment:	0 (Composite material)			
Asbestos Type:	1 (Chrysotile)	Extent Score:	2 (>10 - <50 sq m or >10m - <50m pipe run)

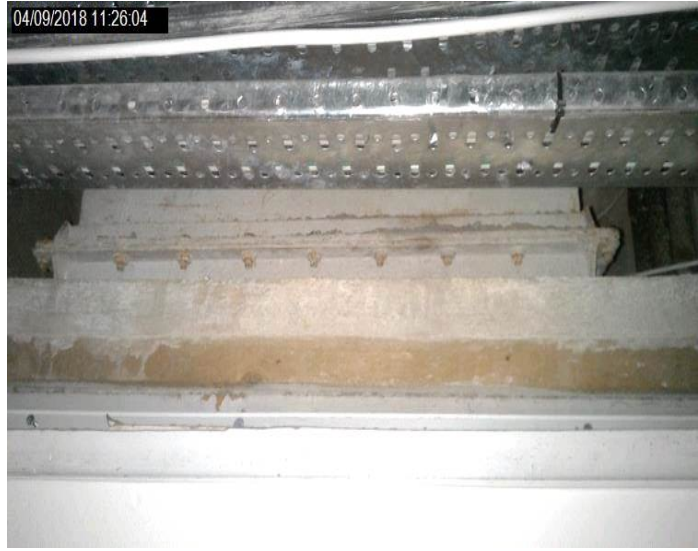
Location:	NAT199A	Block:	Birmingham City University	Floor Level: 1st Floor
Sample No.:	DU002250	Portal Ref No.:	224

Item:	Asbestos Textile rope seal to metal ducting			
Asbestos Content:	Chrysotile			
Result Based on:	Analysis of sample using PLM			
Sample Analysed By:	Reg 13(1)	Extent:	4 linear metres	
Comments: Within timber boxing

Material Assessment Total Score: 5		Likelihood of Disturbance Assessment Total Score: 2		Management Assessment Licensable: No Recommendations: Program removal Reinspection Interval: Not Applicable Overall Risk Category: C7
Product Type:	2 (Asbestos textile)	Location:	1 (Large rooms or well-ventilated areas)	
Condition:	1 (Minor scratches)	Accessibility:	0 (Usually inaccessible or unlikely to be disturbed)	
Surface Treatment:	1 (Enclosed textile/paper)			
Asbestos Type:	1 (Chrysotile)	Extent Score:	1 (<10 sq m or 10m pipe run)

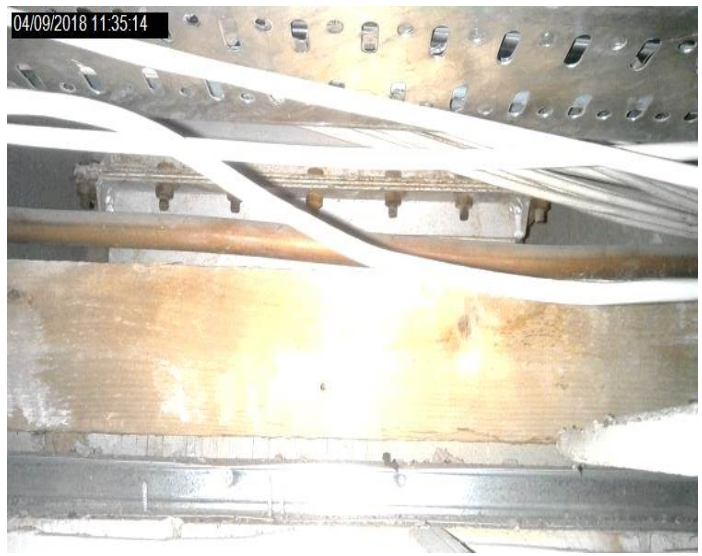
Location:	NAT199A	Block:	Birmingham City University	Floor Level: 1st Floor
Sample No.:	As DU002250	Portal Ref No.:	225

Item:	Asbestos Textile rope seal to metal ducting			
Asbestos Content:	Result Based on:			
Chrysotile	Strongly presumed			
Sample Analysed By:	Not applicable	Extent:	4 linear metres	
Comments: Within timber boxing / riser adjacent double doors

Material Assessment Total Score: 5		Likelihood of Disturbance Assessment Total Score: 2		Management Assessment Licensable: No Recommendations: Program removal Reinspection Interval: Not Applicable Overall Risk Category: C7
Product Type:	2 (Asbestos textile)	Location:	1 (Large rooms or well-ventilated areas)	
Condition:	1 (Minor scratches)	Accessibility:	0 (Usually inaccessible or unlikely to be disturbed)	
Surface Treatment:	1 (Enclosed textile/paper)			
Asbestos Type:	1 (Chrysotile)	Extent Score:	1 (<10 sq m or 10m pipe run)

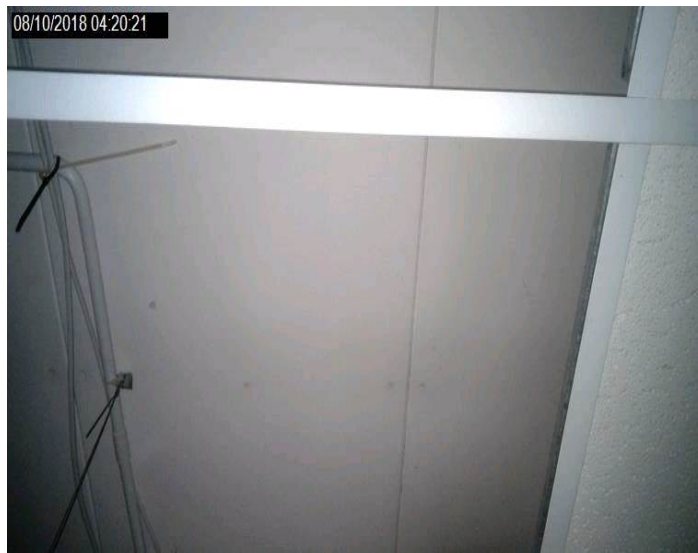
Location:	NAT041B	Block:	Birmingham City University	Floor Level: Ground Floor
Sample No.:	DU002603	Portal Ref No.:	226

Item:	Insulating board ceiling tiles			
Asbestos Content:		Result Based on:		
No Asbestos Detected		Analysis of sample using PLM		
Sample Analysed By:	Reg 13(1)	Extent:	6 m ²	
<p>Comments: No access could be made beyond the insulating board ceiling panels at the time of the survey therefore the presence of further reinforced plastic sleeves should be considered in this void. it is recommended that BECL re visit these areas prior to demolition to determine the possible location and extent of these materials.</p>

Material Assessment Total Score: 0		Likelihood of Disturbance Assessment Total Score: 0		<p>Management Assessment</p> <p>Licensable: Yes</p> <p>Recommendations: Not Applicable</p> <p>Reinspection Interval: Not Applicable</p> <p>Overall Risk Category: E0</p>
Product Type:	0 Not Applicable	Location:	0 Not Applicable	
Condition:	0 Not Applicable	Accessibility:	0 Not Applicable	
Surface Treatment:	0 Not Applicable			
Asbestos Type:	0 Not Applicable	Extent Score:	0 Not Applicable

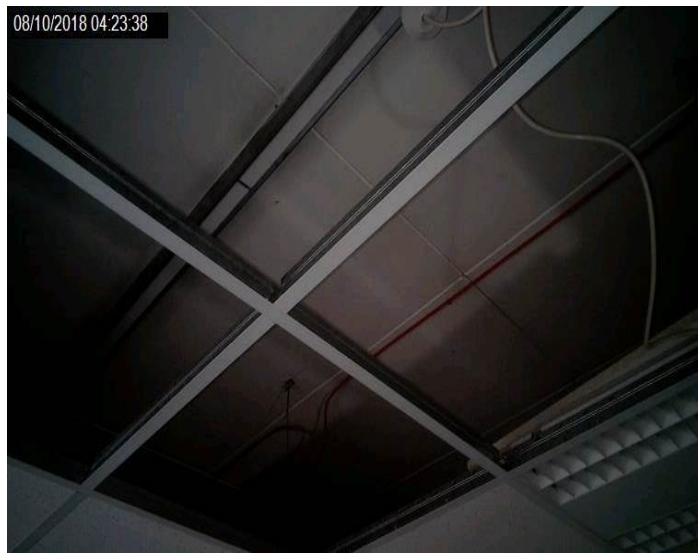
Location:	NAT041A	Block:	Birmingham City University	Floor Level: Ground Floor
Sample No.:	As DU002603	Portal Ref No.:	227

Item:	Insulating board ceiling tiles			
Asbestos Content:		Result Based on:		
No Asbestos Detected		Strongly presumed		
Sample Analysed By:	Not applicable	Extent:	18 m ²	
<p>Comments: No access could be made beyond the insulating board ceiling panels at the time of the survey therefore the presence of further reinforced plastic sleeves should be considered in this void. it is recommended that BECL re visit these areas prior to demolition to determine the possible location and extent of these materials.</p>

Material Assessment Total Score: 0		Likelihood of Disturbance Assessment Total Score: 0		<p>Management Assessment</p> <p>Licensable: Yes</p> <p>Recommendations: Not Applicable</p> <p>Reinspection Interval: Not Applicable</p> <p>Overall Risk Category: E0</p>
Product Type:	0 Not Applicable	Location:	0 Not Applicable	
Condition:	0 Not Applicable	Accessibility:	0 Not Applicable	
Surface Treatment:	0 Not Applicable			
Asbestos Type:	0 Not Applicable	Extent Score:	0 Not Applicable

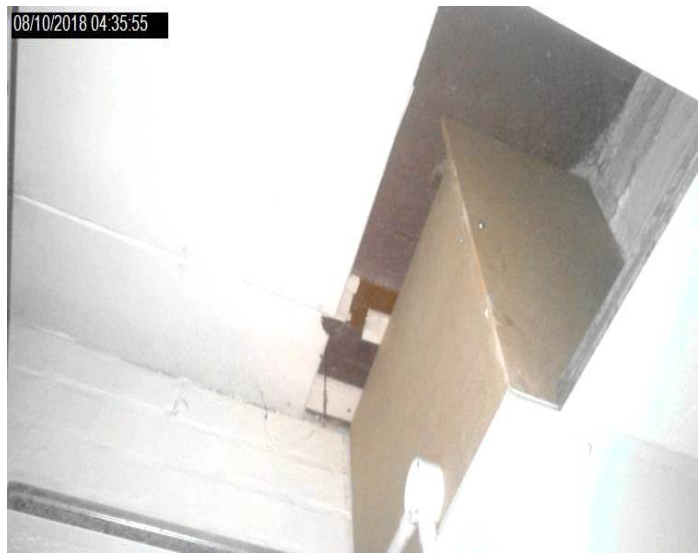
Location:	NAT041C	Block:	Birmingham City University	Floor Level: Ground Floor
Sample No.:	DU002604	Portal Ref No.:	229

Item:	Insulating board ceiling tiles			
Asbestos Content:		Result Based on:		
No Asbestos Detected		Analysis of sample using PLM		
Sample Analysed By:	Reg 13(1)	Extent:	112 m ²	
<p>Comments: No access could be made beyond the insulating board ceiling panels at the time of the survey therefore the presence of further reinforced plastic sleeves should be considered in this void. it is recommended that BECL re visit these areas prior to demolition to determine the possible location and extent of these materials.</p>

Material Assessment Total Score: 0		Likelihood of Disturbance Assessment Total Score: 0		<p>Management Assessment</p> <p>Licensable: Yes</p> <p>Recommendations: Not Applicable</p> <p>Reinspection Interval: Not Applicable</p> <p>Overall Risk Category: E0</p>
Product Type:	0 Not Applicable	Location:	0 Not Applicable	
Condition:	0 Not Applicable	Accessibility:	0 Not Applicable	
Surface Treatment:	0 Not Applicable			
Asbestos Type:	0 Not Applicable	Extent Score:	0 Not Applicable

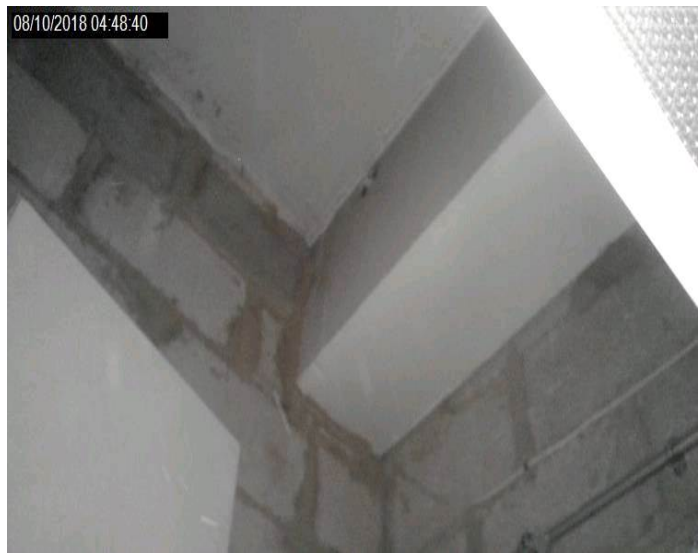
Location:	NAT040A	Block:	Birmingham City University	Floor Level: Ground Floor
Sample No.:	DU002605	Portal Ref No.:	231

Item:	Asbestos Reinforced plastic sleeve			
Asbestos Content:	Result Based on:			
Chrysotile	Analysis of sample using PLM			
Sample Analysed By: Reg 13(1)	Extent:	2 units		
Comments: Through concrete structure

Material Assessment Total Score: 3		Likelihood of Disturbance Assessment Total Score: 3		Management Assessment Licensable: No Recommendations: Program removal Reinspection Interval: Not Applicable Overall Risk Category: D6
Product Type:	1 (Asbestos reinforced plastic)	Location:	2 (Rooms up to 100 sq m)	
Condition:	1 (Minor scratches)	Accessibility:	0 (Usually inaccessible or unlikely to be disturbed)	
Surface Treatment:	0 (Composite material)			
Asbestos Type:	1 (Chrysotile)	Extent Score:	1 (<10 sq m or 10m pipe run)

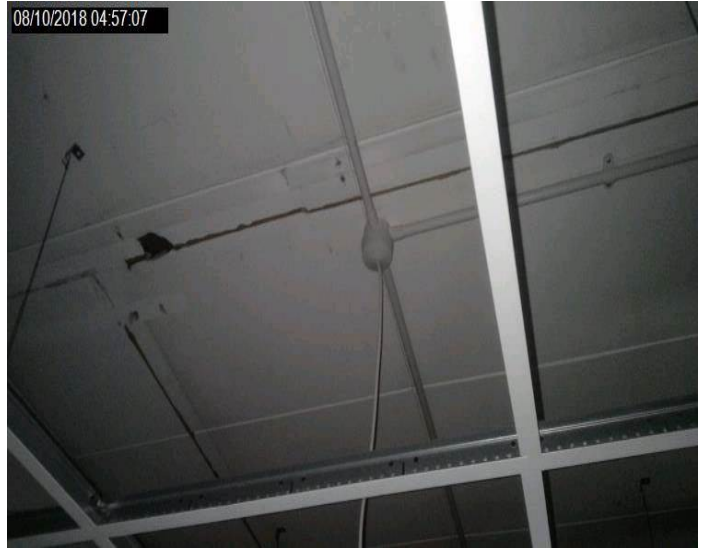
Location:	NAT047	Block:	Birmingham City University	Floor Level: Ground Floor
Sample No.:	DU002606	Portal Ref No.:	232

Item:	Insulating board ceiling tiles			
Asbestos Content:		Result Based on:		
No Asbestos Detected		Analysis of sample using PLM		
Sample Analysed By:	Reg 13(1)	Extent:	18 m ²	
Comments: No access above AIB ceiling tiles without assistance of a licensed contractor

Material Assessment Total Score: 0		Likelihood of Disturbance Assessment Total Score: 0		Management Assessment Licensable: Yes Recommendations: Not Applicable Reinspection Interval: Not Applicable Overall Risk Category: E0
Product Type:	0 Not Applicable	Location:	0 Not Applicable	
Condition:	0 Not Applicable	Accessibility:	0 Not Applicable	
Surface Treatment:	0 Not Applicable			
Asbestos Type:	0 Not Applicable	Extent Score:	0 Not Applicable

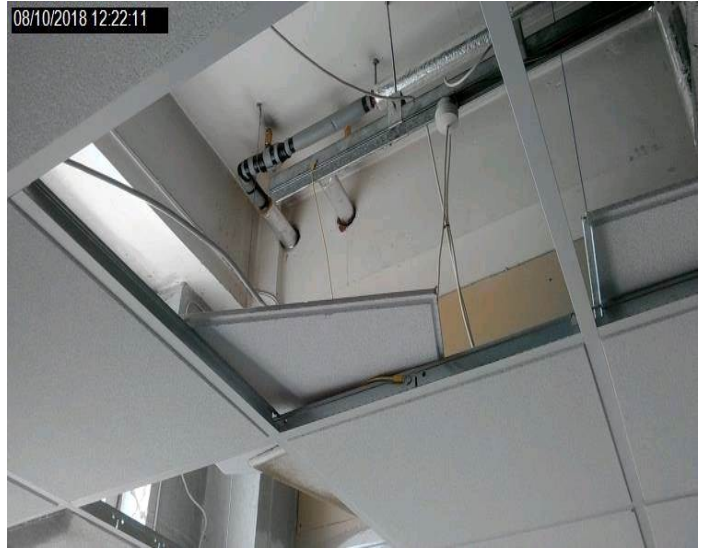
Location:	NAT045	Block:	Birmingham City University	Floor Level: Ground Floor
Sample No.:	As DU002605	Portal Ref No.:	235

Item:	Asbestos Reinforced plastic sleeve			
Asbestos Content:	Result Based on:			
Chrysotile	Strongly presumed			
Sample Analysed By:	Not applicable	Extent:	2 units	
Comments: Through concrete structure

Material Assessment Total Score: 3		Likelihood of Disturbance Assessment Total Score: 3		Management Assessment Licensable: No Recommendations: Program removal Reinspection Interval: Not Applicable Overall Risk Category: D6
Product Type:	1 (Asbestos reinforced plastic)	Location:	2 (Rooms up to 100 sq m)	
Condition:	1 (Minor scratches)	Accessibility:	0 (Usually inaccessible or unlikely to be disturbed)	
Surface Treatment:	0 (Composite material)			
Asbestos Type:	1 (Chrysotile)	Extent Score:	1 (<10 sq m or 10m pipe run)

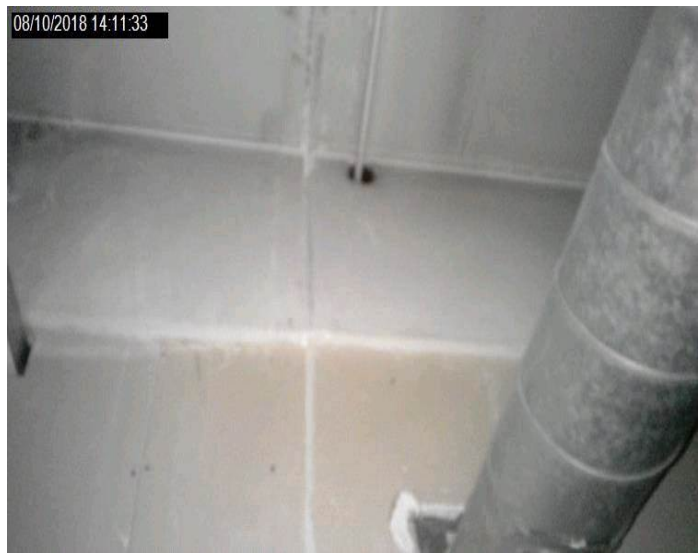
Location:	NAT042	Block:	Birmingham City University	Floor Level: Ground Floor
Sample No.:	As DU002605	Portal Ref No.:	236

Item:	Asbestos Reinforced plastic sleeve			
Asbestos Content:	Result Based on:			
Chrysotile	Strongly presumed			
Sample Analysed By:	Not applicable	Extent:	4 units	
Comments: Through concrete structure

Material Assessment Total Score: 3		Likelihood of Disturbance Assessment Total Score: 3		Management Assessment Licensable: No Recommendations: Program removal Reinspection Interval: Not Applicable Overall Risk Category: D6
Product Type:	1 (Asbestos reinforced plastic)	Location:	2 (Rooms up to 100 sq m)	
Condition:	1 (Minor scratches)	Accessibility:	0 (Usually inaccessible or unlikely to be disturbed)	
Surface Treatment:	0 (Composite material)			
Asbestos Type:	1 (Chrysotile)	Extent Score:	1 (<10 sq m or 10m pipe run)

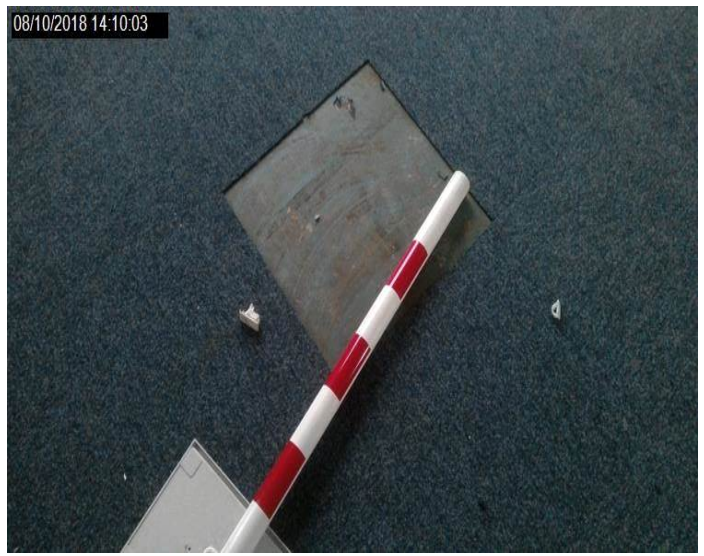
Location:	NAT042	Block:	Birmingham City University	Floor Level: Ground Floor
Sample No.:	DU002607	Portal Ref No.:	237

Item:	Asbestos Thermoplastic floor tiles with bitumen adhesive			
Asbestos Content:	Result Based on:			
Chrysotile in adhesive only	Analysis of sample using PLM			
Sample Analysed By: Reg 13(1)	Extent:	72 m ²		
Comments:

Material Assessment Total Score: 3		Likelihood of Disturbance Assessment Total Score: 6		Management Assessment Licensable: No Recommendations: Program removal Reinspection Interval: Not Applicable Overall Risk Category: C9
Product Type:	1 (Asbestos thermoplastic)	Location:	2 (Rooms up to 100 sq m)	
Condition:	1 (Minor scratches)	Accessibility:	1 (Occasionally likely to be disturbed)	
Surface Treatment:	0 (Composite material)			
Asbestos Type:	1 (Chrysotile)	Extent Score:	3 (>50 sq m or >50m pipe run)

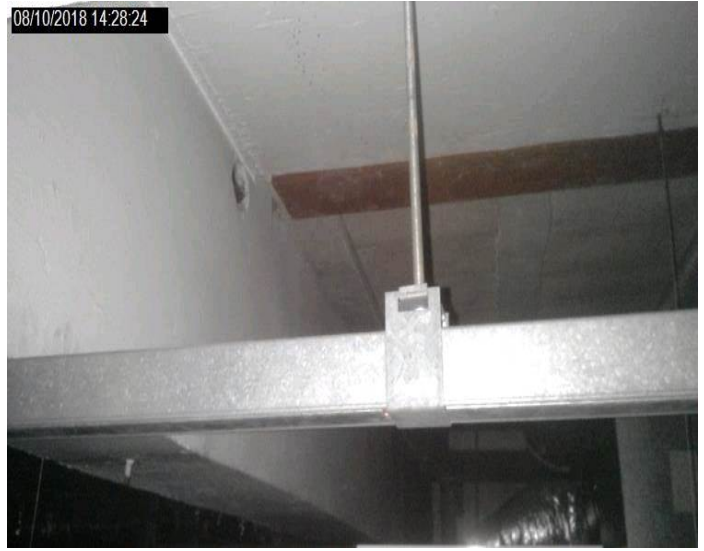
Location:	NAT040	Block:	Birmingham City University	Floor Level: Ground Floor
Sample No.:	As DU002605	Portal Ref No.:	238

Item:	Asbestos Reinforced plastic sleeve			
Asbestos Content:	Result Based on:			
Chrysotile	Strongly presumed			
Sample Analysed By:	Not applicable	Extent:	6 units	
Comments: Through concrete structure

Material Assessment Total Score: 3		Likelihood of Disturbance Assessment Total Score: 3		Management Assessment Licensable: No Recommendations: Program removal Reinspection Interval: Not Applicable Overall Risk Category: D6
Product Type:	1 (Asbestos reinforced plastic)	Location:	2 (Rooms up to 100 sq m)	
Condition:	1 (Minor scratches)	Accessibility:	0 (Usually inaccessible or unlikely to be disturbed)	
Surface Treatment:	0 (Composite material)			
Asbestos Type:	1 (Chrysotile)	Extent Score:	1 (<10 sq m or 10m pipe run)

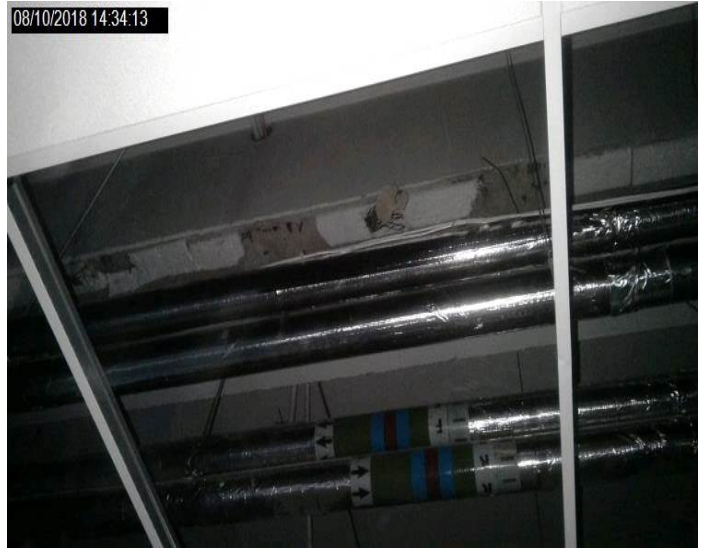
Location:	NAT039	Block:	Birmingham City University	Floor Level: Ground Floor
Sample No.:	As DU002605	Portal Ref No.:	239

Item:	Asbestos Reinforced plastic sleeve			
Asbestos Content:	Result Based on:			
Chrysotile	Strongly presumed			
Sample Analysed By:	Not applicable	Extent:	6 units	
Comments: Through concrete structure

Material Assessment Total Score: 3		Likelihood of Disturbance Assessment Total Score: 3		Management Assessment Licensable: No Recommendations: Program removal Reinspection Interval: Not Applicable Overall Risk Category: D6
Product Type:	1 (Asbestos reinforced plastic)	Location:	2 (Rooms up to 100 sq m)	
Condition:	1 (Minor scratches)	Accessibility:	0 (Usually inaccessible or unlikely to be disturbed)	
Surface Treatment:	0 (Composite material)			
Asbestos Type:	1 (Chrysotile)	Extent Score:	1 (<10 sq m or 10m pipe run)

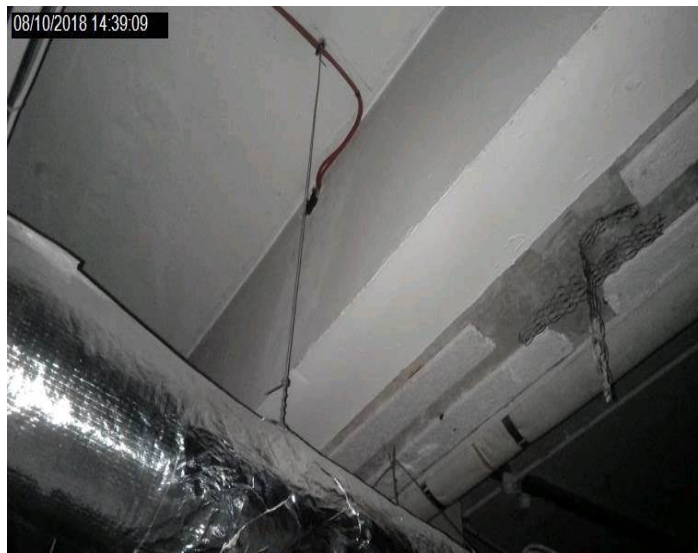
Location:	NAT043	Block:	Birmingham City University	Floor Level: Ground Floor
Sample No.:	As DU002605	Portal Ref No.:	240

Item:	Asbestos Reinforced plastic sleeve			
Asbestos Content:	Result Based on:			
Chrysotile	Strongly presumed			
Sample Analysed By:	Not applicable	Extent:	6 units	
Comments: Through concrete structure

Material Assessment Total Score: 3		Likelihood of Disturbance Assessment Total Score: 3		Management Assessment Licensable: No Recommendations: Program removal Reinspection Interval: Not Applicable Overall Risk Category: D6
Product Type:	1 (Asbestos reinforced plastic)	Location:	2 (Rooms up to 100 sq m)	
Condition:	1 (Minor scratches)	Accessibility:	0 (Usually inaccessible or unlikely to be disturbed)	
Surface Treatment:	0 (Composite material)			
Asbestos Type:	1 (Chrysotile)	Extent Score:	1 (<10 sq m or 10m pipe run)

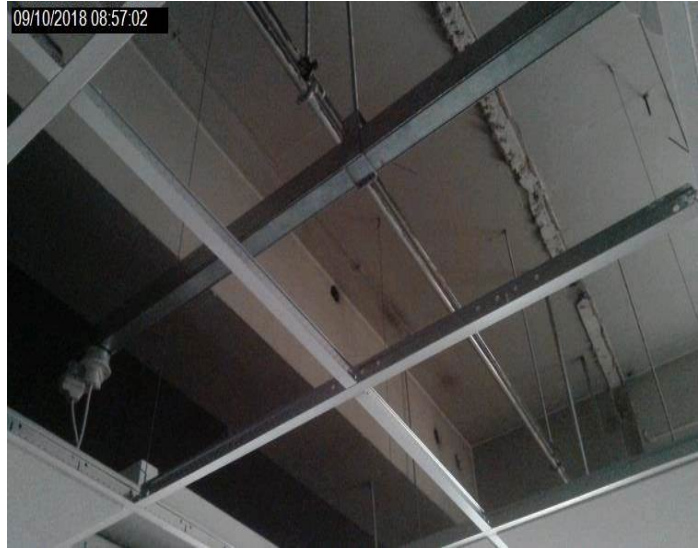
Location:	NAT036	Block:	Birmingham City University	Floor Level: Ground Floor
Sample No.:	As DU002605	Portal Ref No.:	242

Item:	Asbestos Reinforced plastic sleeve			
Asbestos Content:	Result Based on:			
Chrysotile	Strongly presumed			
Sample Analysed By:	Not applicable	Extent:	8 units	
Comments: Through concrete structure

Material Assessment Total Score: 3		Likelihood of Disturbance Assessment Total Score: 3		Management Assessment Licensable: No Recommendations: Program removal Reinspection Interval: Not Applicable Overall Risk Category: D6
Product Type:	1 (Asbestos reinforced plastic)	Location:	2 (Rooms up to 100 sq m)	
Condition:	1 (Minor scratches)	Accessibility:	0 (Usually inaccessible or unlikely to be disturbed)	
Surface Treatment:	0 (Composite material)			
Asbestos Type:	1 (Chrysotile)	Extent Score:	1 (<10 sq m or 10m pipe run)

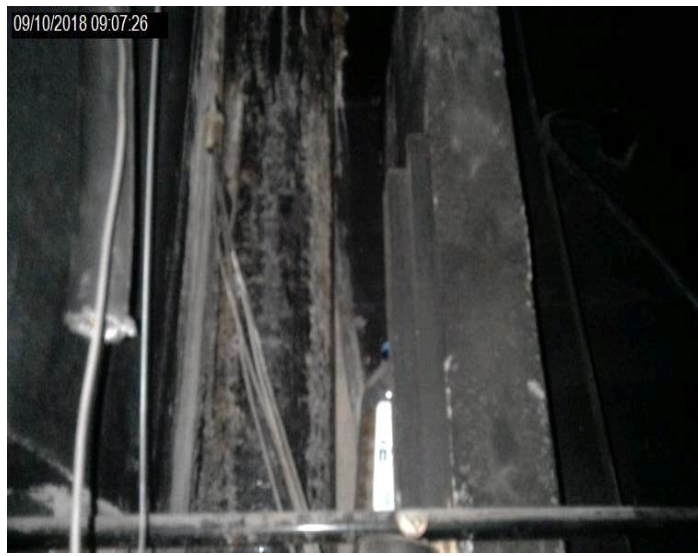
Location:	NAT036	Block:	Birmingham City University	Floor Level: Ground Floor
Sample No.:	DU002609	Portal Ref No.:	244

Item:	Asbestos Reinforced plastic downpipe			
Asbestos Content:	Result Based on:			
Chrysotile	Analysis of sample using PLM			
Sample Analysed By: Reg 13(1)	Extent:	4 linear metres		
Comments: Internally to timber boxing

Material Assessment Total Score: 3		Likelihood of Disturbance Assessment Total Score: 3		Management Assessment Licensable: No Recommendations: Program removal Reinspection Interval: Not Applicable Overall Risk Category: D6
Product Type:	1 (Asbestos reinforced plastic)	Location:	2 (Rooms up to 100 sq m)	
Condition:	1 (Minor scratches)	Accessibility:	0 (Usually inaccessible or unlikely to be disturbed)	
Surface Treatment:	0 (Composite material)			
Asbestos Type:	1 (Chrysotile)	Extent Score:	1 (<10 sq m or 10m pipe run)

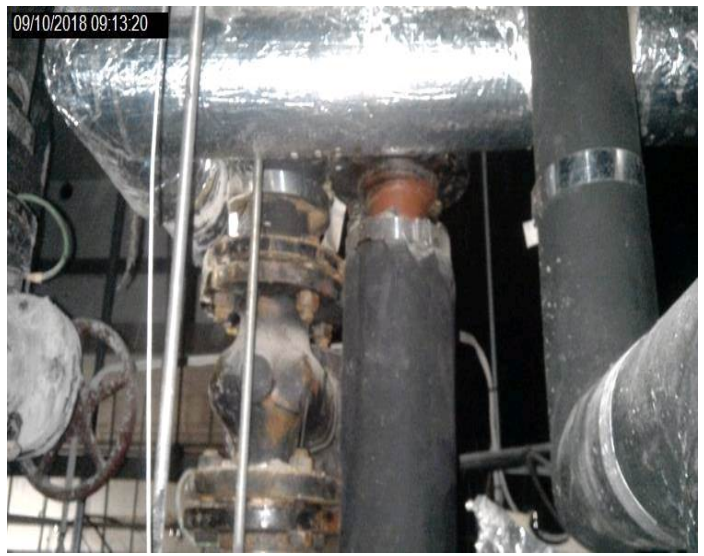
Location:	NAT036	Block:	Birmingham City University	Floor Level: Ground Floor
Sample No.:	DU002610	Portal Ref No.:	245

Item:	Asbestos Compressed fibre gasket			
Asbestos Content:	Chrysotile			
Result Based on:	Analysis of sample using PLM			
Sample Analysed By:	Reg 13(1)	Extent:	6 units	
Comments: Local to stairwell within ceiling void

Material Assessment Total Score: 5		Likelihood of Disturbance Assessment Total Score: 3		Management Assessment Licensable: No Recommendations: Program removal Reinspection Interval: Not Applicable Overall Risk Category: C8
Product Type:	2 (Compressed asbestos fibre)	Location:	2 (Rooms up to 100 sq m)	
Condition:	1 (Minor scratches)	Accessibility:	0 (Usually inaccessible or unlikely to be disturbed)	
Surface Treatment:	1 (Enclosed textile/paper)			
Asbestos Type:	1 (Chrysotile)	Extent Score:	1 (<10 sq m or 10m pipe run)

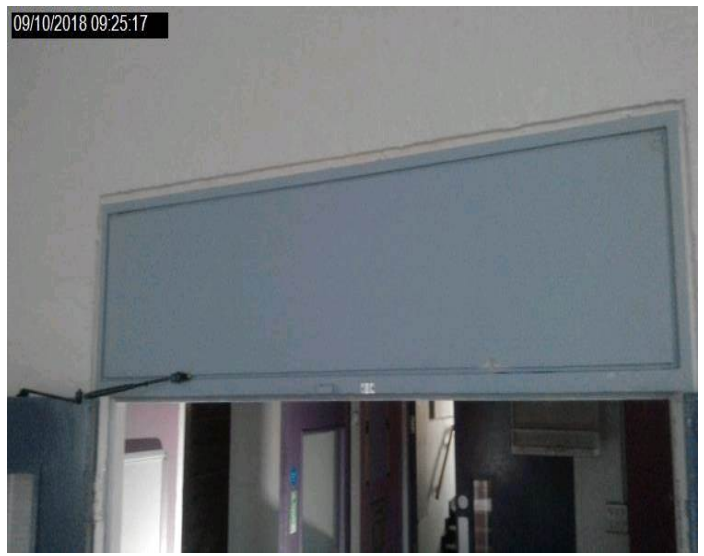
Location:	NAT044	Block:	Birmingham City University	Floor Level: Ground Floor
Sample No.:	DU002612	Portal Ref No.:	248

Item:	Insulating board door header			
Asbestos Content:		Result Based on:		
No Asbestos Detected		Analysis of sample using PLM		
Sample Analysed By:	Reg 13(1)	Extent:	2 m ²	
Comments:

Material Assessment Total Score: 0		Likelihood of Disturbance Assessment Total Score: 0		Management Assessment Licensable: Yes Recommendations: Not Applicable Reinspection Interval: Not Applicable Overall Risk Category: E0
Product Type:	0 Not Applicable	Location:	0 Not Applicable	
Condition:	0 Not Applicable	Accessibility:	0 Not Applicable	
Surface Treatment:	0 Not Applicable			
Asbestos Type:	0 Not Applicable	Extent Score:	0 Not Applicable

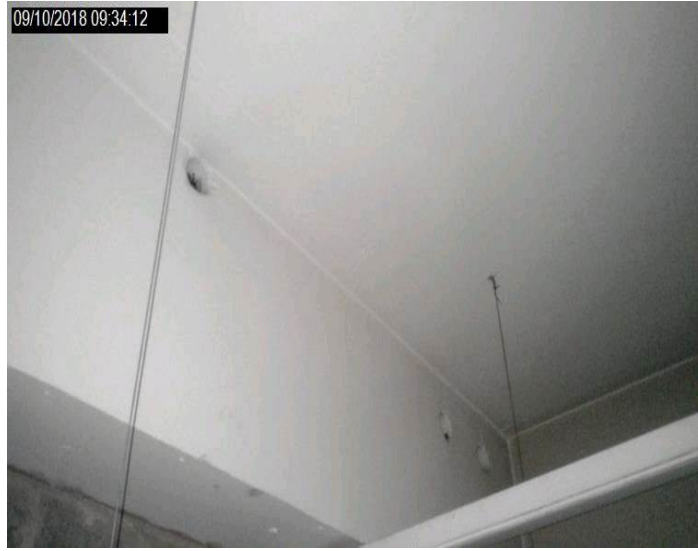
Location:	NAT033	Block:	Birmingham City University	Floor Level: Ground Floor
Sample No.:	As DU002605	Portal Ref No.:	250

Item:	Asbestos Reinforced plastic sleeve			
Asbestos Content:	Result Based on:			
Chrysotile	Strongly presumed			
Sample Analysed By:	Not applicable	Extent:	4 units	
Comments: Through concrete structure

Material Assessment Total Score: 3		Likelihood of Disturbance Assessment Total Score: 3		Management Assessment Licensable: No Recommendations: Program removal Reinspection Interval: Not Applicable Overall Risk Category: D6
Product Type:	1 (Asbestos reinforced plastic)	Location:	2 (Rooms up to 100 sq m)	
Condition:	1 (Minor scratches)	Accessibility:	0 (Usually inaccessible or unlikely to be disturbed)	
Surface Treatment:	0 (Composite material)			
Asbestos Type:	1 (Chrysotile)	Extent Score:	1 (<10 sq m or 10m pipe run)

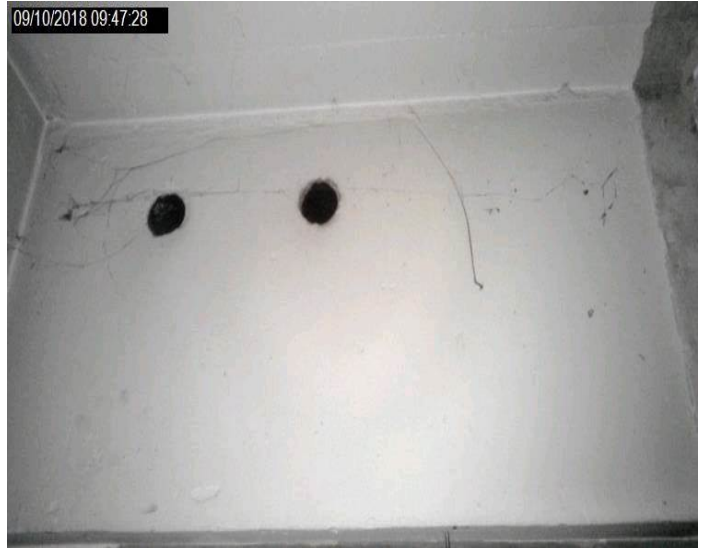
Location:	NAT002	Block:	Birmingham City University	Floor Level: Ground Floor
Sample No.:	As DU002605	Portal Ref No.:	253

Item:	Asbestos Reinforced plastic sleeve			
Asbestos Content:	Result Based on:			
Chrysotile	Strongly presumed			
Sample Analysed By:	Not applicable	Extent:	3 units	
Comments: Through concrete structure

Material Assessment Total Score: 3		Likelihood of Disturbance Assessment Total Score: 3		Management Assessment Licensable: No Recommendations: Program removal Reinspection Interval: Not Applicable Overall Risk Category: D6
Product Type:	1 (Asbestos reinforced plastic)	Location:	2 (Rooms up to 100 sq m)	
Condition:	1 (Minor scratches)	Accessibility:	0 (Usually inaccessible or unlikely to be disturbed)	
Surface Treatment:	0 (Composite material)			
Asbestos Type:	1 (Chrysotile)	Extent Score:	1 (<10 sq m or 10m pipe run)

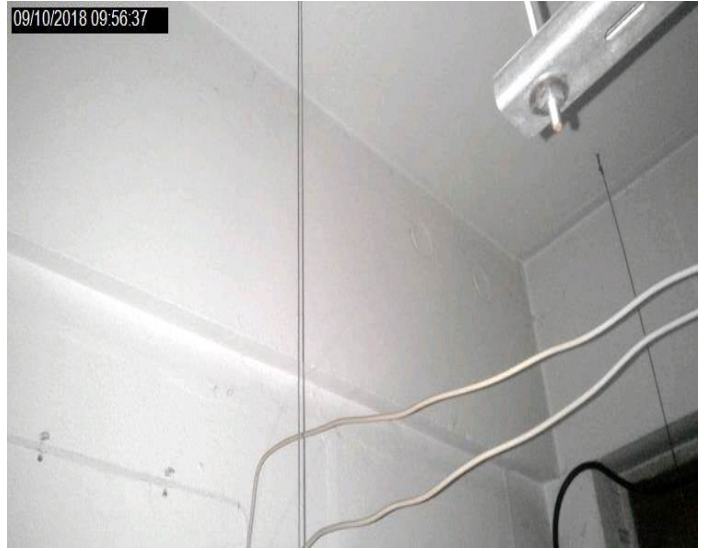
Location:	NAT00B	Block:	Birmingham City University	Floor Level: Ground Floor
Sample No.:	As DU002605	Portal Ref No.:	255

Item:	Asbestos Reinforced plastic sleeve			
Asbestos Content:	Result Based on:			
Chrysotile	Strongly presumed			
Sample Analysed By:	Not applicable	Extent:	3 units	
Comments: Through concrete structure

Material Assessment Total Score: 3		Likelihood of Disturbance Assessment Total Score: 3		Management Assessment Licensable: No Recommendations: Program removal Reinspection Interval: Not Applicable Overall Risk Category: D6
Product Type:	1 (Asbestos reinforced plastic)	Location:	2 (Rooms up to 100 sq m)	
Condition:	1 (Minor scratches)	Accessibility:	0 (Usually inaccessible or unlikely to be disturbed)	
Surface Treatment:	0 (Composite material)			
Asbestos Type:	1 (Chrysotile)	Extent Score:	1 (<10 sq m or 10m pipe run)
