Report No.: J102749
Nature of Work: Demolition Survey
Issue Date: 02/11/2018
Client Name: WYG Engineering Ltd
 Geneva Building, Lake View Drive, Sherwood Business Park,
 Annesley, Nottingham, NG15 0ED
Site Address: Attwood Building, Former City North Campus, Birmingham City
 University, Perry Barr, B42 2US

1.0 Introduction & Scope of Work

A demolition survey in line with HSG264 Asbestos: The Survey Guide was carried out internally and externally to the property.

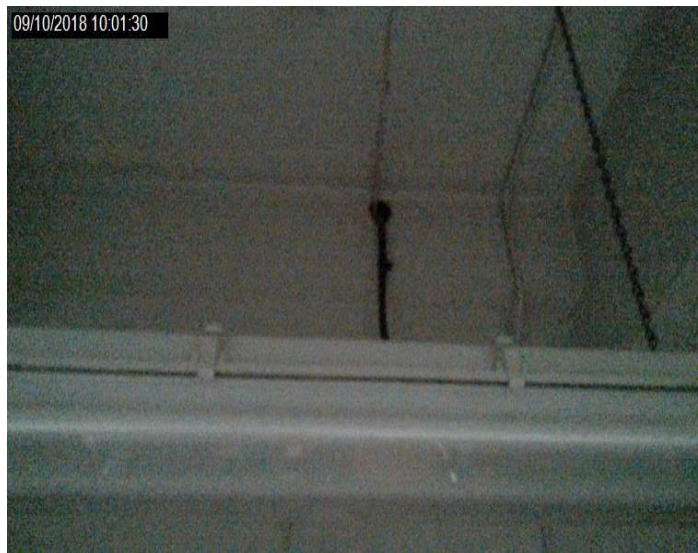
Location:	NAT007	Block:	Birmingham City University	Floor Level: Ground Floor
Sample No.:	As DU002605	Portal Ref No.:	257

Item:	Asbestos Reinforced plastic sleeve			
Asbestos Content:	Result Based on:			
Chrysotile	Strongly presumed			
Sample Analysed By:	Not applicable	Extent:	1 unit	
Comments: Through concrete structure

Material Assessment Total Score: 3		Likelihood of Disturbance Assessment Total Score: 3		Management Assessment Licensable: No Recommendations: Program removal Reinspection Interval: Not Applicable Overall Risk Category: D6
Product Type:	1 (Asbestos reinforced plastic)	Location:	2 (Rooms up to 100 sq m)	
Condition:	1 (Minor scratches)	Accessibility:	0 (Usually inaccessible or unlikely to be disturbed)	
Surface Treatment:	0 (Composite material)			
Asbestos Type:	1 (Chrysotile)	Extent Score:	1 (<10 sq m or 10m pipe run)

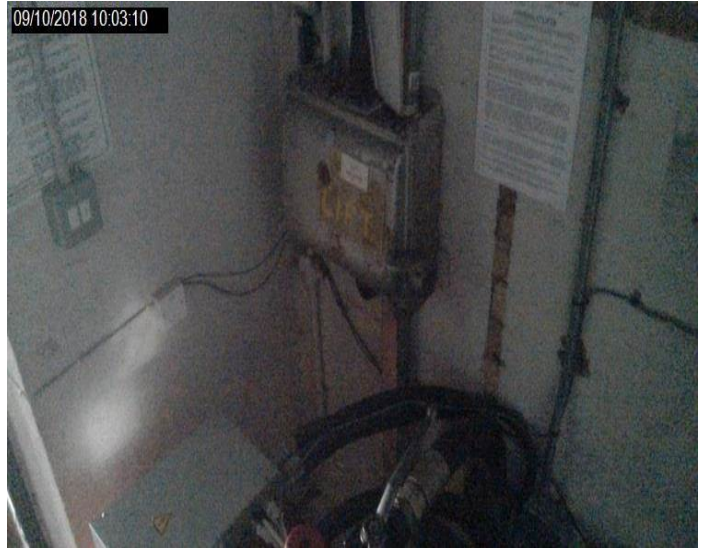
Location:	NAT007	Block:	Birmingham City University	Floor Level: Ground Floor
Sample No.:	No sample - presumed	Portal Ref No.:	258

Item:	Asbestos Textile fuse tapes			
Asbestos Content:	Result Based on:			
Chrysotile	Presumed			
Sample Analysed By:	Not applicable	Extent:	2 units	
Comments: Asbestos content presumed as they remained live and connected and no isolation certificate was available.

Material Assessment Total Score: 5		Likelihood of Disturbance Assessment Total Score: 4		Management Assessment Licensable: No Recommendations: Program removal Reinspection Interval: Not Applicable Overall Risk Category: C9
Product Type:	2 (Asbestos Textiles/Paper)	Location:	2 (Rooms up to 100 sq m)	
Condition:	1 (Minor scratches)	Accessibility:	1 (Occasionally likely to be disturbed)	
Surface Treatment:	1 (Enclosed textile/paper)			
Asbestos Type:	1 (Chrysotile)	Extent Score:	1 (<10 sq m or 10m pipe run)

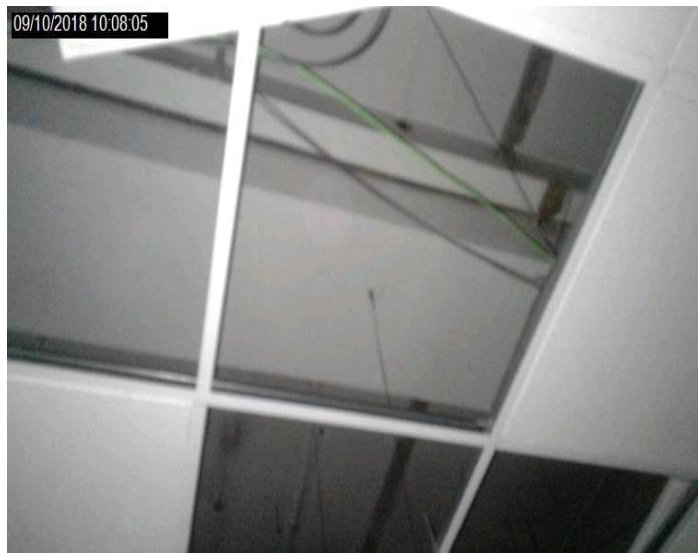
Location:	NAT006	Block:	Birmingham City University	Floor Level: Ground Floor
Sample No.:	As DU002605	Portal Ref No.:	259

Item:	Asbestos Reinforced plastic sleeve			
Asbestos Content:	Result Based on:			
Chrysotile	Strongly presumed			
Sample Analysed By:	Not applicable	Extent:	8 units	
Comments: Through concrete structure

Material Assessment Total Score: 3		Likelihood of Disturbance Assessment Total Score: 3		Management Assessment Licensable: No Recommendations: Program removal Reinspection Interval: Not Applicable Overall Risk Category: D6
Product Type:	1 (Asbestos reinforced plastic)	Location:	2 (Rooms up to 100 sq m)	
Condition:	1 (Minor scratches)	Accessibility:	0 (Usually inaccessible or unlikely to be disturbed)	
Surface Treatment:	0 (Composite material)			
Asbestos Type:	1 (Chrysotile)	Extent Score:	1 (<10 sq m or 10m pipe run)

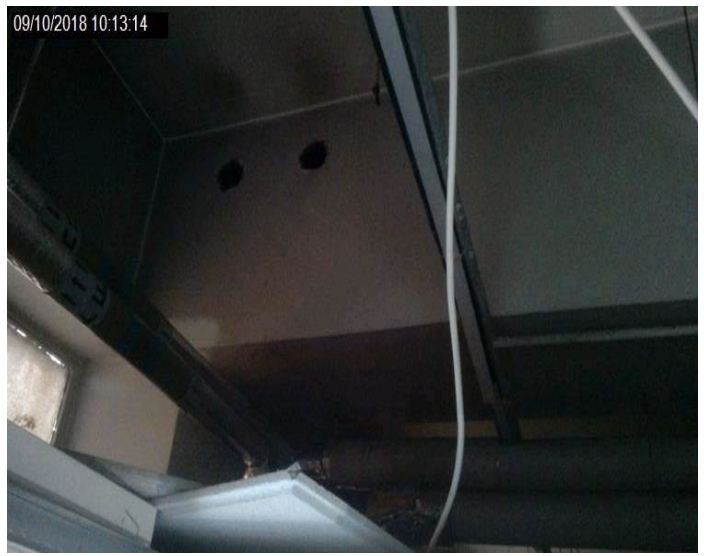
Location:	NAT032	Block:	Birmingham City University	Floor Level: Ground Floor
Sample No.:	As DU002605	Portal Ref No.:	260

Item:	Asbestos Reinforced plastic sleeve			
Asbestos Content:	Result Based on:			
Chrysotile	Strongly presumed			
Sample Analysed By:	Not applicable	Extent:	5 units	
Comments: Through concrete structure

Material Assessment Total Score: 3		Likelihood of Disturbance Assessment Total Score: 3		Management Assessment Licensable: No Recommendations: Program removal Reinspection Interval: Not Applicable Overall Risk Category: D6
Product Type:	1 (Asbestos reinforced plastic)	Location:	2 (Rooms up to 100 sq m)	
Condition:	1 (Minor scratches)	Accessibility:	0 (Usually inaccessible or unlikely to be disturbed)	
Surface Treatment:	0 (Composite material)			
Asbestos Type:	1 (Chrysotile)	Extent Score:	1 (<10 sq m or 10m pipe run)

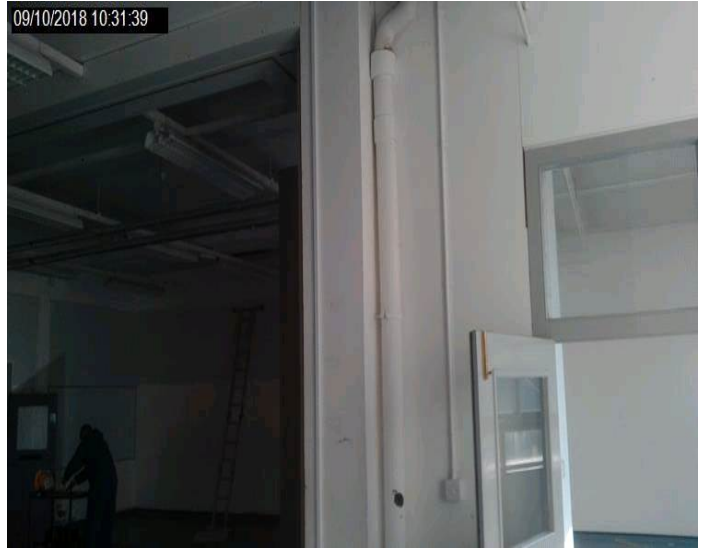
Location:	NAT009	Block:	Birmingham City University	Floor Level: Ground Floor
Sample No.:	DU002616	Portal Ref No.:	263

Item:	Asbestos Reinforced plastic downpipe			
Asbestos Content:	Result Based on:			
Chrysotile	Analysis of sample using PLM			
Sample Analysed By: Reg 13(1)	Extent:	4 linear metres		
Comments:

Material Assessment Total Score: 3		Likelihood of Disturbance Assessment Total Score: 4		Management Assessment Licensable: No Recommendations: Program removal Reinspection Interval: Not Applicable Overall Risk Category: C7
Product Type:	1 (Asbestos reinforced plastic)	Location:	2 (Rooms up to 100 sq m)	
Condition:	1 (Minor scratches)	Accessibility:	1 (Occasionally likely to be disturbed)	
Surface Treatment:	0 (Composite material)			
Asbestos Type:	1 (Chrysotile)	Extent Score:	1 (<10 sq m or 10m pipe run)

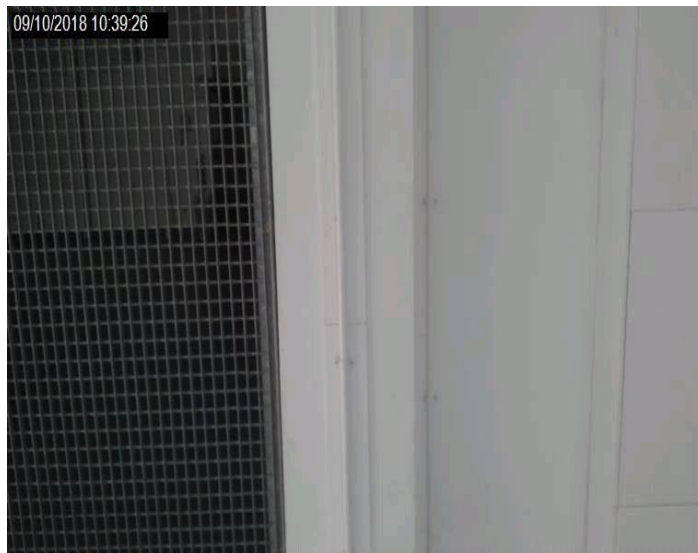
Location:	NAT009C	Block:	Birmingham City University	Floor Level: Ground Floor
Sample No.:	As DU002617	Portal Ref No.:	268

Item:	Textured coating to concrete pillar			
Asbestos Content:		Result Based on:		
No Asbestos Detected		Strongly presumed		
Sample Analysed By:	Not applicable	Extent:	4 m ²	
Comments:

Material Assessment Total Score: 0		Likelihood of Disturbance Assessment Total Score: 0		Management Assessment Licensable: No Recommendations: Not Applicable Reinspection Interval: Not Applicable Overall Risk Category: E0
Product Type:	0 Not Applicable	Location:	0 Not Applicable	
Condition:	0 Not Applicable	Accessibility:	0 Not Applicable	
Surface Treatment:	0 Not Applicable			
Asbestos Type:	0 Not Applicable	Extent Score:	0 Not Applicable

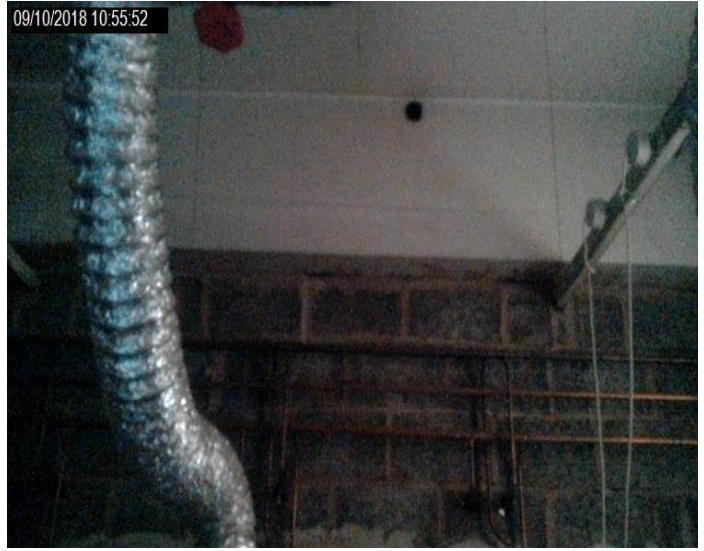
Location:	NAT031A	Block:	Birmingham City University	Floor Level: Ground Floor
Sample No.:	As DU002605	Portal Ref No.:	273

Item:	Asbestos Reinforced plastic sleeve			
Asbestos Content:	Result Based on:			
Chrysotile	Strongly presumed			
Sample Analysed By:	Not applicable	Extent:	3 units	
Comments: Through concrete structure

Material Assessment Total Score: 3		Likelihood of Disturbance Assessment Total Score: 3		Management Assessment Licensable: No Recommendations: Program removal Reinspection Interval: Not Applicable Overall Risk Category: D6
Product Type:	1 (Asbestos reinforced plastic)	Location:	2 (Rooms up to 100 sq m)	
Condition:	1 (Minor scratches)	Accessibility:	0 (Usually inaccessible or unlikely to be disturbed)	
Surface Treatment:	0 (Composite material)			
Asbestos Type:	1 (Chrysotile)	Extent Score:	1 (<10 sq m or 10m pipe run)

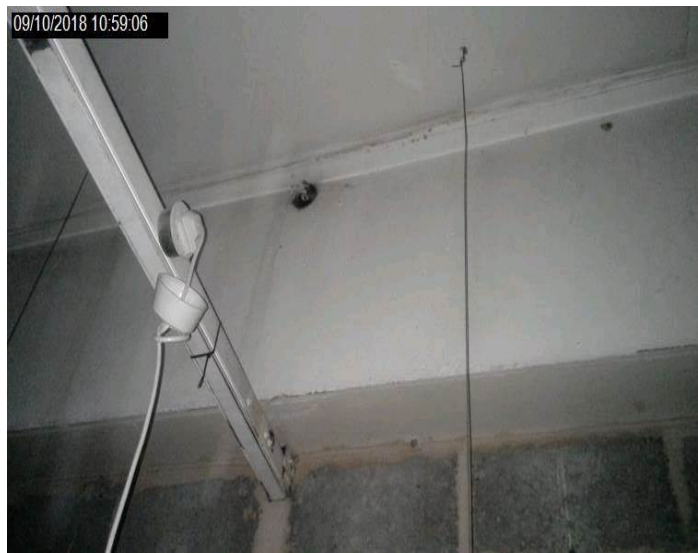
Location:	NAT031D	Block:	Birmingham City University	Floor Level: Ground Floor
Sample No.:	As DU002605	Portal Ref No.:	274

Item:	Asbestos Reinforced plastic sleeve			
Asbestos Content:	Result Based on:			
Chrysotile	Strongly presumed			
Sample Analysed By:	Not applicable	Extent:	1 unit	
Comments: Through concrete structure

Material Assessment Total Score: 3		Likelihood of Disturbance Assessment Total Score: 3		Management Assessment Licensable: No Recommendations: Program removal Reinspection Interval: Not Applicable Overall Risk Category: D6
Product Type:	1 (Asbestos reinforced plastic)	Location:	2 (Rooms up to 100 sq m)	
Condition:	1 (Minor scratches)	Accessibility:	0 (Usually inaccessible or unlikely to be disturbed)	
Surface Treatment:	0 (Composite material)			
Asbestos Type:	1 (Chrysotile)	Extent Score:	1 (<10 sq m or 10m pipe run)

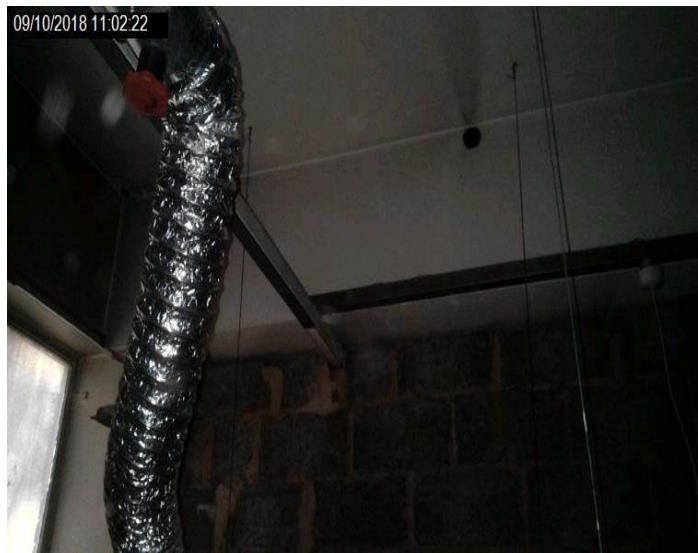
Location:	NAT031	Block:	Birmingham City University	Floor Level: Ground Floor
Sample No.:	As DU002605	Portal Ref No.:	275

Item:	Asbestos Reinforced plastic sleeve			
Asbestos Content:	Result Based on:			
Chrysotile	Strongly presumed			
Sample Analysed By:	Not applicable	Extent:	4 units	
Comments: Through concrete structure

Material Assessment Total Score: 3		Likelihood of Disturbance Assessment Total Score: 3		Management Assessment Licensable: No Recommendations: Program removal Reinspection Interval: Not Applicable Overall Risk Category: D6
Product Type:	1 (Asbestos reinforced plastic)	Location:	2 (Rooms up to 100 sq m)	
Condition:	1 (Minor scratches)	Accessibility:	0 (Usually inaccessible or unlikely to be disturbed)	
Surface Treatment:	0 (Composite material)			
Asbestos Type:	1 (Chrysotile)	Extent Score:	1 (<10 sq m or 10m pipe run)

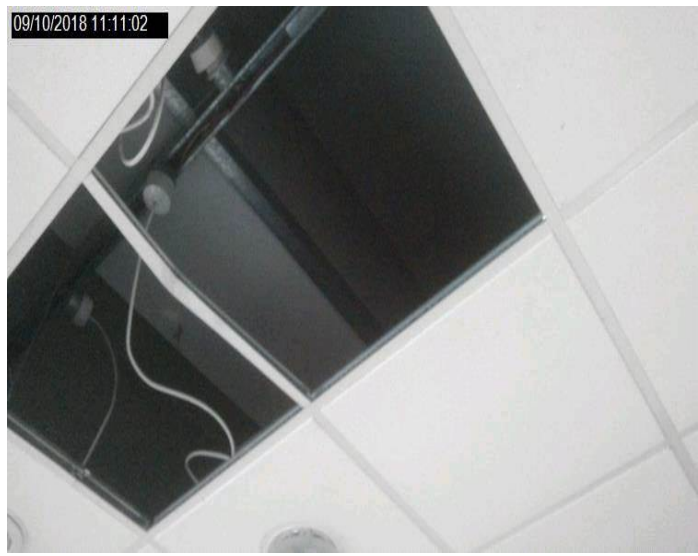
Location:	NAT030	Block:	Birmingham City University	Floor Level: Ground Floor
Sample No.:	As DU002605	Portal Ref No.:	277

Item:	Asbestos Reinforced plastic sleeve			
Asbestos Content:	Result Based on:			
Chrysotile	Strongly presumed			
Sample Analysed By:	Not applicable	Extent:	5 units	
Comments: Through concrete structure

Material Assessment Total Score: 3		Likelihood of Disturbance Assessment Total Score: 3		Management Assessment Licensable: No Recommendations: Program removal Reinspection Interval: Not Applicable Overall Risk Category: D6
Product Type:	1 (Asbestos reinforced plastic)	Location:	2 (Rooms up to 100 sq m)	
Condition:	1 (Minor scratches)	Accessibility:	0 (Usually inaccessible or unlikely to be disturbed)	
Surface Treatment:	0 (Composite material)			
Asbestos Type:	1 (Chrysotile)	Extent Score:	1 (<10 sq m or 10m pipe run)

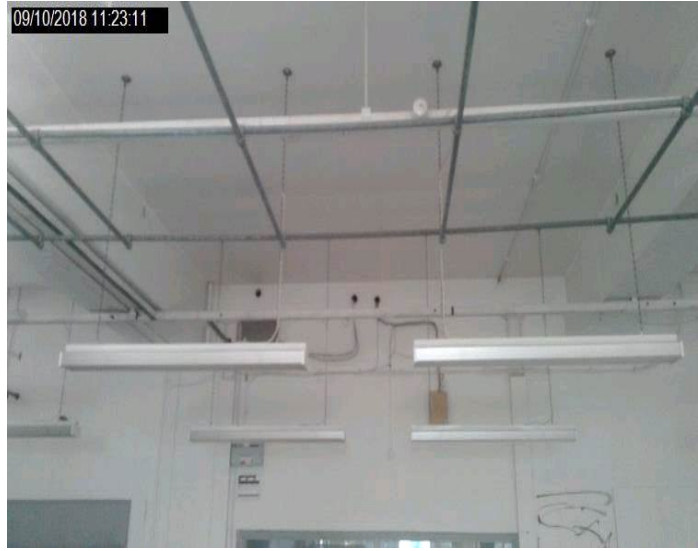
Location:	NAT010	Block:	Birmingham City University	Floor Level: Ground Floor
Sample No.:	As DU002605	Portal Ref No.:	282

Item:	Asbestos Reinforced plastic sleeve			
Asbestos Content:	Result Based on:			
Chrysotile	Strongly presumed			
Sample Analysed By:	Not applicable	Extent:	8 units	
Comments: Through concrete structure

Material Assessment Total Score: 3		Likelihood of Disturbance Assessment Total Score: 3		Management Assessment Licensable: No Recommendations: Program removal Reinspection Interval: Not Applicable Overall Risk Category: D6
Product Type:	1 (Asbestos reinforced plastic)	Location:	2 (Rooms up to 100 sq m)	
Condition:	1 (Minor scratches)	Accessibility:	0 (Usually inaccessible or unlikely to be disturbed)	
Surface Treatment:	0 (Composite material)			
Asbestos Type:	1 (Chrysotile)	Extent Score:	1 (<10 sq m or 10m pipe run)

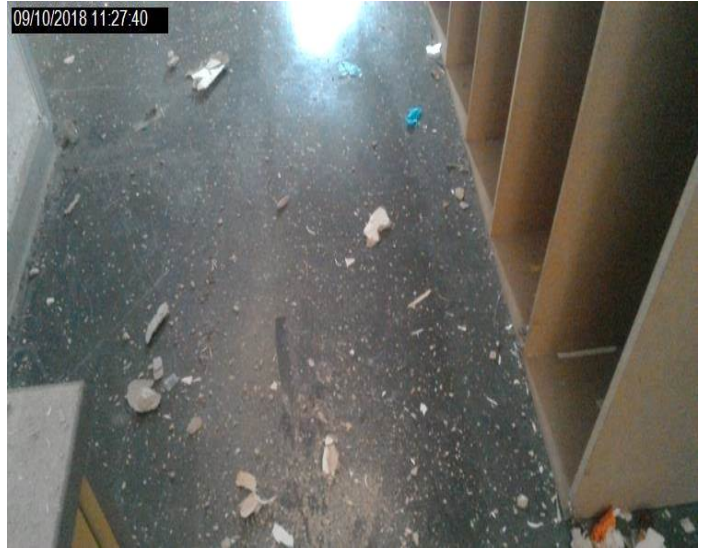
Location:	NAT010A	Block:	Birmingham City University	Floor Level: Ground Floor
Sample No.:	As DU002621	Portal Ref No.:	283

Item:	Bitumen adhesive			
Asbestos Content:		Result Based on:		
No Asbestos Detected		Strongly presumed		
Sample Analysed By:	Not applicable	Extent:	15 m ²	
Comments:

Material Assessment Total Score: 0		Likelihood of Disturbance Assessment Total Score: 0		Management Assessment Licensable: No Recommendations: Not Applicable Reinspection Interval: Not Applicable Overall Risk Category: E0
Product Type:	0 Not Applicable	Location:	0 Not Applicable	
Condition:	0 Not Applicable	Accessibility:	0 Not Applicable	
Surface Treatment:	0 Not Applicable			
Asbestos Type:	0 Not Applicable	Extent Score:	0 Not Applicable

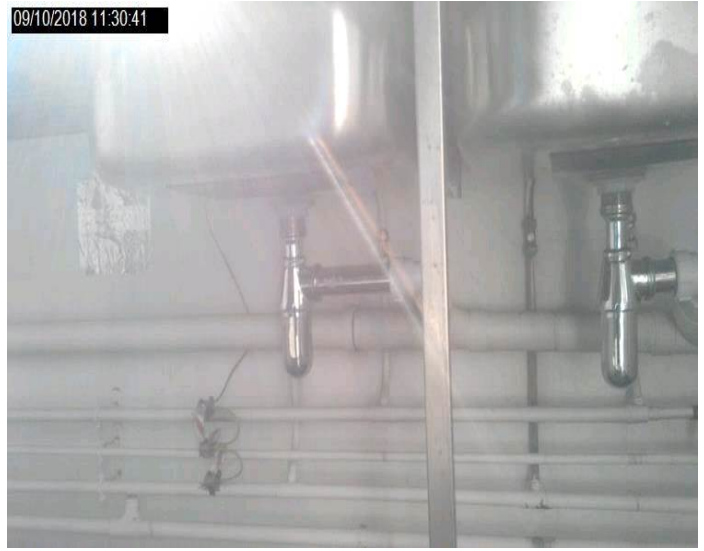
Location:	NAT012	Block:	Birmingham City University	Floor Level: Ground Floor
Sample No.:	DU002622	Portal Ref No.:	285

Item:	Bitumen sink pad			
Asbestos Content:		Result Based on:		
No Asbestos Detected		Analysis of sample using PLM		
Sample Analysed By:	Reg 13(1)	Extent:	5 units	
Comments:

Material Assessment Total Score: 0		Likelihood of Disturbance Assessment Total Score: 0		Management Assessment Licensable: No Recommendations: Not Applicable Reinspection Interval: Not Applicable Overall Risk Category: E0
Product Type:	0 Not Applicable	Location:	0 Not Applicable	
Condition:	0 Not Applicable	Accessibility:	0 Not Applicable	
Surface Treatment:	0 Not Applicable			
Asbestos Type:	0 Not Applicable	Extent Score:	0 Not Applicable

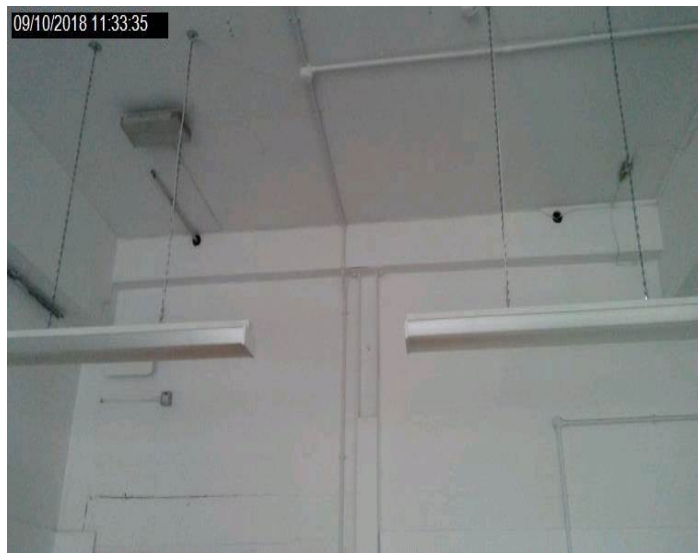
Location:	NAT012	Block:	Birmingham City University	Floor Level: Ground Floor
Sample No.:	As DU002605	Portal Ref No.:	286

Item:	Asbestos Reinforced plastic sleeve			
Asbestos Content:	Result Based on:			
Chrysotile	Strongly presumed			
Sample Analysed By:	Not applicable	Extent:	8 units	
Comments: Through concrete structure

Material Assessment Total Score: 3		Likelihood of Disturbance Assessment Total Score: 3		Management Assessment Licensable: No Recommendations: Program removal Reinspection Interval: Not Applicable Overall Risk Category: D6
Product Type:	1 (Asbestos reinforced plastic)	Location:	2 (Rooms up to 100 sq m)	
Condition:	1 (Minor scratches)	Accessibility:	0 (Usually inaccessible or unlikely to be disturbed)	
Surface Treatment:	0 (Composite material)			
Asbestos Type:	1 (Chrysotile)	Extent Score:	1 (<10 sq m or 10m pipe run)

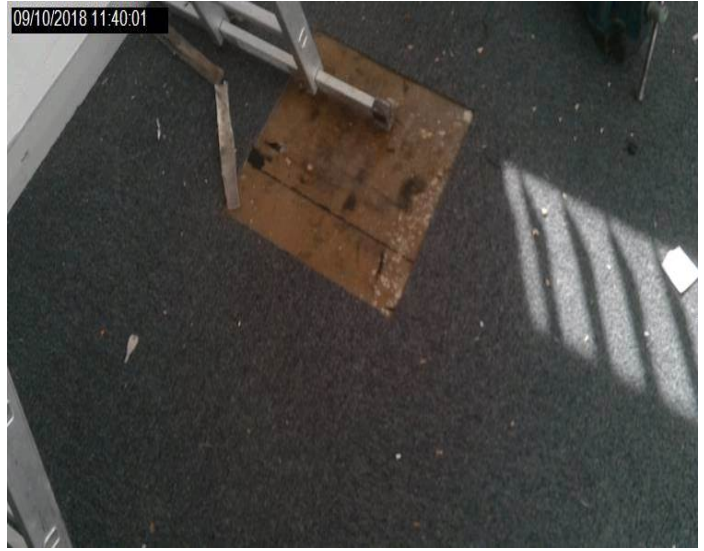
Location:	NAT012E	Block:	Birmingham City University	Floor Level: Ground Floor
Sample No.:	DU002623	Portal Ref No.:	287

Item:	Asbestos Thermoplastic floor tiles			
Asbestos Content:	Result Based on:			
Chrysotile in tile and adhesive	Analysis of sample using PLM			
Sample Analysed By: Reg 13(1)	Extent:	10 m ²		
Comments:

Material Assessment Total Score: 3		Likelihood of Disturbance Assessment Total Score: 3		Management Assessment Licensable: No Recommendations: Program removal Reinspection Interval: Not Applicable Overall Risk Category: D6
Product Type:	1 (Asbestos thermoplastic)	Location:	2 (Rooms up to 100 sq m)	
Condition:	1 (Minor scratches)	Accessibility:	0 (Usually inaccessible or unlikely to be disturbed)	
Surface Treatment:	0 (Composite material)			
Asbestos Type:	1 (Chrysotile)	Extent Score:	1 (<10 sq m or 10m pipe run)

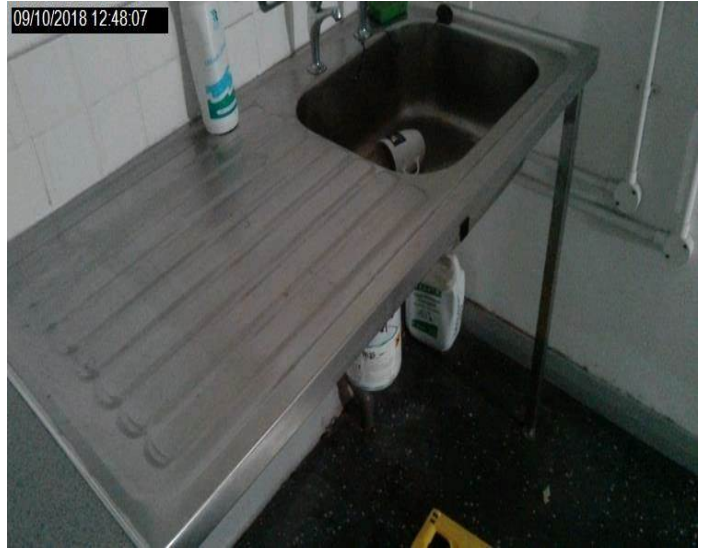
Location:	NAT012B	Block:	Birmingham City University	Floor Level: Ground Floor
Sample No.:	As DU002622	Portal Ref No.:	289

Item:	Bitumen sink pad			
Asbestos Content:		Result Based on:		
No Asbestos Detected		Strongly presumed		
Sample Analysed By:	Not applicable	Extent:	2 units	
Comments:

Material Assessment Total Score: 0		Likelihood of Disturbance Assessment Total Score: 0		Management Assessment Licensable: No Recommendations: Not Applicable Reinspection Interval: Not Applicable Overall Risk Category: E0
Product Type:	0 Not Applicable	Location:	0 Not Applicable	
Condition:	0 Not Applicable	Accessibility:	0 Not Applicable	
Surface Treatment:	0 Not Applicable			
Asbestos Type:	0 Not Applicable	Extent Score:	0 Not Applicable

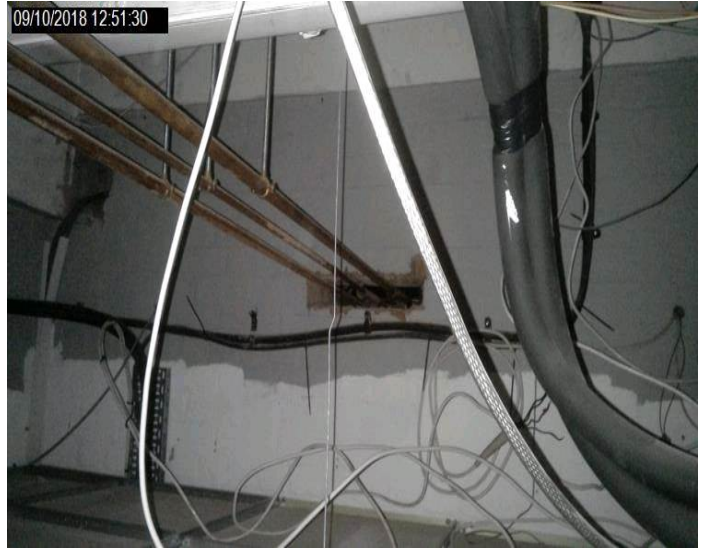
Location:	NAT012A	Block:	Birmingham City University	Floor Level: Ground Floor
Sample No.:	As DU002605	Portal Ref No.:	290

Item:	Asbestos Reinforced plastic sleeve			
Asbestos Content:	Result Based on:			
Chrysotile	Strongly presumed			
Sample Analysed By:	Not applicable	Extent:	3 units	
Comments: Through concrete structure

Material Assessment Total Score: 3		Likelihood of Disturbance Assessment Total Score: 4		Management Assessment Licensable: No Recommendations: Program removal Reinspection Interval: Not Applicable Overall Risk Category: C7
Product Type:	1 (Asbestos reinforced plastic)	Location:	2 (Rooms up to 100 sq m)	
Condition:	1 (Minor scratches)	Accessibility:	1 (Occasionally likely to be disturbed)	
Surface Treatment:	0 (Composite material)			
Asbestos Type:	1 (Chrysotile)	Extent Score:	1 (<10 sq m or 10m pipe run)

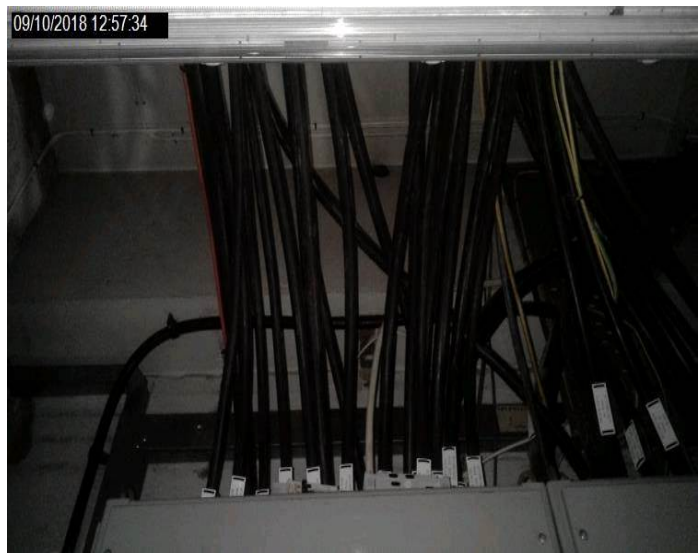
Location:	NAT027A	Block:	Birmingham City University	Floor Level: Ground Floor
Sample No.:	As DU002605	Portal Ref No.:	292

Item:	Asbestos Reinforced plastic sleeve			
Asbestos Content:	Result Based on:			
Chrysotile	Strongly presumed			
Sample Analysed By:	Not applicable	Extent:	1 unit	
Comments: Through concrete structure

Material Assessment Total Score: 3		Likelihood of Disturbance Assessment Total Score: 3		Management Assessment Licensable: No Recommendations: Program removal Reinspection Interval: Not Applicable Overall Risk Category: D6
Product Type:	1 (Asbestos reinforced plastic)	Location:	2 (Rooms up to 100 sq m)	
Condition:	1 (Minor scratches)	Accessibility:	0 (Usually inaccessible or unlikely to be disturbed)	
Surface Treatment:	0 (Composite material)			
Asbestos Type:	1 (Chrysotile)	Extent Score:	1 (<10 sq m or 10m pipe run)

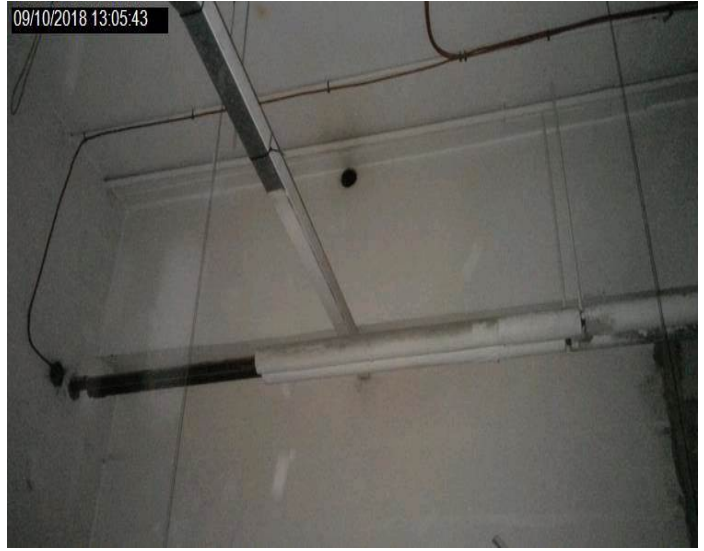
Location:	NAT028B	Block:	Birmingham City University	Floor Level: Ground Floor
Sample No.:	As DU002605	Portal Ref No.:	293

Item:	Asbestos Reinforced plastic sleeve			
Asbestos Content:	Result Based on:			
Chrysotile	Strongly presumed			
Sample Analysed By:	Not applicable	Extent:	1 unit	
Comments: Through concrete structure

Material Assessment Total Score: 3		Likelihood of Disturbance Assessment Total Score: 3		Management Assessment Licensable: No Recommendations: Program removal Reinspection Interval: Not Applicable Overall Risk Category: D6
Product Type:	1 (Asbestos reinforced plastic)	Location:	2 (Rooms up to 100 sq m)	
Condition:	1 (Minor scratches)	Accessibility:	0 (Usually inaccessible or unlikely to be disturbed)	
Surface Treatment:	0 (Composite material)			
Asbestos Type:	1 (Chrysotile)	Extent Score:	1 (<10 sq m or 10m pipe run)

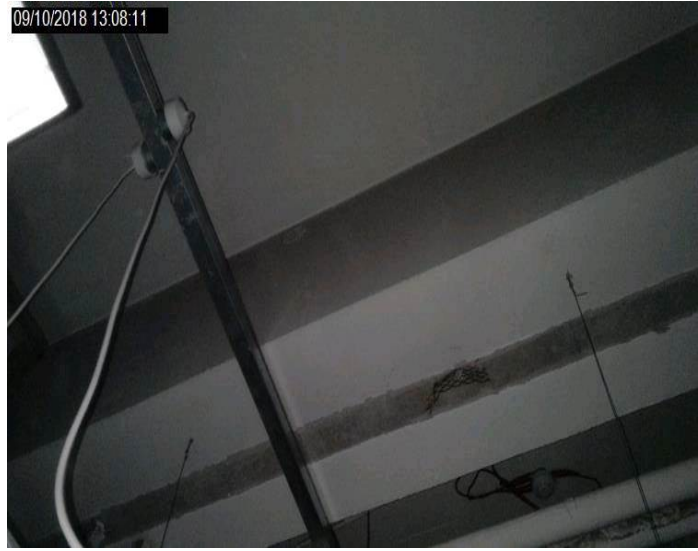
Location:	NAT028	Block:	Birmingham City University	Floor Level: Ground Floor
Sample No.:	As DU002605	Portal Ref No.:	294

Item:	Asbestos Reinforced plastic sleeve			
Asbestos Content:	Result Based on:			
Chrysotile	Strongly presumed			
Sample Analysed By:	Not applicable	Extent:	3 units	
Comments: Through concrete structure

Material Assessment Total Score: 3		Likelihood of Disturbance Assessment Total Score: 3		Management Assessment Licensable: No Recommendations: Program removal Reinspection Interval: Not Applicable Overall Risk Category: D6
Product Type:	1 (Asbestos reinforced plastic)	Location:	2 (Rooms up to 100 sq m)	
Condition:	1 (Minor scratches)	Accessibility:	0 (Usually inaccessible or unlikely to be disturbed)	
Surface Treatment:	0 (Composite material)			
Asbestos Type:	1 (Chrysotile)	Extent Score:	1 (<10 sq m or 10m pipe run)

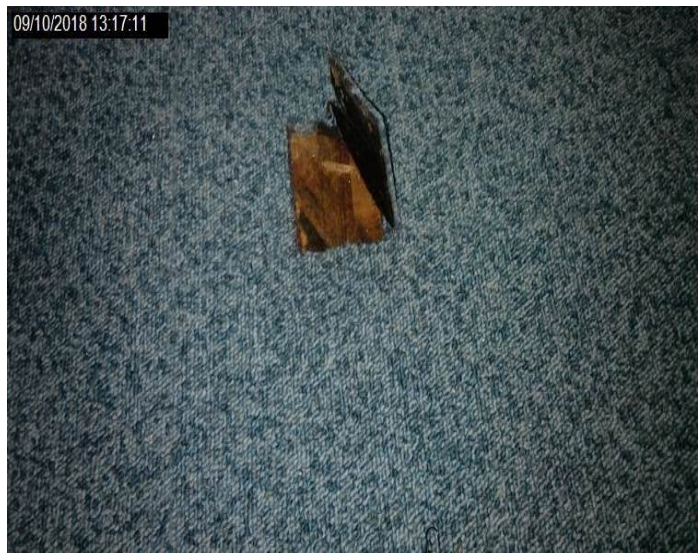
Location:	NAT026A	Block:	Birmingham City University	Floor Level: Ground Floor
Sample No.:	As DU002613	Portal Ref No.:	298

Item:	Bitumen adhesive			
Asbestos Content:		Result Based on:		
No Asbestos Detected		Strongly presumed		
Sample Analysed By:	Not applicable	Extent:	6 m ²	
Comments: To the rear of the parquet flooring

Material Assessment Total Score: 0		Likelihood of Disturbance Assessment Total Score: 0		Management Assessment Licensable: No Recommendations: Not Applicable Reinspection Interval: Not Applicable Overall Risk Category: E0
Product Type:	0 Not Applicable	Location:	0 Not Applicable	
Condition:	0 Not Applicable	Accessibility:	0 Not Applicable	
Surface Treatment:	0 Not Applicable			
Asbestos Type:	0 Not Applicable	Extent Score:	0 Not Applicable

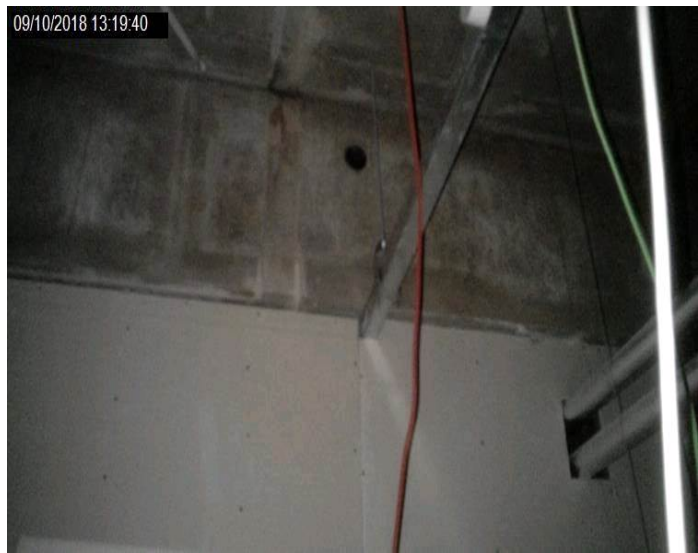
Location:	NAT026	Block:	Birmingham City University	Floor Level: Ground Floor
Sample No.:	As DU002605	Portal Ref No.:	299

Item:	Asbestos Reinforced plastic sleeve			
Asbestos Content:	Result Based on:			
Chrysotile	Strongly presumed			
Sample Analysed By:	Not applicable	Extent:	1 unit	
Comments: Through concrete structure

Material Assessment Total Score: 3		Likelihood of Disturbance Assessment Total Score: 3		Management Assessment Licensable: No Recommendations: Program removal Reinspection Interval: Not Applicable Overall Risk Category: D6
Product Type:	1 (Asbestos reinforced plastic)	Location:	2 (Rooms up to 100 sq m)	
Condition:	1 (Minor scratches)	Accessibility:	0 (Usually inaccessible or unlikely to be disturbed)	
Surface Treatment:	0 (Composite material)			
Asbestos Type:	1 (Chrysotile)	Extent Score:	1 (<10 sq m or 10m pipe run)

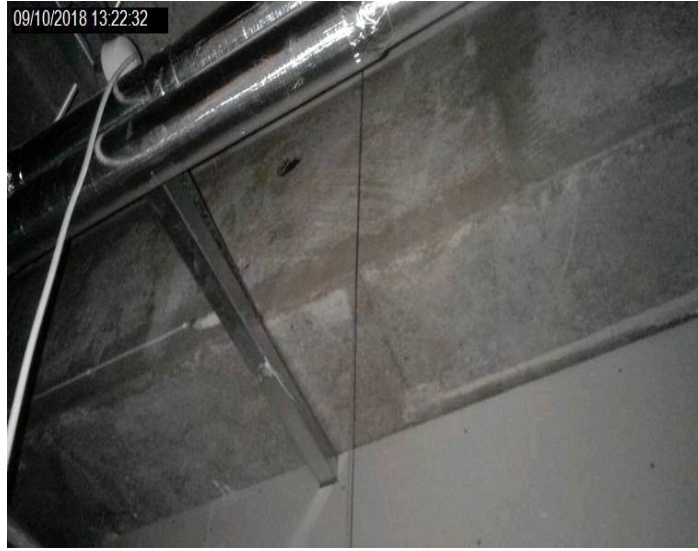
Location:	NAT025A	Block:	Birmingham City University	Floor Level: Ground Floor
Sample No.:	As DU002605	Portal Ref No.:	301

Item:	Asbestos Reinforced plastic sleeve			
Asbestos Content:	Result Based on:			
Chrysotile	Strongly presumed			
Sample Analysed By:	Not applicable	Extent:	1 unit	
Comments: Through concrete structure

Material Assessment Total Score: 3		Likelihood of Disturbance Assessment Total Score: 3		Management Assessment Licensable: No Recommendations: Program removal Reinspection Interval: Not Applicable Overall Risk Category: D6
Product Type:	1 (Asbestos reinforced plastic)	Location:	2 (Rooms up to 100 sq m)	
Condition:	1 (Minor scratches)	Accessibility:	0 (Usually inaccessible or unlikely to be disturbed)	
Surface Treatment:	0 (Composite material)			
Asbestos Type:	1 (Chrysotile)	Extent Score:	1 (<10 sq m or 10m pipe run)

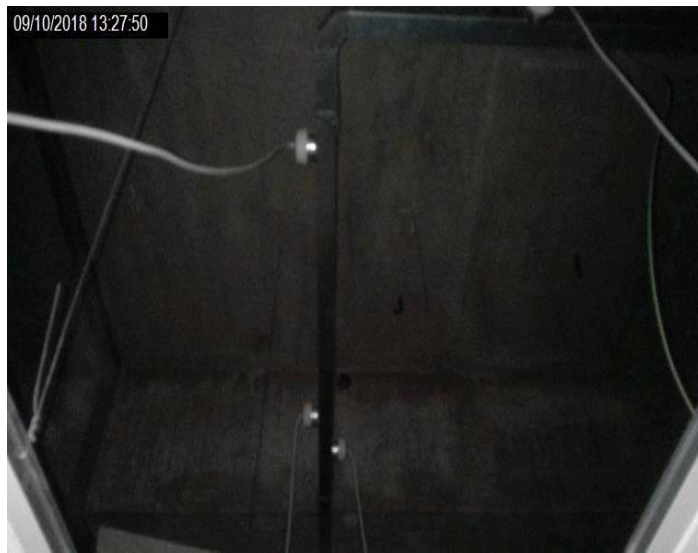
Location:	NAT025	Block:	Birmingham City University	Floor Level: Ground Floor
Sample No.:	As DU002605	Portal Ref No.:	303

Item:	Asbestos Reinforced plastic sleeve			
Asbestos Content:	Result Based on:			
Chrysotile	Strongly presumed			
Sample Analysed By:	Not applicable	Extent:	3 units	
Comments: Through concrete structure

Material Assessment Total Score: 3		Likelihood of Disturbance Assessment Total Score: 3		Management Assessment Licensable: No Recommendations: Program removal Reinspection Interval: Not Applicable Overall Risk Category: D6
Product Type:	1 (Asbestos reinforced plastic)	Location:	2 (Rooms up to 100 sq m)	
Condition:	1 (Minor scratches)	Accessibility:	0 (Usually inaccessible or unlikely to be disturbed)	
Surface Treatment:	0 (Composite material)			
Asbestos Type:	1 (Chrysotile)	Extent Score:	1 (<10 sq m or 10m pipe run)

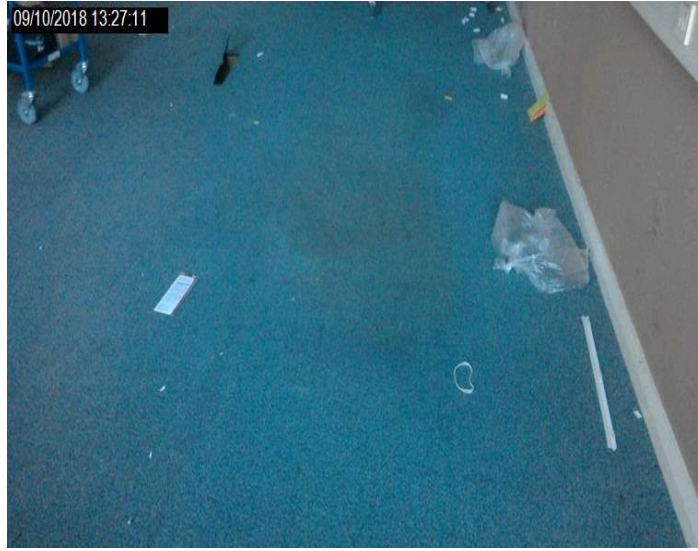
Location:	NAT025	Block:	Birmingham City University	Floor Level: Ground Floor
Sample No.:	As DU002613	Portal Ref No.:	304

Item:	Bitumen adhesive			
Asbestos Content:		Result Based on:		
No Asbestos Detected		Strongly presumed		
Sample Analysed By:	Not applicable	Extent:	25 m ²	
Comments: To the rear of the parquet flooring

Material Assessment Total Score: 0		Likelihood of Disturbance Assessment Total Score: 0		Management Assessment Licensable: No Recommendations: Not Applicable Reinspection Interval: Not Applicable Overall Risk Category: E0
Product Type:	0 Not Applicable	Location:	0 Not Applicable	
Condition:	0 Not Applicable	Accessibility:	0 Not Applicable	
Surface Treatment:	0 Not Applicable			
Asbestos Type:	0 Not Applicable	Extent Score:	0 Not Applicable

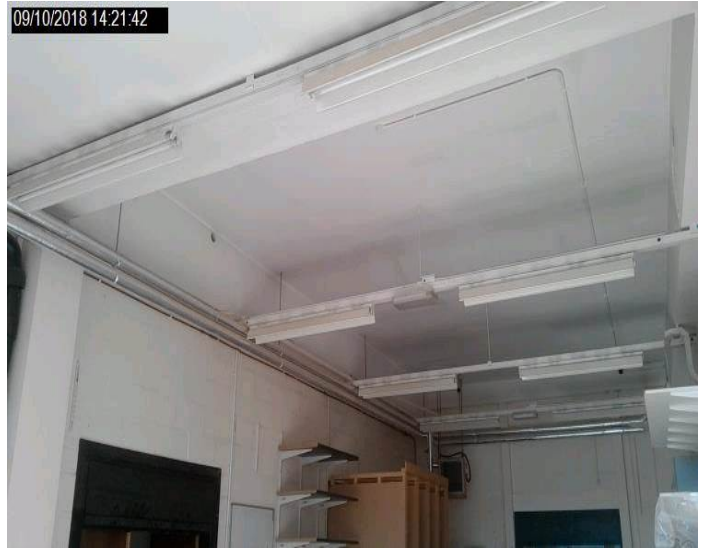
Location:	NAT014	Block:	Birmingham City University	Floor Level: Ground Floor
Sample No.:	As DU002605	Portal Ref No.:	309

Item:	Asbestos Reinforced plastic sleeve			
Asbestos Content:	Result Based on:			
Chrysotile	Strongly presumed			
Sample Analysed By:	Not applicable	Extent:	6 units	
Comments: Through concrete structure

Material Assessment Total Score: 3		Likelihood of Disturbance Assessment Total Score: 3		Management Assessment Licensable: No Recommendations: Program removal Reinspection Interval: Not Applicable Overall Risk Category: D6
Product Type:	1 (Asbestos reinforced plastic)	Location:	2 (Rooms up to 100 sq m)	
Condition:	1 (Minor scratches)	Accessibility:	0 (Usually inaccessible or unlikely to be disturbed)	
Surface Treatment:	0 (Composite material)			
Asbestos Type:	1 (Chrysotile)	Extent Score:	1 (<10 sq m or 10m pipe run)

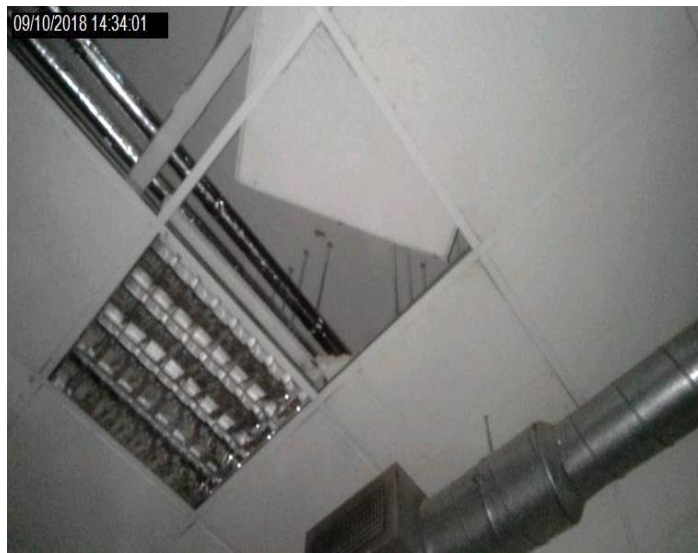
Location:	NAT014D	Block:	Birmingham City University	Floor Level: Ground Floor
Sample No.:	As DU002605	Portal Ref No.:	312

Item:	Asbestos Reinforced plastic sleeve			
Asbestos Content:	Result Based on:			
Chrysotile	Strongly presumed			
Sample Analysed By:	Not applicable	Extent:	3 units	
Comments: Through concrete structure

Material Assessment Total Score: 3		Likelihood of Disturbance Assessment Total Score: 3		Management Assessment Licensable: No Recommendations: Program removal Reinspection Interval: Not Applicable Overall Risk Category: D6
Product Type:	1 (Asbestos reinforced plastic)	Location:	2 (Rooms up to 100 sq m)	
Condition:	1 (Minor scratches)	Accessibility:	0 (Usually inaccessible or unlikely to be disturbed)	
Surface Treatment:	0 (Composite material)			
Asbestos Type:	1 (Chrysotile)	Extent Score:	1 (<10 sq m or 10m pipe run)

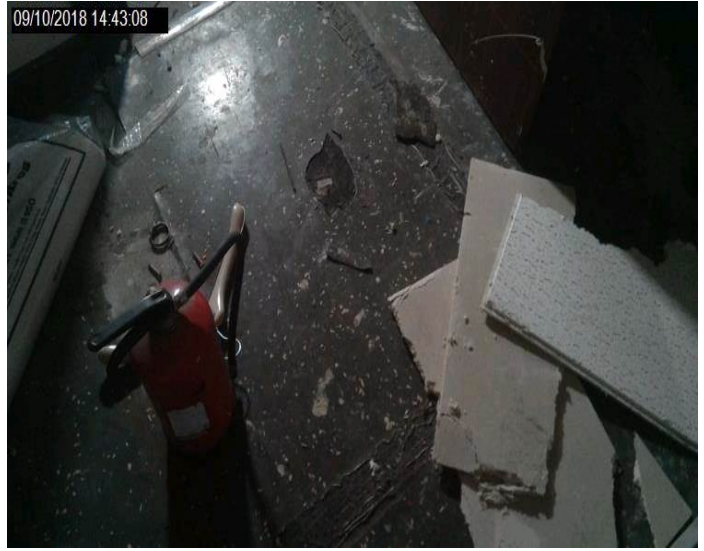
Location:	NAT015	Block:	Birmingham City University	Floor Level: Ground Floor
Sample No.:	DU002625	Portal Ref No.:	315

Item:	Bitumen adhesive			
Asbestos Content:		Result Based on:		
No Asbestos Detected		Analysis of sample using PLM		
Sample Analysed By:	Reg 13(1)	Extent:	8 m ²	
Comments: Beneath modern vinyl

Material Assessment Total Score: 0		Likelihood of Disturbance Assessment Total Score: 0		Management Assessment Licensable: No Recommendations: Not Applicable Reinspection Interval: Not Applicable Overall Risk Category: E0
Product Type:	0 Not Applicable	Location:	0 Not Applicable	
Condition:	0 Not Applicable	Accessibility:	0 Not Applicable	
Surface Treatment:	0 Not Applicable			
Asbestos Type:	0 Not Applicable	Extent Score:	0 Not Applicable

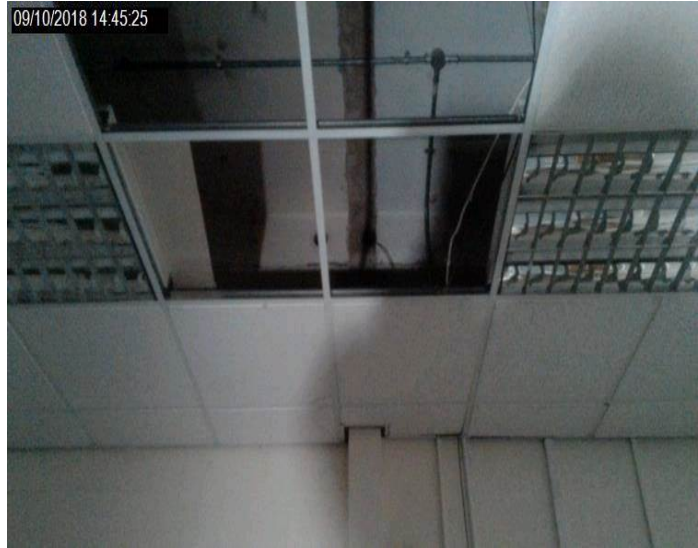
Location:	NAT016	Block:	Birmingham City University	Floor Level: Ground Floor
Sample No.:	As DU002605	Portal Ref No.:	316

Item:	Asbestos Reinforced plastic sleeve			
Asbestos Content:	Result Based on:			
Chrysotile	Strongly presumed			
Sample Analysed By:	Not applicable	Extent:	6 units	
Comments: Through concrete structure

Material Assessment Total Score: 3		Likelihood of Disturbance Assessment Total Score: 3		Management Assessment Licensable: No Recommendations: Program removal Reinspection Interval: Not Applicable Overall Risk Category: D6
Product Type:	1 (Asbestos reinforced plastic)	Location:	2 (Rooms up to 100 sq m)	
Condition:	1 (Minor scratches)	Accessibility:	0 (Usually inaccessible or unlikely to be disturbed)	
Surface Treatment:	0 (Composite material)			
Asbestos Type:	1 (Chrysotile)	Extent Score:	1 (<10 sq m or 10m pipe run)

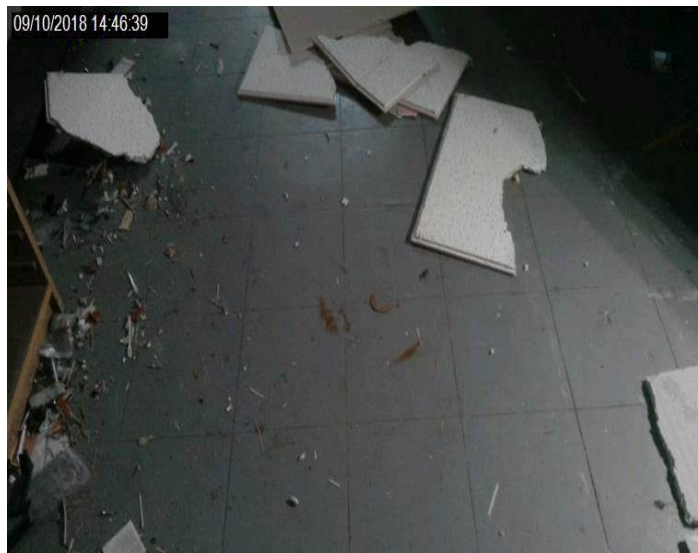
Location:	NAT016	Block:	Birmingham City University	Floor Level: Ground Floor
Sample No.:	DU002626	Portal Ref No.:	317

Item:	Thermoplastic floor tiles			
Asbestos Content:		Result Based on:		
No Asbestos Detected in tile no adhesive present		Analysis of sample using PLM		
Sample Analysed By:	Reg 13(1)	Extent:	18 m ²	
Comments:

Material Assessment Total Score: 0		Likelihood of Disturbance Assessment Total Score: 0		Management Assessment Licensable: No Recommendations: Not Applicable Reinspection Interval: Not Applicable Overall Risk Category: E0
Product Type:	0 Not Applicable	Location:	0 Not Applicable	
Condition:	0 Not Applicable	Accessibility:	0 Not Applicable	
Surface Treatment:	0 Not Applicable			
Asbestos Type:	0 Not Applicable	Extent Score:	0 Not Applicable

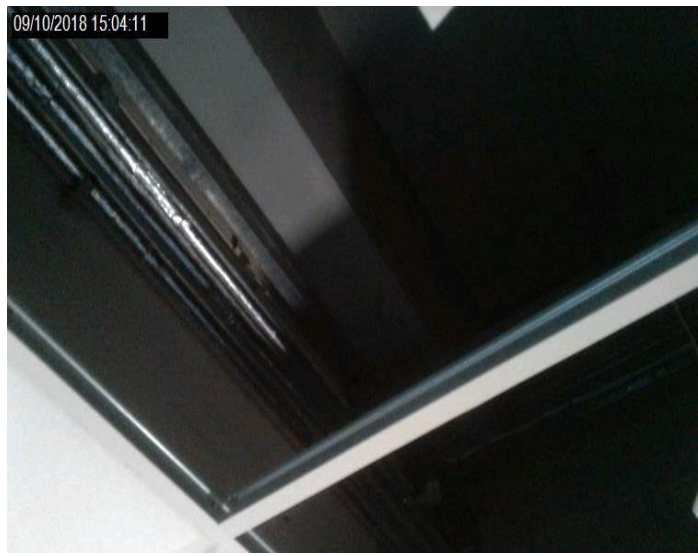
Location:	NAT024A	Block:	Birmingham City University	Floor Level: Ground Floor
Sample No.:	As DU002605	Portal Ref No.:	318

Item:	Asbestos Reinforced plastic sleeve			
Asbestos Content:	Result Based on:			
Chrysotile	Strongly presumed			
Sample Analysed By:	Not applicable	Extent:	1 unit	
Comments: Through concrete structure

Material Assessment Total Score: 3		Likelihood of Disturbance Assessment Total Score: 3		Management Assessment Licensable: No Recommendations: Program removal Reinspection Interval: Not Applicable Overall Risk Category: D6
Product Type:	1 (Asbestos reinforced plastic)	Location:	2 (Rooms up to 100 sq m)	
Condition:	1 (Minor scratches)	Accessibility:	0 (Usually inaccessible or unlikely to be disturbed)	
Surface Treatment:	0 (Composite material)			
Asbestos Type:	1 (Chrysotile)	Extent Score:	1 (<10 sq m or 10m pipe run)

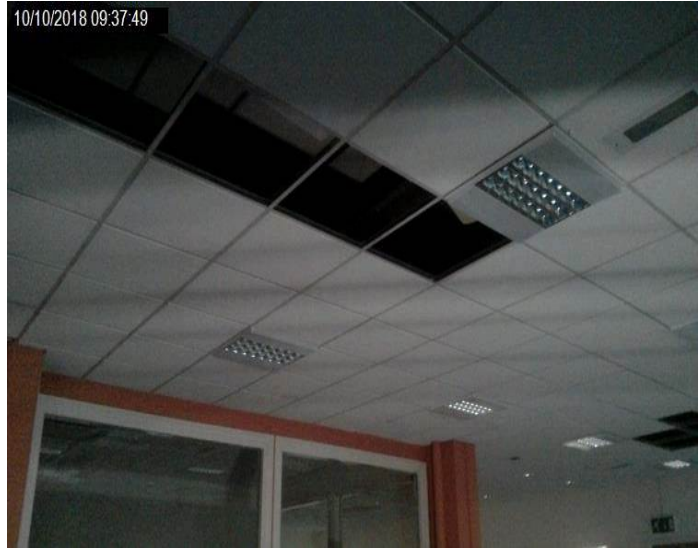
Location:	NAT023	Block:	Birmingham City University	Floor Level: Ground Floor
Sample No.:	As DU002605	Portal Ref No.:	320

Item:	Asbestos Reinforced plastic sleeve			
Asbestos Content:	Result Based on:			
Chrysotile	Strongly presumed			
Sample Analysed By:	Not applicable	Extent:	16 units	
Comments: Through concrete structure, throughout ceiling void

Material Assessment Total Score: 3		Likelihood of Disturbance Assessment Total Score: 3		Management Assessment Licensable: No Recommendations: Program removal Reinspection Interval: Not Applicable Overall Risk Category: D6
Product Type:	1 (Asbestos reinforced plastic)	Location:	2 (Rooms up to 100 sq m)	
Condition:	1 (Minor scratches)	Accessibility:	0 (Usually inaccessible or unlikely to be disturbed)	
Surface Treatment:	0 (Composite material)			
Asbestos Type:	1 (Chrysotile)	Extent Score:	1 (<10 sq m or 10m pipe run)

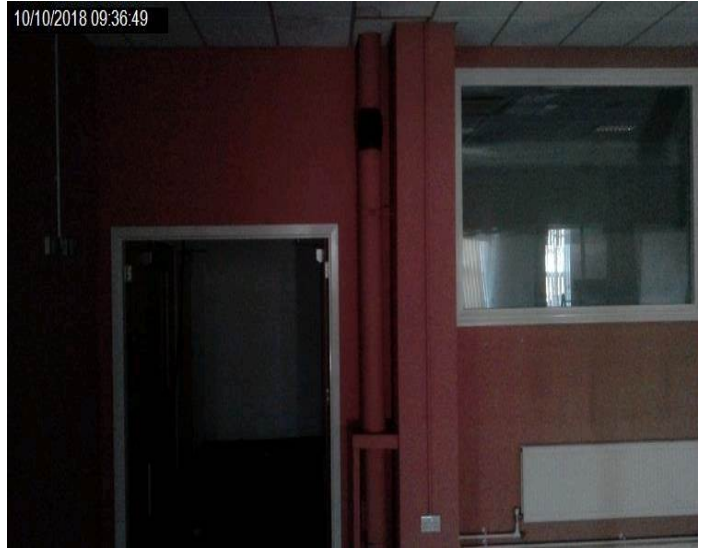
Location:	NAT023	Block:	Birmingham City University	Floor Level: Ground Floor
Sample No.:	DU002627	Portal Ref No.:	321

Item:	Asbestos Reinforced plastic downpipes			
Asbestos Content:	Result Based on:			
Chrysotile	Analysis of sample using PLM			
Sample Analysed By: Reg 13(1)	Extent:	12 linear metres		
Comments: 3 x no downpipes see plan for locations

Material Assessment Total Score: 3		Likelihood of Disturbance Assessment Total Score: 5		Management Assessment Licensable: No Recommendations: Program removal Reinspection Interval: Not Applicable Overall Risk Category: C8
Product Type:	1 (Asbestos reinforced plastic)	Location:	2 (Rooms up to 100 sq m)	
Condition:	1 (Minor scratches)	Accessibility:	1 (Occasionally likely to be disturbed)	
Surface Treatment:	0 (Composite material)			
Asbestos Type:	1 (Chrysotile)	Extent Score:	2 (>10 - <50 sq m or >10m - <50m pipe run)

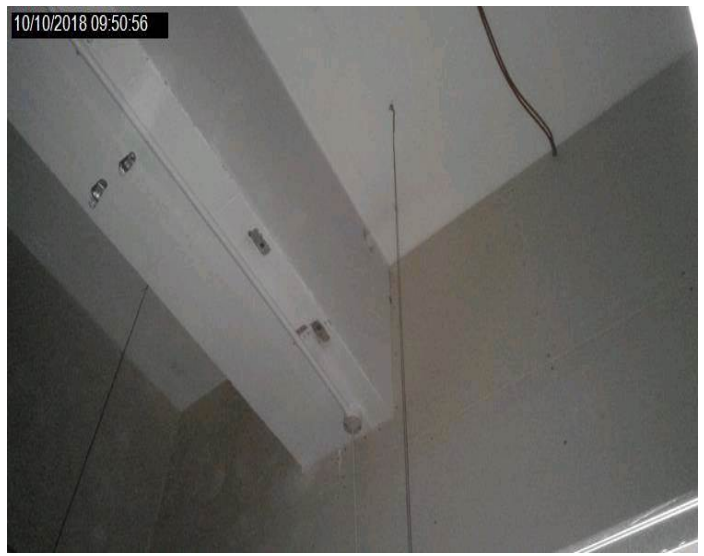
Location:	NAT022	Block:	Birmingham City University	Floor Level: Ground Floor
Sample No.:	As DU002605	Portal Ref No.:	324

Item:	Asbestos Reinforced plastic sleeve			
Asbestos Content:	Result Based on:			
Chrysotile	Strongly presumed			
Sample Analysed By:	Not applicable	Extent:	1 unit	
Comments: Through concrete structure

Material Assessment Total Score: 3		Likelihood of Disturbance Assessment Total Score: 3		Management Assessment Licensable: No Recommendations: Program removal Reinspection Interval: Not Applicable Overall Risk Category: D6
Product Type:	1 (Asbestos reinforced plastic)	Location:	2 (Rooms up to 100 sq m)	
Condition:	1 (Minor scratches)	Accessibility:	0 (Usually inaccessible or unlikely to be disturbed)	
Surface Treatment:	0 (Composite material)			
Asbestos Type:	1 (Chrysotile)	Extent Score:	1 (<10 sq m or 10m pipe run)

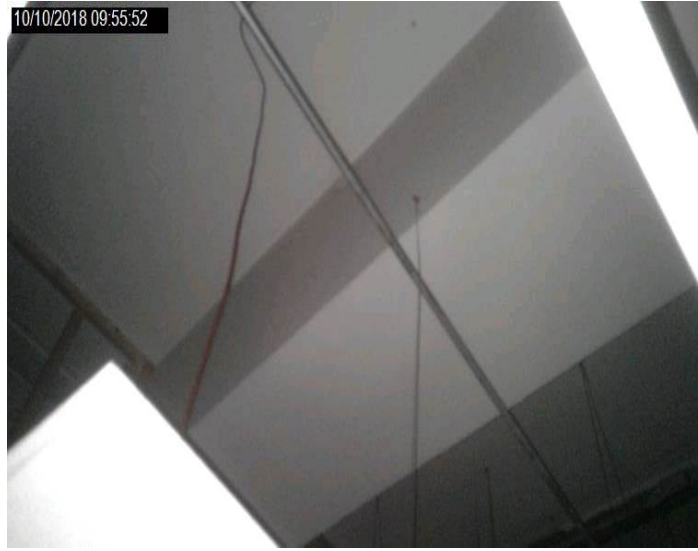
Location:	NAT021A	Block:	Birmingham City University	Floor Level: Ground Floor
Sample No.:	As DU002605	Portal Ref No.:	325

Item:	Asbestos Reinforced plastic sleeve			
Asbestos Content:	Result Based on:			
Chrysotile	Strongly presumed			
Sample Analysed By:	Not applicable	Extent:	1 unit	
Comments: Through concrete structure

Material Assessment Total Score: 3		Likelihood of Disturbance Assessment Total Score: 3		Management Assessment Licensable: No Recommendations: Program removal Reinspection Interval: Not Applicable Overall Risk Category: D6
Product Type:	1 (Asbestos reinforced plastic)	Location:	2 (Rooms up to 100 sq m)	
Condition:	1 (Minor scratches)	Accessibility:	0 (Usually inaccessible or unlikely to be disturbed)	
Surface Treatment:	0 (Composite material)			
Asbestos Type:	1 (Chrysotile)	Extent Score:	1 (<10 sq m or 10m pipe run)

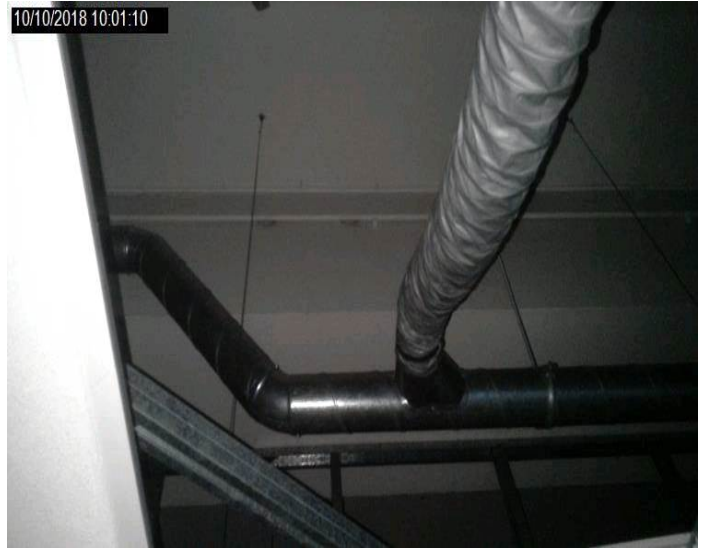
Location:	NAT021B	Block:	Birmingham City University	Floor Level: Ground Floor
Sample No.:	As DU002605	Portal Ref No.:	326

Item:	Asbestos Reinforced plastic sleeve			
Asbestos Content:	Result Based on:			
Chrysotile	Strongly presumed			
Sample Analysed By:	Not applicable	Extent:	3 units	
Comments: Through concrete structure

Material Assessment Total Score: 3		Likelihood of Disturbance Assessment Total Score: 3		Management Assessment Licensable: No Recommendations: Program removal Reinspection Interval: Not Applicable Overall Risk Category: D6
Product Type:	1 (Asbestos reinforced plastic)	Location:	2 (Rooms up to 100 sq m)	
Condition:	1 (Minor scratches)	Accessibility:	0 (Usually inaccessible or unlikely to be disturbed)	
Surface Treatment:	0 (Composite material)			
Asbestos Type:	1 (Chrysotile)	Extent Score:	1 (<10 sq m or 10m pipe run)
