Report No.: J102749
Nature of Work: Demolition Survey
Issue Date: 02/11/2018
Client Name: WYG Engineering Ltd
 Geneva Building, Lake View Drive, Sherwood Business Park,
 Annesley, Nottingham, NG15 0ED
Site Address: Attwood Building, Former City North Campus, Birmingham City
 University, Perry Barr, B42 2US

1.0 Introduction & Scope of Work

A demolition survey in line with HSG264 Asbestos: The Survey Guide was carried out internally and externally to the property.

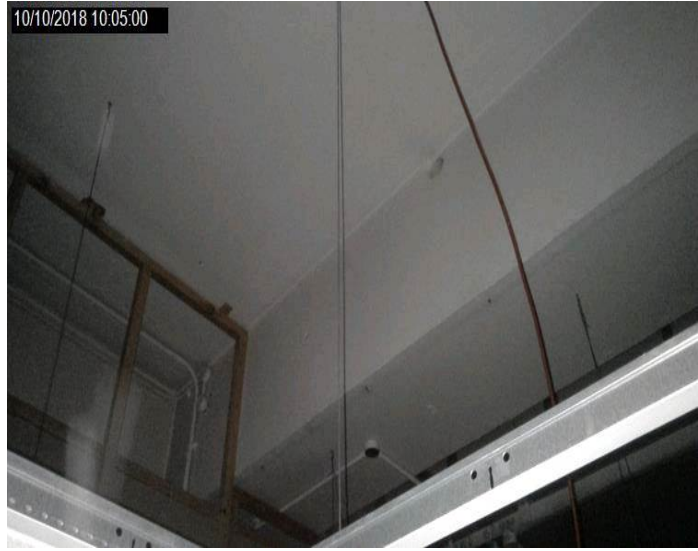
Location:	NAT020	Block:	Birmingham City University	Floor Level: Ground Floor
Sample No.:	As DU002605	Portal Ref No.:	327

Item:	Asbestos Reinforced plastic sleeve			
Asbestos Content:	Result Based on:			
Chrysotile	Strongly presumed			
Sample Analysed By:	Not applicable	Extent:	2 units	
Comments: Through concrete structure

Material Assessment Total Score: 3		Likelihood of Disturbance Assessment Total Score: 3		Management Assessment Licensable: No Recommendations: Program removal Reinspection Interval: Not Applicable Overall Risk Category: D6
Product Type:	1 (Asbestos reinforced plastic)	Location:	2 (Rooms up to 100 sq m)	
Condition:	1 (Minor scratches)	Accessibility:	0 (Usually inaccessible or unlikely to be disturbed)	
Surface Treatment:	0 (Composite material)			
Asbestos Type:	1 (Chrysotile)	Extent Score:	1 (<10 sq m or 10m pipe run)

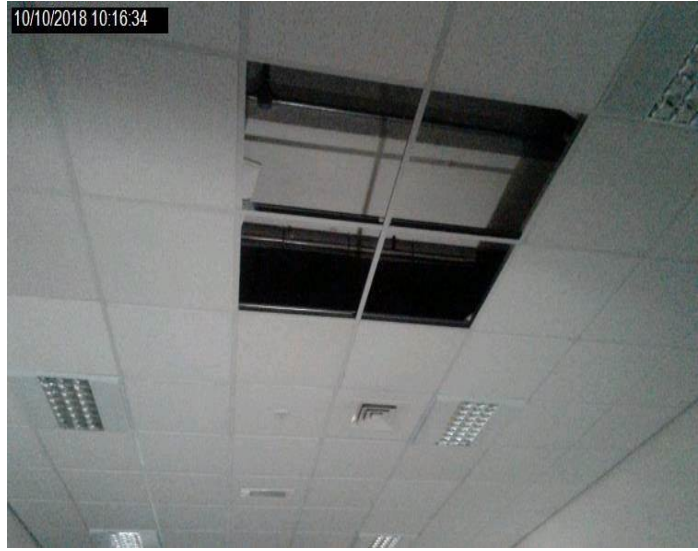
Location:	NAT019A	Block:	Birmingham City University	Floor Level: Ground Floor
Sample No.:	As DU002605	Portal Ref No.:	328

Item:	Asbestos Reinforced plastic sleeve			
Asbestos Content:	Result Based on:			
Chrysotile	Strongly presumed			
Sample Analysed By:	Not applicable	Extent:	4 units	
Comments: Through concrete structure

Material Assessment Total Score: 3		Likelihood of Disturbance Assessment Total Score: 3		Management Assessment Licensable: No Recommendations: Program removal Reinspection Interval: Not Applicable Overall Risk Category: D6
Product Type:	1 (Asbestos reinforced plastic)	Location:	2 (Rooms up to 100 sq m)	
Condition:	1 (Minor scratches)	Accessibility:	0 (Usually inaccessible or unlikely to be disturbed)	
Surface Treatment:	0 (Composite material)			
Asbestos Type:	1 (Chrysotile)	Extent Score:	1 (<10 sq m or 10m pipe run)

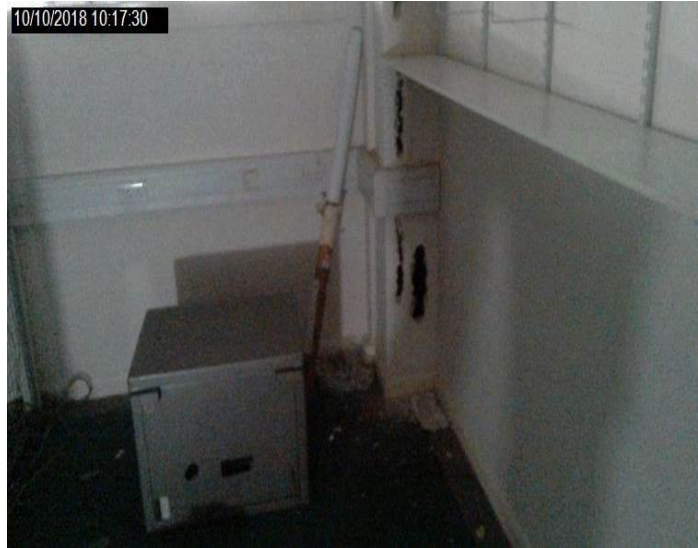
Location:	NAT019A	Block:	Birmingham City University	Floor Level: Ground Floor
Sample No.:	As DU002627	Portal Ref No.:	329

Item:	Asbestos Reinforced plastic downpipe			
Asbestos Content:	Result Based on:			
Chrysotile	Strongly presumed			
Sample Analysed By:	Not applicable	Extent:	4 linear metres	
Comments: Within plasterboard boxing

Material Assessment Total Score: 3		Likelihood of Disturbance Assessment Total Score: 4		Management Assessment Licensable: No Recommendations: Program removal Reinspection Interval: Not Applicable Overall Risk Category: C7
Product Type:	1 (Asbestos reinforced plastic)	Location:	2 (Rooms up to 100 sq m)	
Condition:	1 (Minor scratches)	Accessibility:	1 (Occasionally likely to be disturbed)	
Surface Treatment:	0 (Composite material)			
Asbestos Type:	1 (Chrysotile)	Extent Score:	1 (<10 sq m or 10m pipe run)

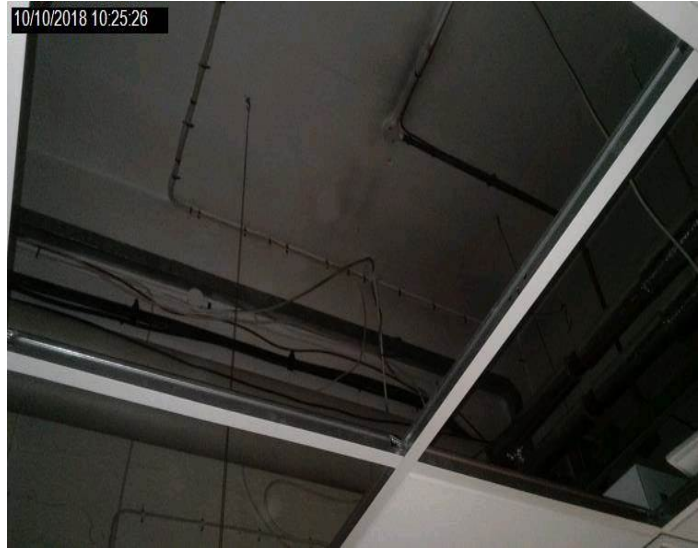
Location:	NAT099H	Block:	Birmingham City University	Floor Level: Ground Floor
Sample No.:	As DU002605	Portal Ref No.:	331

Item:	Asbestos Reinforced plastic sleeve			
Asbestos Content:	Result Based on:			
Chrysotile	Strongly presumed			
Sample Analysed By:	Not applicable	Extent:	3 units	
Comments: Through concrete structure, core holes have been filled

Material Assessment Total Score: 3		Likelihood of Disturbance Assessment Total Score: 3		Management Assessment Licensable: No Recommendations: Program removal Reinspection Interval: Not Applicable Overall Risk Category: D6
Product Type:	1 (Asbestos reinforced plastic)	Location:	2 (Rooms up to 100 sq m)	
Condition:	1 (Minor scratches)	Accessibility:	0 (Usually inaccessible or unlikely to be disturbed)	
Surface Treatment:	0 (Composite material)			
Asbestos Type:	1 (Chrysotile)	Extent Score:	1 (<10 sq m or 10m pipe run)

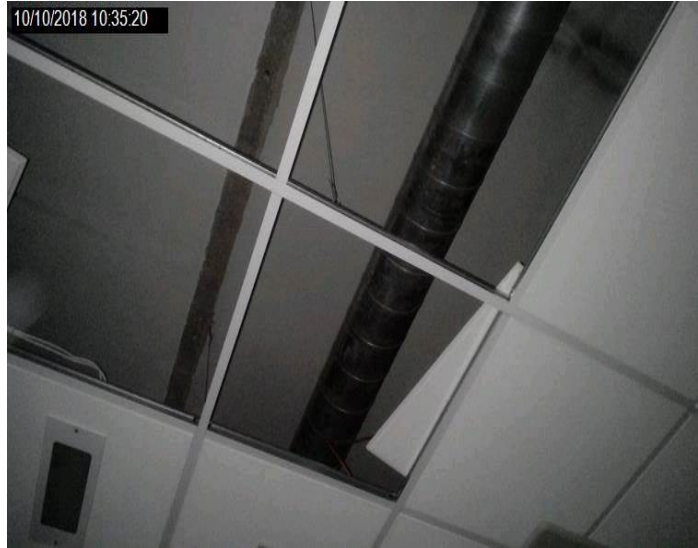
Location:	NAT019	Block:	Birmingham City University	Floor Level: Ground Floor
Sample No.:	As DU002605	Portal Ref No.:	332

Item:	Asbestos Reinforced plastic sleeve			
Asbestos Content:	Result Based on:			
Chrysotile	Strongly presumed			
Sample Analysed By:	Not applicable	Extent:	8 units	
Comments: Through concrete structure

Material Assessment Total Score: 3		Likelihood of Disturbance Assessment Total Score: 3		Management Assessment Licensable: No Recommendations: Program removal Reinspection Interval: Not Applicable Overall Risk Category: D6
Product Type:	1 (Asbestos reinforced plastic)	Location:	2 (Rooms up to 100 sq m)	
Condition:	1 (Minor scratches)	Accessibility:	0 (Usually inaccessible or unlikely to be disturbed)	
Surface Treatment:	0 (Composite material)			
Asbestos Type:	1 (Chrysotile)	Extent Score:	1 (<10 sq m or 10m pipe run)

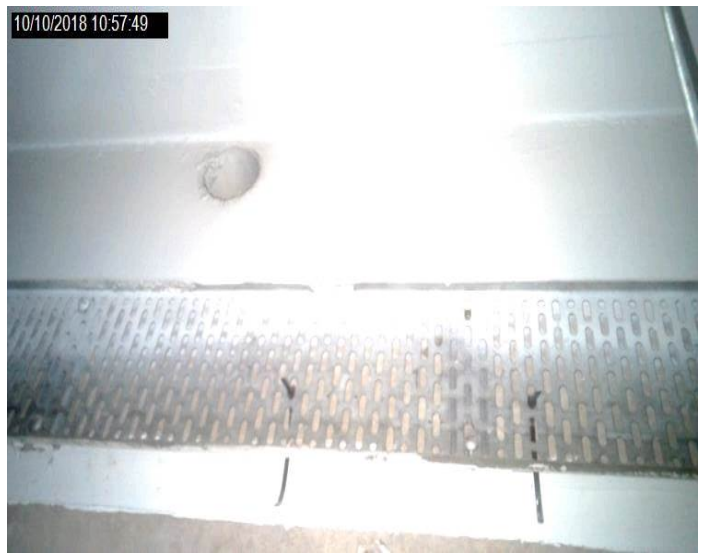
Location:	NAT099J	Block:	Birmingham City University	Floor Level: Ground Floor
Sample No.:	As DU002605	Portal Ref No.:	333

Item:	Asbestos Reinforced plastic sleeve			
Asbestos Content:	Result Based on:			
Chrysotile	Strongly presumed			
Sample Analysed By:	Not applicable	Extent:	2 units	
Comments: Through concrete structure

Material Assessment Total Score: 3		Likelihood of Disturbance Assessment Total Score: 3		Management Assessment Licensable: No Recommendations: Program removal Reinspection Interval: Not Applicable Overall Risk Category: D6
Product Type:	1 (Asbestos reinforced plastic)	Location:	2 (Rooms up to 100 sq m)	
Condition:	1 (Minor scratches)	Accessibility:	0 (Usually inaccessible or unlikely to be disturbed)	
Surface Treatment:	0 (Composite material)			
Asbestos Type:	1 (Chrysotile)	Extent Score:	1 (<10 sq m or 10m pipe run)

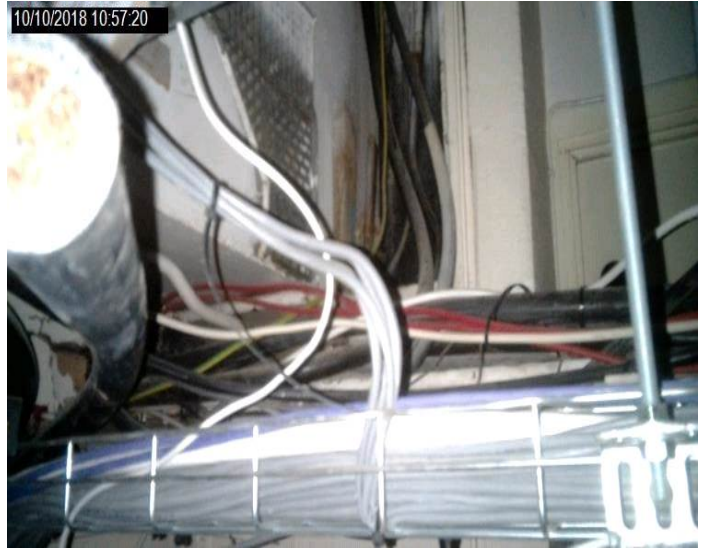
Location:	NAT099J	Block:	Birmingham City University	Floor Level: Ground Floor
Sample No.:	As DU002627	Portal Ref No.:	334

Item:	Asbestos Reinforced plastic downpipe			
Asbestos Content:	Result Based on:			
Chrysotile	Strongly presumed			
Sample Analysed By:	Not applicable	Extent:	4 linear metres	
Comments: Within timber boxing

Material Assessment Total Score: 3		Likelihood of Disturbance Assessment Total Score: 4		Management Assessment Licensable: No Recommendations: Program removal Reinspection Interval: Not Applicable Overall Risk Category: C7
Product Type:	1 (Asbestos reinforced plastic)	Location:	2 (Rooms up to 100 sq m)	
Condition:	1 (Minor scratches)	Accessibility:	1 (Occasionally likely to be disturbed)	
Surface Treatment:	0 (Composite material)			
Asbestos Type:	1 (Chrysotile)	Extent Score:	1 (<10 sq m or 10m pipe run)

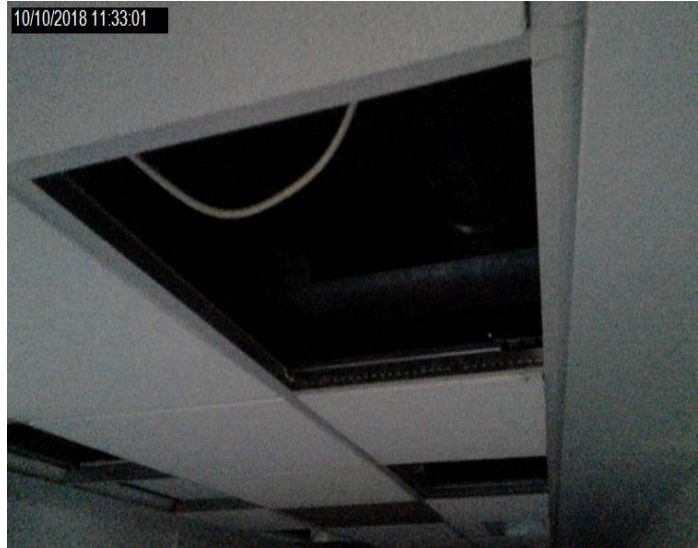
Location:	NAT099K	Block:	Birmingham City University	Floor Level: Ground Floor
Sample No.:	As DU002605	Portal Ref No.:	335

Item:	Asbestos Reinforced plastic sleeve			
Asbestos Content:	Result Based on:			
Chrysotile	Strongly presumed			
Sample Analysed By:	Not applicable	Extent:	18 units	
Comments: Through concrete structure

Material Assessment Total Score: 3		Likelihood of Disturbance Assessment Total Score: 3		Management Assessment Licensable: No Recommendations: Program removal Reinspection Interval: Not Applicable Overall Risk Category: D6
Product Type:	1 (Asbestos reinforced plastic)	Location:	2 (Rooms up to 100 sq m)	
Condition:	1 (Minor scratches)	Accessibility:	0 (Usually inaccessible or unlikely to be disturbed)	
Surface Treatment:	0 (Composite material)			
Asbestos Type:	1 (Chrysotile)	Extent Score:	1 (<10 sq m or 10m pipe run)

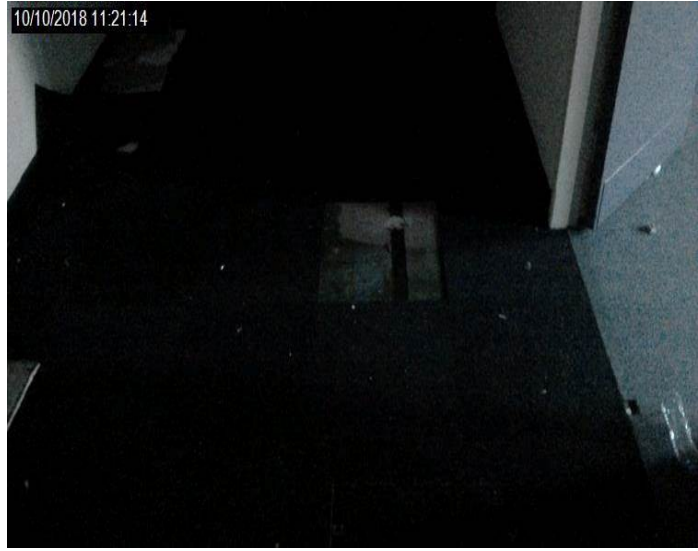
Location:	NAT099K	Block:	Birmingham City University	Floor Level: Ground Floor
Sample No.:	DU002628	Portal Ref No.:	338

Item:	Thermoplastic floor tiles			
Asbestos Content:		Result Based on:		
No Asbestos Detected in tile or adhesive		Analysis of sample using PLM		
Sample Analysed By:	Reg 13(1)	Extent:	18 m ²	
Comments: Blue, to section of floor to corridor

Material Assessment Total Score: 0		Likelihood of Disturbance Assessment Total Score: 0		Management Assessment Licensable: No Recommendations: Not Applicable Reinspection Interval: Not Applicable Overall Risk Category: E0
Product Type:	0 Not Applicable	Location:	0 Not Applicable	
Condition:	0 Not Applicable	Accessibility:	0 Not Applicable	
Surface Treatment:	0 Not Applicable			
Asbestos Type:	0 Not Applicable	Extent Score:	0 Not Applicable

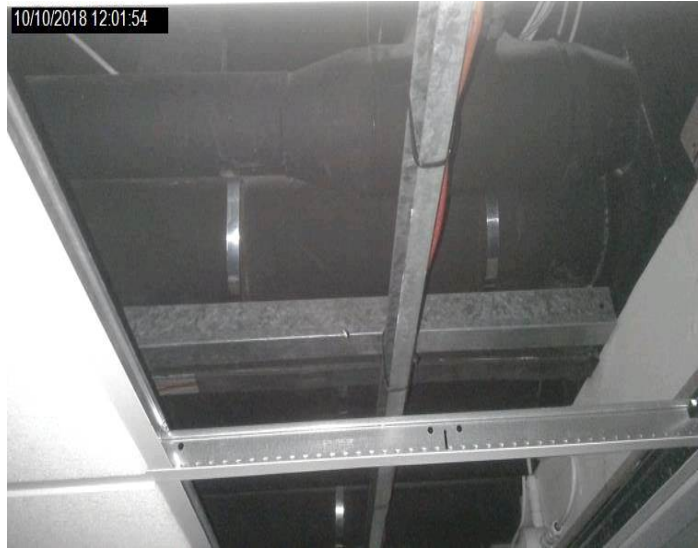
Location:	NAT099D	Block:	Birmingham City University	Floor Level: Ground Floor
Sample No.:	As DU002605	Portal Ref No.:	342

Item:	Asbestos Reinforced plastic sleeve			
Asbestos Content:	Result Based on:			
Chrysotile	Strongly presumed			
Sample Analysed By:	Not applicable	Extent:	8 units	
Comments: Through concrete structure

Material Assessment Total Score: 3		Likelihood of Disturbance Assessment Total Score: 3		Management Assessment Licensable: No Recommendations: Program removal Reinspection Interval: Not Applicable Overall Risk Category: D6
Product Type:	1 (Asbestos reinforced plastic)	Location:	2 (Rooms up to 100 sq m)	
Condition:	1 (Minor scratches)	Accessibility:	0 (Usually inaccessible or unlikely to be disturbed)	
Surface Treatment:	0 (Composite material)			
Asbestos Type:	1 (Chrysotile)	Extent Score:	1 (<10 sq m or 10m pipe run)

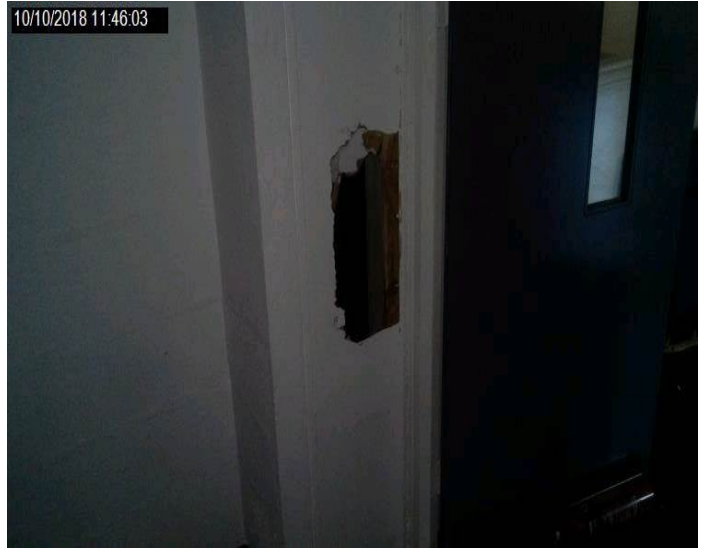
Location:	NAT099D	Block:	Birmingham City University	Floor Level: Ground Floor
Sample No.:	As DU002627	Portal Ref No.:	343

Item:	Asbestos Reinforced plastic downpipe			
Asbestos Content:	Result Based on:			
Chrysotile	Strongly presumed			
Sample Analysed By:	Not applicable	Extent:	16 linear metres	
Comments: Within timber boxing 4No

Material Assessment Total Score: 3		Likelihood of Disturbance Assessment Total Score: 5		Management Assessment Licensable: No Recommendations: Program removal Reinspection Interval: Not Applicable Overall Risk Category: C8
Product Type:	1 (Asbestos reinforced plastic)	Location:	2 (Rooms up to 100 sq m)	
Condition:	1 (Minor scratches)	Accessibility:	1 (Occasionally likely to be disturbed)	
Surface Treatment:	0 (Composite material)			
Asbestos Type:	1 (Chrysotile)	Extent Score:	2 (>10 - <50 sq m or >10m - <50m pipe run)

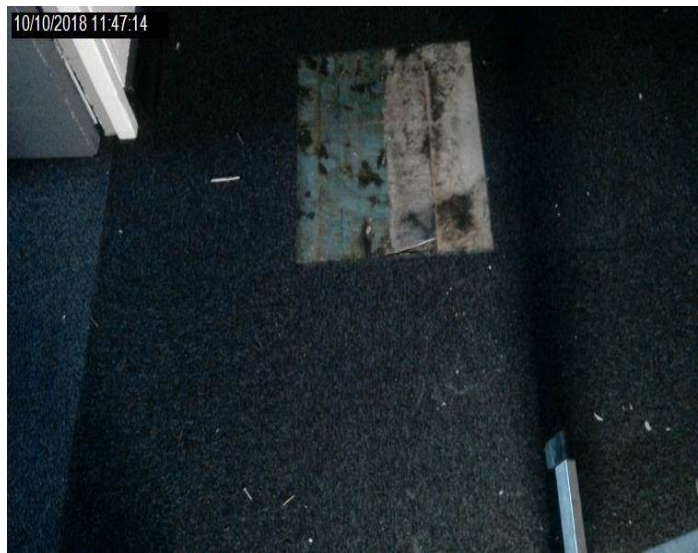
Location:	NAT099D	Block:	Birmingham City University	Floor Level: Ground Floor
Sample No.:	As DU002628	Portal Ref No.:	345

Item:	Thermoplastic floor tiles			
Asbestos Content:		Result Based on:		
No Asbestos Detected in tile or adhesive		Strongly presumed		
Sample Analysed By:	Not applicable	Extent:	38 m ²	
Comments: Blue, to section of floor to corridor

Material Assessment Total Score: 0		Likelihood of Disturbance Assessment Total Score: 0		Management Assessment Licensable: No Recommendations: Not Applicable Reinspection Interval: Not Applicable Overall Risk Category: E0
Product Type:	0 Not Applicable	Location:	0 Not Applicable	
Condition:	0 Not Applicable	Accessibility:	0 Not Applicable	
Surface Treatment:	0 Not Applicable			
Asbestos Type:	0 Not Applicable	Extent Score:	0 Not Applicable

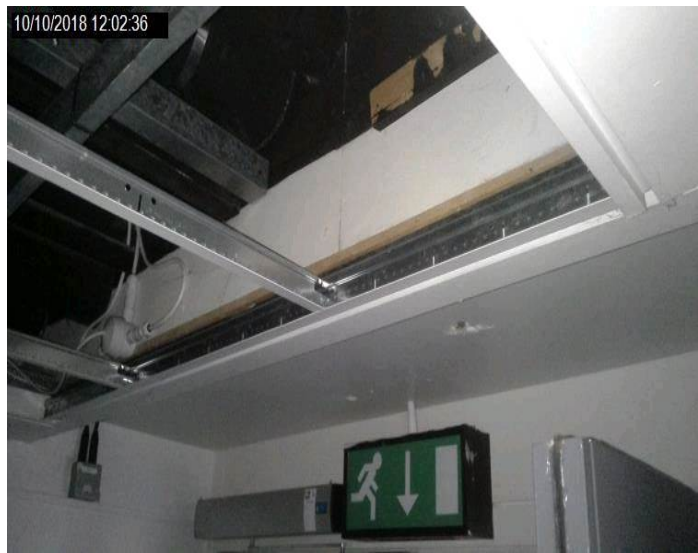
Location:	NAT099D	Block:	Birmingham City University	Floor Level: Ground Floor
Sample No.:	DU002629	Portal Ref No.:	346

Item:	Insulating board upstand and ceiling			
Asbestos Content:		Result Based on:		
No Asbestos Detected		Analysis of sample using PLM		
Sample Analysed By:	Reg 13(1)	Extent:	4 m ²	
Comments: Local to double doors

Material Assessment Total Score: 0		Likelihood of Disturbance Assessment Total Score: 0		Management Assessment Licensable: Yes Recommendations: Not Applicable Reinspection Interval: Not Applicable Overall Risk Category: E0
Product Type:	0 Not Applicable	Location:	0 Not Applicable	
Condition:	0 Not Applicable	Accessibility:	0 Not Applicable	
Surface Treatment:	0 Not Applicable			
Asbestos Type:	0 Not Applicable	Extent Score:	0 Not Applicable

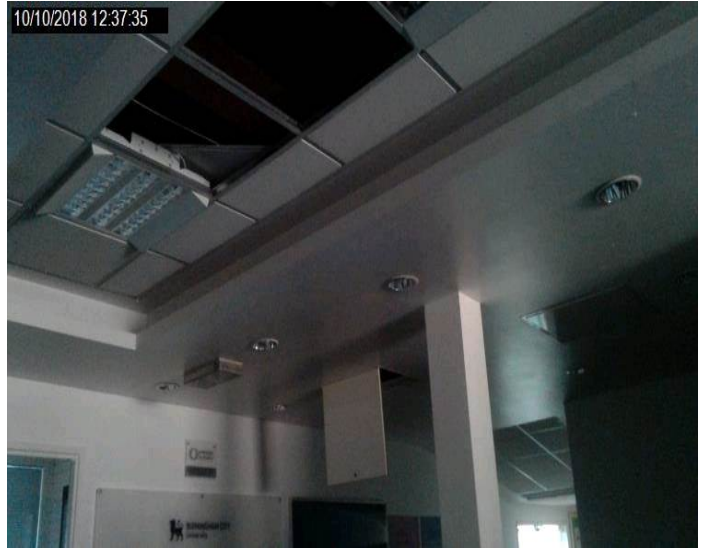
Location:	NAT099C	Block:	Birmingham City University	Floor Level: Ground Floor
Sample No.:	As DU002605	Portal Ref No.:	347

Item:	Asbestos Reinforced plastic sleeve			
Asbestos Content:	Result Based on:			
Chrysotile	Strongly presumed			
Sample Analysed By:	Not applicable	Extent:	6 units	
Comments: Through concrete structure, within corridor section only

Material Assessment Total Score: 3		Likelihood of Disturbance Assessment Total Score: 3		Management Assessment Licensable: No Recommendations: Program removal Reinspection Interval: Not Applicable Overall Risk Category: D6
Product Type:	1 (Asbestos reinforced plastic)	Location:	2 (Rooms up to 100 sq m)	
Condition:	1 (Minor scratches)	Accessibility:	0 (Usually inaccessible or unlikely to be disturbed)	
Surface Treatment:	0 (Composite material)			
Asbestos Type:	1 (Chrysotile)	Extent Score:	1 (<10 sq m or 10m pipe run)

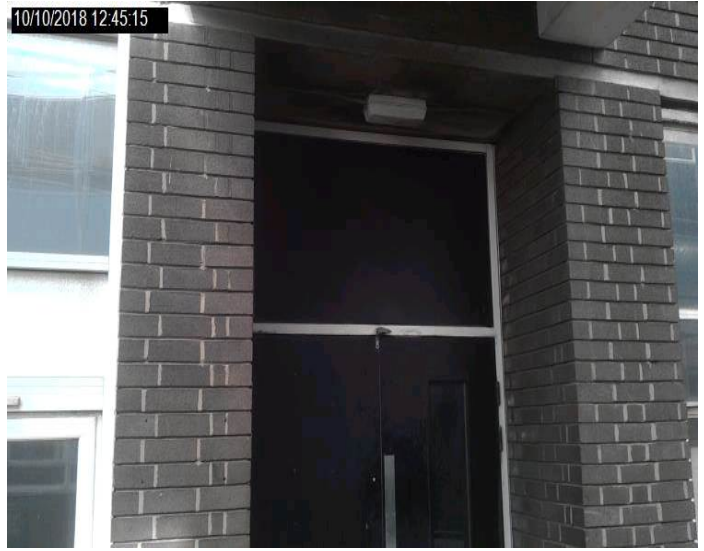
Location:	NAT EXT	Block:	Birmingham City University	Floor Level: E - External
Sample No.:	DU002630	Portal Ref No.:	348

Item:	Insulating board door header			
Asbestos Content:		Result Based on:		
No Asbestos Detected		Analysis of sample using PLM		
Sample Analysed By:	Reg 13(1)	Extent:	2 m ²	
Comments:

Material Assessment Total Score: 0		Likelihood of Disturbance Assessment Total Score: 0		Management Assessment Licensable: Yes Recommendations: Not Applicable Reinspection Interval: Not Applicable Overall Risk Category: E0
Product Type:	0 Not Applicable	Location:	0 Not Applicable	
Condition:	0 Not Applicable	Accessibility:	0 Not Applicable	
Surface Treatment:	0 Not Applicable			
Asbestos Type:	0 Not Applicable	Extent Score:	0 Not Applicable

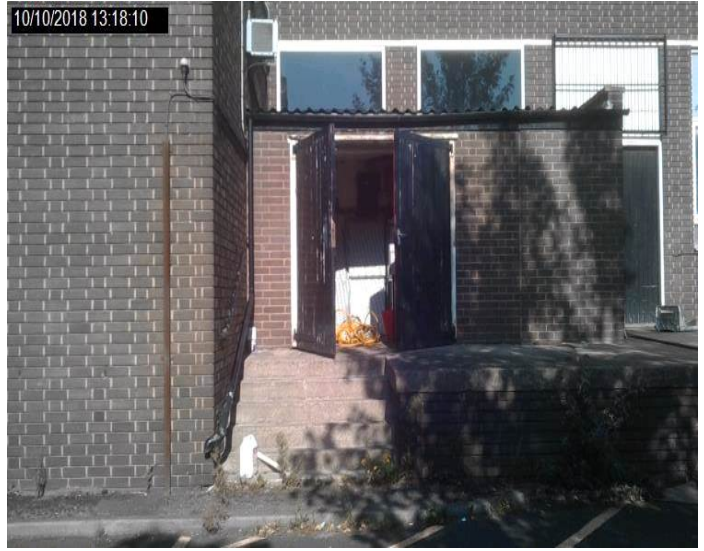
Location:	NAT002A	Block:	Birmingham City University	Floor Level: Ground Floor
Sample No.:	DU002631	Portal Ref No.:	351

Item:	Insulating board ceiling panels			
Asbestos Content:		Result Based on:		
No Asbestos Detected		Analysis of sample using PLM		
Sample Analysed By:	Reg 13(1)	Extent:	6 m ²	
Comments: Damaged

Material Assessment Total Score: 0		Likelihood of Disturbance Assessment Total Score: 0		Management Assessment Licensable: Yes Recommendations: Not Applicable Reinspection Interval: Not Applicable Overall Risk Category: E0
Product Type:	0 Not Applicable	Location:	0 Not Applicable	
Condition:	0 Not Applicable	Accessibility:	0 Not Applicable	
Surface Treatment:	0 Not Applicable			
Asbestos Type:	0 Not Applicable	Extent Score:	0 Not Applicable

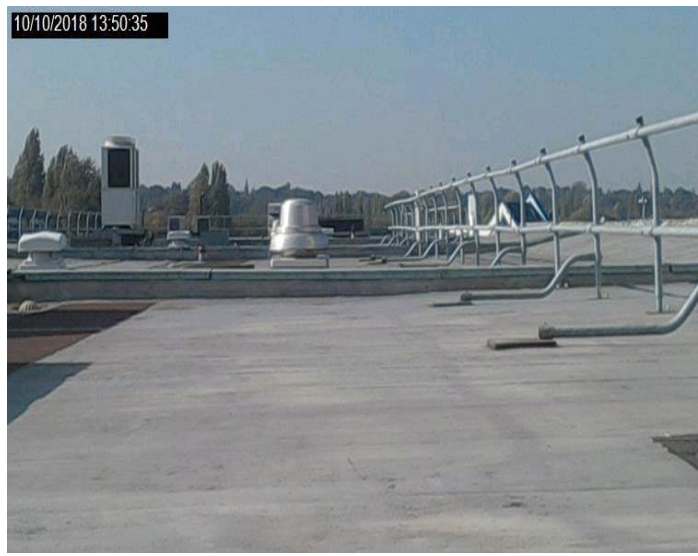
Location:	NAT EXT	Block:	Birmingham City University	Floor Level: E - External
Sample No.:	DU002632	Portal Ref No.:	352

Item:	Asbestos Cement cowl			
Asbestos Content:	Result Based on:			
Chrysotile	Analysis of sample using PLM			
Sample Analysed By:	Reg 13(1)	Extent:	1 unit	
Comments: To rear section of the roof right of centre

Material Assessment Total Score: 4		Likelihood of Disturbance Assessment Total Score: 1		Management Assessment Licensable: No Recommendations: Program removal Reinspection Interval: Not Applicable Overall Risk Category: D5
Product Type:	1 (Asbestos cement)	Location:	0 (Outdoors)	
Condition:	1 (Minor scratches)	Accessibility:	0 (Usually inaccessible or unlikely to be disturbed)	
Surface Treatment:	1 (Unencapsulated asbestos cement)			
Asbestos Type:	1 (Chrysotile)	Extent Score:	1 (<10 sq m or 10m pipe run)

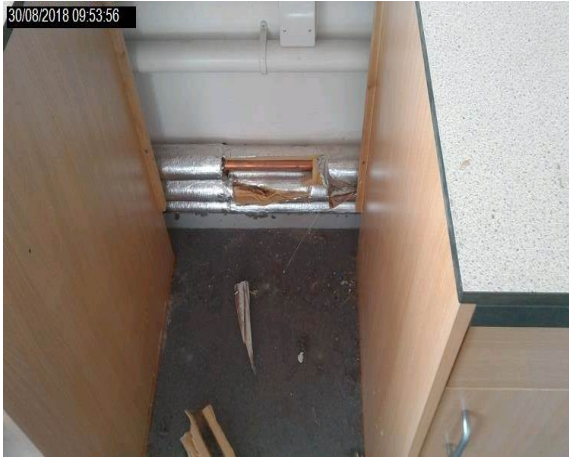
Intrusion 01 - Foil tape glass fibre insulation to copper pipework

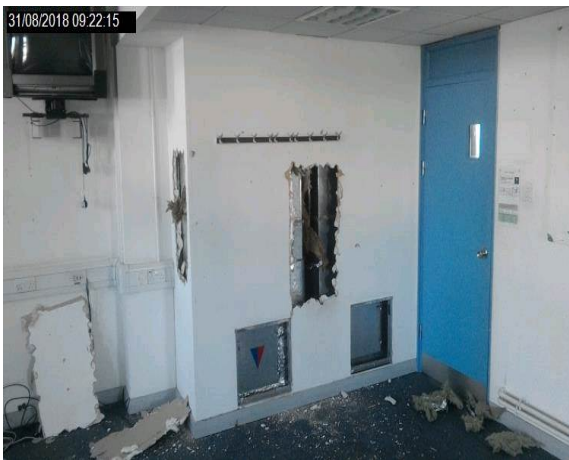
Intrusion 07 - Plasterboard surround to service duct

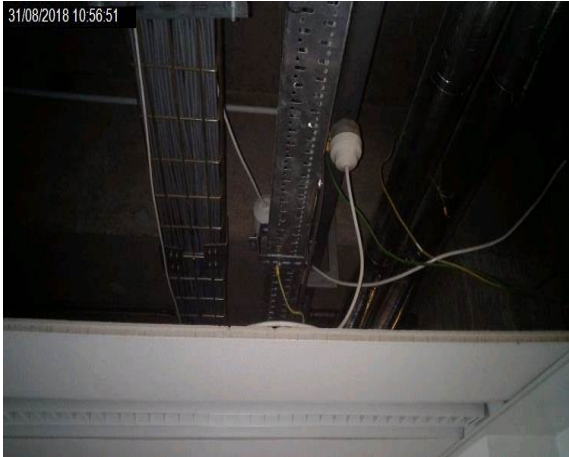
Intrusion 09 - Ceiling void

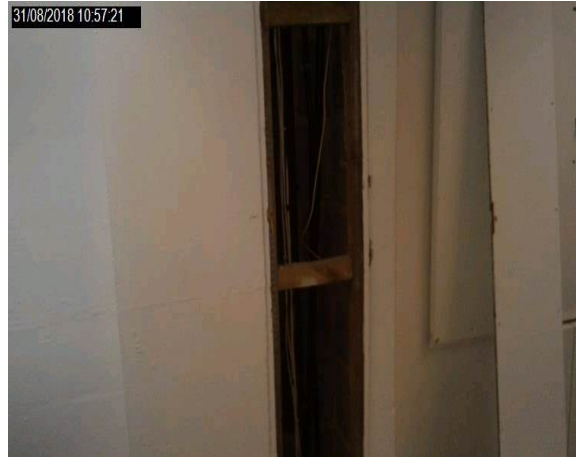
Intrusion 10 - Riser

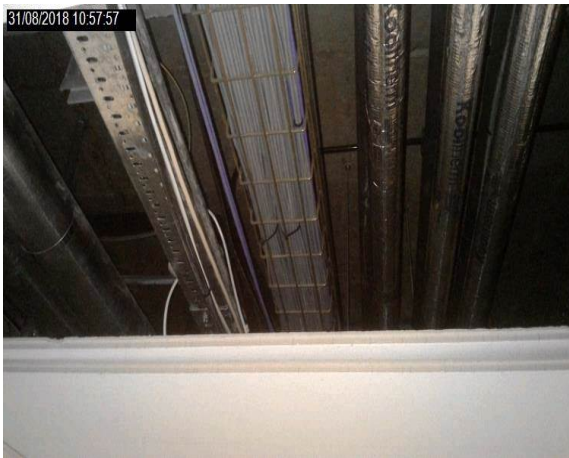
Intrusion 11 - Ceiling void

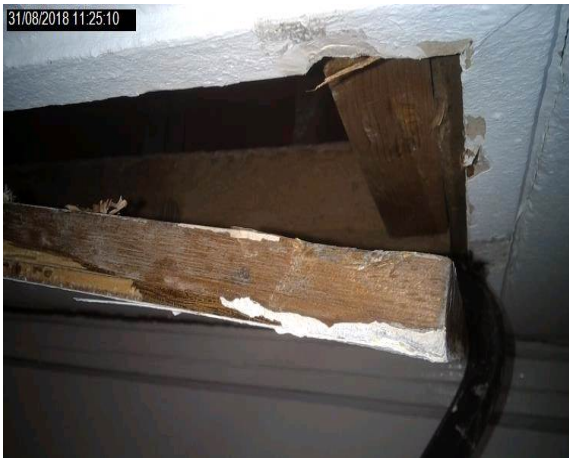
Intrusion 15 - Timber panel above link corridor doors

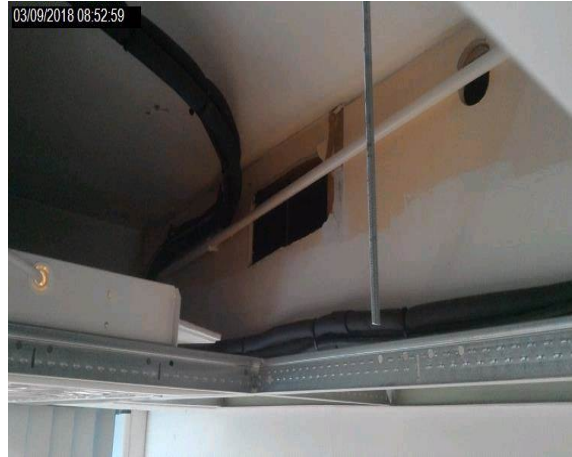
Intrusion 18 - Plasterboard boxing to metal ducting

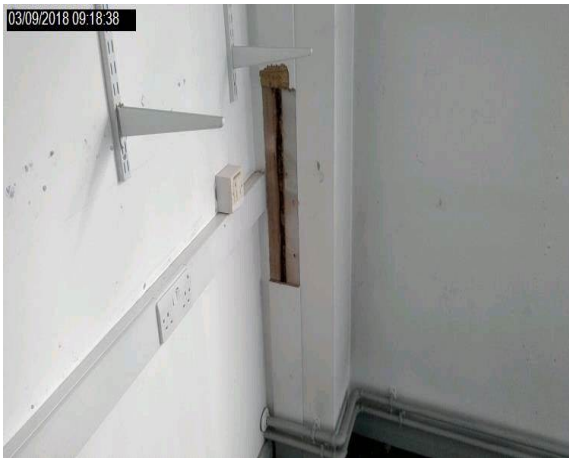
Intrusion 19 - Cork expansion joint to external wall

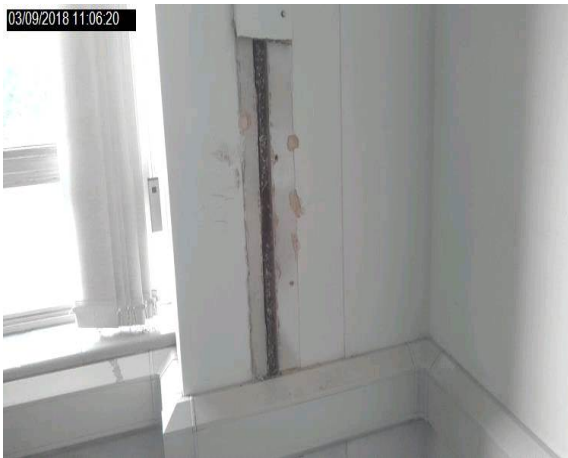
Intrusion 23 - Cork expansion joint

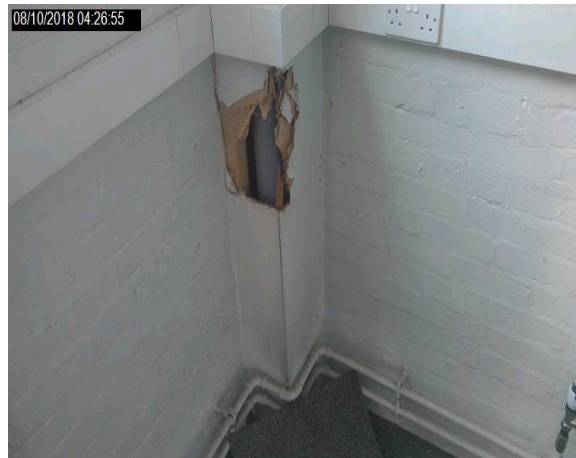
Intrusion 29 - Insulating board ceiling tiles to straw board

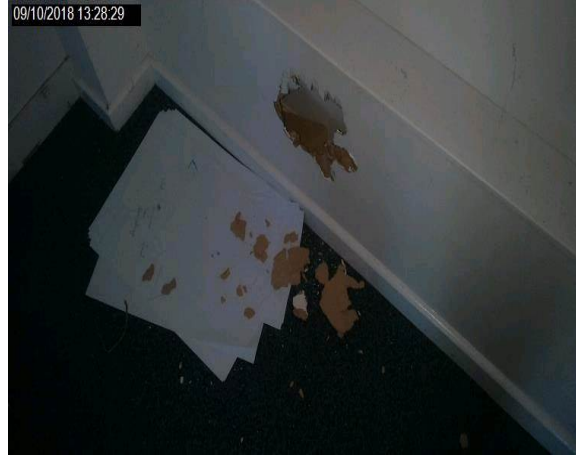
Intrusion 35 - Timber panel to modern electrics

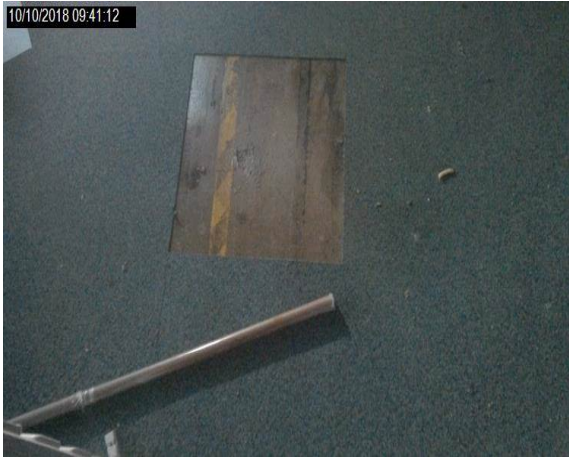
Intrusion 38 - Cork expansion joint

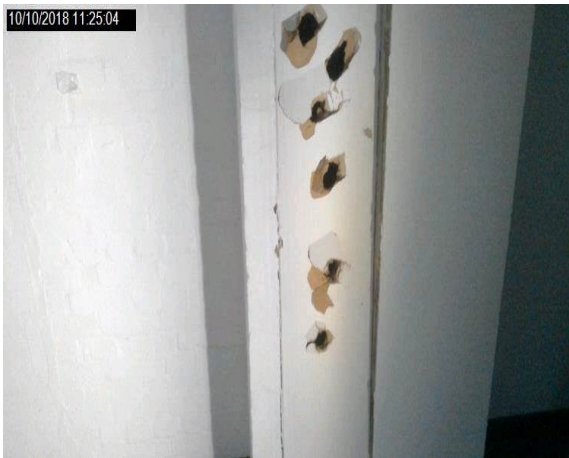
Intrusion 40 - Metal panels to foam to underside of external windows
