Report on the investigation of
the death of a third officer struck by a freight vehicle
on the stern ramp of the ro-ro freight ferry

Seatruck Progress

Brocklebank Dock, Liverpool

15 May 2019

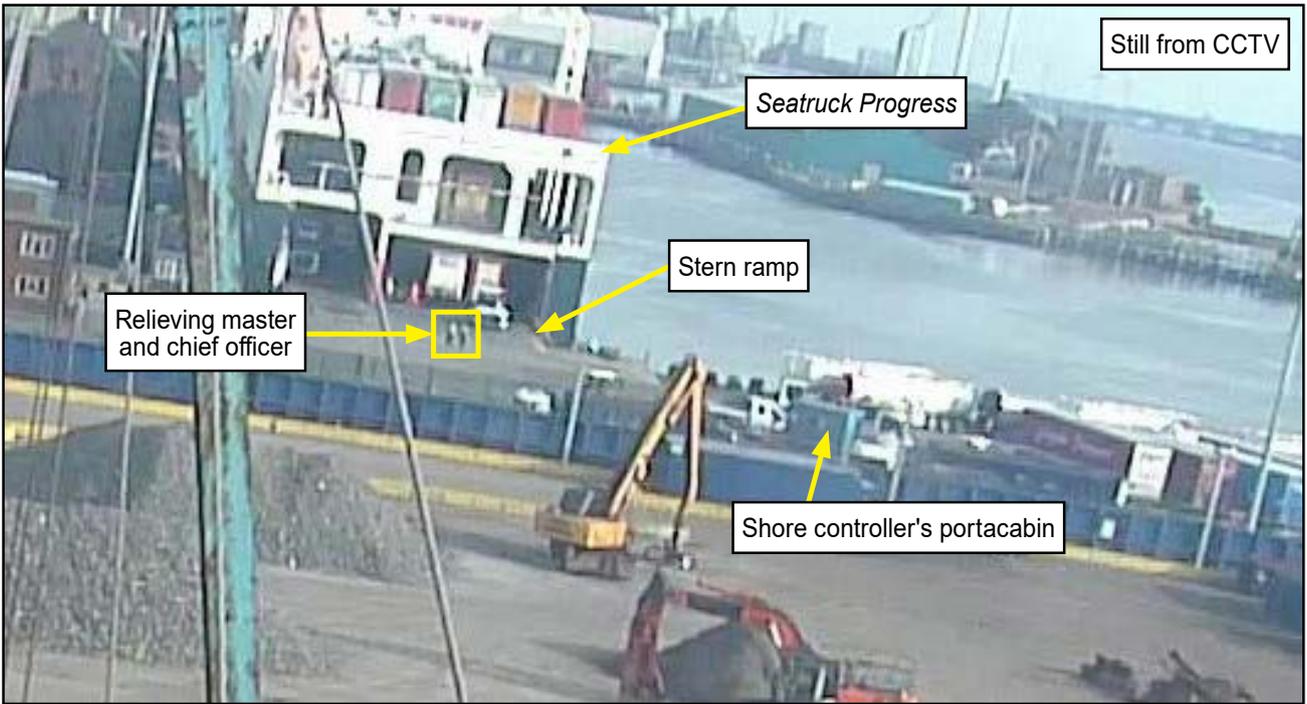
Figure 2: Stern ramp in its lowered position on the quay

At 1826 on 15 May 2019, the Isle of Man registered ro-ro freight ferry *Seatruck Progress* berthed at Brocklebank Dock, Liverpool, England (**Figure 1**) following passage from Dublin, Ireland. The stern ramp was lowered on to the dockside (**Figure 2**) and the relieving master and chief officer, who had been waiting on the quay, boarded. Cargo discharge commenced and the relieving master went to his cabin while the relieving chief officer went to the cargo control room (CCR) on the port side of the ferry's main vehicle deck, where the third officer (3/O), Bartosz Wronski, was working. The outgoing chief officer soon joined his relief in the CCR and started to hand over his duties. Meanwhile, the 3/O left the CCR and drove the outgoing master's car off the ferry and parked it on the quay outboard of the stern ramp's starboard side.

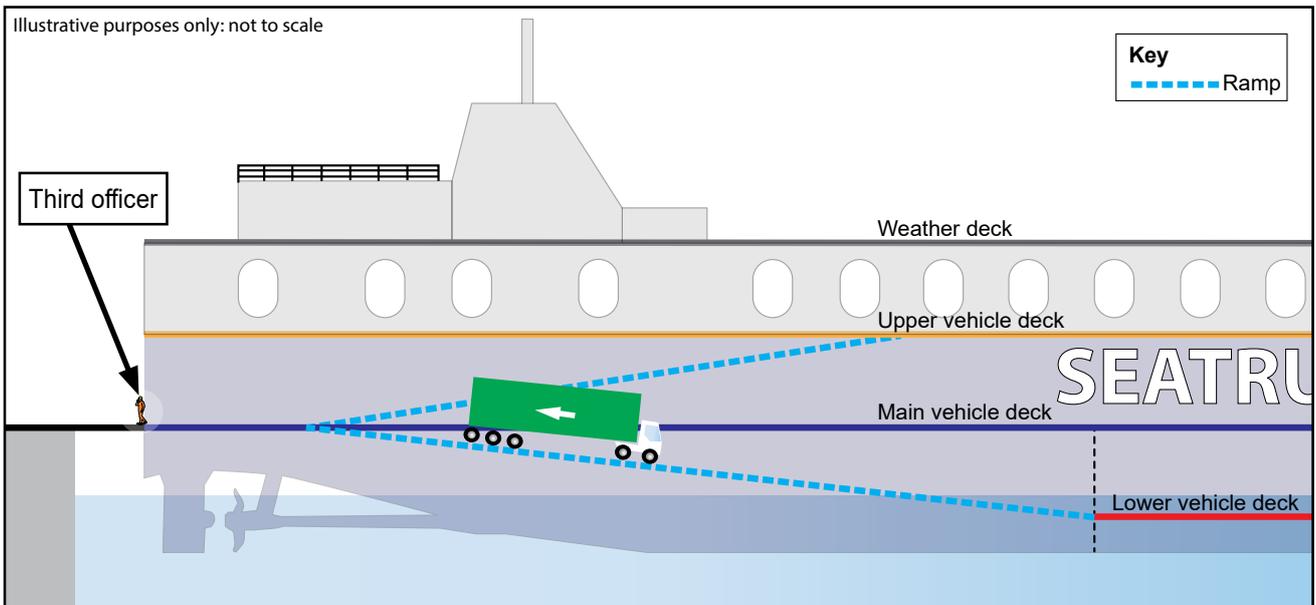
Figure 4a: Route from lower vehicle deck to stern ramp – semi-trailer and tractor unit on lower vehicle deck ramp

At 1926, a tractor on the lower vehicle deck started to push a semi-trailer up the vehicle deck ramp towards the main deck and the stern ramp (**Figure 4a**). Meanwhile, the 3/O loitered on the ramp's starboard side, gradually moving down the ramp towards the quay while talking on his mobile telephone.

When pushing the semi-trailer from the lower to the main vehicle deck (**Figures 4a and 4b**), the tractor driver had to keep the semi-trailer in a straight line between the sides of the lower deck ramp. A slight alteration to the right was made towards the top of the ramp to avoid hitting a protective barrier around the stern ramp's starboard hydraulic ram. It was also noted that when transiting down the stern ramp, the semi-trailer was kept parallel and close to the starboard side (**Figure 9**).

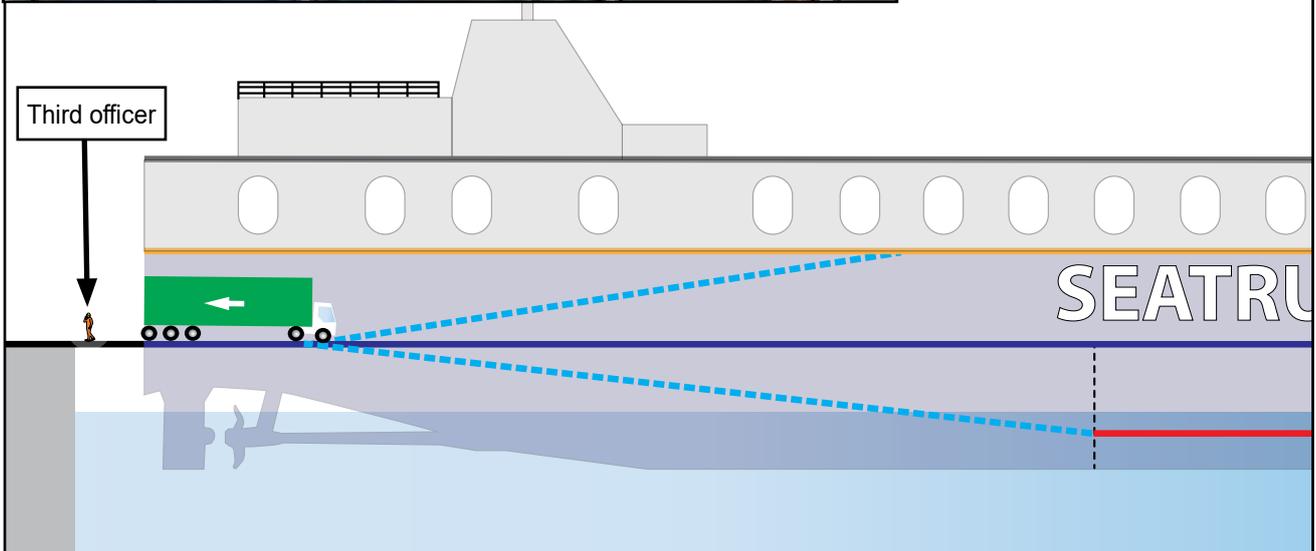
Figure 4b: Semi-trailer and tractor unit approaching the stern ramp

At 1926:38, the rear end of the semi-trailer that had been pushed from the lower deck reached the top of the stern ramp (**Figure 4b**). At the same time, another tractor driver in his cab, who was on the quay and approaching the stern ramp, saw the 3/O facing down the ramp and the semi-trailer moving towards him, so sounded his horn to give warning. Approximately 3 seconds later, the rear of the semi-trailer struck the 3/O (**Figure 5**).

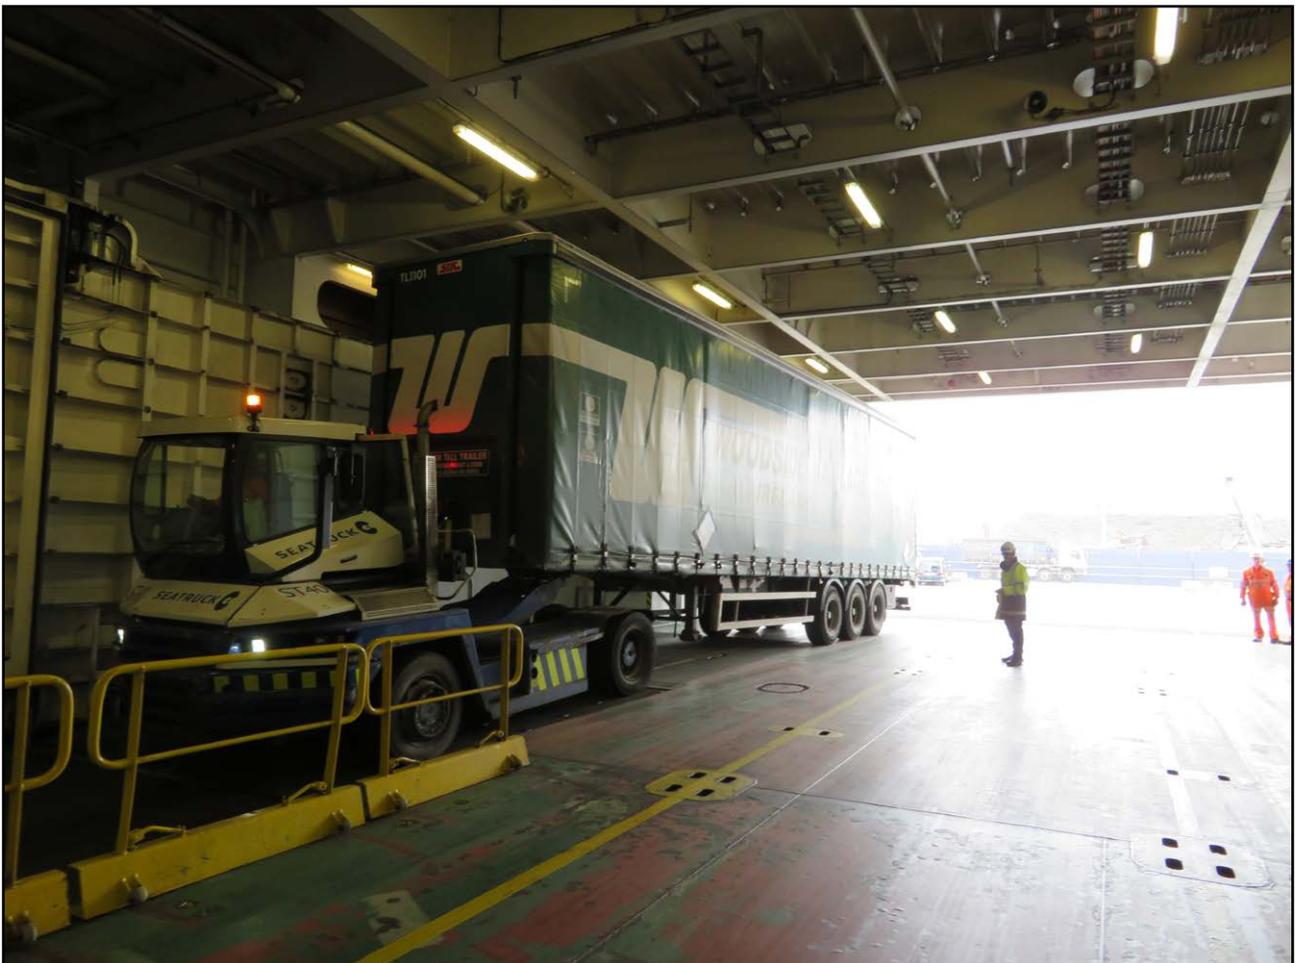
Figure 8: Vehicle handling reconstruction on board *Seatruck Power*

The noise from the tractor's engine as the semi-trailer approached was difficult to distinguish when standing at the bottom of the stern ramp. The tractor's audible reversing and pushing alarm could not be heard until the back end (free end) of the semi-trailer drew level with the observer's position. The tractor's orange flashing warning beacon was obscured by the semi-trailer and could not be seen.

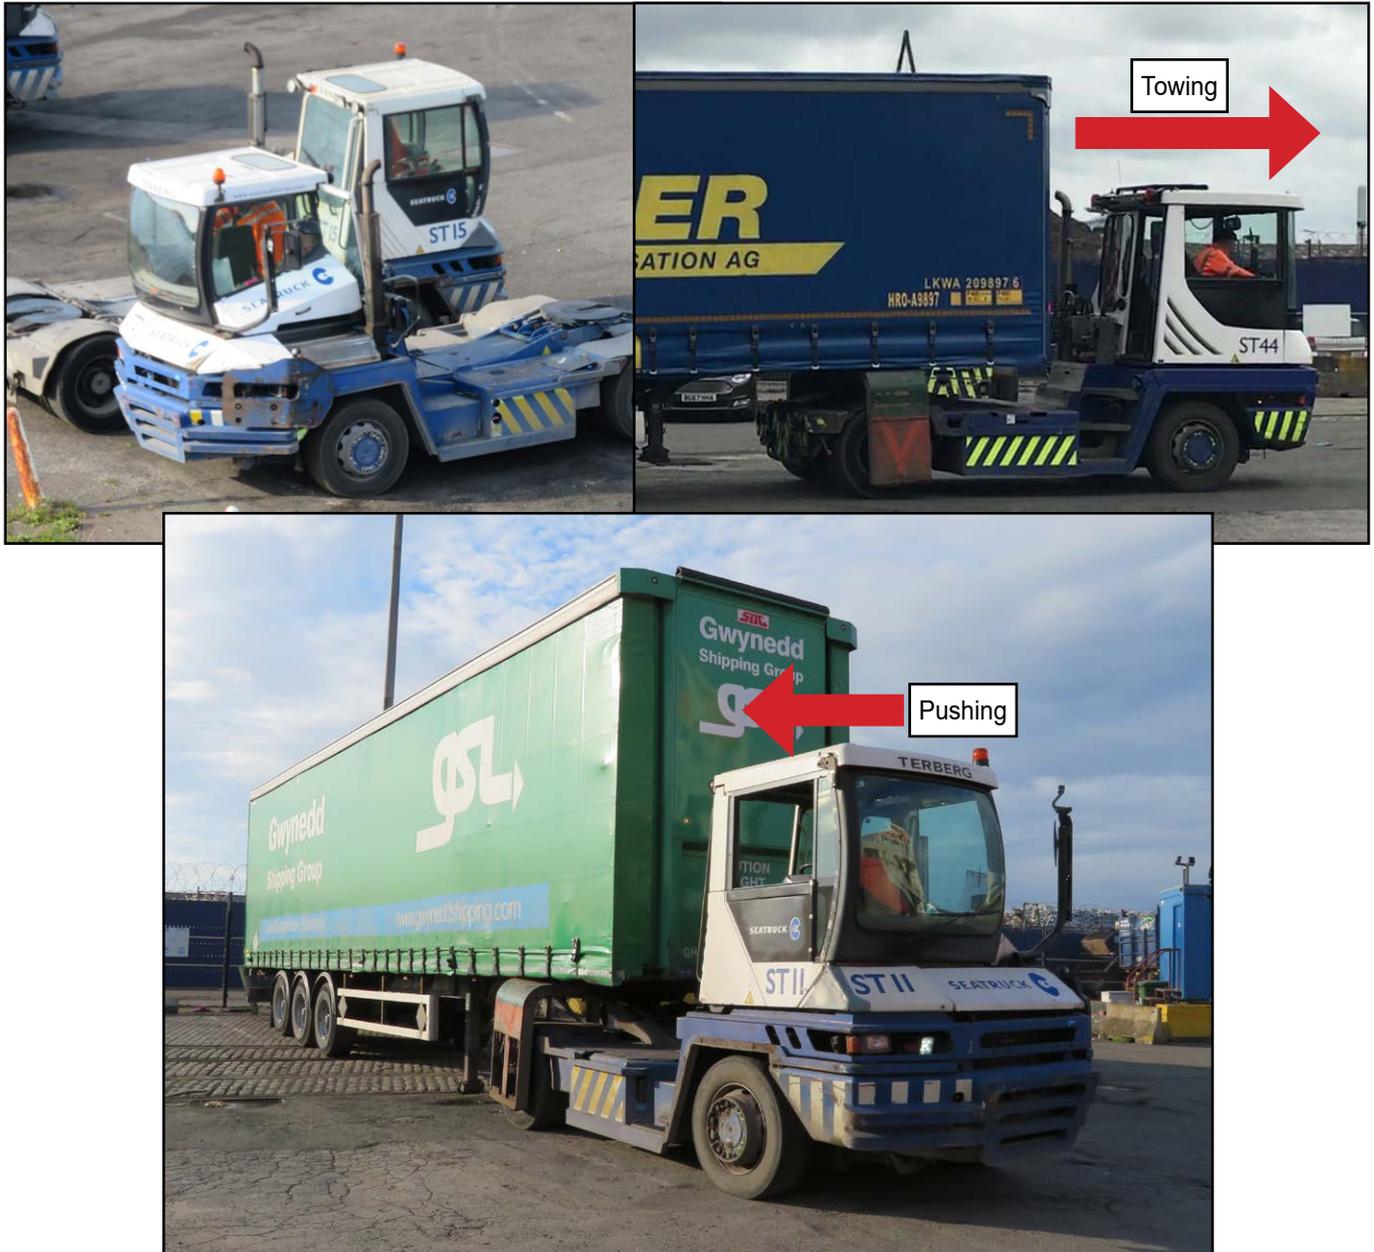
Figure 11: Tractor unit with semi-trailer

The tractors used to load and unload unaccompanied semi-trailers at Brocklebank Dock were manufactured in the Netherlands by Terberg Group B.V. The terminal had 45 Terberg RT222 tractor units that were specifically designed for use on board ro-ro freight vessels. The driver's seat and console were offset to the right-hand side of the cab (**Figure 11**) and could be rotated through 180°.

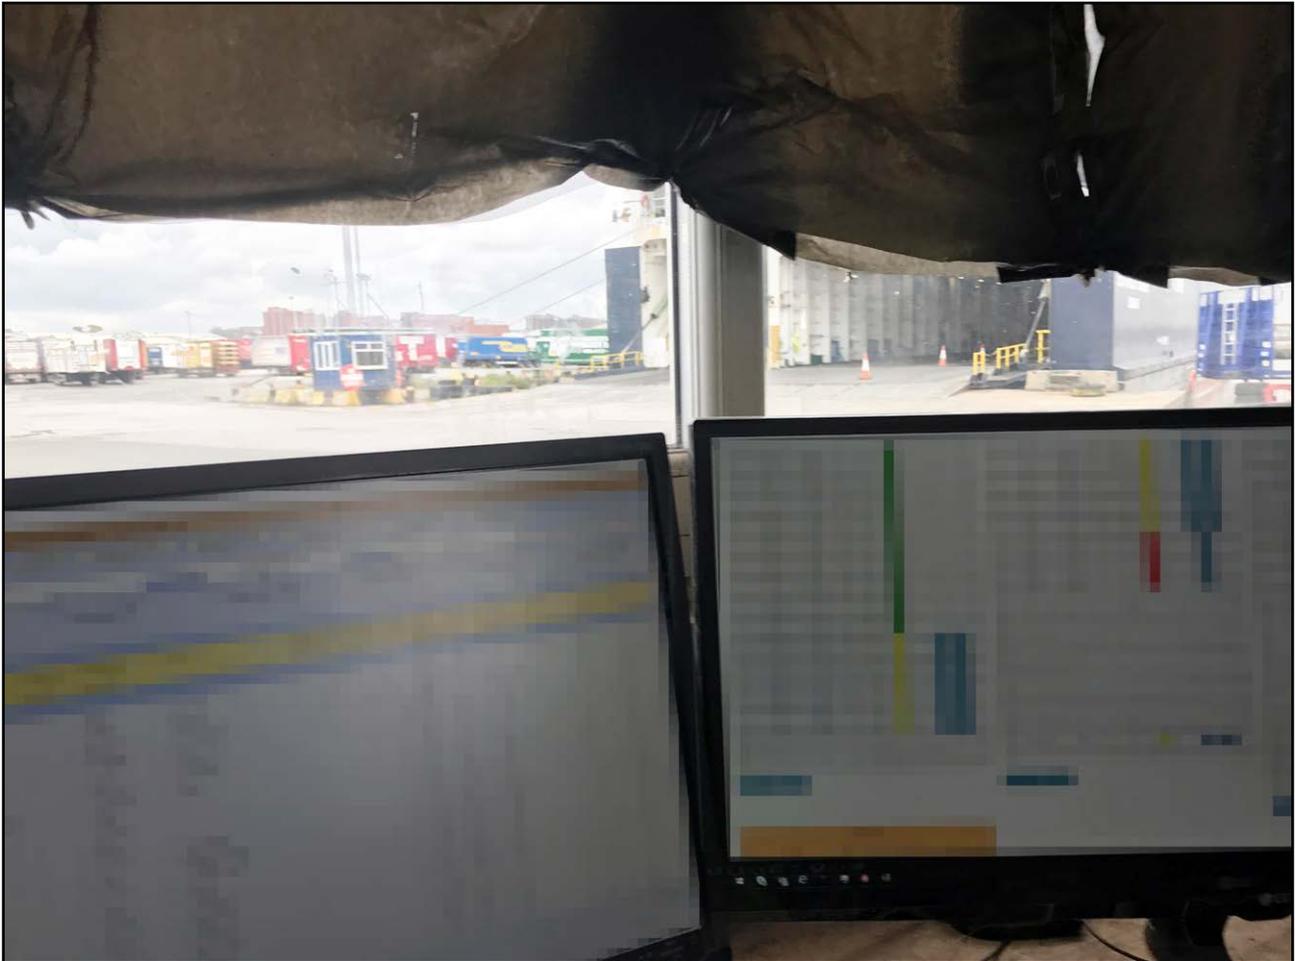
Figure 13: View from shore controller's portacabin

The movement and storage of semi-trailers inside the Brocklebank terminal were overseen by a Docklands shore controller from a portacabin on the quay opposite the ferry berth. The portacabin windows were partially covered by plastic bags to eliminate glare of the sun on the display screens inside. Despite this, the shore controller had a good view of the vehicle turning area at the bottom of the ferry's stern ramp and of the stern ramp itself (**Figure 13**).

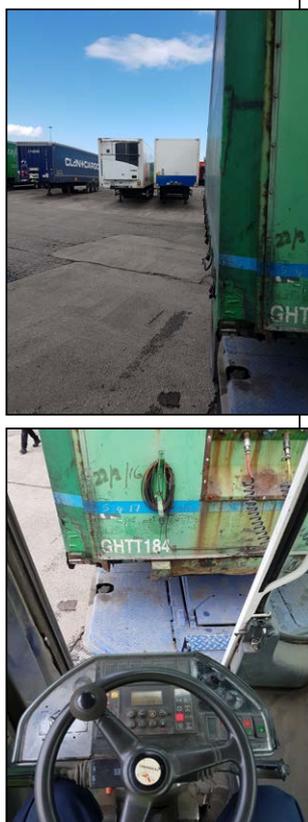
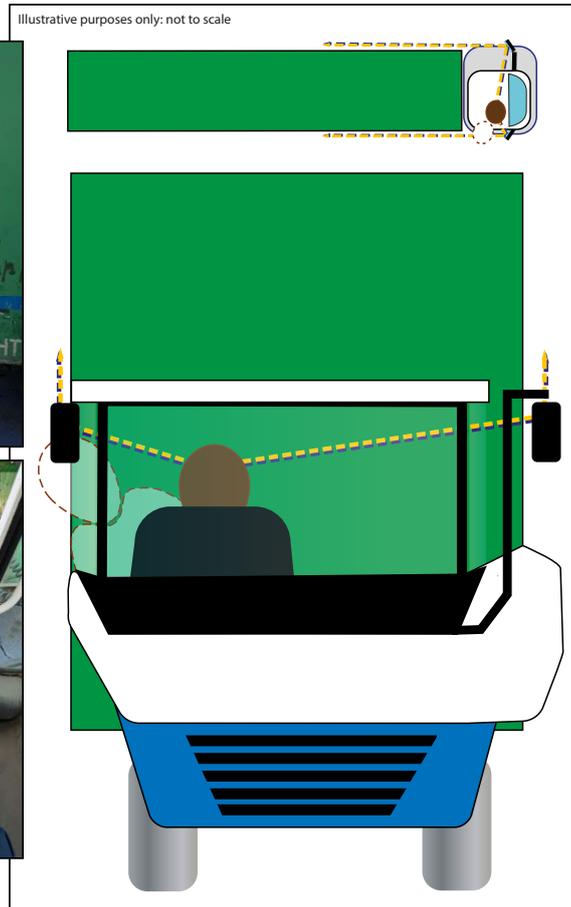
Figure 2: Driver's view ahead when pushing a semi-trailer

The tug driver was unable to see the third officer due to the semi-trailer blocking his view ahead (**Figure 2**) and he was not expecting any pedestrians to be on the stern ramp.

- When the stern ramp is the only means of access for pedestrians and vehicles, it is clear in the applicable codes of practice that either a protected walkway or other means of segregating vehicles and pedestrians is provided. Procedures based on a policy of ‘see and be seen’ are fraught with danger.

- Painted walkways on vehicle ramps and decks that are not protected are liable to be encroached upon by vehicles and are not safe unless other measures to control pedestrian access and vehicular traffic are also implemented. They are even less safe if they are not used.
