Report on the investigation of the near miss
between the ro-ro ferry
Stena Superfast VII
and a submerged
Royal Navy submarine
in the North Channel
on 6 November 2018

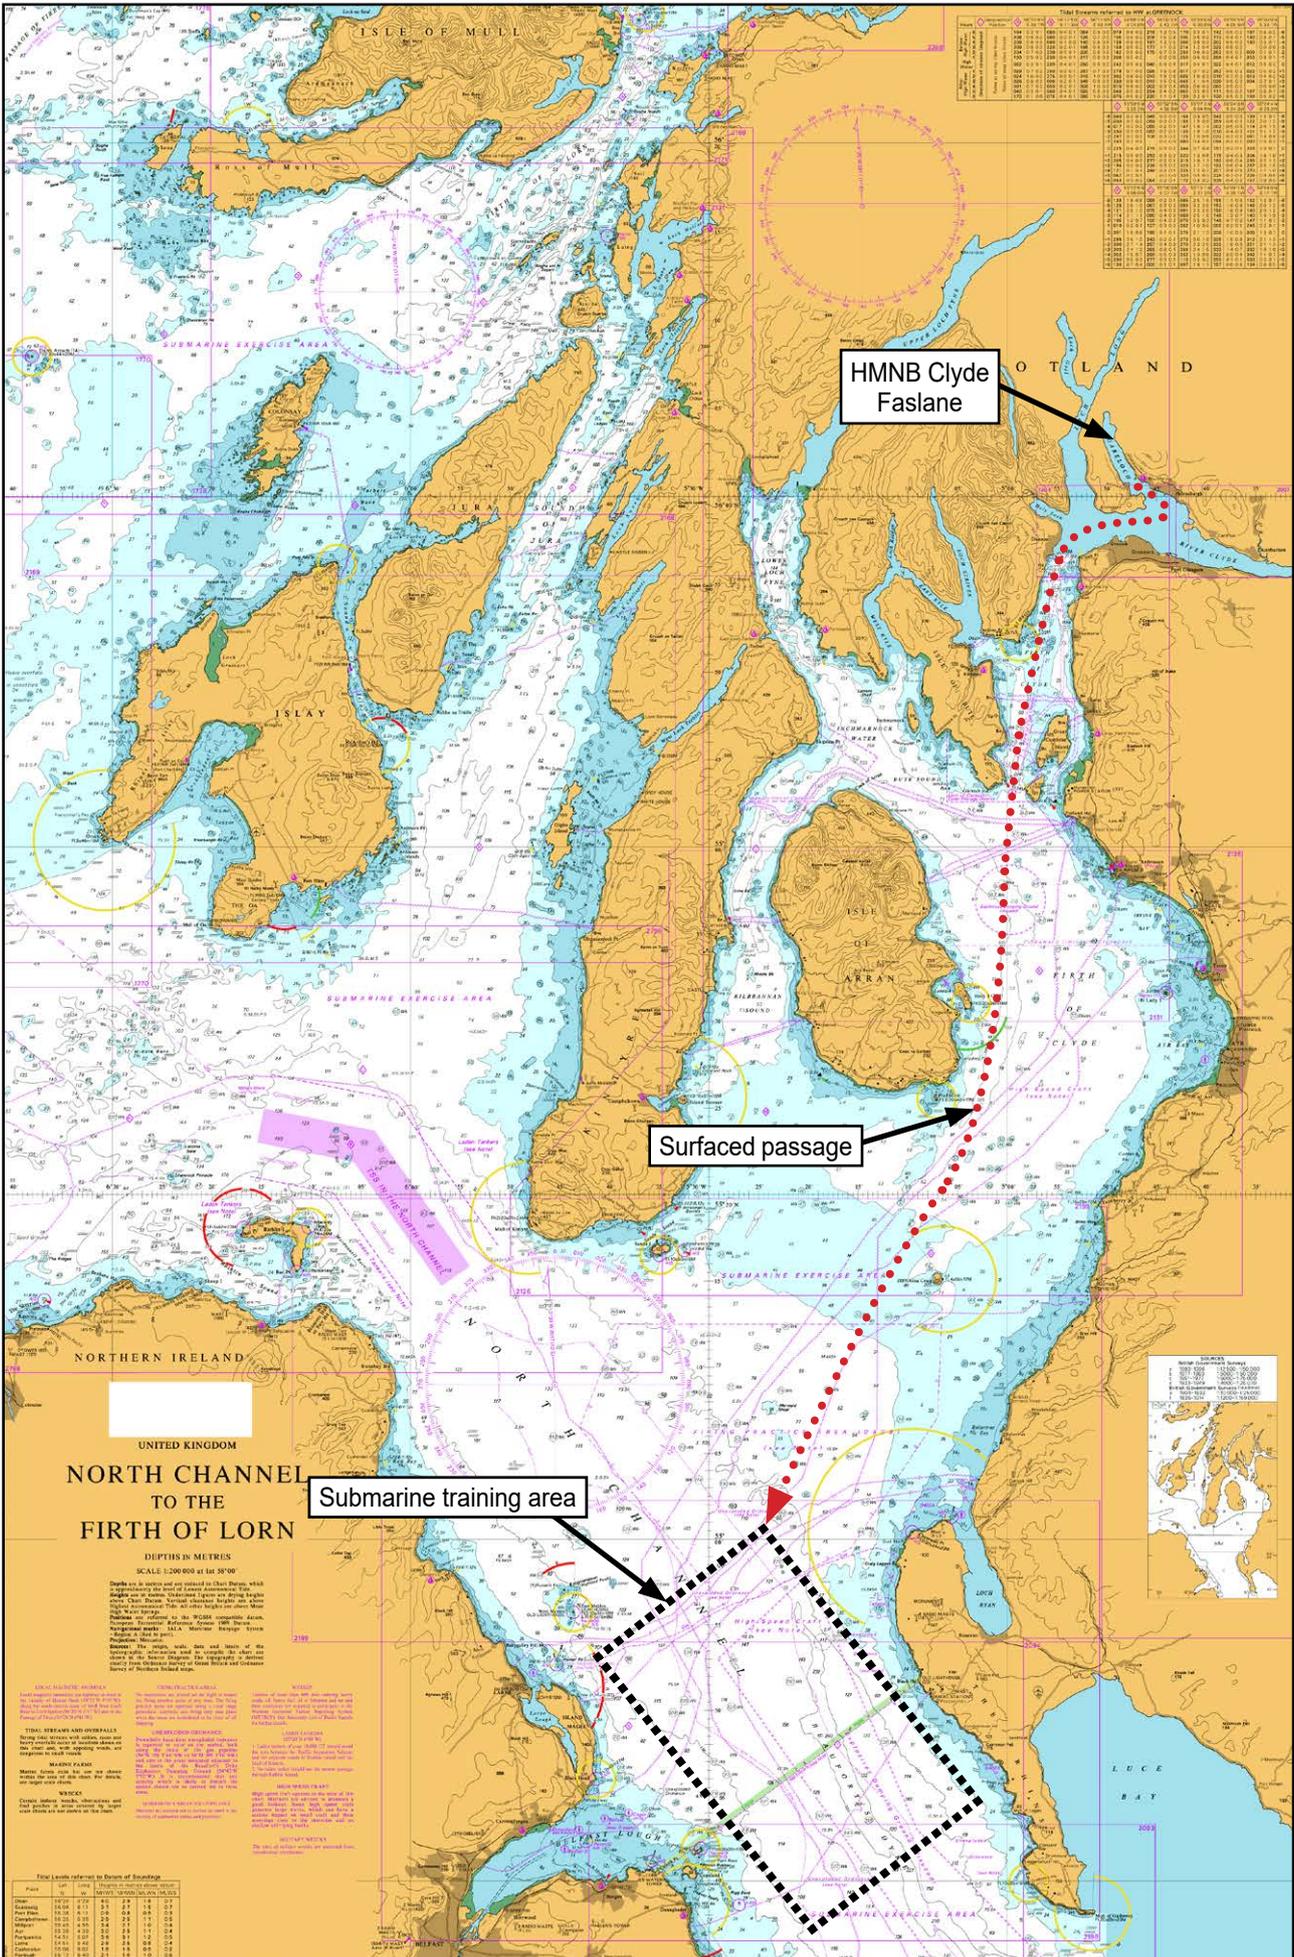
Figure 1: Overview of the submarine's operating base and allocated area for safety training

A Royal Navy (RN) submarine sailed from its base at Faslane, Scotland on 4 November 2018 and conducted a surface passage to the North Channel, where it submerged (**Figure 1**). The submarine was conducting pre-deployment safety training. Members of staff from the Flag Officer Sea Training (FOST) organisation were on board to facilitate the training and assess the submarine crew's performance.

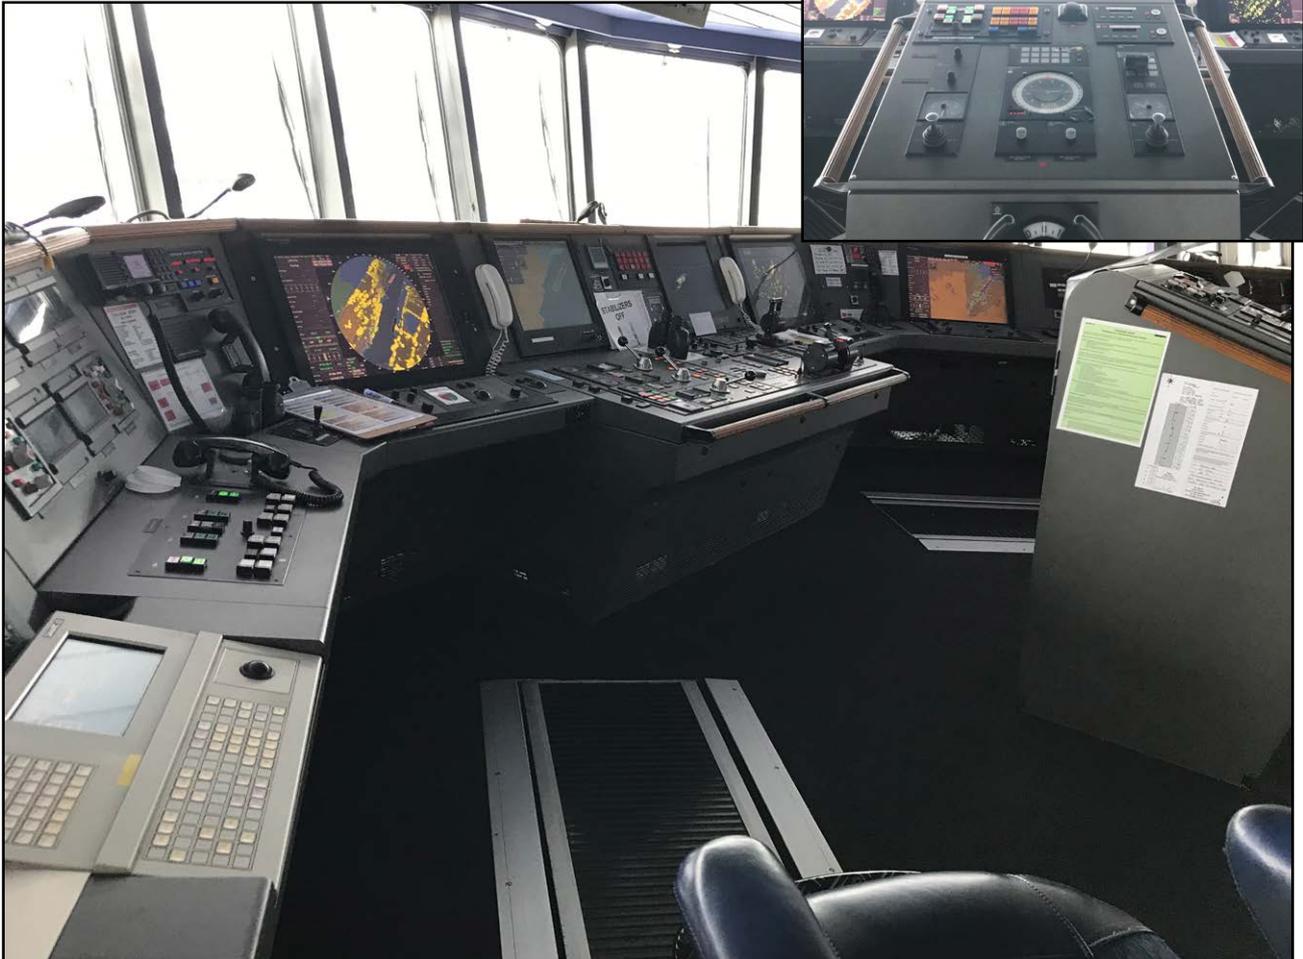
Figure 5: *Stena Superfast VII*'s bridge with centre console inset

Stena Superfast VII had three bridge control consoles: one on the centreline and one on each bridge wing. The centre console (**Figure 5**) was equipped with two radar displays, an electronic chart display and information system (ECDIS), very high frequency (VHF) radio and machinery controls. The primary steering position was integrated into the centreline console.

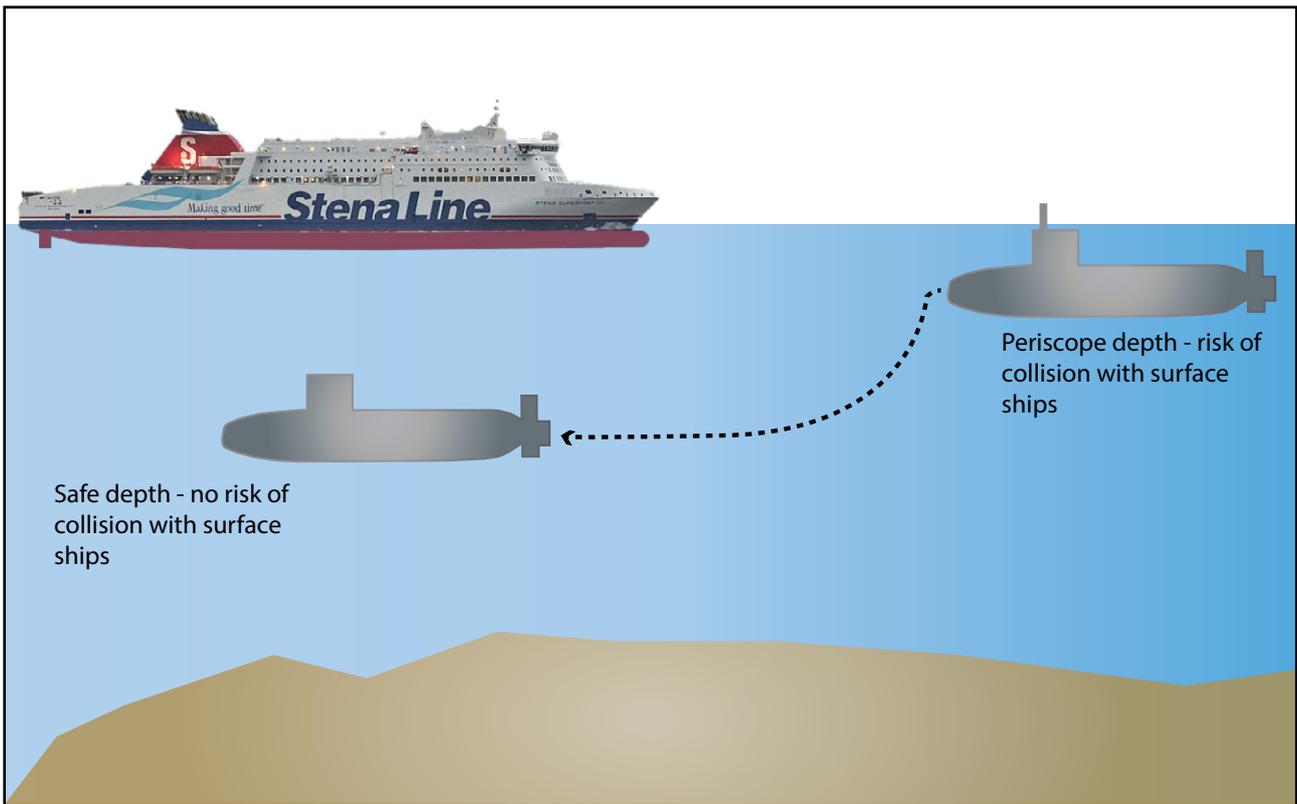
Figure 6: Illustration of periscope depth and safe depth used by Royal Navy submarines

Submarines can operate in two modes: surfaced or dived. When surfaced, the submarine is fully buoyant with the fin and casing visible; the OOW and a lookout are on the bridge. When dived, a submarine will either operate at periscope depth or deep. At periscope depth, the submarine is fully submerged but at a shallow depth where periscopes or radar can be used, and there is a risk of collision with surface ships. When deep, submarines operate at a depth where there is no risk of collision with any surface vessel that could be encountered; this is known as 'safe depth' (**Figure 6**).

Safety when operating at periscope depth was achieved by manoeuvring the submarine to ensure that surface vessels do not approach within the calculated go-deep range. Should a surface ship approach the go-deep range, collision was avoided by the submarine going deep to a safe depth (**Figure 6**). It takes about 1 minute for a submarine to go deep to a safe depth, so the go-deep range for any given vessel was the distance travelled at the combined speeds of both vessels in that time. This calculation was based on the worst case of both vessels heading directly towards each other.
