Person struck by tram at Gravel Hill tram stop, Croydon, 10 March 2020

Summary of the accident

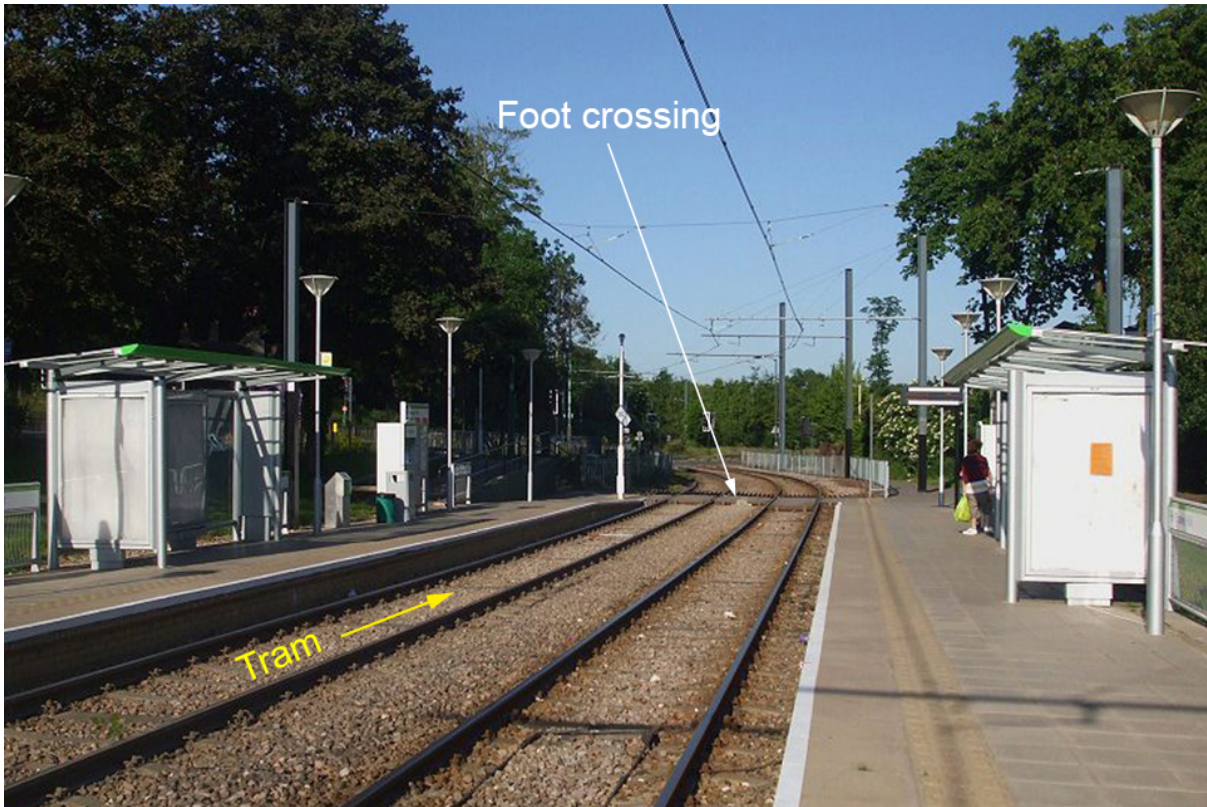
Gravel Hill tram stop looking towards road junction (photograph by Sunil060902, distributed under a CC-BY-SA 3.0 licence.)
