**ACCIDENT**

<b>Aircraft Type and Registration:</b>	DJI M600 Pro (UAS, registration N/A)	
<b>No &amp; Type of Engines:</b>	6 electric motors	
<b>Year of Manufacture:</b>	2019 (Serial no: 2016DP6137)	
<b>Date &amp; Time (UTC):</b>	13 December 2019 at 1521 hrs	
<b>Location:</b>	Wallsend, Tyne and Wear	
<b>Type of Flight:</b>	Aerial Work	
<b>Persons on Board:</b>	Crew - None	Passengers - None
<b>Injuries:</b>	Crew - N/A	Passengers - N/A
<b>Nature of Damage:</b>	Propellers, arms, landing gear, gimbal and camera lens damaged	
<b>Commander's Licence:</b>	Not applicable	
<b>Commander's Age:</b>	31 years	
<b>Commander's Flying Experience:</b>	44 hours (of which 6 were on type) Last 90 days - 8 hours Last 28 days - 4 hours	
<b>Information Source:</b>	AAIB Field investigation

**Synopsis**

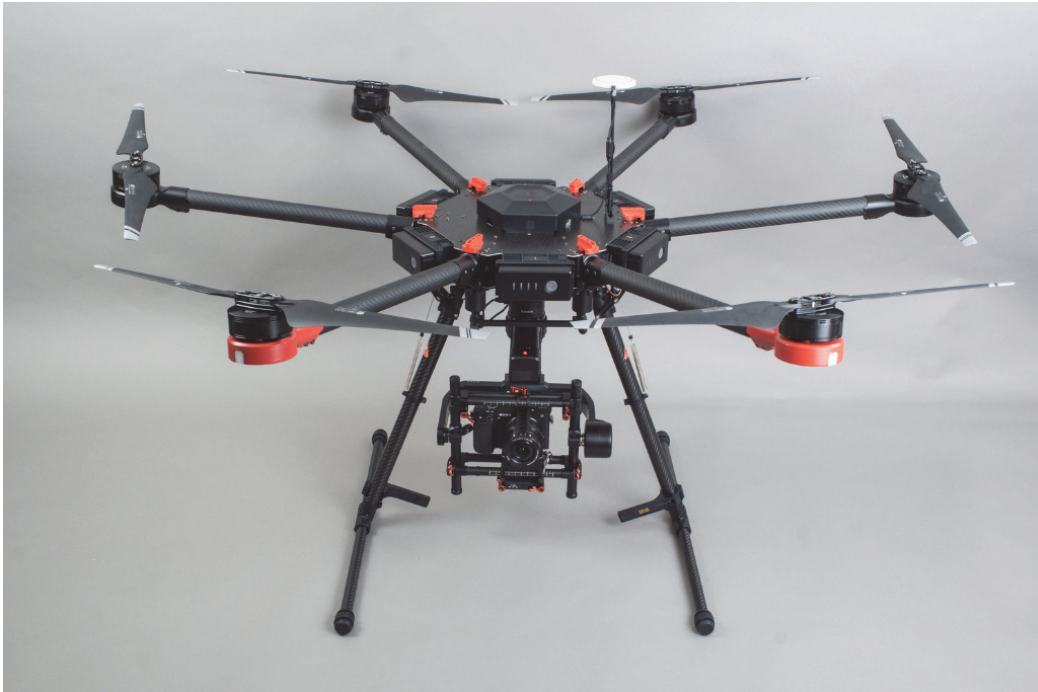
**Figure 4**

M600 series aircraft

The accident aircraft was fitted with three GPS antenna (white circular components)  
(photograph used with permission)

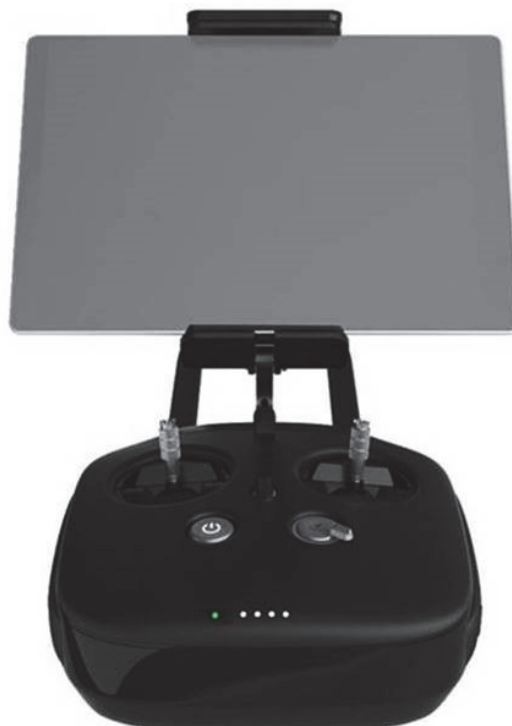
**Figure 5**

M600 Pro aircraft controller
