## ACCIDENT

<b>Aircraft Type and Registration:</b>	Standard Cirrus 75, G-DDGX	
<b>No &amp; Type of Engines:</b>	No engines	
<b>Year of Manufacture:</b>	1975 (Serial no: 619)	
<b>Date &amp; Time (UTC):</b>	27 July 2019 at 1130 hrs	
<b>Location:</b>	Gwernesney Airfield, Monmouthshire	
<b>Type of Flight:</b>	Private	
<b>Persons on Board:</b>	Crew - 1	Passengers - None
<b>Injuries:</b>	Crew - 1 (Fatal)	Passengers - N/A
<b>Nature of Damage:</b>	Aircraft destroyed	
<b>Commander's Licence:</b>	British Gliding Association (BGA) Certificate with B Badge Endorsement	
<b>Commander's Age:</b>	54 years	
<b>Commander's Flying Experience:</b>	Total hours not determined 182 flights totalling 41 hours since August 2015 (of which 2 hours and 20 minutes were on type) Last 90 days - 3 hours and 42 minutes Last 28 days - 1 hour and 38 minutes	
<b>Information Source:</b>	AAIB Field Investigation

## Synopsis

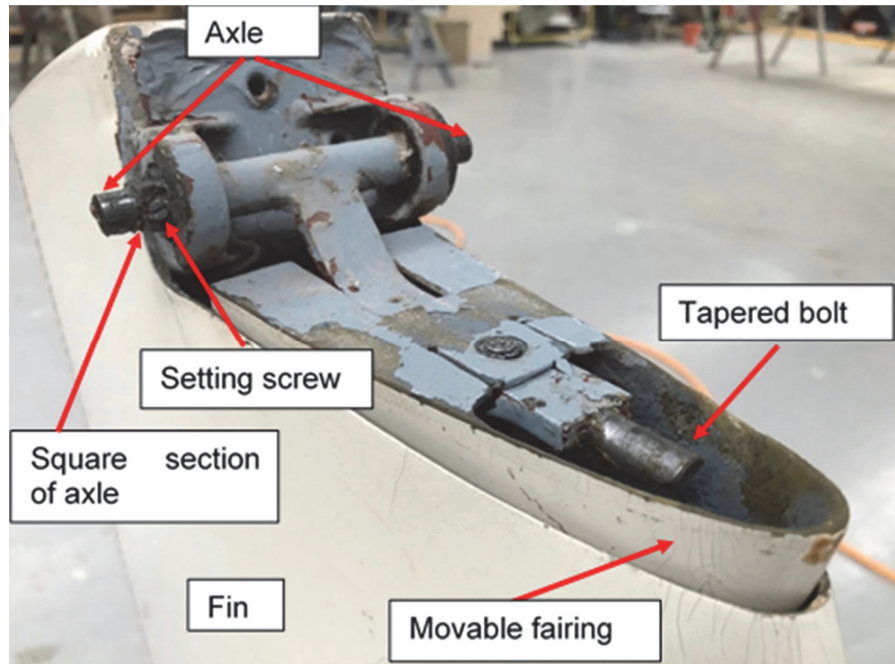
**Figure 4**

Standard Cirrus 75 Modified tailplane attachment fitting at top of fin

Disruption to the top of the tail fin caused by the impact, meant that the moveable fairing around the tailplane attachment mechanism had separated, but the mechanism was otherwise intact. There was no evidence of grease on the mechanism, but it rotated freely. No tangential play was evident in the mechanism and the setting screws had several threads wound out, indicating that they had previously been adjusted.

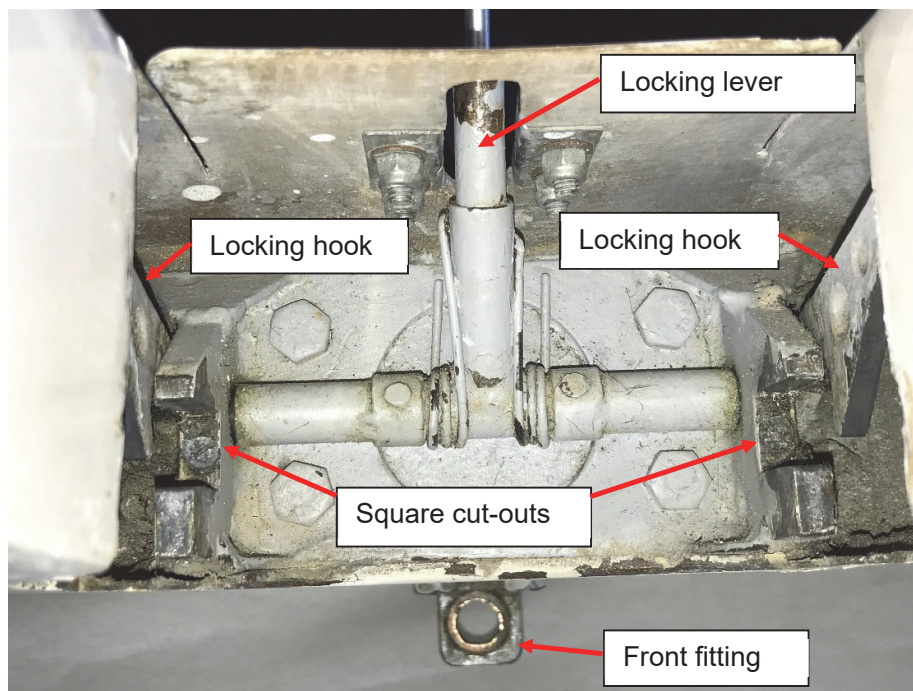
**Figure 5**

Standard Cirrus 75 Modified tailplane attachment mechanism  
(view looking forward)

When the tailplane is placed on top of the fin, square cut-outs in the mounting bracket engage with the square sections of the axle on the fin fitting, to locate the tailplane. Two adjustable setting screws on the square axle sections are used to remove any tangential play in the mechanism. The locking hooks engage with the circular ends of the axle. The hooks are spring-loaded to the closed position and are operated by a locking lever.

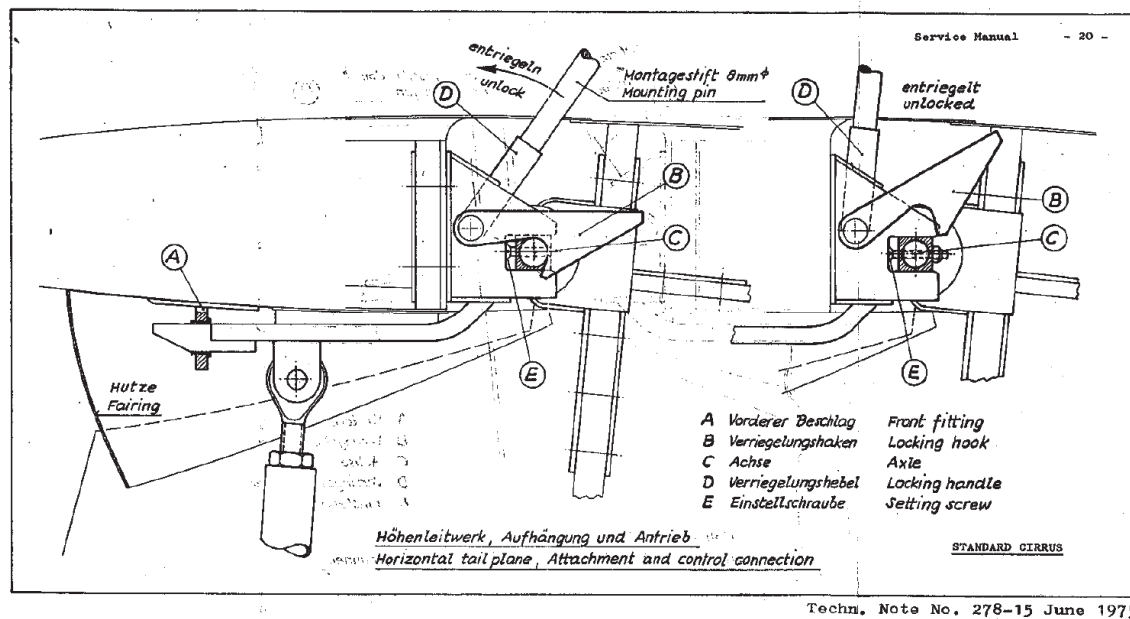
**Figure 7**

In 1975, the modified tailplane attachment mechanism was introduced by Technical Notice (TN) 278-15 *'Attachment and control connection of the horizontal tailplane'* (Figure 7). The reason for the modification was described as *'Simplification of the mounting, easy checking of the mounting, adjustable tangential backlash of the elevator control.'* Later models of the Standard Cirrus, including G-DDGX, were manufactured with TN 278-15 already embodied.

Tailplane attachment and control connection from TN 278-15 and Standard Cirrus flight manual

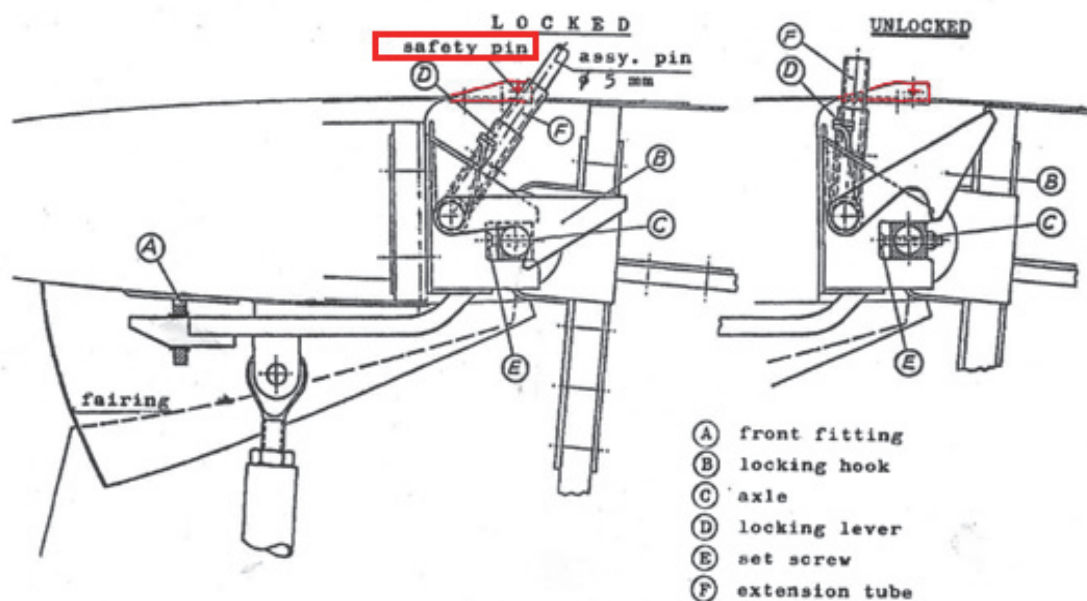
**Figure 8**

TN 278-36 'Safety device for the locking lever of the tailplane attachment,' was introduced on 24 November 1994 and was subsequently mandated by Airworthiness Directive 95-015<sup>6</sup> dated 15 December 1994. It was required to be embodied before 31 March 1995. The reason for the modification was described as: 'Due to the lack of maintenance or because of wear, the locking hook on the tailplane attachment bracket became disengaged in a number of cases, so that the horizontal tailplane was no longer securely attached to the fin.' The actions required by TN 278-36 included: 'Re-adjustment of the set screws on the tailplane attachment bracket to eliminate any tangential play ... Installation of a safety device [pin] for the locking lever... Check of the rigged and secured horizontal tailplane for full and free movement up to the stops.' It did not stipulate any amendments to the existing rigging instructions in the flight manual. An illustration from TN 278-36 is shown in Figure 8.

Tailplane attachment and control connection from TN 278-36 showing addition of a metal bracket and safety pin
