Signals passed at danger due to reduced brake performance, near Crofton West Junction, West Yorkshire, 7 May 2020

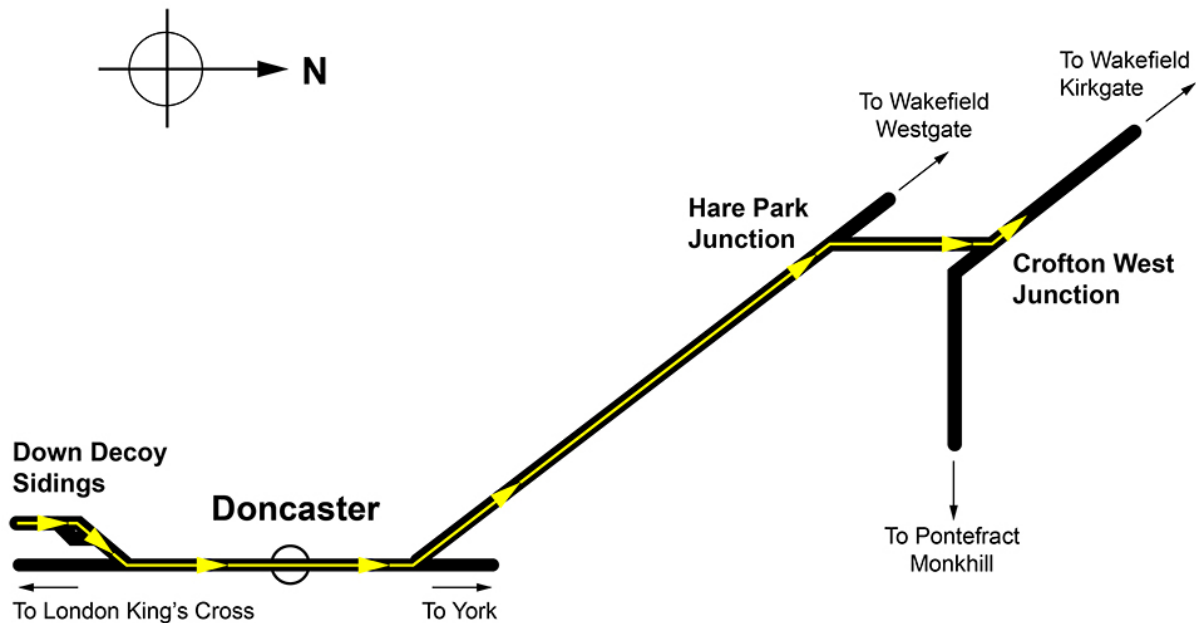
At around 09:54 hrs, the driver of a freight train applied the brakes on the approach to a red signal at Hare Park Junction, near Wakefield but was unable to stop. The train continued with the brakes applied and passed a second red signal, about 2200 metres later, that was protecting Crofton West Junction. The train came to a stop 250 metres beyond the junction. A passenger train that was approaching Crofton West Junction on a conflicting route was stopped by signals when it was approximately 3 km away.
