SERIOUS INCIDENT

Aircraft Type and Registration:	Airbus A319-111, G-EZNM	
No & Type of Engines:	2 CFM56-5B5/P turbofan engines	
Year of Manufacture:	2005 (Serial no: 2402)	
Date & Time (UTC):	11 May 2019 at 0630 hrs	
Location:	En route to Bristol Airport	
Type of Flight:	Commercial Air Transport (Passenger)	
Persons on Board:	Crew - 6	Passengers - 107
Injuries:	Crew - None	Passengers - None
Nature of Damage:	None	
Commander's Licence:	Airline Transport Pilot's Licence	
Commander's Age:	41 years	
Commander's Flying Experience:	9,159 hours (of which 5,737 were on type) Last 90 days - 54 hours Last 28 days - 26 hours	
Information Source:	AAIB Field Investigation

Synopsis

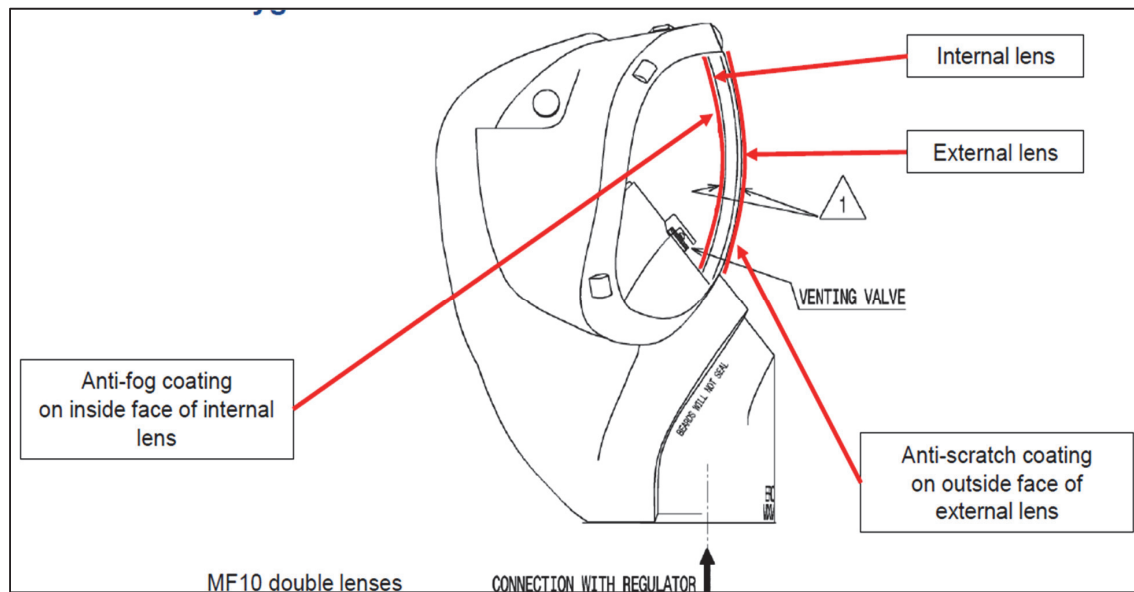
Figure 1
Mask lens arrangement

The mask type fitted to G-EZNM was a 'MF10' full-face mask-regulator that provides protection during depressurisation and smoke events, while allowing the pilots to communicate with each other. The window has two lenses with an air gap between them. The internal lens has an anti-fogging coating (Figure 1).

The commander's external and internal lenses were reported to be in a "good condition". The inner surface of the internal lens was sensitive to fogging (uniform blurring), and fogging remained for a few seconds on the inner surface of the internal lens after exhaling on it.

The co-pilot's external and internal lenses were reported to be in a "bad condition", with scratches present. The inner surface of the internal lens was sensitive to fogging (with non-uniform blurring reported), and fogging remained for a few seconds on the inner surface of the internal lens after exhaling on it. When fogging appeared on the inner surface of the internal lens, elongated shapes were visible that looked as though the surface had been wiped (Figure 3).

'CAUTION: BE CAREFUL NOT TO PUT DETERGENT SOLUTION, DISINFECTANT OR WATER ON THE MASK VISOR. IF YOU DO, DAMAGE TO THE ANTI-MIST LAYER OF THE MASK VISOR CAN OCCUR.'
