ACCIDENT

Aircraft Type and Registration:	Britten-Norman Islander, VP-MNI	
No & Type of Engines:	2 Lycoming 0-540-E4C5 piston engines	
Year of Manufacture:	1971 (Serial no: 183)	
Date & Time (UTC):	23 September 2019 at 2020 hrs	
Location:	John A Osborne Airport, Montserrat	
Type of Flight:	Commercial Air Transport (Passenger)	
Persons on Board:	Crew - 1	Passengers - 6
Injuries:	Crew - None	Passengers - None
Nature of Damage:	Left tailplane spar and elevator bent, left wingtip and aileron damaged	
Commander's Licence:	Commercial Pilot's Licence with Montserrat Certificate of Validation	
Commander's Age:	30 years	
Commander's Flying Experience:	660 hours (of which 303 were on type) Last 90 days - 85 hours Last 28 days - 21 hours	
Information Source:	AAIB Field investigation

Synopsis

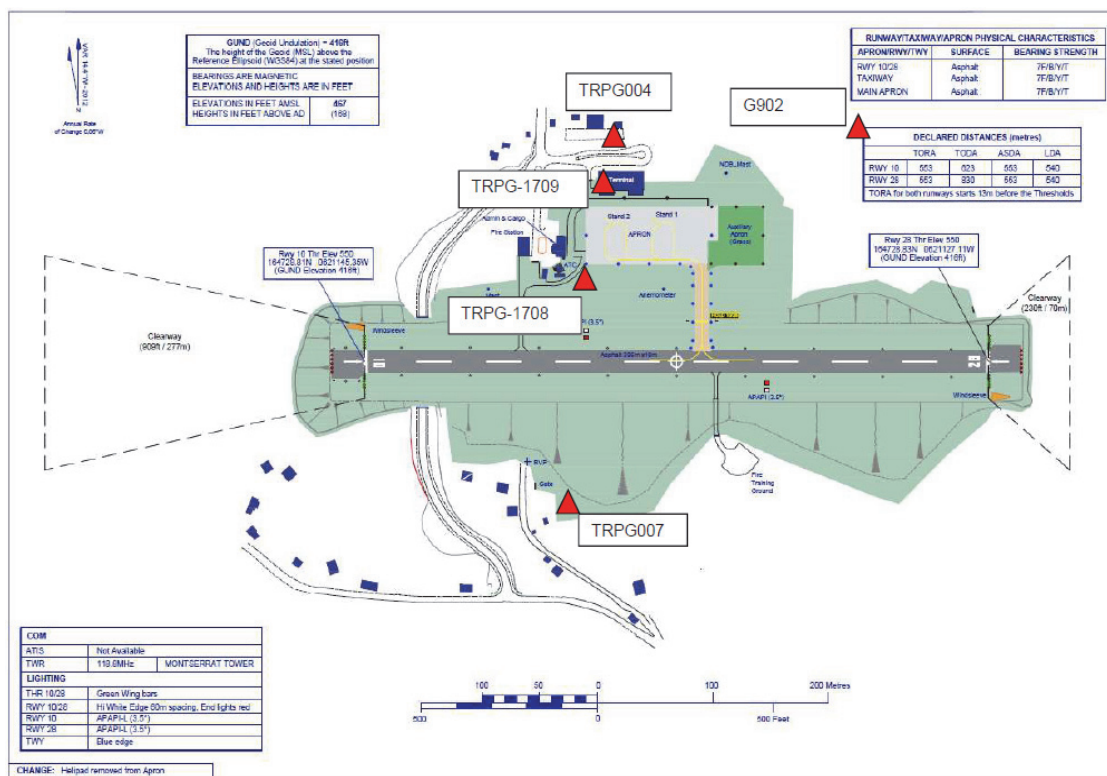
Figure 5

The airport is sited on a hill with a single runway orientated 10/28 (Figure 5). The thresholds of Runway 10 and 28 are 550 ft amsl. Runway 10 has Precision Approach Path Indicators (PAPIs) set to an approach angle of 6° and Runway 28 has Abbreviated PAPIs (APAPIs) set to an approach angle of 4°.

The Aeronautical Information Publication chart for Montserrat, John A Osborne Airport
