Report on the investigation of the grounding
and recovery of the container feeder vessel

Thea II

Svitzer Josephine

in the approaches to the Humber Estuary

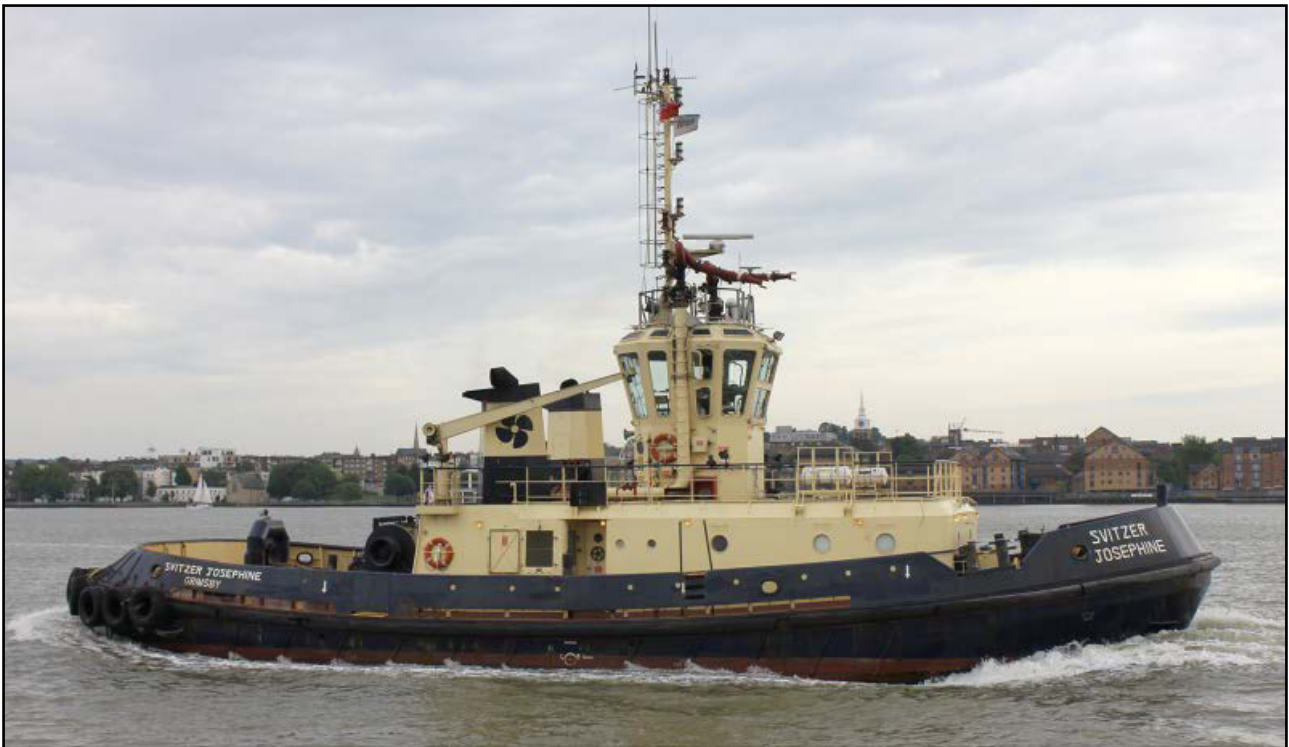
Figure 2: Svitzer Josephine

The VTSO then tried to raise the crew of *Svitzer Josephine* (**Figure 2**), Immingham Oil Terminal's (IOT) duty fire tug, on VHF radio, to enquire if they were able to assist *Thea II*. The call went unheard as the tug's bridge was not manned. The VTSO then contacted the IOT duty officer and requested that he activate the duty fire tug alarm. The alarm was heard on board the tug, and *Svitzer Josephine*'s master immediately contacted VTS Humber. The VTSO informed him that the container feeder vessel *Thea II* had broken down, was anchored on the north side of the channel and needed urgent tug assistance. *Svitzer Josephine*'s master agreed to assist. He then asked the VTSO to notify the Svitzer office of their tasking so that they could arrange a replacement fire tug.

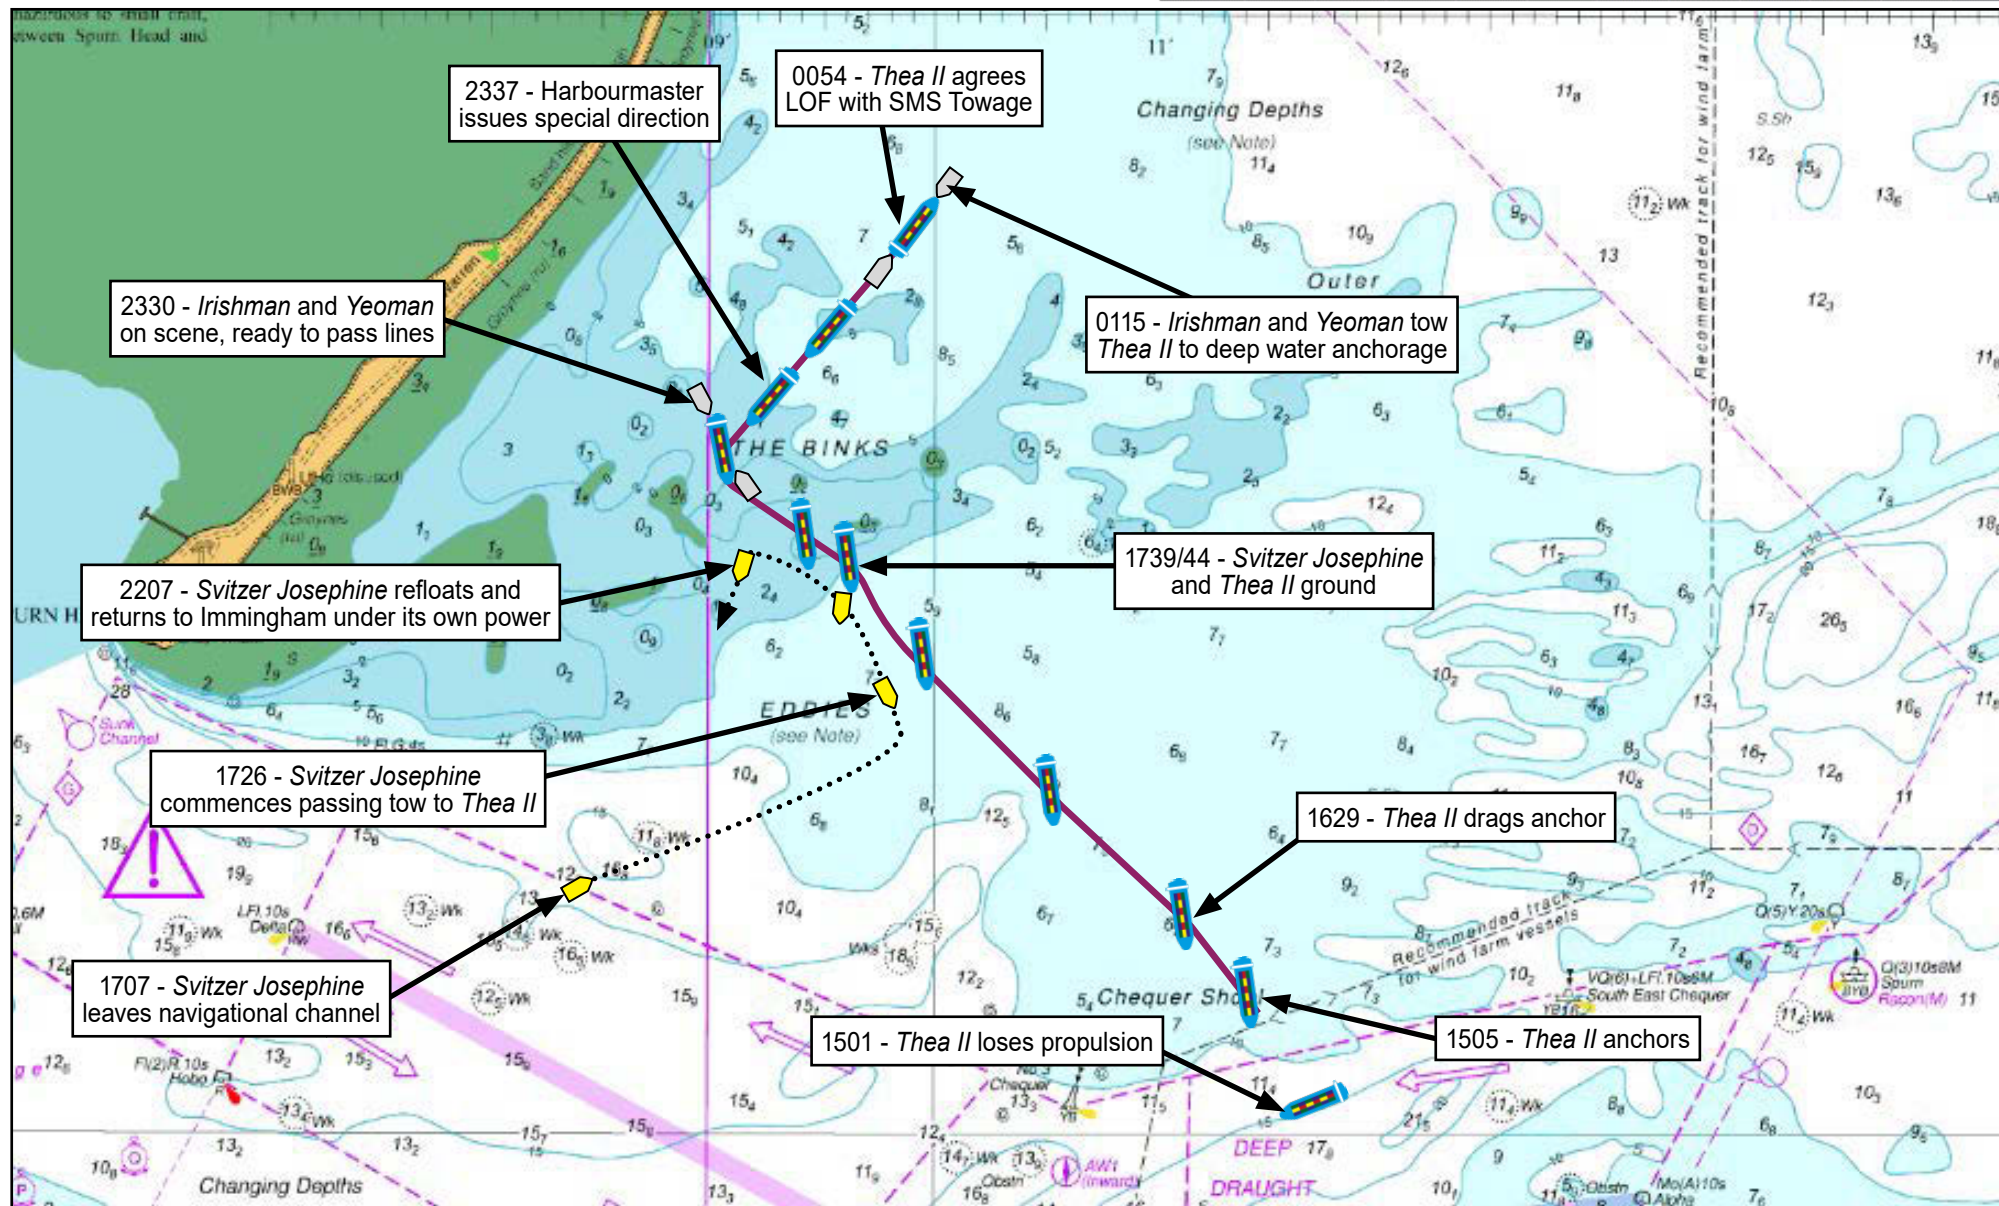
Figure 3: Overview of the accident track from 1501 on 15 December until 0115 on 16 December

At 1633, just before low water Spurn Head², the VTSO observed *Thea II* drifting north-west at 1.7kts (knots) (**Figure 3**). He called the vessel and enquired if *Thea II* was dragging its anchor. The master confirmed that this was the case and reported that he was deploying a further shackle of anchor cable. However, this did not stop the vessel's drift.

The tidal streams in the approaches to the Humber Estuary near the Binks shoal flowed south-south-west on the flood and north-north-east on the ebb tide, at rates of up to 2kts. Initially the tidal stream set north-north-east until 1800, south-south-west until midnight, before setting north-north-east again (**Figure 3**).

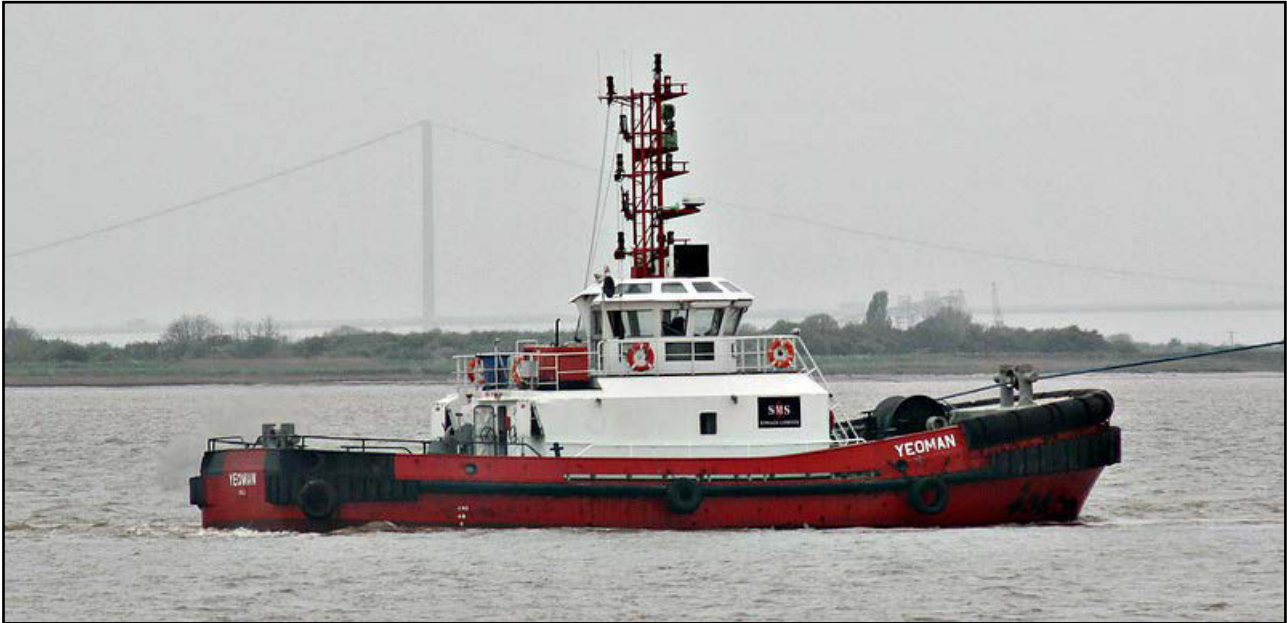
Figure 5: *Yeoman* (Hong Kong class) tug

At 2145, the tugs *Yeoman* and *Irishman* (**Figure 5**) left the main channel to approach *Thea II*. Shortly afterwards, *Yeoman* reported to VTS that the weather conditions were unsuitable to pass towlines.

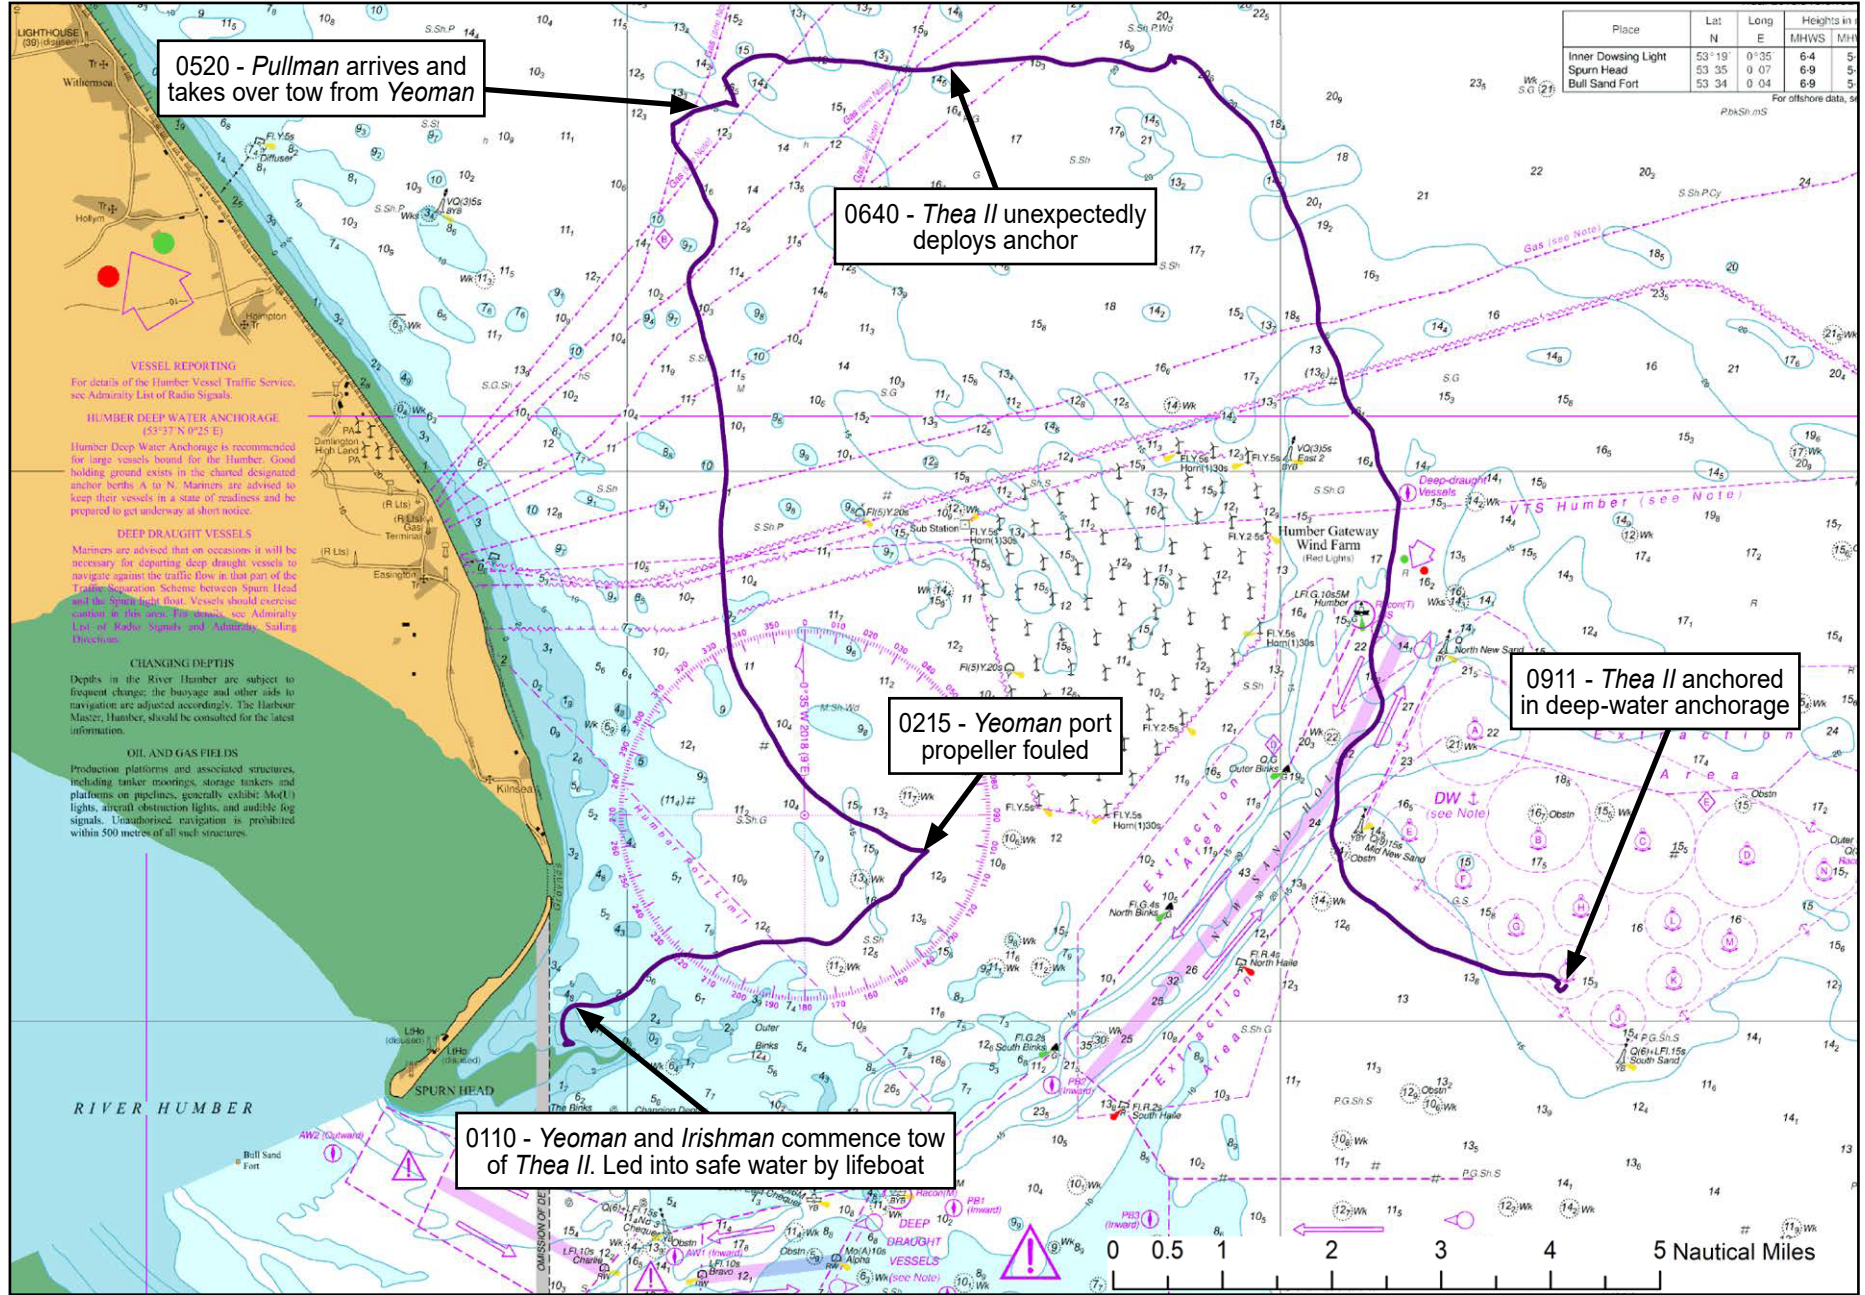
Figure 6: Thea II's passage, under tow, from the Binks shoal to the deep water anchorage

The tugs towed *Thea II* to the north following a passage plan agreed with the harbourmaster (**Figure 6**). This took the vessel down sea, between the mainland and the Humber Gateway windfarm. From there, the plan took *Thea II* east of the windfarm, before taking it south to the port's deep water anchorage. Thereafter, the plan was that *Thea II* would remain at anchor until the weather moderated and the vessel could be safely towed into harbour.

Shortly after 0200 the forward tug, *Yeoman*, unexpectedly lost the use of its starboard azimuth unit. This was quickly followed by the failure of its port azimuth unit at 0215. The remaining tug, *Irishman*, was able to control the tow as the three vessels ran down sea at slow speed. VTS Humber was informed and SMS Towage

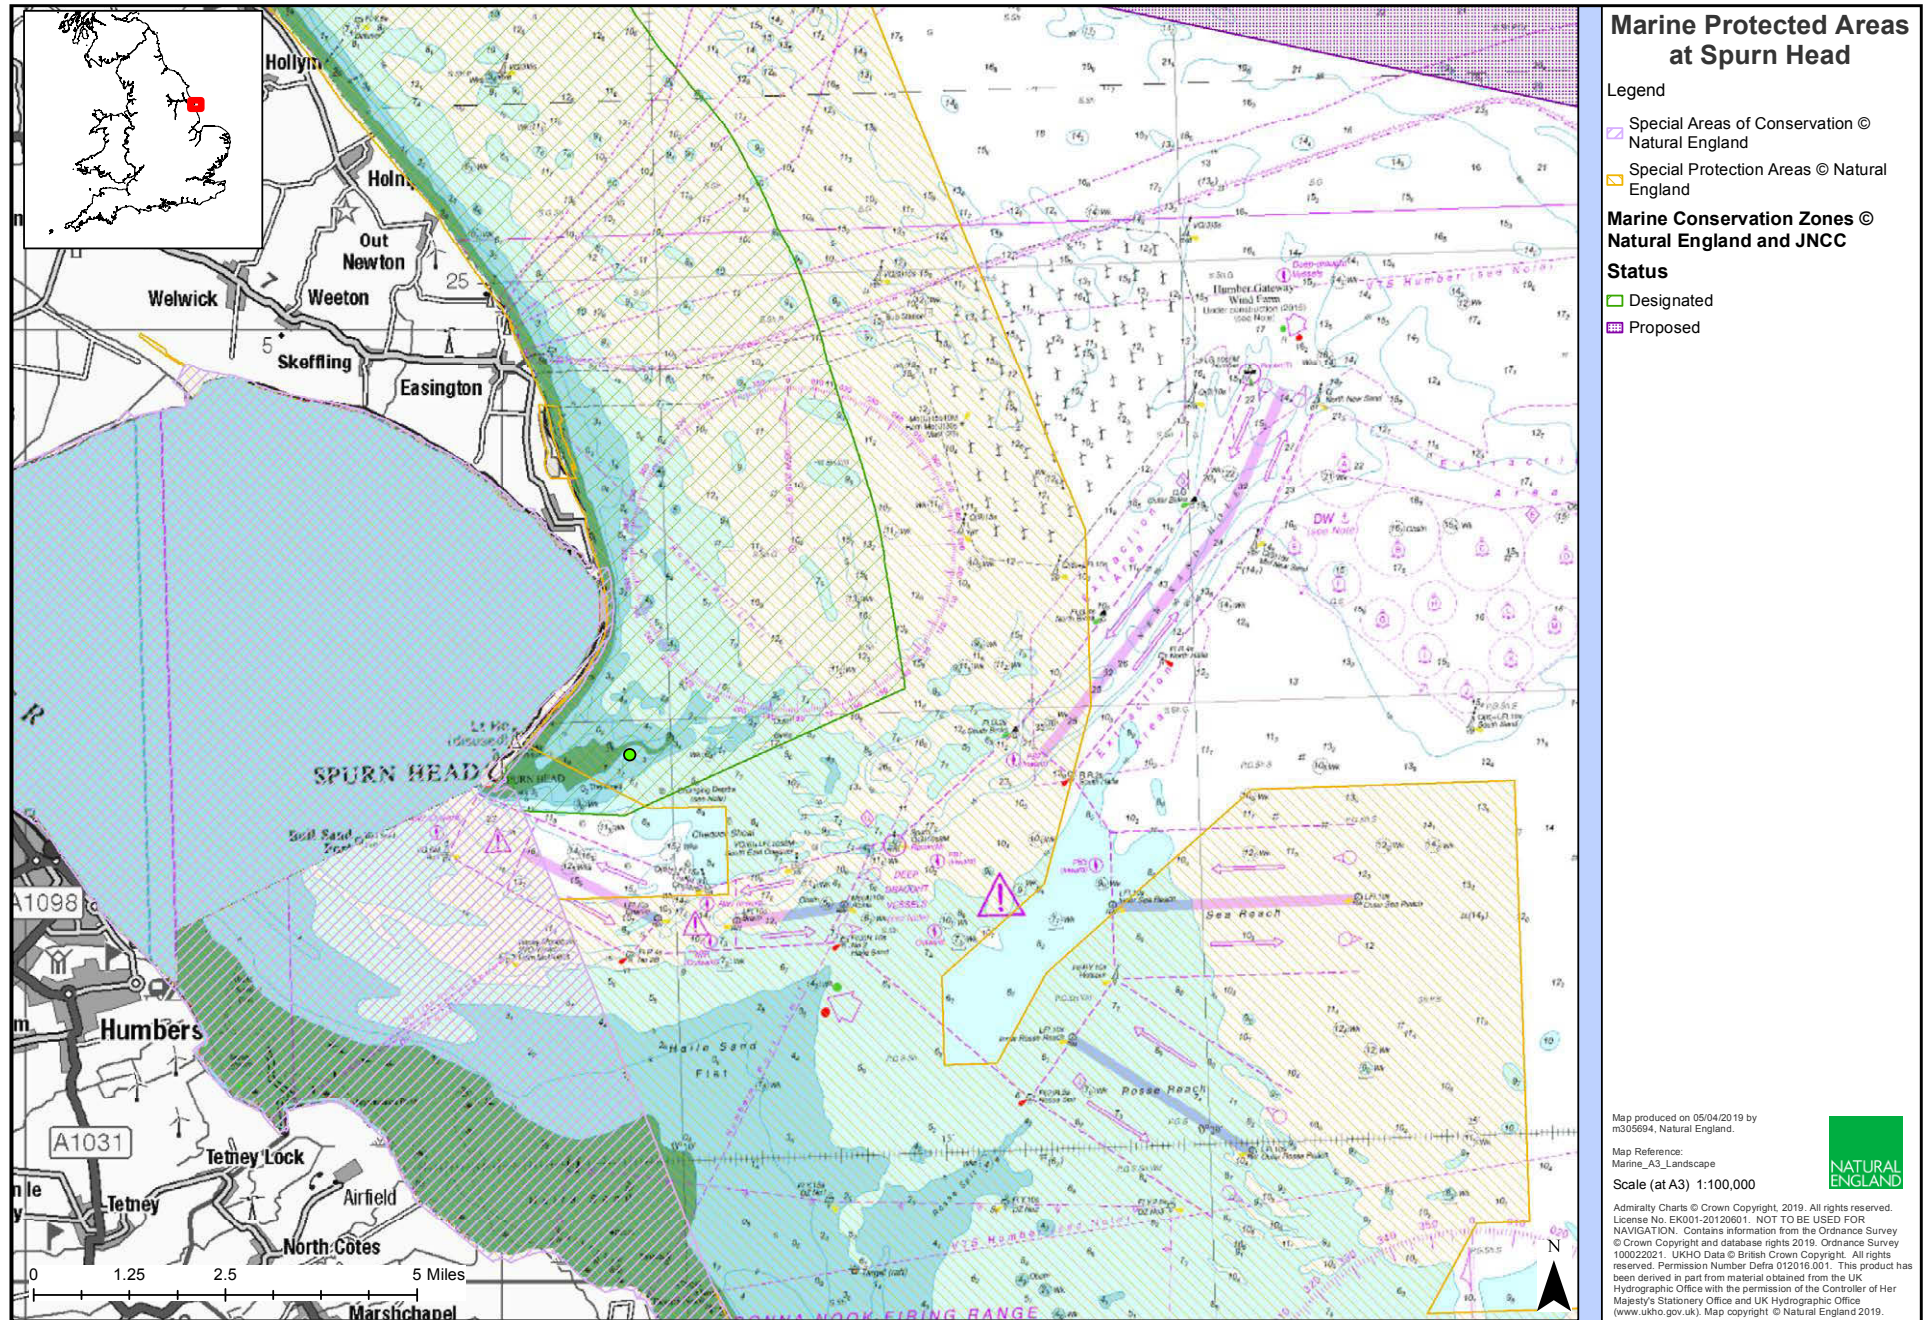
Figure 10: Marine protected areas at Spurn Head

The Humber port area contained several environmentally sensitive sites. *Thea II* and *Svitzer Josephine* grounded in a Marine Conservation Zone³ and Special Protection Area⁴, which were adjacent to a Special Area of Conservation and Ramsar site⁵ (**Figure 10**).

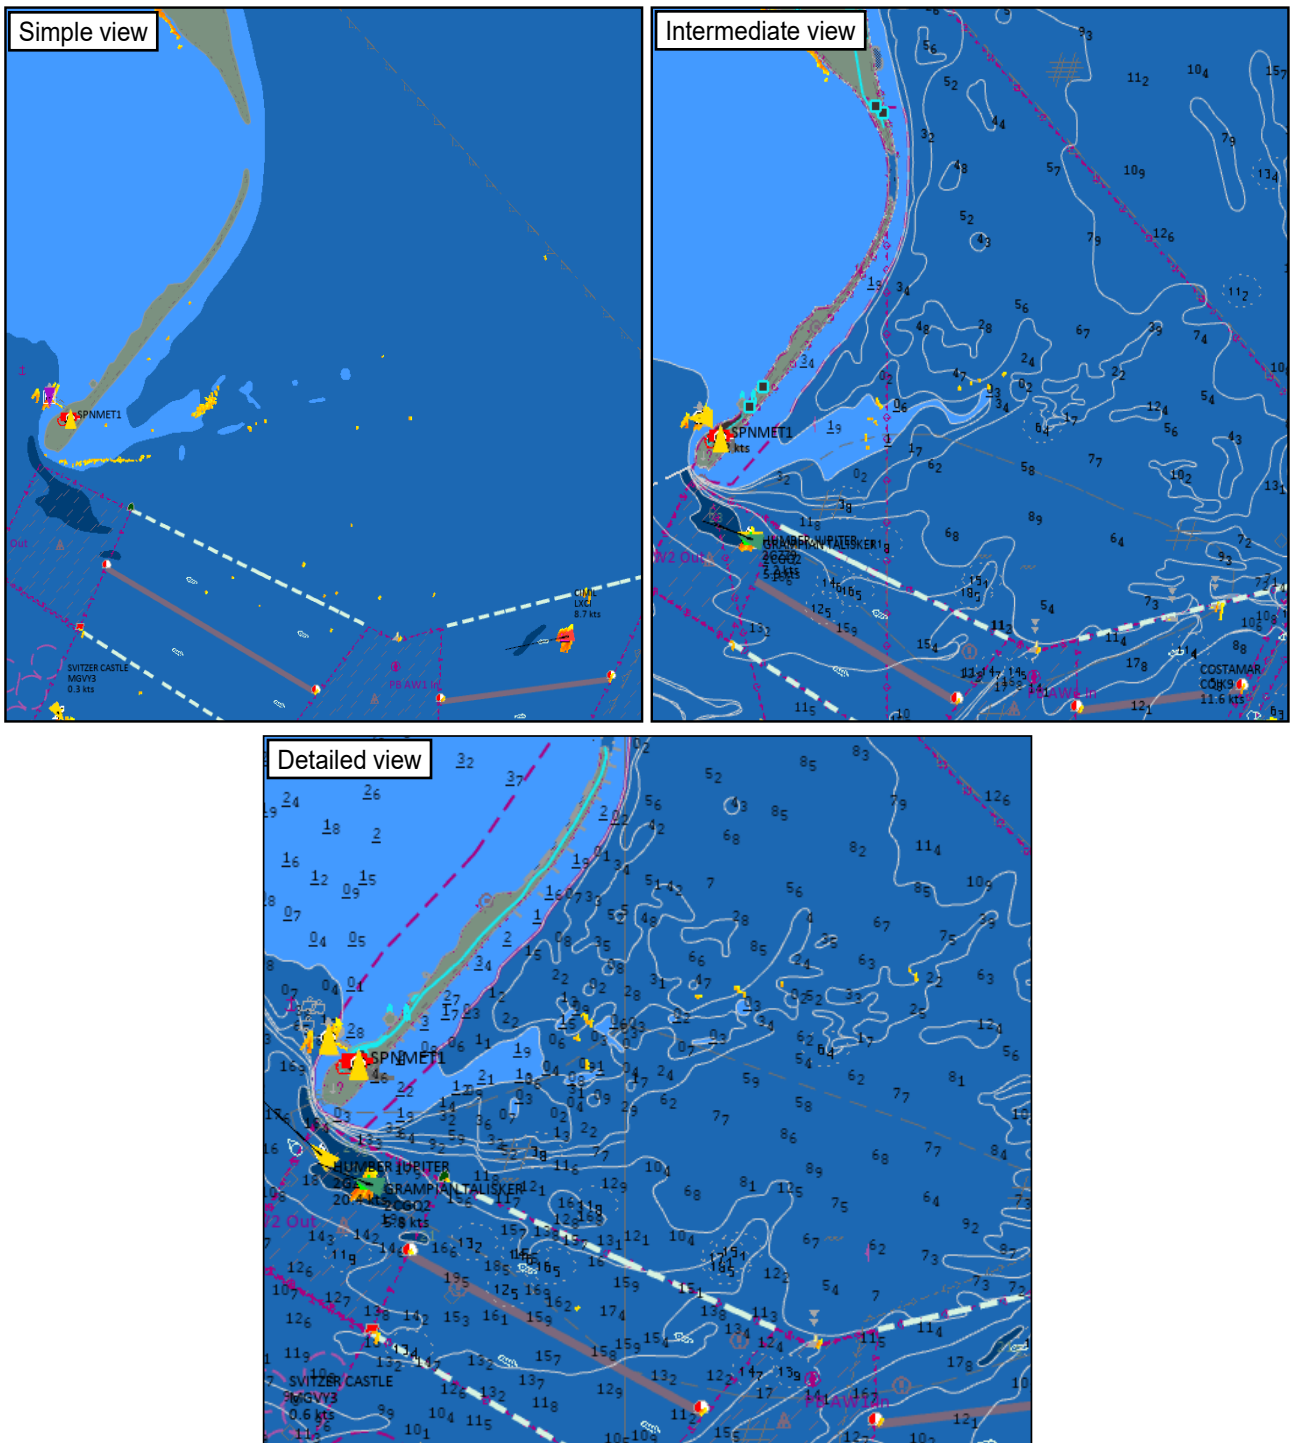
Figure 11: VTS display showing up to date S57 chart data

Charts for the VTS area were available in both electronic and paper form. The electronic chart data could be displayed on the VTSO's computer system in simple, intermediate and detailed views (**Figure 11**). In most cases operators configured their display to use the uncluttered, simple view, so that they could monitor vessel traffic without distraction.
