## Accident

<b>Aircraft Type and Registration:</b>	Beechcraft Super King Air 200, G-FLYW	
<b>No &amp; Type of Engines:</b>	2 Pratt & Whitney Canada PT6A-61 turboprop engines	
<b>Year of Manufacture:</b>	1977 (Serial no: BB-209)	
<b>Date &amp; Time (UTC):</b>	20 March 2020 at 1141 hrs	
<b>Location:</b>	Exeter Airport	
<b>Type of Flight:</b>	Training	
<b>Persons on Board:</b>	Crew - 2	Passengers - None
<b>Injuries:</b>	Crew - None	Passengers - N/A
<b>Nature of Damage:</b>	Propeller damage, engines shock-loaded, minor rear fuselage damage	
<b>Commander's Licence:</b>	Commercial Pilot's Licence	
<b>Commander's Age:</b>	59 years	
<b>Commander's Flying Experience:</b>	8,500 hours (of which over 3,000 were on type) Last 90 days - 26 hours Last 28 days - 26 hours	
<b>Information source:</b>	Aircraft Accident Report Form submitted by the pilot, engineering diagnostic report, ATC investigation report and further enquiries by the AAIB

## Synopsis

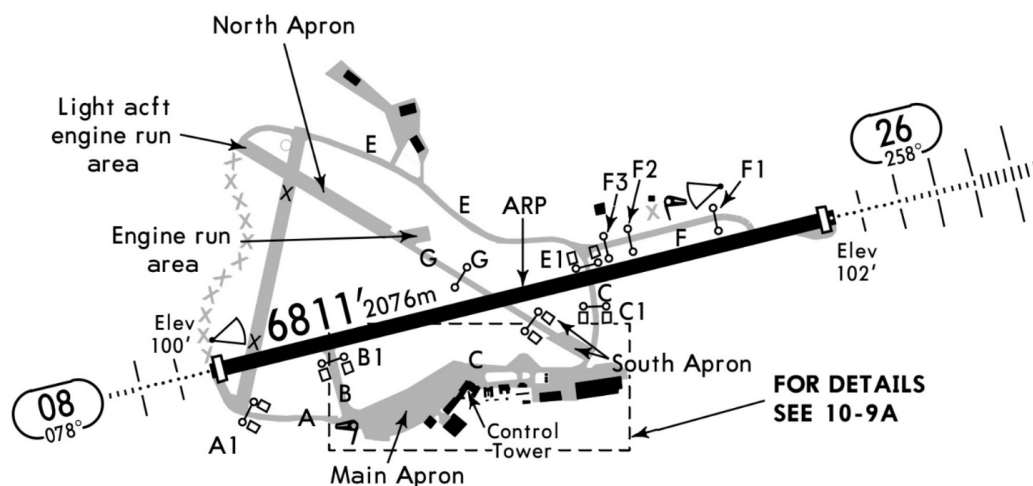
Figure 1

Just before G-FLYW touched down, the driver of an airfield operations vehicle parked on the Main Apron (Figure 1) saw the aircraft approaching the runway with its gear retracted. The driver attempted to alert ATC using his UHF radio, but the aircraft touched down before he could do so. Similarly, the pilot of an aircraft conducting pre-takeoff checks at Holding Point B1 saw G-FLYW too late to transmit an alert over the VHF Tower frequency.

Exeter Airport landing chart

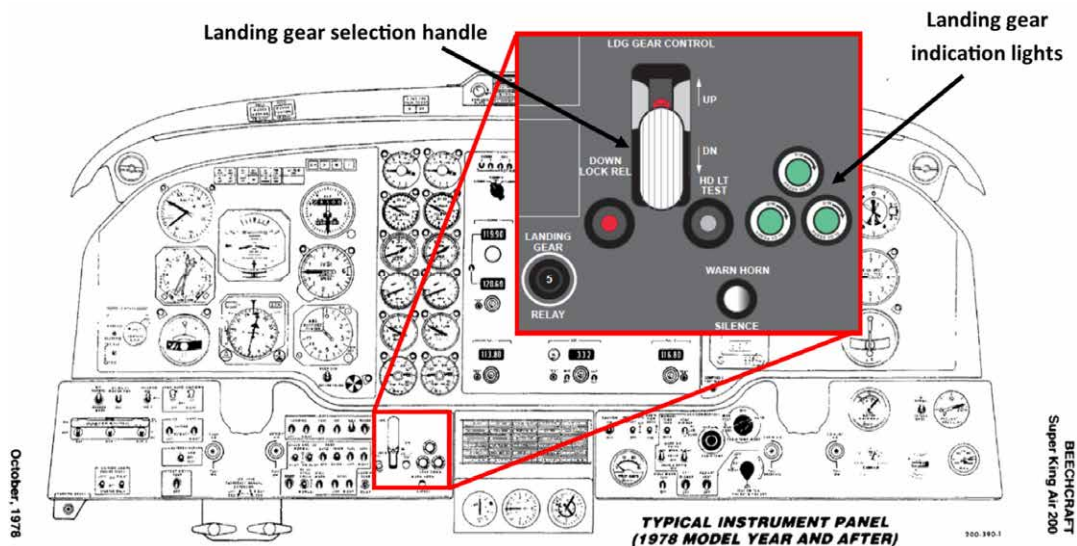
**Figure 3**

G-FLYW is a variant of the Beechcraft Super King Air with electro-mechanically actuated landing gear. The Pilots Operating Manual<sup>3</sup> (POM) describes the landing gear operation as being '*controlled by the switch placarded LDG GEAR CONT · UP · DN on the pilot's right subpanel*' (Figure 3). Three lights adjacent to the landing gear selection lever illuminate green when the respective undercarriage leg is down and locked. Two red indicator lights located in the control handle illuminate to show that the gear is in transit or not locked. They also illuminate when the landing gear warning horn is actuated.

Typical King Air instrument panel with highlighted cockpit controls for landing gear
