## ACCIDENT

<b>Aircraft Type and Registration:</b>	Jabiru UL-450, G-ROYC	
<b>No &amp; Type of Engines:</b>	1 Jabiru 2200A piston engine	
<b>Year of Manufacture:</b>	2003 (Serial no: PFA 274A-13990)	
<b>Date &amp; Time (UTC):</b>	27 October 2019 at 1421 hrs	
<b>Location:</b>	Gransden Lodge Airfield, Sandy, Cambridgeshire	
<b>Type of Flight:</b>	Private	
<b>Persons on Board:</b>	Crew - 1	Passengers - 1
<b>Injuries:</b>	Crew - 1 (Minor)	Passengers - None
<b>Nature of Damage:</b>	Substantial	
<b>Commander's Licence:</b>	National Private Pilot's Licence	
<b>Commander's Age:</b>	57 years	
<b>Commander's Flying Experience:</b>	267 hours (of which 28 were on type) Last 90 days - 6 hours Last 28 days - 4 hours	
<b>Information Source:</b>	AAIB Field Investigation

## Synopsis

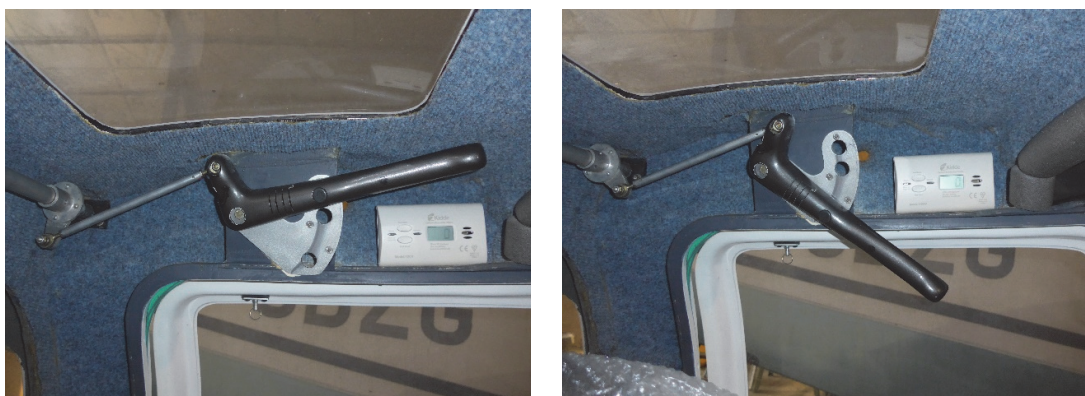
**Figure 7**

The Jabiru UL-450 kit is supplied with manual flaps which are operated via a lever mounted on the side wall to the left of the pilot's head (Figure 7). The lever has a button which latches it in three positions to give flaps up, a mid position or full flap.

Jabiru manual flap lever

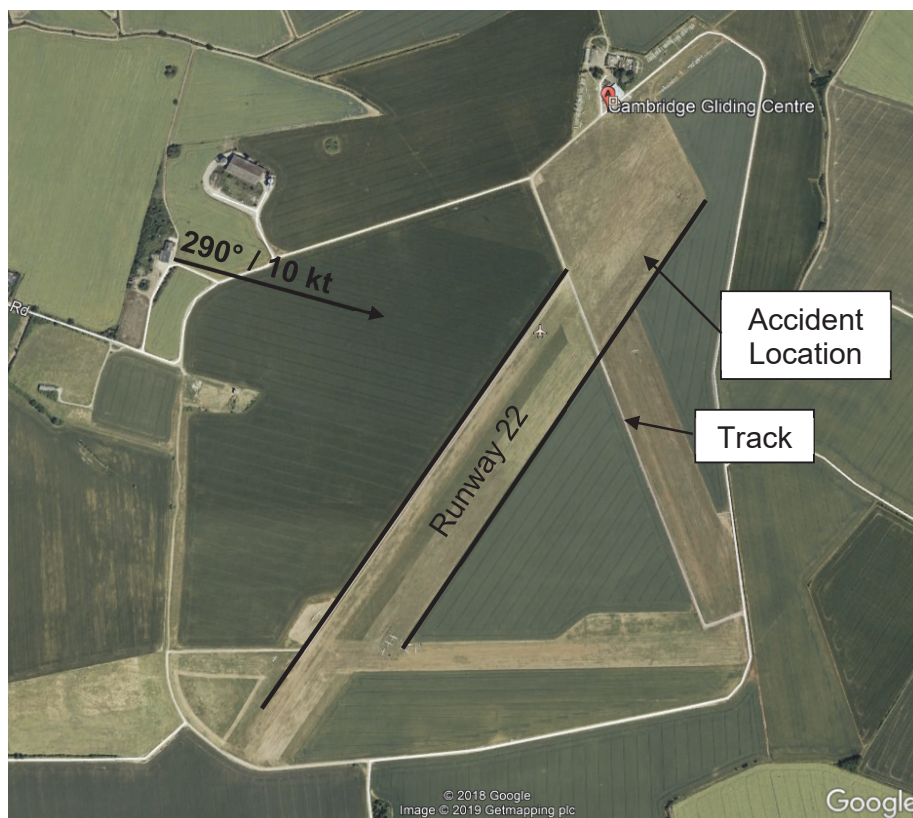
**Figure 9**

Gransden Lodge airfield is a former wartime airfield located 10 miles west of Cambridge. Cambridge Gliding Club moved to Gransden Lodge airfield in 1991. The airfield has three grass runways. Runway 22, in use on the day of the accident, is approximately 1,400 m long and 130 m wide (Figure 9). In addition to the powered aircraft providing air

On the day of the accident, in accordance with the club's normal procedures, gliders were being winch launched from the left side of the runway. Two queues of gliders were established with winch cables run-out down the left side of the runway. Powered aircraft and gliders were landing on the remaining width.

A small track crosses the runway approximately 380 m from the threshold. All the aircraft and gliders seen on the CCTV were landing and stopping before the track. This enabled them to vacate, or be moved off, the runway quickly without needing to backtrack the runway. The gliding club highlighted that all pilots are taught that they should land further along the runway if there is any congestion at the start of the runway.

Gransden Lodge airfield with Runway 22 highlighted
