SERIOUS INCIDENT

Aircraft Type and Registration:	Boeing 737-86N, I-NEOT	
No & Type of Engines:	2 CFMI CFM56-7B26 turbofan engines	
Year of Manufacture:	2002 (Serial no: 33004)	
Date & Time (UTC):	1 June 2019 at 1319 hrs	
Location:	Bristol Airport	
Type of Flight:	Commercial Air Transport (Passenger)	
Persons on Board:	Crew - 6	Passengers -167
Injuries:	Crew - None	Passengers - None
Nature of Damage:	None reported	
Commander's Licence:	Airline Transport Pilot's Licence	
Commander's Age:	55 years	
Commander's Flying Experience:	14,750 hours (of which 10,770 were on type) Last 90 days – 174 hours Last 28 days – 60 hours	
Information Source:	AAIB Field Investigation

Synopsis

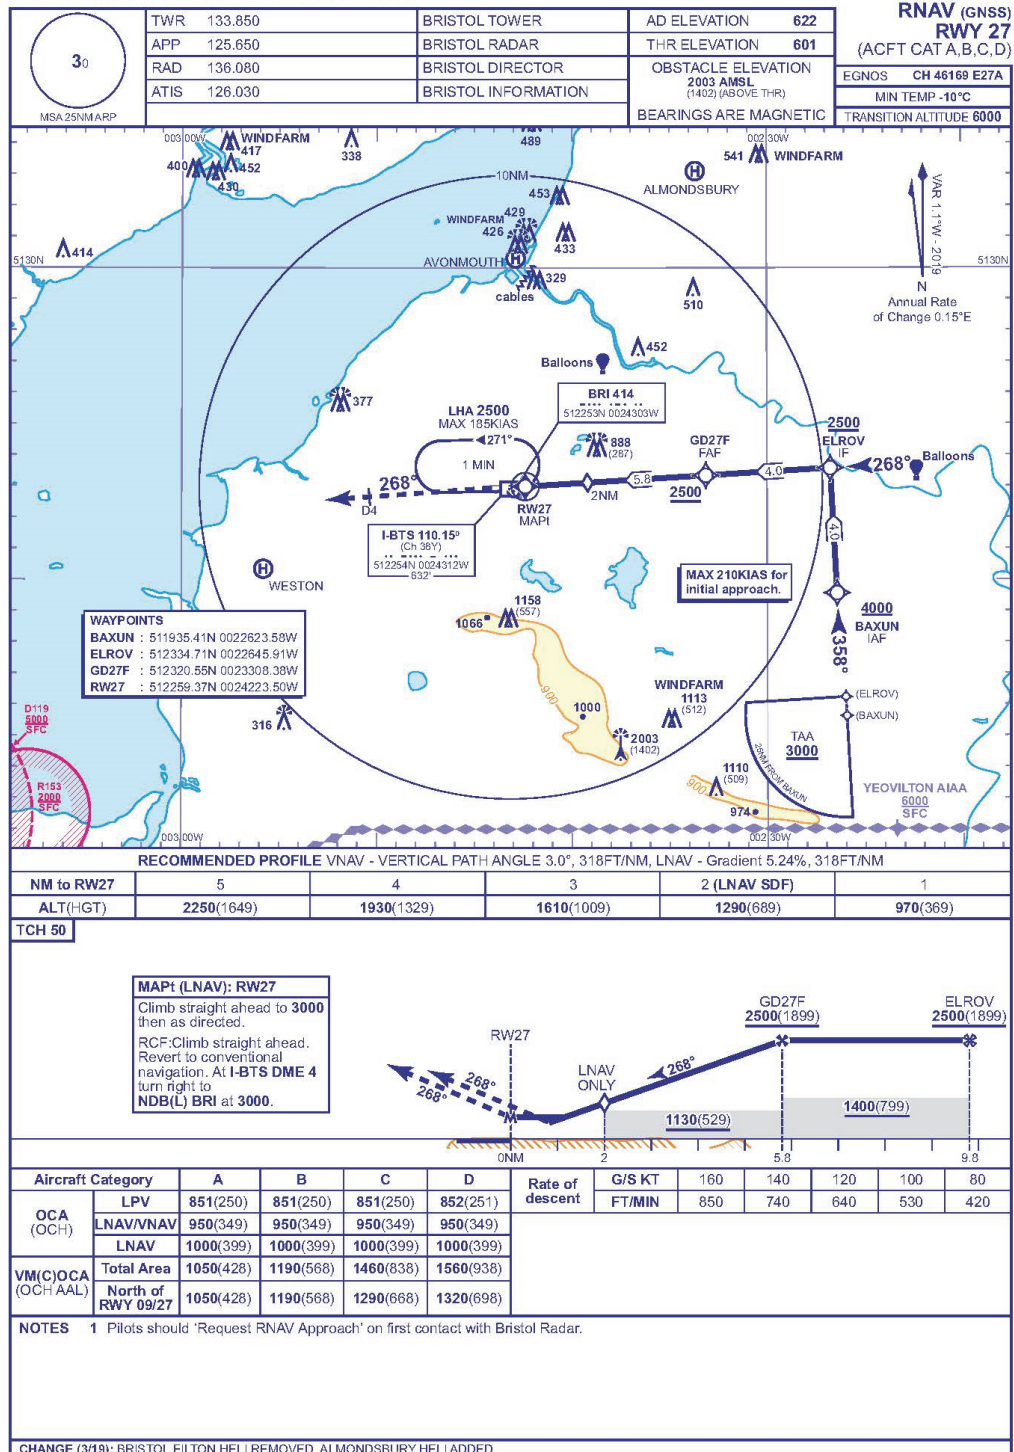
The controller routed the aircraft direct to the intermediate fix³ which was at 9.8 nm from the threshold of the runway. This point was named ELROV and the procedure limited the aircraft to a maximum of 210 kt, with an expected altitude of 2,500 ft or above. I-NEOT crossed ELROV at 3,276 ft and 271 kt CAS. The approach chart from the UK Aeronautical Information Publication is shown in Figure 1.

Figure 1
Approach Chart for RNAV (GNSS) Runway 27
