# THAMES ESTUARY BUXEY SAND (TE10) ASSESSMENT TE10/2016-V3

An assessment of the 2016 hydrographic survey of the area TE10: to monitor recent seabed movement; to identify any implications for shipping; and to make recommendations for future surveys.

#### BUXEY SAND TE10, 2016

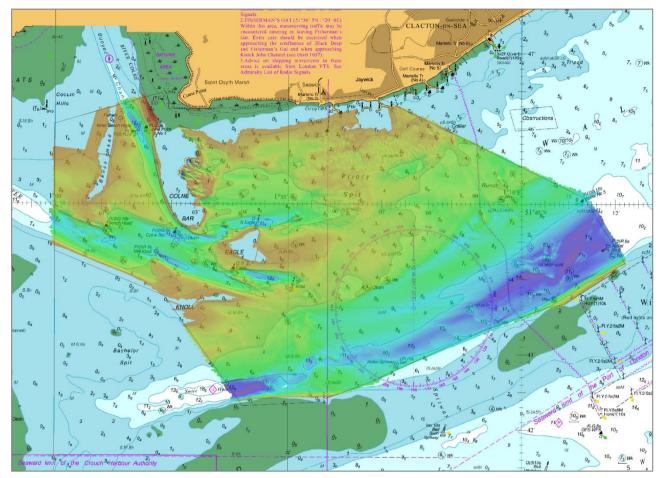
- 4.2 The shoalest depth is -2m (drying height) in the northwest of the survey area close to the entrance to River Colne.
- 4.3 Within the approach channel between Knoll and Eagle buoys there is a sand ridge with a controlling depth of 3.7m, which has shoaled by 1m since 1985.
- 4.4 Area Covered: 21 NM<sup>2</sup> (72 km<sup>2</sup>) as shown in Figure 1 below.

Figure 1 – 2016 survey data sun-illuminated view overlaid on BA Chart 1975

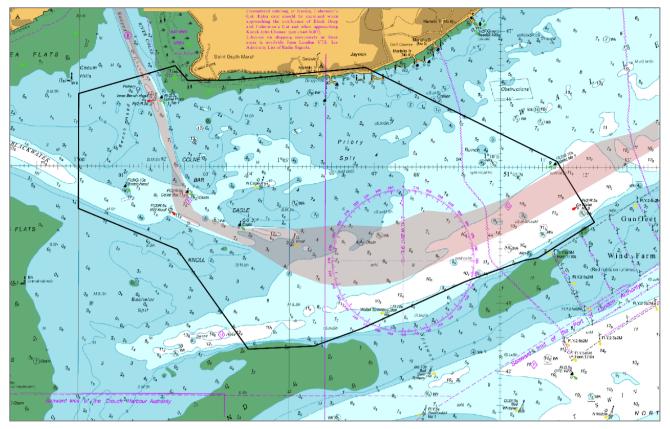
- 5.2 In Figure 2 AIS data indicates most vessels transiting TE10 had a draught between 4 and 6m, and followed the buoyed approach from the east towards River Colne. Broadly vessels with similar draughts continue to transit the areas as reported in 1985 but with most vessel traffic indicated to be heading towards the River Colne. Brightlingsea Harbour accepts vessels with draughts up to 5m and is reported to be used by various windfarm support vessels. The available AIS data indicates no vessels with the above parameters transited towards River Blackwater.

Figure 2 – Indicative shipping routes overlaid on BA Chart 1975
