ACCIDENT

Aircraft Type and Registration:	Guimbal Cabri G2, G-CILR	
No & Type of Engines:	1 Lycoming O-360-J2A piston engine	
Year of Manufacture:	2015 (Serial no: 1090)	
Date & Time (UTC):	22 July 2019 at 1730 hrs	
Location:	Wycombe Air Park	
Type of Flight:	Private	
Persons on Board:	Crew - 1	Passengers - None
Injuries:	Crew - None	Passengers - N/A
Nature of Damage:	Destroyed	
Commander's Licence:	Private Pilot's Licence (Helicopters)	
Commander's Age:	21 years	
Commander's Flying Experience:	174 hours (of which 110 were on type) Last 90 days - 22 hours Last 28 days - 9 hours	
Information Source:	AAIB Field Investigation

Synopsis

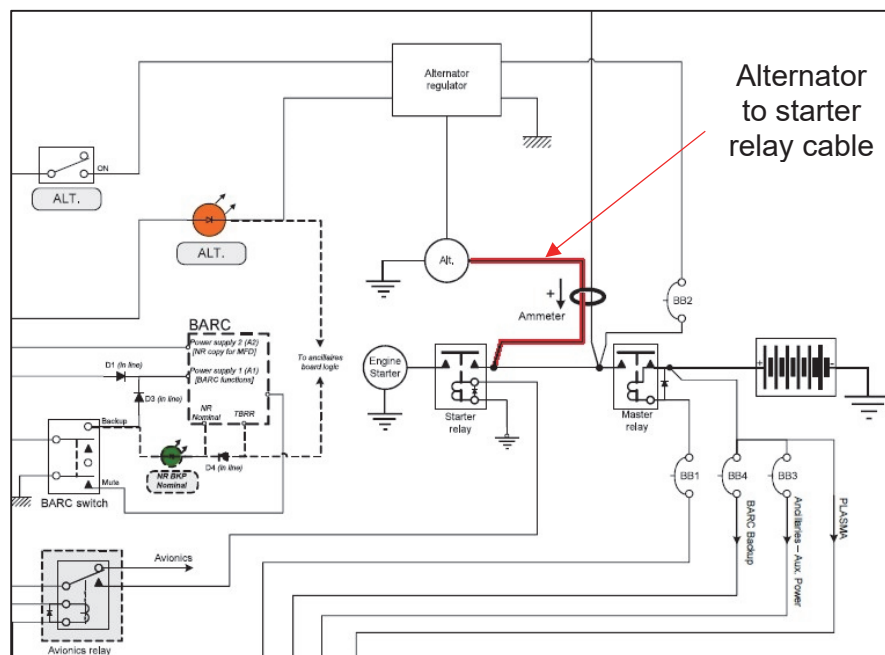
Figure 2

The engine remained attached to its support frame. The battery had been destroyed, however the electrical cables that had been connected to the battery were present. The insulation on the cables had been consumed by fire. The cable connecting the alternator output to the starter relay in the battery compartment was found to be in two pieces. Where it had broken the cable material had fused together, creating a globule of re-solidified molten material (Figure 2). Both ends of the broken cable was removed from the wreckage and taken to the AAIB for further assessment. A section of the helicopter's power generation and distribution circuit diagram can be found in Figure 3.

Helicopter cables within the wreckage
