ACCIDENT

Aircraft Type and Registration:	Sikorsky S-61N Sea King, G-ATBJ	
No & Type of Engines:	2 General Electric Co CT58-140-2 turboshaft engines	
Year of Manufacture:	1965 (Serial no: 61269)	
Date & Time (UTC):	1 February 2018 at 1100 hrs	
Location:	Marchwood, Hampshire	
Type of Flight:	Commercial Air Transport (Non-Revenue)	
Persons on Board:	Crew - 2	Passengers - None
Injuries:	Crew - None	Passengers - N/A
Nature of Damage:	Damaged beyond economical repair	
Commander's Licence:	Air Transport Pilot's Licence	
Commander's Age:	60 years	
Commander's Flying Experience:	11,233 hours (of which 1,501 ¹ were on type) Last 90 days - 26 hours Last 28 days - 0 hours	
Information Source:	AAIB Field Investigation

Synopsis

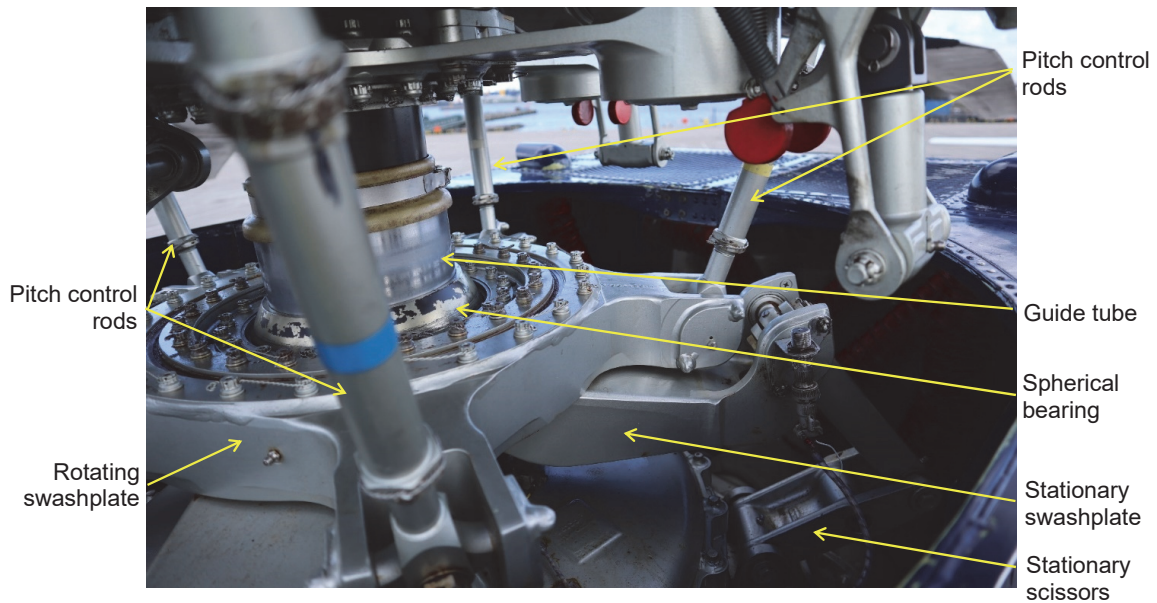
**Figure 7**

The main rotor head is splined onto the main gearbox output, its principal components are the hub, swashplate and bifilar vibration absorber. The swashplate transmits movement of the flight controls to each main rotor blade through pitch control rods. A spherical bearing, sometimes referred to as a ball-ring socket, allows the swashplate to be tilted off its horizontal plane and moved on its vertical axis. The rotating swashplate is connected to the rotary wing hub by rotating scissors and the pitch control rods. The stationary swashplate is connected to the main gearbox by stationary scissors and the primary servo cylinders. The rotating swashplate can rotate around the stationary swashplate. When the servo cylinders are actuated, movements of the stationary swashplate are transmitted to the rotating swashplate and then to the main rotor blades via the pitch control rods (Figure 7).

S-61N swashplate configuration

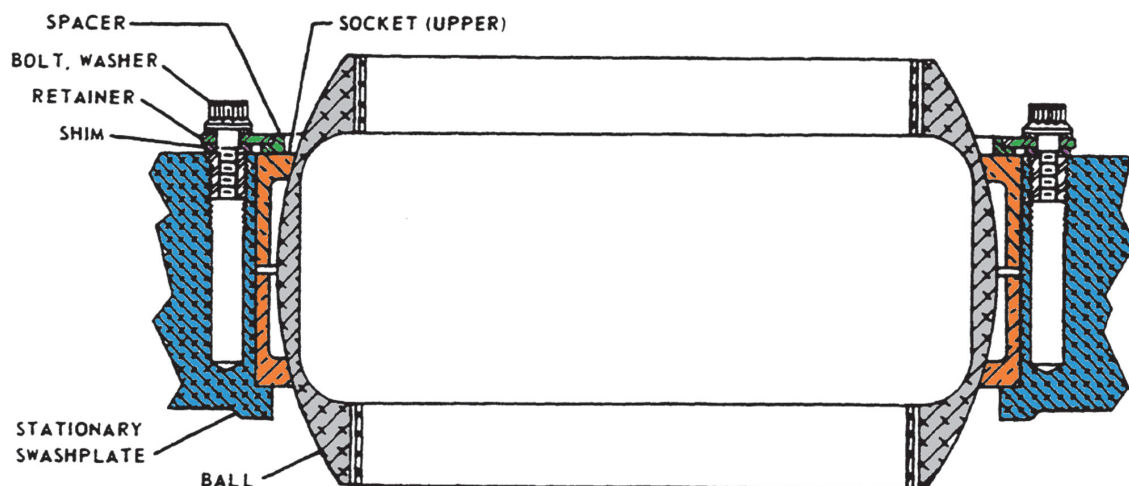
**Figure 8**

The anodised aluminium spherical bearing is held in position by two opposing phosphor bronze sockets which are inserted into the stationary swashplate housing. The lower socket is located on a flange at the bottom of the housing. The upper socket is held in place by a retainer and spacer. An adjustable shim is used to set the height of the retainer and hence the amount of clamping it provides to the spherical bearing (Figure 8). In-service adjustment of the shim can be made if the vertical play of the bearing exceeds 0.070 in. The bearing is packed with grease when assembled and cannot be replenished during normal maintenance.

Arrangement of S-61N swashplate spherical bearing (reproduced with permission)

The grease between the sockets and the spherical bearings was in very poor condition, with crystalline deposits within it (Figures 11 and 12). Elemental analysis of the deposits found them to contain aluminium, chlorine, sodium, copper, tin and oxygen. This indicates that the aluminium spherical bearing had corroded, and deposits had been retained within the grease. A section of the grease was cleaned from the bearing to reveal areas of corrosion pitting to a depth of 0.018 in (Figure 13). A build-up of plaque-like material was adhered to the bearing. Analysis of this material found it to be bronze material that had released from the socket, combined with the grease and adhered to the bearing surface.
