ACCIDENT

Aircraft Type and Registration:	Grob G109B, G-KHEH	
No & Type of Engines:	1 Grob 2500 E1 piston engine	
Year of Manufacture:	1986 (Serial no: 6436)	
Date & Time (UTC):	10 June 2018 at 0959 hrs	
Location:	Near Raglan, Monmouthshire	
Type of Flight:	Training	
Persons on Board:	Crew - 2	Passengers - None
Injuries:	Crew - 2 (Fatal)	Passengers - N/A
Nature of Damage:	Aircraft destroyed	
Commander's Licence:	Private Pilot's Licence	
Commander's Age:	68 years	
Commander's Flying Experience¹:	550 hours (of which 27 were on type) Last 90 days - 7 hours Last 28 days - 2 hours	
Information Source:	AAIB Field Investigation

Synopsis

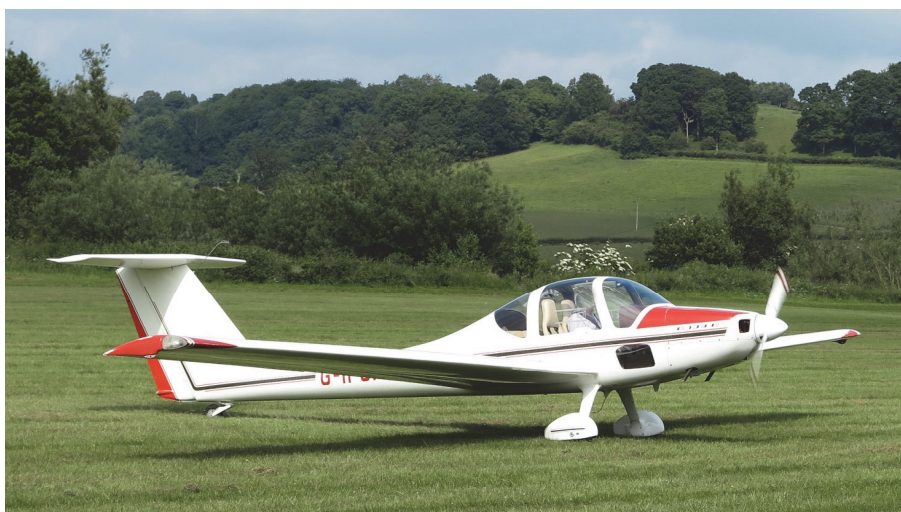
**Figure 5**

Example of a Grob 109B

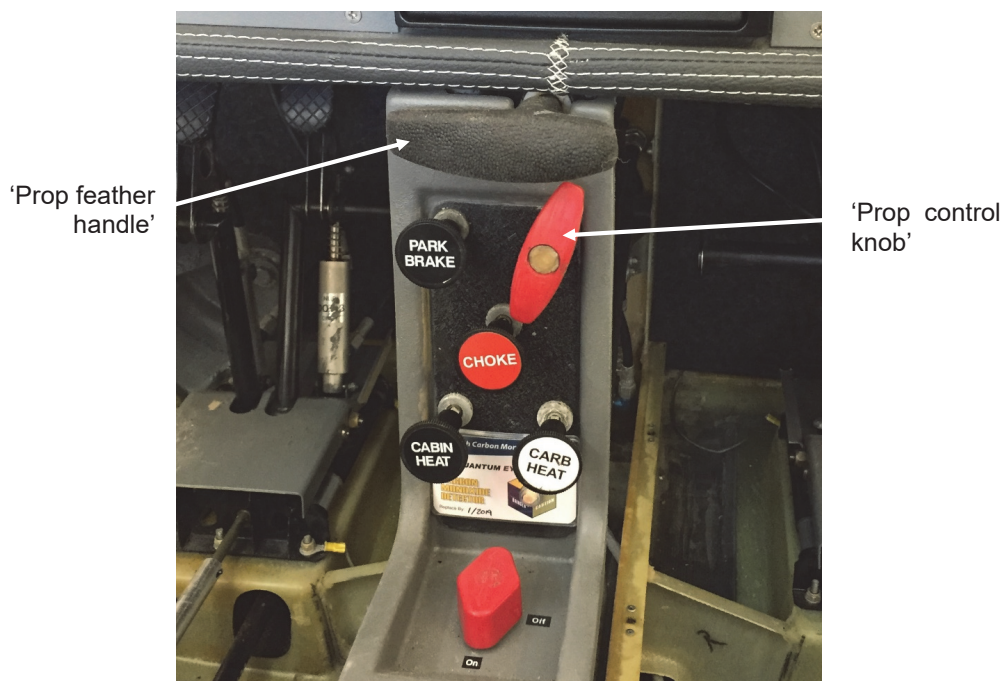
Figure 6

The propeller pitch can be set to CLIMB, CRUISE or FEATHER positions, and the position is altered by pulling one of two handles located on the centre console in the cockpit (Figure 6). The CRUISE propeller position is set by pulling the propeller control handle (also referred to as the 'prop control knob') when the engine is set above 2,300 rpm. The CLIMB position is set by pulling on the propeller control handle whilst the engine speed is at or below 1,400 rpm. The FEATHER setting is used when the aircraft is gliding and the engine has been shut down. It is set by pulling the 'prop feather handle' then turning it through 90°.

Grob 109B propeller pitch controls
