ACCIDENT

Aircraft Type and Registration:	Eurocopter EC135T1, VP-CPS	
No & Type of Engines:	2 Turbomeca Arrius 2B1A turboshaft engines	
Year of Manufacture:	1999	
Date & Time (UTC):	26 February 2019 at 1631 hrs	
Location:	Owen Roberts International Airport, Cayman Islands	
Type of Flight:	Training and search	
Persons on Board:	Crew - 3	Passengers - None
Injuries:	Crew - 3 (Minor)	Passengers - N/A
Nature of Damage:	Damage to tail boom, landing gear and transmission deck	
Commander's Licence:	Commercial Pilot's Licence	
Commander's Age:	58 years	
Commander's Flying Experience:	7,842 hours (of which 3,879 were on type) Last 90 days - 56 hours Last 28 days - 22 hours	
Information Source:	AAIB Field Investigation

Synopsis

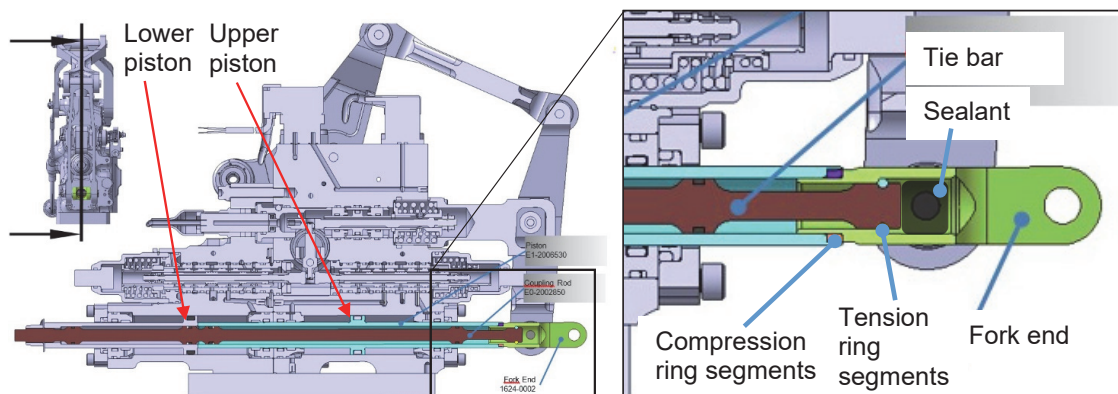
Figure 3

The MRA is installed vertically and, depending on control input, the actuators either push upwards or pull downwards on the swashplate linkage. Inside each individual actuator are two axial pistons, one per hydraulic system, which are linked with a tie bar (Figure 3). This bar is manufactured from passivated, high-strength, corrosion-resistant steel, and attached to a fork end which connects to the swashplate linkage. Tension loads from the pistons are transferred to the fork end by the tension ring segments and compressive loads are transferred through the compression ring segments. Sealant is applied to the centre bore of the fork end to prevent moisture ingress into the upper piston through the tension ring segments.

Cross section views of a single axis actuator from the MRA (rotated)
