**INCIDENT**

<b>Aircraft Type and Registration:</b>	DHC-8-402 Dash 8, G-ECOC	
<b>No &amp; Type of Engines:</b>	2 Pratt & Whitney Canada PW150A turboprop engines	
<b>Year of Manufacture:</b>	2007 (Serial no: 4197)	
<b>Date &amp; Time (UTC):</b>	13 December 2018 at 2105 hrs	
<b>Location:</b>	En route from Aberdeen to Birmingham	
<b>Type of Flight:</b>	Commercial Air Transport (Passenger)	
<b>Persons on Board:</b>	Crew - 4	Passengers - 77
<b>Injuries:</b>	Crew - None	Passengers - None
<b>Nature of Damage:</b>	None	
<b>Commander's Licence:</b>	Airline Transport Pilot's Licence	
<b>Commander's Age:</b>	46 years	
<b>Commander's Flying Experience:</b>	7,655 hours (of which 7100 were on type) Last 90 days - 204 hours Last 28 days - 49 hours	
<b>Information Source:</b>	Aircraft Accident Report Form submitted by the pilot

**Synopsis**

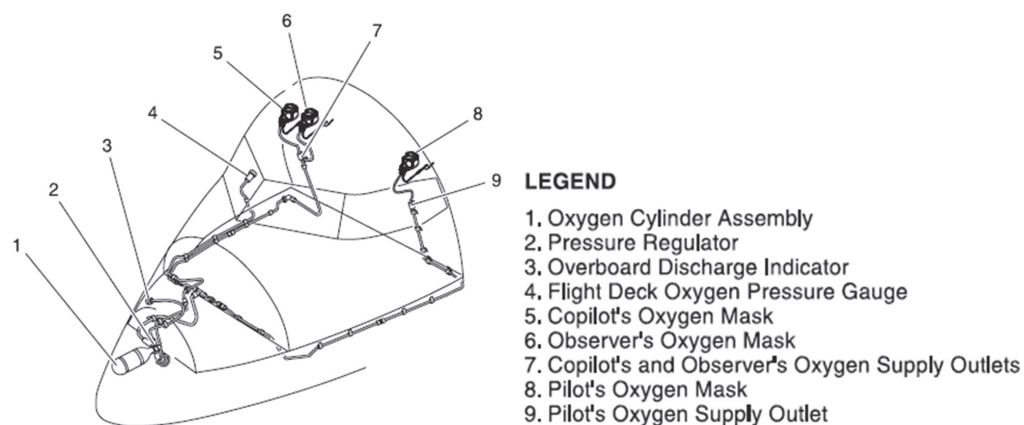
**Figure 1**

Crew fixed oxygen system

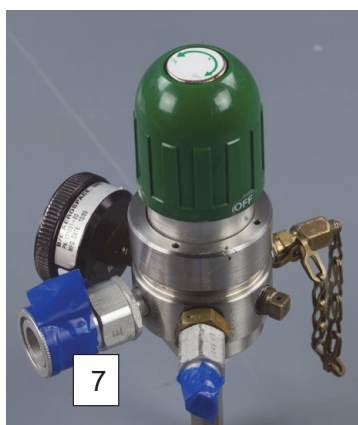
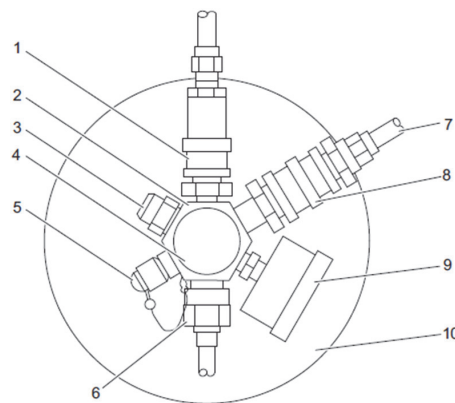
**Figure 3**  
Oxygen cylinder regulator assembly

The regulator was fully dismantled, and abrasion damage was observed to the valve pin when viewed through the low-pressure relief valve port ([3] in Figure 3). The valve body was sectioned at right angles to the port and further visual examination of the debris revealed that it was threaded. Energy dispersive x-ray (EDX) analysis of the metal attached to the end of the debris confirmed that the debris had damaged the valve pin (Figure 5). EDX analysis of the debris showed it to be a low alloy steel containing chromium and molybdenum, whereas the valve pin and the regulator body are manufactured from a corrosion-resistant steel.

It is possible that a screw extractor tool had been inserted into the crew oxygen supply port at some point and turned until it contacted the valve pin and cut into the wall of the port. If torque continued to be applied to the tool it would result in overload failure of the tool in shear. The subsequent damage to the fracture surface may have been the result of attempts to remove the debris. With the debris in place normal oxygen flow would have been restricted but it did not fully block the port therefore allowing, over time, for the system pressure to read normally on the flight deck gauge.
