ACCIDENT

Aircraft Type and Registration:	Midget Mustang, G-AWIR
No & Type of Engines:	1 Continental Motors Corp O-200-A piston engine
Year of Manufacture:	1973 (Serial no: PFA 1315)
Date & Time (UTC):	21 July 2019 at 1630 hrs
Location:	Woods near Spanhoe Airfield, Northamptonshire
Type of Flight:	Private
Persons on Board:	Crew - 1 Passengers - None
Injuries:	Crew - 1 (Serious) Passengers - N/A
Nature of Damage:	Destroyed
Commander's Licence:	Private Pilot's Licence
Commander's Age:	56 years
Commander's Flying Experience:	677 hours (of which 10 were on type) Last 90 days - 71 hours Last 28 days - 16 hours
Information Source:	Aircraft Accident Report Form submitted by the pilot

Synopsis

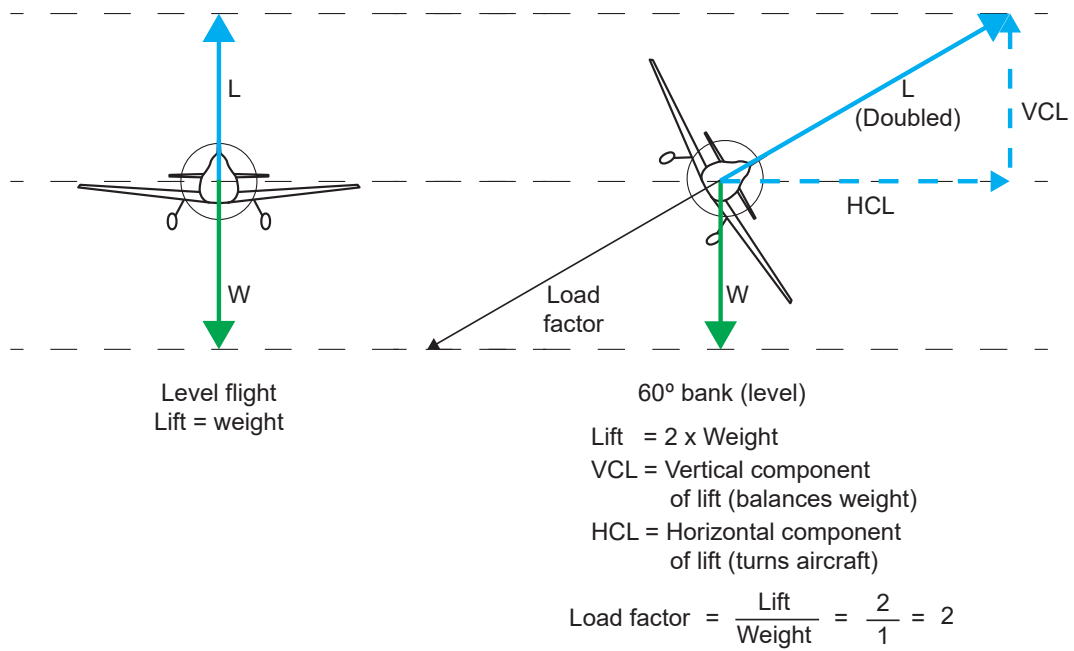
**Figure 2**

Load factor is the ratio of the lift produced by the aircraft and its weight. In level flight, when the lift produced by the wings equals the aircraft weight, an aircraft experiences a load factor of 1. When an aircraft is banked, lift must be increased to maintain altitude because the lift vector is no longer directly opposing the aircraft's weight. At 60° of bank, the lift must be doubled to maintain level flight, this corresponds to a load factor of 2¹, Figure 2.

Effect of a level 60° banked turn
