ACCIDENT

Aircraft Type and Registration:	DJI Matrice 210 (UAS, registration n/a)	
No & Type of Engines:	4 electric motors	
Year of Manufacture:	2018 (Serial no: 0GODF4R023001)	
Date & Time (UTC):	4 September 2018 at 1451 hrs	
Location:	Tilbury Docks, Essex	
Type of Flight:	Emergency services operation	
Persons on Board:	Crew - N/A	Passengers - N/A
Injuries:	Crew - N/A	Passengers - N/A
Nature of Damage:	Destroyed	
Commander's Licence:	N/A	
Commander's Age:	42 years	
Commander's Flying Experience:	11 hours (of which 11 were on type) Last 90 days - 2 hours Last 28 days - 2 hours	
Information Source:	Aircraft Accident Report Form submitted by the pilot and further enquiries by the AAIB

After about six minutes into the flight, a battery low voltage condition was detected by the UAS causing it to enter an automatic landing mode. Shortly afterwards, while the aircraft was 20 m above the ground, it powered down and the electric motors stopped, causing it to fall to the ground. An investigation of this and similar accidents was conducted by the manufacturer which found that the batteries' State of Charge (SOC) was indicating an erroneously high level of charge remaining. Safety actions we

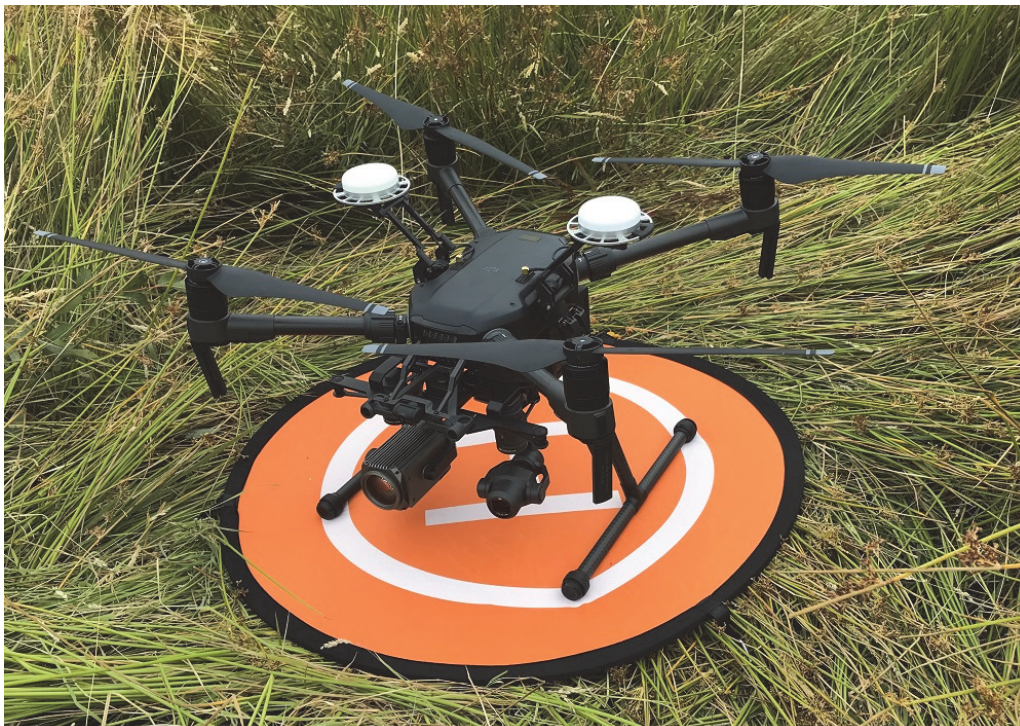
Figure 1

DJI Matrice 210

(This depicts the RTK version of the Matrice 210 – the accident aircraft did not have the two white external GPS antennas attached.)
