ACCIDENT

Aircraft Type and Registration:	Airbus A320-214, G-EZWC	
No & Type of Engines:	2 CFM56-5B4/3 turbofan engines	
Year of Manufacture:	2012 (Serial no: 5236)	
Date & Time (UTC):	3 April 2019 at 1410 hrs	
Location:	Belfast International Airport	
Type of Flight:	Commercial Air Transport (Passenger)	
Persons on Board:	Crew - 6	Passengers - 180
Injuries:	Crew - None	Passengers - None
Nature of Damage:	Damage to leading edge of No 2 engine nacelle, underside of fuselage, leading edge of right wing, nose landing gear, and to tyre	
Commander's Licence:	Airline Transport Pilot's Licence	
Commander's Age:	56 years	
Commander's Flying Experience:	11,886 hours (of which 7,943 were on type) Last 90 days - 58 hours Last 28 days - 9 hours	
Information Source:	Aircraft Accident Report Form submitted by the pilot and a report into the incident by the ground handling agent

Synopsis

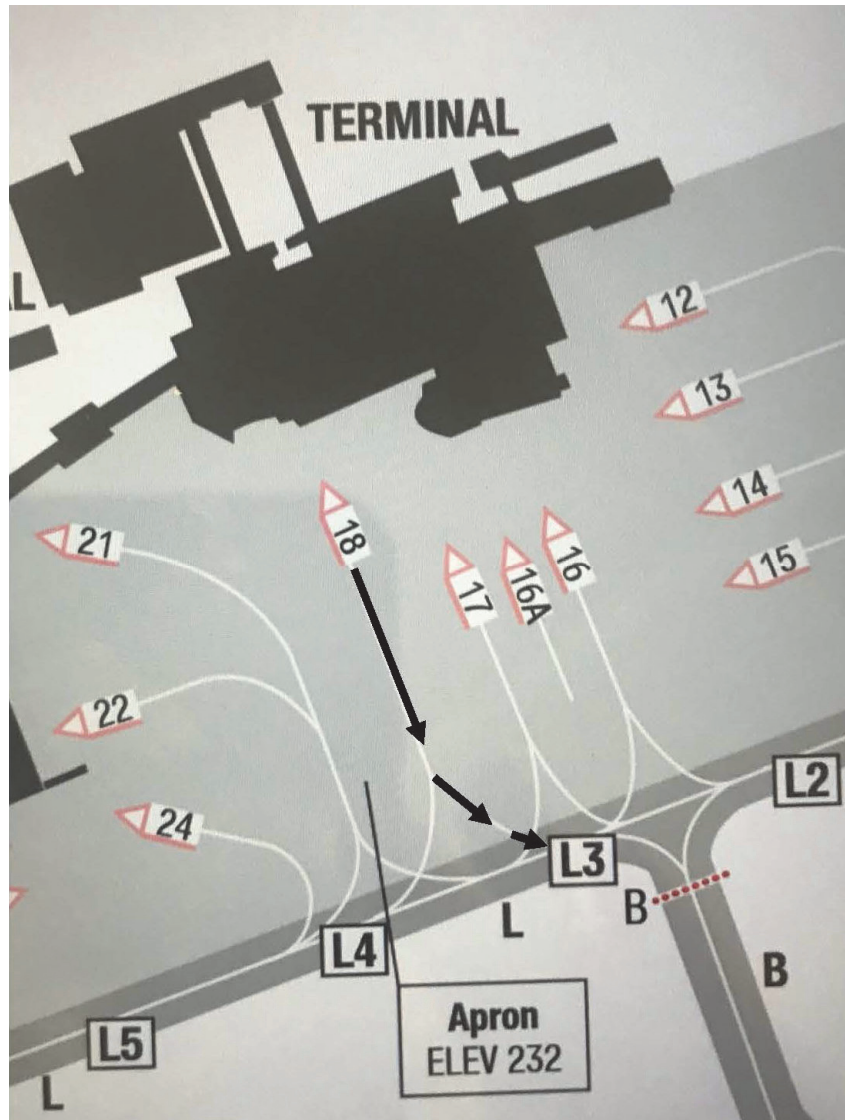
Figure 1

The aircraft was scheduled for a flight from Belfast International Airport to Malaga Airport in Spain and was parked on Stand 18 at the terminal building. It was to depart from Runway 35, and clearance had been given to pushback to Spot L3 facing west and for engine start (Figure 1). It was raining, and the parking area was wet with the pushback being carried out in daylight.

Parking Stand 18 showing the taxi line for the pushback to position L3
