ACCIDENT

Aircraft Type and Registration:	Reims Cessna F172N Skyhawk, G-BGSV	
No & Type of Engines:	1 Lycoming O-320-H2AD piston engine	
Year of Manufacture:	1979 (Serial no: 1830)	
Date & Time (UTC):	10 October 2018 at 1825 hrs	
Location:	Wilfholme, East Yorkshire	
Type of Flight:	Private	
Persons on Board:	Crew - 1	Passengers - 1
Injuries:	Crew - 1 (Fatal)	Passengers - 1 (Fatal)
Nature of Damage:	Aircraft destroyed	
Commander's Licence:	Private Pilot's Licence	
Commander's Age:	76 years	
Commander's Flying Experience:	586 hours (of which 546 were on type) Last 90 days - 8 hours Last 28 days - 3 hours	
Information Source:	AAIB Field Investigation

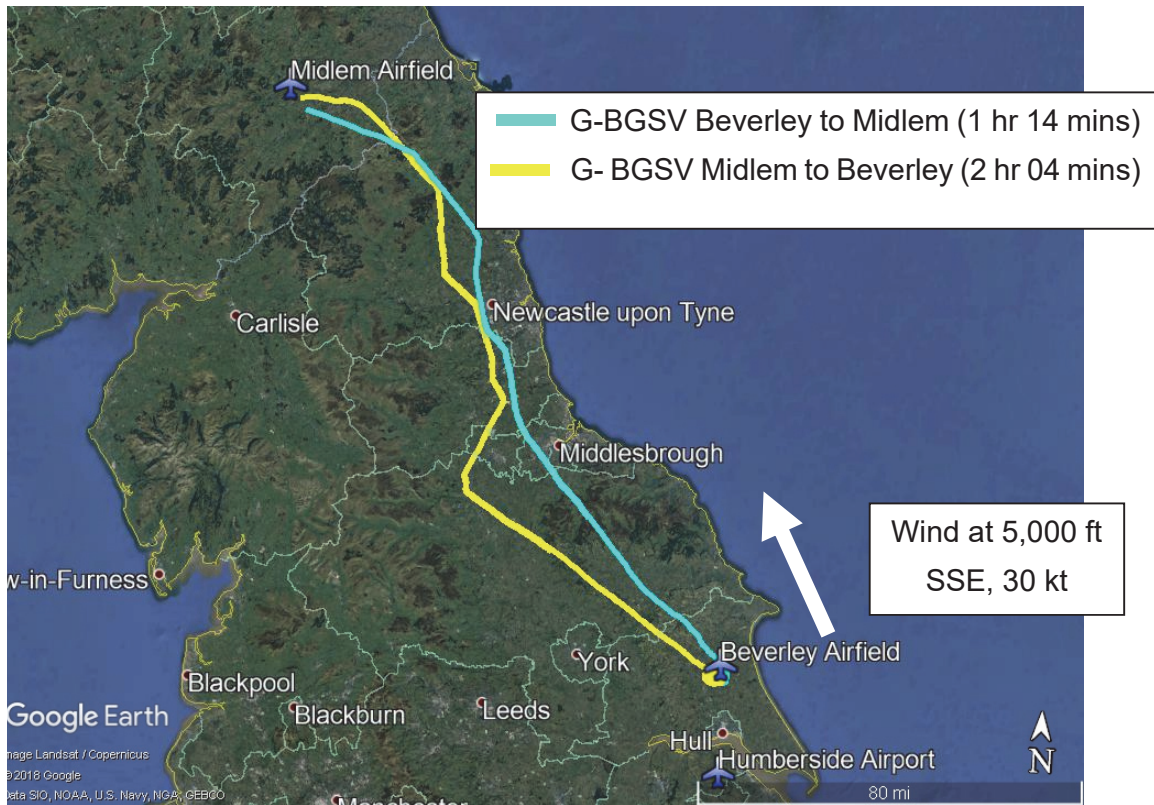
Figure 1

At 1717 hrs the aircraft turned from its south-easterly track to a south-westerly track and continued in that direction for 11 minutes before turning south and then south-east onto a direct track to Beverley. This routeing took the aircraft some 15 nm further to the west of the outbound track and clear of Durham Tees Valley airspace.

G-BGSV flights of 10 October 2018 from radar recordings
