ACCIDENT

Aircraft Type and Registration:	DHC-8-402 Dash 8 Q400, G-JEDU
No & Type of Engines:	2 Pratt & Whitney Canada PW150A turboprop engines
Year of Manufacture:	2004 (Serial no: 4089)
Date & Time (UTC):	10 November 2017 at 1330 hrs
Location:	Belfast International Airport
Type of Flight:	Commercial Air Transport (Passenger)
Persons on Board:	Crew - 4 Passengers - 53
Injuries:	Crew - None Passengers - 2 (Minor)
Nature of Damage:	Forward underside of the nose, front pressure bulkhead, nose landing gear and landing gear doors damaged
Commander's Licence:	Airline Transport Pilot's Licence
Commander's Age:	47
Commander's Flying Experience:	9,112 hours (of which 8,734 were on type) Last 90 days - 208 hours Last 28 days - 40 hours
Information Source:	AAIB Field Investigation

Synopsis

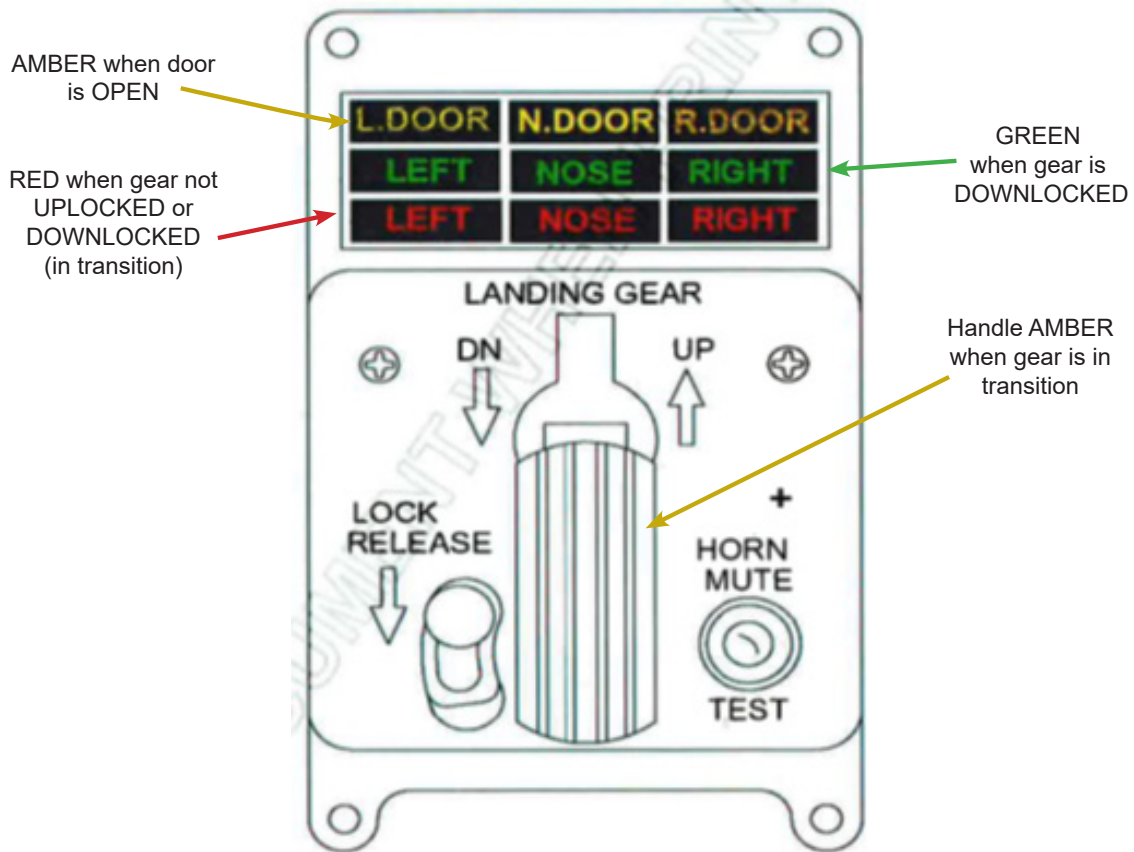
Figure 6

Shortly after takeoff, the landing gear selector lever was selected to the UP position. On the Landing Gear Control and Indication Panel (LGCIP), which is shown in Figure 6, the crew observed that the landing gear green lights extinguished, the three red lights and the amber landing gear door lights as well as the amber light in the landing gear selector lever all illuminated. After a short time, all three red lights extinguished, the left and right DOOR lights extinguished but the nose door light and the light in the landing gear selector lever remained illuminated. The crew kept the airspeed below the 185 kt landing gear limit speed and climbed to 4,000 feet, routing to waypoint Magee to take up the hold whilst they assessed the problem. The aircraft entered the hold at 1132 hrs and the total fuel onboard was 2,800 kg.

Dash 8 Q400 landing gear control and indication panel
