ACCIDENT

Aircraft Type and Registration:	1) Pierre Robin DR400/180R Remorqueur, G-LGCC 2) Schleicher ASK 21, G-CFYF
No & Type of Engines:	1) 1 Lycoming O-360-A4M piston engine 2) None
Year of Manufacture:	1) 1975 (Serial no: 1021) 2) 1990 (Serial no: 21470)
Date & Time (UTC):	8 June 2018 at 1502 hrs
Location:	Dunstable Airfield, Bedfordshire
Type of Flight:	1) Private 2) Training
Persons on Board:	1) Crew - 1 Passengers - None 2) Crew - 1 Passengers - 1
Injuries:	1) Crew - None Passengers - N/A 2) Crew - None Passengers - None
Nature of Damage:	1) Top of fin sliced off, rudder detached 2) Full depth gash in outboard section of right wing
Commander's Licence:	1) EASA Private Pilot's Licence (Aeroplanes) 2) BGA Glider Pilot's Licence with Full Instructor Rating
Commander's Age:	1) 62 years 2) 69 years
Commander's Flying Experience:	1) 2,825 hours (of which 1,238 were on type and 1,324 were in gliders) Last 90 days - 23 hours Last 28 days - 8 hours 2) 1,670 hours (of which 785 were on type) Last 90 days - 15 hours Last 28 days - 6 hours

Synopsis

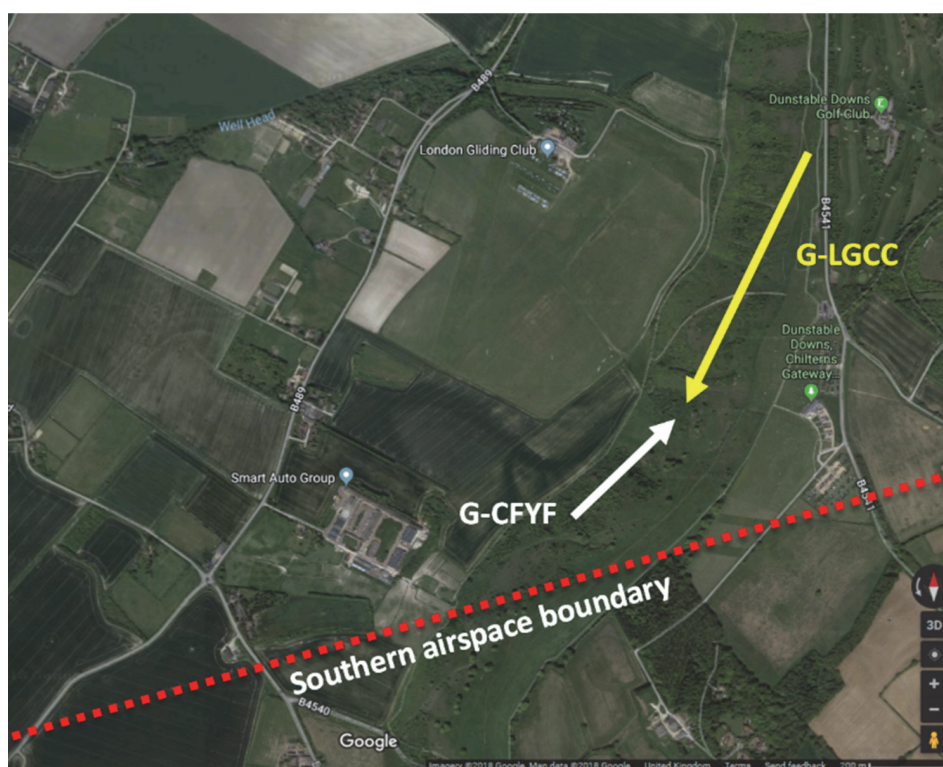
Figure 1

Tracks of G-LGCC and G-CFYF just prior to collision

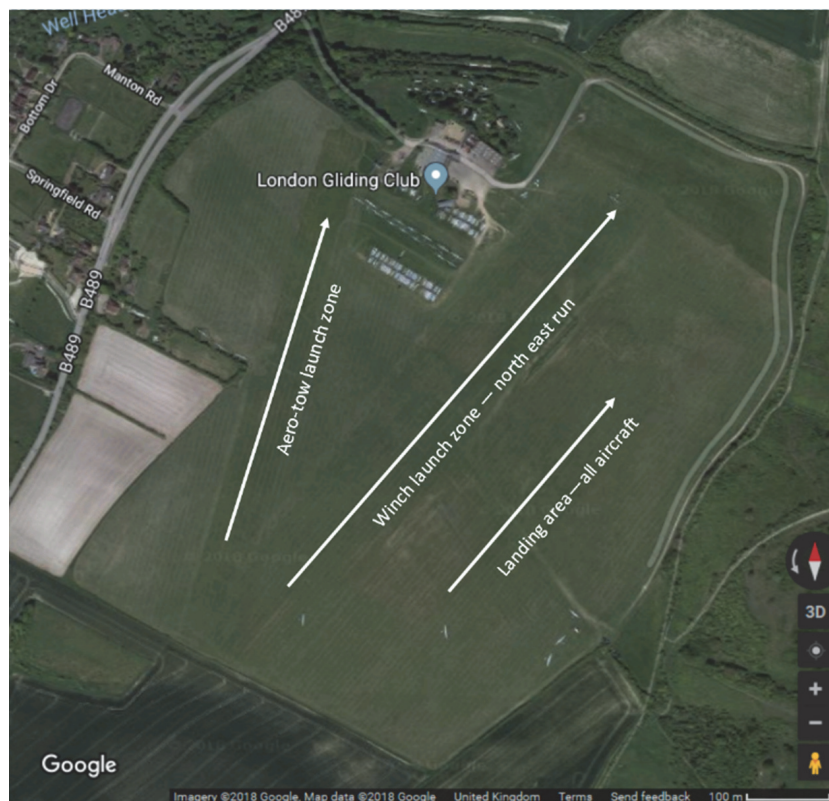
Figure 6

On the day of the accident, flight operations were taking place from the north-east run (Figure 6). In this configuration, aero-tow aircraft operate from the west side of the launch point and track northwards on departure, winch-launched gliders depart to the north-east. All aircraft aim to land to the right of, and parallel with, the winch launch track.

Satellite image of Dunstable Downs Airfield with north-east run depicted
