ACCIDENT

Aircraft Type and Registration:	Morane Saulnier Rallye 150ST, G-BDWH	
No & Type of Engines:	1 Lycoming O-320-E2A piston engine	
Year of Manufacture:	1976 (Serial no: 2697)	
Date & Time (UTC):	21 August 2018 at 1247 hrs	
Location:	Blackpool Corner, Dorset	
Type of Flight:	Private	
Persons on Board:	Crew - 2	Passengers - None
Injuries:	Crew - 2	Passengers - N/A
Nature of Damage:	Aircraft destroyed	
Commander's Licence:	Private Pilot's Licence	
Commander's Age:	77 years	
Commander's Flying Experience:	700 hours Last 90 days - 6 hours Last 28 days - 1 hour	
Information Source:	Aircraft Accident Report Form submitted by the pilot and further enquiries by the AAIB

Synopsis

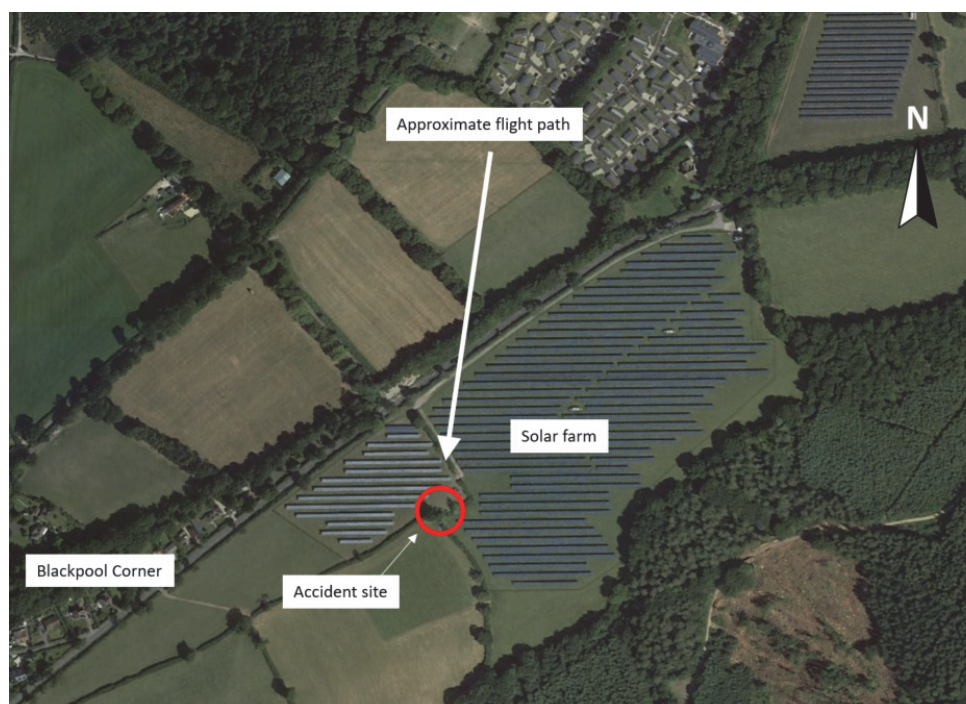
Figure 1

Approximately five minutes after takeoff the pilot noticed smoke entering the cabin from beneath the instrument panel. He unlatched the canopy and slid it open slightly to vent the smoke. The pilot recalled that the engine instruments displayed readings consistent with normal operation of the engine. Suspecting an electrical fire, he switched the electrical master switch OFF, and about this time the engine stopped but the propeller continued to windmill. The pilot switched the fuel selector valve from the right tank to the left tank, but the engine did not restart; he could not recall whether he then switched the fuel valve OFF. The aircraft was flying above an undulating area of small fields and woodland and the pilot selected a field to land in but was too high and had to overshoot towards a solar farm that lay beyond his selected field. The aircraft was too low to clear the solar farm into another field beyond and the aircraft landed within the solar farm complex, avoiding contact with the solar panels and a sub-station building but colliding with the boundary hedge (Figure 1). A witness who saw the accident confirmed that it was on fire during the final stages of the flight.

Accident location (courtesy Google Earth)
