SERIOUS INCIDENT

Aircraft Type and Registration:	DHC-8-402 Dash 8, G-ECOE	
No & Type of Engines:	2 Pratt & Whitney Canada PW150A turboprop engines	
Year of Manufacture:	2008 (Serial no: 4212)	
Date & Time (UTC):	11 January 2018 at 1632 hrs	
Location:	Belfast City Airport	
Type of Flight:	Commercial Air Transport (Passenger)	
Persons on Board:	Crew - 4	Passengers - 44
Injuries:	Crew - None	Passengers - None
Nature of Damage:	None	
Commander's Licence:	Airline Transport Pilot's Licence	
Commander's Age:	60 years	
Commander's Flying Experience:	14,122 hours (of which 464 were on type) Last 90 days - 91 hours Last 28 days - 39 hours	
Information Source:	AAIB Field Investigation

Synopsis

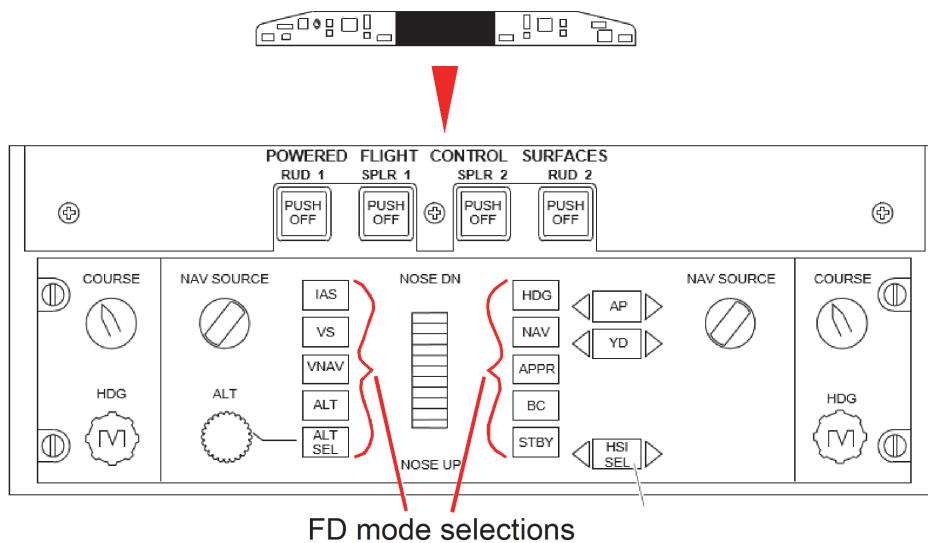
Figure 1
FMGC Panel

Autopilot engagement and associated selection of FD modes, that include HDG, ALT SEL and ALT, are made using push buttons on the Flight Guidance Control Panel (FGCP) that is located on the upper instrument panel (Figure 1). The FD GA mode is selected by buttons on the power levers.
