## ACCIDENT

| <b>Aircraft Type and Registration:</b> | DH82A Tiger Moth, G-ANRM | |
| <b>Date &amp; Time (UTC):</b> | 30 June 2018 at 1725 hrs | |
| <b>Location:</b> | Sywell Aerodrome, Northamptonshire | |

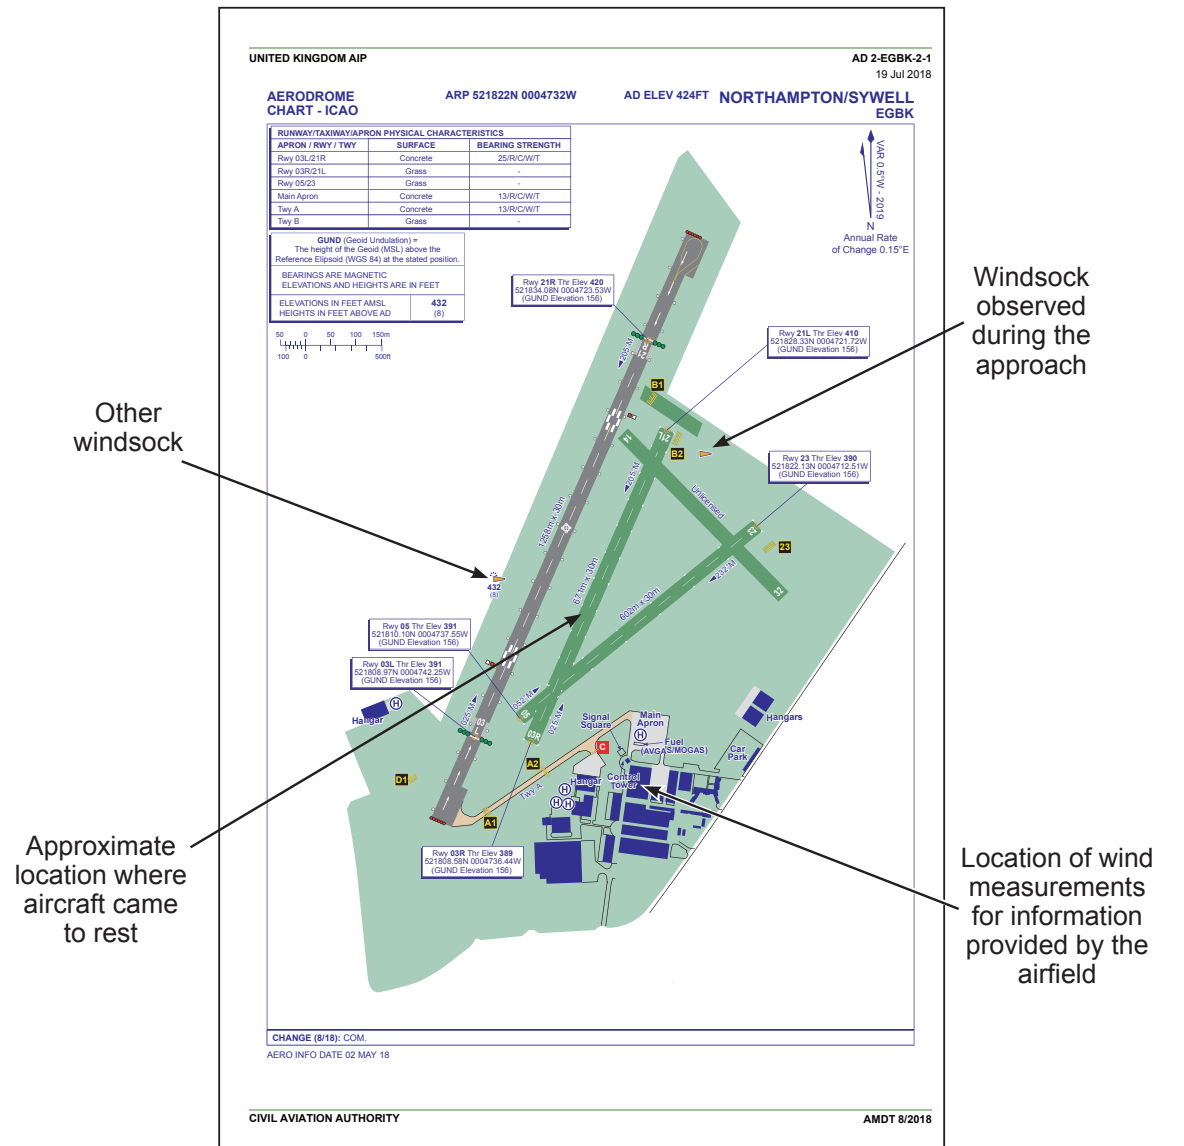
**Figure 2**

Over the course of the evening, the wind had varied between 030° to 050° at 12 to 18 kt. The maximum gust recorded was 20 kt. Around the time of the incident, Sywell Information briefly observed an anemometer reading of 070° at 18 kt. They reported that this reading differed from the direction indicated by the windsock nearest to the incident. The chief pilot for the aircraft operator investigated the accident and visited Sywell. During the visit, he found that the indications provided by the two windsocks differed from each other and from the wind information provided by Sywell (Figure 2).

Aerodrome chart (amended and used with permission from NATS aeronautical information service)
