ACCIDENT

Aircraft Type and Registration:	AS350 B3e Ecureuil, G-MATH	
No & Type of Engines:	1 Turbomeca Arriel 2D turboshaft engine	
Year of Manufacture:	2016 (Serial no: 8274)	
Date & Time (UTC):	5 May 2017 at 0830 hrs	
Location:	Wycombe Air Park, Buckinghamshire	
Type of Flight:	Training	
Persons on Board:	Crew - 2	Passengers - 1
Injuries:	Crew - 1 (Fatal) 1 (Serious)	Passengers - 1 (Serious)
Nature of Damage:	Extensive	
Commander's Licence:	Commercial Pilot's Licence (Helicopters)	
Commander's Age:	45 years	
Commander's Flying Experience:	5,747 hours (of which 579 were on type) Last 90 days - 53 hours Last 28 days - 17 hours	
Information Source:	AAIB Field Investigation

Synopsis

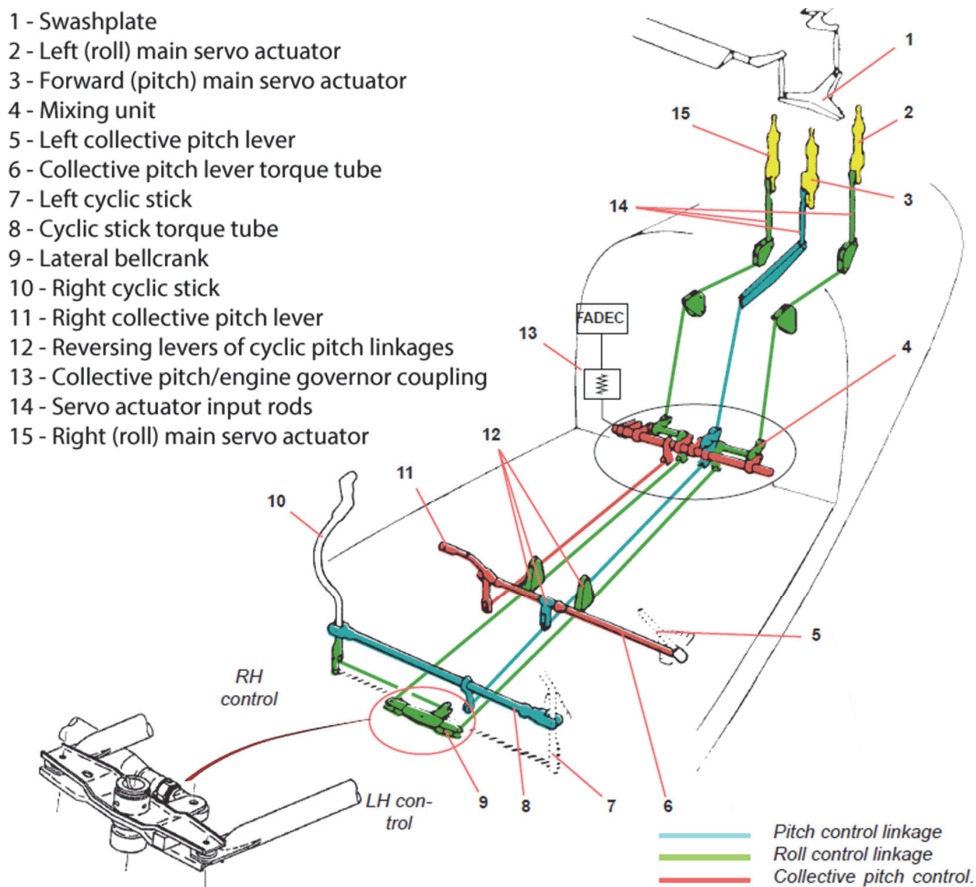
Figure 2

The cyclic pitch control stick and collective pitch control lever operate three main servo actuators via a series of push-pull rods, bellcranks and a mixer unit (Figure 2). Moving the cyclic fore and aft actuates the forward servo actuator; this actuator controls pitch attitude by tilting the main rotor swash plate fore and aft. Moving the cyclic left and right actuates the left and right servo actuators; these actuators control roll attitude by tilting the swash plate left and right. The collective lever actuates all three servo actuators together to increase blade pitch, and it also increases engine power, with a resulting increase in rotor thrust.

Diagram of the AS350 B3e main rotor flight controls
(Image courtesy Airbus Helicopters)

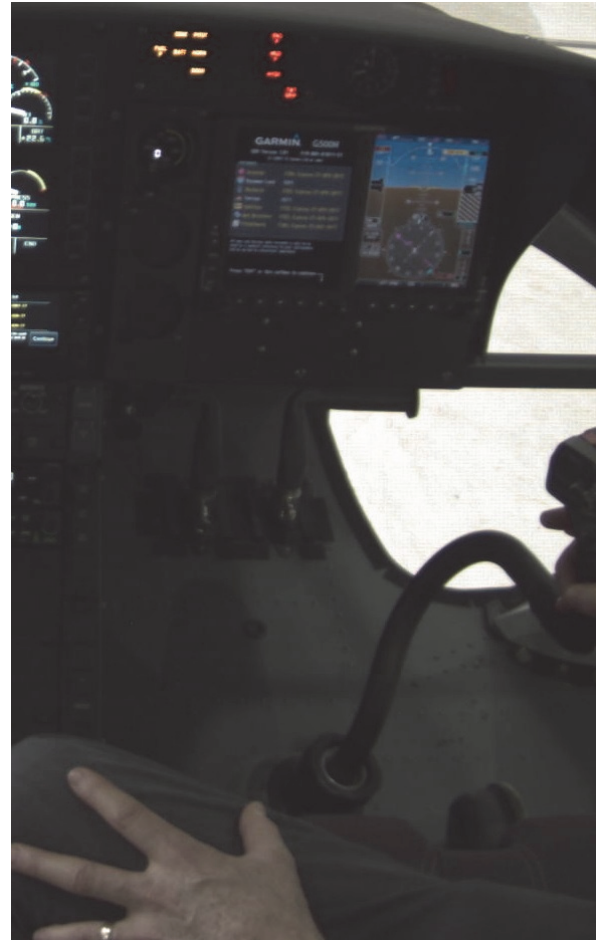
Figure 10

During the final stages of the flight, only the right-seat pilot's cyclic was visible as the instructor had changed his hand position, obscuring the Vision 1000 view of his controls. The video imagery showed that at 0832:58 hrs and a left AOB of 62° (3.5 seconds prior to impact), the right-seat pilot's cyclic was positioned in the furthest right position which is shown in Figure 9. This figure also shows how his grip had tightened on the cyclic. While the exact cyclic position could not be established, when comparing to the 'full and free' check performed on the test helicopter, it shows that the cyclic had not reached its right limit (Figure 10).

View from exemplar helicopter Vision 1000 showing full right cyclic in mid fore-aft position
