## ACCIDENT

<b>Aircraft Type and Registration:</b>	DJI Matrice 210 (UAS, registration N/A)	
<b>No &amp; Type of Engines:</b>	4 electric motors	
<b>Year of Manufacture:</b>	2018 (Serial no: 0G0DF8F0240057)	
<b>Date &amp; Time (UTC):</b>	16 March 2019 at 1310 hrs	
<b>Location:</b>	Temple Newsam, Leeds, Yorkshire	
<b>Type of Flight:</b>	Commercial Operation	
<b>Persons on Board:</b>	Crew - N/A	Passengers - N/A
<b>Injuries:</b>	Crew - N/A	Passengers - N/A
<b>Nature of Damage:</b>	Damage to rotor arms, propellers, and camera payload	
<b>Commander's Licence:</b>	Not applicable	
<b>Commander's Age:</b>	42 years	
<b>Commander's Flying Experience:</b>	67 hours (of which 67 were on type) Last 90 days - 17 hours Last 28 days - 9 hours	
<b>Information Source:</b>	Aircraft Accident Report Form submitted by the pilot and further enquiries by the AAIB

## Synopsis

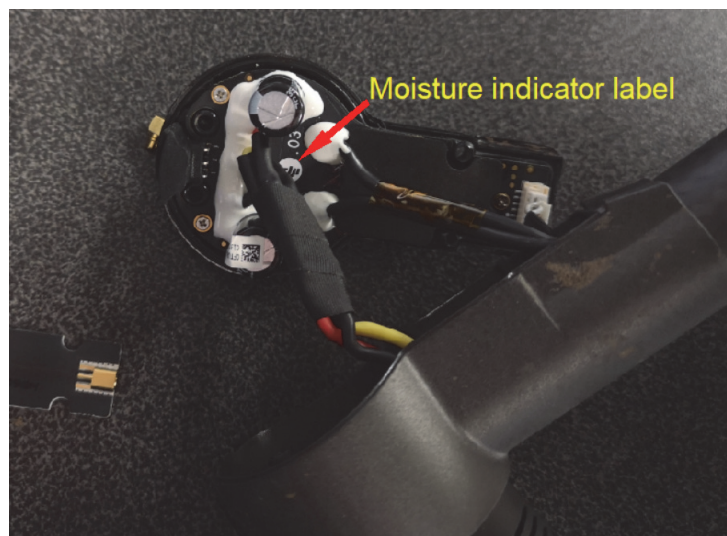
**Figure 6**

ESC moisture indicator position

The pilot sent the aircraft to an Enterprise dealer in the UK for examination. It was found that the No 3 motor ESC moisture indicator had been activated and evidence of liquid residue was found on the ESC circuit board (Figure 7).
