ACCIDENT

Aircraft Type and Registration:	Piper PA-28R-200-2 Cherokee Arrow II, G-EDVL	
No & Type of Engines:	1 Lycoming IO-360-C1C piston engine	
Year of Manufacture:	1972 (Serial no: 28R-7235245)	
Date & Time (UTC):	18 June 2018 at 1735 hrs	
Location:	Redhill Aerodrome, Surrey	
Type of Flight:	Training	
Persons on Board:	Crew - 2	Passengers - None
Injuries:	Crew - None	Passengers - N/A
Nature of Damage:	Right main landing gear trunnion failed, right wing skin damaged	
Commander's Licence:	Commercial Pilot's Licence	
Commander's Age:	69 years	
Commander's Flying Experience:	11,034 hours (of which 200 were on type) Last 90 days - 168 hours Last 28 days - 76 hours	
Information Source:	Aircraft Accident Report Form submitted by the pilot

Synopsis

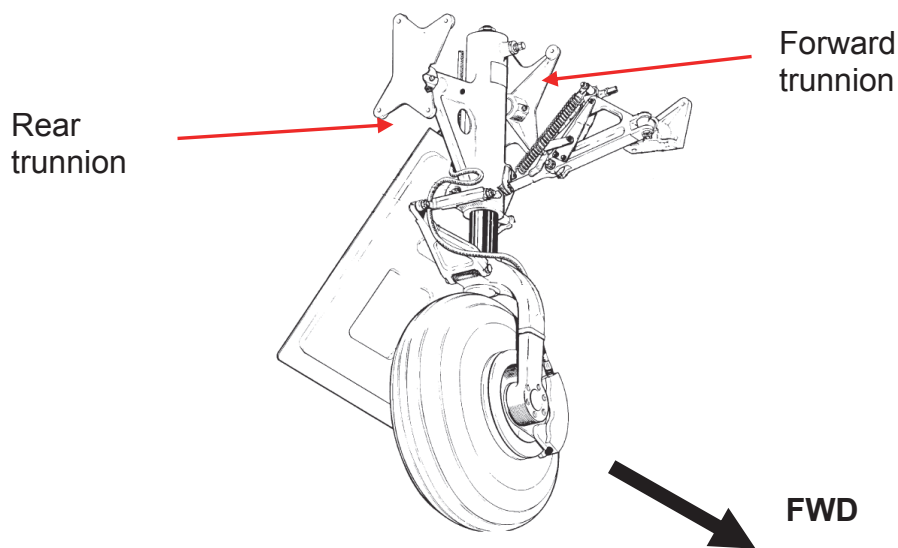
Figure 1

The Piper PA-28R is a variant of the PA-28 fitted with retractable tricycle landing gear, designed to operate from paved and unpaved surfaces. The main landing gear retracts inboard, into bays within the wing structure. Each main landing gear leg is held in place by two trunnions, secured to the rear face of the forward wing spar and the forward face of the rear spar (Figure 1).

PA-28R main landing gear
