**ACCIDENT**

<b>Aircraft Type and Registration:</b>	AS350B2 Ecureuil, G-PLMH	
<b>No &amp; Type of Engines:</b>	1 Turbomeca Arriel 1D1 turboshaft engine	
<b>Year of Manufacture:</b>	1989 (Serial no: 2156)	
<b>Date &amp; Time (UTC):</b>	13 June 2018 at 0911 hrs	
<b>Location:</b>	Loch Scadavay, North Uist, Western Isles	
<b>Type of Flight:</b>	Specialised Operation	
<b>Persons on Board:</b>	Crew - 1	Passengers - None
<b>Injuries:</b>	Crew - 1 (Fatal)	Passengers - N/A
<b>Nature of Damage:</b>	Helicopter destroyed	
<b>Commander's Licence:</b>	Airline Transport Pilot's Licence (Helicopters)	
<b>Commander's Age:</b>	59 years	
<b>Commander's Flying Experience:</b>	9,260 hours (of which 1,892 were on type) <sup>1</sup> Last 90 days - 127 hours Last 28 days - 37 hours	
<b>Information Source:</b>	AAIB Field Investigation

**Synopsis**

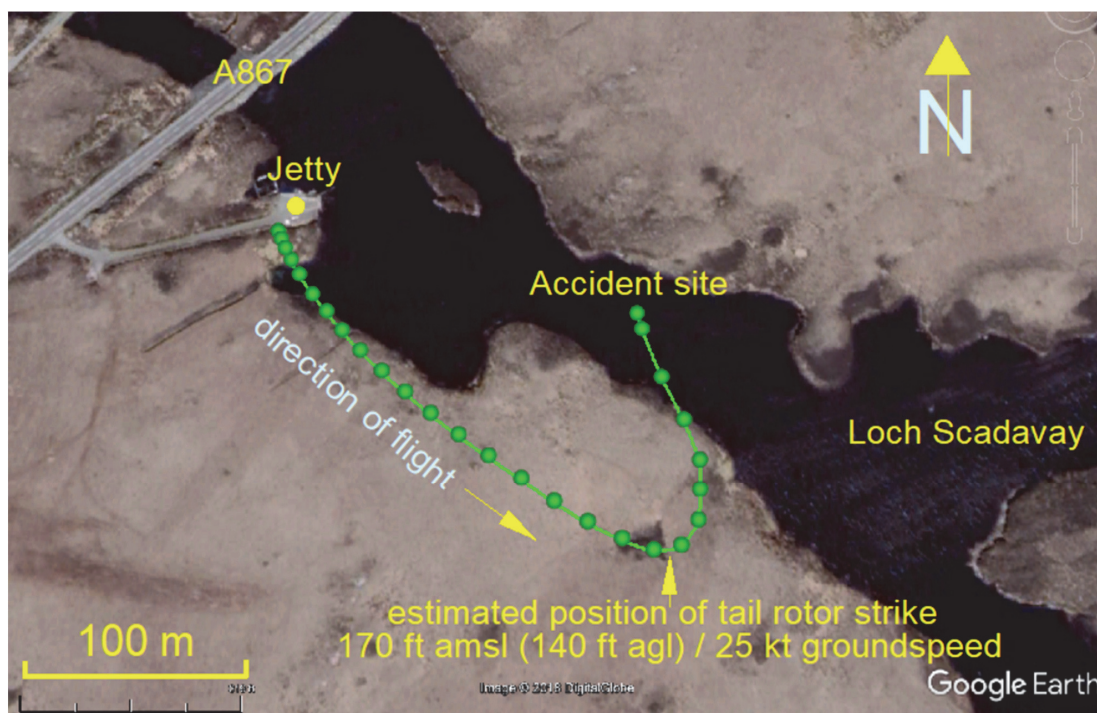
**Figure 3**

GPS-derived track of accident flight

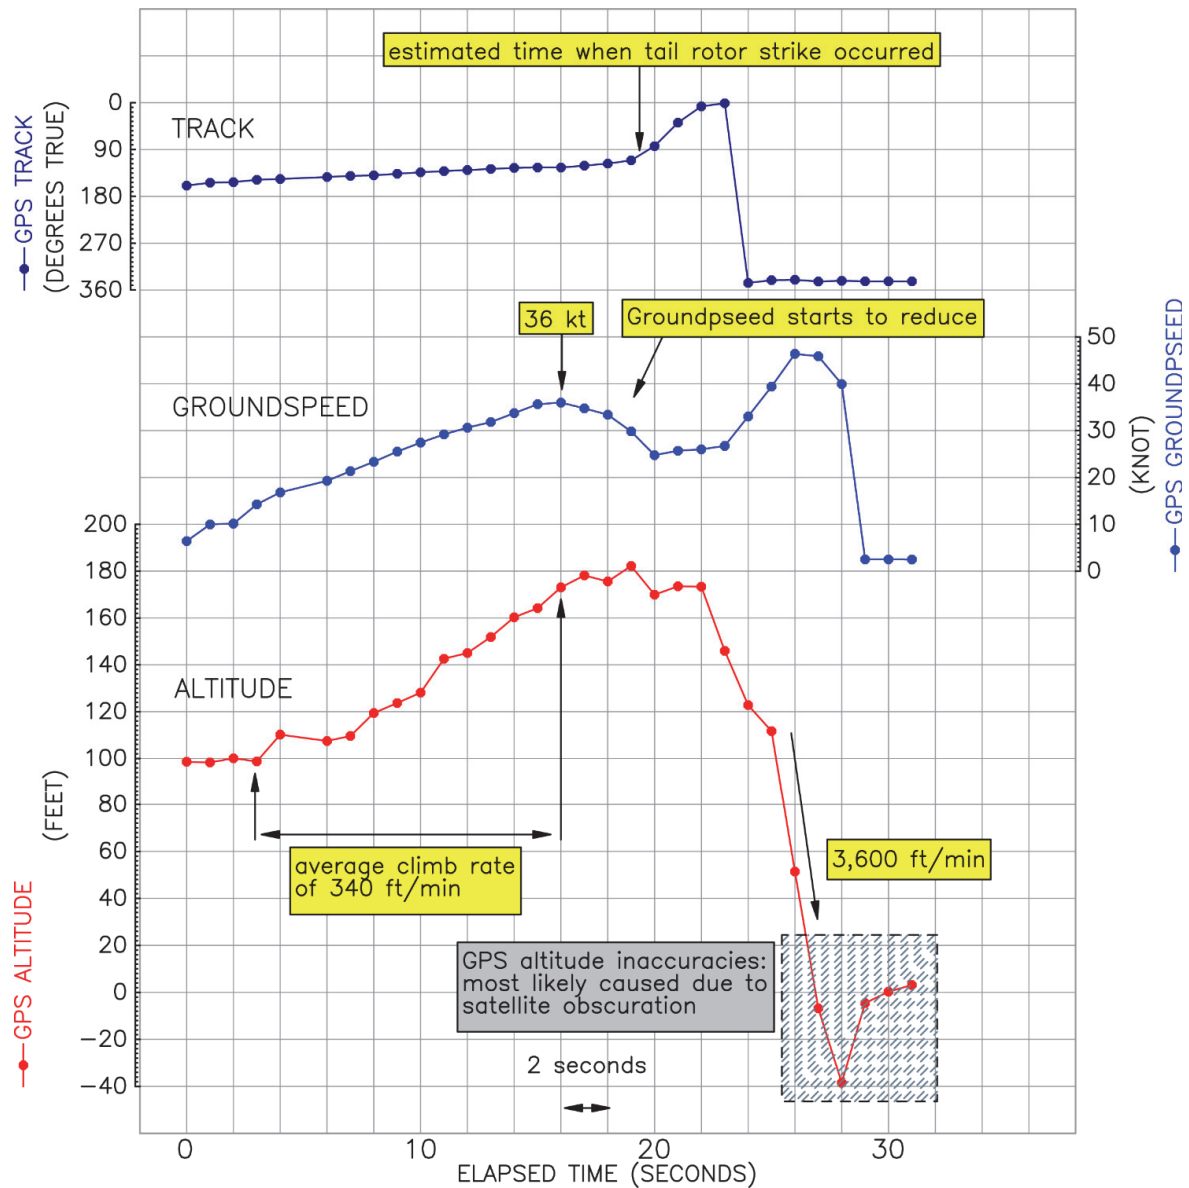
**Figure 4**

GPS-derived data salient to the accident flight are presented in Figure 4.

GPS-derived data from the accident flight

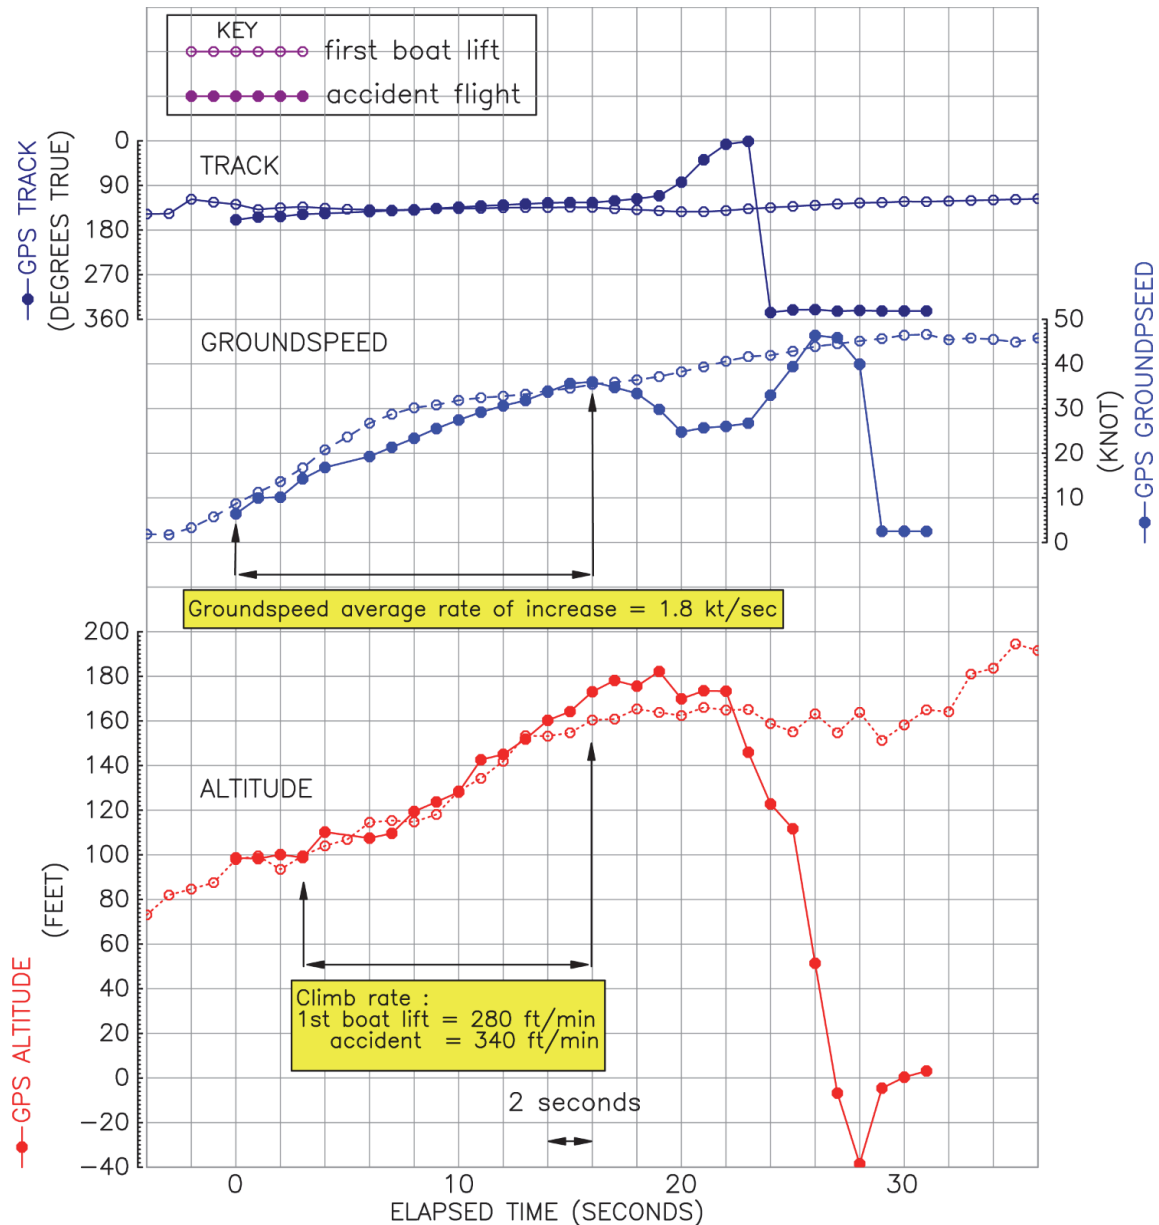
**Figure 5**

The recorded GPS data for the first boat lift was compared with the accident flight (Figure 5). The first boat lift occurred 20 minutes prior to the accident lift. The track of the helicopter during both flights was almost identical. Therefore, if the wind direction and speed had not altered significantly in the 20-minute period between the two flights, the groundspeed during both flights may be directly compared.

Comparison of GPS data from first boat lift and accident flight
