ACCIDENT

Aircraft Type and Registration:	1) DHC-8-402, G-JECK 2) EMB-145EP, G-SAJS
No & Type of Engines:	1) 2 Pratt & Whitney Canada PW150A turboprop engines 2) 2 Allison AE 3007/A1/1 turbofan engines
Year of Manufacture:	1) 2005 (Serial no: 4113) 2) 2001 (Serial no: 145390)
Date & Time (UTC):	16 June 2020 at 1646 hrs
Location:	Aberdeen International Airport
Type of Flight:	1) Commercial Air Transport (Non-Revenue) 2) N/A
Persons on Board:	1) Crew - 2 Passengers - None 2) Crew - None Passengers - None
Injuries:	1) Crew - None Passengers - N/A 2) Crew - N/A Passengers - N/A
Nature of Damage:	1) Damage to forward fuselage section and windscreen 2) Right engine nacelle dented
Commander's Licence:	1) Airline Transport Pilot's Licence 2) N/A
Commander's Age:	1) 31 years 2) N/A
Commander's Flying Experience:	1) 2,677 hours (of which 2,518 were on type) Last 90 days - 0 hours Last 28 days - 0 hours 2) N/A
Information Source:	Aircraft Accident Report Form submitted by the pilot and additional enquiries by the AAIB

Synopsis

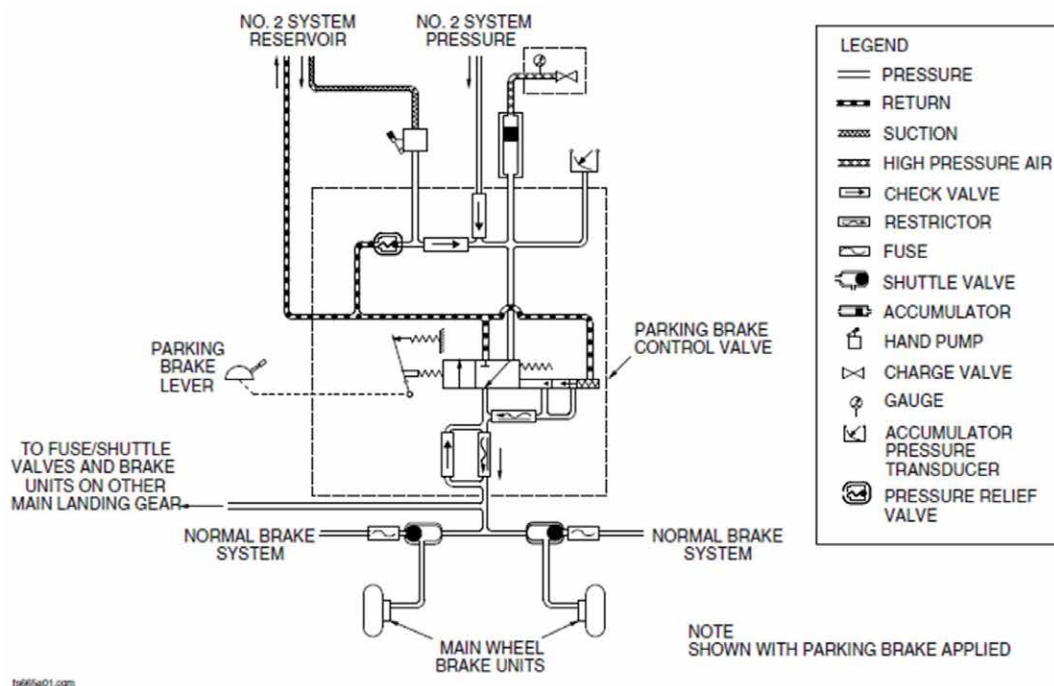
Figure 5

The DHC-8-402 brake system is powered by two hydraulic systems that have a nominal working pressure of 3,000 psi. Each system is pressurised by a pump driven by the No 1 and No 2 engines respectively. The No 1 system supplies the normal brake system that is operated using the toe pedals, and the No 2 system supplies the parking brake (Figure 5) which is applied using a lever in the cockpit.

The park brake and normal braking systems of G-JECK were tested after the accident. No defects were found.

There was no evidence of an external effect, such as a gust of wind or airflow from a nearby manoeuvring aircraft, that caused the aircraft to start to move. Therefore, the movement of the aircraft appears to have been coincidental with the brake pressure reducing to zero.
