ACCIDENT

Aircraft Type and Registration:	Cessna 152, G-UFCO
No & Type of Engines:	1 Lycoming O-235-L2C piston engine
Year of Manufacture:	1978 (Serial no: 152-81734)
Date & Time (UTC):	19 April 2018 at 1119 hrs
Location:	Near Crumlin, County Antrim
Type of Flight:	Private
Persons on Board:	Crew - 1 Passengers - 1
Injuries:	Crew - 1 (Fatal) Passengers - 1 (Fatal)
Nature of Damage:	Aircraft destroyed
Commander's Licence:	Private Pilot's Licence
Commander's Age:	77 years
Commander's Flying Experience:	18,383 hours (of which 900 were on type) Last 90 days - 5 hours Last 28 days - 4 hours
Information Source:	AAIB Field Investigation

Synopsis

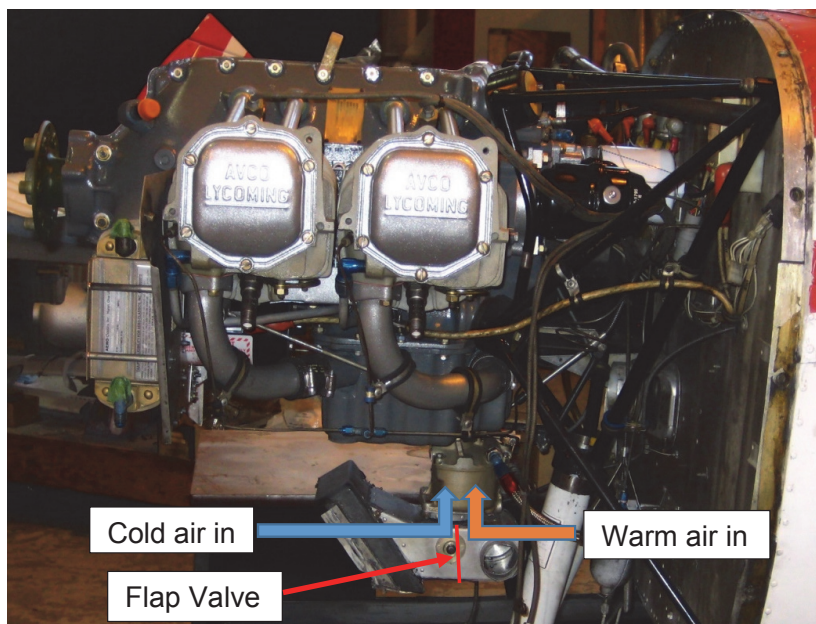
Figure 4
Carburettor heat valve

During normal operation, air passes through a filter, is mixed with fuel in the carburettor and then goes into the engine but in certain atmospheric conditions, ice can form in the carburettor, restricting and ultimately preventing, fuel and air from reaching the engine. To provide protection against carburettor icing, the aircraft, in common with other piston engine aircraft, is fitted with a carburettor heating system. The cockpit carburettor heat selector is connected to a flap valve in the air intake box by a cable and lever arm (Figure 4). When the selector is moved to the ON or HOT position, the cable pulls the lever arm, rotating the valve and allowing air heated by the exhaust manifold to flow into the carburettor to melt any ice present.
